Rocky Branch @ Hickory Hollow Lane Stream Restoration Project 65% Design Review

Community Meeting November 17, 2022

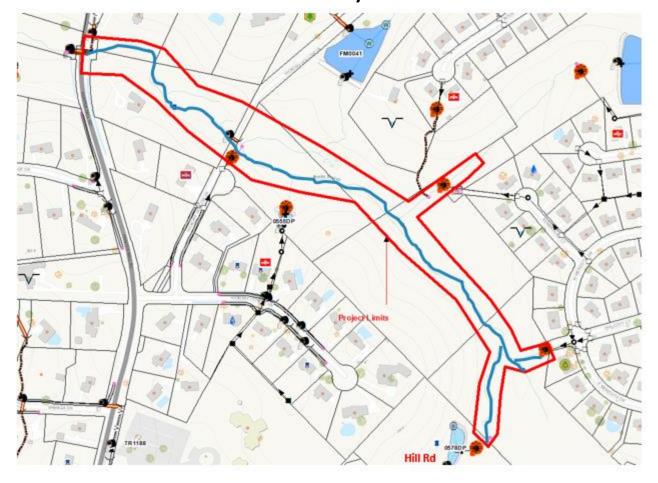
• Restoration of about 3,300 linear feet of main Rocky Branch and three outfall channels

totaling ~3,800 ft

Project Limits:

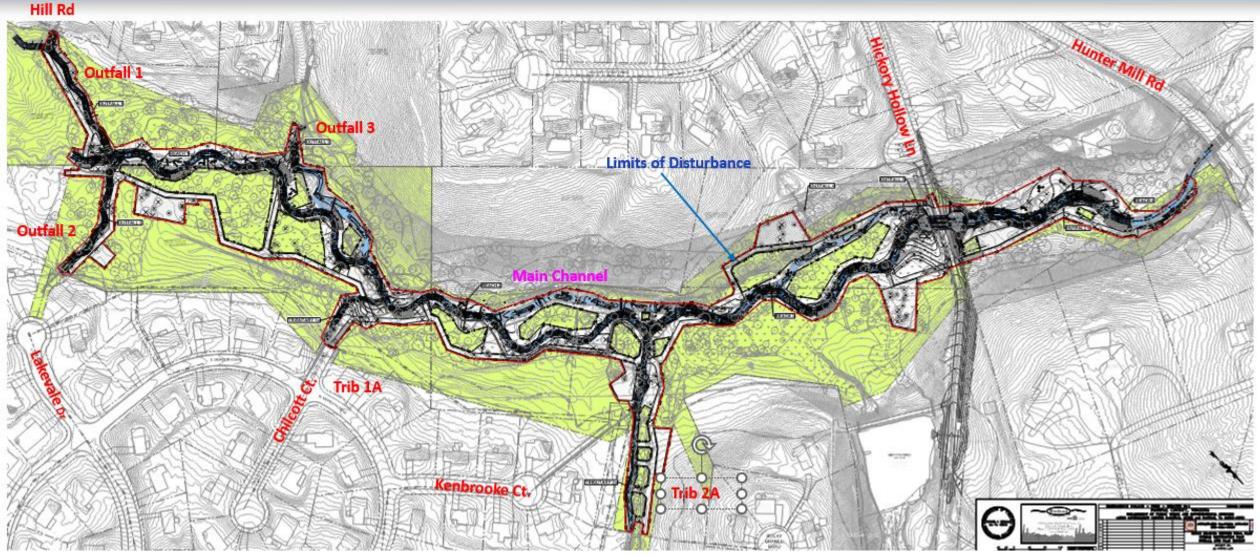
Rocky Branch @ Hickory Hollow Lane Stream Restoration Project Summary of 65% Design: Stream Layout

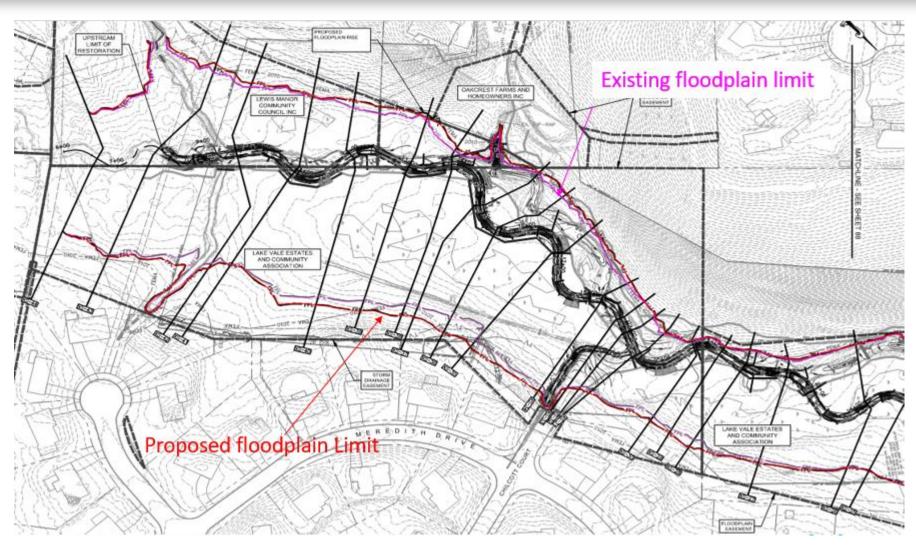
Summary of 65% Design: 100 Year Floodplain

- Floodplain rise:
 - Within existing floodplain easement limits
- Impact:
 - No impact to private properties

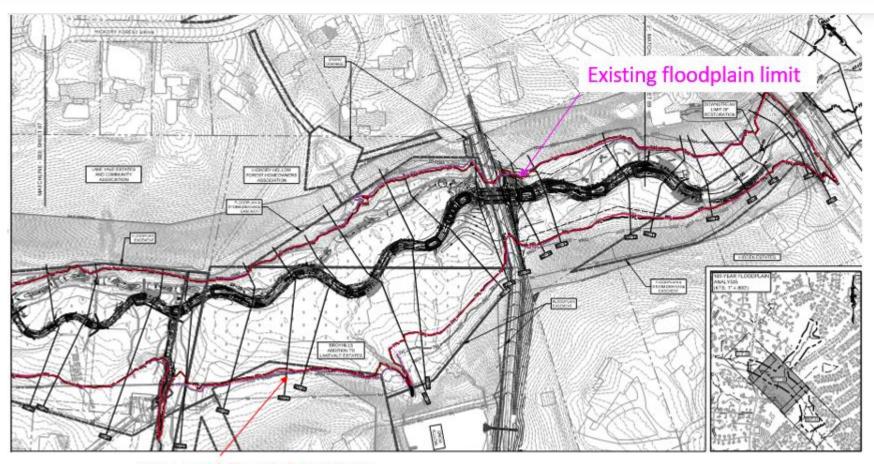
Summary of 65% Design: 100 Year Floodplain (contd.)

- Within existing floodplain easement limits
- Impact:
 - No adverse impact to private properties

Proposed floodplain Limit

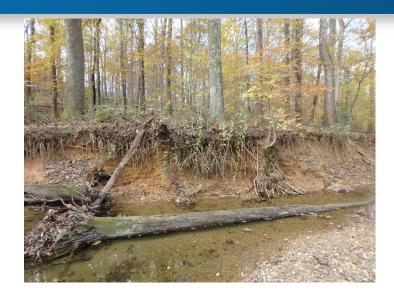
Most of the trees in project areas rated as fair/poor health conditions

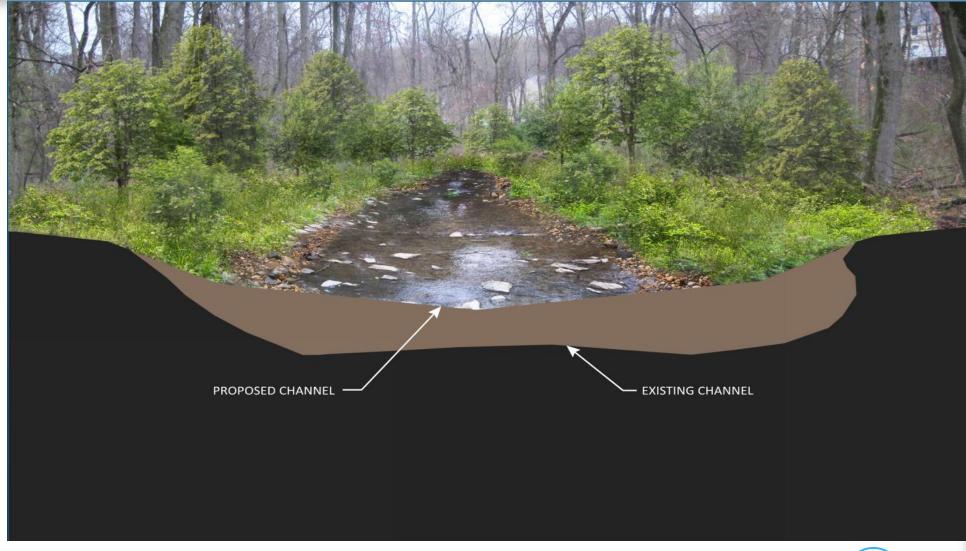
Rocky Branch @ Hickory Hollow Lane Stream Restoration Project Restoration Approach—Proposed Section Rendering

Raising stream to reconnect with floodplain

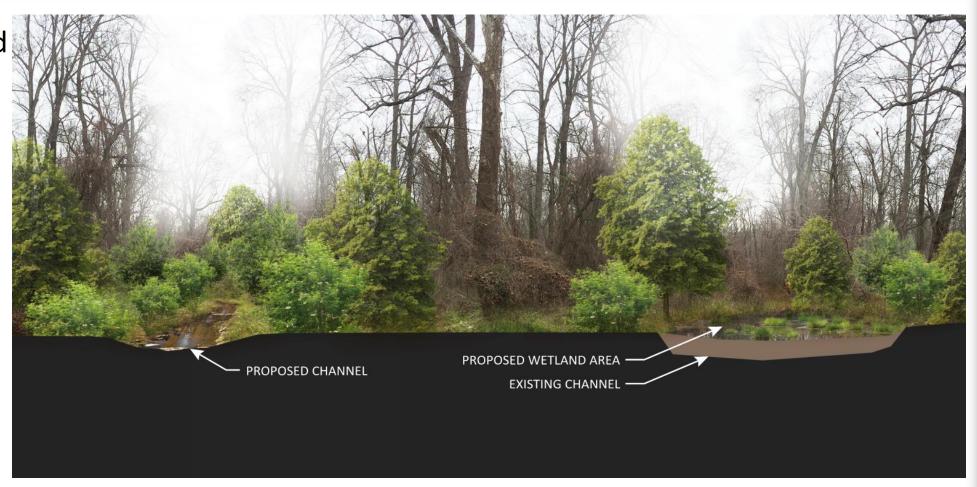
Restoration Approach – Wetland Area and Proposed Section Rendering

Old channel converted to wetland area

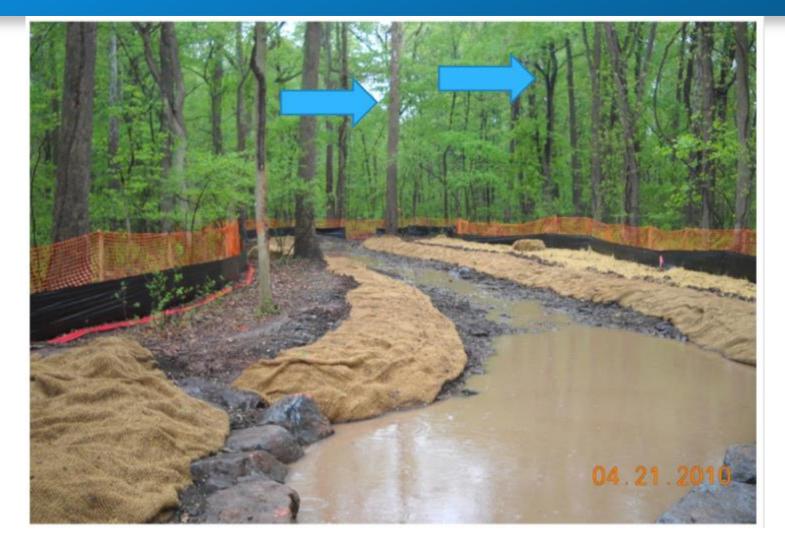
Rocky Branch @ Hickory Hollow Lane Stream Restoration Project Example: Construction

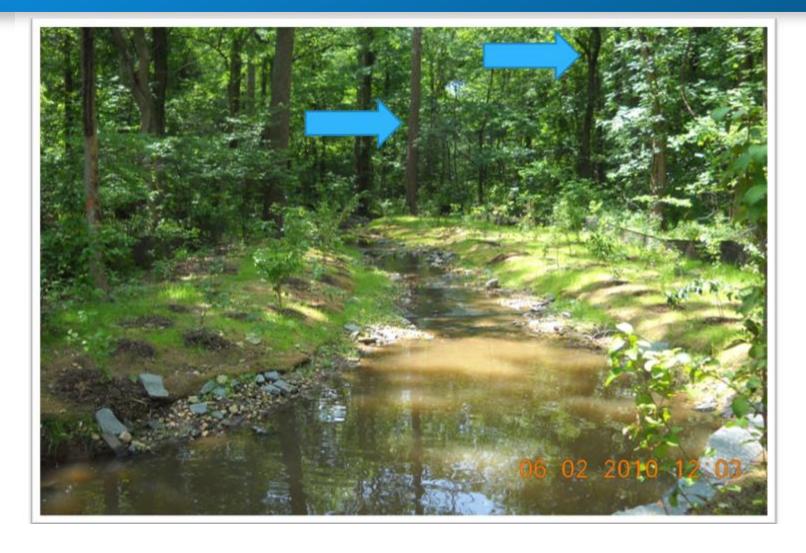
Rocky Branch @ Hickory Hollow Lane Stream Restoration Project Example: Growing Season Following Construction Completion

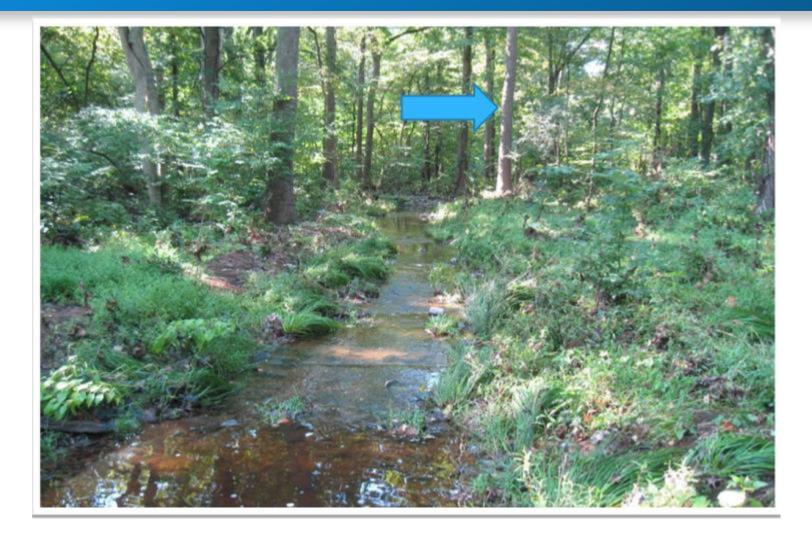
One Year After Construction Completion
