Little Rocky Run Johnny Moore Creek

Watershed Workbook Draft

Fairfax County
Stormwater Planning Division
Department of Public Works and
Environmental Services

October 2008

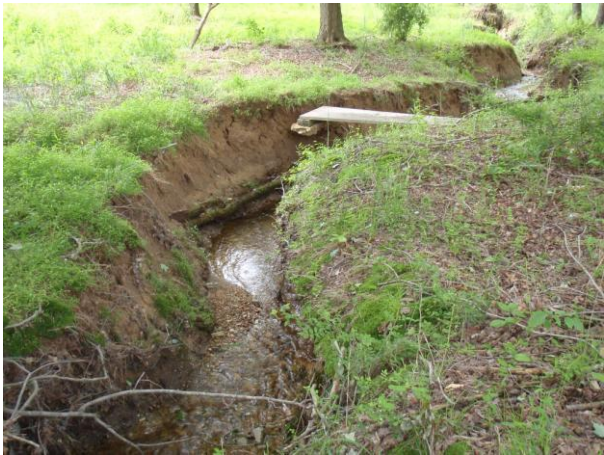
Figure 2-8: Bank erosion in excess of 3ft on small tributary near Cedar Ridge Drive

Severe erosion was observed on tributaries as well as the main stem of Johnny Moore Creek. The tributary located near the intersection of Clifton Road and Cedar Ridge Drive is experiencing severe erosion and headcuts. The following pictures show the erosion near the intersection.

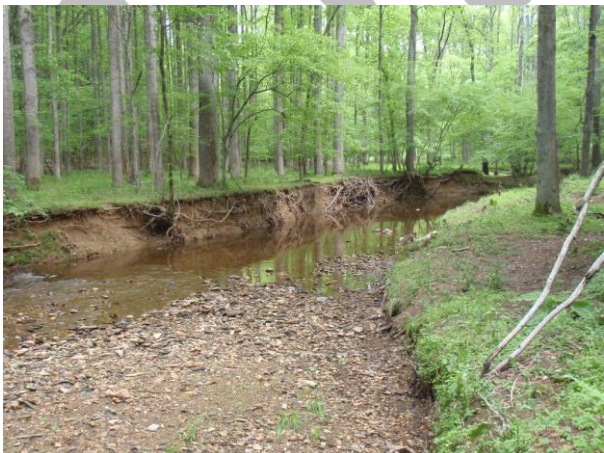
Figure 2-10: Bank erosion in excess of 3ft on Johnny Moore Creek near Balmoral Greens Subdivision

Severe bank erosion was also observed along the main channel of Johnny Moore Creek near the Balmoral Greens neighborhood in the same location as noted in the 2005 SPA. The following pictures show an update of erosion occurring in this area.

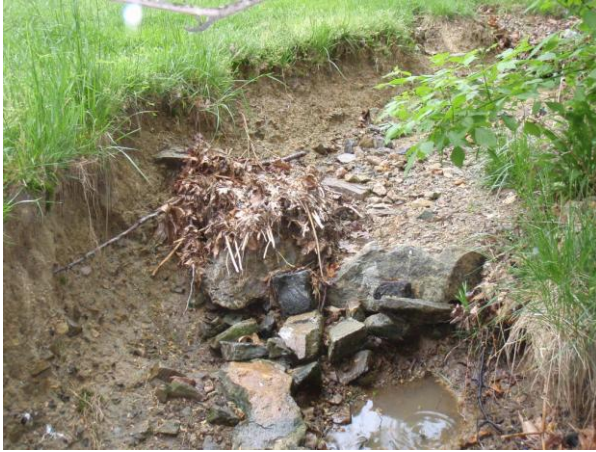
Figure 2-20: Severe erosion occurring at the end of a concrete trickle ditch in the Little Rocky Run subdivision (Battle Rock Drive)

The tributary segment observed as poor in 2005 near South Springs Dr. is currently experiencing severe erosion problems. The following photos show the severe erosion and headcuts occurring at several different locations in this area. This erosion is affecting several smaller tributaries, however the main channel of the tributary appears fairly stable.

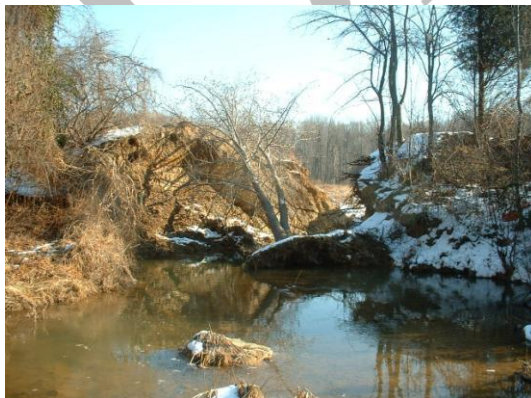
Figure 2-27: Erosion area on Little Rocky Run upstream of Willow Springs Branch

A severe erosion site was located on Little Rocky Run just upstream of its confluence with Willow Springs Branch. The picture below shows that this is a dam that appears to have failed. There was also an area of moderate erosion noted on Willow Springs Branch approximately 1,400 feet upstream of Ashleigh Road.
