PC9201 Stream Restoration

Address: Behind 7756 Matisse Way, Springfield, Virginia
Location: Stream behind Matisse Way
Land Owner: Public/Local – FCPA
PIN: 0984 06 E, 0984 06 C
Control Type: Water quality control
Drainage Area:
Receiving Waters: Tributary of Pohick Creek

Description: This stream restoration is located west of Matisse Way and east of Godolphin Dr., and is located on Fairfax County Park Authority land. This project proposes repairing bank and bed erosion, restoring channel morphology, and reducing excessive channel meander. Stream stabilization will reduce sediment loads to the stream while maintaining capacity of the channel and controlling unwanted meander.

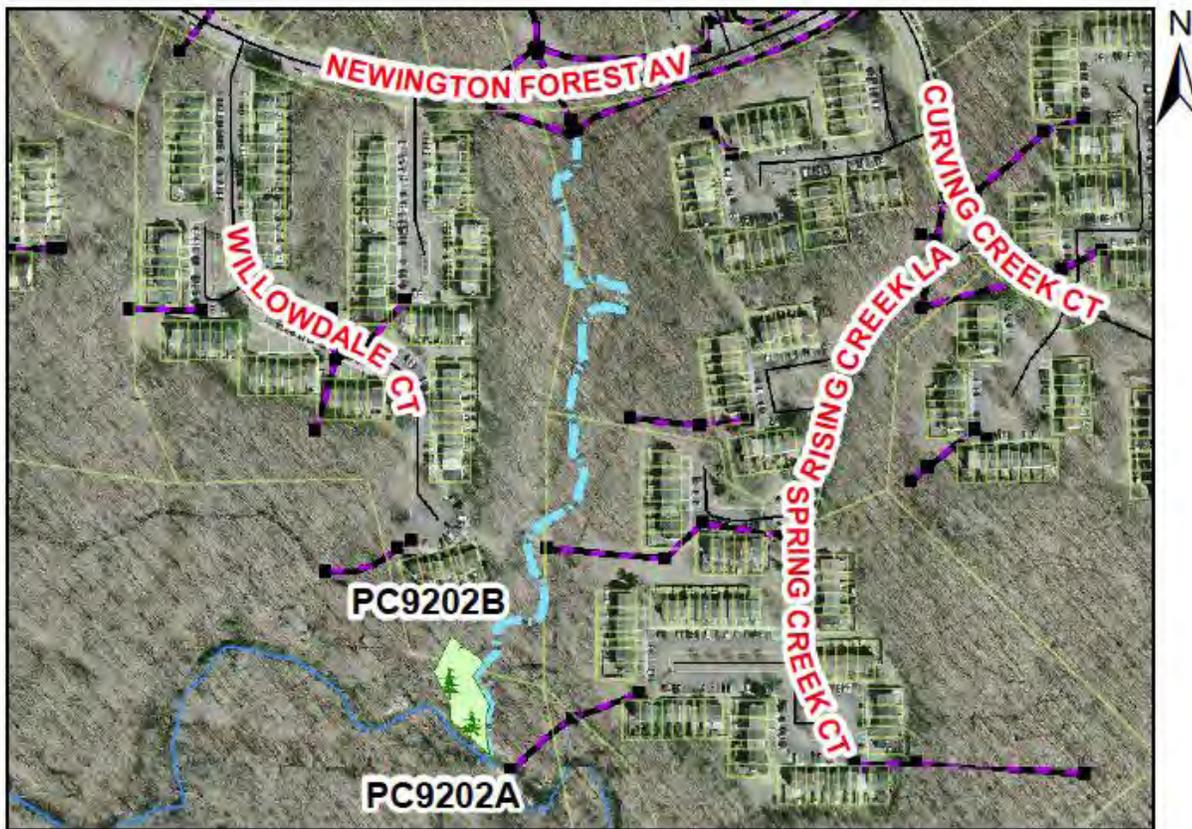
PC9202 Stream Restoration Suite

Description: Subproject A is a stream restoration and will repair bank and bed erosion in the stream west of Spring Creek Court and southeast of Willowdale Court. Erosion will be stabilized through the use of bank shaping, toe protection, erosion control fabrics, and rapid vegetation establishment. Subproject B is a buffer repair near the downstream end of the stream restoration. This buffer will provide additional treatment for runoff from the adjacent townhouses. The indicators are stream bank buffer deficiencies in headwater riparian habitat.

- Stream Restoration
- Buffer Restoration
- Storm Network
- Property Line
- Streams

Project Design Considerations: Stream banks are steep and stream access is obstructed. Trees were hanging into the stream and there were many sediment deposits creating "islands." Areas were dammed. The degraded buffer area is surrounded by vegetation; therefore its deficiency is minimized. The degraded area could act as a staging point for the stream restoration. Records show no existing easements and stream appears to be in HOA open space. Project should be coordinated with outfall improvement project PC9204 (located just west of Rising Creek Court) to try and maximize the project benefits.

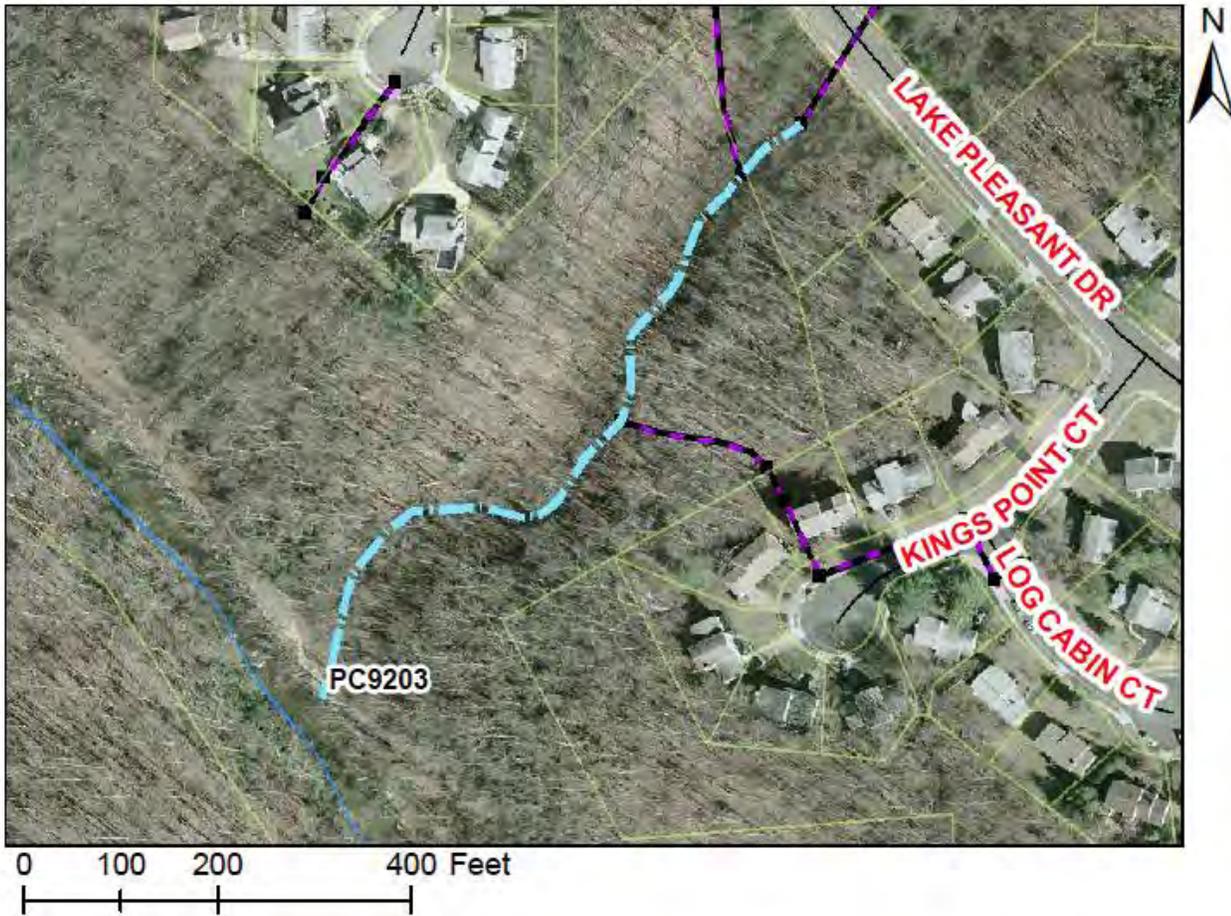
PC9203 Stream Restoration

Description: Stream is southwest of Lake Pleasant Drive and north of Kings Point Court. The stream conveys runoff from adjacent residential neighborhoods and flows southwest. This project proposes repairing bank and bed erosion to restore channel morphology. The primary indicator is poor channel morphology. Erosion will be stabilized through the use of bank shaping, toe protection, erosion control fabrics, and rapid vegetation establishment.

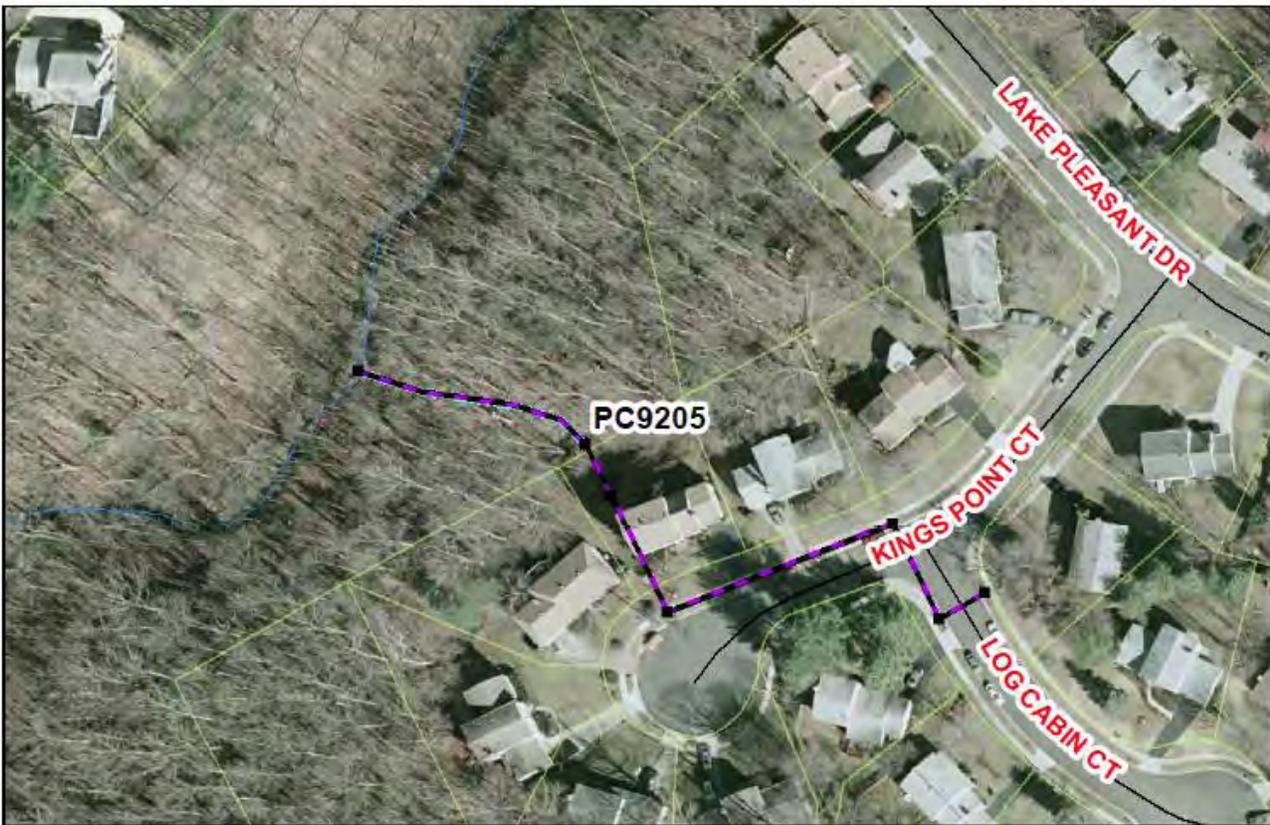
PC9205 Stream Restoration

Description: Closed system collects runoff from Kings Point Court and one other cul-de-sac. The systems outfalls into a stream to the northwest. This project proposes daylighting the outfall pipe farther upstream. The primary problem indicator is poor channel morphology. This project returns the water to its natural state before entering the stream, allowing more time for the water to infiltrate and the flow velocities to decrease.

Stream Restoration Storm Network Property Line Streams

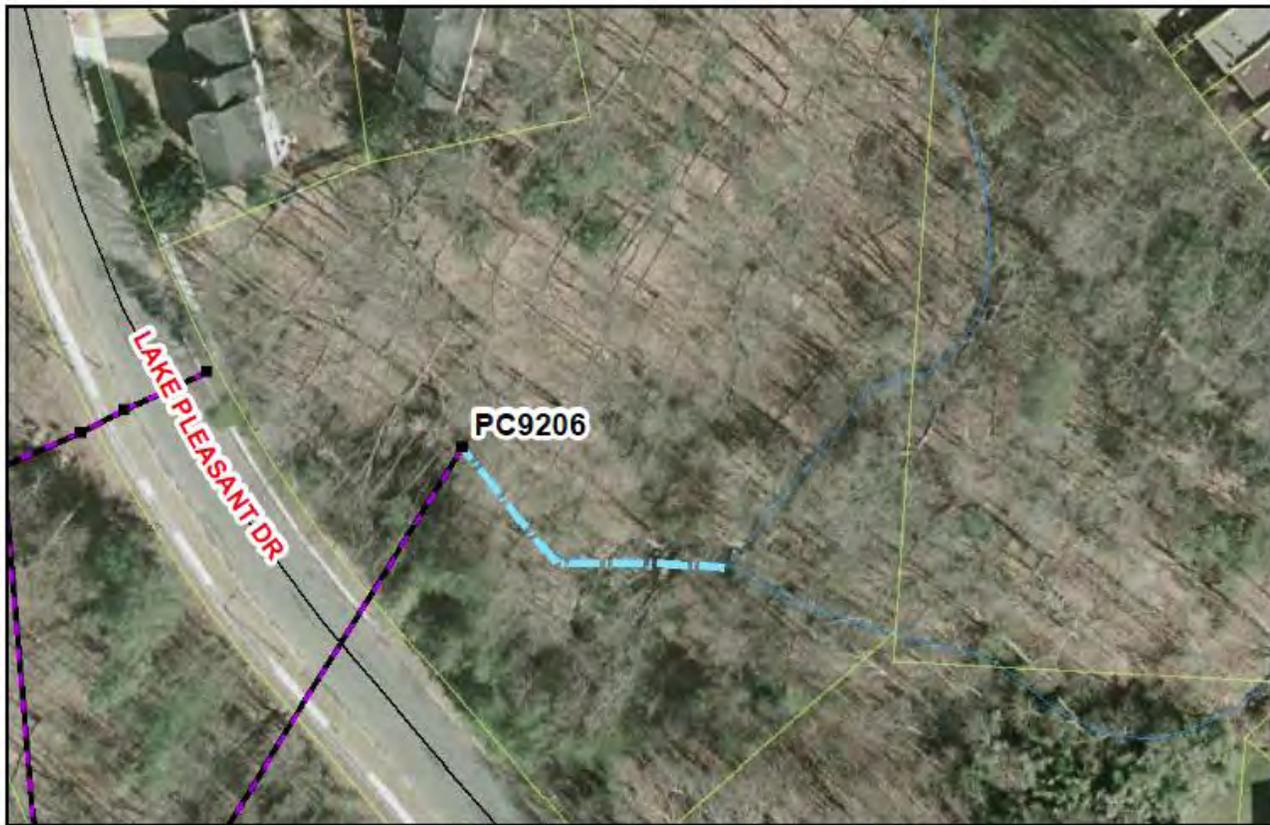
Description: The project proposes restoring the stream just northeast of Lake Pleasant drive. The current stream has bank and bed erosion and poor channel morphology. The stream stabilization will reduce sediment loads to the stream while maintaining capacity and controlling unwanted meander. This stream segment is steep and receives runoff from townhomes and a roadway outfall. Erosion will be stabilized through the use of bank shaping, toe of slope protection, erosion control fabric, and rapid vegetation establishment.

- Stream Restoration
- Storm Network
- Property Line
- Streams

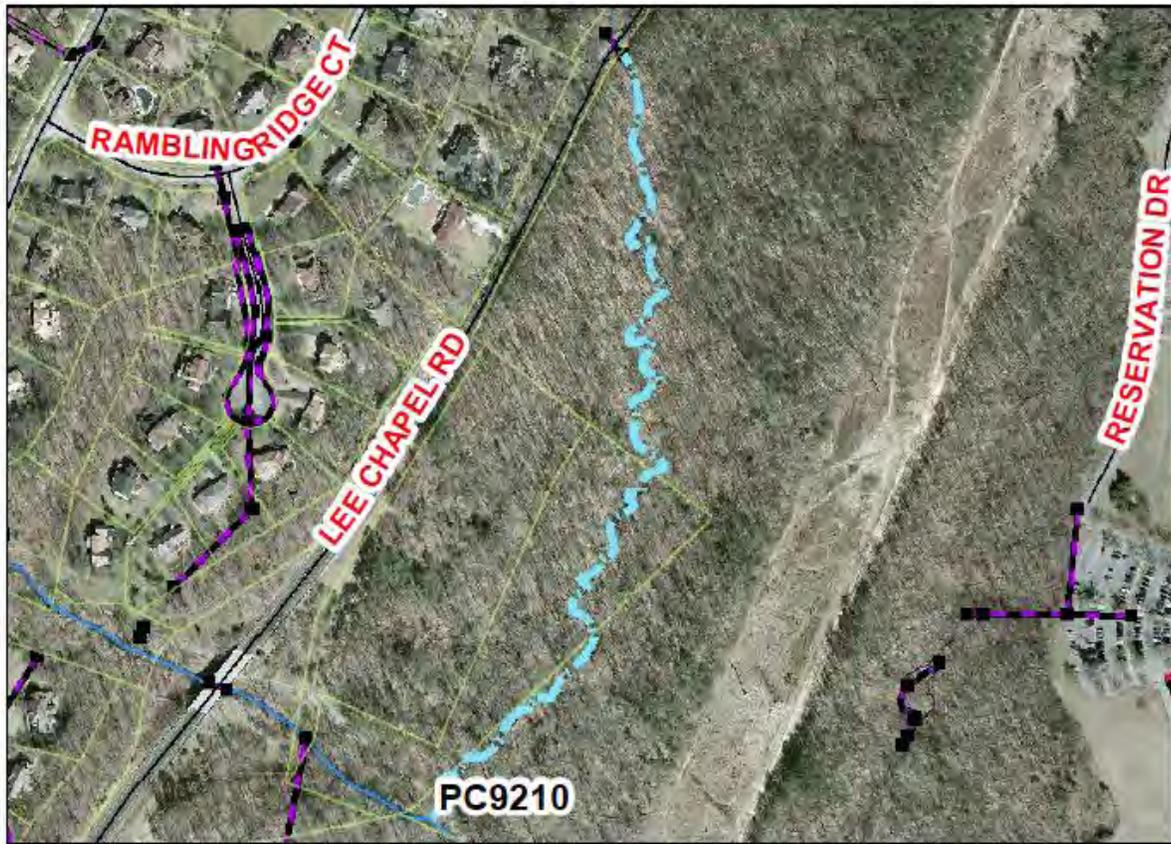
Description: This project proposes repairing bank and bed erosion and restoring the channel morphology of the stream that runs parallel on the east side of Lee Chapel Road. The proposed restoration ends where the stream connects with a perpendicular stream to the south. The primary indicator is the poor channel morphology. Erosion will be stabilized through the use of bank shaping, toe protection, erosion control fabrics, and rapid vegetation establishment.

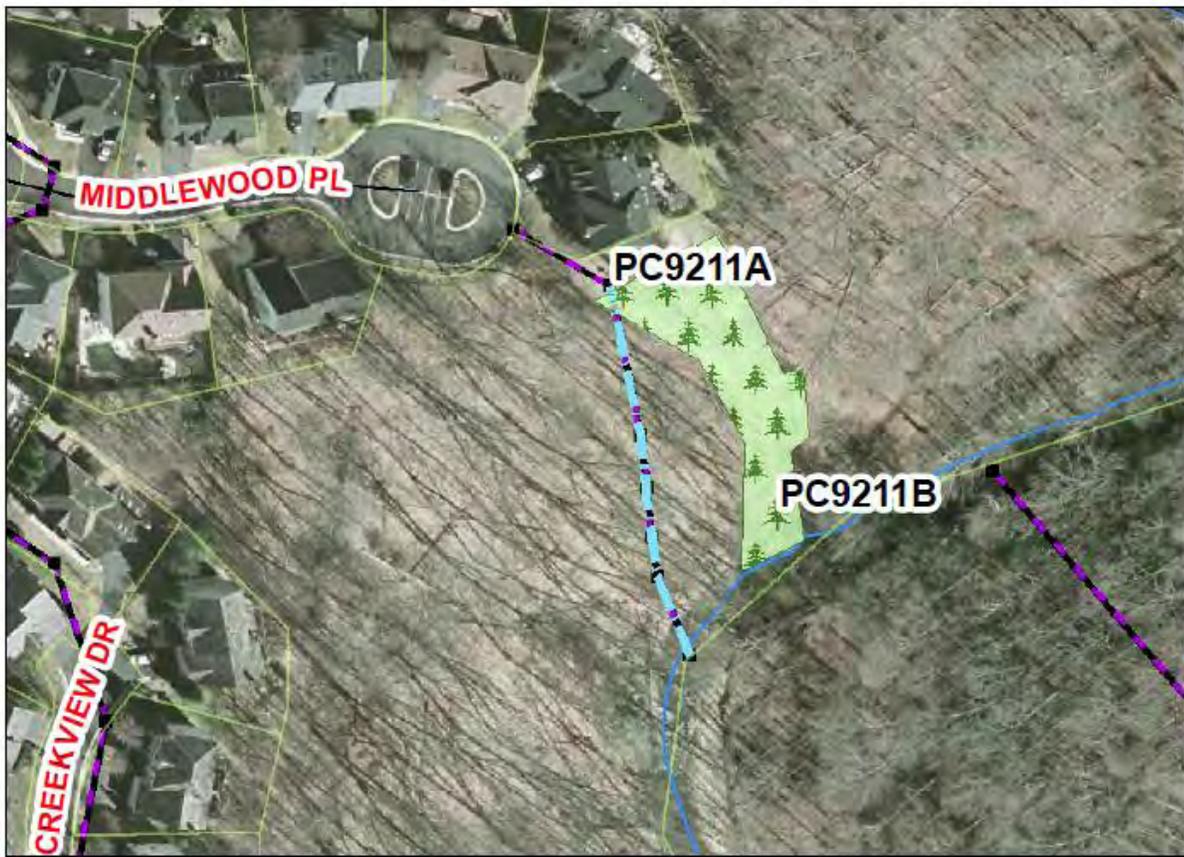
Description: Subproject A proposes to daylight a pipe that collects runoff at the end of Middlewood Place and pipes it south into a stream. The primary indicator is channel morphology. The pipe leading into the stream is very steep, outfalling runoff at potentially erosive velocities. Subproject B proposes re-planting upland buffer area and providing reforestation. This project was proposed due to the existing stream buffer being deficient.

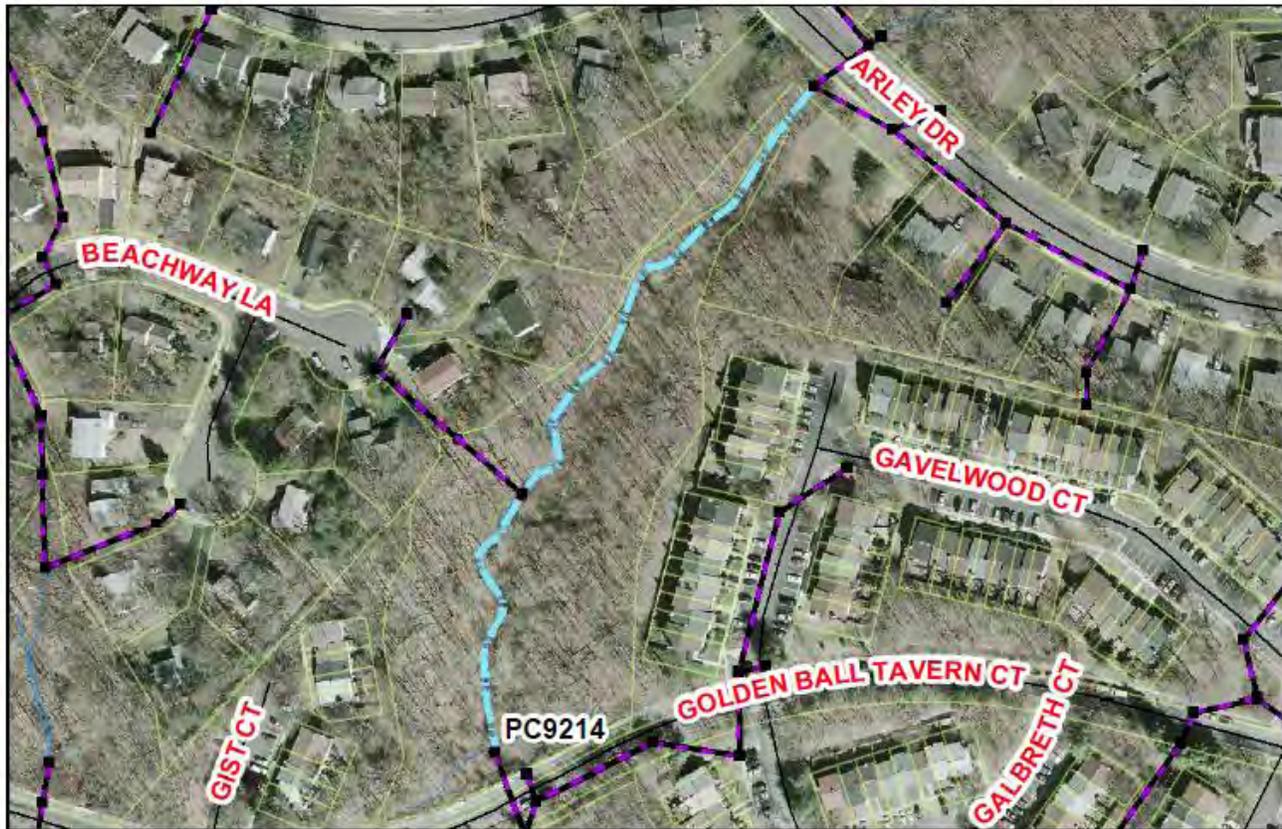
Description: The stream is between Arley Drive and Golden Ball Tavern Court. This project proposes repairing bank and bed erosion, thereby restoring channel morphology. The primary indicator is poor channel morphology. Stream stabilization will reduce sediment loads to the stream, maintaining the capacity of the stream channel and controlling unwanted meander.

Project Design Considerations: The stream is located on Fairfax County Park Authority property. The stream restoration starts and ends at roadway culverts. A storm pipe discharges directly to the middle of the stream restoration. The installation of settling basins and boulder clusters at the outfalls would help roadway sediment settle out of the stormwater runoff and lessen impacts from the increased velocity caused by inflows from the roadway. Stream stabilization techniques would include streambank shaping, rootwad revetments, and rock toe reinforcements. The stream appears to have adequate buffer from the townhouses.

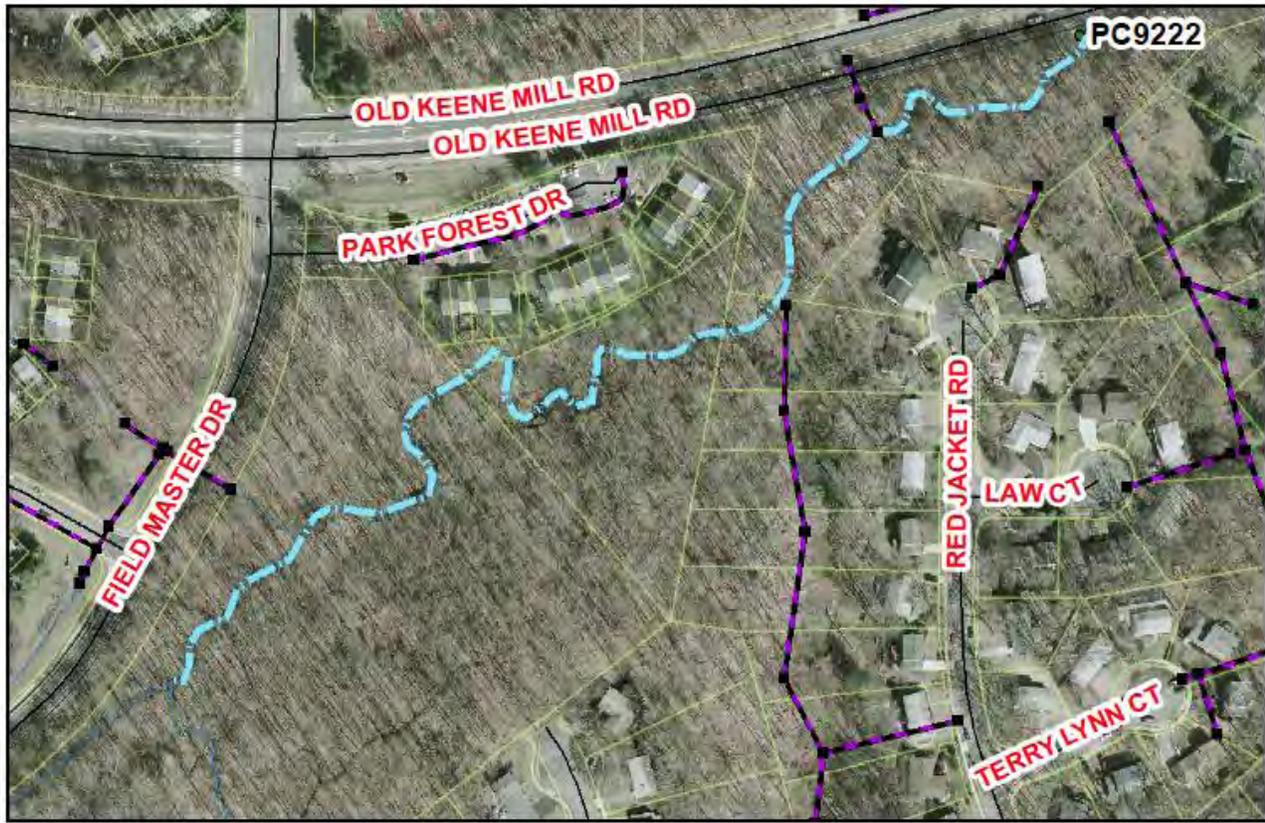
Description: Stream flowing northeast towards Old Keene Mill Road. Stream collects runoff from several adjacent neighborhoods. This project proposes repairing bank and bed erosion to restore channel morphology. Stream stabilization will reduce sediment loads to the stream while maintaining capacity and controlling unwanted meander. The primary indicators are poor channel morphology. The stream is located on Fairfax County Park Authority land.

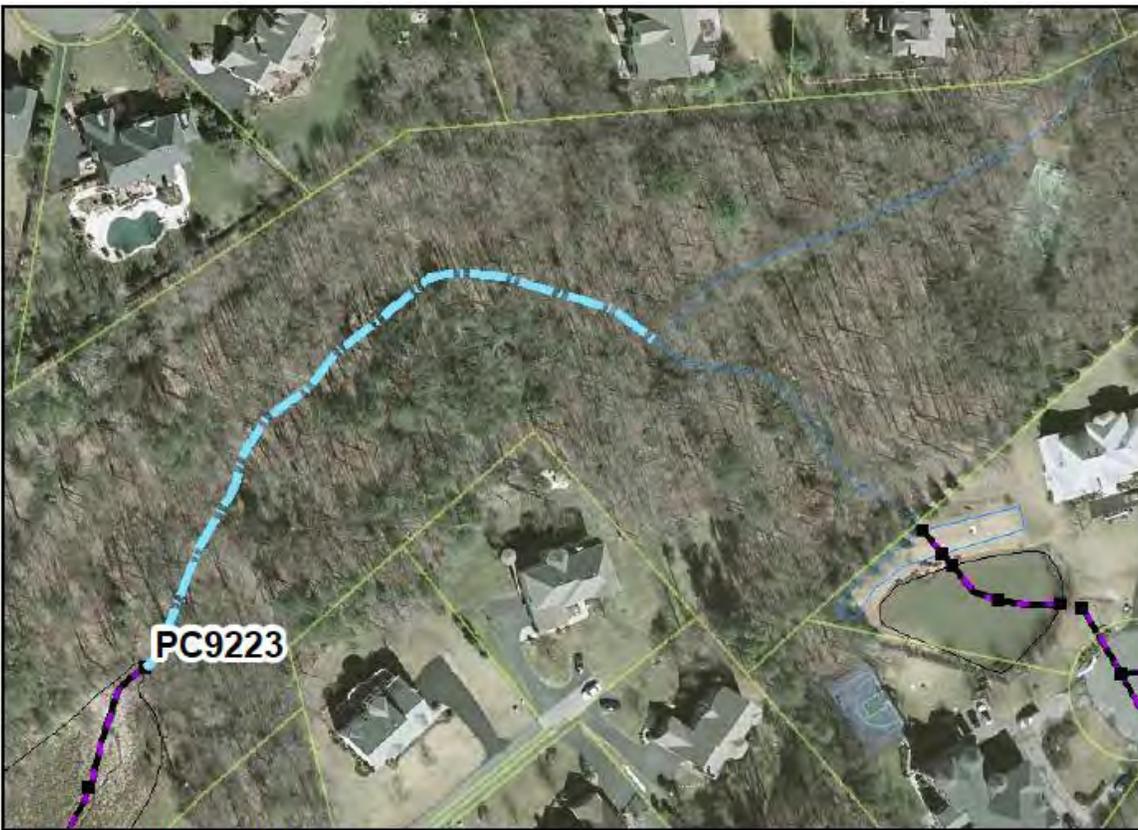
Description: The stream outfalls into a pond northeast of Lake Meadow Drive. The stream collects runoff by sheetflow from adjacent single family housing development. The primary indicator is poor channel morphology. The project proposes repairing bank and bed erosion, thereby restoring channel morphology. Erosion will be stabilized through the use of bank shaping, toe protection, erosion control fabrics, and rapid vegetation establishment.

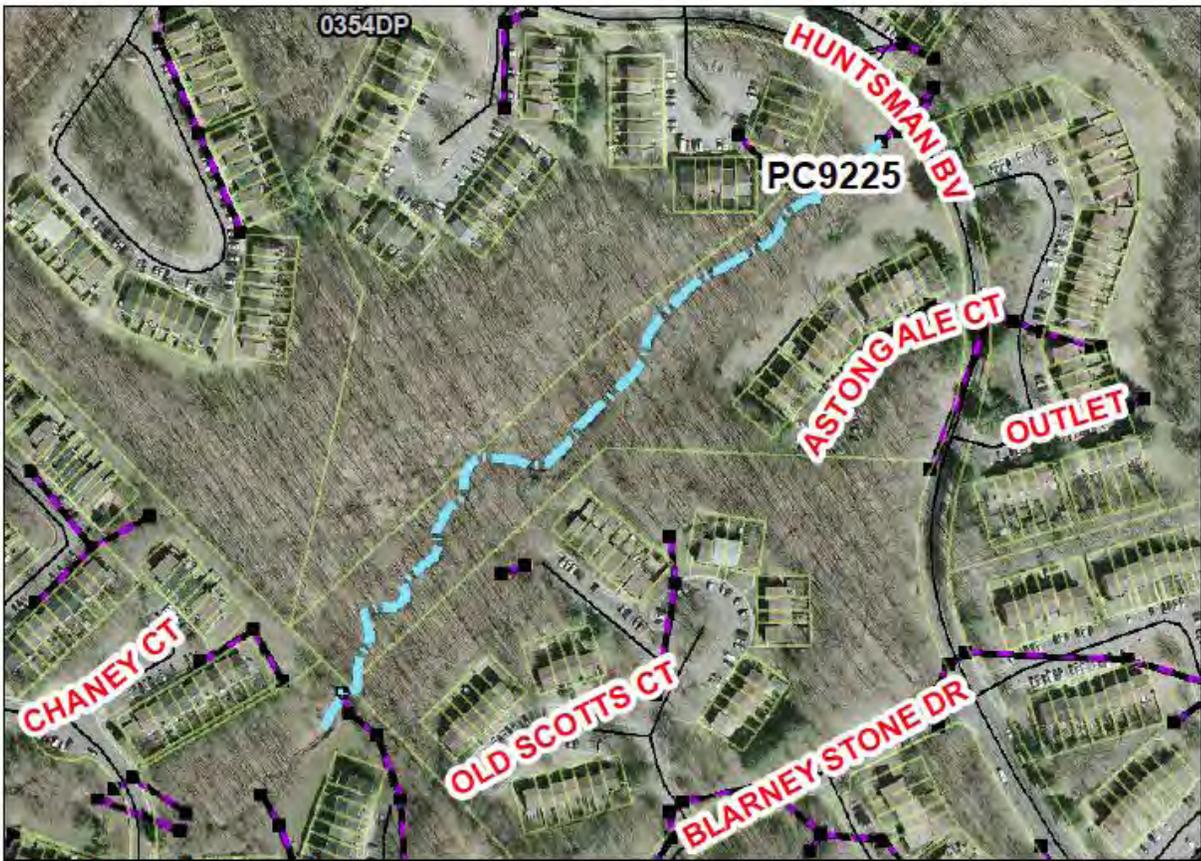
Description: Stream is located southwest of Huntsman Boulevard. Receives runoff from adjacent neighborhoods. This project proposes repairing bank and bed erosion to restore channel morphology. The primary indicator is poor channel morphology. Stream conveys runoff from dense residential development. Erosion will be stabilized through the use of bank shaping, toe protection, erosion control fabrics, and rapid vegetation establishment.

- Stream Restoration
- Storm Network
- Property Line
- Streams

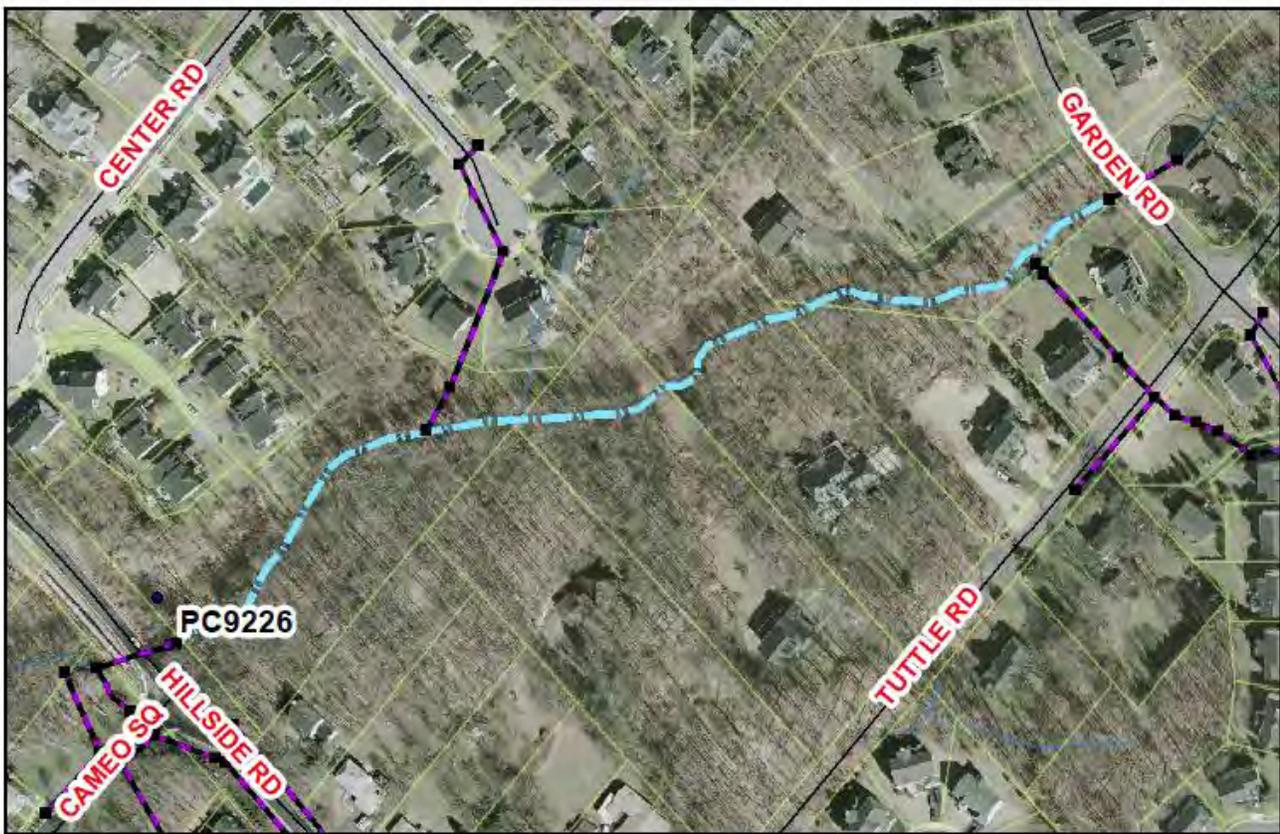
Description: The stream is located northeast of Hillside Road. The stream receives stormwater runoff as sheet flow from adjacent neighborhoods and three closed systems from the Red Fox Estates neighborhood. Stream restoration proposes repairing bank and bed erosion to restore channel morphology. The primary indicator is poor channel morphology. Stream stabilization will reduce sediment loads while maintaining capacity of the stream and controlling unwanted meander.

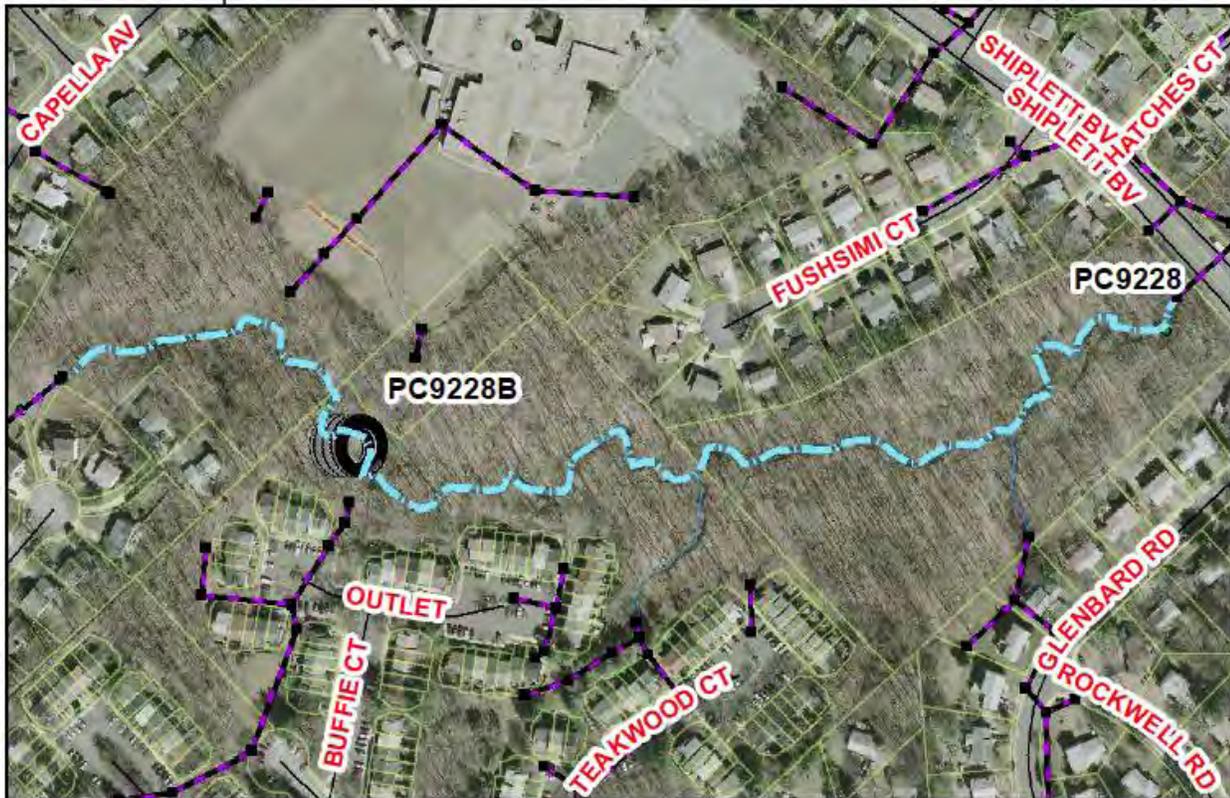
Description: Subproject A is a stream restoration of the stream west of Shiplett Boulevard and northwest of Glenbard Road, and is located on Fairfax County Park Authority land. This project proposes repairing bank and bed erosion, restoring the channel morphology. Stream stabilization will reduce sediment loads to the stream while maintaining capacity of the channel and controlling unwanted meander. Subproject B is an obstruction removal in the stream north of Buffie Court and west of Orion Court. The obstruction was verified during a field visit. This project proposes to remove the obstructions blocking the stream channel to restore natural conditions. Removal of obstructions will help restore the function of the stream.

Project Design Considerations: Streambed is excessively wide and dry. Measures should be implemented to help restore baseflow. These measures could include rock vane deflectors, which would help concentrate flow to a stable deeper baseflow channel. During larger flows caused by storm events the water would utilize the entire streambank width. Other measures to improve water quality should include improving outfall connections to the stream for the six outfalls discharging runoff from the townhomes and single family homes. A positive condition for the success of this restoration is that there is a good existing stream buffer.

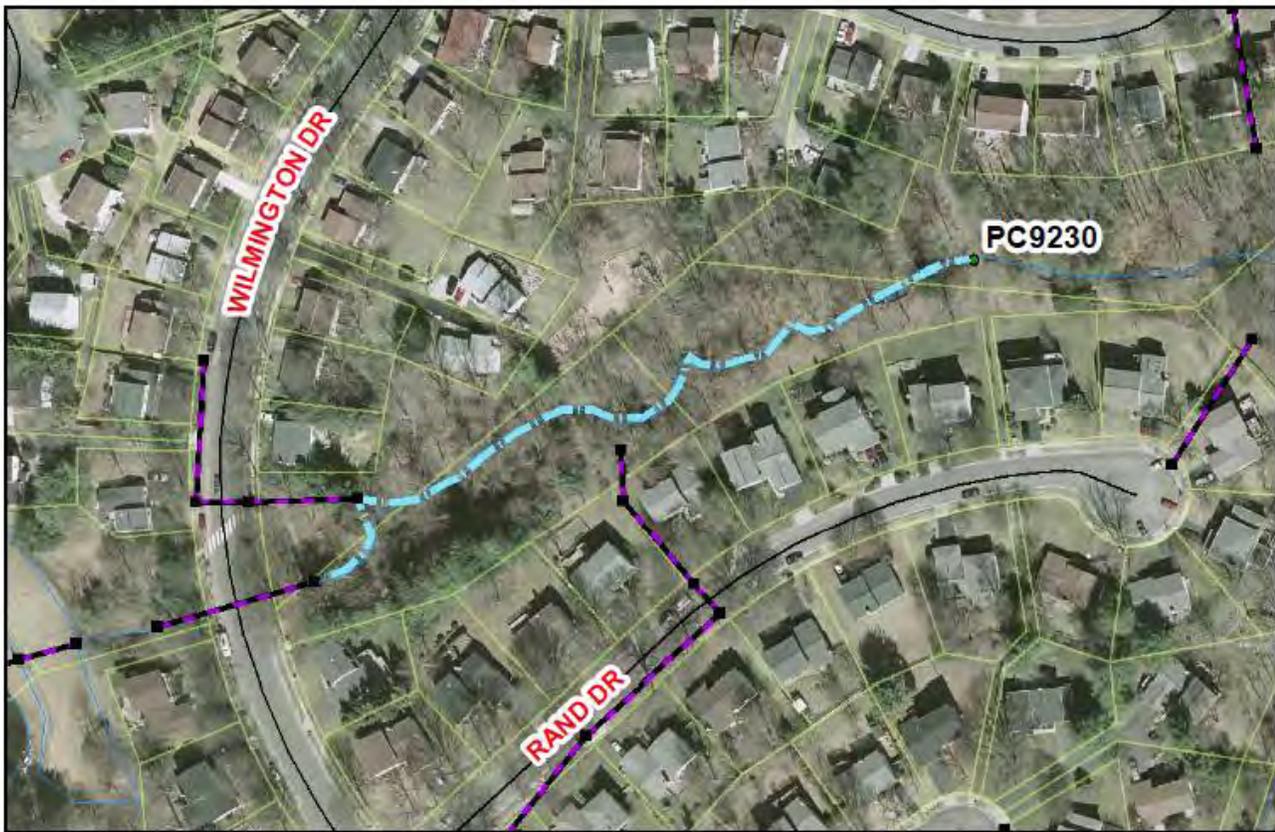
Description: The stream east of Wilmington Drive and north of Rand Drive has poor channel morphology. This project proposes repairing bank and bed erosion to restore channel morphology. Erosion will be stabilized through the use of bank shaping, toe of slope protection, erosion control fabric, and rapid vegetation establishment. The stream stabilization will reduce sediment loads while maintaining the capacity of the stream and controlling unwanted meander.

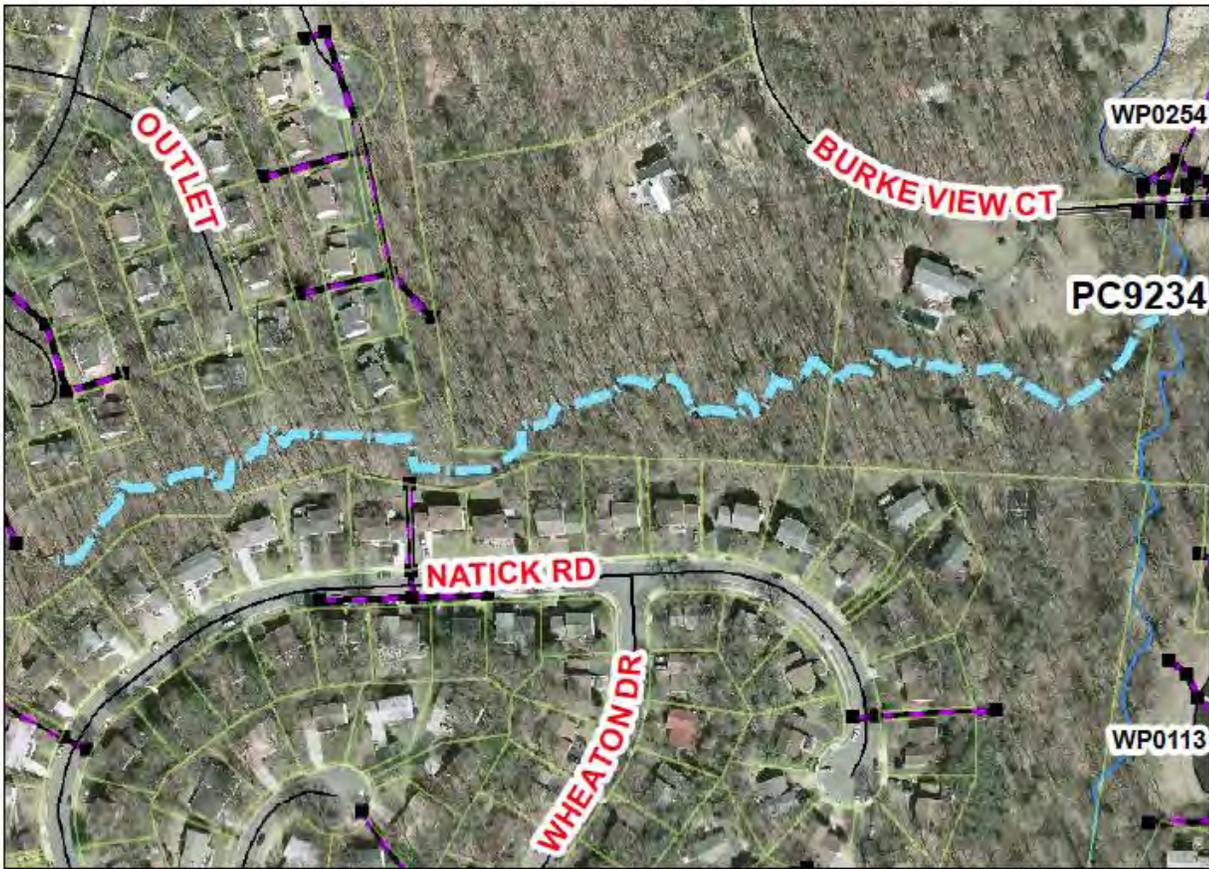
Description: This project proposes repairing bank and bed erosion, restoring channel morphology to a stream north of Natick Road. Stream receives runoff from a residential neighborhood by both direct runoff and from a closed system. Erosion will be stabilized through the use of bank shaping, toe protection, erosion control fabrics, and rapid vegetation establishment. The primary indicator is poor stream stabilization.

- Stream Restoration
- Storm Network
- Property Line
- Streams

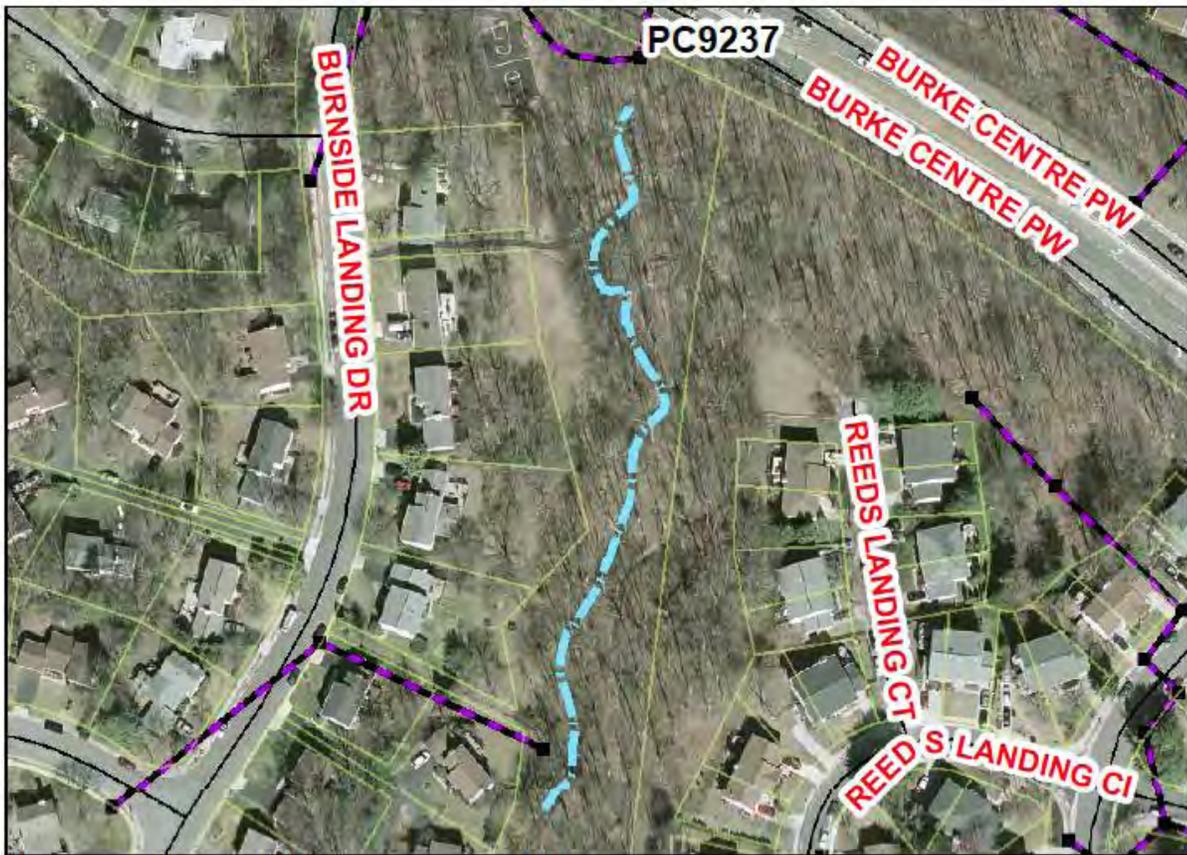
Description: The stream runs between Reeds Landing Court and Burnside Landing Drive. Pipes discharge directly into the stream from adjacent subdivisions. This project consists of repairing bank and bed erosion and restoring channel morphology. The primary indicator is poor channel morphology. Erosion will be stabilized through the use of bank shaping, toe protection, erosion control fabrics, and rapid vegetation establishment.

- Stream Restoration
- Storm Network
- Property Line
- Streams

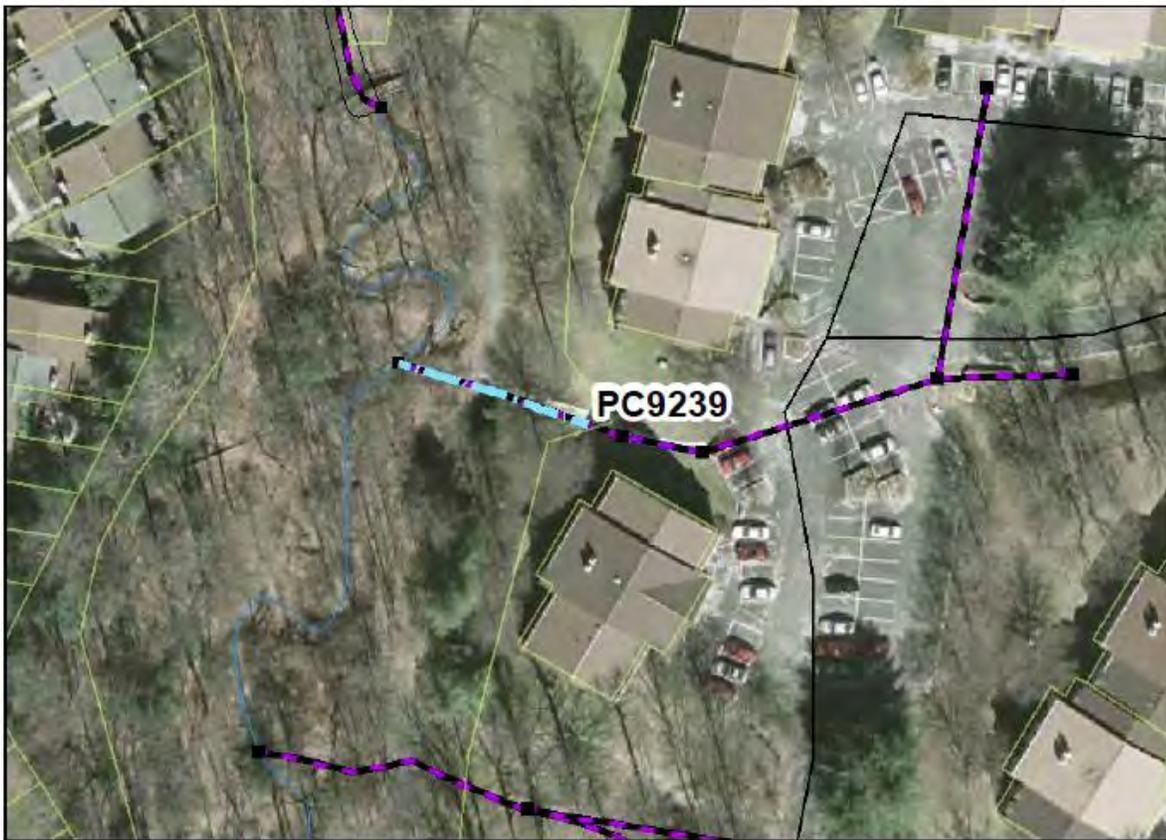
Description: Runoff from a residential neighborhood is collected in a closed system of pipes. Currently, a concrete channel between residential buildings conveys stormwater to a closed system that outfalls directly into the stream. This project proposes to remove a portion of the concrete channel and closed system to create a more natural channel to convey stormwater to the stream. Due to the slope, a series of check dams or step pools may be necessary to keep velocities low.

- Stream Restoration
- Storm Network
- Property Line
- Streams

Project Benefits: This project will retrofit a concrete channel and closed system into a natural channel, returning the water to its natural state and helping reduce runoff rates, which will help minimize stream erosion. Runoff will also travel through the buffer and reduce pollutant loads. Below are the stream’s estimated instream sediment pollutant amounts that will be eliminated after the stream restoration.

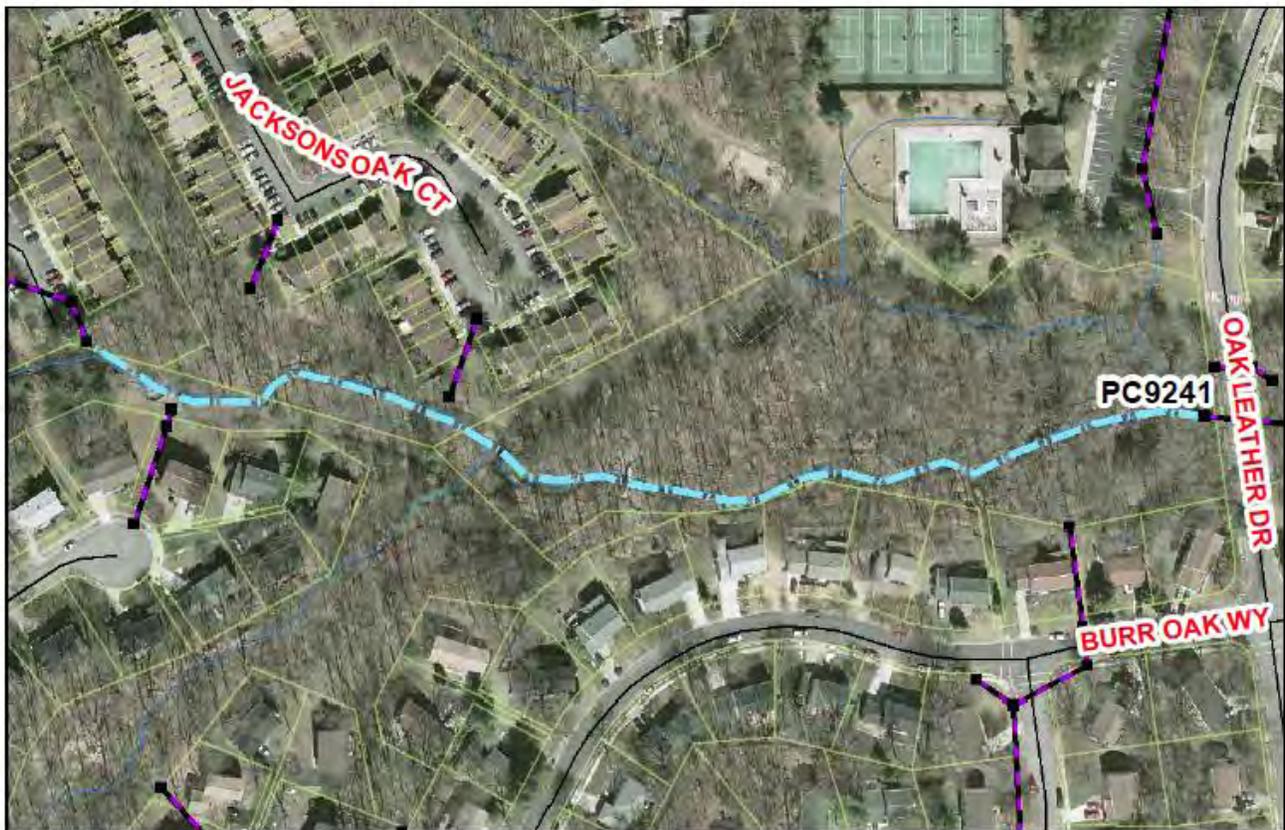
Description: The stream is upstream of a culvert under Oak Leather Drive. The stream conveys runoff from neighborhood and community recreation facilities. Stream stabilization will repair bank and bed erosion and restore stream morphology. This project will also improve the five direct stormwater outfalls to the stream bed. This project will focus on insuring proper buffers from the dense residential areas.

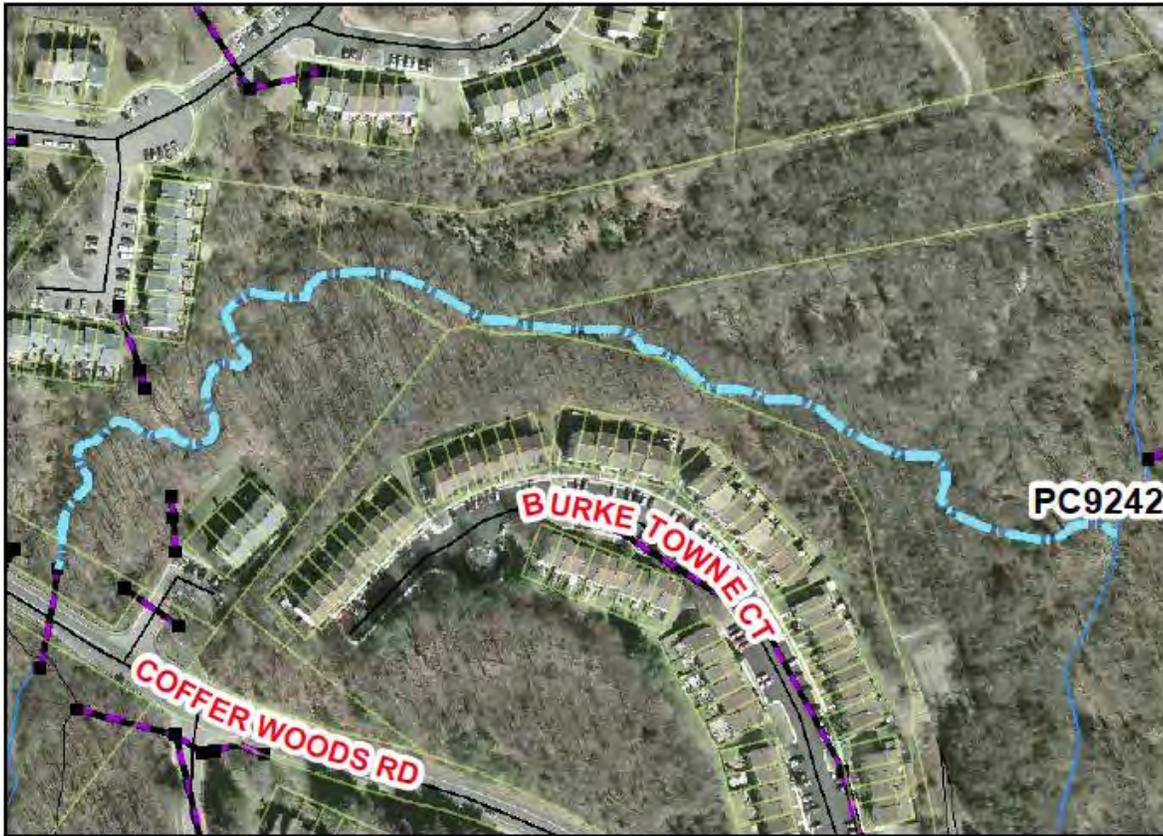
Description: This project proposes the repair of bank and bed erosion to a stream north of Burke Towne Court. The primary indicator is poor channel morphology. Stream receives runoff from adjacent residential neighborhood. The stream stabilization will reduce sediment loads while maintaining capacity of the stream and controlling unwanted meander. Erosion will be stabilized through the use of bank shaping, toe protection, erosion control fabrics, and rapid vegetation establishment.

- Stream Restoration
- Storm Network
- Property Line
- Streams

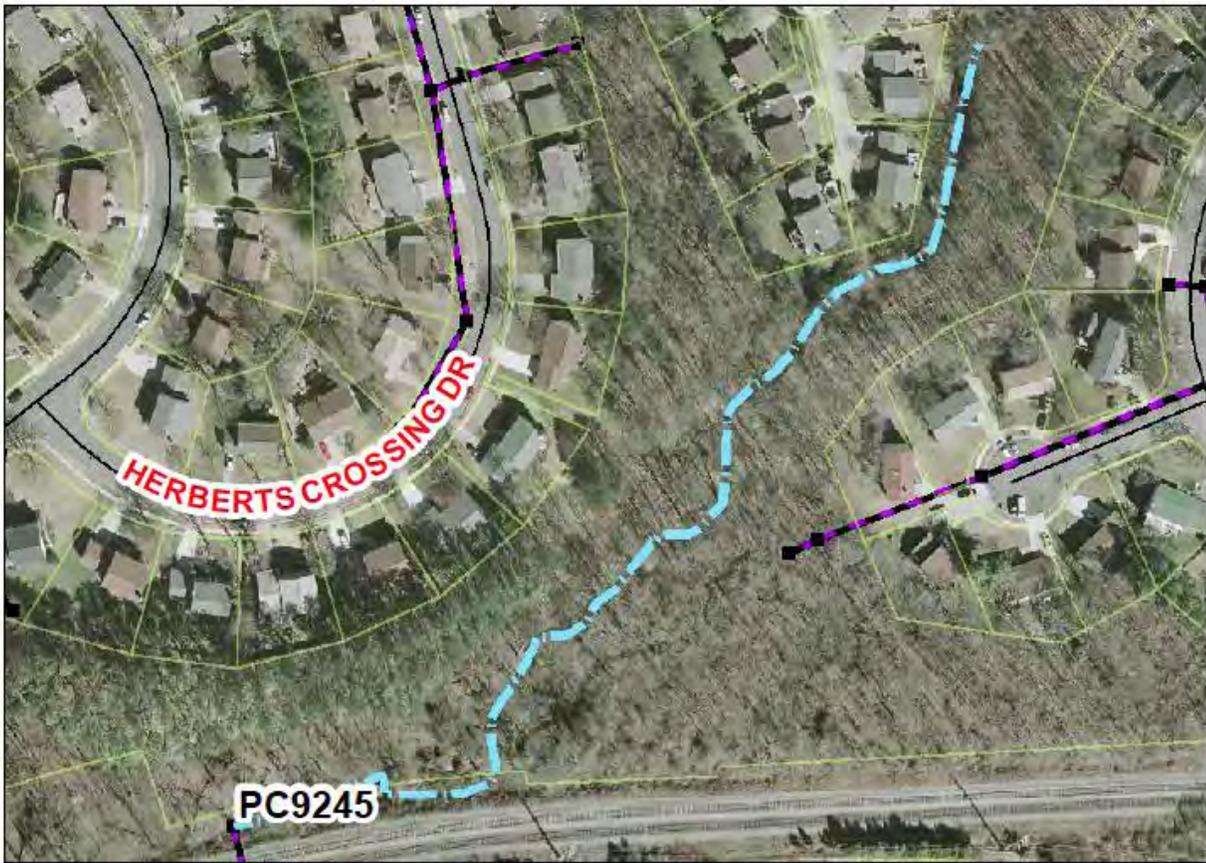
Description: This project proposes repairing bank and bed erosion to restore channel morphology of the stream north of Burke Road. Primary indicator is poor channel morphology. Stream conveys runoff from adjacent single family residential neighborhoods to the stream through closed systems or direct runoff. Erosion will be stabilized through the use of bank shaping, toe protection, erosion control fabrics, and rapid vegetation establishment.

- Stream Restoration
- Storm Network
- Property Line
- Streams
