PC9201 Stream Restoration

Address: Behind 7756 Matisse Way, Springfield, Virginia
Location: Stream behind Matisse Way
Land Owner: Public/Local – FCPA
PIN: 0984 06 E, 0984 06 C
Control Type: Water quality control
Drainage Area:
Receiving Waters: Tributary of Pohick Creek

Description: This stream restoration is located west of Matisse Way and east of Godolphin Dr., and is located on Fairfax County Park Authority land. This project proposes repairing bank and bed erosion, restoring channel morphology, and reducing excessive channel meander. Stream stabilization will reduce sediment loads to the stream while maintaining capacity of the channel and controlling unwanted meander.

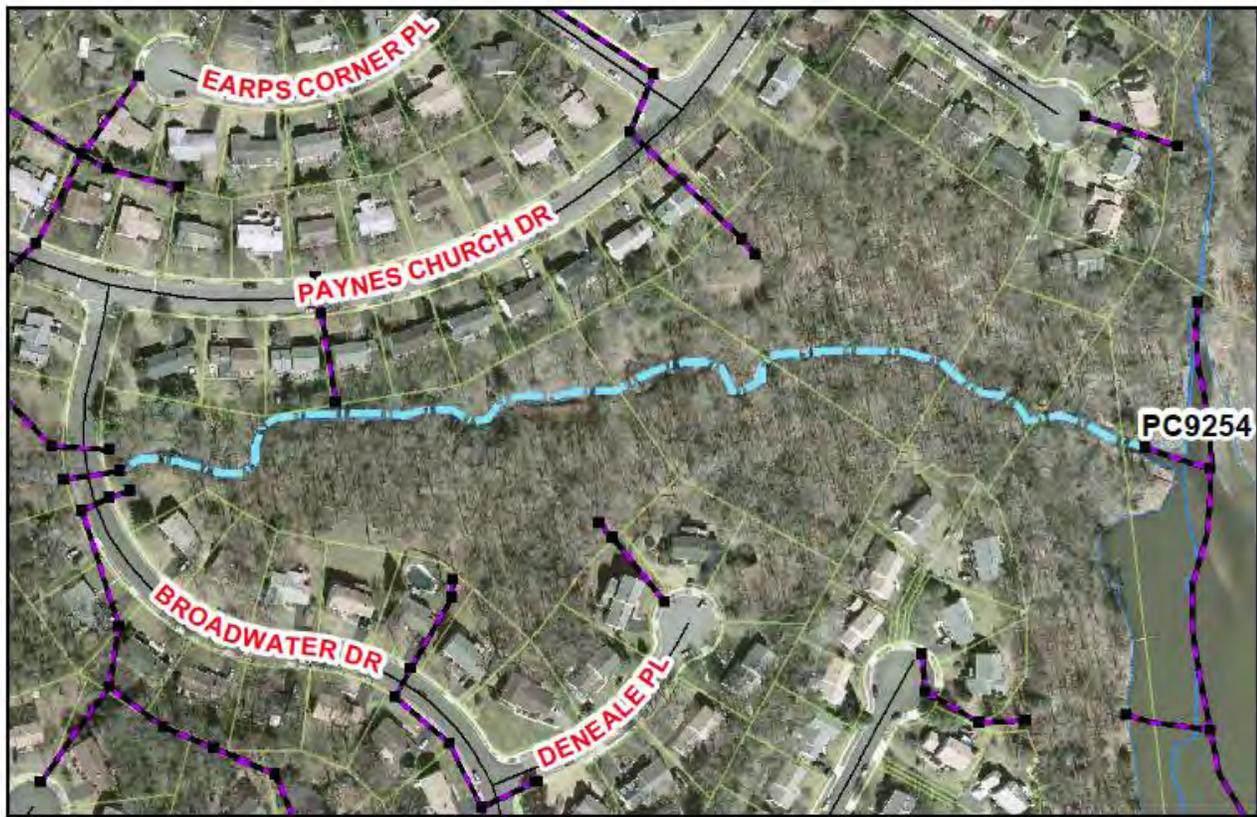
Description: The project consists of restoration of a stream that discharges into Woodglen Pond. The primary indicator is poor channel morphology. This project proposes restoring the stream by repairing bank and bed erosion and restoring channel morphology. This will reduce sediment loads to the stream while maintaining capacity of the stream channel and controlling unwanted meander of the stream. Erosion will be stabilized through the use of bank shaping, toe of slope protection, erosion control fabric, and rapid vegetation establishment.

Project Benefits: This stream restoration will reduce erosion and instream sediment. This project will stabilize banks and reestablish the streambed away from the single family homes. Below are the stream’s estimated instream sediment pollutant amounts that will be eliminated after the stream restoration.

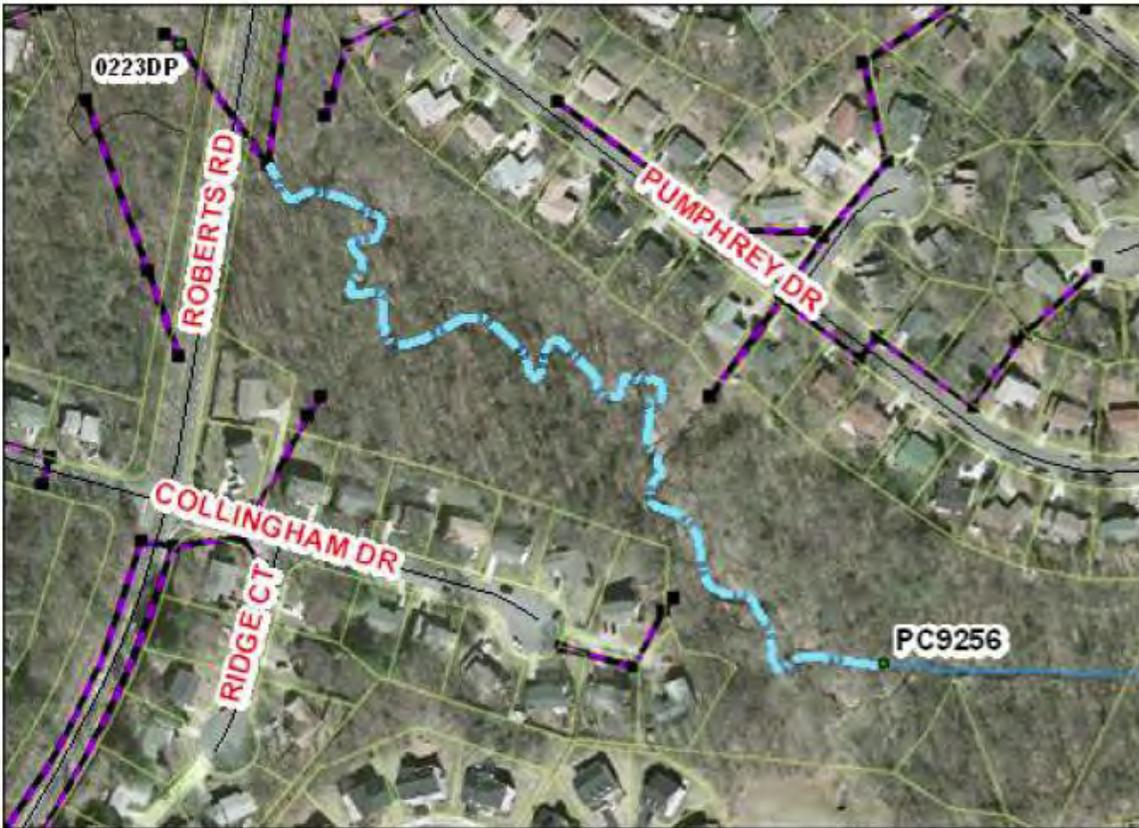
Description: The stream north of Windsor Hills Drive has indicators of poor channel morphology. In order to improve the channel, this project proposes repairing bank and bed erosion. This stream is located on Fairfax County Park Authority land. The stream receives water from adjacent residential neighborhoods. The stormwater is collected in pipes and receives no treatment before discharging to the stream. Stream stabilization will reduce sediment while maintaining capacity of the channel and controlling unwanted meander.

Project Benefits: Restoring this stream will reduce erosion and instream sediment. Below are the stream's estimated instream sediment pollutant amounts that will be eliminated after the stream restoration.

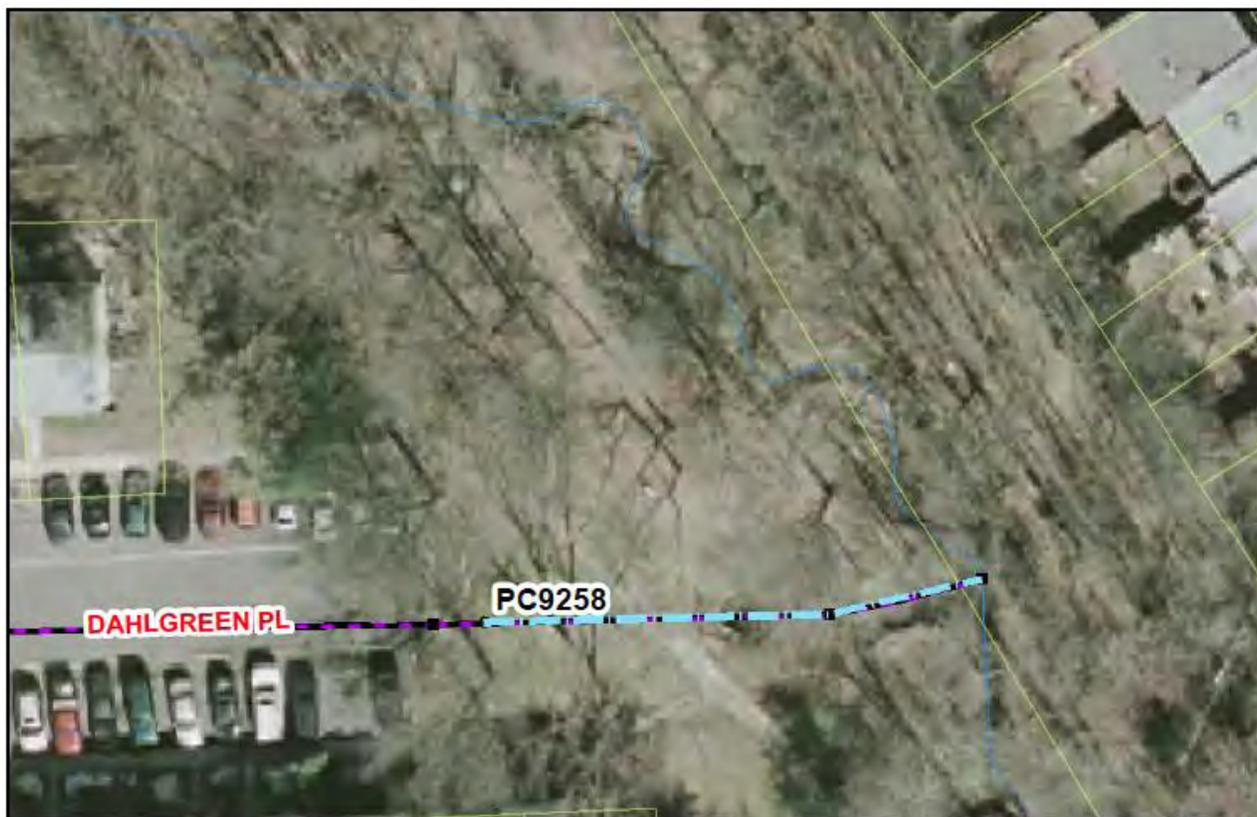
Description: This project proposes daylighting a pipe from a residential neighborhood (Dahlgreen Place) farther upstream. The primary indicator is poor channel morphology. This project will return the water to its natural state. This will reduce the velocity at which stormwater enters the stream. Additionally, the daylighting will provide more opportunity for the stormwater to infiltrate. This will help reduce runoff rates and stream erosion.

- Stream Restoration
- Storm Network
- Property Line
- Streams

Project Benefits: Restoring this stream will lessen the amount of erosion downstream and result in less instream sediment. Daylighting this pipe will allow the stormwater to return to a natural state earlier, which will allow the water to infiltrate better and will help reduce erosive velocities. Below are the stream's estimated instream sediment pollutant amounts that will be eliminated after the stream restoration.
