Rabbit Branch @ Collingham Drive Stream Restoration Project

Information Meeting: Concept Review

A Fairfax County, VA, publication
July 16, 2019

Shanes Creek @ Royal Lake Park Stream Restoration Project

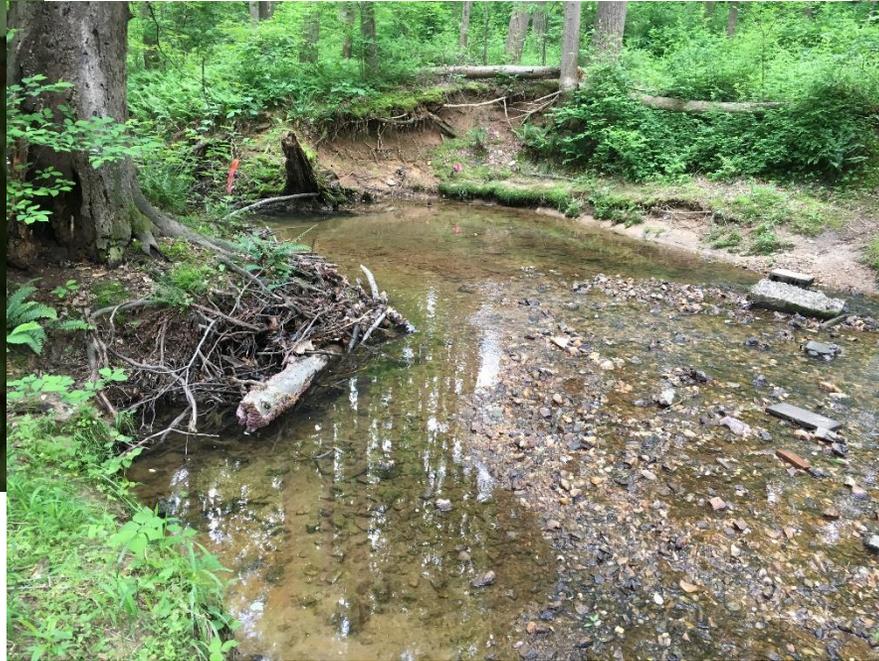
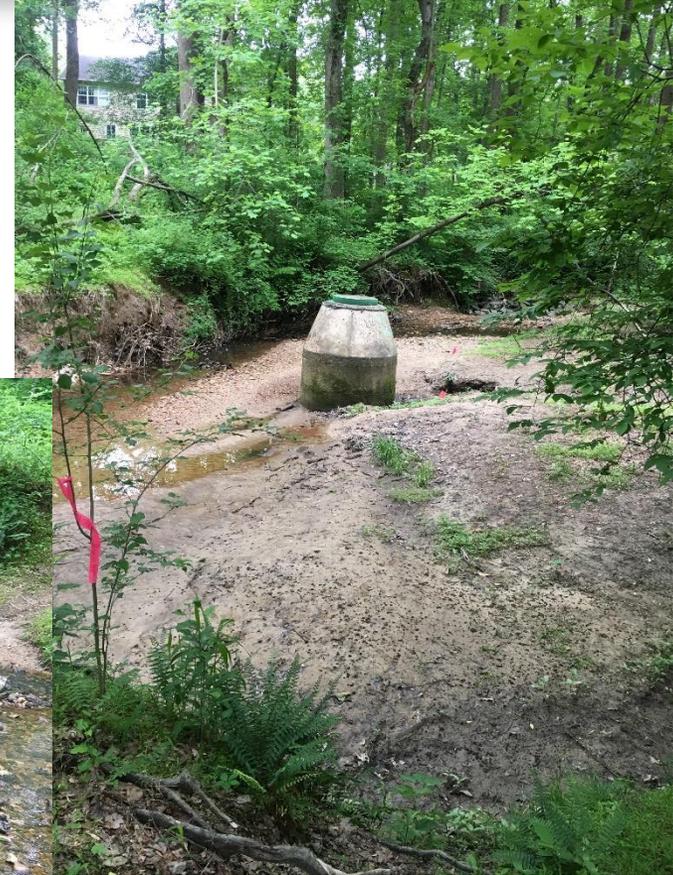
Non-native
invasive species

Severely eroding and
undercut banks

Exposed sanitary sewer

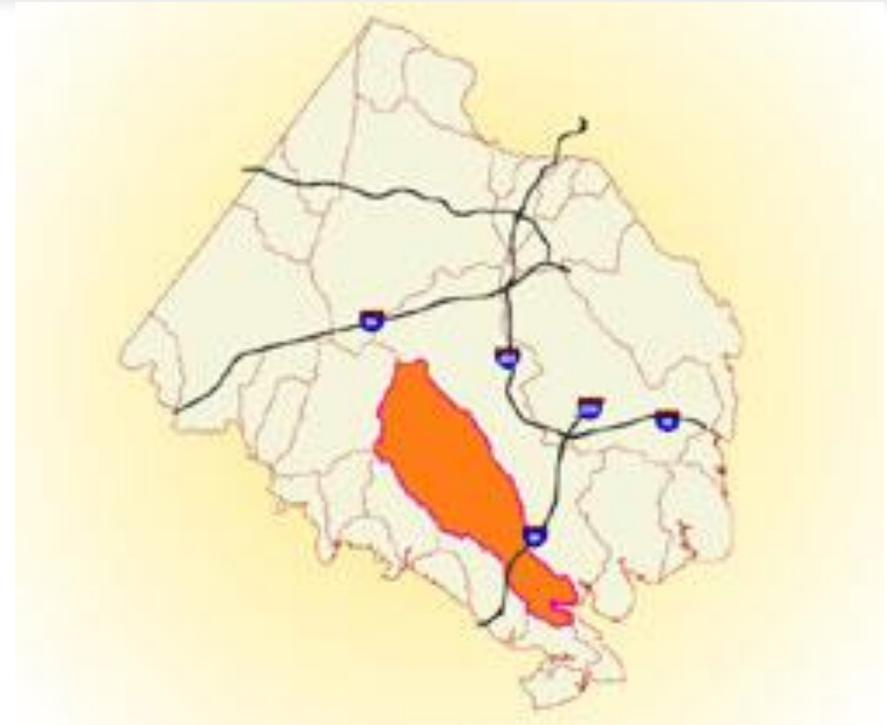
Stream Assessment

1. **Physical Assessment:** Conducted in 2005.

Results:

- Poor condition with severely incised stream and significant
- Portion with unstable banks – 75% channels
- Most of watershed's tributaries in widening stage

Results: ~ 0% excellent, ~15% Good, ~54% Fair, ~28% Poor, ~3% Very poor

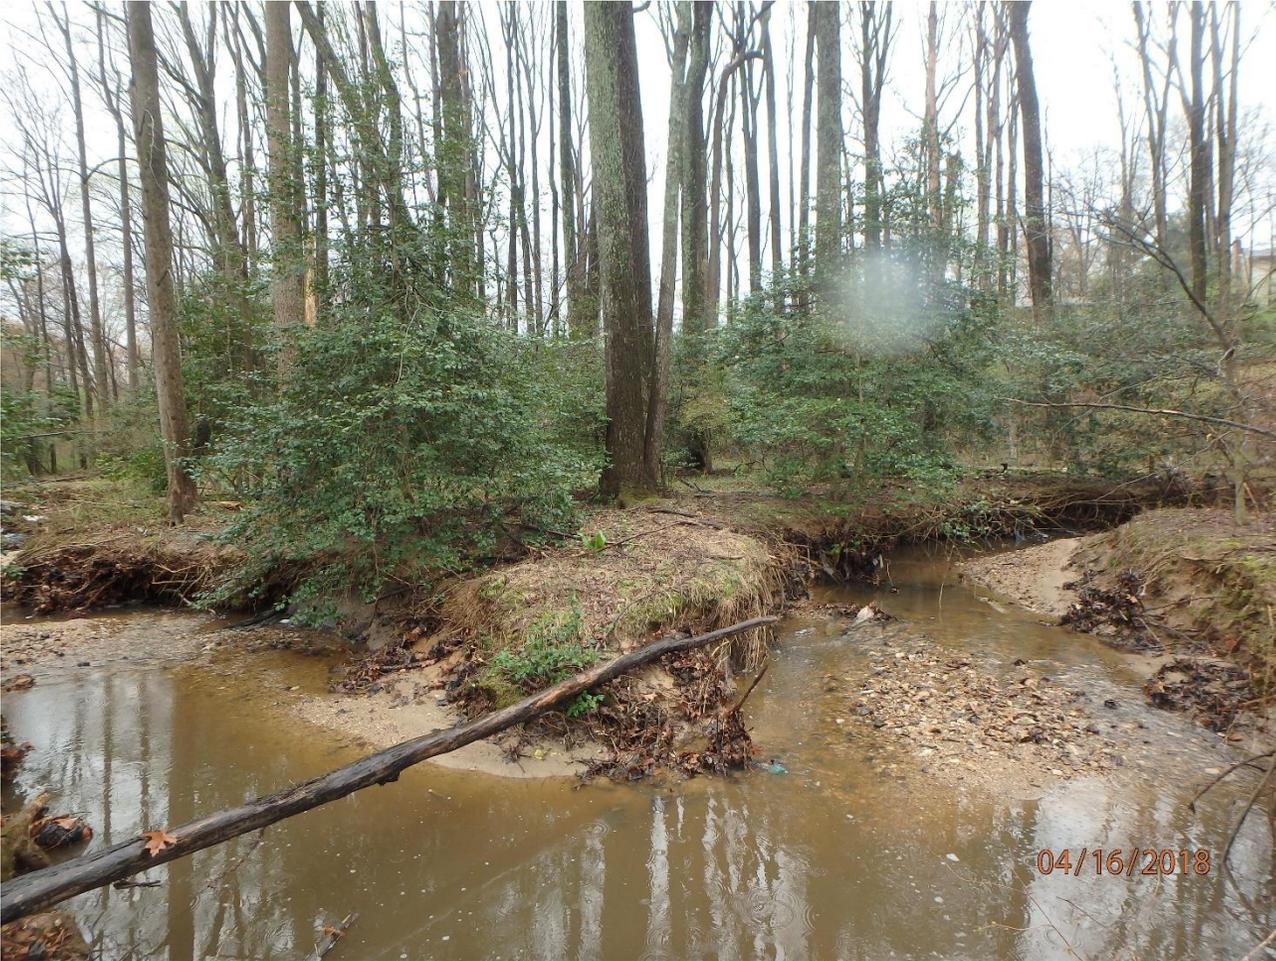
Proposed Project Site- Shanes Creek

Current Condition:

- Incised channel
- Eroded bed and banks
- Unstable slopes
- Exposed utilities *sanitary sewer

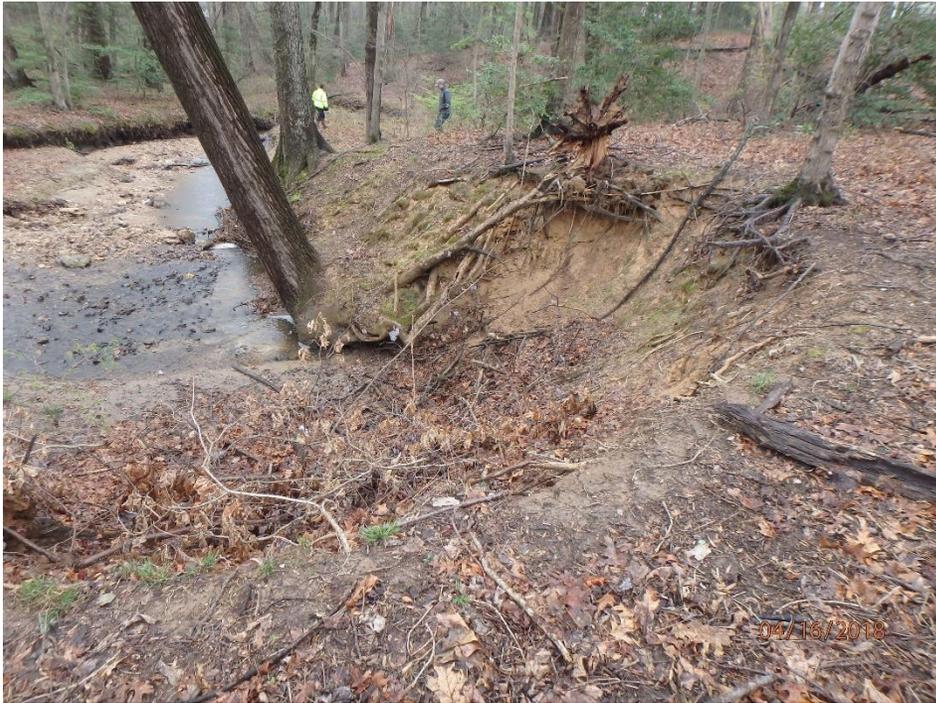
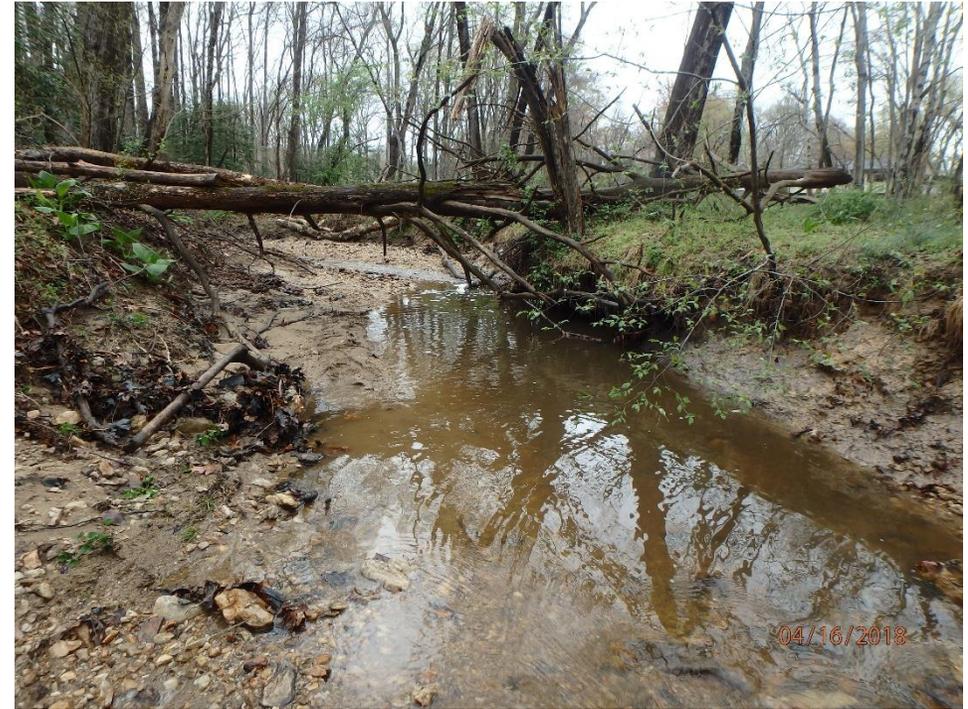
Existing Conditions

Unstable banks, incised channel, and tree loss.

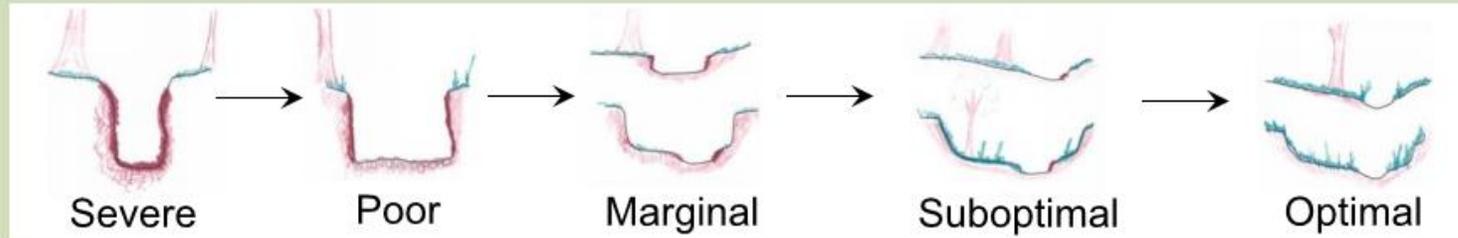
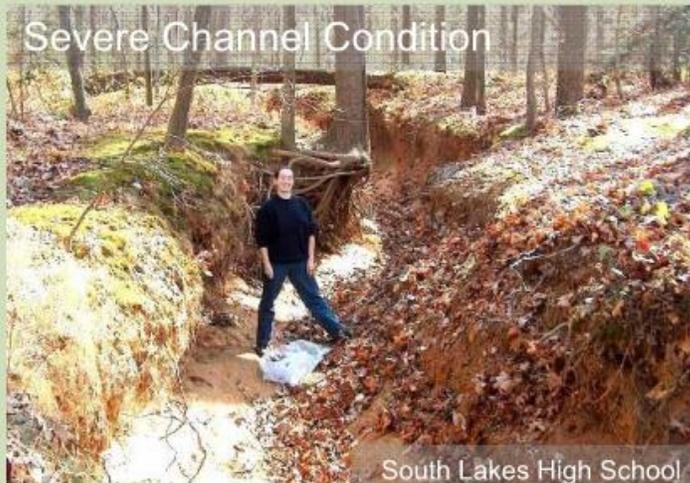
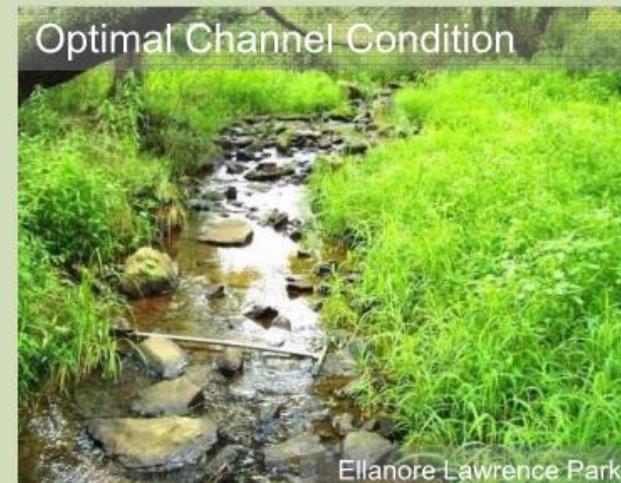
Restoration Approach – Natural Channel Design

DESIGN METHODOLOGY FOR URBAN STREAMS - NATURAL CHANNEL EVOLUTION -

Evolutionary process considers the channel's incision, bank stability, & sedimentation load (aggrading or degrading)

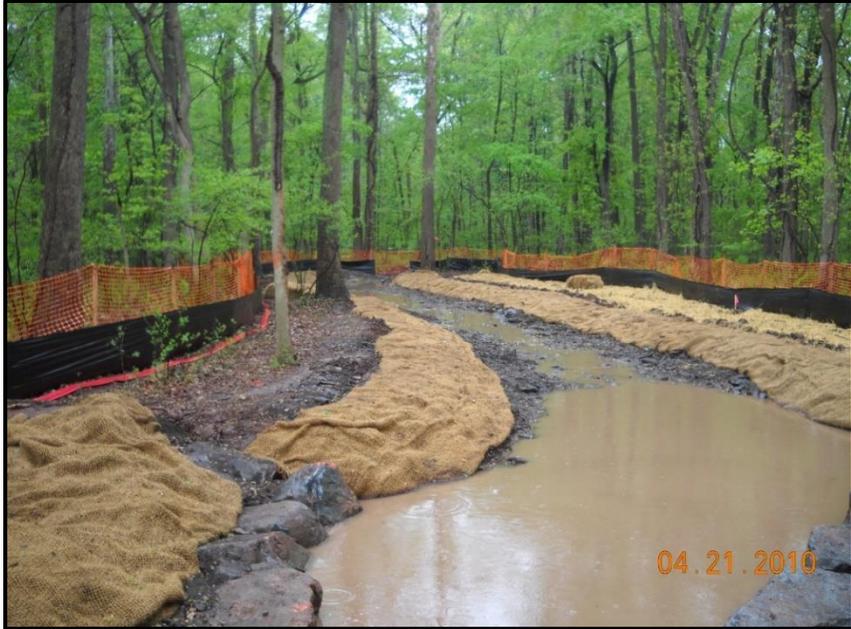
Immediately After Construction

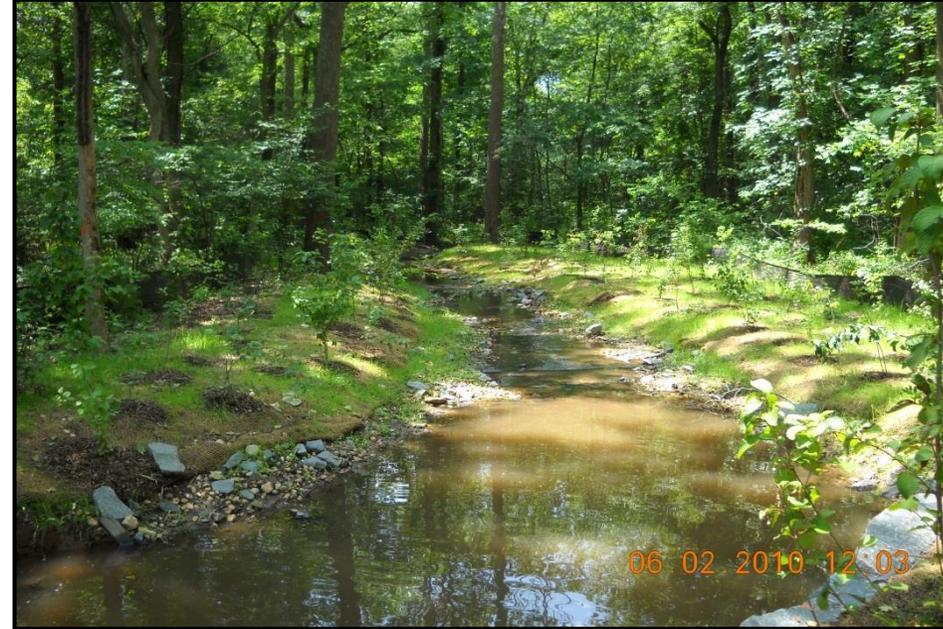
Growing Season Following Construction Completion

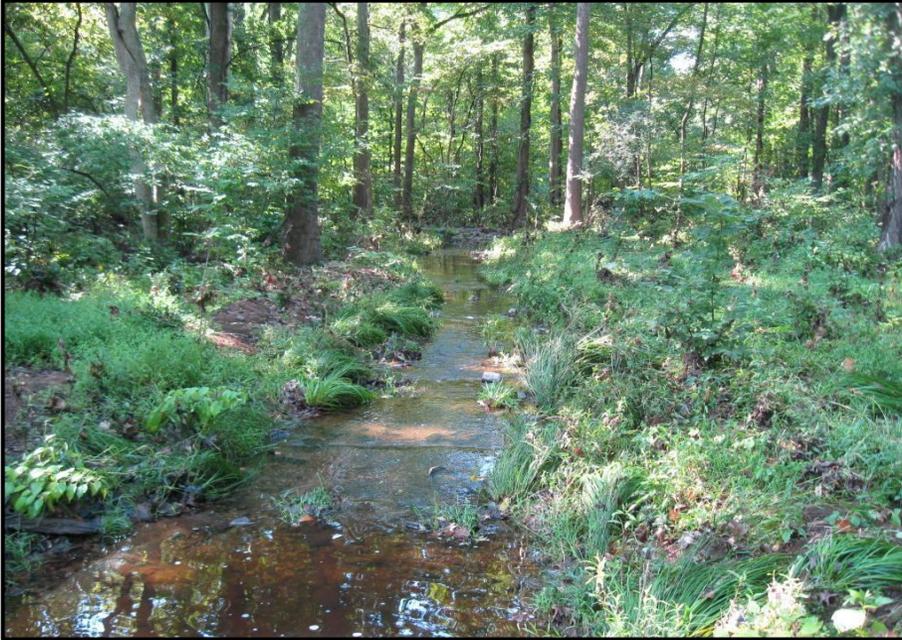
One Year After Construction

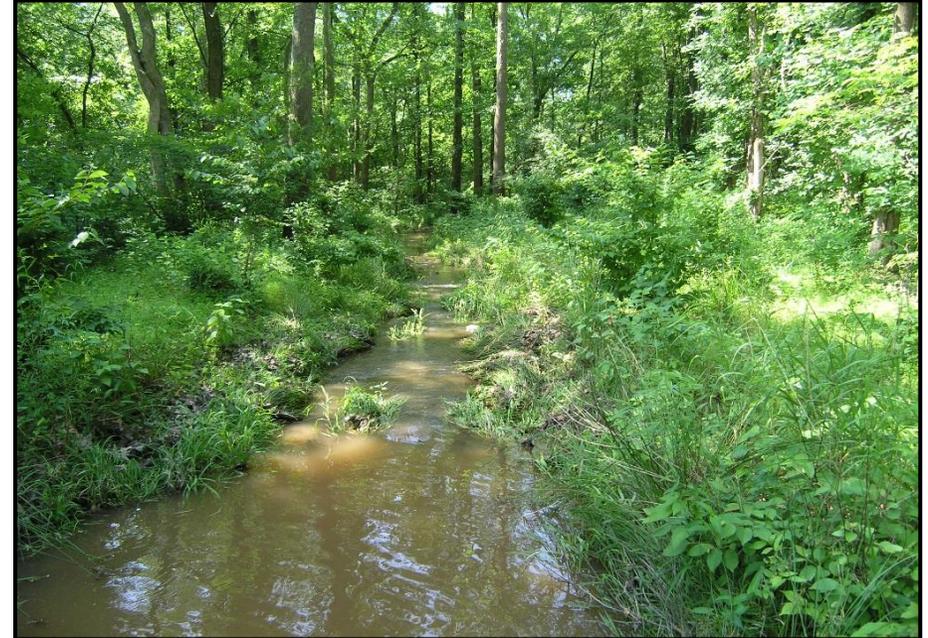
Three Years After Construction

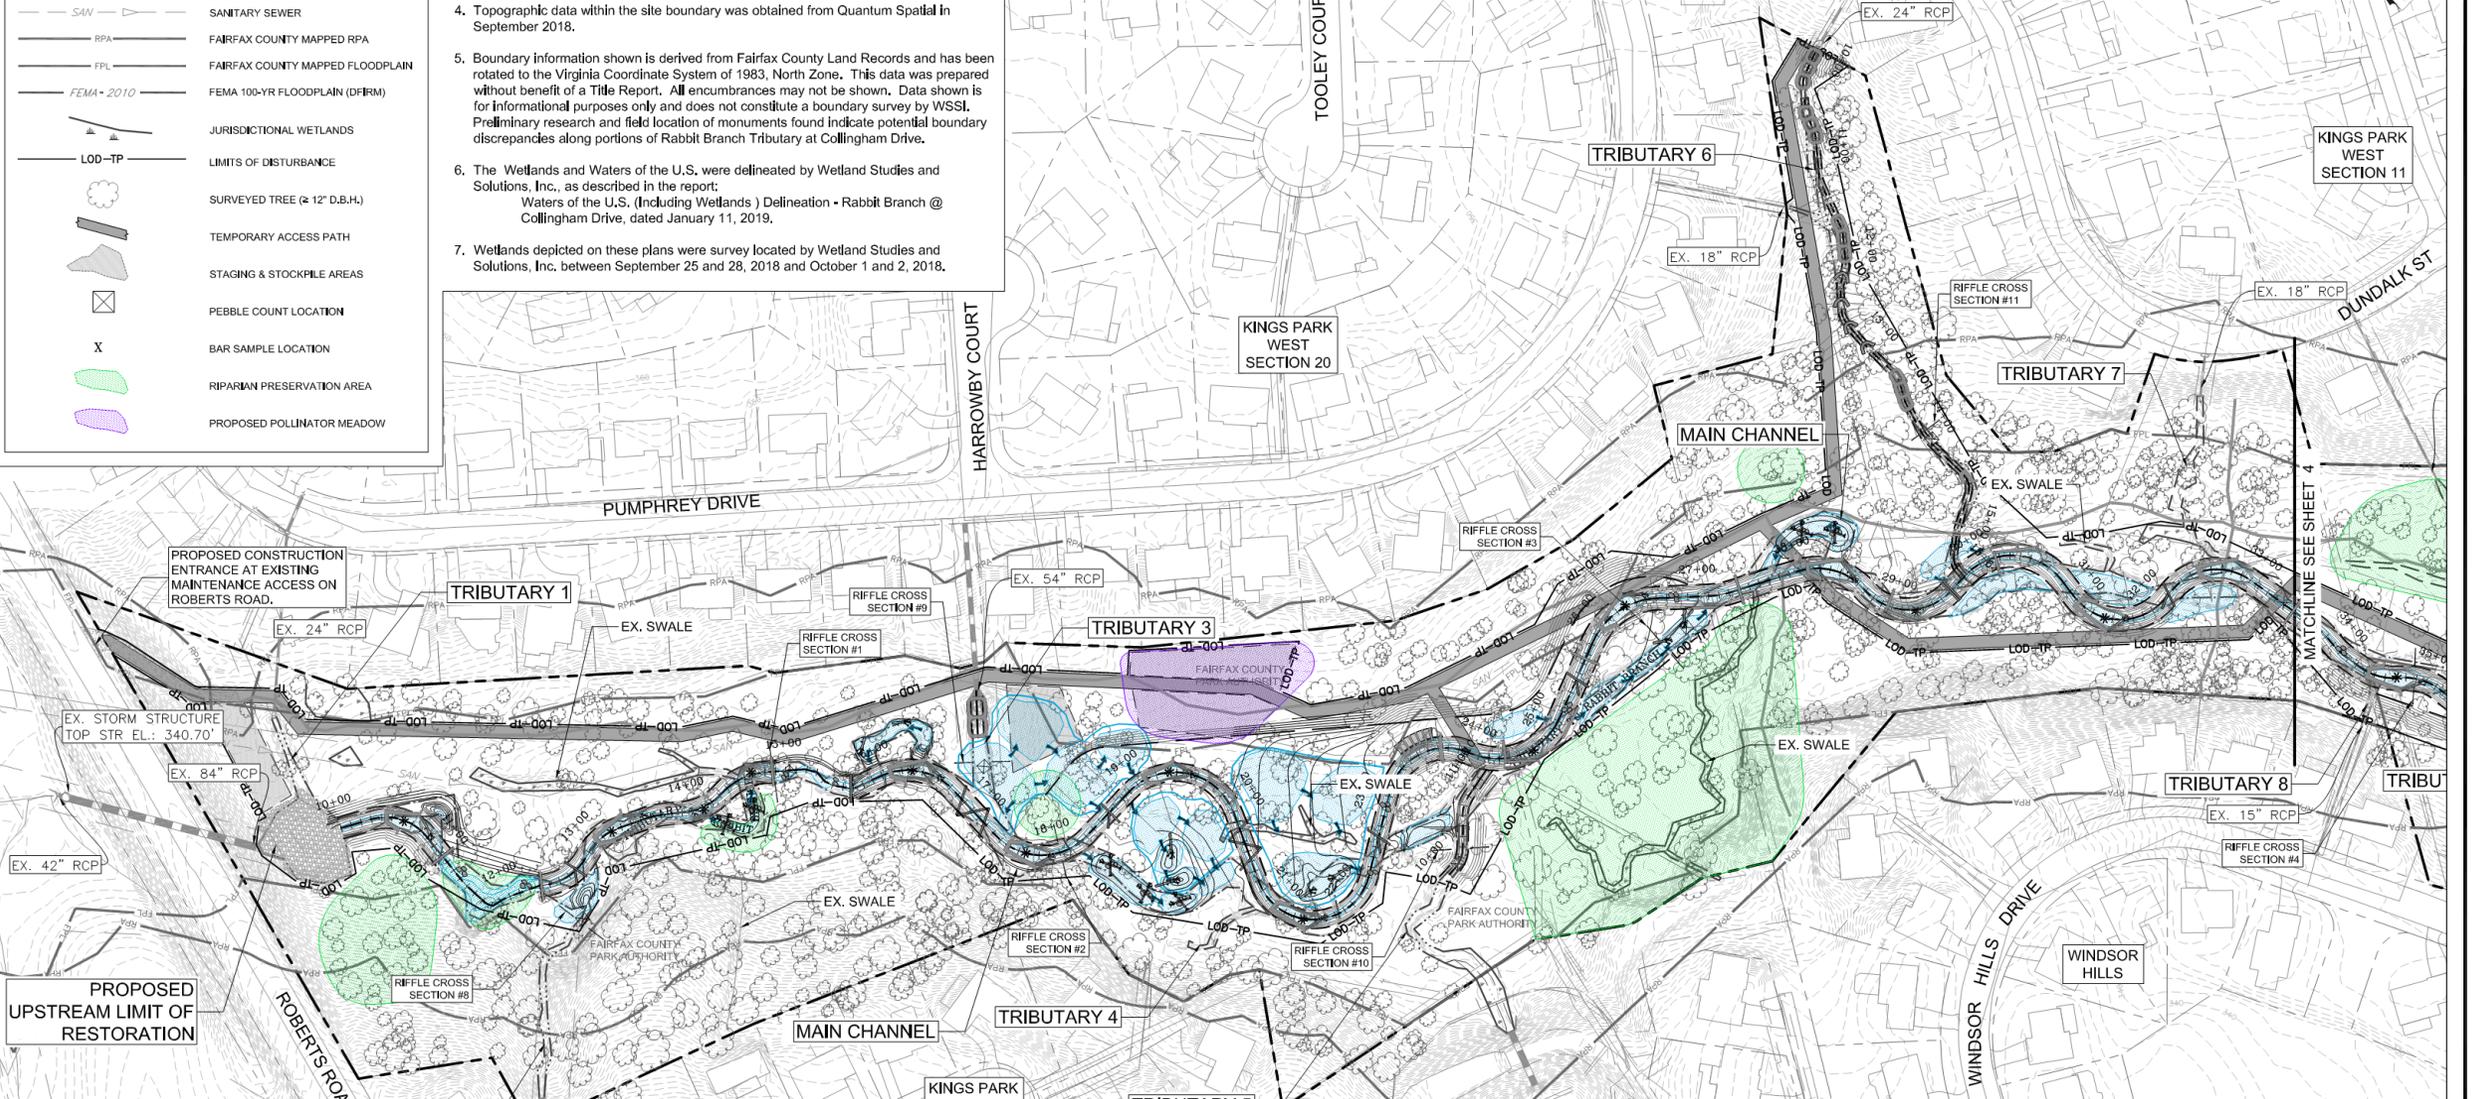
Stream Restoration Concept (35%)

- Topographic data within the site boundary was obtained from Quantum Spatial In September 2018.
- Boundary information shown is derived from Fairfax County Land Records and has been rotated to the Virginia Coordinate System of 1983, North Zone. This data was prepared without benefit of a Title Report. All encumbrances may not be shown. Data shown is for informational purposes only and does not constitute a boundary survey by WSSI. Preliminary research and field location of monuments found indicate potential boundary discrepancies along portions of Rabbit Branch Tributary at Collingham Drive.

- The Wetlands and Waters of the U.S. were delineated by Wetland Studies and Solutions, Inc., as described in the report: Waters of the U.S. (Including Wetlands) Delineation - Rabbit Branch @ Collingham Drive, dated January 11, 2019.

- Wetlands depicted on these plans were survey located by Wetland Studies and Solutions, Inc. between September 25 and 28, 2018 and October 1 and 2, 2018.
