Rabbit's Branch at Collingham Drive Stream Restoration/Shanes Creek

Department of Public Works and Environmental Services
Working for You!

A Fairfax County, VA, publication
March 28, 2022

Community Meeting: Pardon Our Dust

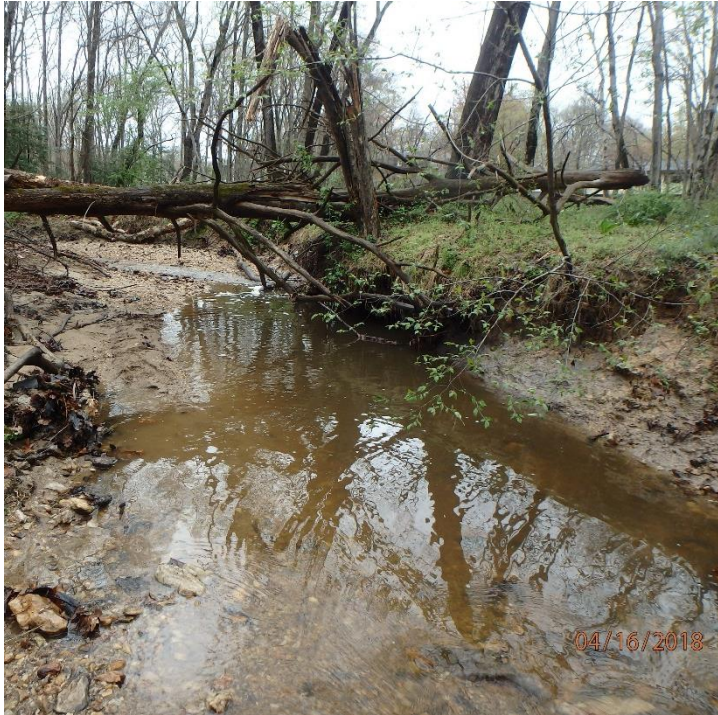
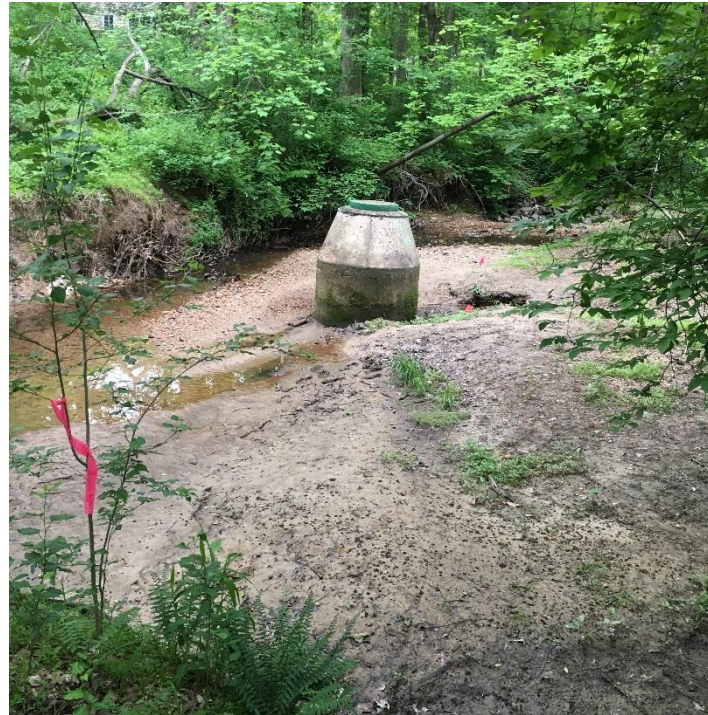
Existing Stream Condition has active erosion and threatens infrastructure

Erosion and incision of stream bed causing tree loss and vulnerable infrastructure.
Invasive species interfere with natural recovery.

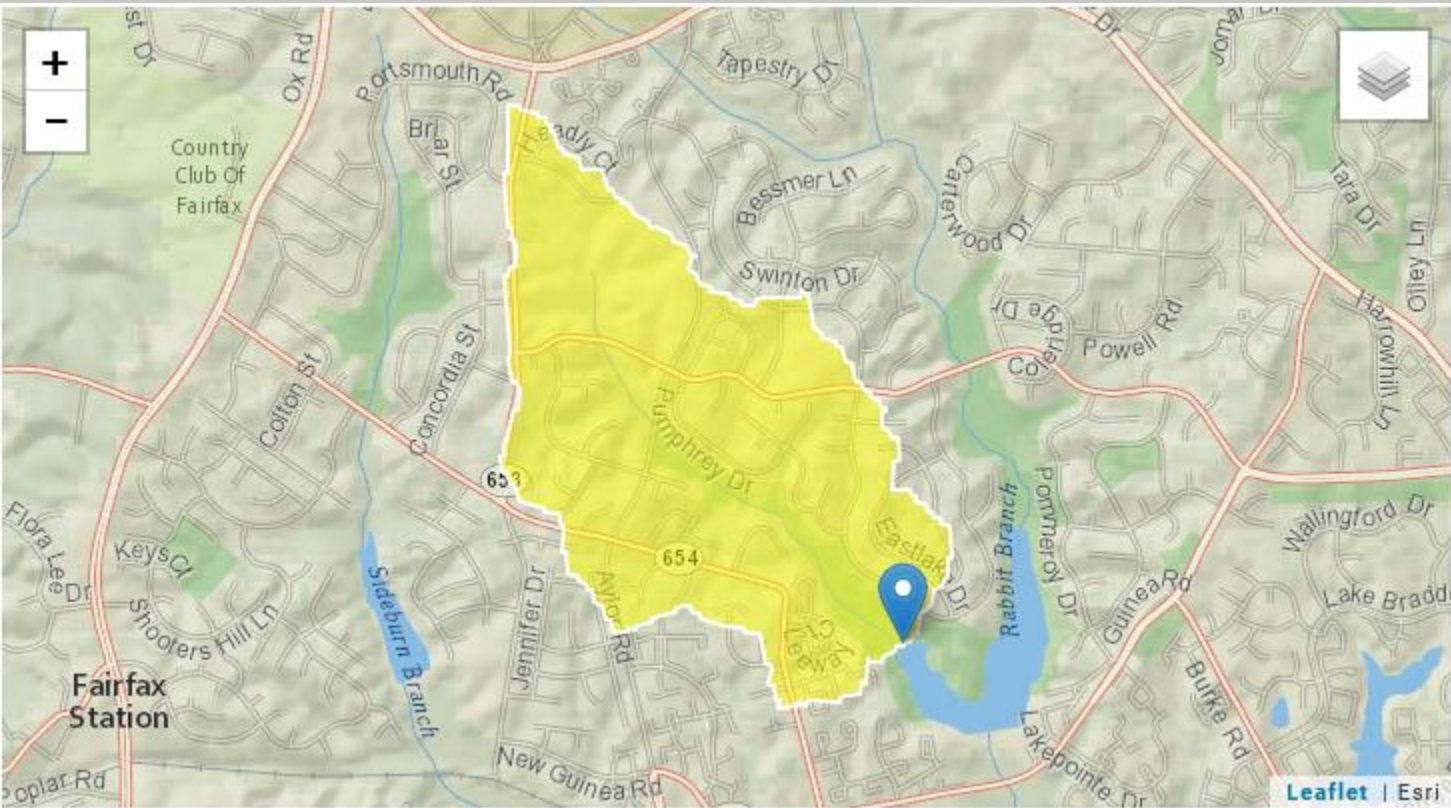
StreamStats

Watershed Condition

Watersheds/Drainage Areas

Shanes Creek - Pohick Creek

~ 0.8 square miles

~ 5600 linear feet of stream

~ 32% of land use in impervious category

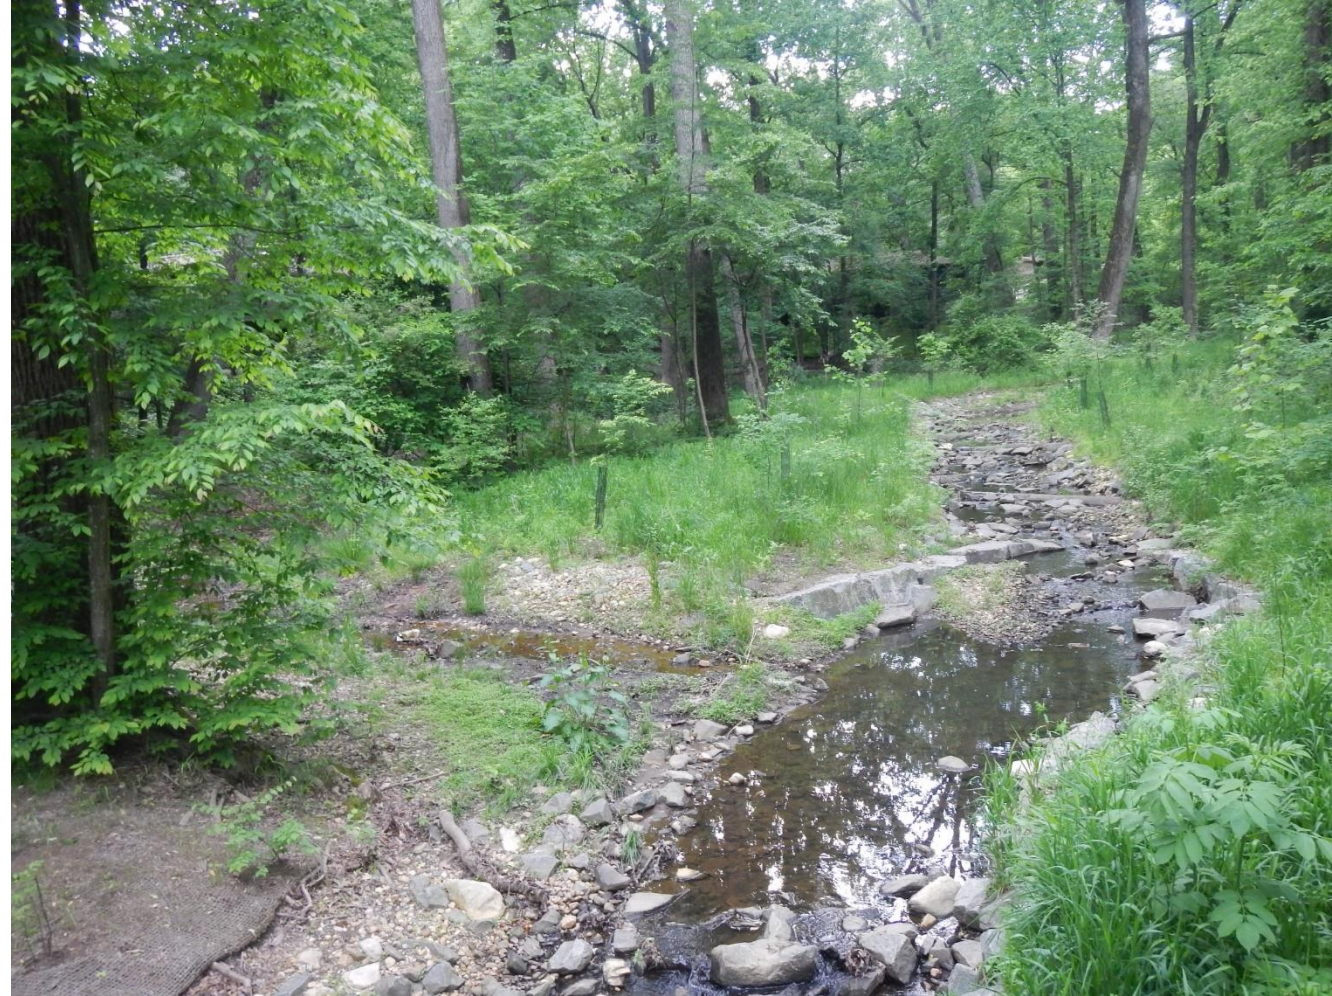
Enhanced Floodplain Reconnection Area

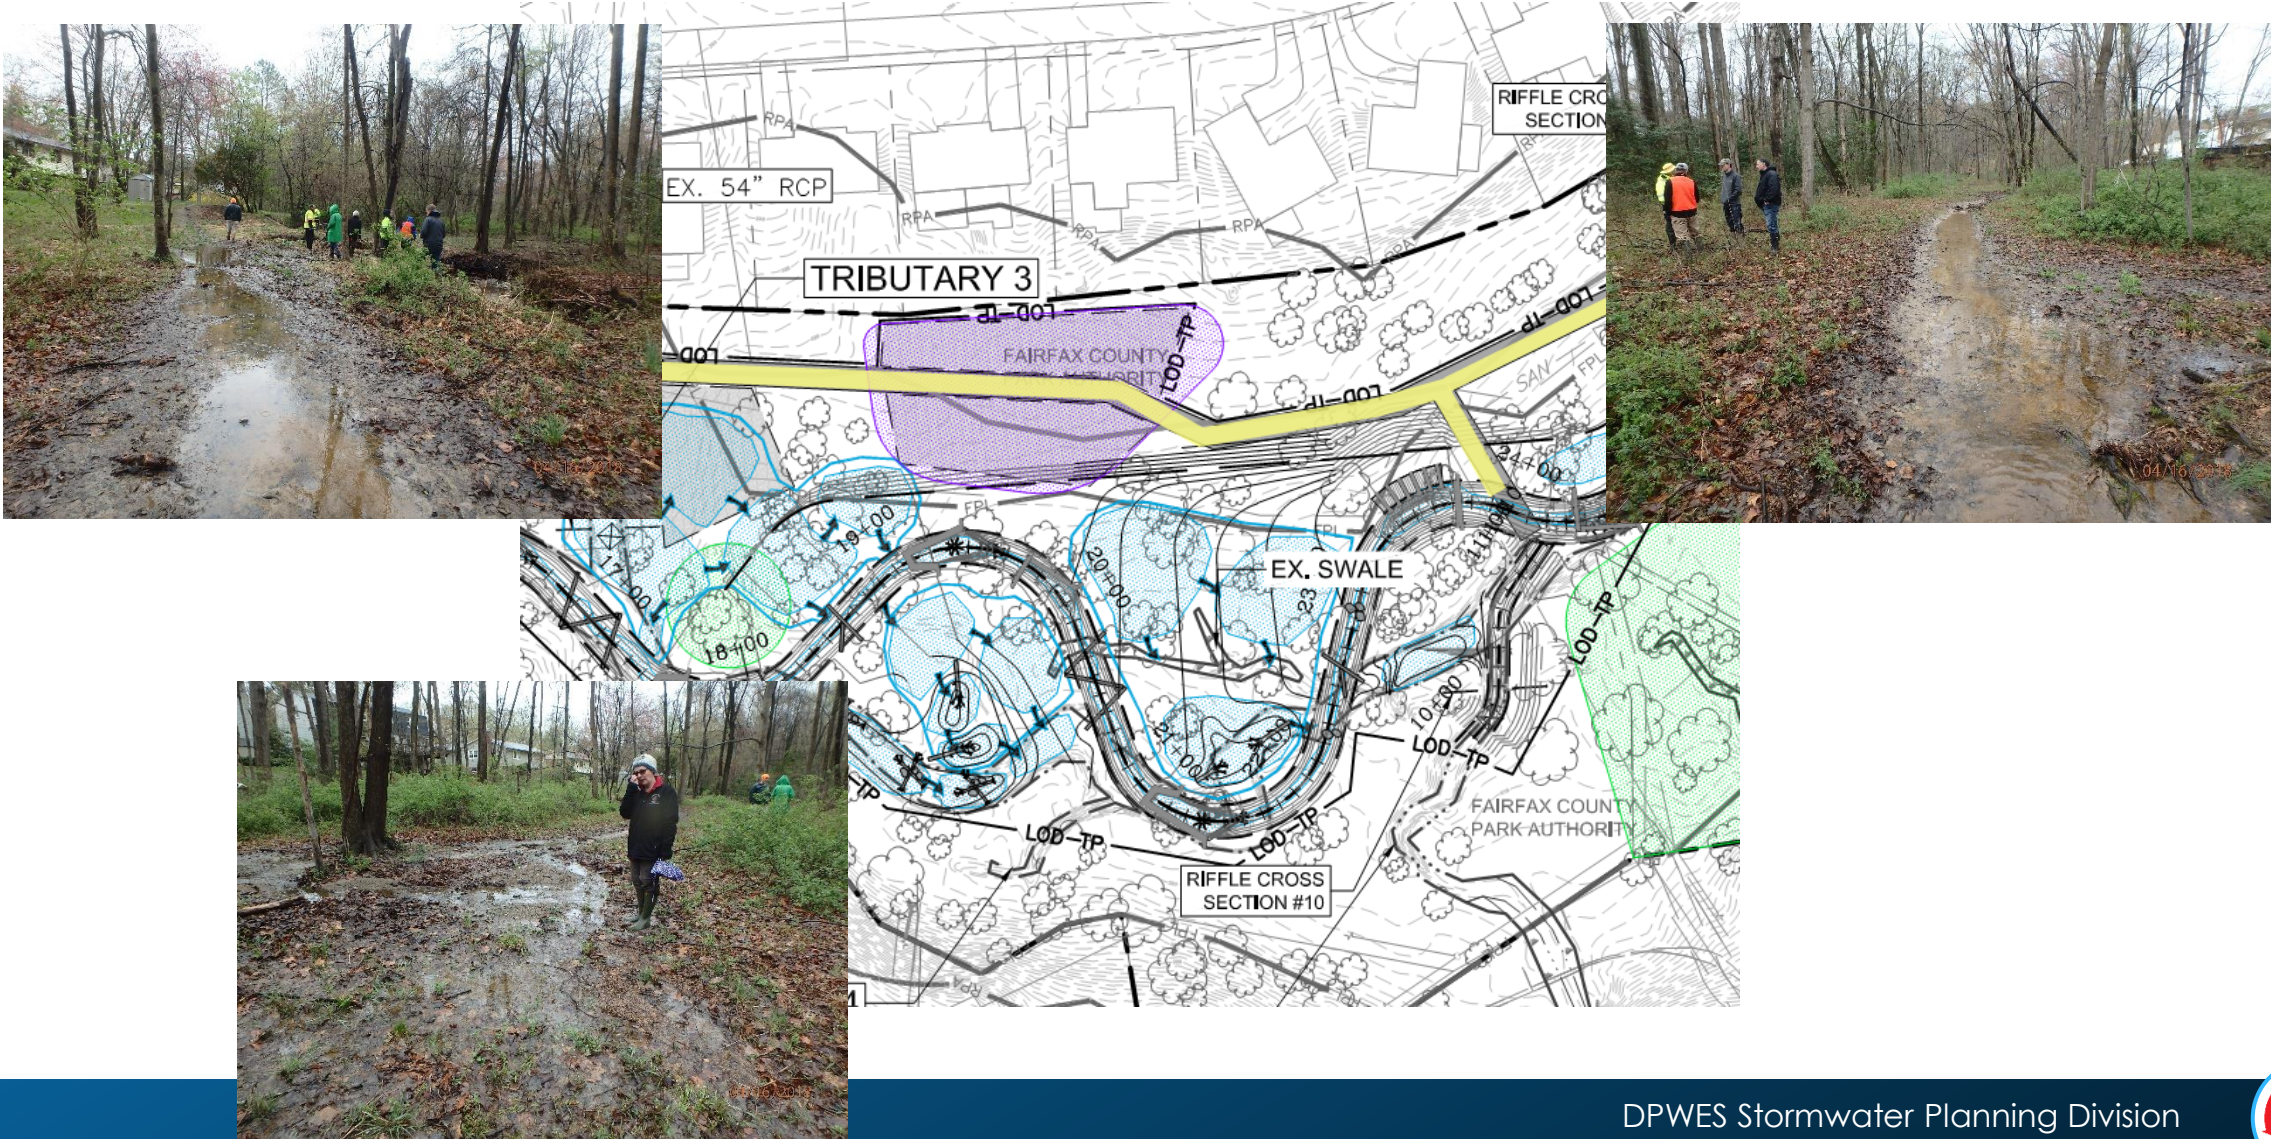
Enhanced Floodplain Reconnection Area

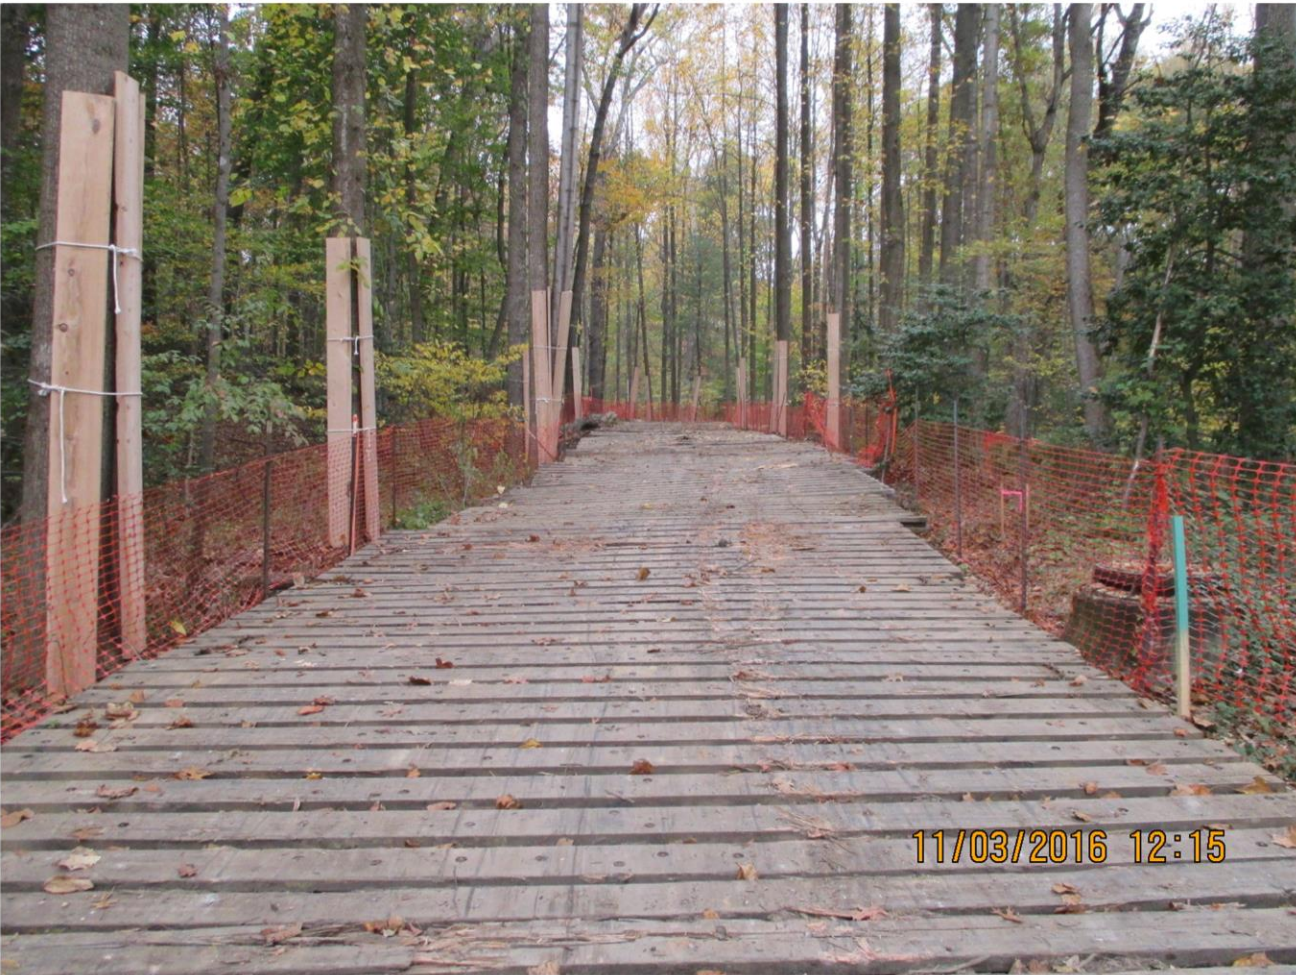
Access road and tree protection area

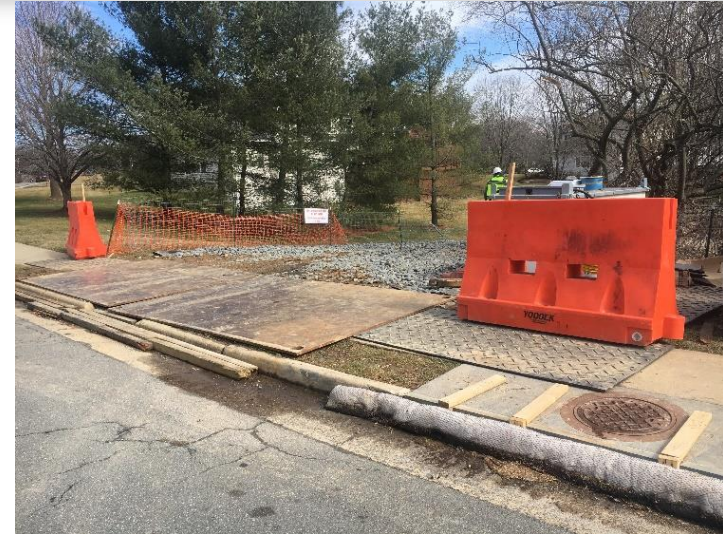
Construction staging and stockpile

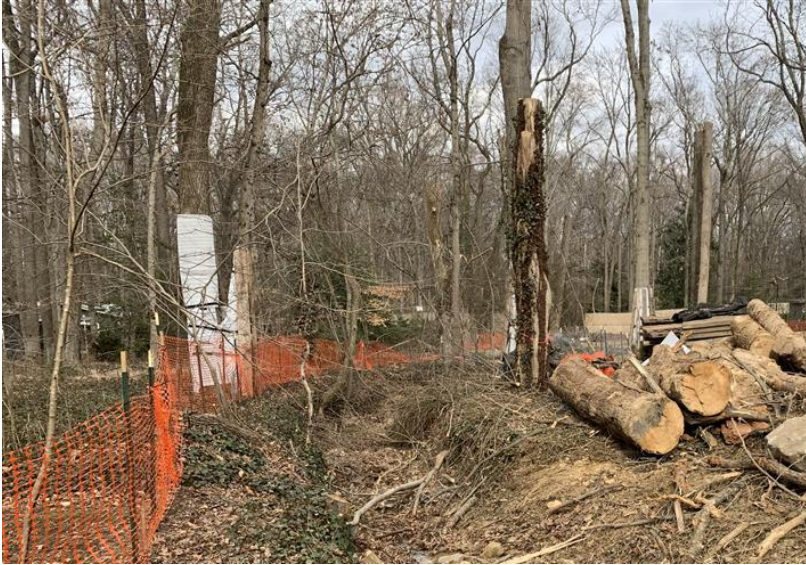
Tree Protection and snags

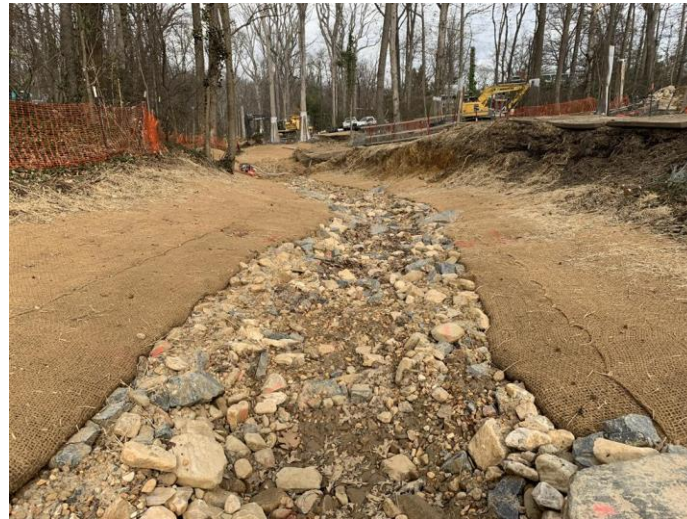
Coir stabilization

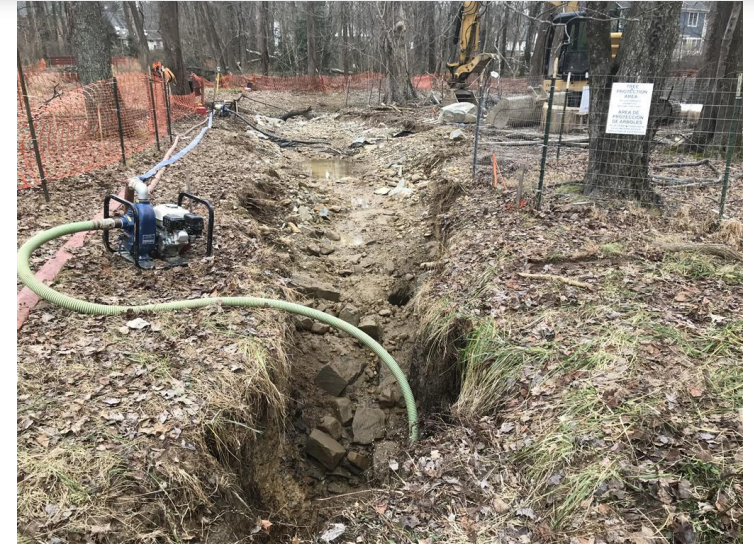
Stream pump around

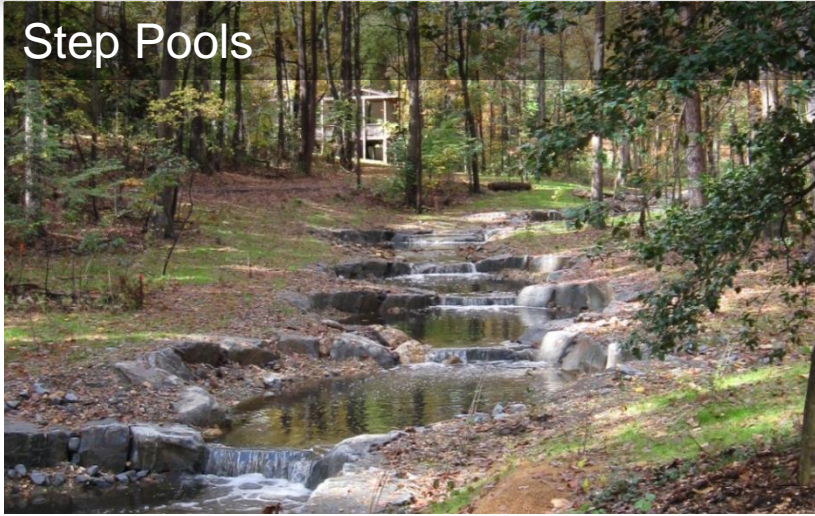
Step Pools

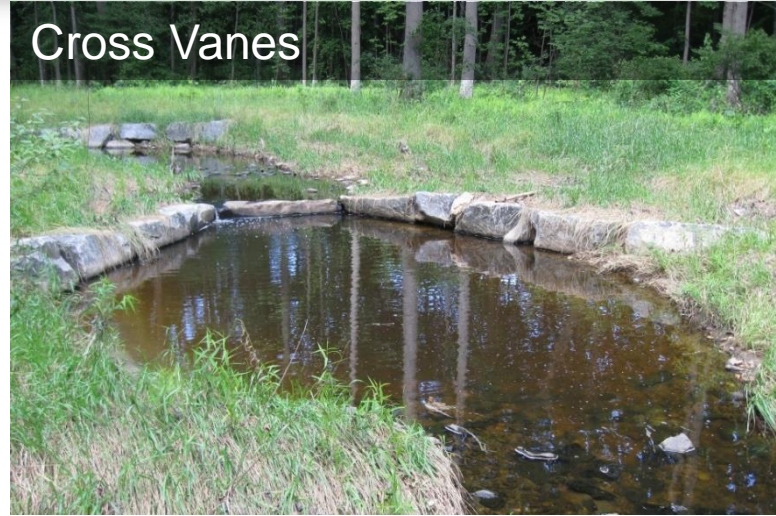
Cross Vanes

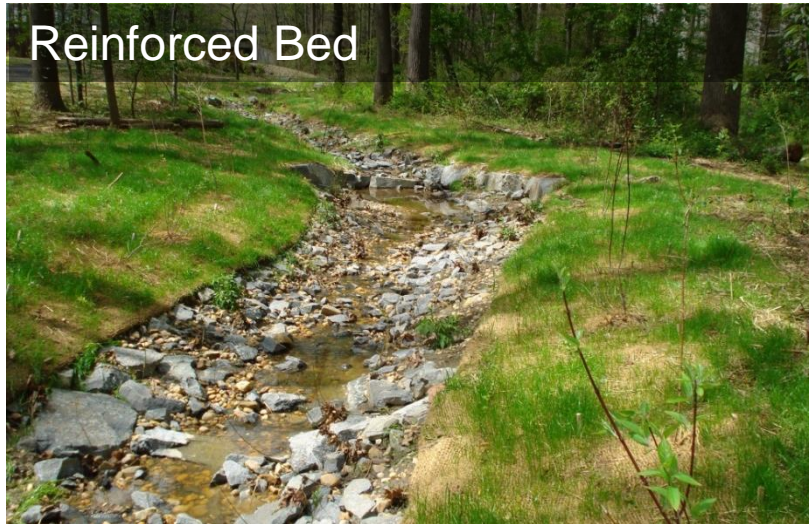
Reinforced Bed

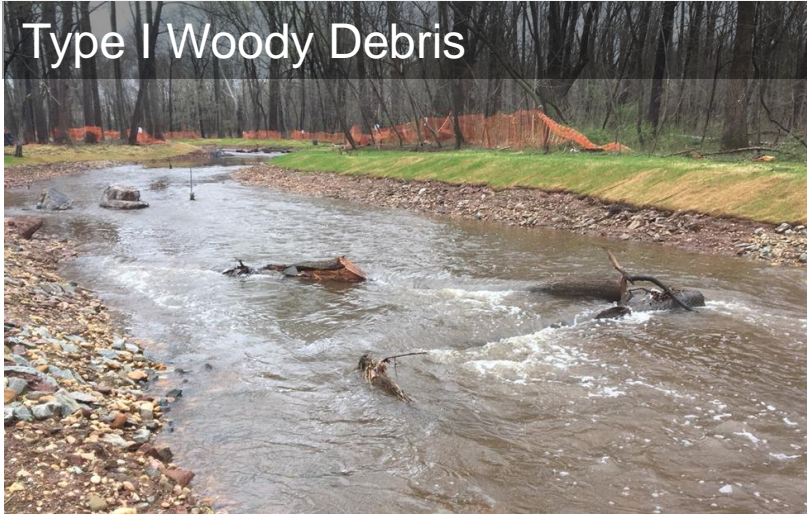
Type I Woody Debris

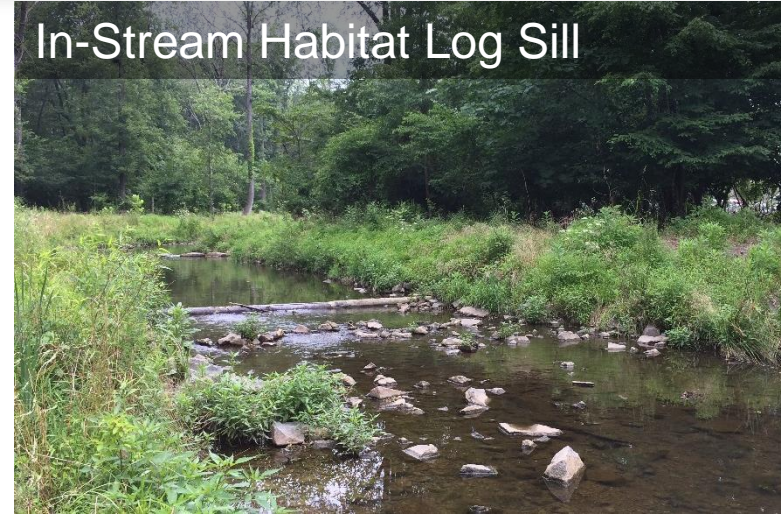
In-Stream Habitat Log Sill

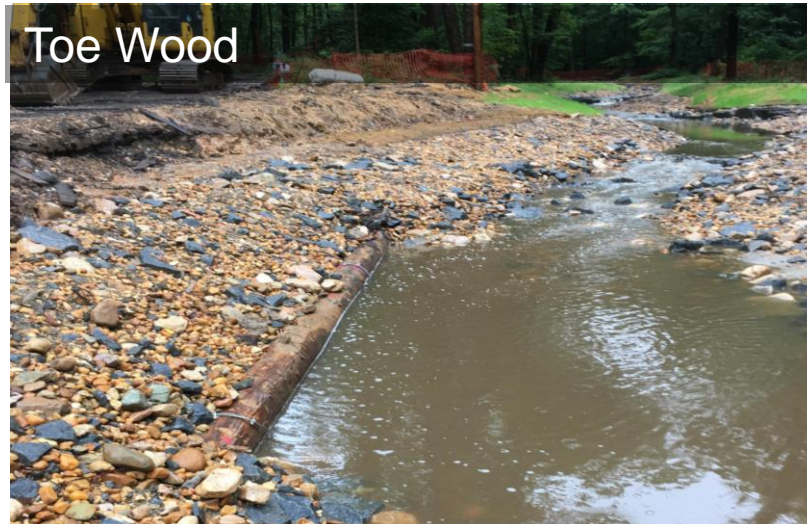
Toe Wood

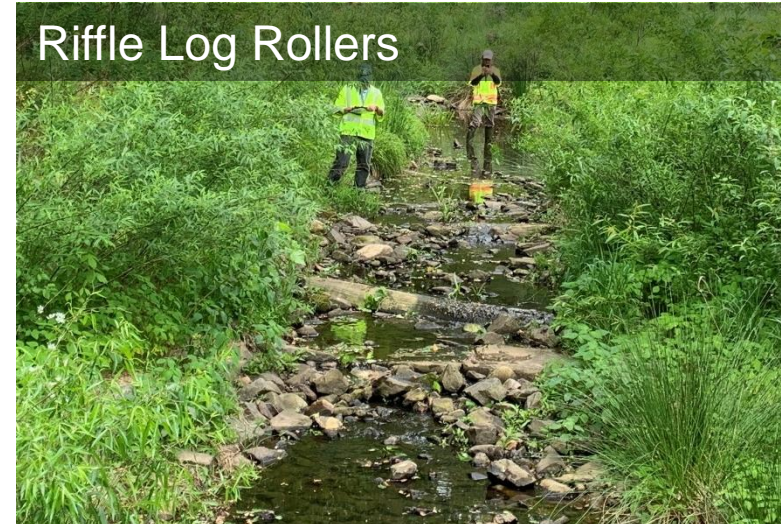
Riffle Log Rollers

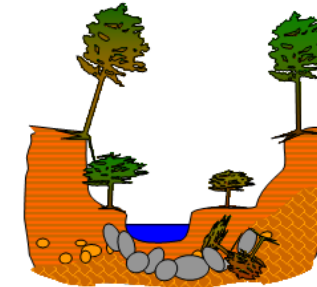
Figure 8-2
Channel Evolution Model (cont.).

Channel Evolution Model

Stage V Deposition

- Deposition begins from liberated sediment
- Vegetation establishes near water line

Stage VI Recovery and Reconstruction

- Bankfull floodplains may be reconstructed from liberated sediment
- Woody vegetation establishes near water line
- Stability re-established
