# Popes Head Creek

## Watershed Management Plan

Final

**Fairfax County**

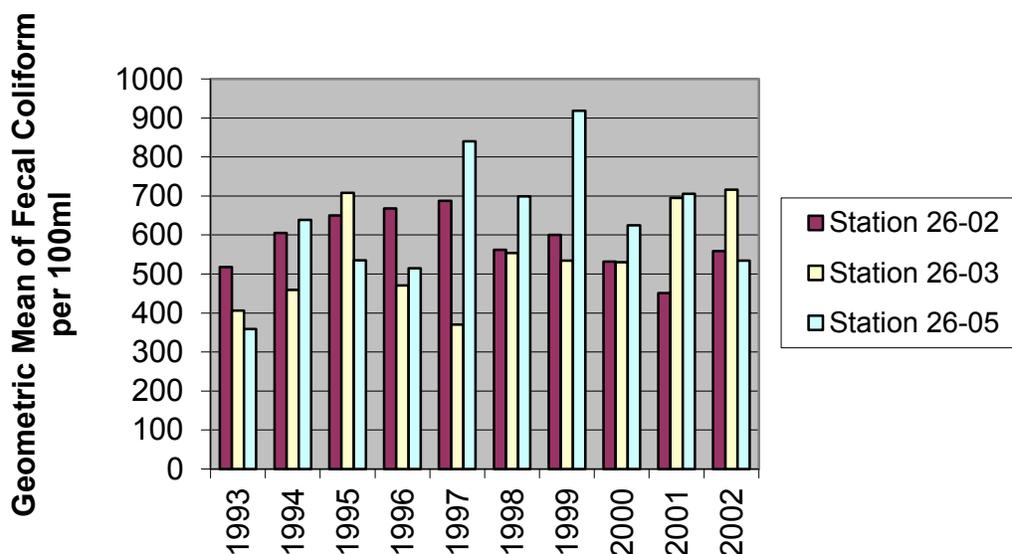
Figure 2.1 Yearly Geometric Mean of Fecal Coliform for Popes Head Creek

The Fairfax County Health Department formerly monitored stream water quality at three sampling sites in the watershed. The *Fairfax County 2002 Stream Water Quality Report* concluded that the overall water quality for Popes Head Creek is good for the chemical and physical parameters, including excellent dissolved oxygen levels. In 2002, an average of 9% of the samples in the watershed met the good water quality criteria for fecal coliform, as opposed to an average of 15% in 2001.

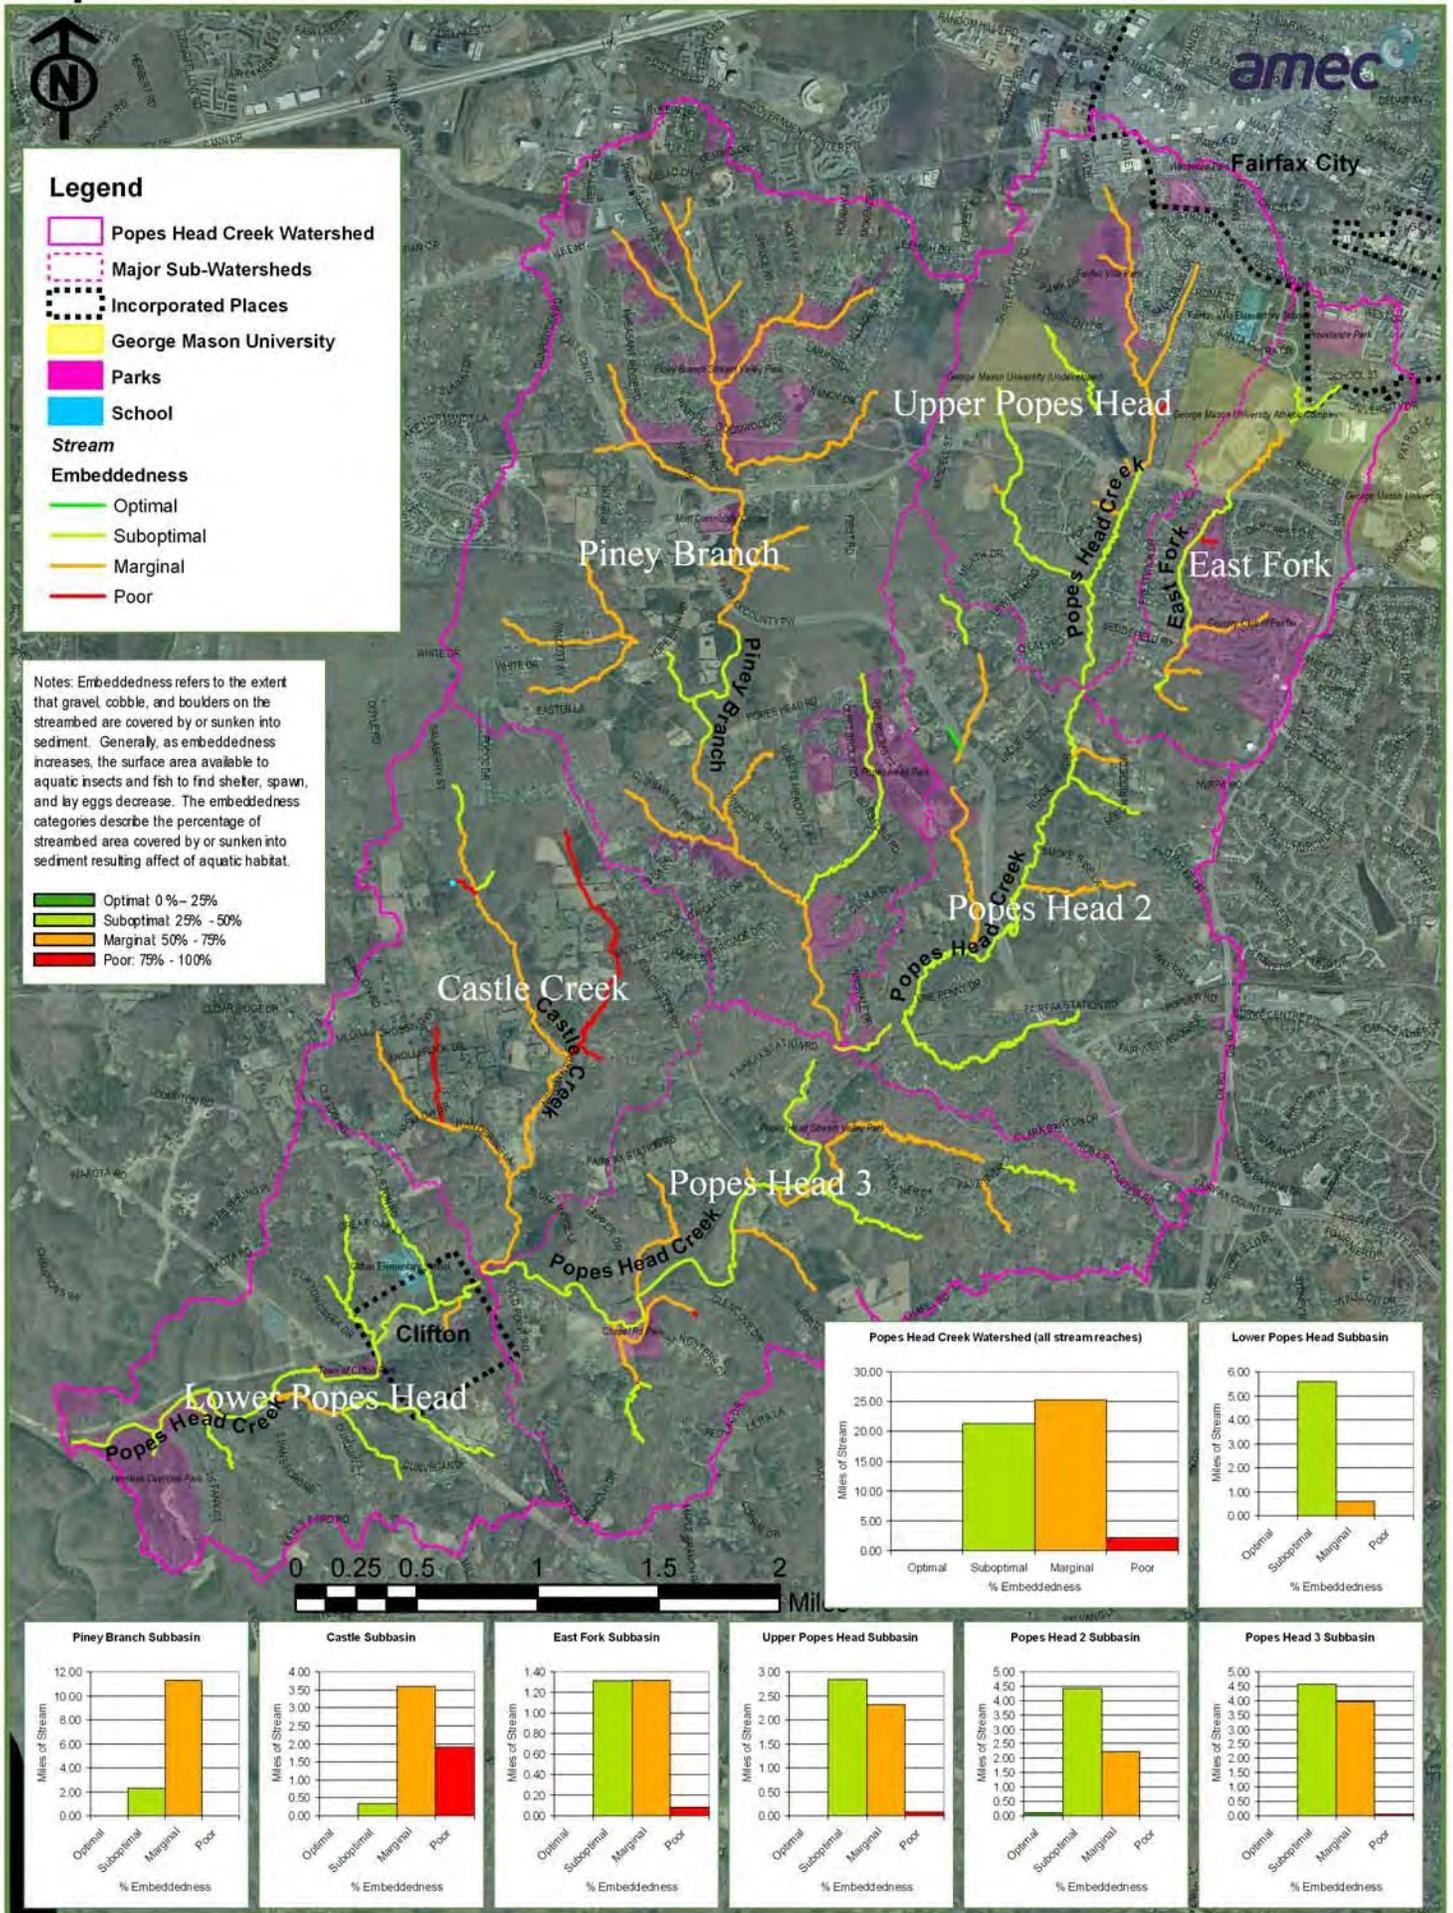
# Map 2.14 Streambed Embeddedness

The stream assessment documented the degree of streambed embeddedness. Embeddedness, referring to the degree to which cobbles and gravel on the streambed are covered with or sunken into sediment, is a measure used to quantify the impact of sedimentation on stream habitat. As the streambed becomes more embedded, the habitat of bottom dwelling organisms is increasingly impaired. Embeddedness is a critical issue in the Popes Head Creek watershed, with roughly 55% of stream reaches exhibiting high levels of embeddedness, thus resulting in marginal to poor habitat for bottom dwelling organisms. This supports the findings of the *Stream Protection Strategy* study, which found that measures of benthic macroinvertebrate community integrity were generally below average. Map 2.14 shows the streambed embeddedness in the Popes Head Creek watershed.

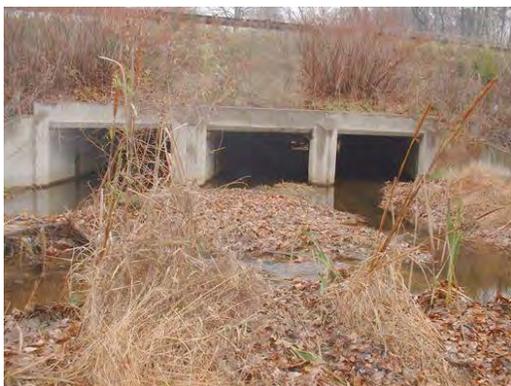
*Photo 3.1 A triple box culvert (PHPH044.C001) has at Braddock Road has a severe impact on the stream*

concrete culvert (PHPH044.C001) has a severe impact on the main stem, as shown in Photo 3.1.

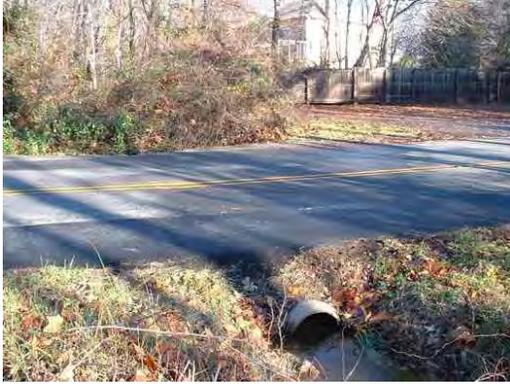
*Photo 3.4 A culvert (PHPH036.C002) at Popes Head Road has a minor impact on the stream*

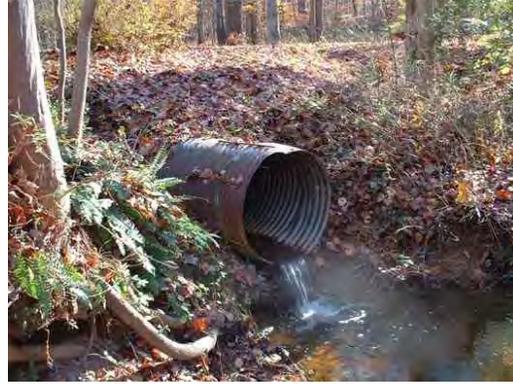
*Photo 3.5 A culvert (PHPH039.C002) at McDuffie Lane has a minor impact on the stream*

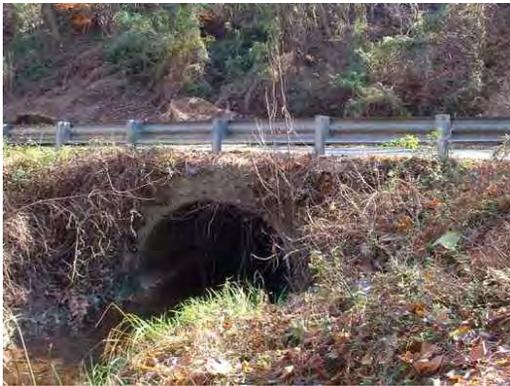
*Photo 3.6 A culvert (PHPH028.C002) at Fairfax Station Road has a minor impact on the stream*

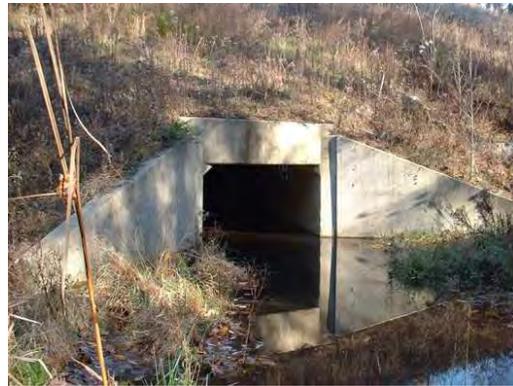
*Photo 3.7 A box culvert (PHPH028.C003) near Fairfax County Parkway has a minor impact on the stream*

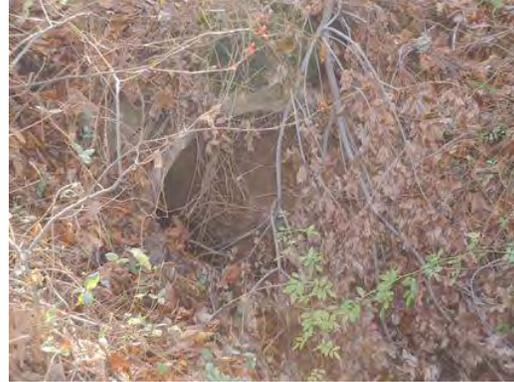
*Photo 3.9 A culvert (PHCC005.C002) at Knollbrook Drive has a minor impact on the stream*

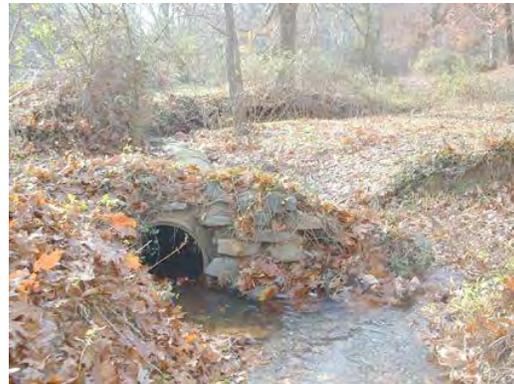
*Photo 3.11 A culvert (PHCC004.C002) at Wandering Lane has a moderate impact on the stream*

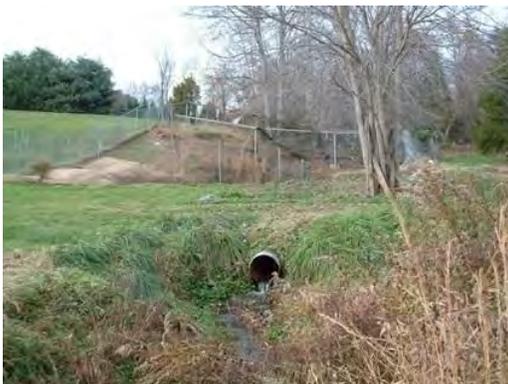
*Photo 3.12 A storm drain outfall pipe near Wandering Lane has a moderate impact on the stream*

Five storm drain outfall pipes discharge into Castle Creek. One pipe causes moderate erosion, as shown in Photo 3.12.

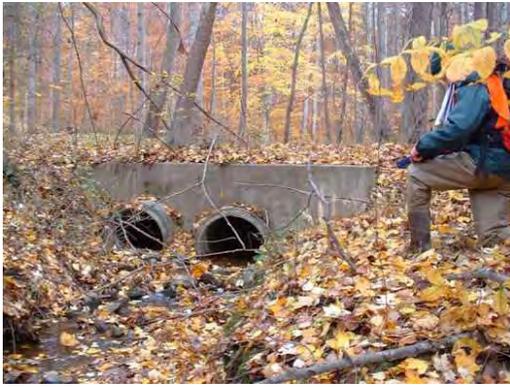
Photo 3.13 A double barrel culvert (PHPH025.C002) near Havenner Court has a minor impact on the stream

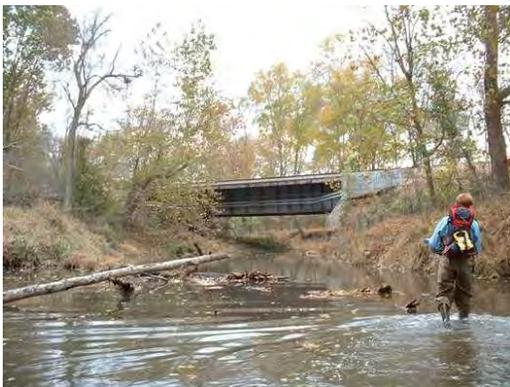
Photo 3.15 An iron bridge (PHPH014.C001) at Chapel Road has a minor impact on the stream

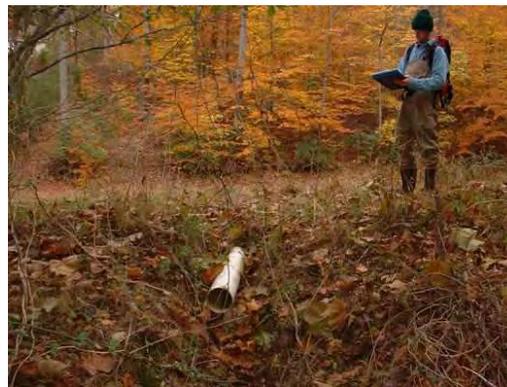
Photo 3.16 A storm drain pipe outfall is causing moderate erosion

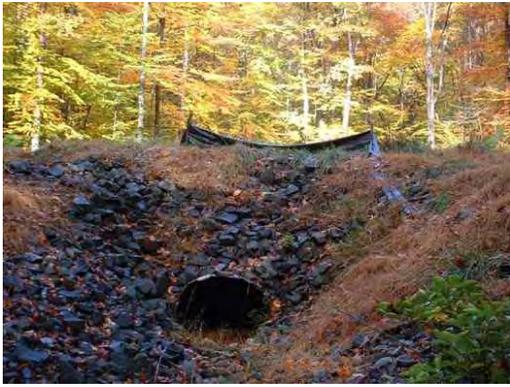
Photo 3.17 A culvert (PHPH014.C001) at Great Oak Lane has a minor impact on the stream

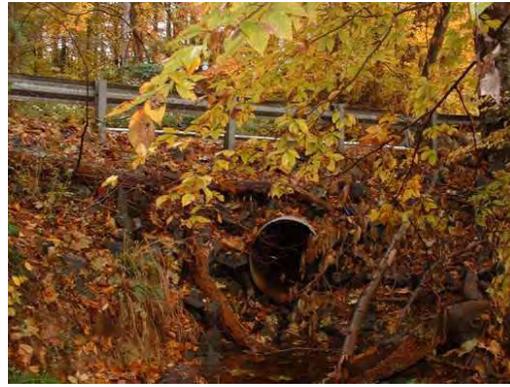
Photo 3.18 A culvert (PHPH009.C001) at Clifton Creek Drive has a minor impact on the stream

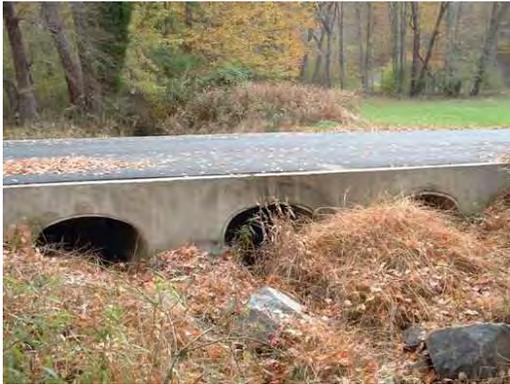
Photo 3.19 A culvert at (PHPH005.C001) Dunquin Court has a minor impact on the stream

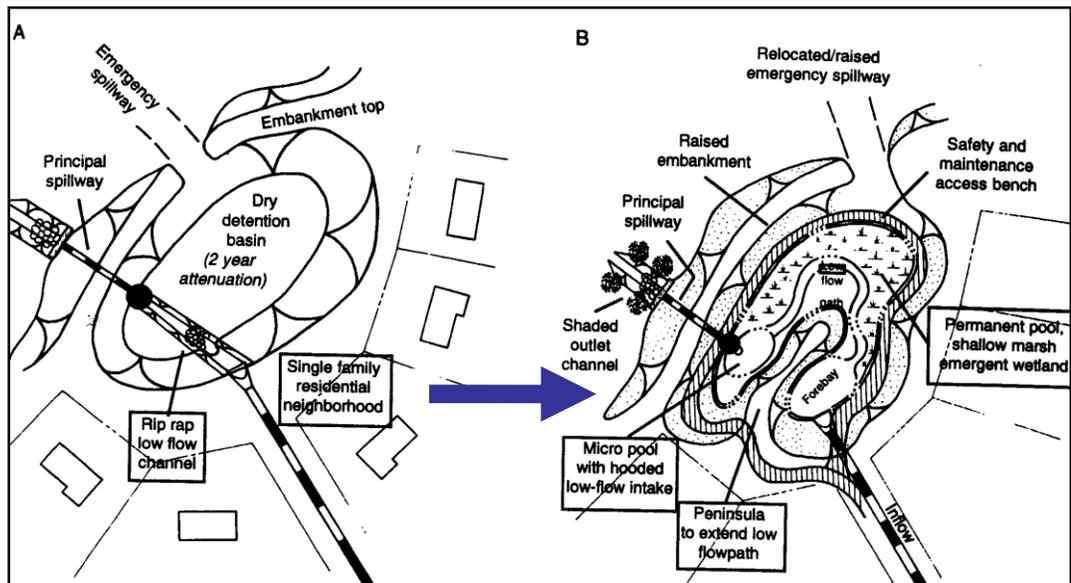
Figure 4.1: Stormwater Pond Retrofit

**Maintenance:** The maintenance requirements of a retrofitted pond are not significantly more than a traditional stormwater pond. A typical pond is inspected by County personnel trained in dam safety and pond maintenance, looking at the dam, pipes, and riser structure to ensure it is functioning properly and not failing. Additional items that need to be inspected are any pretreatment facilities for clogging by sediments and large debris items. If sediment buildup or clogging is evident, the area needs to be cleaned. Manufacturer's maintenance recommendations need to be followed for all Manufactured LID products.

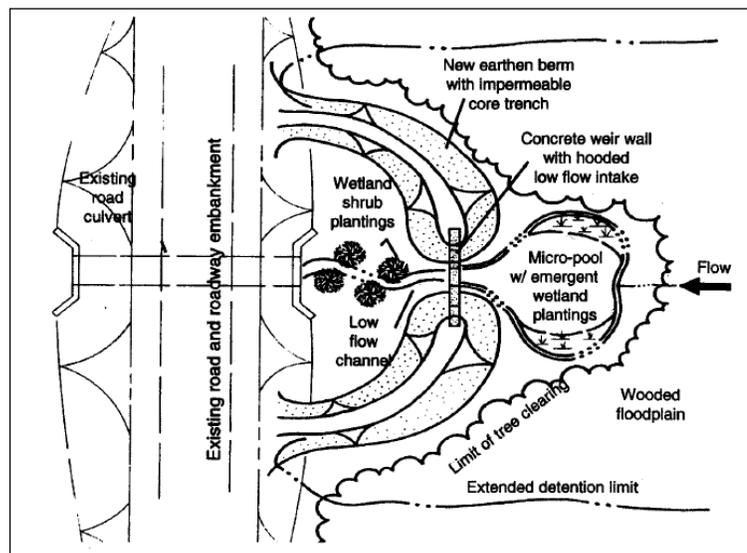
Figure 4.2: Culvert Retrofit

These facilities have an expected life span of 25 years.

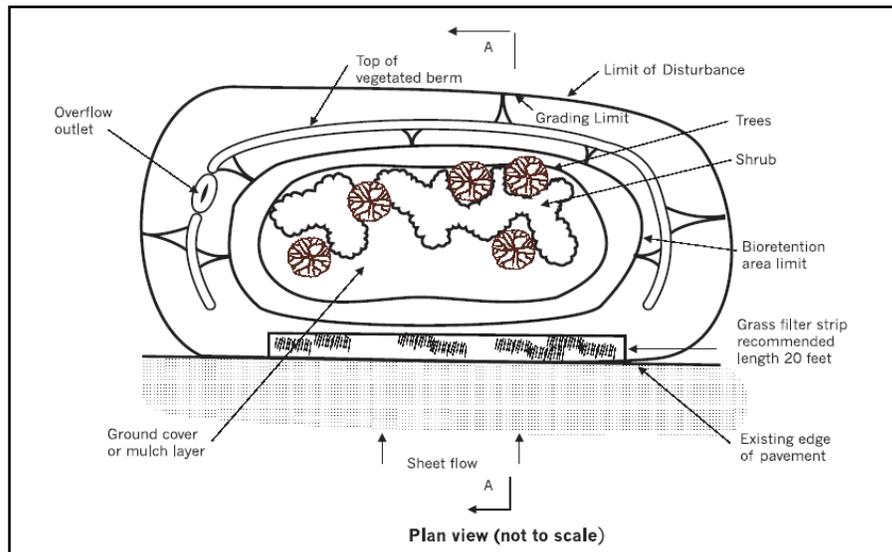
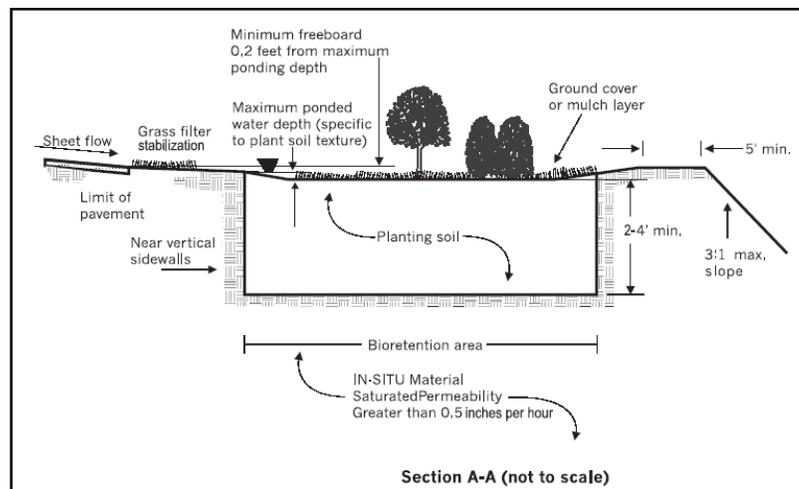
Figure 4.3: Bioretention Area

These facilities have an expected life span of 25 years.

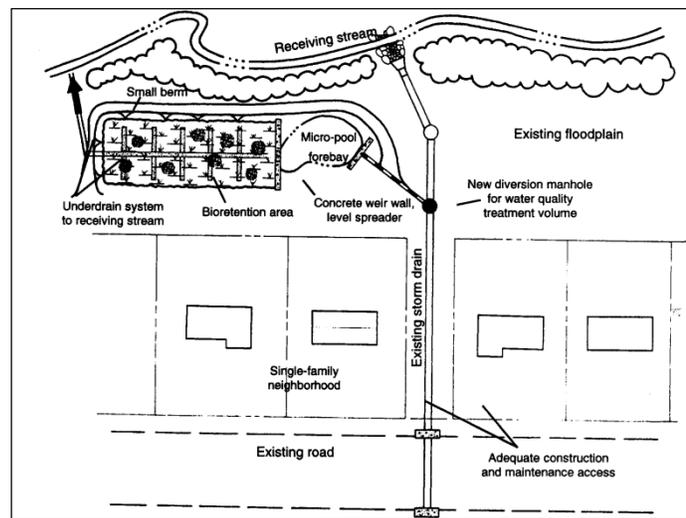
Figure 4.4: Pipe Outfall Retrofit

These facilities have an expected life span of 25 years.

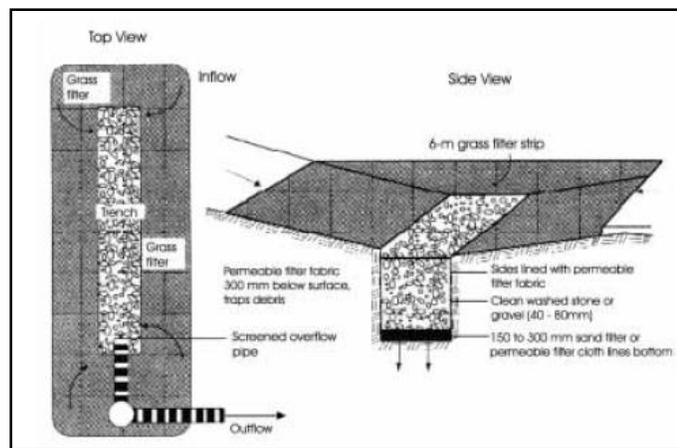
Figure 4.5: Infiltration Trench

These trenches have an expected life span of 10 years.

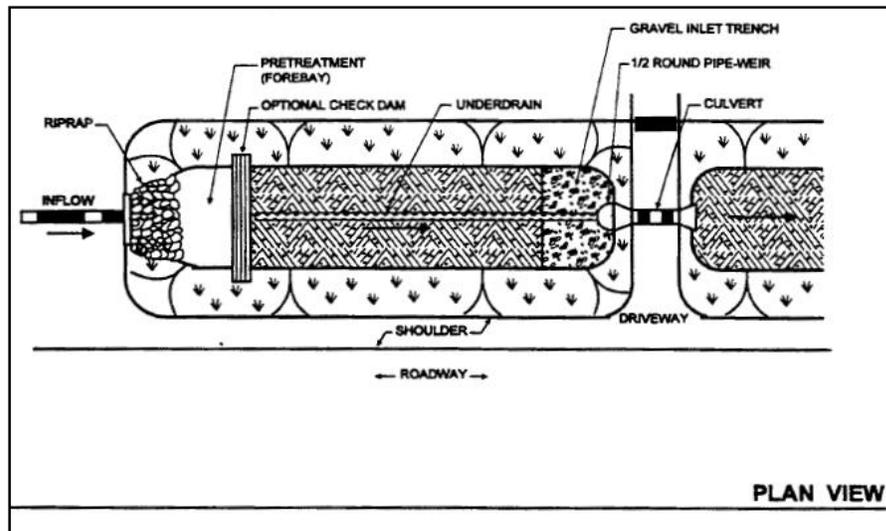
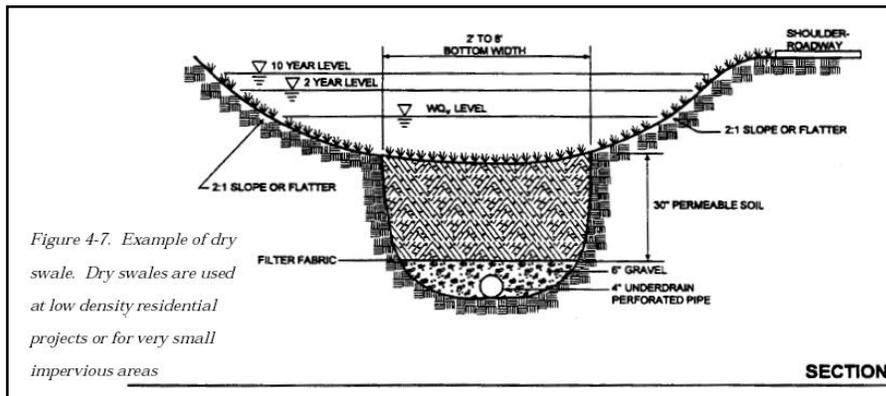
Figure 4.6: Grassed Swale

These swales have an expected life span of 25 years.

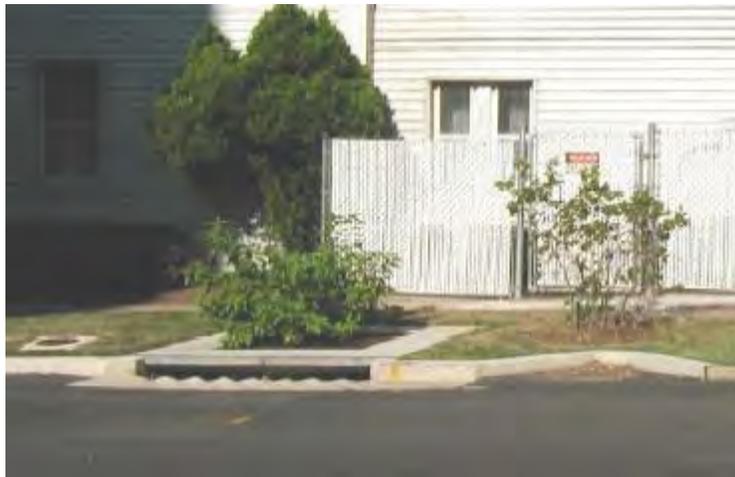
Figure 4.7: Manufactured LID

Manufactured LIDs have an expected life span of 25 years.

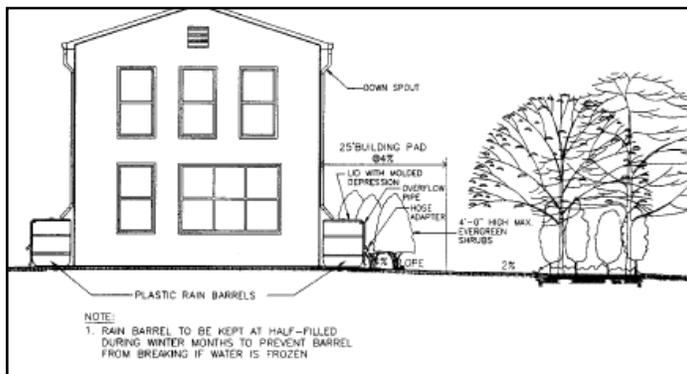
Figure 4.8: Rain barrel

Rain barrels have an expected life span of 25 years.
