Historic Huntley

General Management Plan

GENERAL MANAGEMENT PLAN FOR HISTORIC HUNTLEY

**FAIRFAX COUNTY PARK AUTHORITY
January 2002**

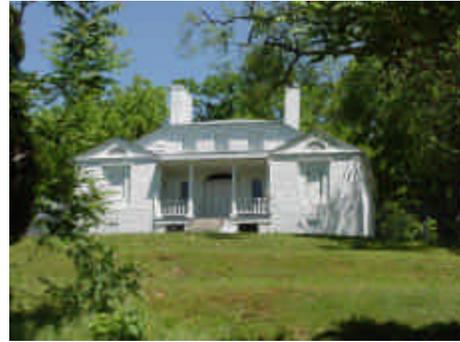
The house is of brick construction laid in common American bond with a course of headers every fifth row. The average brick size is 8-3/8 inches by 4 inches by 2-1/4 inches thick.

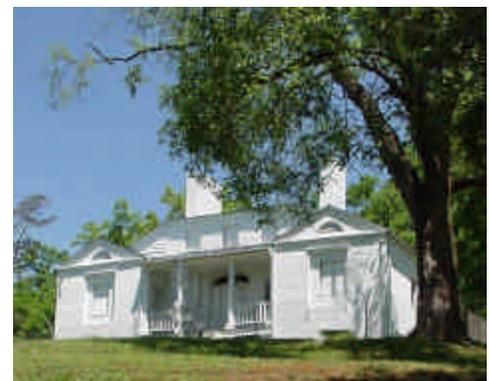
Originally, the house was "H" shaped. The center block is two stories with a banked cellar opening on the south side and one room deep. The wings on either side are one story with a cellar and two rooms deep. The major entrances are on the first floor of the main block, although each southern facing wing has a cellar opening. The wings project about half their width south and north from the center section. This arrangement provides a large center room on the first floor, with two rooms on each side. On the second floor, which is likely a later development, there is only one large center room, while the cellar has a large center room with two flanking rooms on each side. There is no obvious physical evidence for an interior stairway to the second floor.

A wing has been added to the northwest portion of the house. This is of brick and wood construction. The north side of the main block has been framed to create a hall space and an enclosed stairway to the second floor room and access to the cellar. It too is built partially of

brick and wood. On the second floor, the extension provided an extra room and a bath. The exact construction date is unknown.

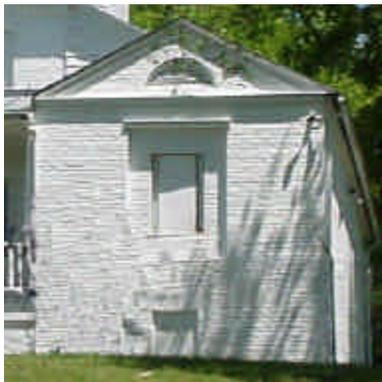
Windows in the facade are unique in that they are set into recessed brick frames. While the frames in the root cellar (below the office) are arched, those in the residence are square panels, with the window set into the center of the frame. According to architectural historian E. Blaine Cliver, the exterior window construction is quite simple with a double beaded frame set into the brick two to three inches from the front surface. The simplicity of the window framing, which is Federal in style, would place the house somewhat after the late Colonial period, in the early 19th century. Windows on the cellar and first floor are six-over-six, double-hung sash, except adjacent to the south side entrance where they are four-over-four. The windows on the second floor consist of a single, nine-pane sash, which opens to the side on hinges. The pane size is 8-1/2 inches by 10 inches. The exterior shutters consist of a single

panel of fixed louvers and some shutter hardware survives. This includes several types of shutter stops, which are generally wrought rather than stamped.

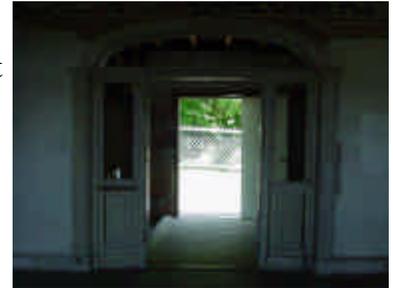
The south door entrance has framing sidelights and an elliptical fanlight with wood tracery. In general, the oval fanlight came into use after the 1790s and went out of common use around 1825; although according to Mr. Cliver it probably was not

common in this area until after 1800. The stiles of the entrance are basically the pilaster types, although the reeding within the pilaster is rounded rather than flat. An opposing door at the north facade of the main block also was originally an exterior entrance but is now incorporated in the later addition. The keystone over the fanlight has a beaded center portion, which is similar to those found in the work of 19th-century architect Asher Benjamin.

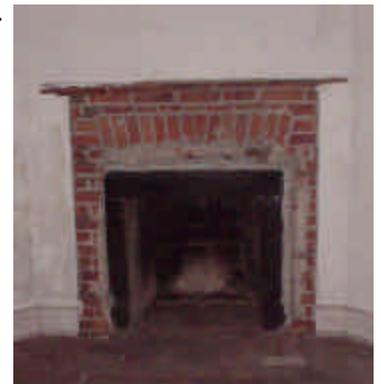
The center block first floor room has an excellent fireplace mantel, which is also similar in proportion to the Federal styles of Asher Benjamin. The mantel is somewhat busy, and a little heavy, yet it has delicate detailing and reeding on the sides. Basically, the proportions are the same and dateable to the early 19th Century. All four of the side mantels are of the same basic design, but each has been given an individual detail or refinement.

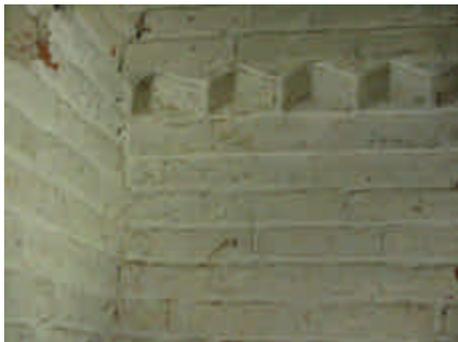
On the two wings the wooden cornice is fairly deep, approximately 8 inches, providing a slight projection. This may be indicative of a later date architectural development more in keeping with the Greek Revival period. If they are of a later date, it is certainly within 30 to 40 years after the house was constructed, or no later than the mid-19th century. The saw-tooth cornice line does not run behind the

present wooden cornice, indicating, along with the fact that brick bonding continues into the gable end, that the roof configuration on the wings is probably original. The only probable differences between the original roof and what is now in place is that the gable ends over the center section were clipped, giving the appearance of a hip roof when seen from the front. This roof continued, shed style, over the wings.

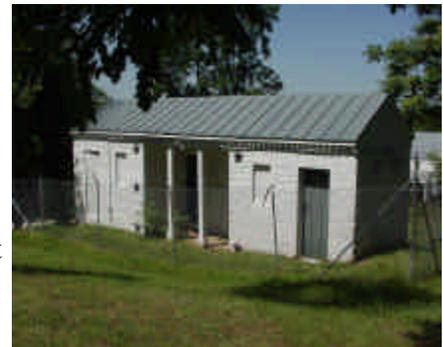
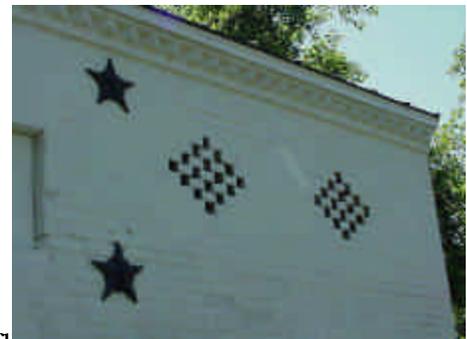
The building, once referred to as the slave quarters, does not seem

to have been suitable for the housing of human beings, and likely was never used for this purpose. It is a one-story brick structure with a gable

roof over three rooms. Neither of the end rooms has a finished floor or ceiling, nor do they appear to have had finished walls; the windows are wall openings protected by iron bars; each room has four brick

diamond-shaped ventilators and neither seems to have been heated, as there is no evidence of

chimneys or flues. It is likely that both rooms were used for storage spaces and, from the evidence in existing doors and windows, secure ones. The overall measurements of the building are approximately 34 feet 8 inches by 10 feet 10 inches, each end room measuring approximately 11 feet 11 inches by 10 feet 10 inches.

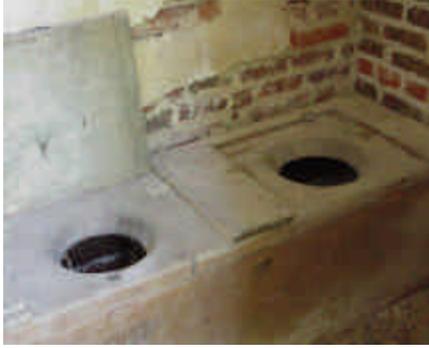
The necessary, a privy or outdoor toilet, occupies the central recessed portion of the structure between the two end storage rooms. It measures approximately 10 feet 10 inches by 5 feet 5 inches, and includes (what was probably) separate men's and women's sections.

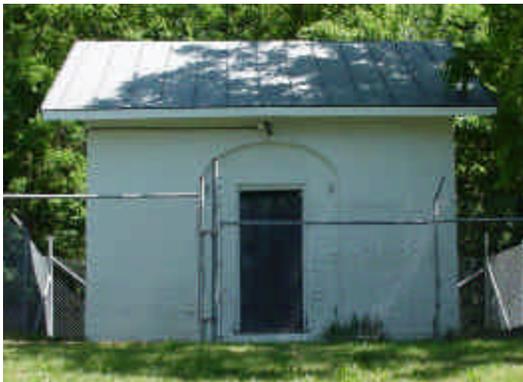
This building, located 15 feet northwest of the house and adjacent to the icehouse, consists of a one-story brick structure above ground (office), approximately 15 feet 2 inches square, with a full cellar below ground level (root cellar). Access to the root cellar is through steep steps of rough cut stone, located on the east side of the structure. Access to the icehouse is directly opposite the stairway.

Evidence of ventilators can be seen on both north and south walls. These were barred openings approximately 6 inches deep with vents to the surface. They were finished with brick and faced with quarried stone at ground level. The bars are now gone, but they were horizontal, instead of vertical, as are those in the storage rooms adjacent to the necessary, and are of approximately the same size.

The root cellar walls are brick, laid in common bond, with three courses of stretchers to one of headers. This bond is uniform for the structure, above and below ground. The average size of bricks is 8-3/8 by 4 by 2-1/2 inches. The plain cornice is uniform, probably indicating that the roof was originally hipped.

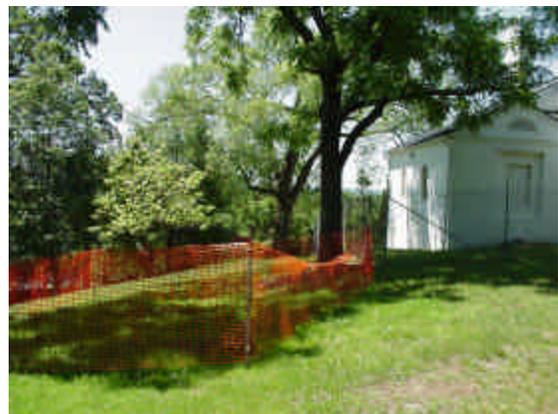
To date there has been one subterranean building site archaeologically located at Huntley Historic Site. It lies directly east of the existing above ground "office" or storage outbuilding found adjacent to the icehouse. The archaeological site defines a one-story building measuring 16 by 16 feet and lying approximately 15 feet north and 15 feet east of the main house. It is a mirror image of the "office" and completes the five-part classical format of the main house complex.

The structure differs from the above ground "office" by lacking a cellar and being banked slightly into the sloping terrain of the east side of the park. The building's construction is somewhat unusual in that the last course of bricks forming the

east foundation wall rests on subsoil that was not completely excavated to the corresponding depth of the west foundation wall. This seems to have more to do with the expediency than some type of unique building method. The short cut may have led to the building's early demise, as the clays in this area of Fairfax County are not very stable.

The building function could not be identified archaeologically but it is likely that it was an additional storage area for dry goods. Because few artifacts were found that could help date the structure, other means were employed. A comparison of brick size and manufacturing style between the main house and "office" were found to be identical. Additionally, the composition of the mortar was analyzed and reflects a sand and shell base, a mix used extensively in the early 19th century and before. Dating can also be accomplished through architectural means. Based on the symmetry presented in the design of the main house, construction of the "office" alone on the landscape would be incompatible with the classical architecture so evident at Huntley.

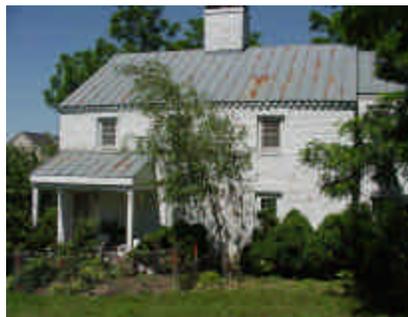
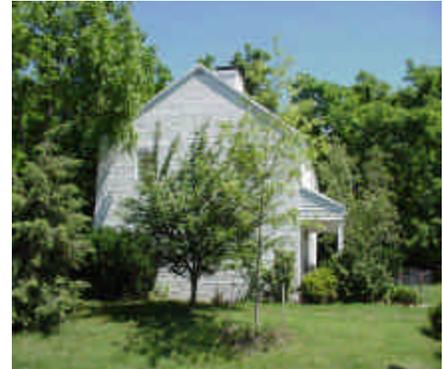
The tenant house is a brick two-story structure with a gable roof, a slightly off-center interior chimney and a three-bay front. The building is approximately 32 feet long and 22 feet wide. A seven-foot projection on the right end, added in the 20th century, houses bath and kitchen facilities. It is approximately 270 feet west of the house.

This structure reportedly burned in 1947 leaving only the exterior brick walls. However, there is no burn evidence in the attic or from archaeological

excavations adjacent to the structure. The windows, doors and interior features are modern, but whether this is due to a fire or done to update the aging house is unclear. As part of the Huntley complex, it is still a visually important building.

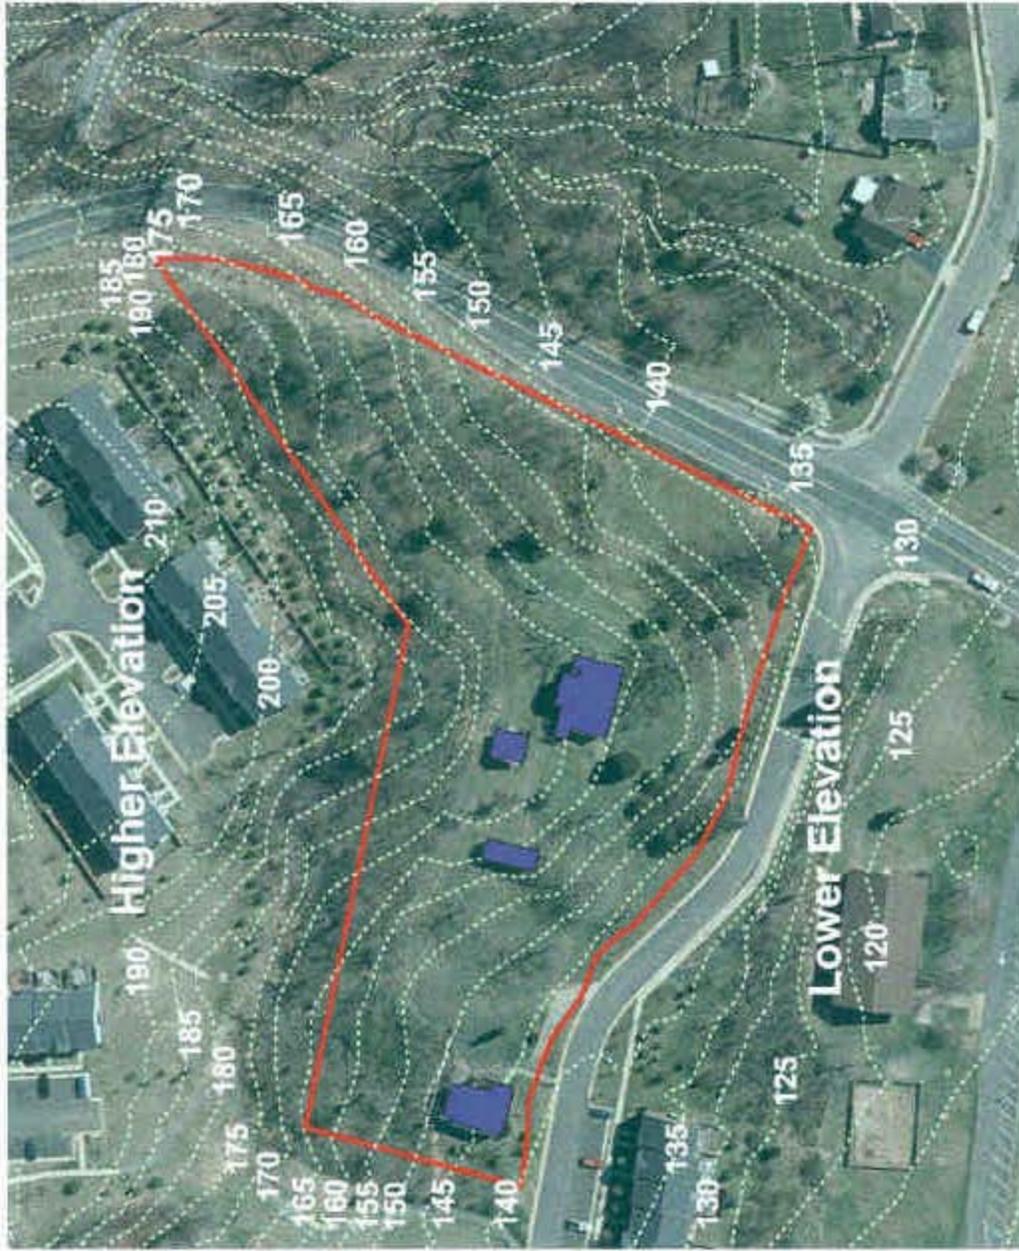
Historic Huntley: Slope Map

Legend:
Contour Intervals = 5 feet

Due to the severe slope and the terracing found at the Historic Huntley Site, any construction, such as a parking area or entrance road, will greatly affect the site (see Page 16a). The gradient is most severe at the north portion of the property and slopes downward toward the southeast, near the ruins of the springhouse. The steepest slope is at the terracing of the house and along Harrison Lane. The terracing was built at the south and east sides of the main house structure leading down to the lower elevations. The terracing elevation rises 20 feet within 90 feet. Along the third and fourth terrace from the house lies the carriage way/drive that parallels Harrison Lane. The flattest area on the site lies in between the tenant house and the necessary. The elevation rises 11 feet

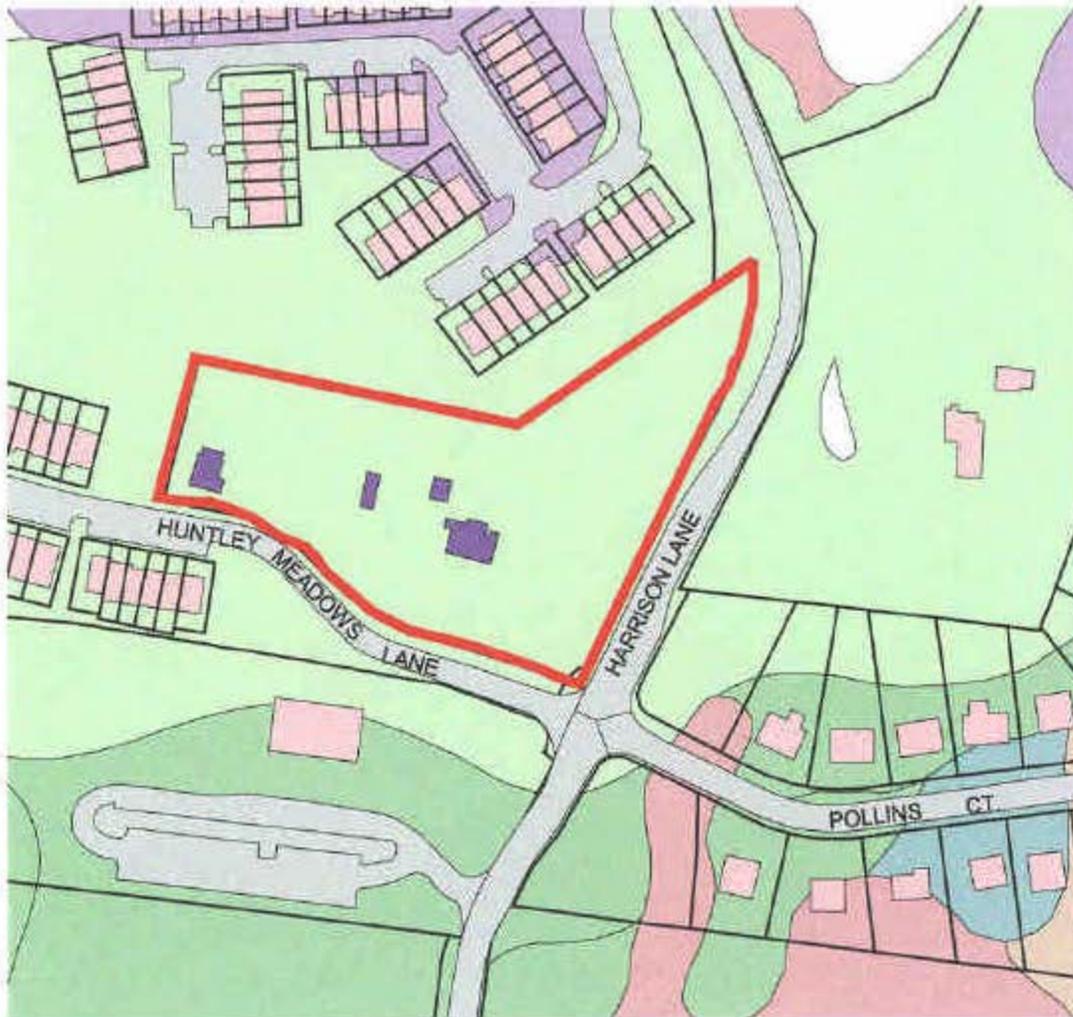
Historic Huntley: Soils Map

- Type A Soils are characterized as having unstable slopes and land slippage, high shrink-swell clays, poor foundation support and/or high water table conditions. A geotechnical report is mandatory for all construction and grading within these problem soils areas.

- Type B Soils are characterized as having wetness and drainage problems that can be addressed with foundation drainage and waterproofing for basements and crawl spaces. A geotechnical report may not be required if the site plan includes adequate provisions to address soil related problems.

The soil that is found at the Historic Huntley site is marine clay (Patapsco clay formation) as shown on page 16b. This clay material is yellowish-brown, dark brown to gray color and in some places has a greenish tint. It is plastic and sticky when wet and becomes quite hard when dry. This formation contains sand lenses that may be water bearing. This is especially true where these lenses are connected to overlying porous material of land or sand mixed with gravel. In areas where the clay has been exposed for long periods during the removal of gravel or during grading operations, the clay shrinks during long dry spells. Shrinkage results in deep cracks and fissures creating more serious deep-seating progressive clay instability. The Patapsco clay formation occurs in disconnected areas from Lincolnia to Gunston. This clay material ranges from 5 to 40 feet or more in thickness with an average of about 25 feet. In most cases, land slippage has occurred on slopes that exceed 15 percent.

Patapsco clay shrinks when it dries under footings. This change in volume of clay has resulted in damage to many homes in Fairfax County. The damage is usually in the form of broken footings, cracked walls, windows that will not open, doors that fail to close, and chimneys pulling away from houses. All tree roots within 20 feet of the walls of the house should be cut because they interfere with the foundation soil moisture stability by absorption through the roots. Under no conditions should the Patapsco clay be used for back fill material around buildings. Where slab construction is used, a special design will be required.

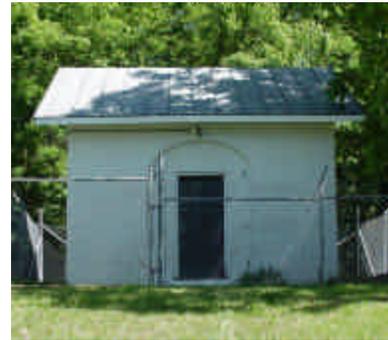
3. Office and Root Cellar

The existing west office will be stabilized.

It may be used as an interpretive area to reflect family life and architecture of the time period. The root cellar may also be utilized for interpretation of the icehouse.

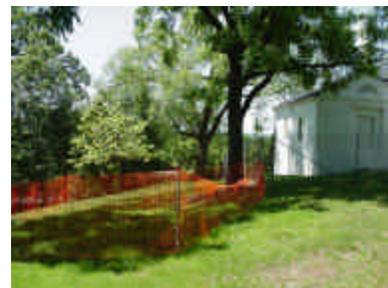
4. Archaeology Site

The east office may be reconstructed to complete the architectural symmetry of the site. A secondary use may be to meet visitor services needs. The exterior of the new structure should resemble the existing office in style.

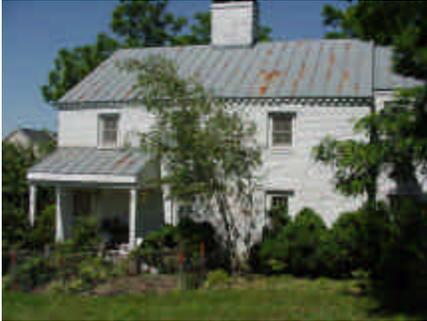
5. Tenant House

The tenant house may be used as office space with a retail area on the first floor. There may be an area designed as an interpretation area used for orientation to the site. History of the site and possibly the vicinity, will be displayed in this area. The

tenant house may also contain restrooms and a cold pantry. The second floor may be renovated for resident staff pending the final recommendation from the Historic Structures Report. The first and second floors may contain storage space.

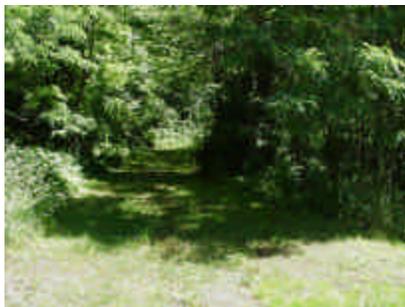
a. Carriageway

The carriageway is to be maintained as a site feature for interpretation. The ground surface will be grass.
