GENERAL MANAGEMENT PLAN
AND CONCEPTUAL
DEVELOPMENT PLAN

WOODGLEN LAKE PARK

APPROVAL DATE: JULY 28, 2004
FAIRFAX COUNTY PARK AUTHORITY

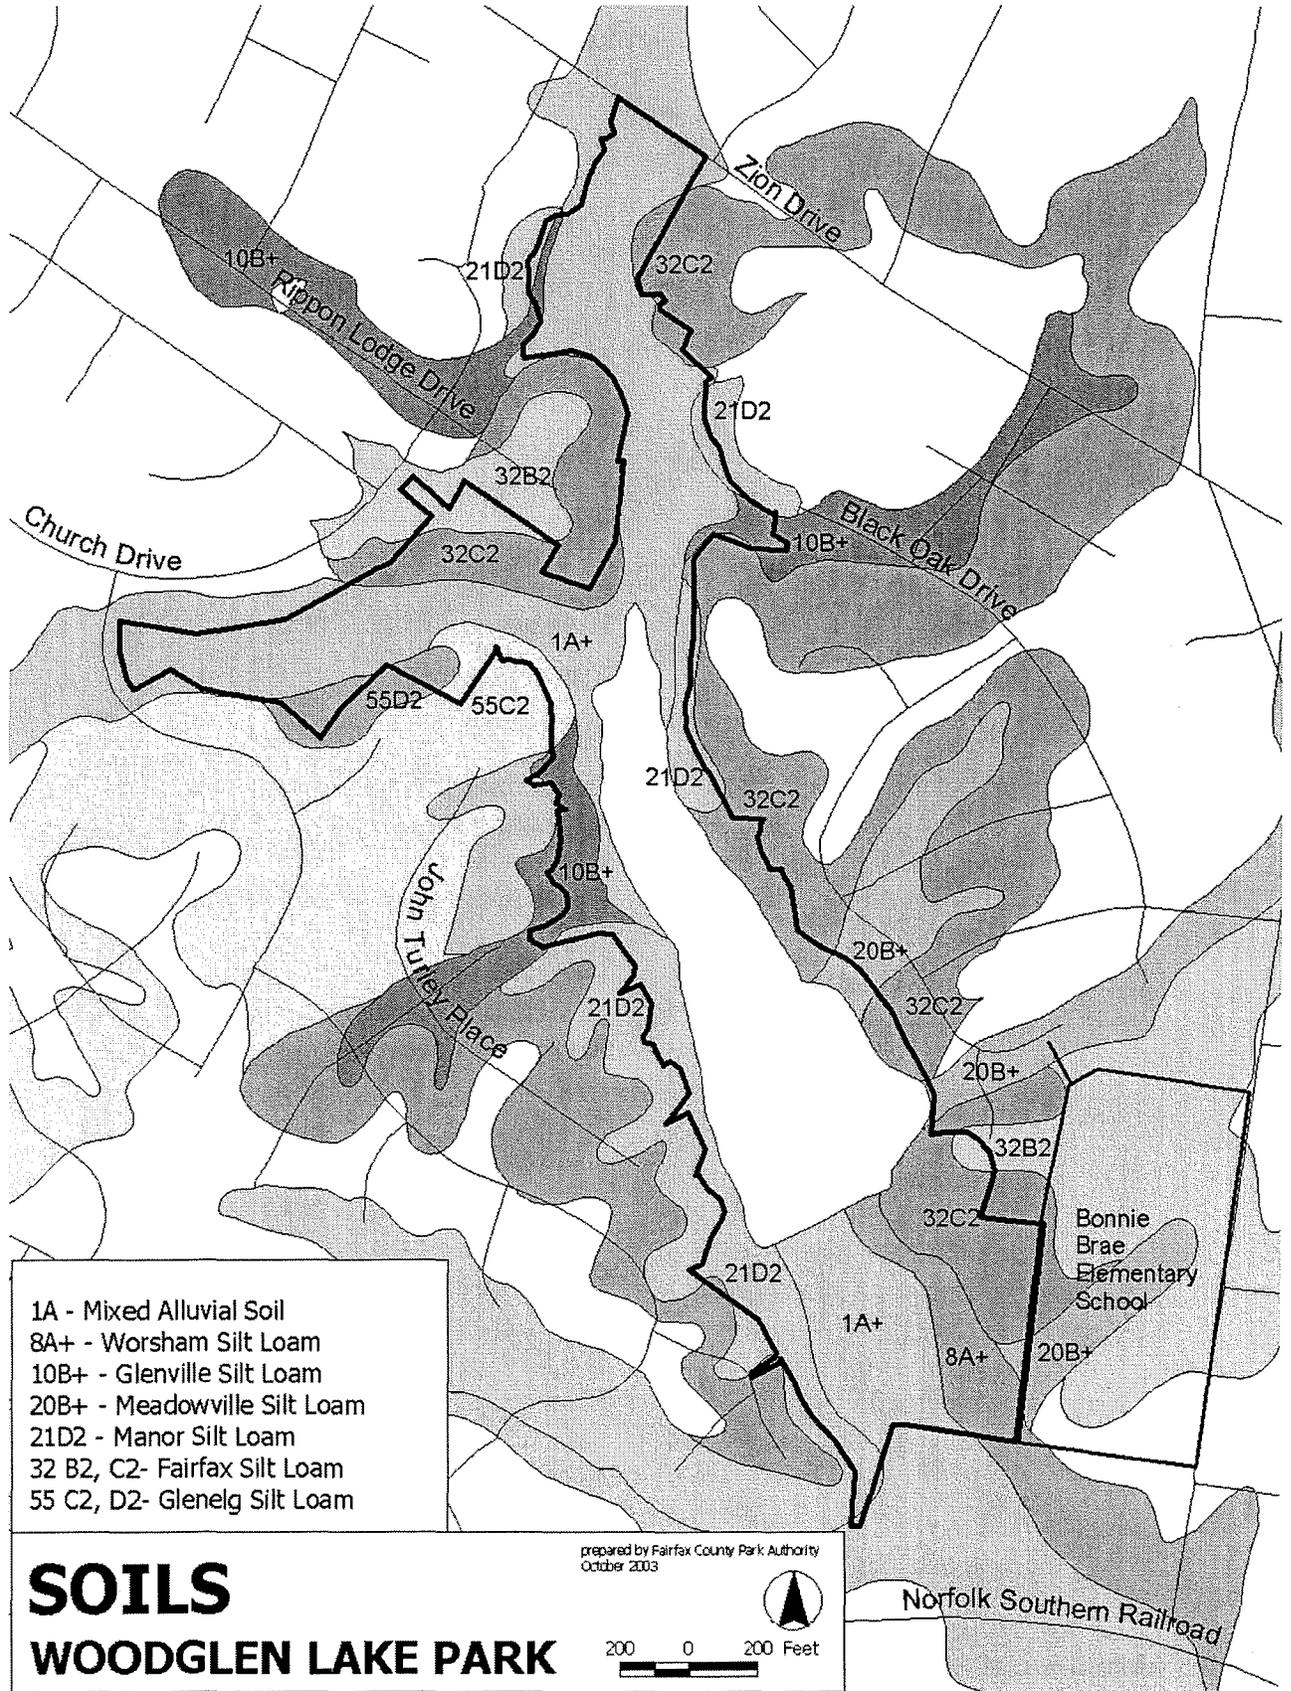
SOILS

- 1A - Mixed Alluvial Soil
- 8A+ - Worsham Silt Loam
- 10B+ - Glenville Silt Loam
- 20B+ - Meadowville Silt Loam
- 21D2 - Manor Silt Loam
- 32 B2, C2- Fairfax Silt Loam
- 55 C2, D2- Glencg Silt Loam

prepared by Fairfax County Park Authority
October 2003

(1A) **Mixed Alluvial Soil** is derived from recent soil materials which have washed from the uplands and deposited along the stream bottoms. It consists mainly of somewhat poorly and poorly drained soils and mixed soil materials including very sandy areas and gravelly bars. It is subject to frequent flooding and needs drainage in many places for any developed uses. More than half of the land area of the park is this soil type, which is characterized as a hydric soil with a high probability of containing wetlands. Stream bank erosion within these soils may result in undercutting of embankments on adjacent properties. This soil is rated poor in the silty and silty clay areas for road and street subgrade, but good in the sandy

(8A+) **Worsham Silt Loam** is also classified as a hydric soil with a high probability of wetlands. It is poorly drained, gray, flat and occurs along foot slopes and upper drainageways. It is subject to seepage waters from surrounding slopes. It is rated poor for most development.

(10B+) **Glenville Silt Loam** is a deep, moderately well to somewhat poorly drained soil in the upper courses of drainageways, in swales in uplands, in saddles between major drainage sheds and on lower footslopes influenced by seepage. The water table is seasonally high and the soil rates fair to poor for most development.

(20B+) **Meadowville Silt Loam** is a deep, brown moderately well drained, friable, fertile soil that is derived from recent colluvial materials which have washed mainly out of the Glenelg, Elioak, and Manor soil areas. The soil accumulates seepage water from the surrounding slopes and has a high water table during wet seasons. The soil rates poor for most development.

(21D2) **Manor Silt Loam**, hilly phase is a strongly sloping, excessively drained, weakly developed, highly micaceous soil that is derived from quartz sercicite schist rock materials. It is difficult to compact and susceptible to erosion. It rates good to fair for development.

(55 C2, D2) – **Glenelg Silt Loam** is a moderately deep, well-drained brown loamy soil formed in materials weathered from quartz mica schist rocks. This soil is located on the upper slopes and hilltops in the Piedmont uplands. It is extensive and typically found in large tracts ranging to several hundred acres in size. It has desirable properties for many uses and rates good for most development.

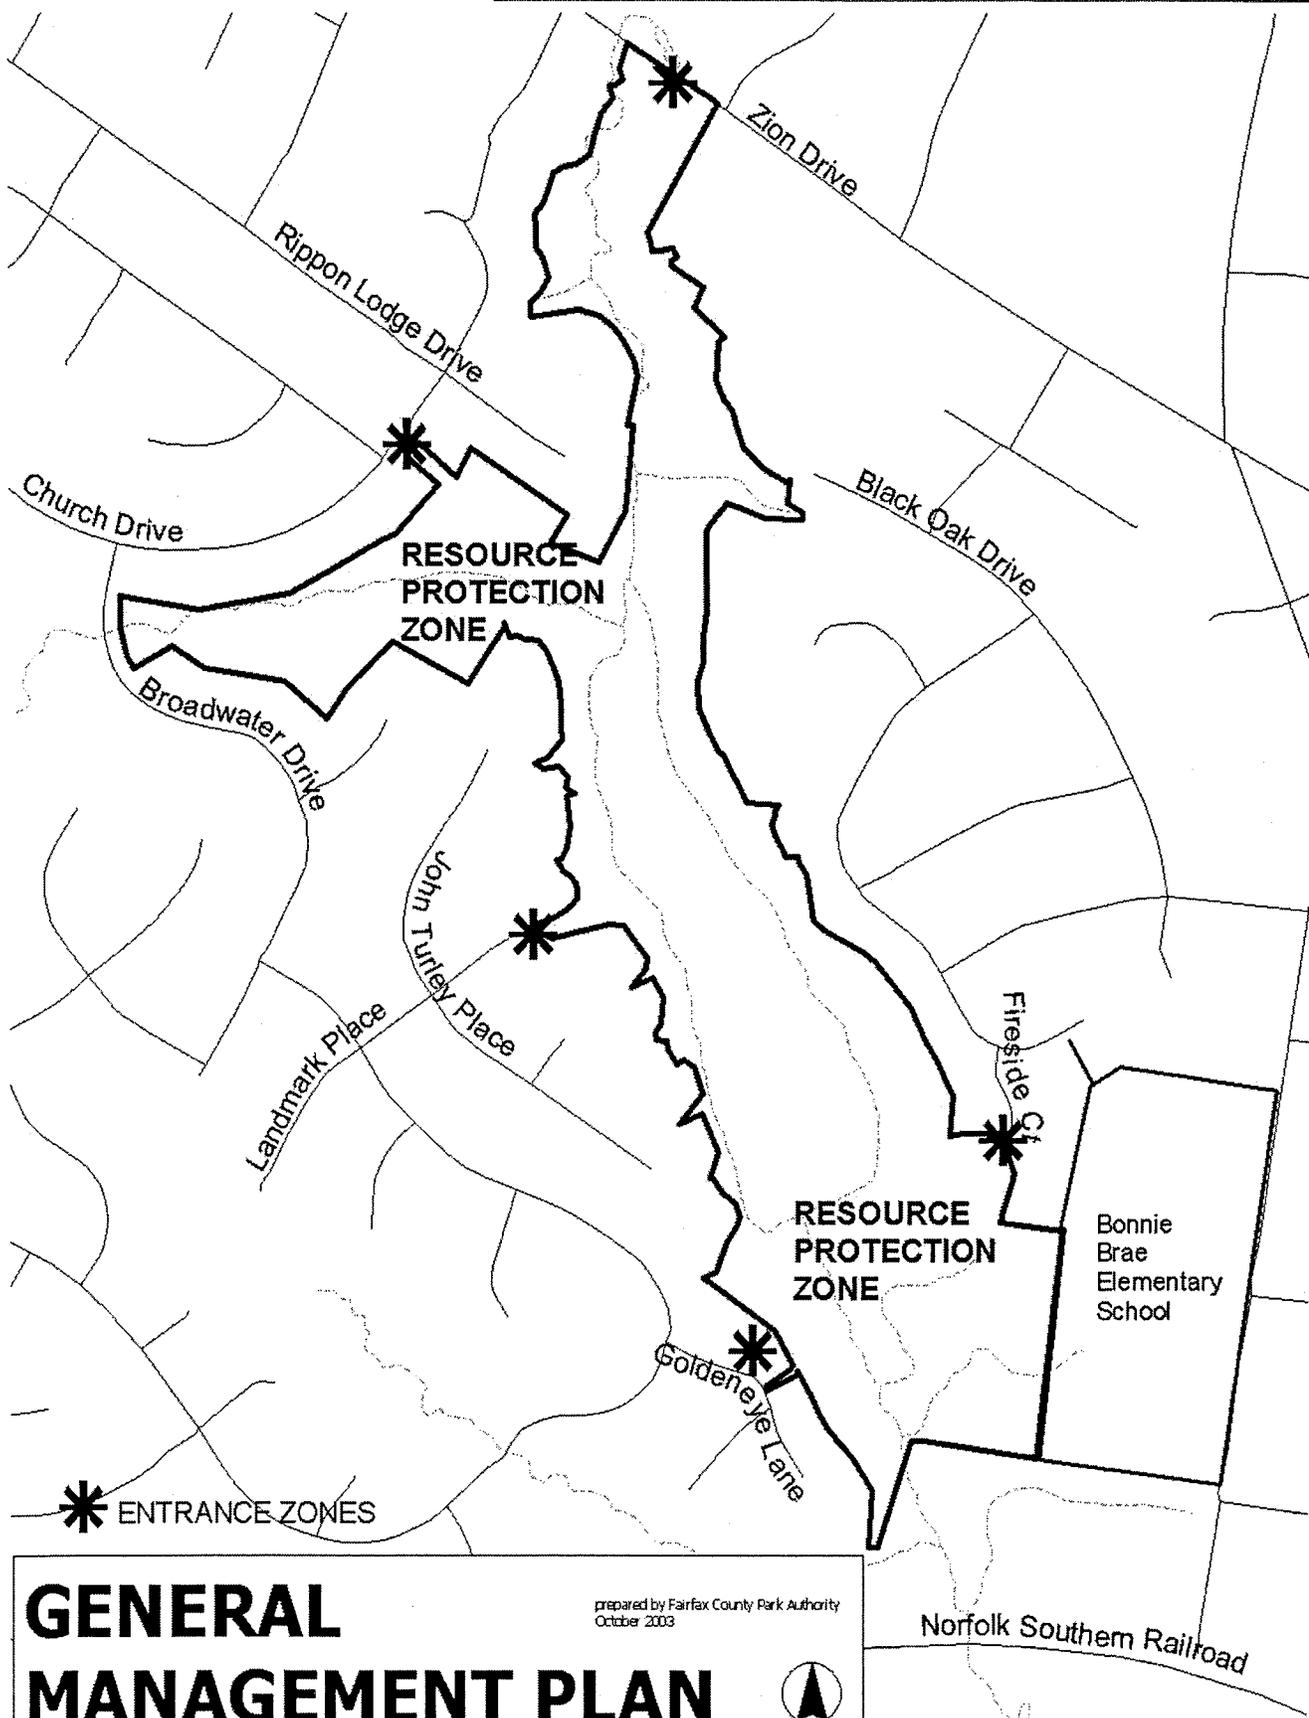
GENERAL MANAGEMENT PLAN WOODGLEN LAKE PARK

prepared by Fairfax County Park Authority
October 2003

The entire park should be protected in a Resource Protection Zone (RPZ). Human impact in this zone will be kept to a minimum. Management of the natural resources will be allowed, however, new structures or environmental degradation of this zone shall be prohibited.
