VDOT Repaving Design and
Operational Analysis
2024 Road Diet Assessments

DRAFT REPORT – Huntington Avenue

April 30, 2024

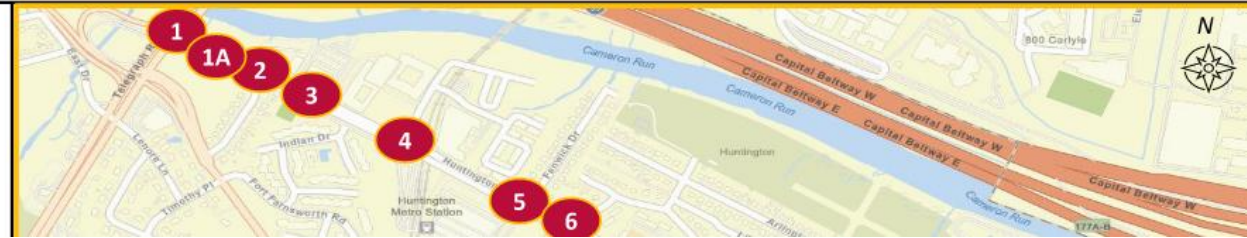
Figure 2: Huntington Avenue Peak Hour Traffic Volumes (7:30-8:30 AM, 4:45-5:45 PM)

*Turning movement count data not collected. Turning volumes are estimated based on turning volumes at upstream and downstream intersections of a similar nature. Through volumes along Huntington Avenue are approximated by balancing with upstream and downstream intersections, rounded to the nearest 10 vehicles.

**Turning movement count data not collected. Ramp volume identified by balancing to zero between Telegraph Road and Kathryn Street.

The network peak hours were used to evaluate the existing traffic conditions and build scenario conditions (with road diet). Peak hour turning movement count data is summarized in **Figure 2**. Based on a review of the network peak hour volumes in Synchro, traffic volumes were fairly balanced along the corridor and no adjustments were made to the source volumes.

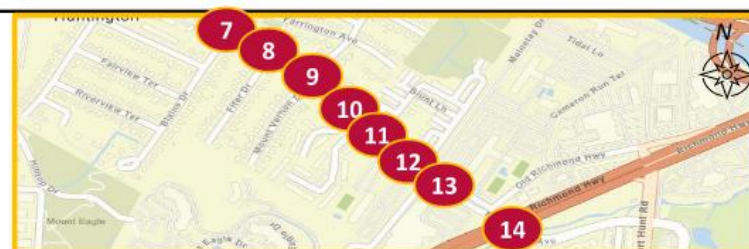
Figure 2: Huntington Avenue Peak Hour Traffic Volumes (7:30-8:30 AM, 4:45-5:45 PM) (Continued)

*Turning movement count data not collected. Turning volumes are estimated based on turning volumes at upstream and downstream intersections of a similar nature. Through volumes along Huntington Avenue are approximated by balancing with upstream and downstream intersections, rounded to the nearest 10 vehicles.

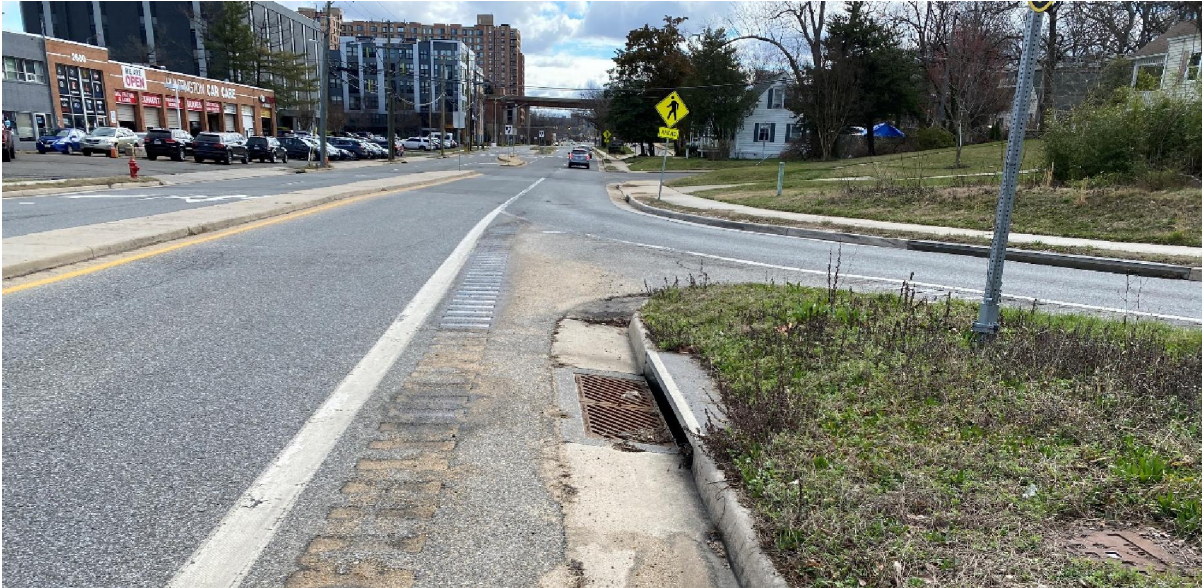
Figure 3: Curb inlet at access ramp between Telegraph Road and Kathryn Street

Potential bike lane impacts include poor pavement conditions, which will be remedied by the repaving project, and one in-road inlet at the access ramp between Telegraph Road and Kathryn Street, visible in **Figure 3**. However, since this inlet is within the two-foot gutter pan, it does not directly conflict with any modifications made to accommodate a bike lane.

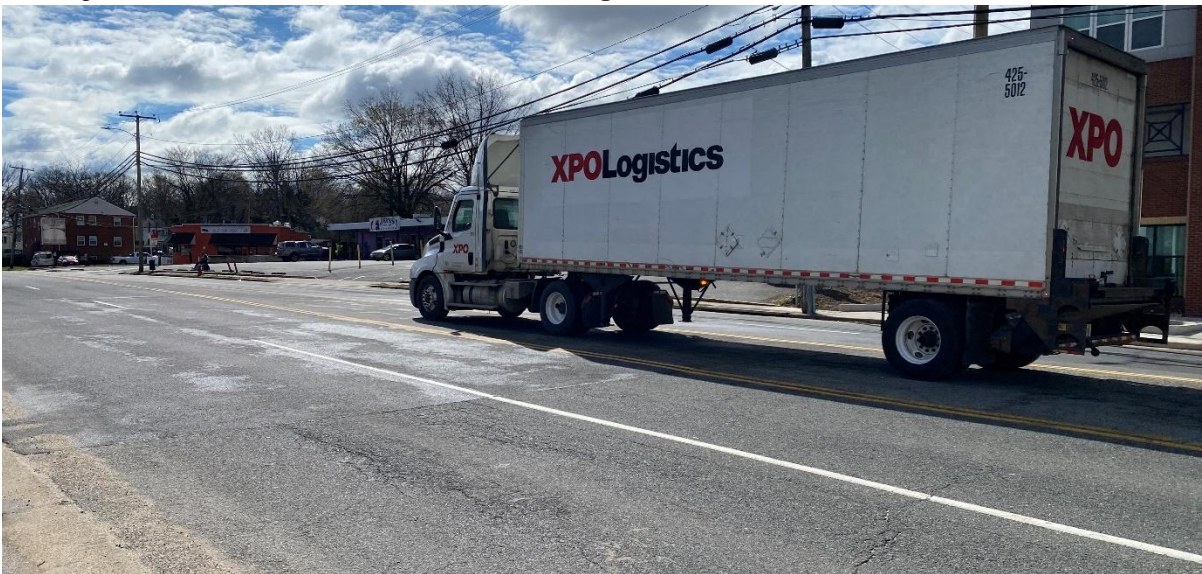
Figure 4: Truck parked in the painted median on the east leg of Farrington Avenue and Huntington Avenue

Vehicles present on the corridor included school buses, garbage trucks, and delivery trucks. There was one semi-trailer truck parked in the painted median on the east leg of the Farrington Avenue and Huntington Avenue intersection, visible below in **Figure 4**.

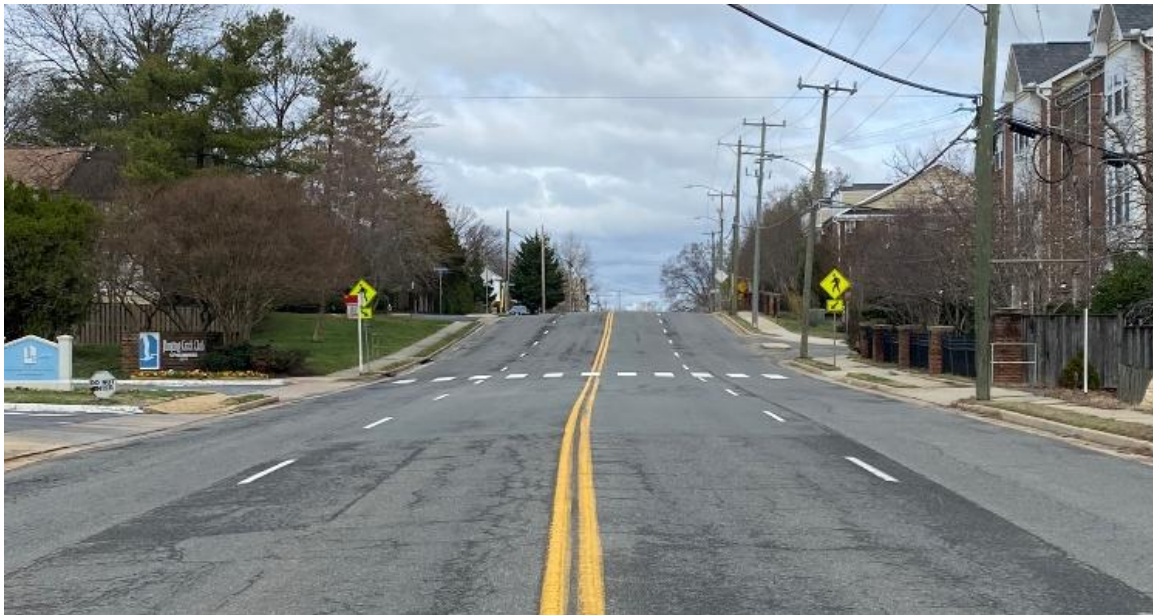
Figure 5: Crosswalk at Foley Street and Huntington Avenue, looking west

It also should be noted that the stopping sight distance is limited by the vertical curve for vehicles traveling eastbound at Foley Street. This can be referenced below in **Figure 5**. The photograph was taken east of the crosswalk east of the intersection of Foley Street and Huntington Avenue, looking west.

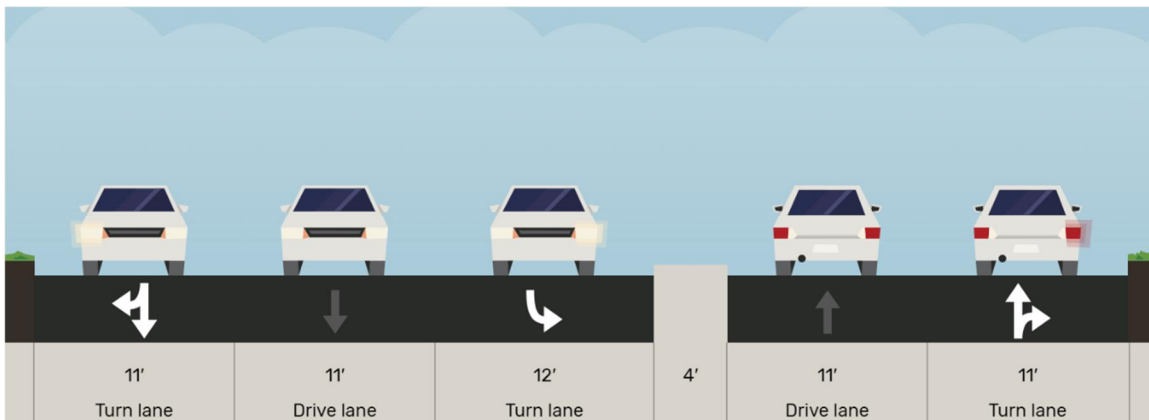
Figure 6: Huntington Avenue Existing Conditions Cross Section – With Median

Using the information from the analysis of existing roadway geometry and traffic conditions, an assessment of the impact of the proposed road diet was completed. The modifications of the corridor include the removal of one eastbound and one westbound through travel lane to install a buffered bike lane along the north and south curbs. **Figure 6** and **Figure 8** show the existing cross sections of the corridor, while **Figure 8** and **Figure 9** show typical cross sections for the potential build conditions. The graphics were created using Streetmix.

Cross section graphics do not include existing gutters, which represent additional horizontal space to accommodate the reconfiguration of the roadway width for bike lanes. Gutters along Huntington Avenue were measured to be 2 feet. The bike lane is proposed to be 4' wide, leveraging additional 2 feet of gutter to provide an effective bike lane width of 6 feet and a resulting buffer of 2.5 feet.

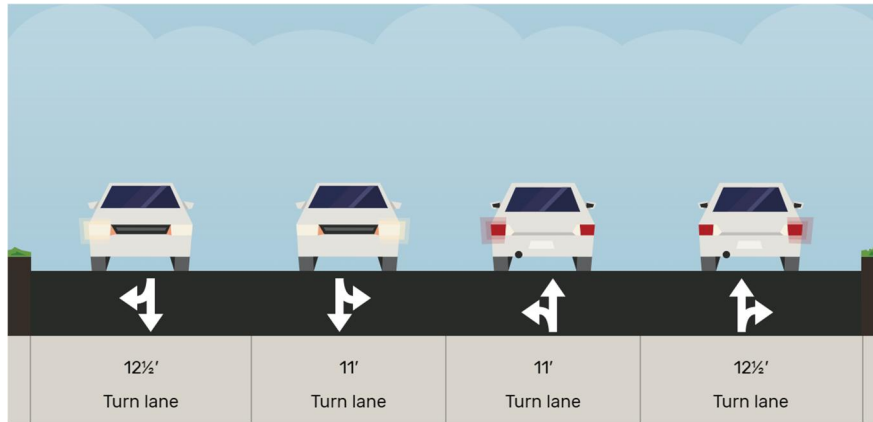
Figure 7: Huntington Avenue Existing Conditions Cross Section – No Median

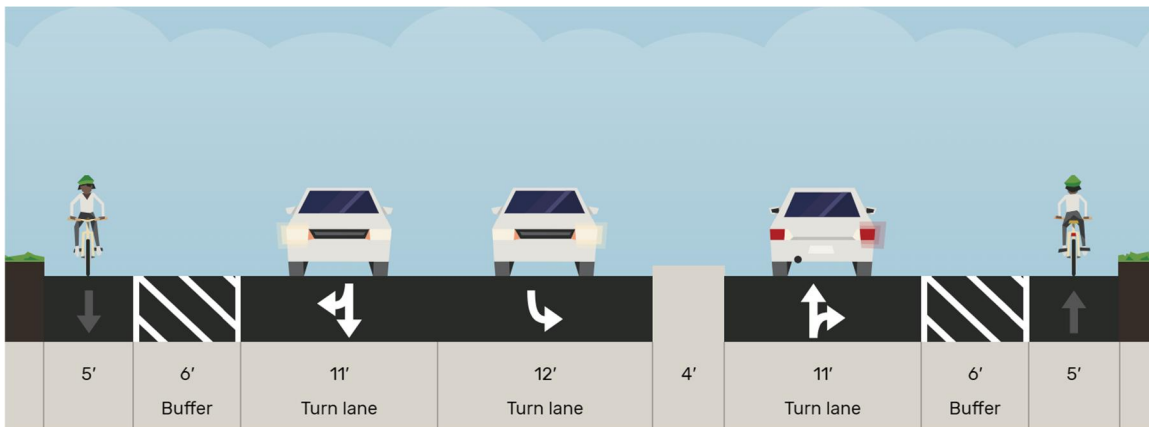
Figure 8: Huntington Avenue Build Conditions Typical Cross Section – With Median

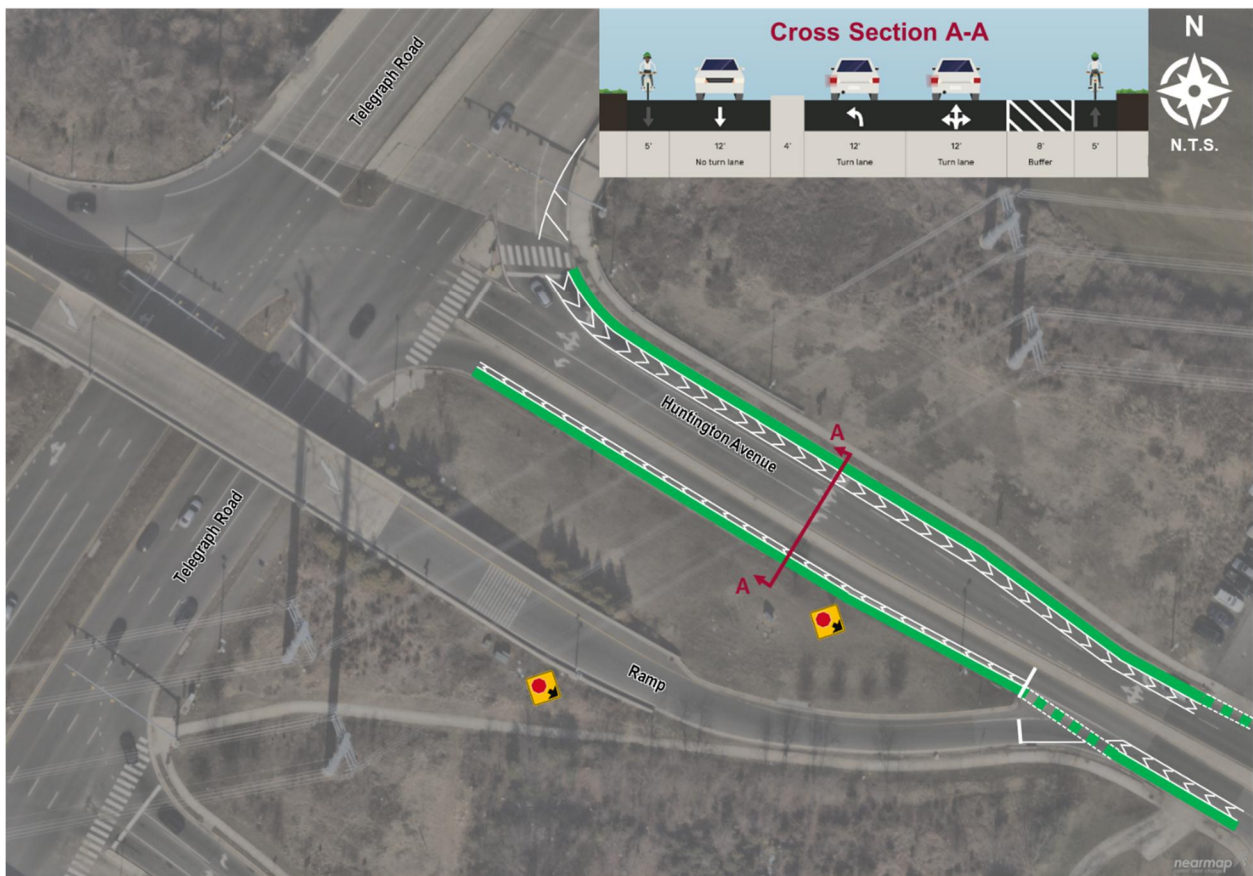
Figure 10 illustrates the modifications proposed at this signalized intersection outlined above (cross section and plan view). The five-foot bike lane will begin on the east leg of the intersection and continue along the north and south curb along Huntington Avenue. Bicyclists will enter or exit the Huntington Avenue corridor from the shared-use path which parallels Telegraph Road. As shown in **Figure 10**, the removal of the second westbound right-turn lane is required to provide access to the shared-use path for bicyclists traveling westbound.

Figure 10: Huntington Avenue and Telegraph Road Alternative Build Conditions Cross Section and Plan View

Potential changes to the geometry at the intersection of Huntington Avenue and Telegraph Road are recommended as follows to accommodate bike lanes at the intersection:

- Repurpose the existing eastbound and westbound outside travel lanes as bike lanes with a buffer for the westbound bike lane
- Remove one westbound right-turn lane
- Add stop control on the eastbound approach at the access ramp for both approaches

Two Build configurations were initially considered at the intersection of Huntington Avenue and Telegraph Road. The first preserved the existing geometry of the westbound approach, providing 125 feet of storage for the rightmost turn lane. A second build condition (Alternative Telegraph) removed one westbound right-turn lane at Huntington Avenue and Telegraph Road, reducing pedestrian crossing distance and allowing the proposed on-street bike lane to connect to the trail along Telegraph Road. This initial build analysis at Telegraph Road is presented to demonstrate the limited operational benefit of retaining two westbound right-turn lanes at the intersection in support of the recommended intersection configuration shown in **Figure 10**.

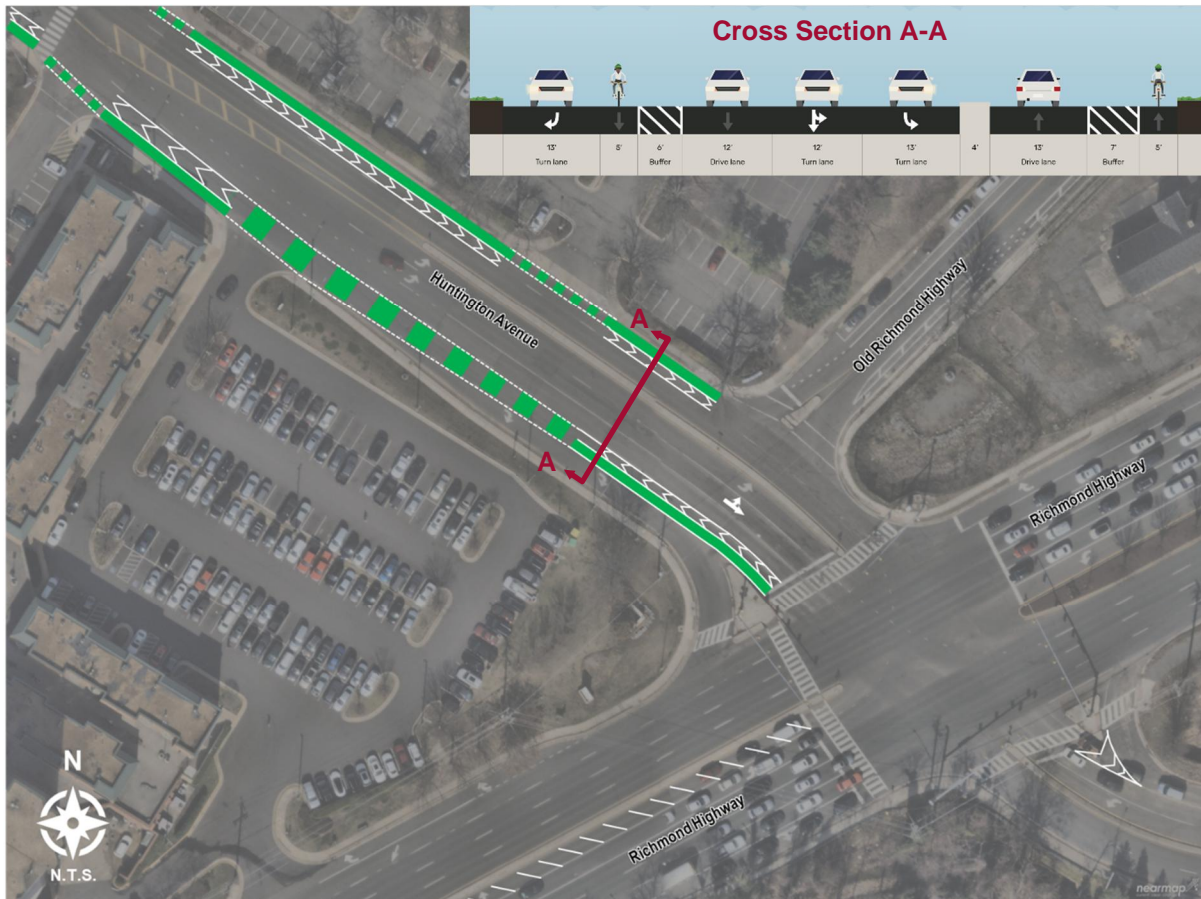
Figure 11 illustrates the modifications proposed at this signalized intersection (cross section and plan view). Given the reduction to one travel lane westbound downstream of the signal, lanes on other approaches must be removed or adjusted. The westbound bike lane begins after the intersection with Old Richmond Highway. Lane control figures for existing and proposed conditions can be found in **Appendix D**. The proposed configuration likely does not require moving the traffic signal detector loops and will not require an evaluation in auto-turn as the existing lane geometry will be maintained. Furthermore, the proposed configuration reduces the crossing distance for pedestrians.

Figure 11: Intersection of Huntington Avenue and Richmond Highway Build Conditions Cross Section and Plan View

When identifying potential geometry changes at Richmond Highway, a Build condition was identified that provided bike lanes in both directions and included the following modifications:

- Remove a northbound left-turn lane
- Remove a westbound through lane
- Repurpose the outside eastbound and westbound travel lane as a bike lane with a buffer
- Re-stripe the rightmost eastbound left-turn lane to a shared through and left-turn lane
