Phase I / II Environmental Site Assessment

Lewinsville Senior Center
1609 Great Falls Street
Fairfax County, Virginia

October 15, 2008

ECC Project No. 07-9091

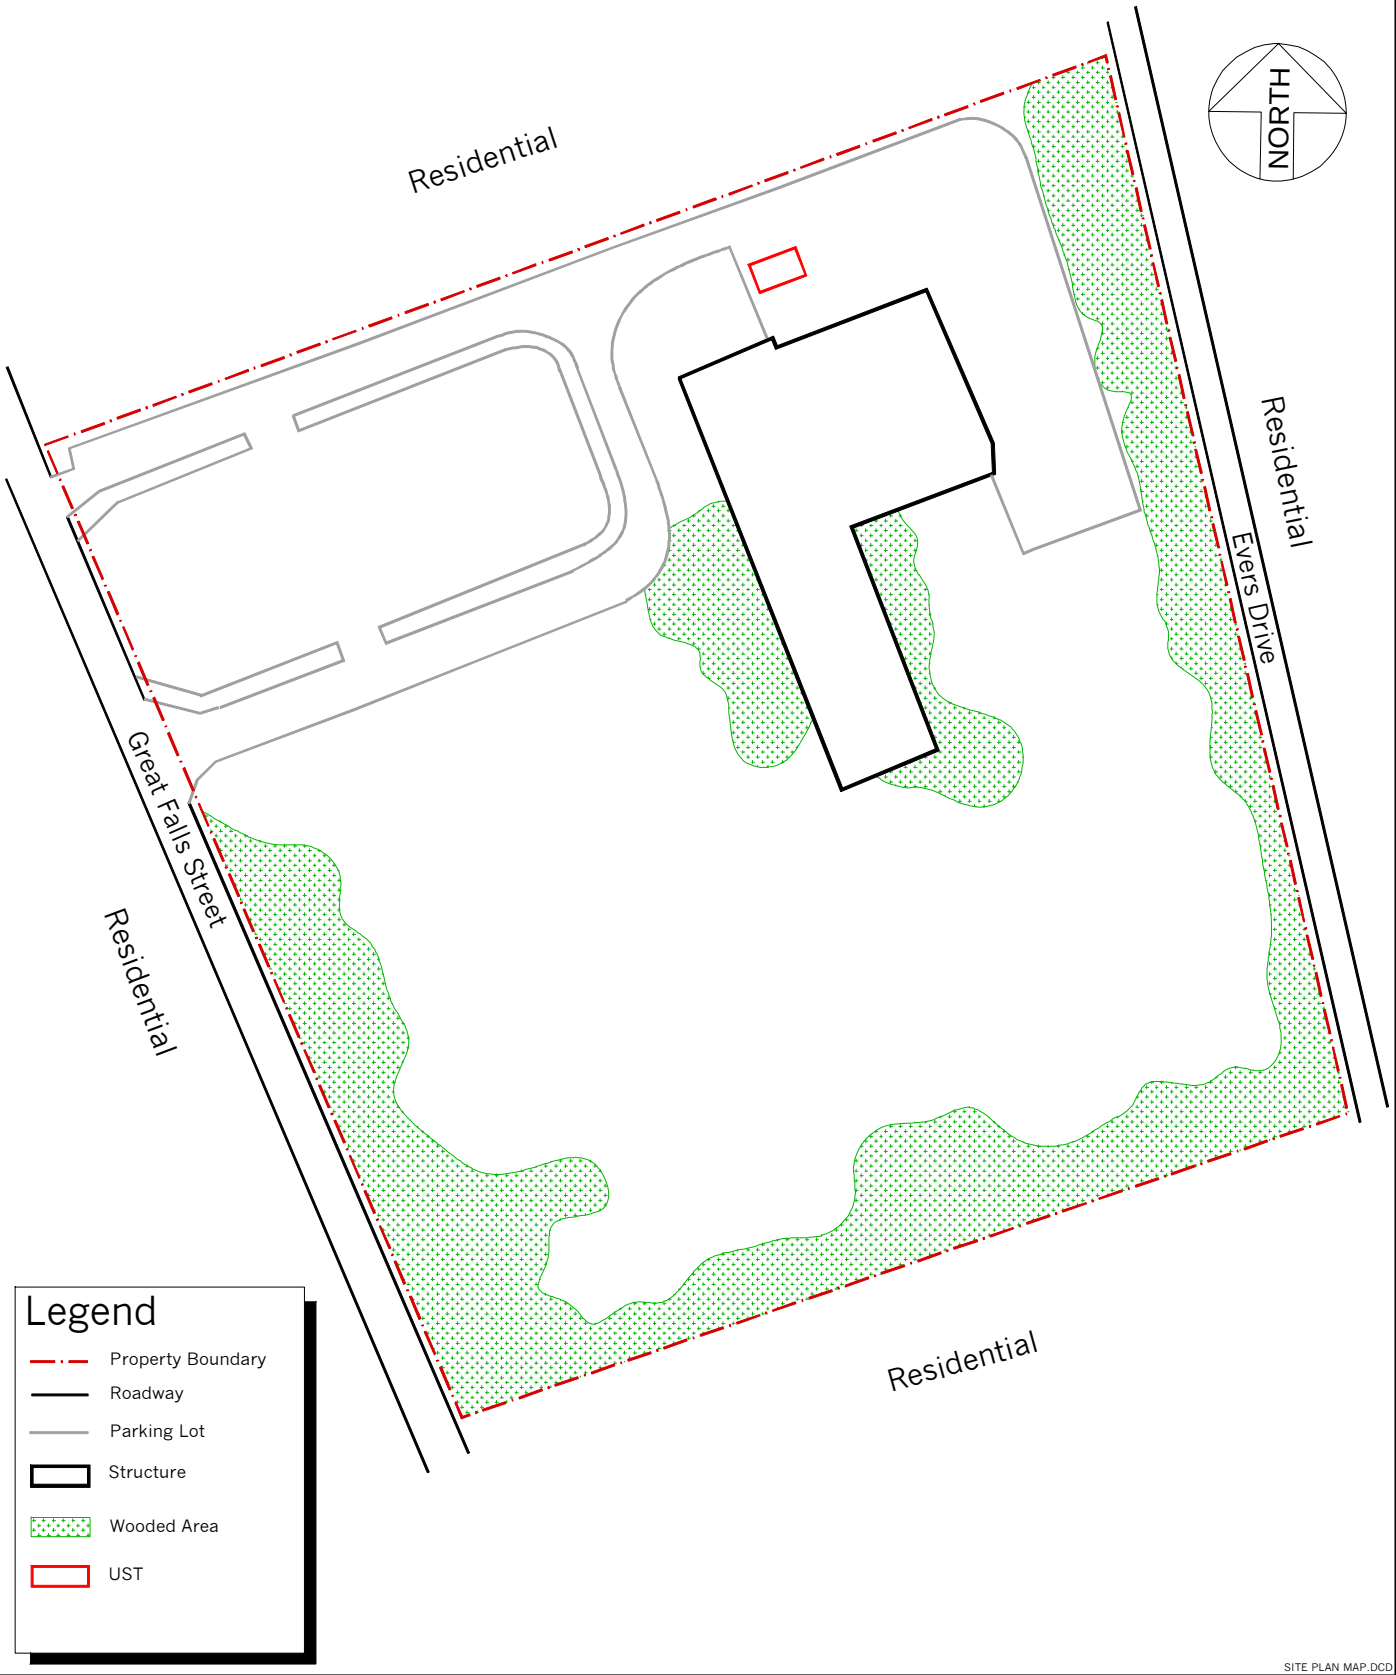
FIGURE 2

A vent pipe, fill pipe, and manhole for a 15,000-gallon UST were observed on the north side of the structure, adjacent west of the entrance to the adult day care center. According to Mr. Armstrong, heating oil was stored in the tank and was used to heat the building prior to natural gas service being extended to the Subject Property.

ECC recommends that the status of the 15,000-gallon heating oil UST on the Subject Property be determined. Specifically, any product remaining in the UST should be removed. If this tank will not be used in the future, ECC recommends that it be removed from the Subject Property.

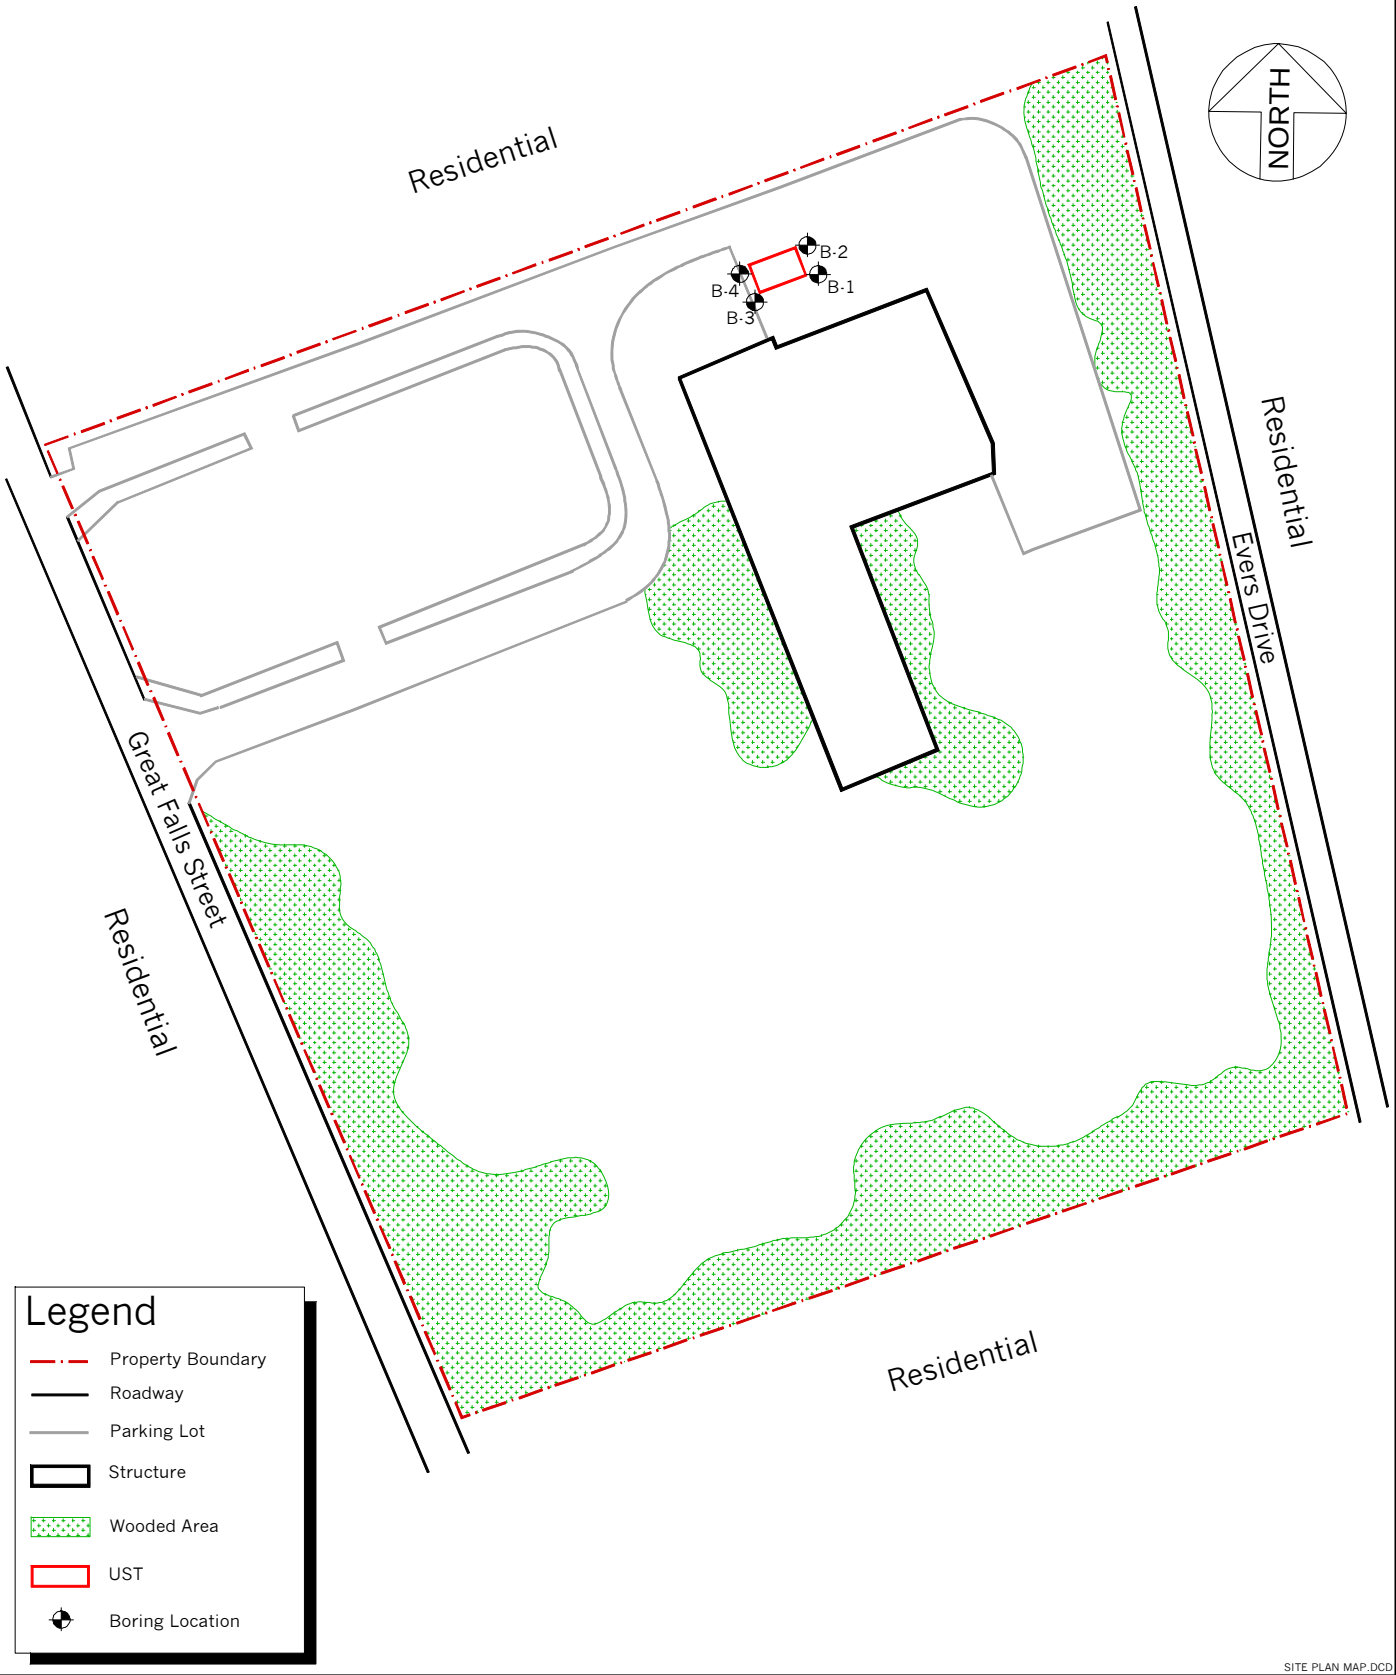
FIGURE 3

The piezometers were developed using bailer surge techniques to repeatedly surge and remove groundwater to remove formation sediments and to insure free fluid flow into the casings.
