# FAIRFAX COUNTY PARK AUTHORITY

## Final Progress Report

## Fitzhugh Park Ecological Restoration

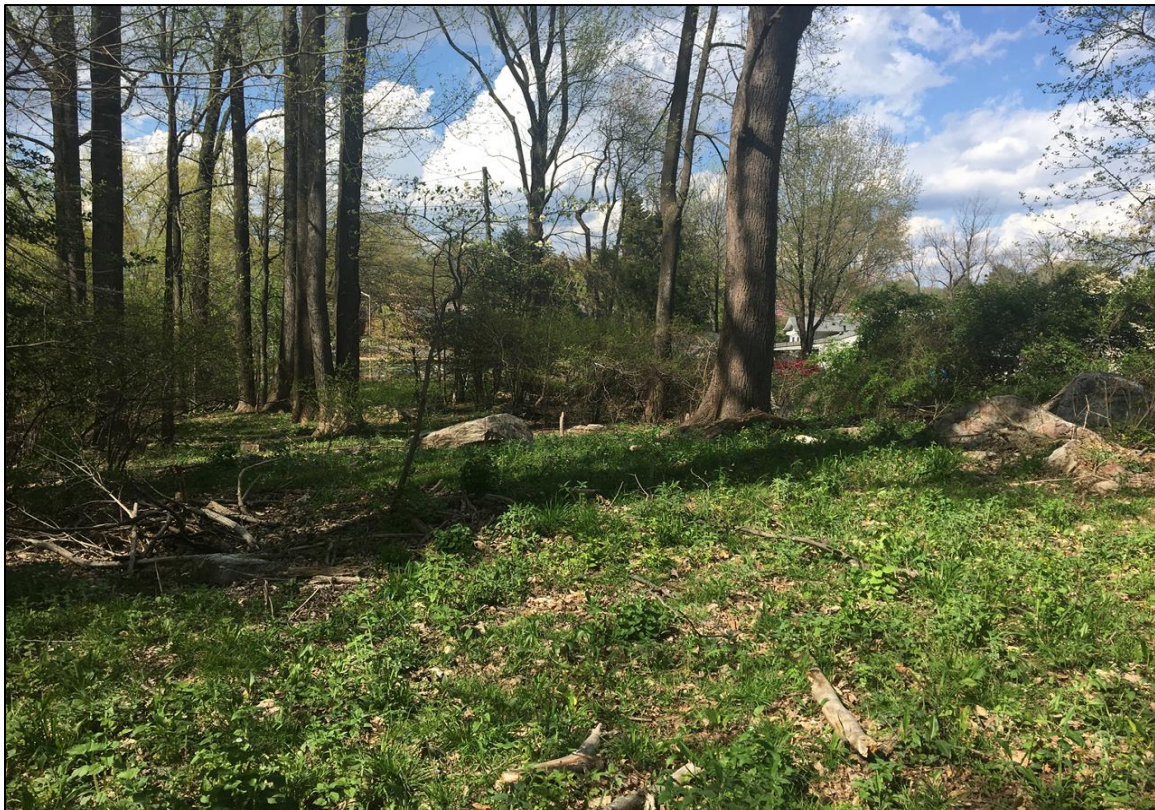
**Native herbaceous vegetation germinating and establishing strongly in Unit 1 following seeding in Fall 2018. Photo was taken in Spring 2019.**

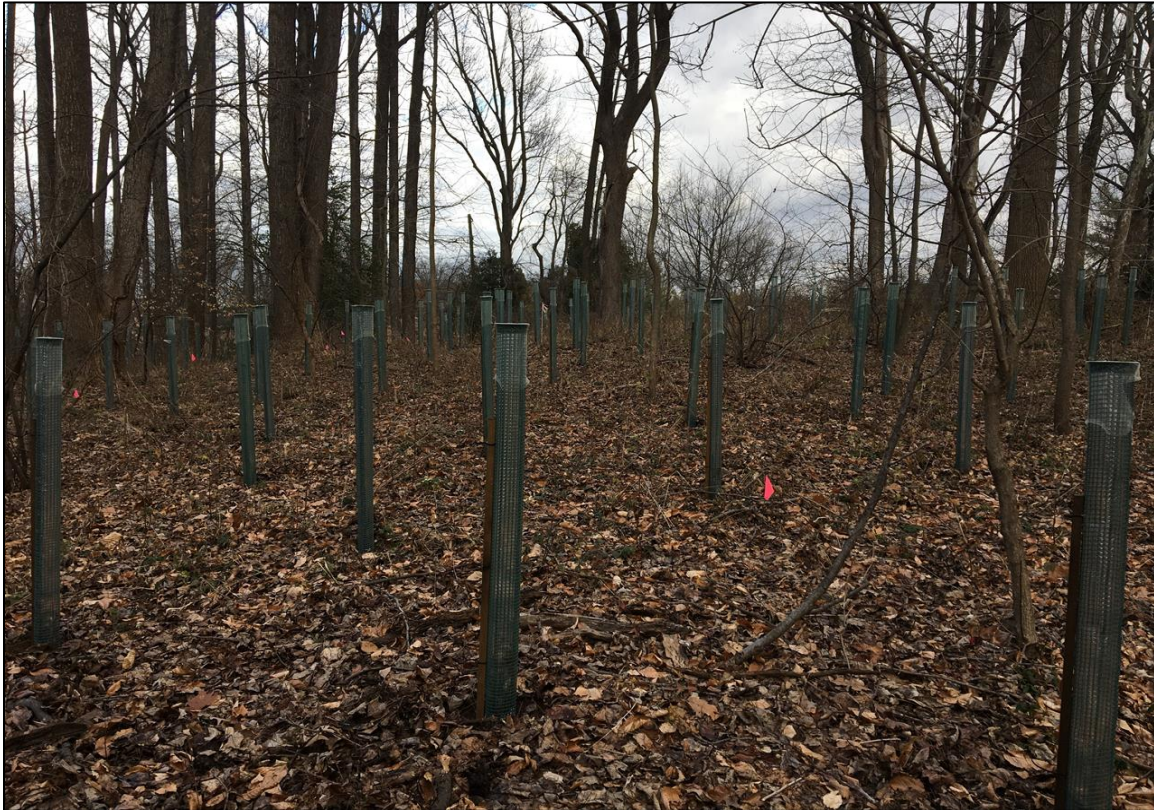
**Mixed bare-root planting of trees and shrubs typically found in Piedmont Mesic Mixed Hardwood forests. TubeX Shelterguard tubes should provide protection from deer, while allowing adequate light to reach young seedlings.**

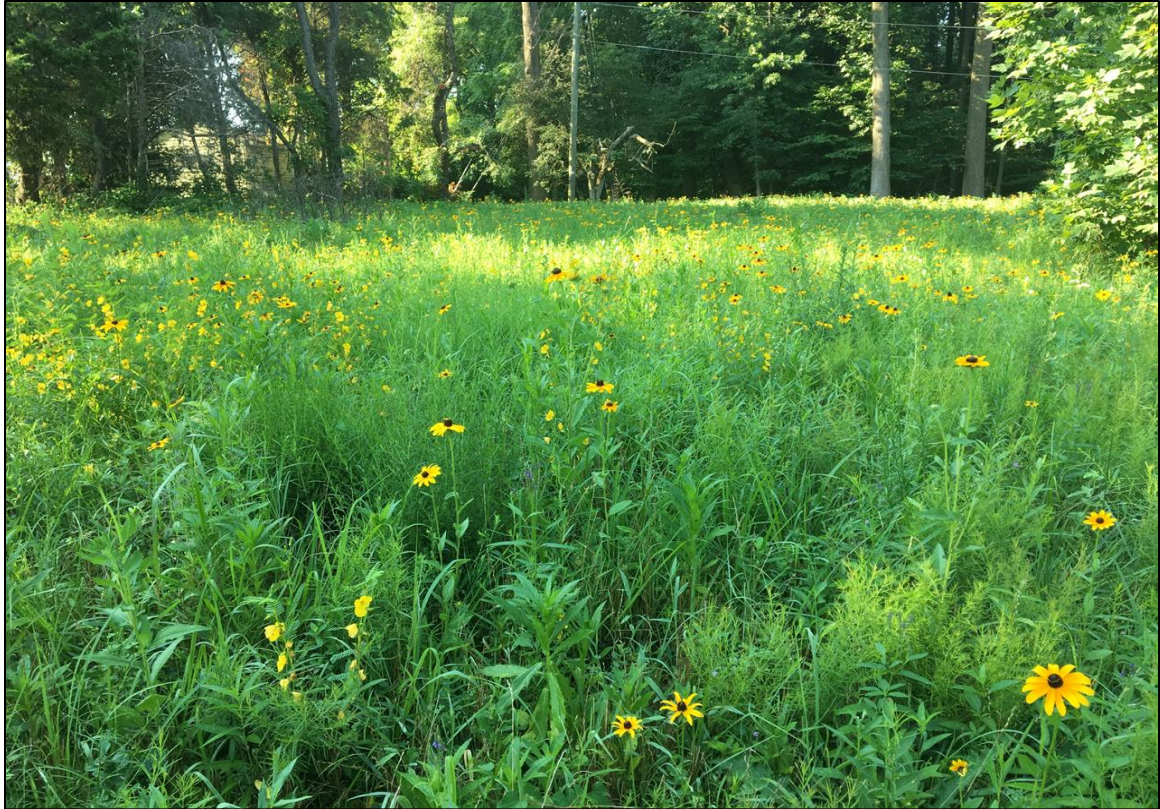
**Diverse native grasses and forbs establishing in Unit 4 in Summer 2019. Seeding occurred in Fall 2018; dormant seeding allowed native forbs to break dormancy and germinate immediately in Spring 2019 and establish well.**

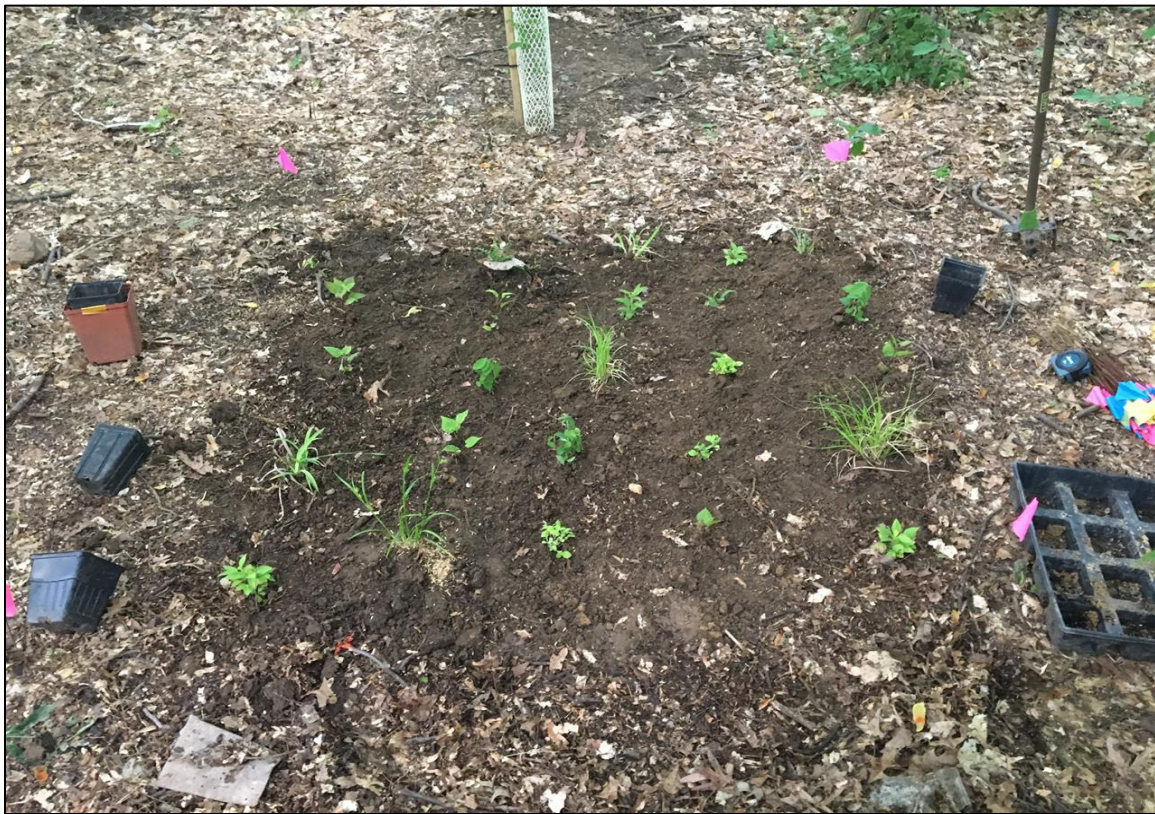
**Newly planted "mother colony" of native sedges and forbs in Unit 2S. Survival of these plantings was excellent, with many planting producing seed the following season.**
