FAIRFAX COUNTY PARK AUTHORITY

White Gardens

MEP Assessment

**3301 Hawthorne Lane
Falls Church, VA 22042**

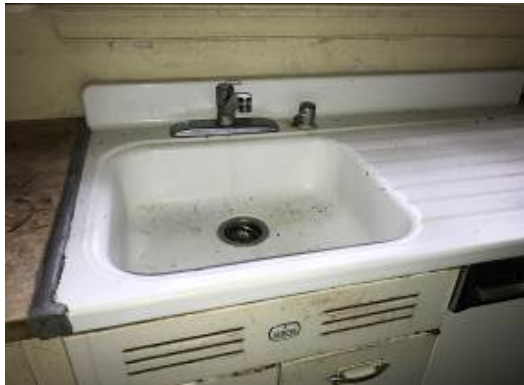
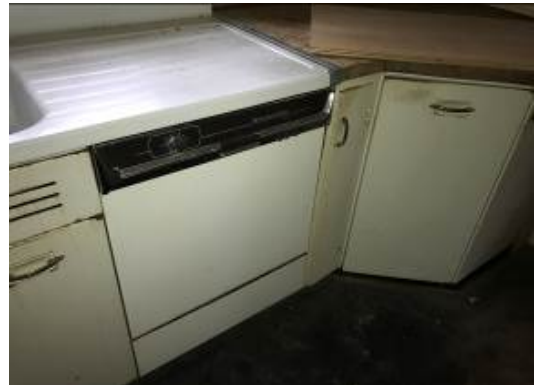
The kitchen has a single compartment sink with faucet connected to a Kitchen Aid dishwasher and does not have a garbage disposer.

- Plumbing recommendations are only if the house is structurally repaired, all leaks repaired, and all contaminants throughout remediated.
- Replace the water heater.
- Insulate the domestic hot and cold water piping in the basement.
- Provide new faucet and sink for the kitchen and install a garbage disposal.
- Replace the dishwasher.
- Provide new clothes washer and dryer.
- Replace the utility sink and faucet.
- Replace faucets and sinks in all toilet/bath rooms.
- Replace flapper and fill valves in all toilets.
- Replace the shower and bathtub controls and the shower heads.
- Clean gutters and downspouts to verify they are clear.
- Provide splashblocks at all downspouts.
- Make arrangements with the gas utility to relocate the gas meter from the basement to an outdoor location.

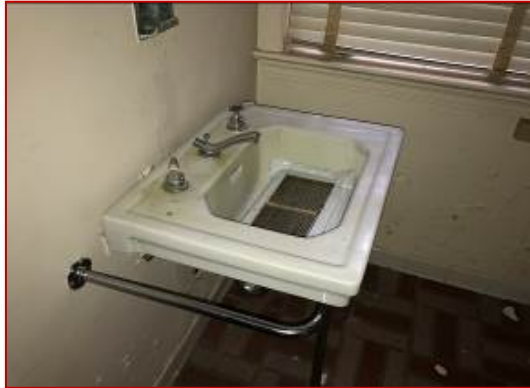
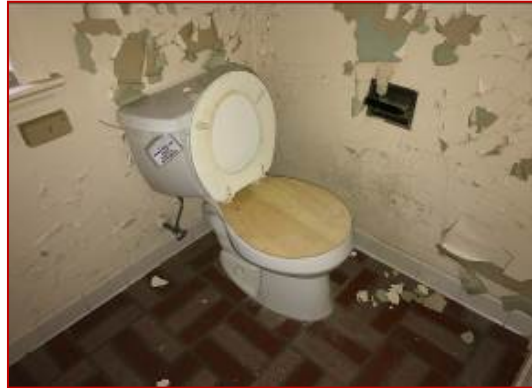
The first floor toilet room has a water closet and a wall-mounted lavatory.

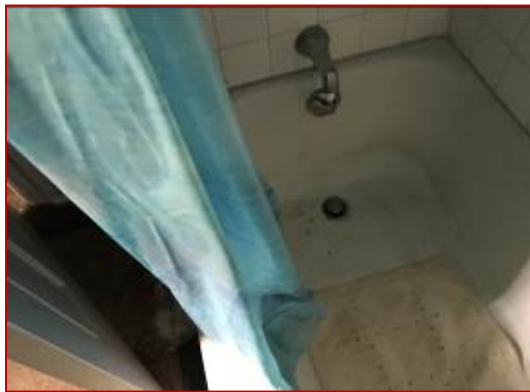
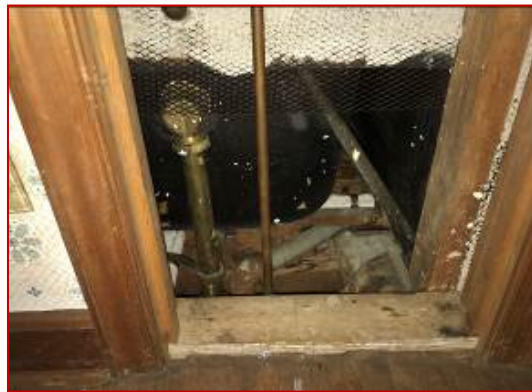
There are three bathrooms on the second floor. Each bathroom has a wall-mounted lavatory and a water closet. Two bathrooms have standup showers and one has a bathtub.

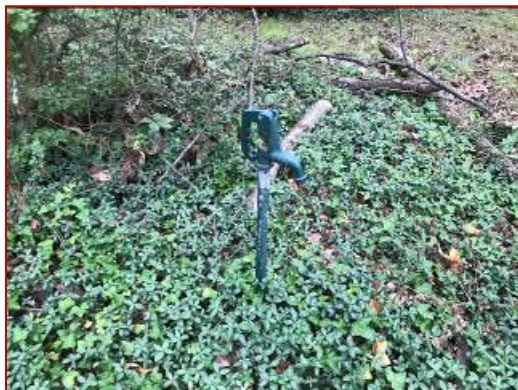
The property has a frost proof yard hydrant.
