3.21 The Glade – Subwatershed Condition

3.21.1 Subwatershed Characteristics

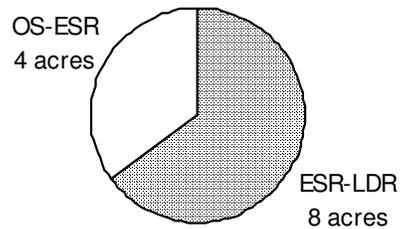
Figure 3.20: Changed Land Use

According to Figure 3.20, 8 acres are projected to shift from estate residential in the existing land use to low-density residential in the future land use, and 4 acres were projected to shift from open space to estate residential in the future land use.
