## Chapter 3: Subwatershed Condition

### 3.1 North Little Hunting Creek Subwatershed

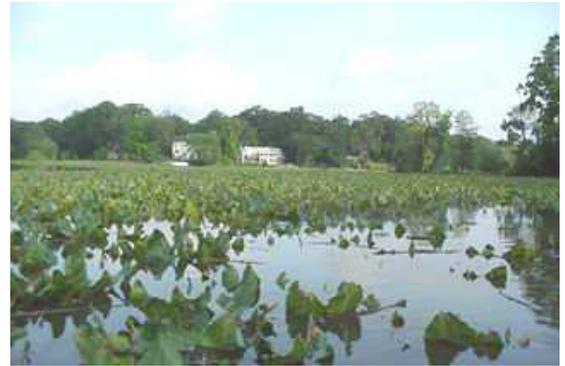
Photo 3.9 Tidal portion of Little Hunting Creek

The South Little Hunting Creek Subwatershed contains the southern portion of Little Hunting Creek, seen in Photo 3.9, and South Branch, a tributary of Little Hunting Creek located on the east side of the creek. Other smaller streams are located on the west side of the subwatershed and discharge directly into Little Hunting Creek as shown on Map 3.5. The South Little Hunting Creek Subwatershed’s condition is summarized as follows.

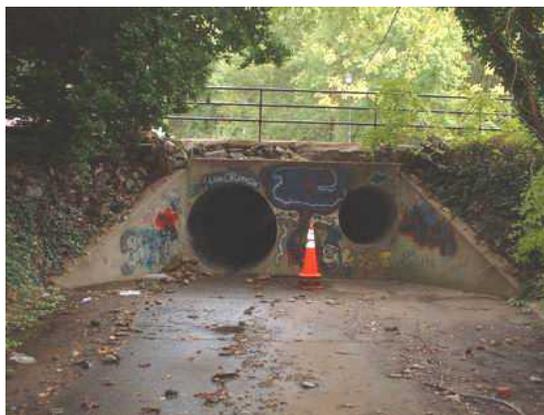
- Brady Street: The five-foot diameter concrete pipe drains to the tributary located on the west side of South Little Hunting Creek as shown in Photo 3.10.
- Linton Lane: Five-foot and three-foot (diameter) concrete pipes drain to South Branch as shown in Photo 3.11.
- Linton Lane: A triple six-foot by three-foot concrete box culvert drains to South Branch.
- East of Linton Lane: Two wooden foot bridges, each 12 feet long with four-foot openings, and four wooden foot bridges, each eight feet long with four-foot openings, are located on South Branch between Linton Lane and Vernon View Drive.

Photo 3.11 5' and 3' diameter pipes located under Linton Lane

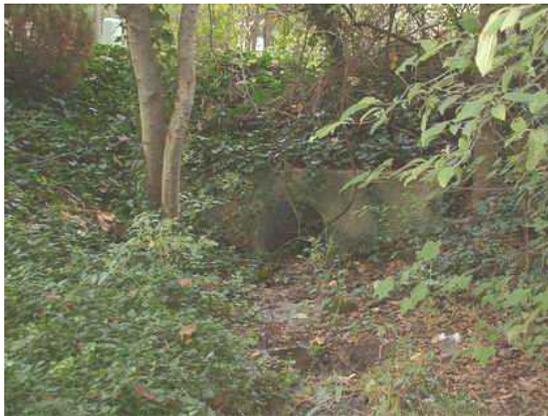
- South of Wessynton Way: A wooden foot bridge, eight feet long with a four-foot opening, is located on a tributary on the west side of South Little Hunting Creek.
- Wessynton Way: A two-foot (diameter) concrete culvert is located on a tributary on the west side of South Little Hunting Creek as shown in Photo 3.12.
- East of Doeg Indian Court: Five-foot, three-foot, and two-foot (diameter) concrete pipes are located on a tributary on the west side of South Little Hunting Creek.
- East of Doeg Indian Court: A wooden foot bridge, 10 feet long with a four-foot opening, is located on a tributary on the west side of South Little Hunting Creek.

*Photo 3.12 2' (diameter) concrete pipe located under Wessynton Way*

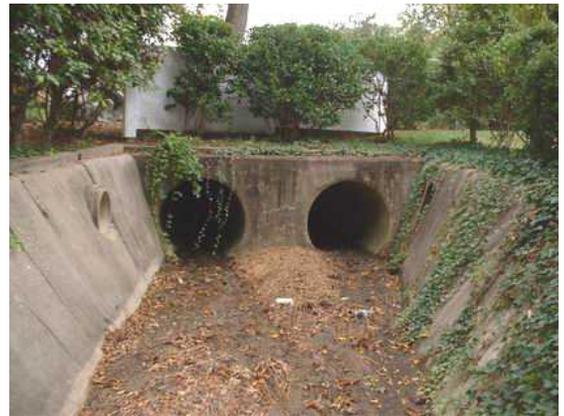
Four storm drain outfall pipes discharge into South Branch. All outfall pipe material is concrete and the pipes range in size from 15 to 36 inches in diameter. Double 36-inch (diameter) outfall pipes located under Vernon View Drive discharge runoff collected from the River Bend Estates subdivision and are shown in Photo 3.13. These pipe outfalls are causing minor erosion but are not of significant concern. No private or public stormwater management facilities are listed in the county's inventory for this subwatershed.

*Photo 3.13 Double 3' (diameter) concrete pipes located west of Vernon View Drive*

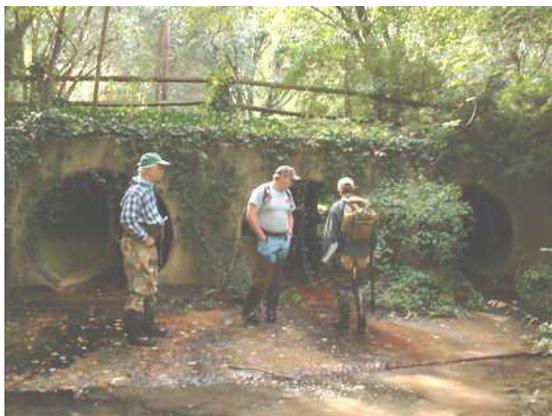
- Davenport Street: Three 60-inch (diameter) corrugated metal pipe culverts with minor stream bed erosion of two-foot height were observed downstream of the pipe as shown in Photo 3.30.

*Photo 3.30 Triple 60" corrugated metal pipe culverts located under Davenport Street*

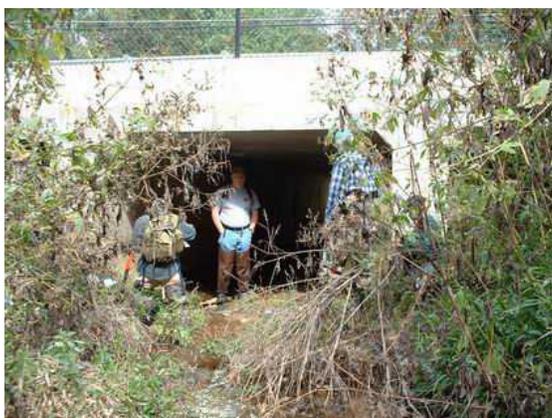
- Sherwood Hall Lane: Two 72-inch (diameter) corrugated metal pipe culverts have no impact on the stream as shown in Photo 3.31.
- Collingwood Road: Five 12-foot by eight-foot box culverts, shown in Photo 3.32, cause minor stream bed erosion upstream of the crossing.
- Collingwood Road: Four 10-foot by 15-foot concrete box culverts, shown in Photo 3.33, with sedimentation upstream of the crossing, are causing a moderate impact on the stream.
- Stacey Road: Four elliptical, five-foot by three-foot corrugated metal pipe culverts are causing minor downstream bed erosion.

*Photo 3.32 Five 12' x 8' concrete box culverts located under Collingwood Road to convey North Branch main stem flows*

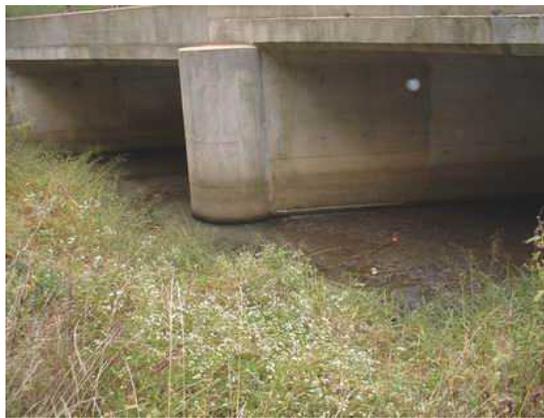
*Photo 3.33 Four 10' x 15' concrete box culverts located under Collingwood Road to convey flows of the eastern tributary*

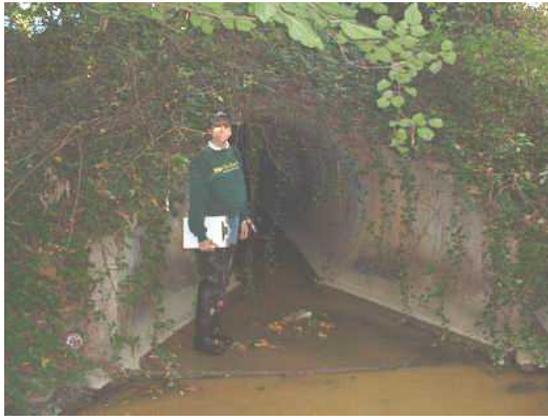
Fifteen concrete pipe outfalls discharge to North Branch and its tributaries. They range in size from 12 to 72 inches in diameter. Photo 3.34 shows a 60-inch concrete pipe outfall located at the headwaters of the tributary LHNB001 to North Branch. Discharges from the majority of pipe outfalls are causing only minor erosion and their locations are shown on Map 3.14. Downstream of the confluence with Paul Spring Branch, a small ditch with an 18-inch width discharges into the stream and causes moderate erosion (shown in Photo 3.35).

Photo 3.34 A 60" diameter concrete pipe outfall at the headwaters of the tributary to North Branch

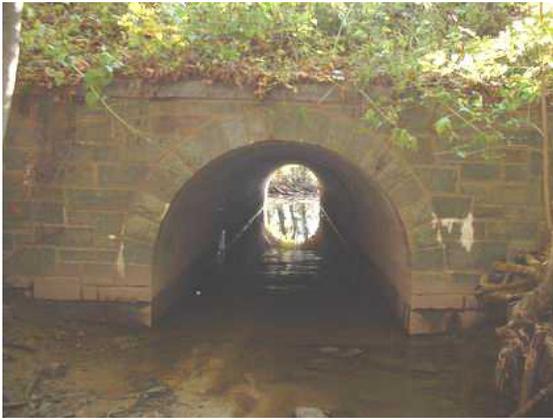
The developed areas such as the Waynewood subdivision have storm drain systems that discharge directly into the Potomac River. The major road crossings include a seven-foot by six-foot concrete arch culvert under the George Washington Memorial Parkway (shown in Photo 3.41). This crossing is free of sediment, trash, and obstructions and causes no impact

*Photo 3.41 Concrete arch culvert of size 7' by 6' located under George Washington Memorial Parkway*

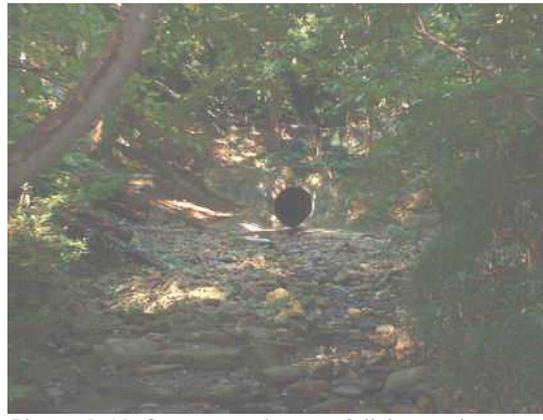
*Photo 3.42 Concrete pipe outfall located west of Eaglebrook Court*

on the stream. A 66-inch (diameter) concrete pipe discharges into one of the streams in the East Potomac portion of the subwatershed without causing any erosion (shown in Photo 3.42). There are no private or public stormwater management facilities in this subwatershed.

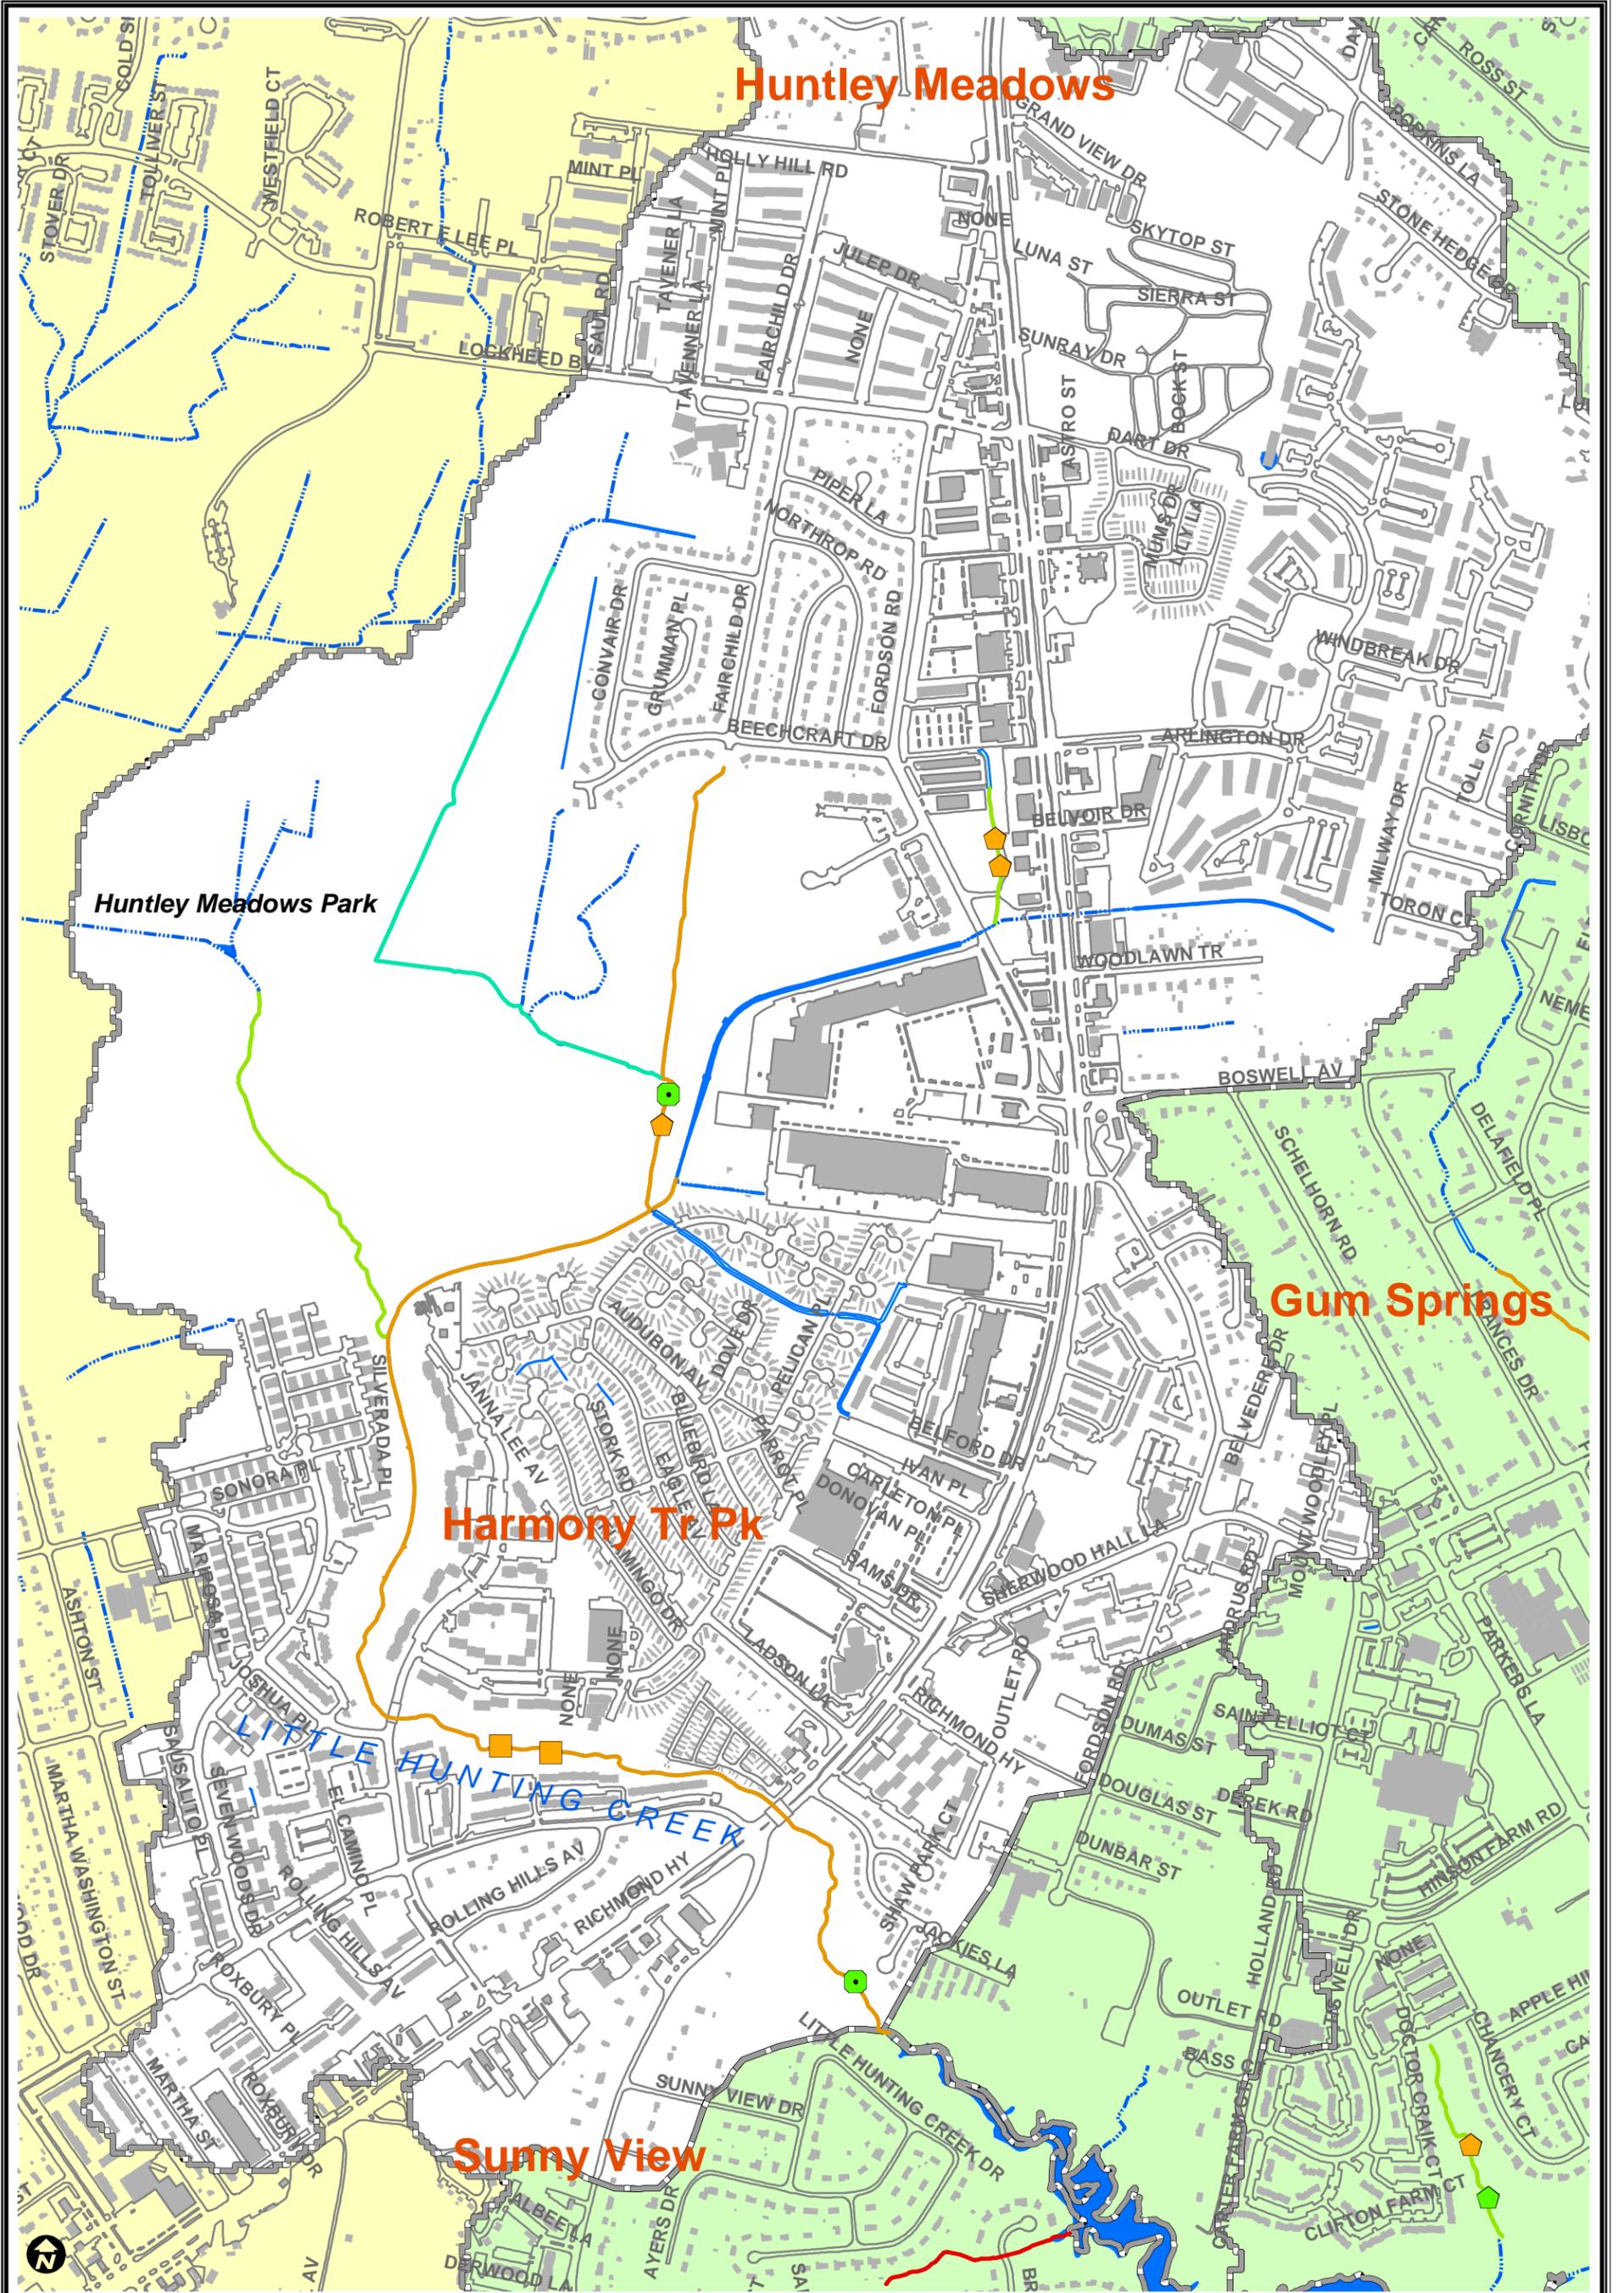
**Map 3.3**  
**Little Hunting Creek Watershed**  
**Stream Geomorphology**  
**North Little Hunting Creek**

Map 3.3 shows the stream segment CEM type in the subwatershed. Fallen trees and debris obstructing the flow were observed at two locations in the upstream reaches. The impact of this debris on the stream is moderate and can be seen in Photo 3.3. In the downstream stream segment, the stream is littered with shopping carts, trash, and a camper shell. Photos

3.4 and 3.5 show dumpsites in the downstream segments. The locations of the dumpsites identified during the stream physical assessment are shown on Map 3.3. Two additional dumpsites have been identified in the area behind the Hybla Valley Shopping Center. A partially buried 12-inch sanitary sewer pipe crosses the stream in the downstream segment and does not cause a significant impact. A raised sanitary sewer manhole is located in the upstream stream segment north of Audubon Avenue and has little impact on the stream as shown in Photo 3.6.

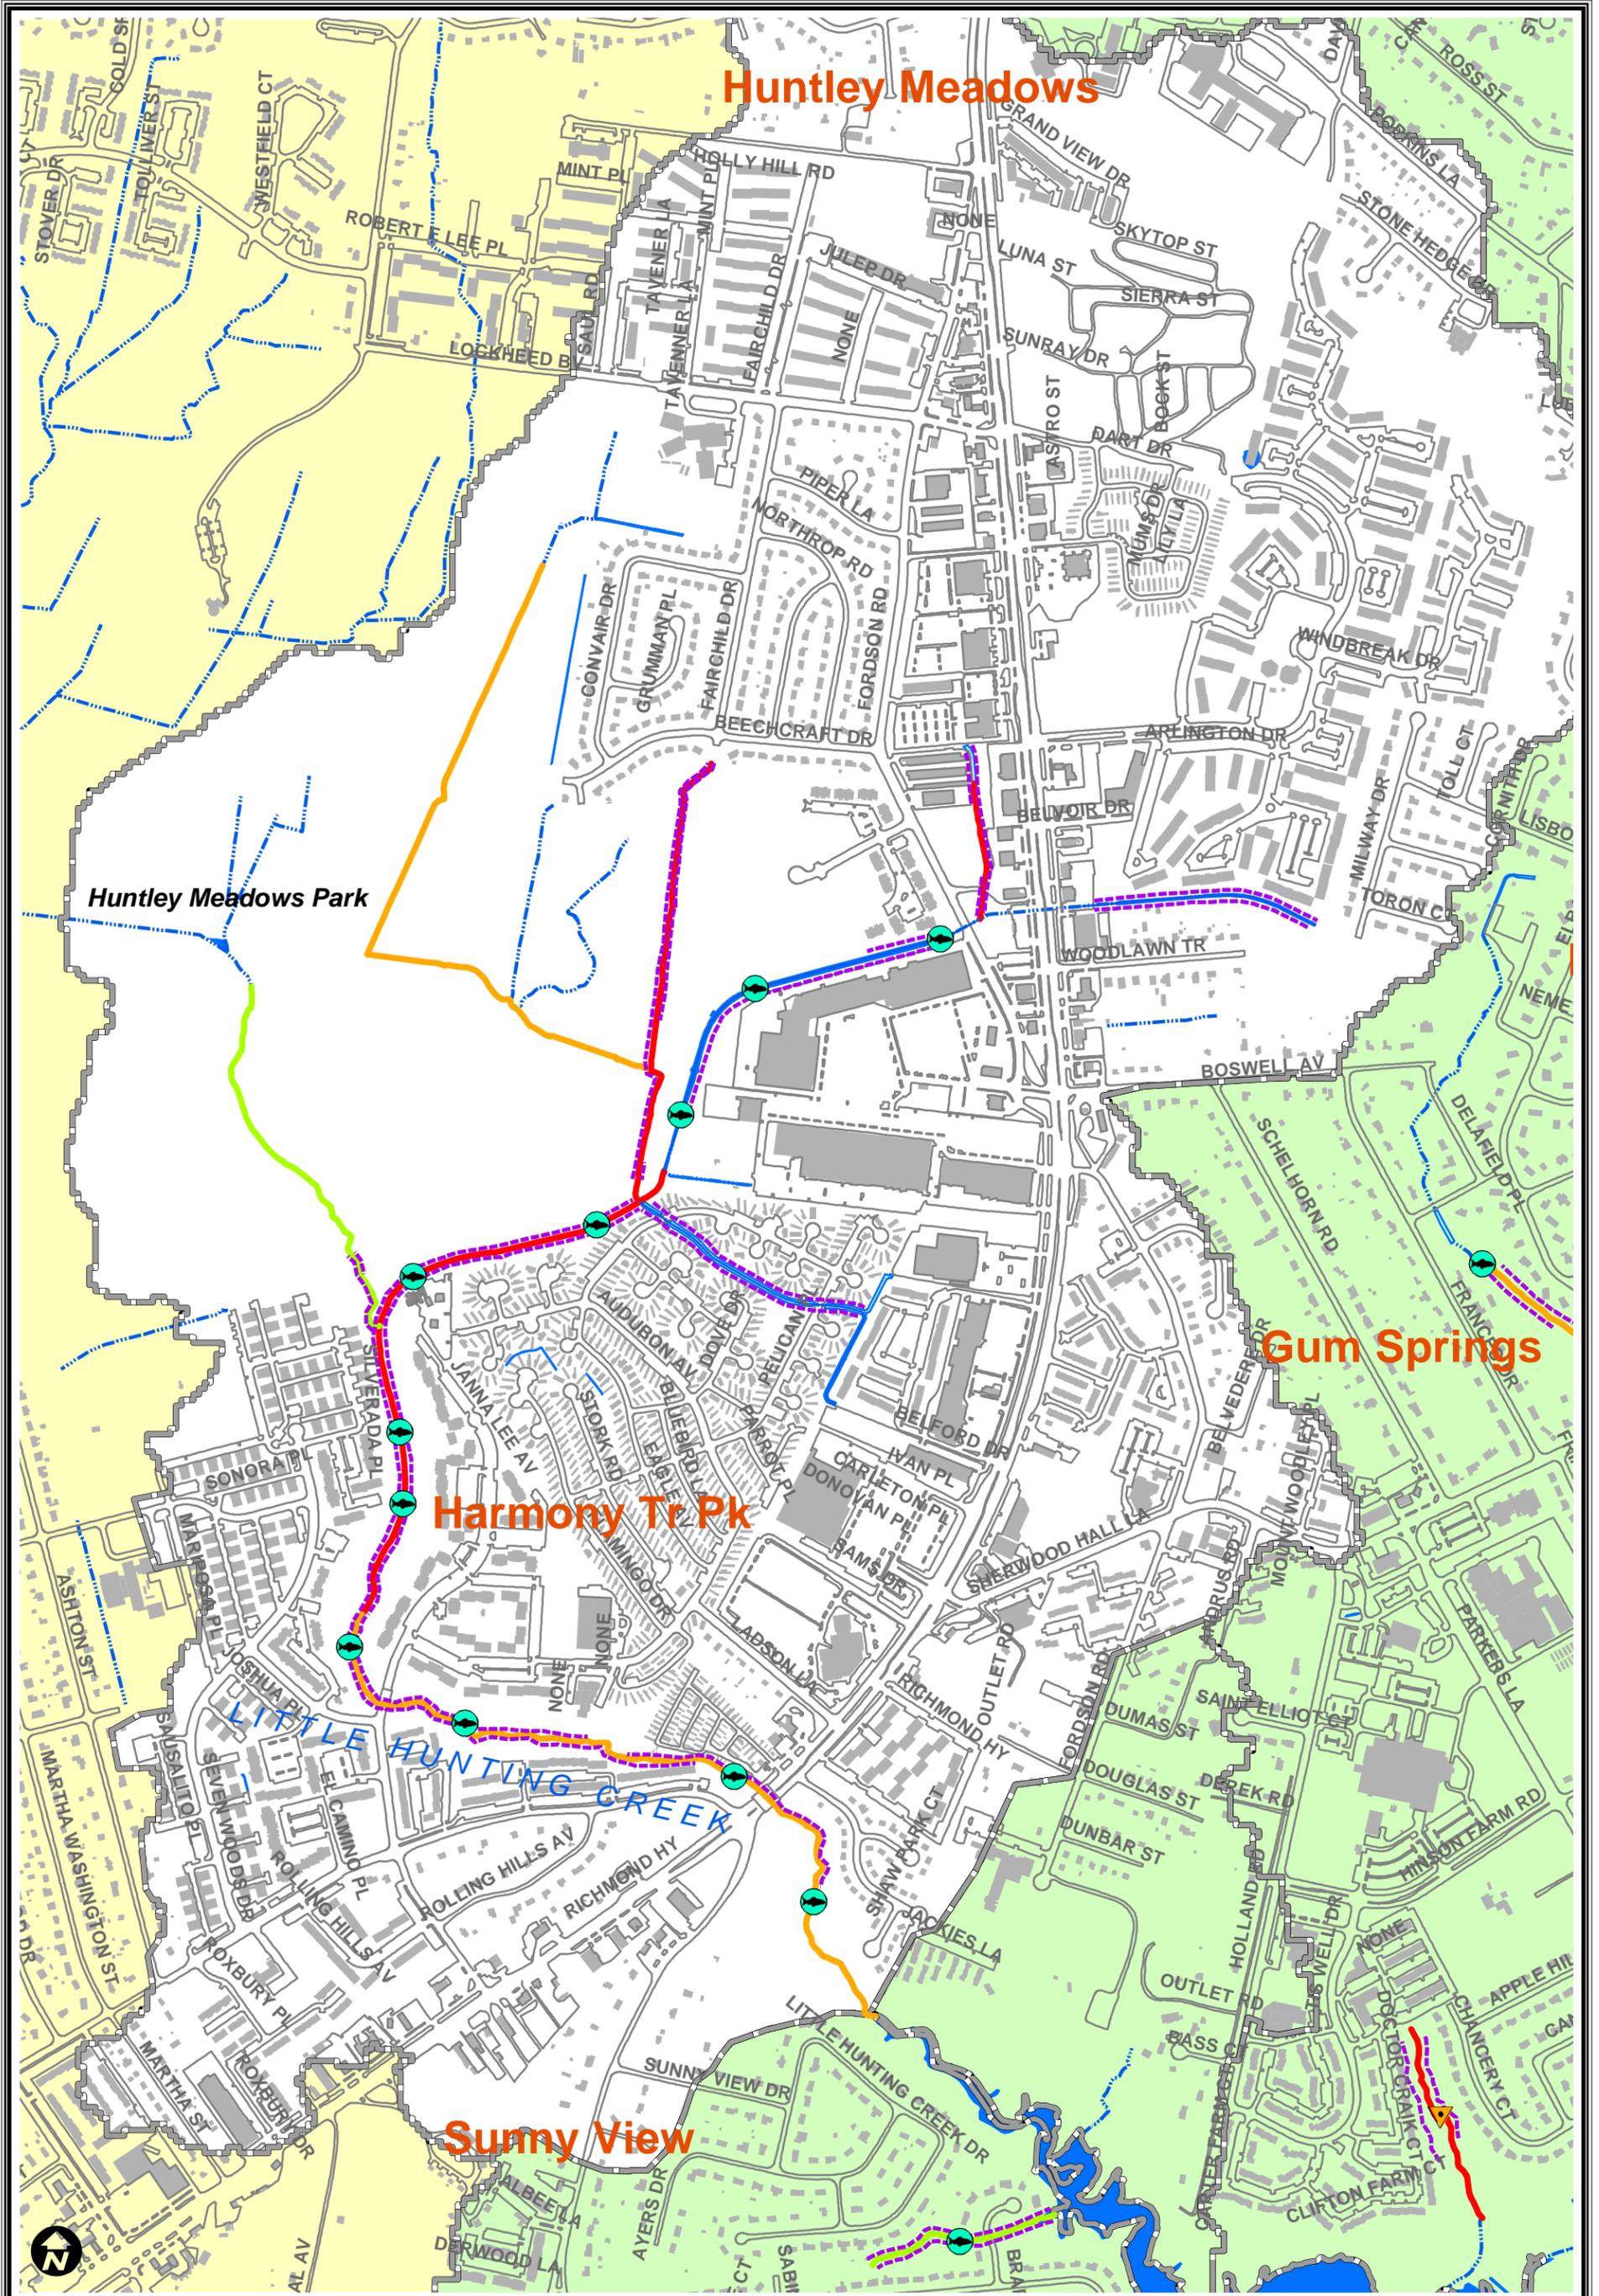
**Map 3.4**  
**Little Hunting Creek Watershed**  
**Stream Habitat Quality**  
**North Little Hunting Creek**

- Fifty-one percent of North Little Hunting Creek exhibits poor habitat quality and 33% of the creek exhibits very poor habitat quality as depicted on Map 3.4. Flows were observed in the stream channel for the majority of the creek and no erosion and/or head cuts were observed. The majority of the stream segments are good candidates for stream restoration projects because each individual project would have adequate stream length, would not involve easement acquisition, and would have good access for construction.

At several locations in the downstream stream segments, there is a severe to extreme impact due to a lack of natural forested buffer as shown in Photo 3.7. At one location in the upstream stream segments, the buffer zone is covered with a parking lot and roadway, causing the severe impact shown in Photo 3.8. Overall, North Little Hunting Creek does not have adequate natural buffer widths of 100 feet. The locations of deficient buffer areas along the stream corridor are shown on Map 3.4.

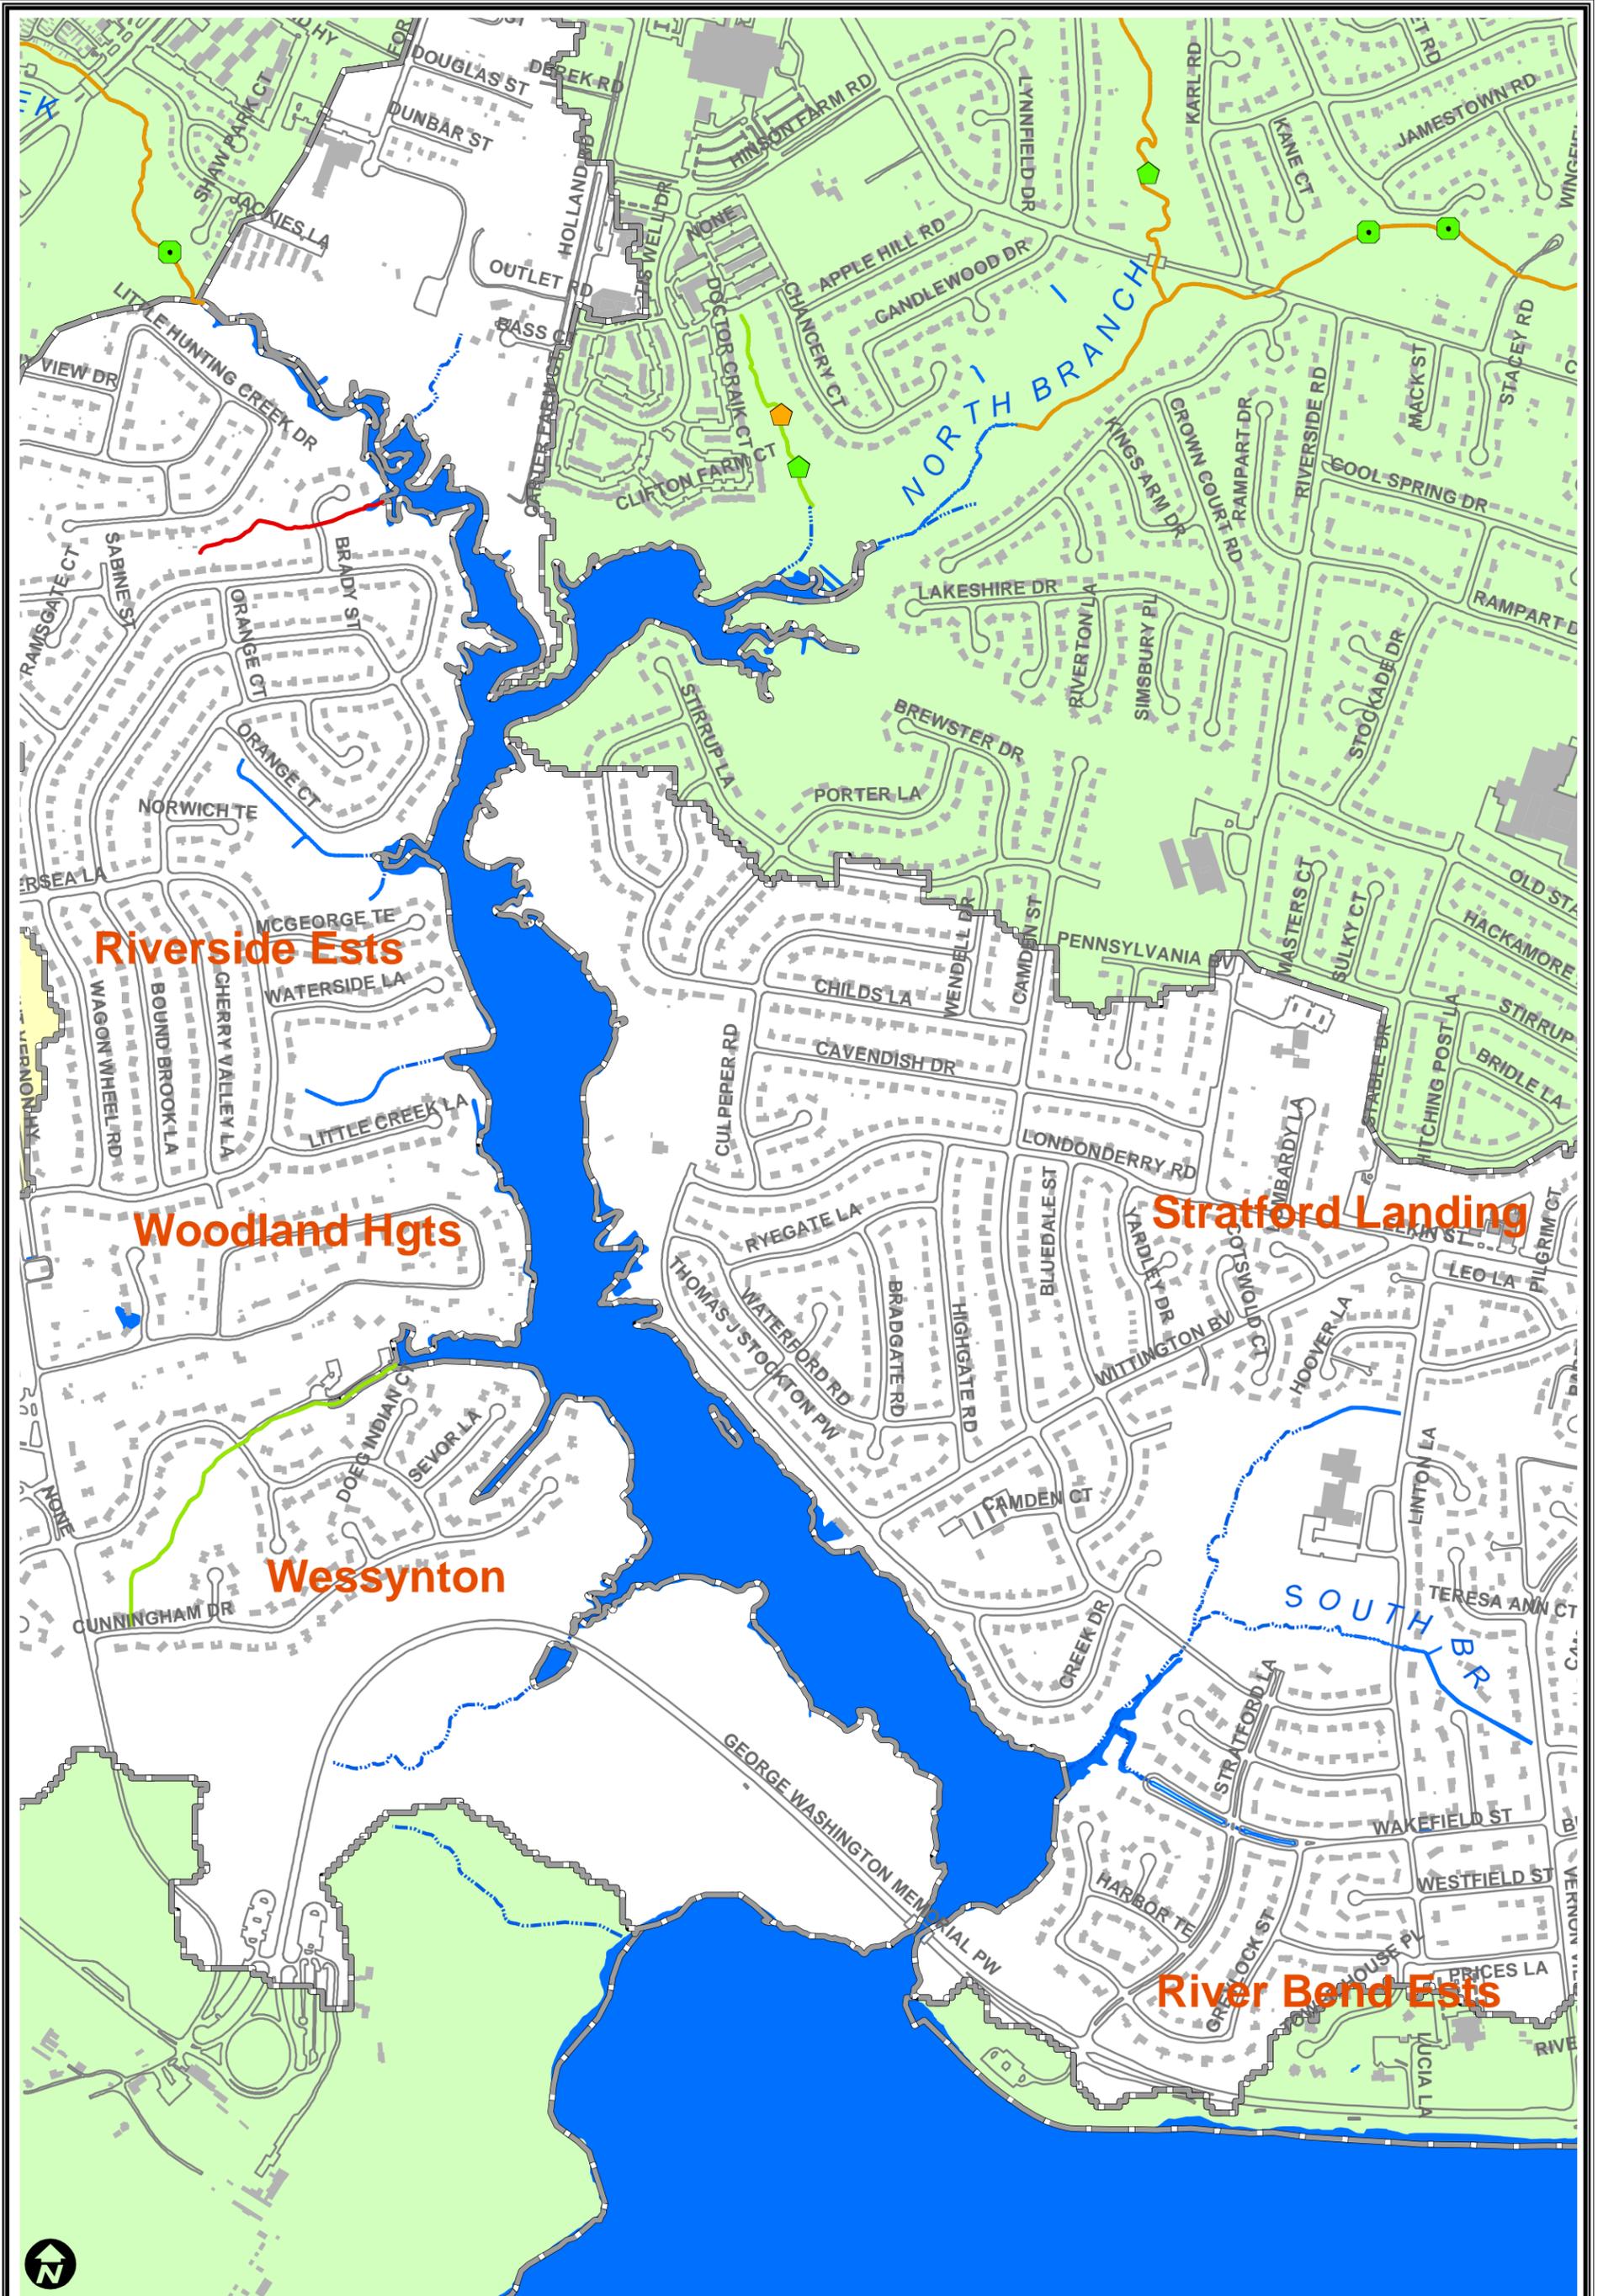
**Map 3.7**  
**Little Hunting Creek Watershed**  
**Stream Geomorphology**  
**South Little Hunting Creek**

- The tributary located near Brady Street has a dominant substrate of gravel and is classified as CEM type 4, referring to a stabilizing stream bank and channel. The stream will widen if encroachment in the stream corridor continues to increase.
- The tributary located near Wessynton Way has a dominant substrate of sand and is beginning to show the characteristics of CEM type 2, referring to a deep, incised channel formed by head cutting of the stream bed.
- Flow obstructions or trash/debris were not observed in the South Little Hunting Creek stream segments, and there are no utility crossings located in this subwatershed (as shown on Map 3.7). A private industrial dumpsite is located east of Martin Luther King, Jr. Park with piles of construction debris, several pieces of earthmoving equipment, and large industrial

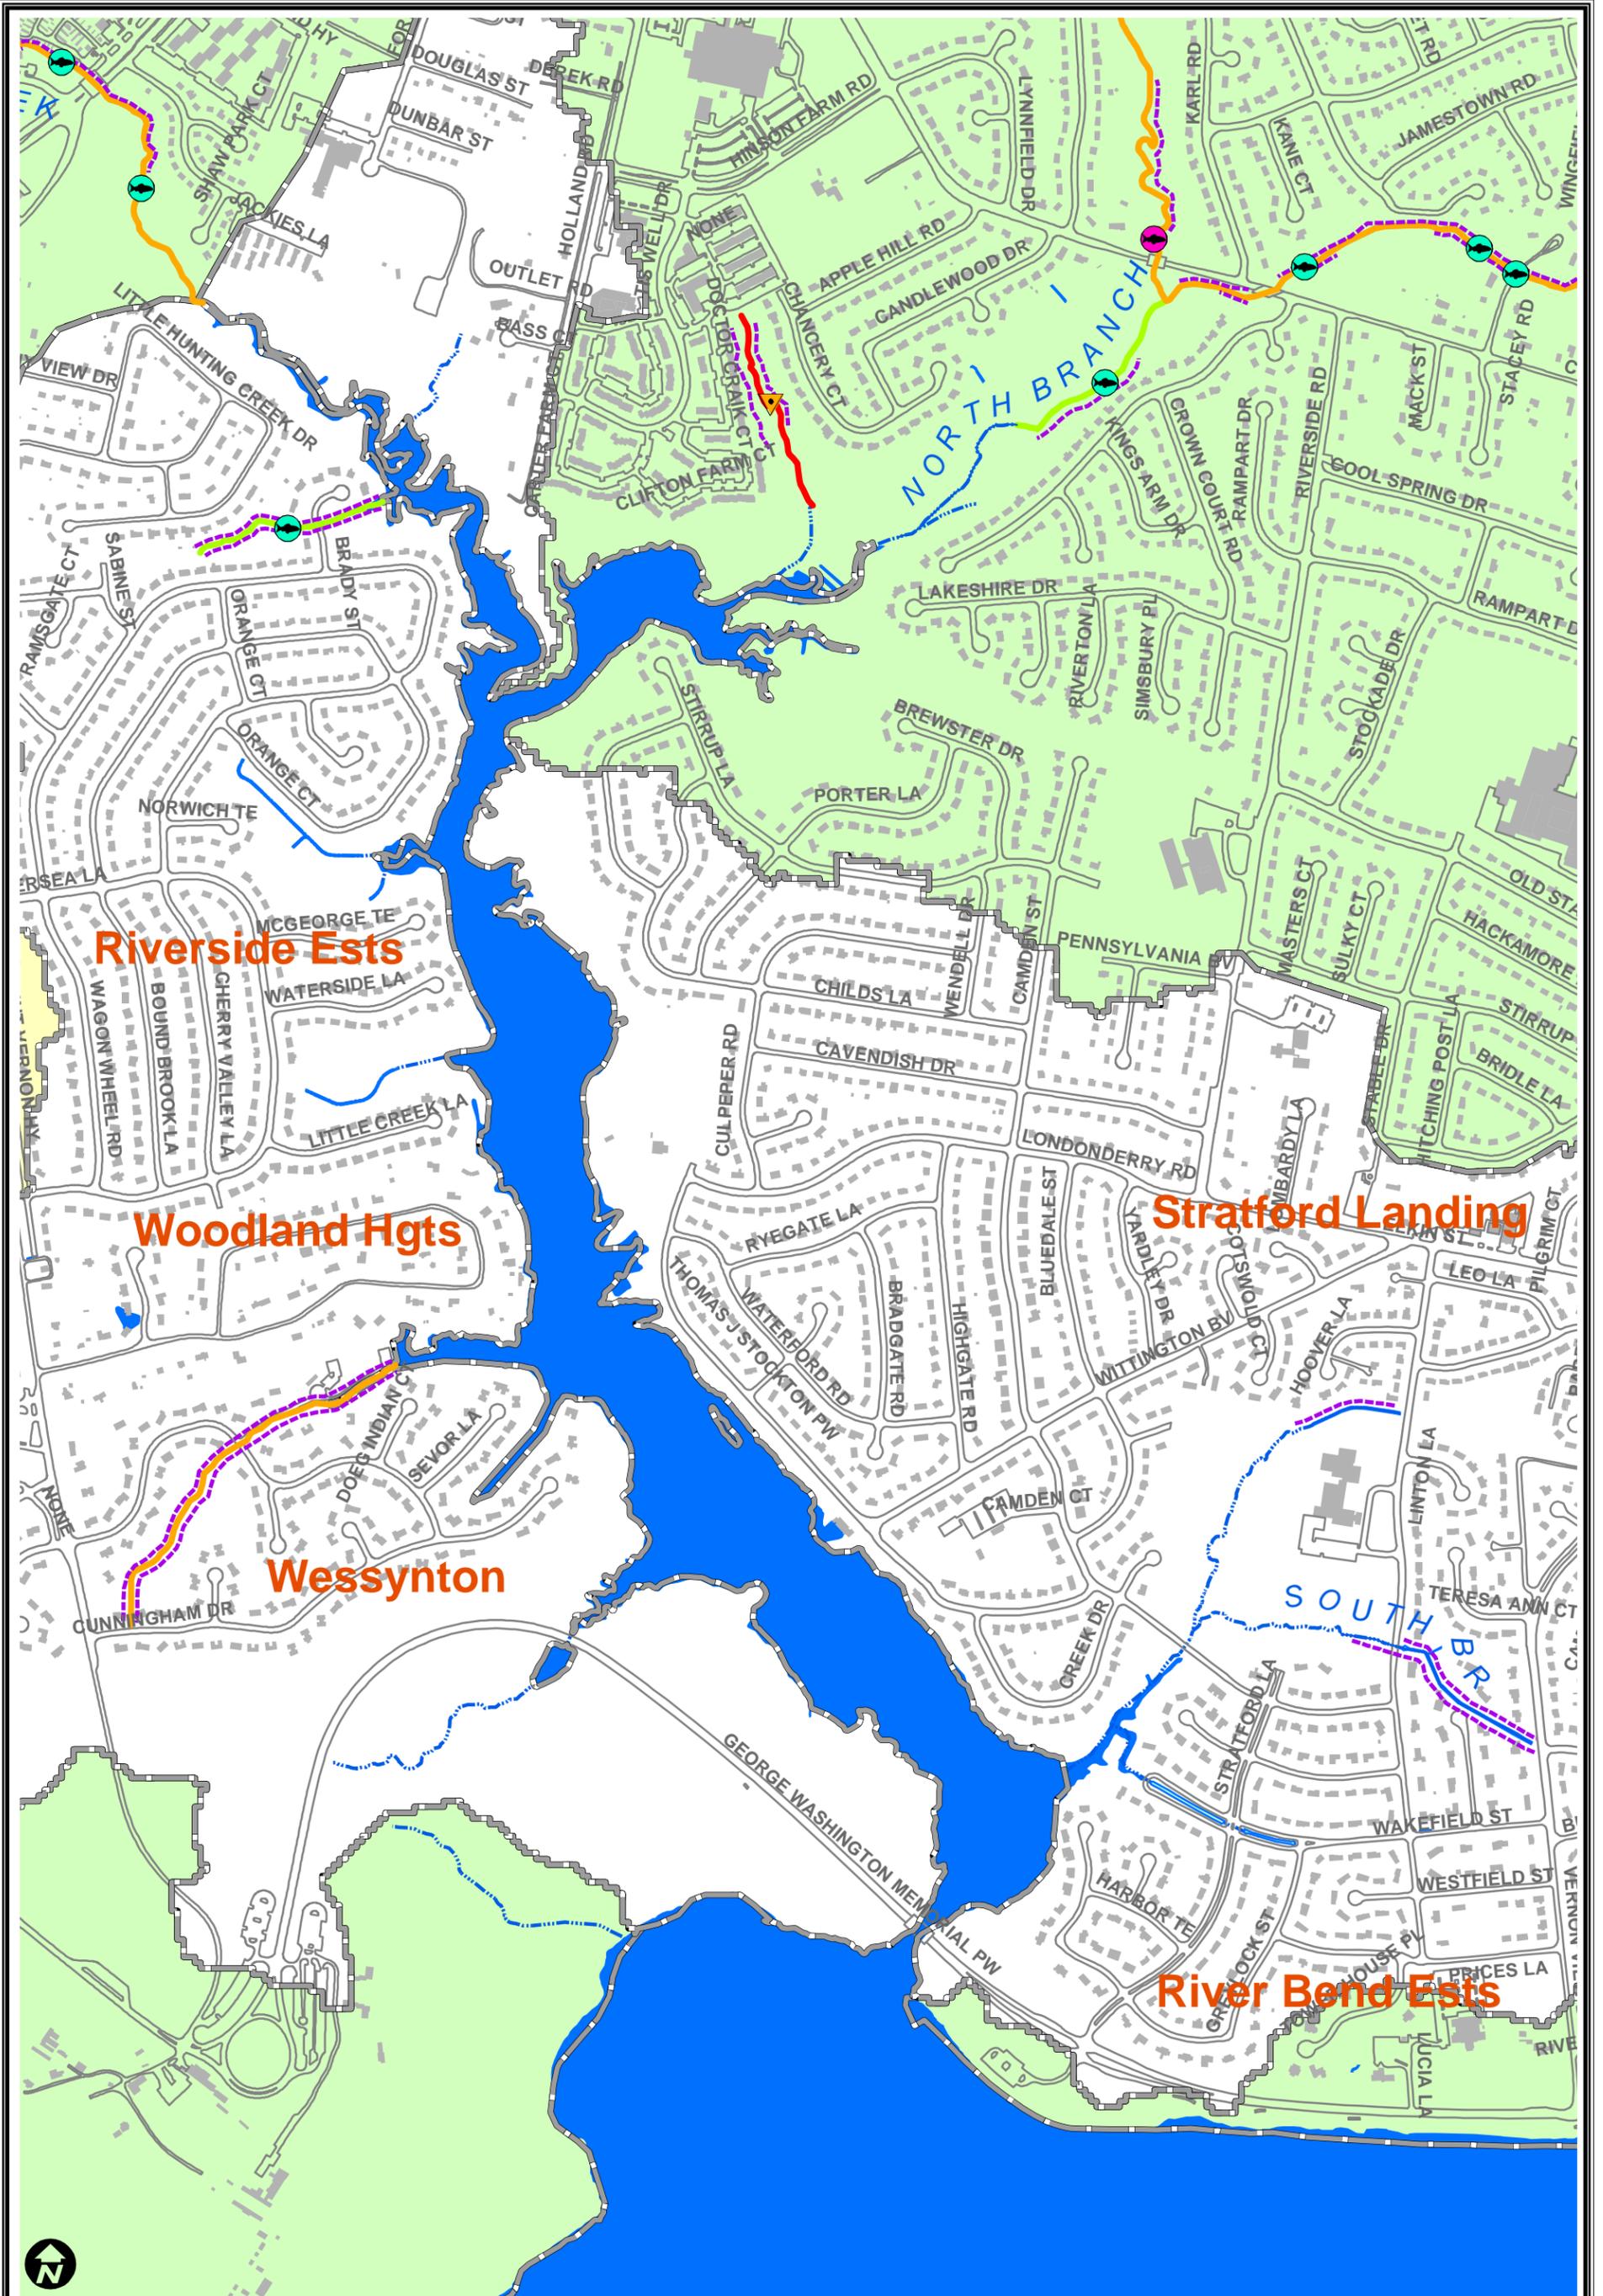
**Map 3.8**  
**Little Hunting Creek Watershed**  
**Stream Habitat Quality**  
**South Little Hunting Creek**

Habitat quality is considered fair for LHLH011 and poor for LHLH012 as shown on Map 3.8. An adequate buffer width does not exist along most of the stream corridors of the tributaries in the South Little Hunting Creek Subwatershed due to residential development in the area. Photo 3.14 shows planted lawns located in the buffer zone along the north branch of South Branch, west of Linton Lane; Photo 3.15 shows deficient buffer along the tributary LHLH012 located on the west side of South Little Hunting Creek. The impact of deficient buffer areas on the streams in this subwatershed is moderate. The stream segments of South Branch and the tributary (LHLH011) located near Brady Street are ideal candidates for stream restoration projects because each individual project would be of adequate stream length, would not involve easement acquisition, and would appear to have good access for construction. No head cuts or erosion of the stream bed and banks were observed as part of the stream physical assessment. An eroded area with large trees along the banks being undercut was identified at a stream tributary on the west side of South Little Hunting Creek near the George Washington Memorial Parkway.
