## 2.3 Johnny Moore Creek Watershed (Johnny Moore Creek and Johnny Moore Creek – Bull Run WMAs)

### 2.3.4 Stream Condition

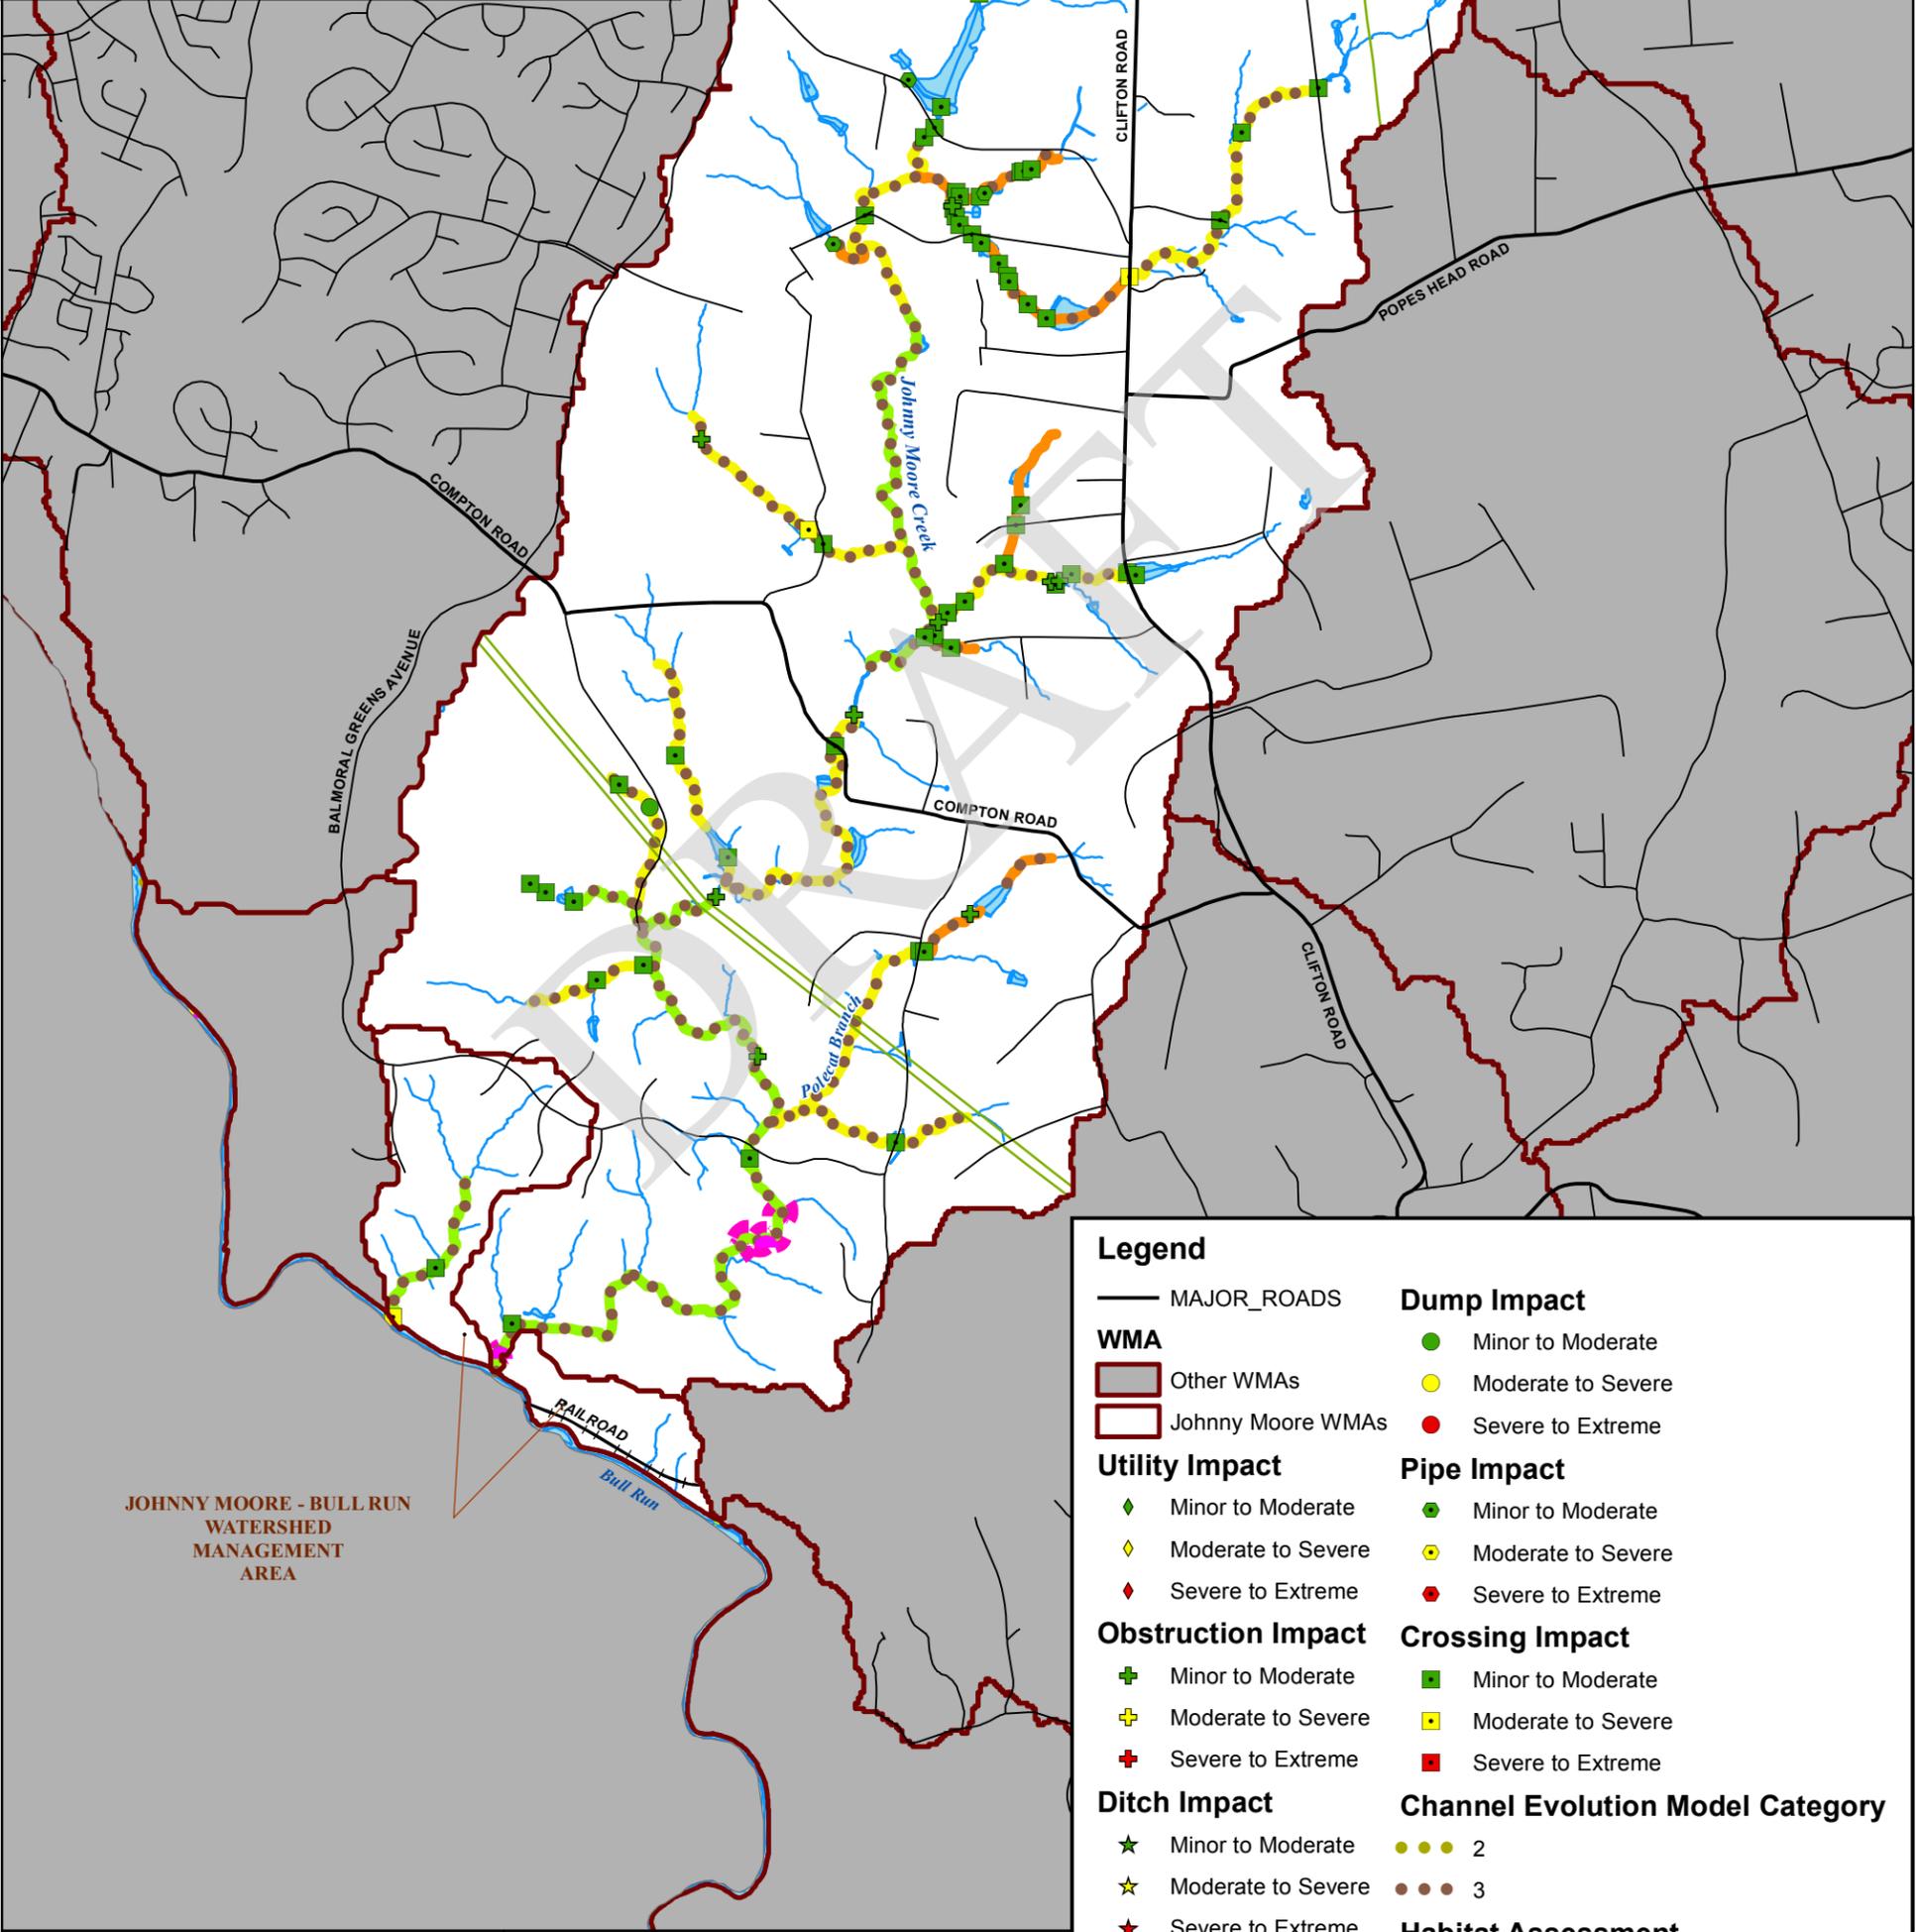
Stream Condition

The CEM Types 2 and 3 are shown on the stream condition map because these types are considered the most unstable. In the WMAs, all of the assessed reaches are CEM Type 3, except for the tributary that crosses Fox Shadow Lane, which is a CEM Type 4.
