TREATMENT PLAN

ARCHITECTURAL CONDITION ASSESSMENT AND TREATMENT PLAN

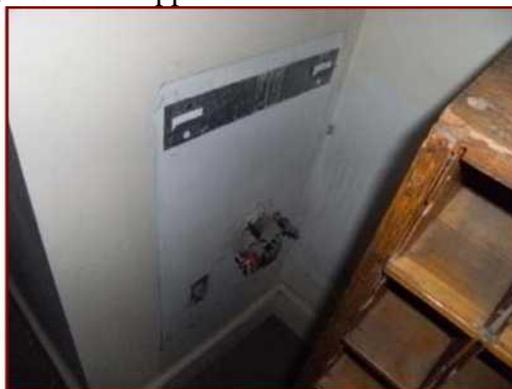
Image 4.21: Earlier Location of Drinking Fountain

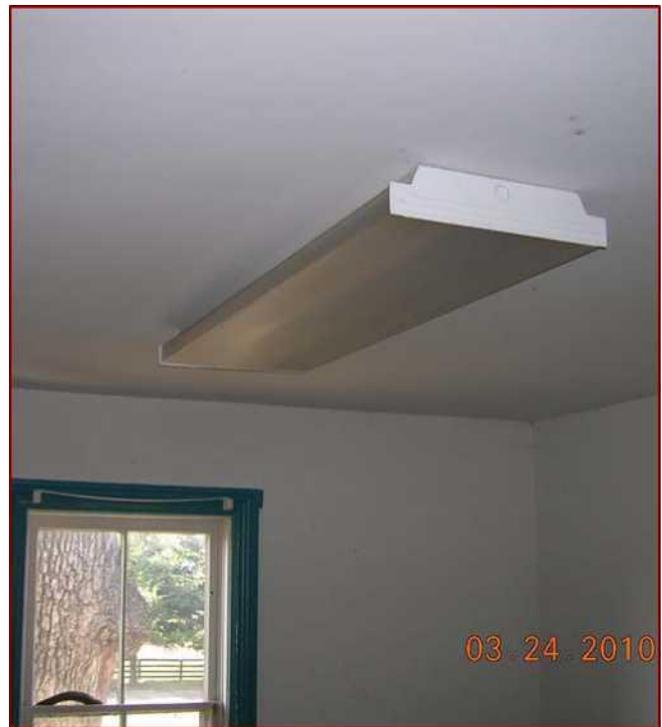
Image 427: Surface Mounted Light Fixture

- Salvage and reuse existing light fixtures in the basement and where possible throughout the house.
- Replace existing light fixtures in the kitchen.
- Install surface mounted fluorescent fixtures in proposed office space.
- Install compact fluorescent bulbs in closet and basement porcelain screw-in lamp holders.
- Replace exterior flood lights with HID fixtures with photocell and time clock.
