TURNER FARM
Turner Farm Treatment Report

10609 Georgetown Pike
Great Falls, Virginia 22066

Draft Report
July 8, 2016
WJE No. 2015.3162.2

Prepared for:
Fairfax County Park Authority
12055 Government Center Parkway, Suite 927
Fairfax, Virginia 22035

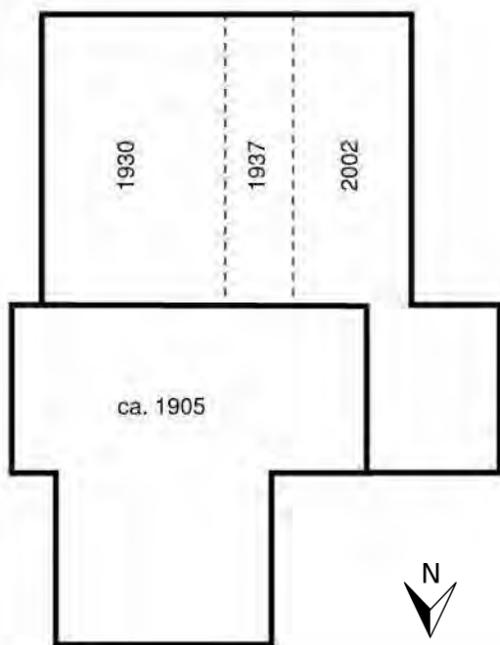
Figure 1. House development since the original construction. North is down.

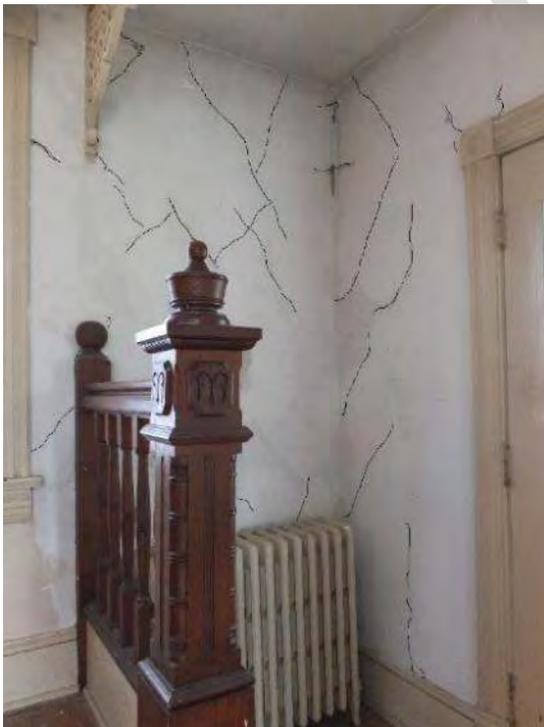
At the interior of the farmhouse, there are numerous cracks, damage, and water staining throughout the plaster walls at the original 1905 portion and 1930 and 1937 additions. The cracks are most severe at the Hallway (100), Hall, Bedroom (201), and main stairwell. (Figure 8 and Figure 9) Almost all of the historic interior doors and built-in cabinets still in place are racked and unable to close. (Figure 10) There is evidence of historic exterior siding enclosed by the 2002 addition at the doorway from the Kitchen (104) to the Parlor (106). There is a gap between the ceiling and door trim at this location. The transom above the door has been infilled. Hinges are still mostly in place along jambs at openings where doors have been removed, which provide evidence of their historic nature as the 1905 hinges are more decorative with steeple tips and the 1930s hinges are simple with ball/globe tips. At the large sliding wood living room doors, the frame is chipped in a few locations and the doors were not able to be moved. The interior door framing at the south wall of the Casual Dining Room (103) is damaged with part of the wood frame missing.

Figure 9. Example of cracking at the entryway at the northwest corner. Cracks have been traced for clarity.

- Clean and repair/replace deteriorated wood elements at the historic attic window. Paint.
- As we have determined that the plaster cracking is likely a result of the house being lifted in 2002, repair plaster cracking once structural repairs have been completed. Repaint all interior plaster finishes once repaired.
- Remove and clean spindlework at entryway while plaster repairs are being undertaken. Reinstall spindlework once plaster repairs and repainting is complete.
- Infill penetrations in wood floor of the Hallway (100) and Formal Dining Room (102) with wood filler and finish.

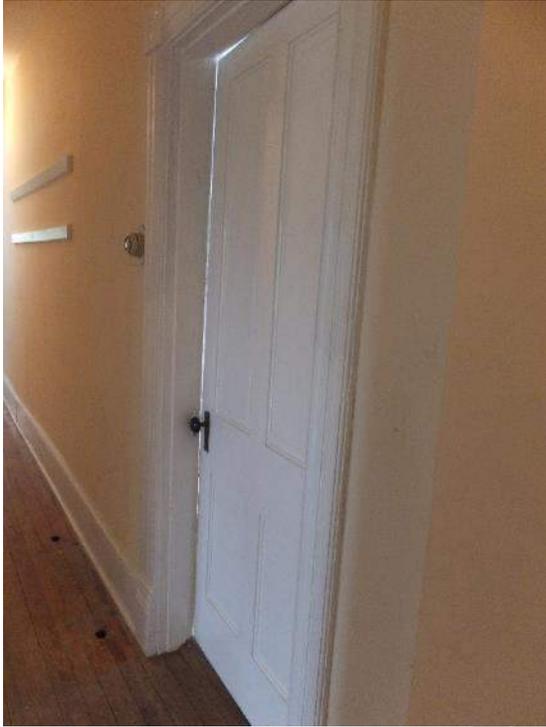
Figure 10. Door leading into room 102 does not fully close.

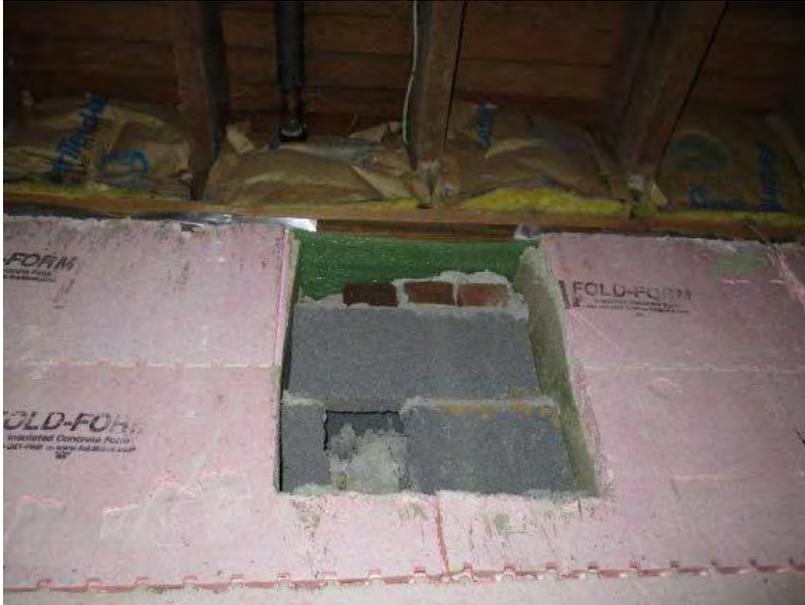
The original foundation walls are concealed. At both the exterior and interior facing sides of the foundation wall, WJE observed rigid foam insulation believed to be, in part, a manufactured system used to form new concrete walls. These types of systems utilize two (2) separate layers of insulation boards that are separated and braced with hard plastic struts. The void space between the two layers of insulation can vary between 4 inches and 16 inches. Wet concrete is poured into the void space between the two layers of insulation to form the structural/load bearing wall. The insulation remains after the concrete is cured to provide insulating value to the new wall system. The sill plate and other structural elements may be tied into the new foundation wall assembly. What is unclear, due to the insulation boards running from floor to ceiling and obscuring a visual review, is whether any of the original foundation wall remains in place or if the original walls were replaced in totality with the new formwork and concrete spanning from floor to ceiling. There are multiple blockouts in the top of the walls that are partially infilled with miscellaneous building materials, i.e. CMU, brick masonry units, and grout (Figure 14). At one blockout location where a CMU unit was damaged, we observed a reinforcing bar in an interior cell (Figure 15). Although no information is available concerning the method by which the house was raised, we anticipate that these blockouts were locations where equipment was installed to raise the house and after the house was positioned on the new walls, the equipment was removed and the blockouts were infilled.

Figure 14. Blockout in cellar wall infilled with CMU, brick masonry, and grout.

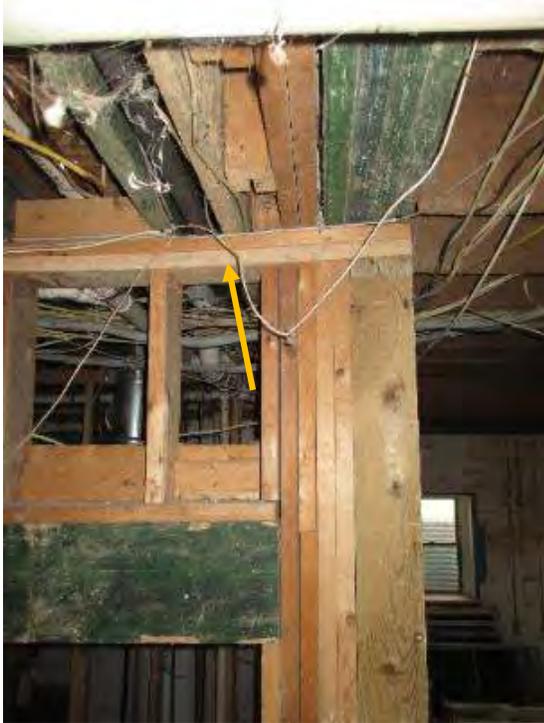
Original main structural members have been removed while several new ones have been installed, resulting in a different distribution of load to framing members than was originally designed for. We observed deflection of members in interior partition walls (Figure 16), which are not typically designed to carry load, indicating that they are taking load. It is unlikely they were designed to act as structural supports and the amount of deflection observed indicates that they are potentially overloaded. The first floor walking surface is significantly warped and out of level and gaps exist between many of the interior finishes as discussed in the Architectural section. There does not appear to be a subfloor below the original finished floor at the first

floor but a subfloor is visible at the additions. It is unclear what the condition of the floor was prior to being raised, but it is possible that the process of raising the house to create additional height in the basement combined with the reconfiguration of structural support for the floor has caused the noted warping. In general, the load distribution is difficult to follow and will require further documentation and evaluation.

Figure 16. Deflection of header at interior partition wall.

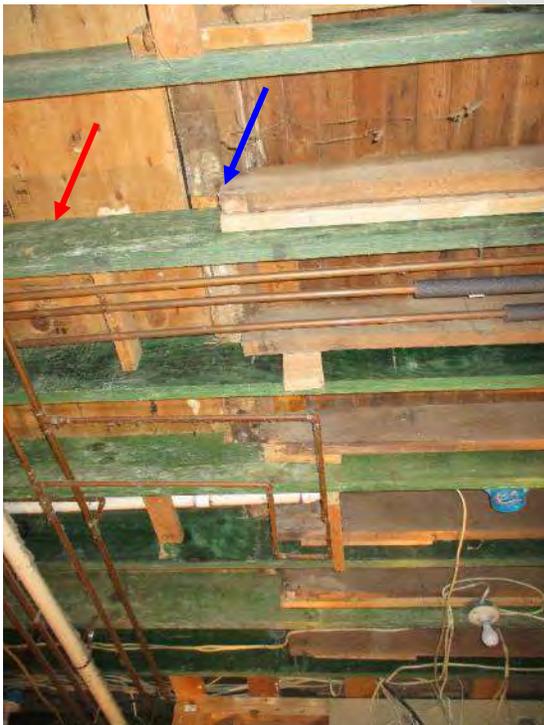
Built-up areas of wood members are located throughout the first floor framing in apparent attempts to make up differences in framing and wall heights (Figure 17). Framing members installed during the first southward expansion are no longer being utilized for structural support as the west ends are no longer supported (Figure 18); new structural composite lumber (SCL) joists now span the entire twenty-seven foot length of the south expansion from east to west. This is a long distance for wood to span and it is common to see steel used to carry load when this distance between supports is necessary or desirable. The SCL joists are notched at their tops at what appears to be an old perimeter beam which runs perpendicular to the joists²⁰ (Figure 19). New built-up wood columns are installed at several locations in the north portion of the original house and are offset from the interior walls approximately one inch. At one location the bearing area at the base of the column is not sound (Figure 20). Several bolts mechanically connecting built-up flexural members together along the south edge of the original construction are disengaged or missing (Figure 21). Wood bridging between first floor joists, which provides lateral support for the joists, is disengaged or missing at a majority of locations (Figure 22). A new masonry structure consisting of CMU and brick masonry units is installed under the fireplace near the center of the original house and several new and existing wood beams frame into it (Figure 23).

Figure 18. New framing members span the entire width of the south addition (red arrow). Original framing is no longer supported at west ends (blue arrow).

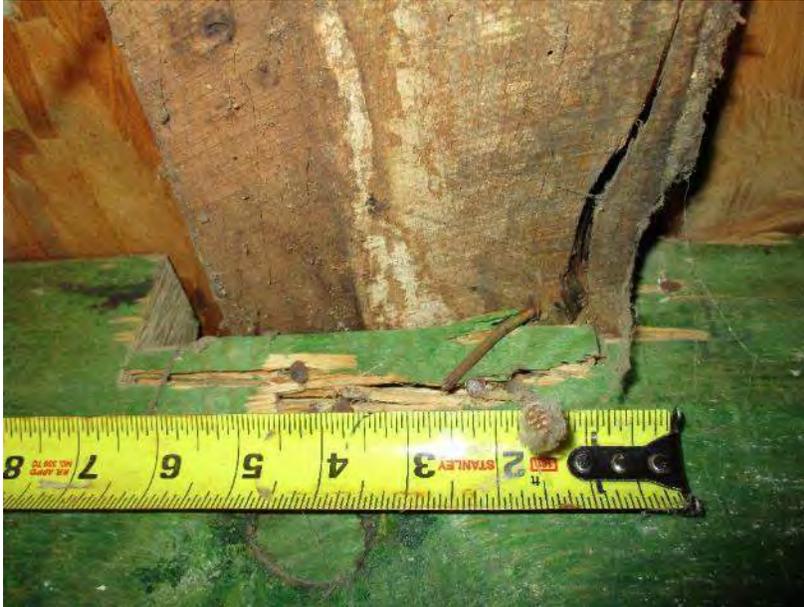
Figure 19. SCL joists are notched at their tops at what appears to be an old perimeter beam which runs perpendicular to the joists.

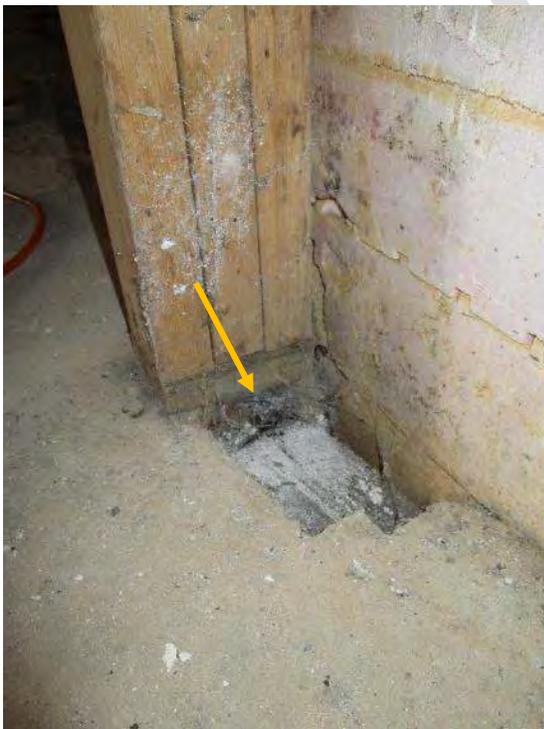
Figure 20. Void in concrete slab below column.

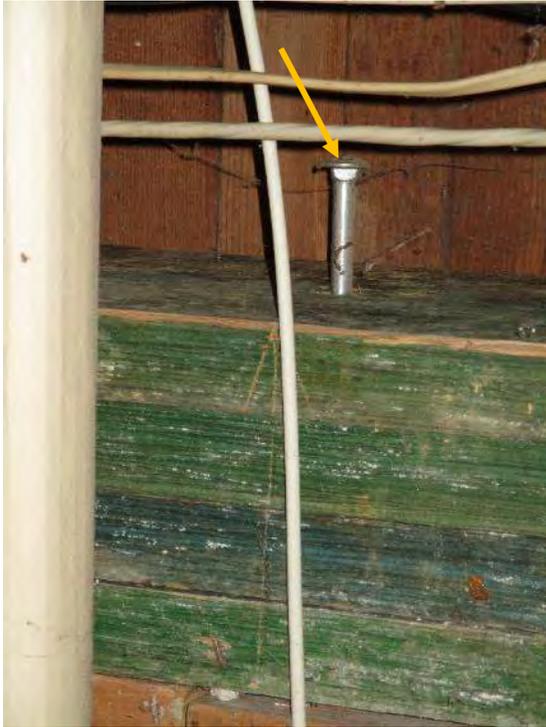
Figure 21. Disengaged bolt in built-up member.

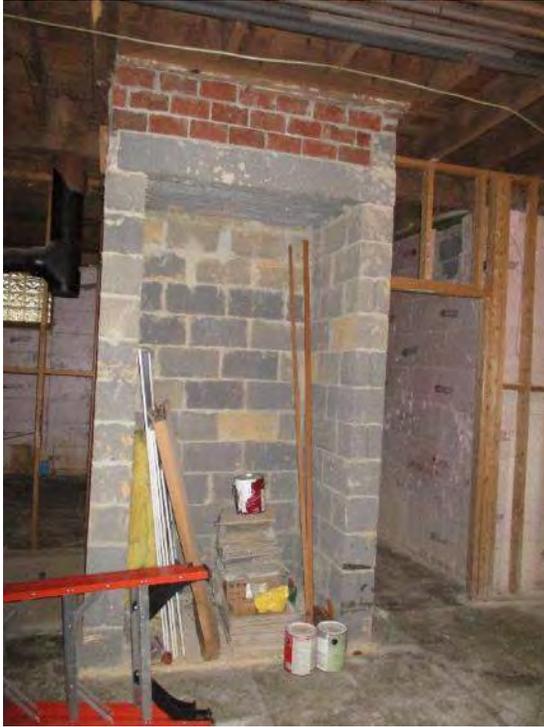
Figure 23. New CMU structure supporting fireplace.

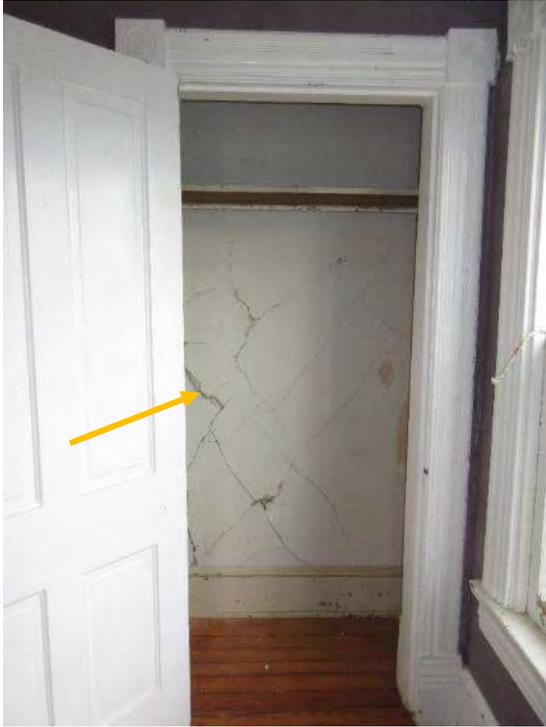
The second floor framing is concealed by interior ceiling and floor finishes and therefore was not included in our review. Significant cracking is present in the plaster wall finish and ceilings throughout the second floor. The cracking is concentrated along the eastern portion of the original house and is most significant in Rooms 201 and 202 (Figure 8 and Figure 9). It is unclear how long the cracks have existed but based on their patterns, i.e. diamond shaped (Figure 27), and our observations from the first floor framing review, it is likely that the cracking occurred while the house was being raised or shortly thereafter. We anticipate that the house experienced substantial movement during the lifting process and the plaster finish did not have enough flexibility to withstand the movement, resulting in cracking. The cracks appear to be static, i.e. not actively moving, and we do not anticipate that they will grow.

Figure 27. Diamond shaped cracking in closet of Bedroom 202.

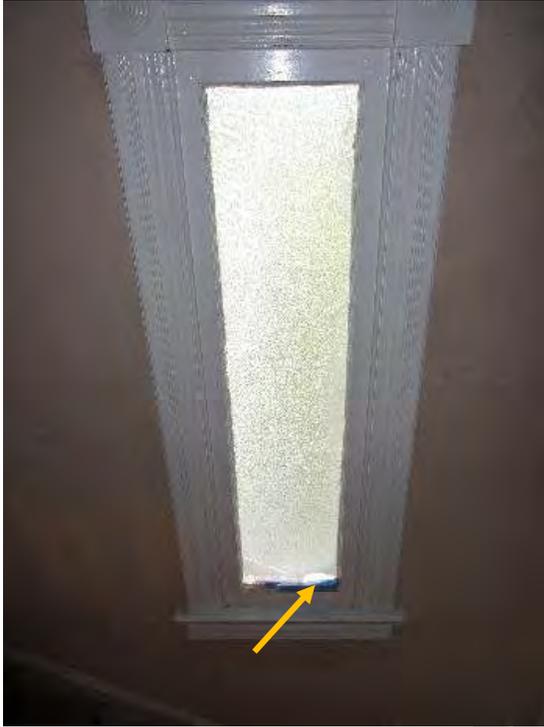
Figure 34. Broken glazing in stairwell fixed window.

- At doors with broken or missing glazing, replace glass with similar glazing, clean and repair wood where needed, and paint. Remove boards at the exterior from obscured doors and windows, inspect and address any additional damage not observable from interior.
- Replace broken glazing and replace with an era appropriate pattern/texture on west facade. (Figure 34)
- Once windows are cleaned and repainted where needed, install sealant fillet joint at perimeter of windows between the window frame and the adjacent exterior siding to help limit air infiltration at the rough opening for the window.
- Replace damaged, non-historic, screen on west facade first floor window.

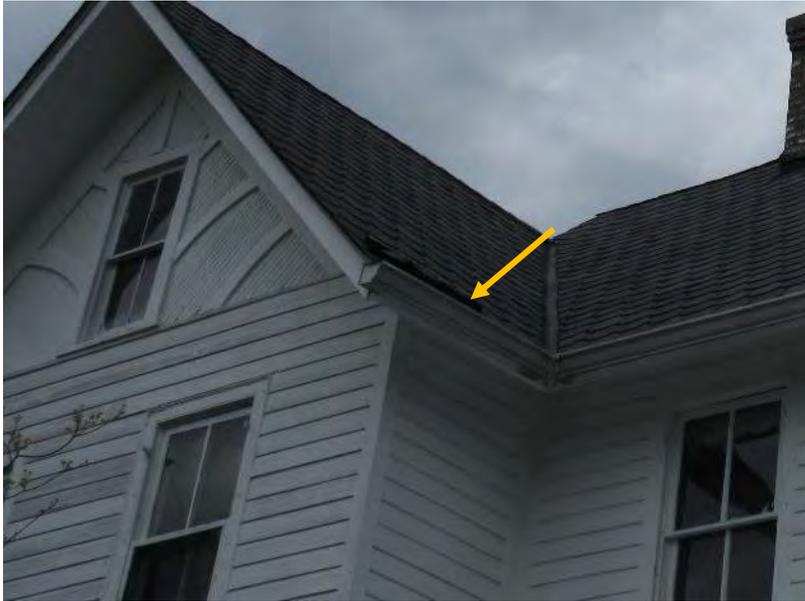
Figure 36. Asphalt shingles out of plane above the gutter.

- Repair shingles at the northeast corner to ensure roofing is watertight. (Figure 36)
- Infill fastener holes at window of enclosed porch on the north facade. Paint.
- Inspect flashing at Juliet balcony to ensure secure and lapped properly to encourage water shed. (Figure 37)
- Repair cracked wood decorative spindle element at Juliet balcony. (Figure 38)
- Remove miscellaneous horizontal boards at decorative gable shingles above Juliet balcony unless archival documentation provides information on why these were installed.

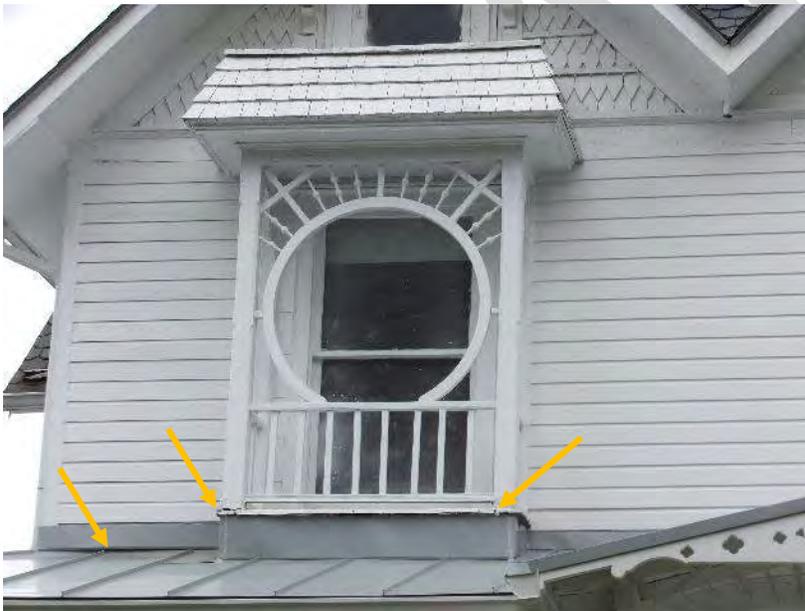
Figure 37. Lifted and separated flashing at Juliet balcony. Note gap between second floor flashing and porch roof.

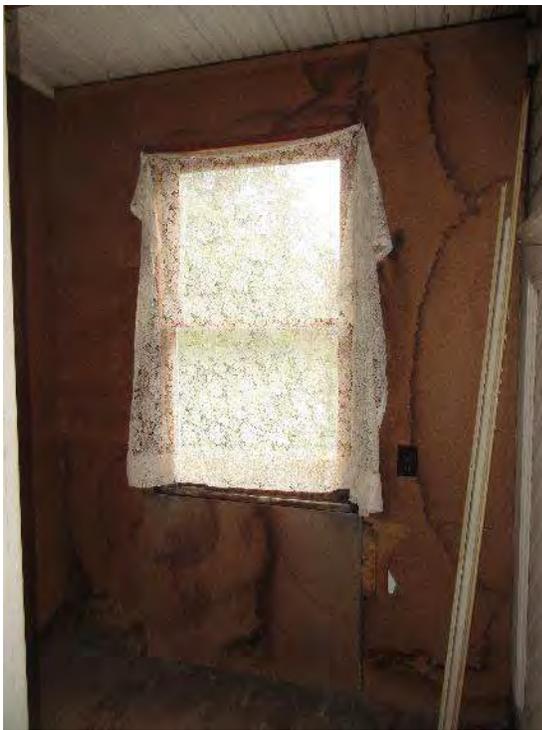
Figure 40. Deteriorated and stained particle board at the enclosed patio on the second floor.

- Remove baseboard and repair any deteriorated areas below windows on the east wall of the Casual Dining Room (103). Re-install once plaster has been repaired and paint.
- Modern windows in Kitchen (104) are exposed wood. Wood should be protected either by clear coating or paint.
- Complete interior finishes in Bedroom (204) and Bedroom (207) around windows to obscure insulation and gaps.
- Replace window at the Enclosed Porch (208) with a proper fitting window. Replace all non-historic wood wall finish (particle board) and install new interior finishes with proper interfaces with window. (Figure 40)

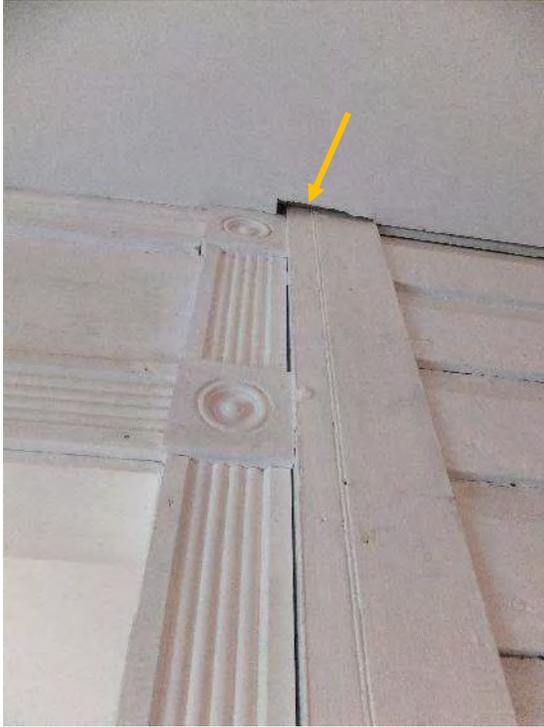
Figure 43. Gap at ceiling and historic door frame.

- Re-secure faucet cap at shower in the Bathroom (105).
- Install backer rod and sealant above medicine cabinet in the Bathroom (105).
- Remove abandoned fasteners and patch at the walls of the Bathroom (105).
- Install sealant at crown molding joints where they have separated in the Bathroom, paint (105).
- Inspect for soft deteriorated wood at the door frame and repair and repaint at the Bathroom (105).
- Infill gap at ceiling at the 2000s Kitchen (104) and the original doorway of the house with backer rod and sealant, which allows for this material to be removed in the future (reversible). (Figure 43)

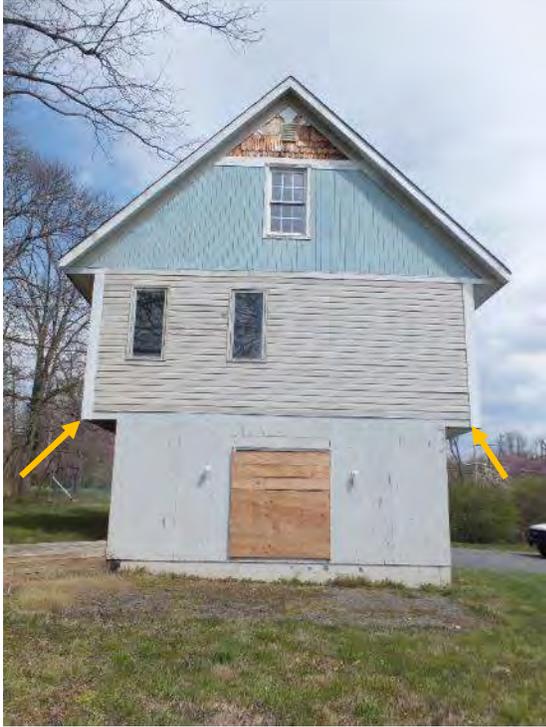
The two-story garage was constructed in multiple phases as evidenced by construction detailing and variety of materials used; however, the actual sequencing and extent of construction phases and modifications are not known at this time. Access was not provided to the second level of the garage therefore our review was limited to the first floor and the exterior. Based upon aerial surveys available publicly, we can discern that a garage has been in existence at this location since before 1998, but had a footprint about half the size and was expanded sometime between 2002 and 2005. A phone call with the Fairfax County Tax Administration indicates they have a record of a major alteration to this structure occurring in 2004. WJE speculates that at one time, the upper portion of the garage may have been a separate structure and was lifted and set on top of the walls of the first level based upon the unusual overhang on either side of the building. (Figure 47) The entire first level is unfinished on the interior, revealing all of the structural framing. It appears that the first level was constructed in two different phases with the north portion being built first and the south portion at a later time.

Figure 47. South elevation of garage. Note the overhang at the second floor line.

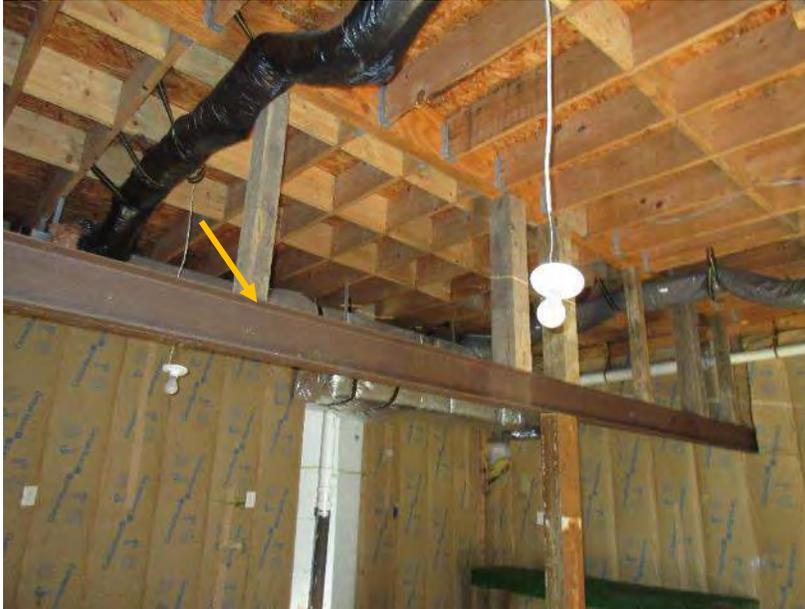
Figure 50. Steel beam runs longitudinally through the first floor of the north portion of the garage.

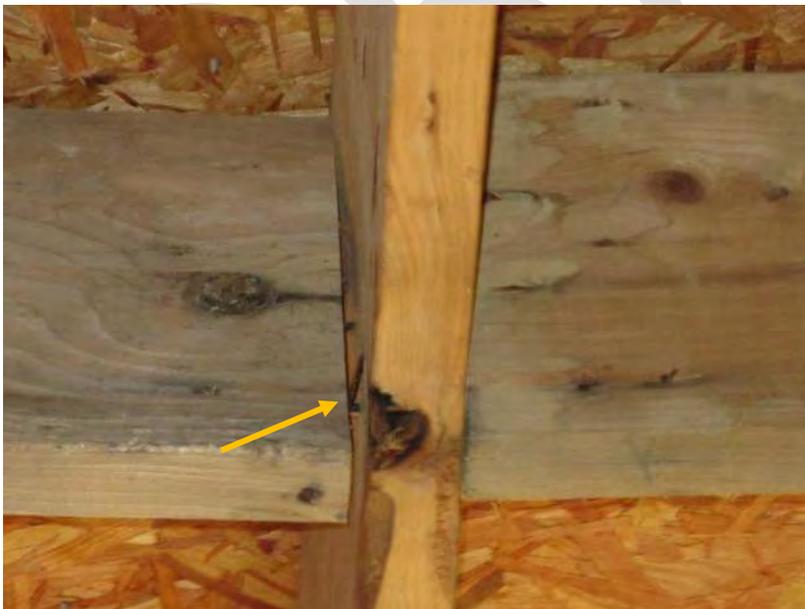
between wood joists (Figure 52) and gaps are present between the ends of the wood bridging and the joists at multiple locations. (Figure 53) Since the interior of the second level was not accessible during our site visits, a review of the interior space should be completed to determine if there is distress resulting from lifting a portion of the house similar to what was observed at the farmhouse. No structural analysis was performed as a part of our evaluation as it is outside of our current scope. In general, the load distribution is difficult to follow as a result of the different additions to the structure. Connections between the first level and second level along with the framing should be further documented and evaluated.

Figure 53. Gap is present between end of wood bridging and joist.

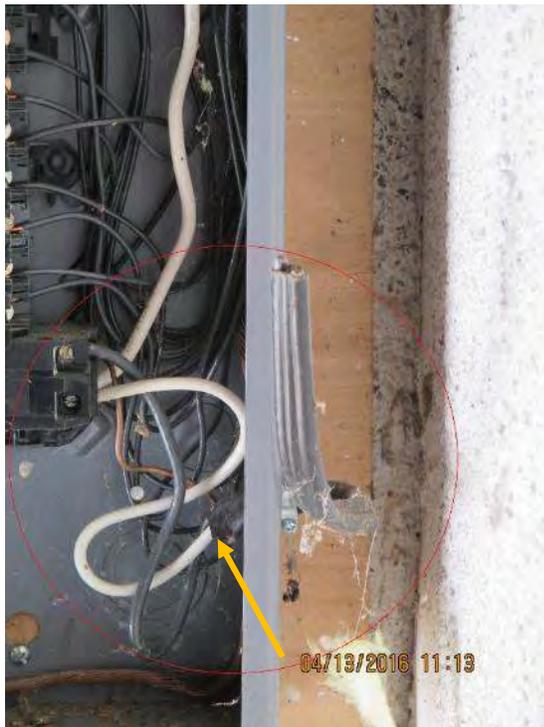
Visible systems located in the spaces opened at the first level were inspected. The garage had relatively modern electrical equipment; however, the panels did not have final inspection stickers from Fairfax County indicating that the equipment was either temporary or roughed-in. Several open junction boxes in the upper levels were observed. Some of the wires extended outside the enclosure and were cut and not properly terminated. (Figure 54) The plumbing systems also lacked a final inspection sticker from Fairfax County. The water supply was turned off at the utility meter located approximately 25 feet west of the driveway. As such, most of the systems in the garage could not be tested. Septic piping for the garage could not be located, but it is anticipated that it goes back to the same distribution box and septic fields tied to the farmhouse. The garage has a natural gas supply line, which feeds one or more high efficiency gas furnaces. The furnace is modern, but was not functioning due to the turned off utilities. The indoor heat pump is in relatively good condition, but ductwork at the unit should be cleaned and insulated. Areas of previous water infiltration at the upper floors was observed at interior finishes and around electrical boxes. The garage has systems for air conditioning; however, one or more of the condensing units had been removed, which was evident from cut refrigerant lines.

Figure 54. Improperly terminated electrical lines. Photo courtesy of MBP.

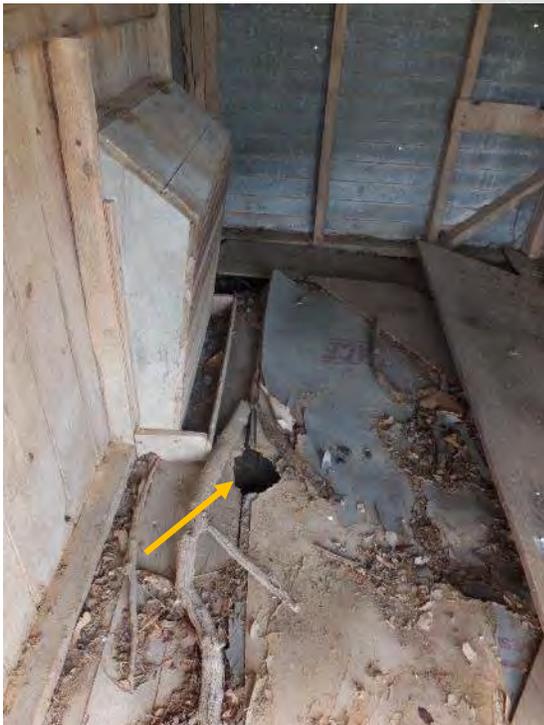
The shed is supported by timber sills which appear to bear directly on the ground. (Figure 59) No evidence of a foundation was observed. The shed appears to have settled over time as a result of deteriorated wood framing. Tongue and groove floor planks were visible on the east half of the shed. The floor planks are significantly deteriorated towards the north half of the shed. Complete section loss of the plank members along with the presence of an animal habitat, as evidenced by chew marks in a wood plank, are apparent in the east bay. (Figure 60) Carpet is installed on the floor of the west side of the shed and generally conceals the substrate below. At areas that are not concealed by carpet, we observed exposed soil. (Figure 61)

Figure 60. Complete section loss of the plank members along with the presence of an animal habitat, as evidenced by chew marks in a wood plank (orange arrow).

- Excavate the soil below the shed and create short foundation walls to hold the wood structure off the ground, thereby limiting future deterioration of the wood framing due to moisture.
- Perform repairs to the timber sills or replace as necessary.
- Consider installing a new floor system commensurate with the building's function in lieu of tongue and groove floor planks.
- Perform isolated repairs to the wall framing and rafters.

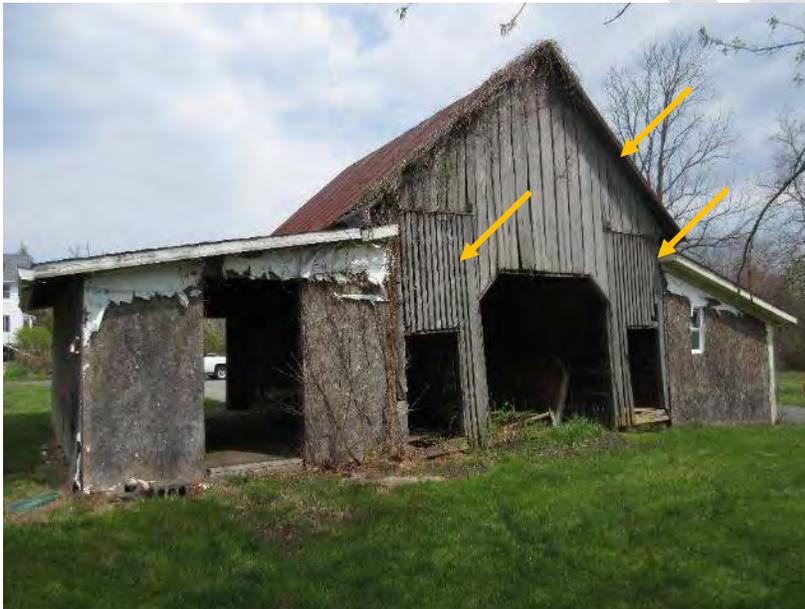
Figure 64. South elevation of the crib barn as viewed from the southwest. Note the historic wood slats and siding.

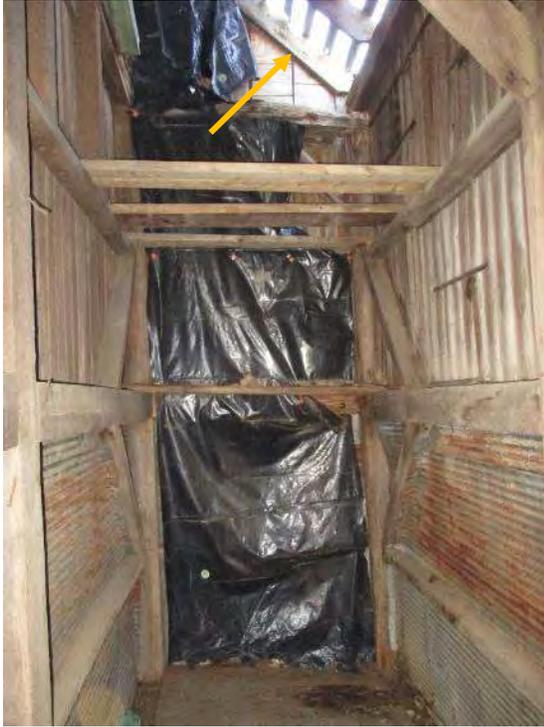
Portions of the metal roof are missing at the northeast and southwest corners of the original structure. (Figure 69) The wood framing below the openings in the roof is significantly deteriorated, likely as a result of long-term exposure to water. Nearly complete loss of bearing is present at the northeast corner column in the east crib. (Figure 70)

Figure 69. A portion of the metal roof is missing at the northeast and corner of the original structure.

- Remove large modern window above central bay and infill with wide wood vertical siding (similar to the historic siding on the south facade).
- Remove areas of deteriorated metal at roof at central bay and perform large patches.

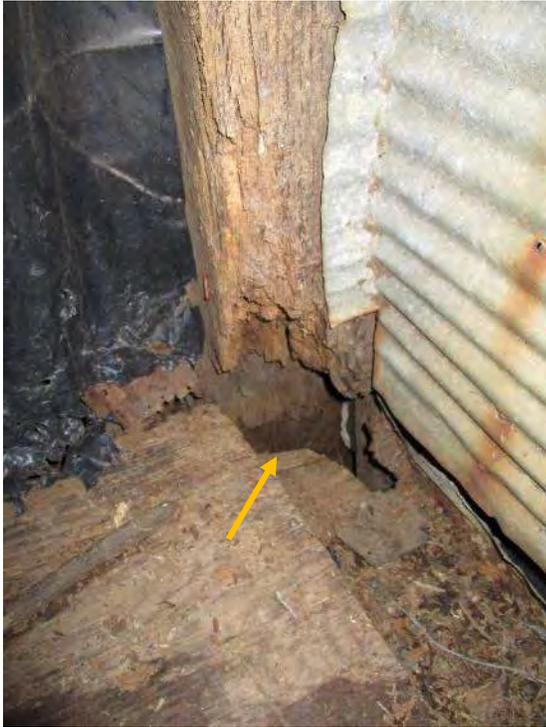
Figure 70. Nearly complete loss of bearing at the northeast corner column in the east crib.

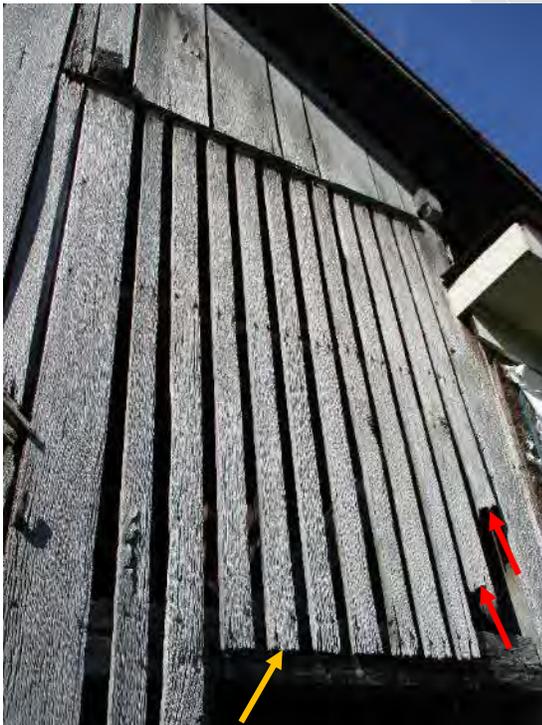
Non-structural vertical wood slats installed on the interior are generally in fair condition; however, WJE did observe several that are fractured from what appears to be impact damage (Figure 75) and several that are deteriorated near grade. Vertical wood slats and vertical rough sawn boards installed as cladding on the exterior facades are slightly deteriorated. Splits in the rough sawn boards and splintering at the ends of the wood slats were observed on the south elevation (Figure 76). WJE anticipates that they will continue to deteriorate unless they are coated with an exterior grade of paint in the near-term.

Figure 76. Splintering at the ends of the wood slats (orange arrow) on the south elevation along with two fractured slats (red arrows).

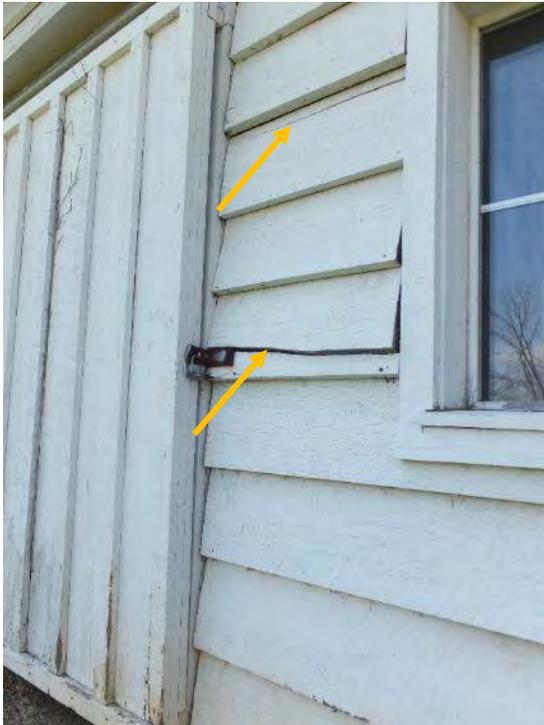
At the exterior, there are areas of siding of loose boards and some board with gaps (no overlap). Throughout the siding there are also areas of cracked siding. (Figure 85) There is a consistent gap between the window

Figure 85. Cracks in siding. The lower crack is due to the installed latch.

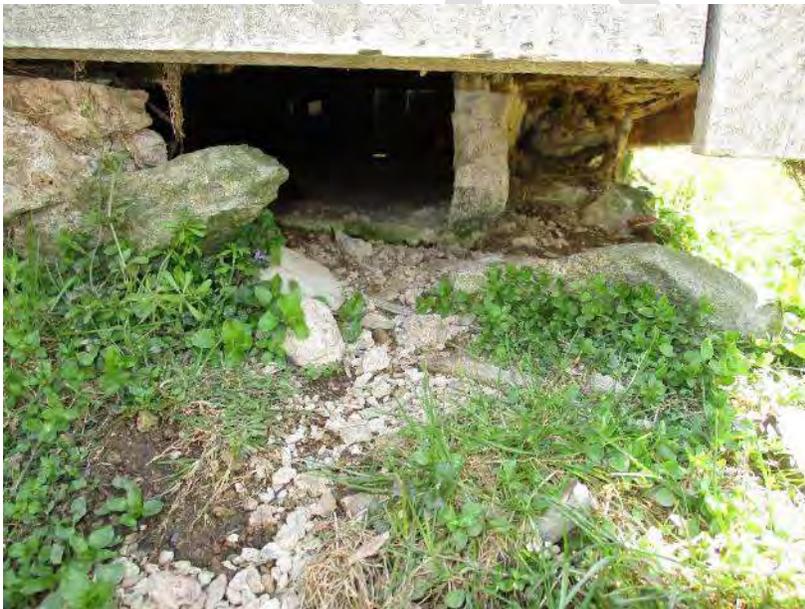
Figure 87. Stones present at foundation wall along west elevation.

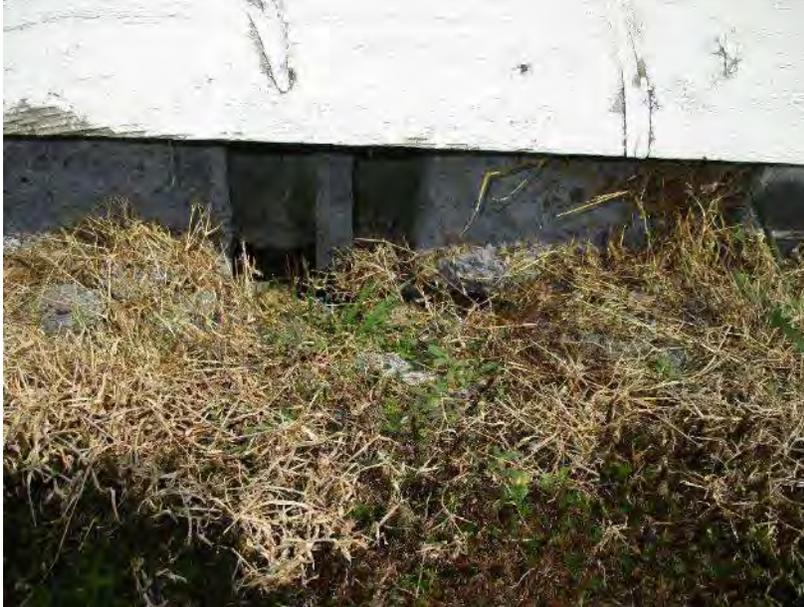
Figure 88. CMU present at foundation wall along west elevation.

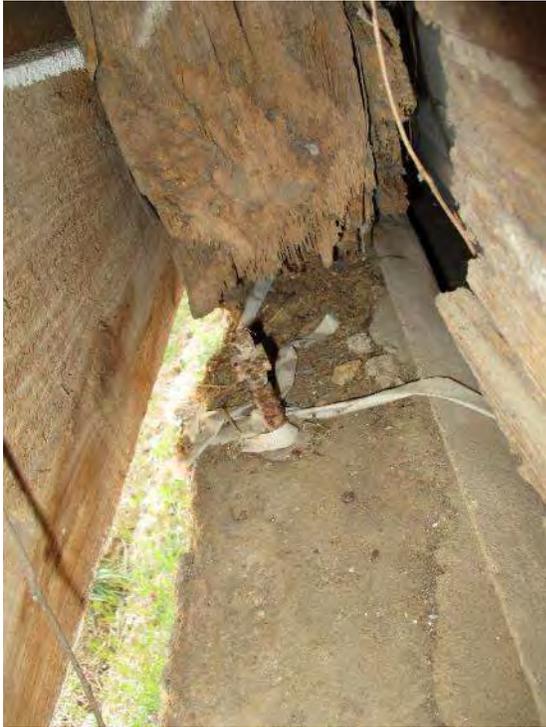
At one location where an opening in the wood cladding exists, we were able to observe a wood column on top of the concrete foundation wall. The base of the column is significantly deteriorated. (Figure 90) Several interior steel pipe columns have been removed. (Figure 91) Complete section loss through the thickness of the member is present at several of the pipe columns which support built-up wood beams in the loft floor. (Figure 92) The built-up wood beams are clad in wood trim; therefore, we were not able to evaluate their condition except at isolated locations. At one location, trim was removed from the end of the beam and the wood appears to be in good condition. (Figure 93)

Figure 90. Loss of bearing at wood column.

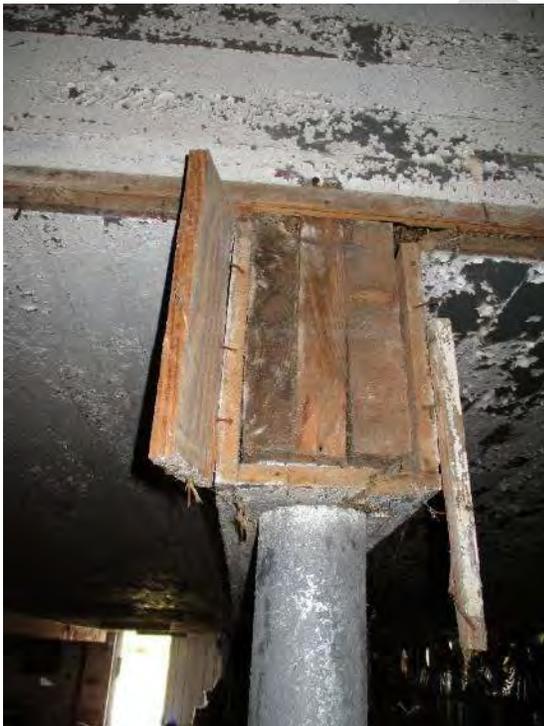
Figure 93. Ends of built up interior beam appear to be in good condition.

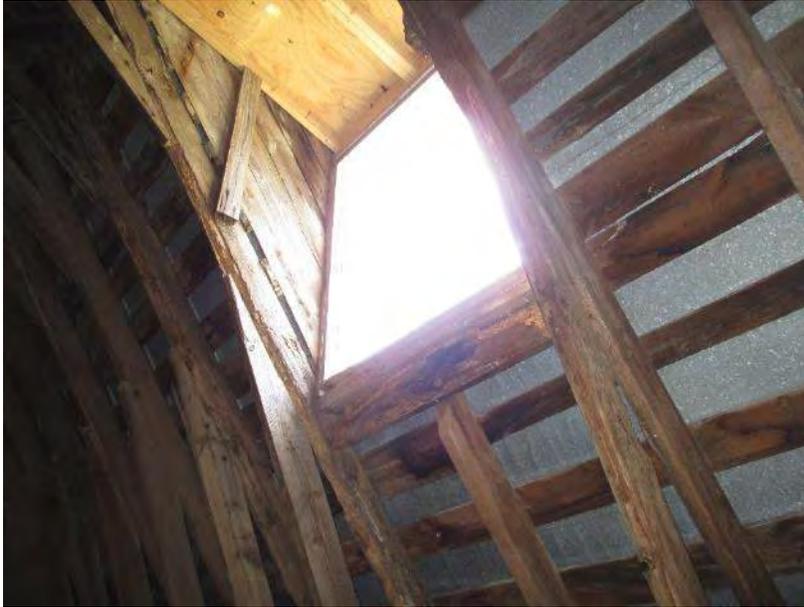
The wood framing and tongue and groove flooring in the loft are generally in good condition and only exhibit isolated deterioration. Deterioration of the wood framing is present at the central dormer along the west elevation (Figure 94) and at floor boards directly below the dormer. (Figure 95) This deterioration was presumably the result of uncontrolled water penetration from an open dormer. Evidence of insect damage

Figure 94. Deterioration of the wood framing at the central dormer along the west elevation.

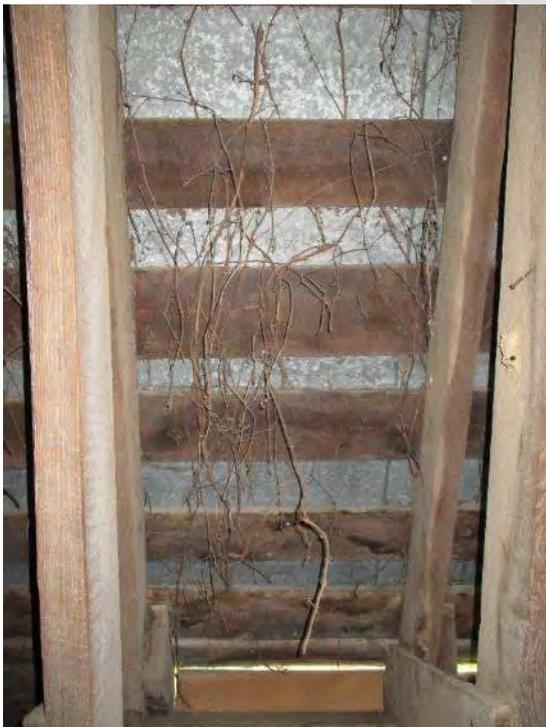
Figure 98. Vegetation between the roof framing and the metal roof.

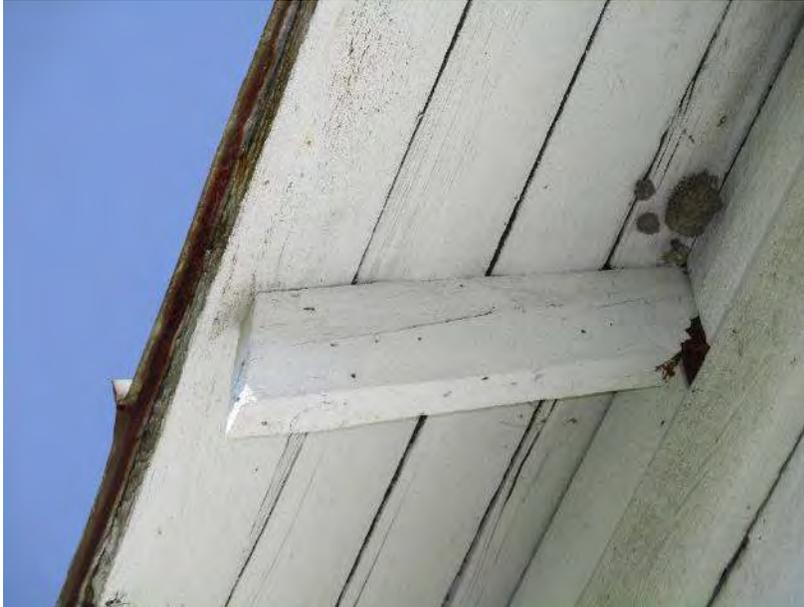
Figure 99. Deterioration at eave rafter.

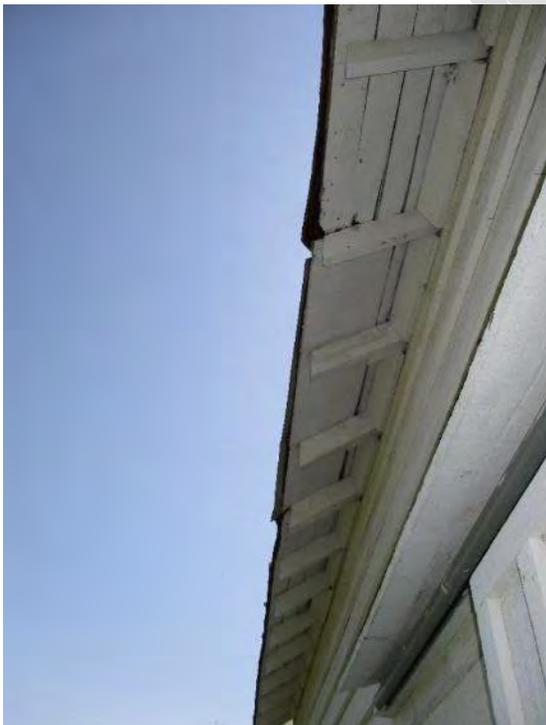
Figure 100. Painted plywood installed at isolated area of soffit.

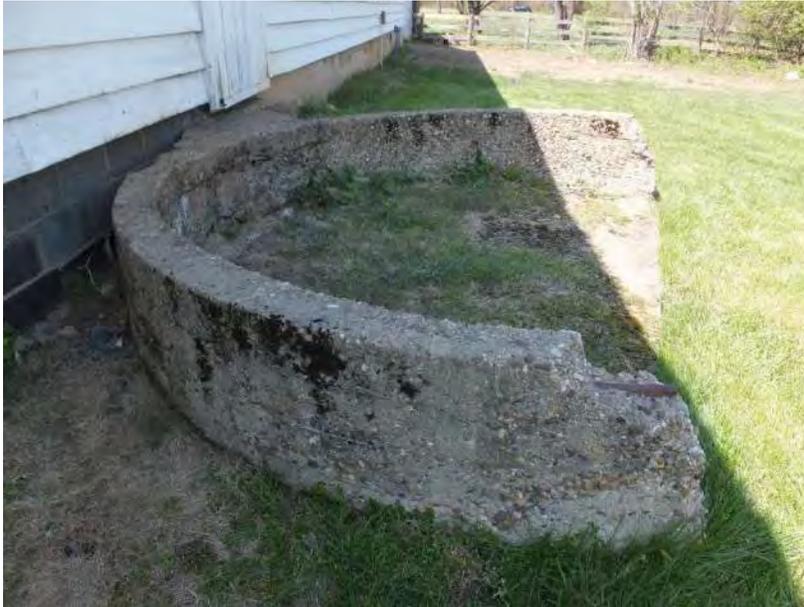
A crescent shaped concrete pit structure is connected to the dairy barn along the east elevation adjacent to a door opening. (Figure 101) Concrete spalls and exposed reinforcing are apparent at the edge of the concrete walls.

Figure 101. Concrete structure along east elevation of dairy barn. Note exposed reinforcing and concrete spalls.

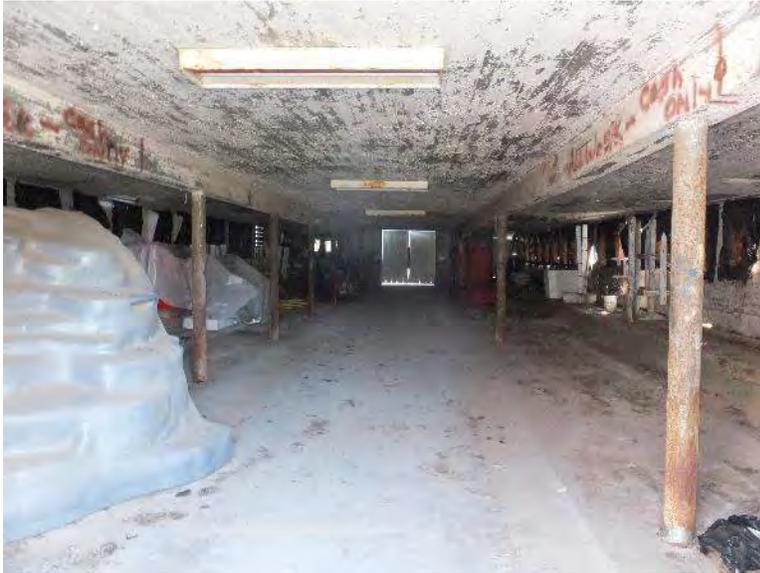
Figure 102. Interior condition of the dairy barn.

- Clean and inspect wood soffit. Remove soft and deteriorated wood and replace. Paint. (Figure 102)
- Document interior evidence of previous doors. (Figure 103)

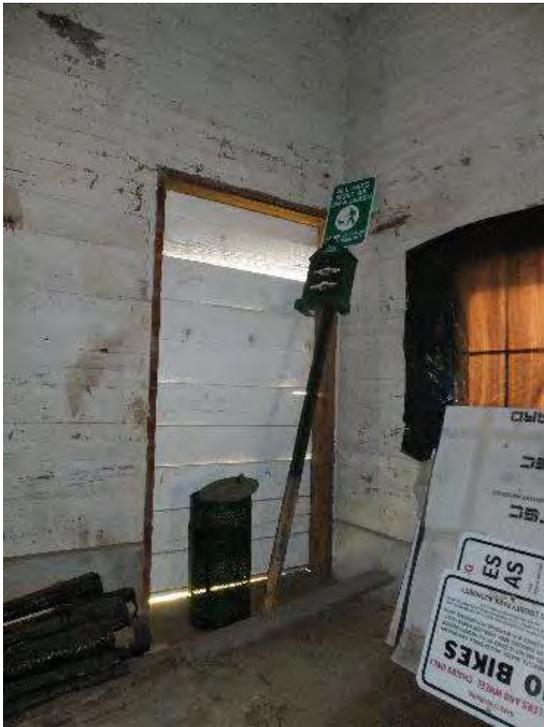
Figure 103. Evidence of previous door at the southwest corner of the barn. This would have connected to the silo.

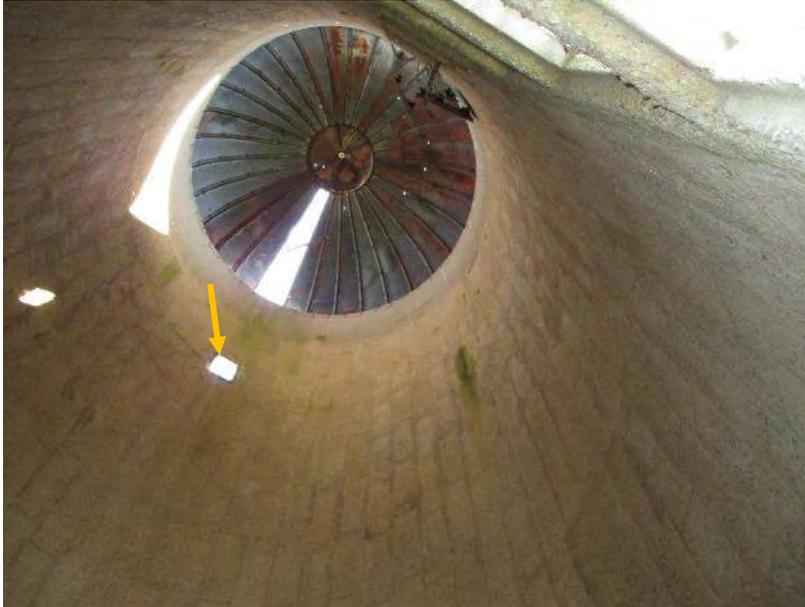
There is an open segment in the main roof, which has allowed water to enter the interior of the structure resulting in some green staining at the interior concrete. Just below the roof on this facade, a square cut opening has been made into the concrete. (Figure 105) There is related cracking of the concrete at the interior of this opening which is likely static and no longer actively moving. At the ladder enclosure, there is deterioration of the secondary roof resulting in material loss, which appears to be of similar metal as the main roof. (Figure 106) One concrete spall is present at the base of the silo. (Figure 107)

Figure 105. Interior view of silo. Note small hatch (orange arrow).

- Install hatch at roof and wall opening to prevent further moisture infiltration.
- Green staining at the upper interior portion of the silo may be a result of the open roof. The source of moisture will be mitigated once the roof opening is closed. The staining could be cleaned, if desired, however it is mostly aesthetic.
- Repair metal roof at secondary roof to stop deterioration and protect ladder enclosure.
- Perform isolated concrete repair at base of silo.
