TURNER FARM
Turner Farm Treatment Report

10609 Georgetown Pike
Great Falls, Virginia 22066

Draft Report
July 8, 2016
WJE No. 2015.3162.2

Prepared for:
Fairfax County Park Authority
12055 Government Center Parkway, Suite 927
Fairfax, Virginia 22035

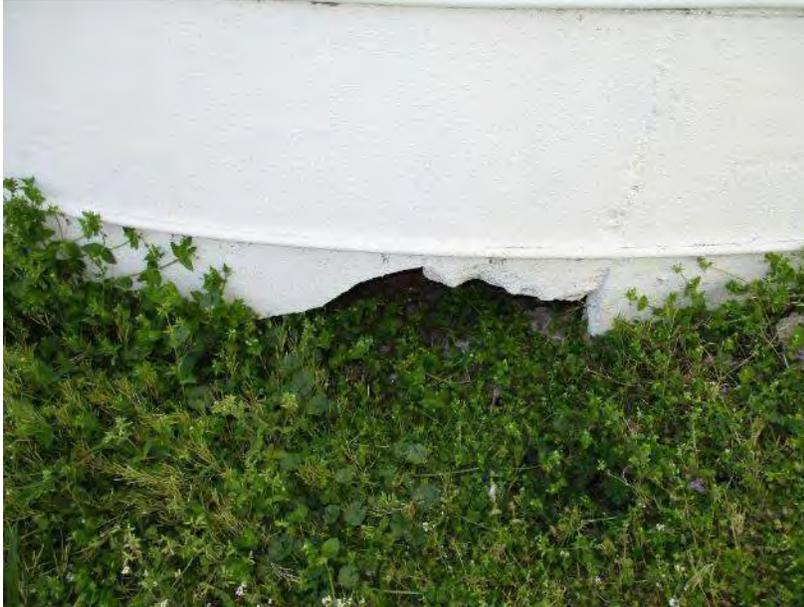
Figure 107. Concrete spall at the base of silo.

- Install hatch at roof and wall opening to prevent further moisture infiltration.
- Green staining at the upper interior portion of the silo may be a result of the open roof. The source of moisture will be mitigated once the roof opening is closed. The staining could be cleaned, if desired, however it is mostly aesthetic.
- Repair metal roof at secondary roof to stop deterioration and protect ladder enclosure.
- Perform isolated concrete repair at base of silo.

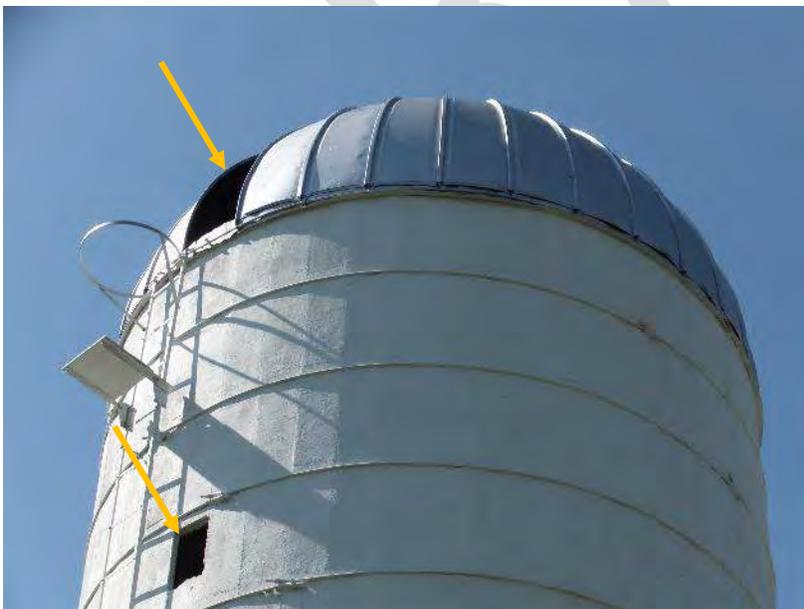
Figure 108. Openings in silo from historic use.

- Install closure piece for roof or, if the silo were to be used as a silo again, temporarily close this opening to allow for future use. (Figure 108)

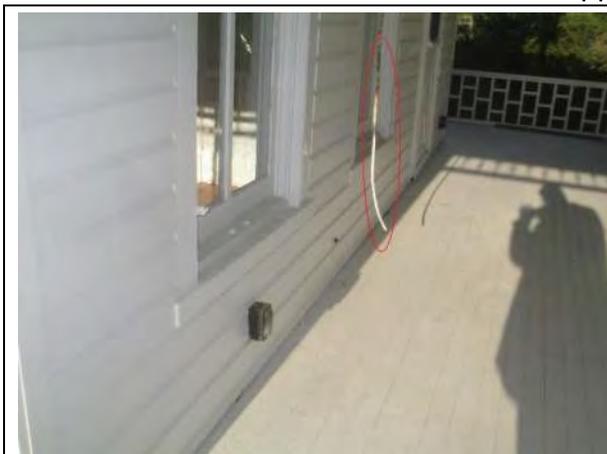
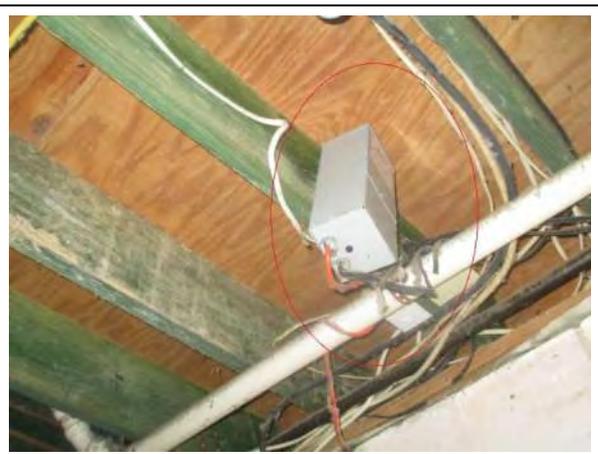
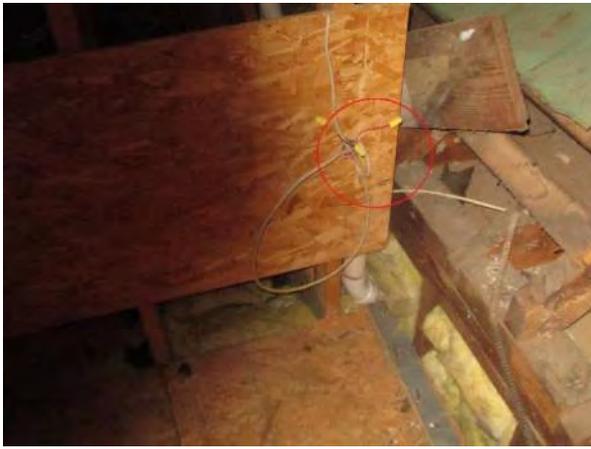
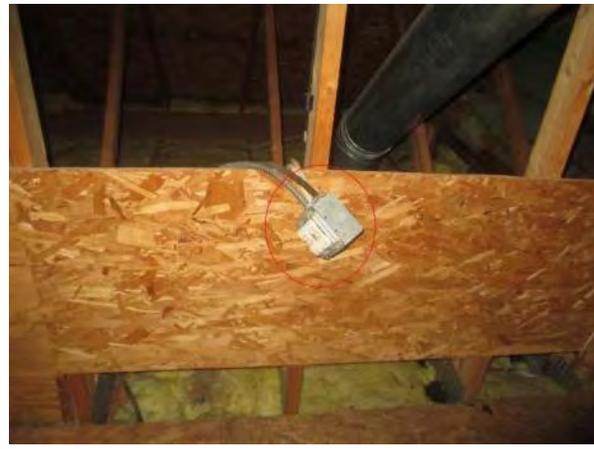
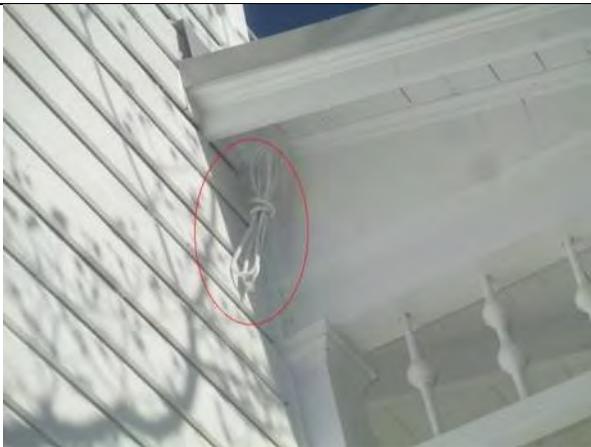
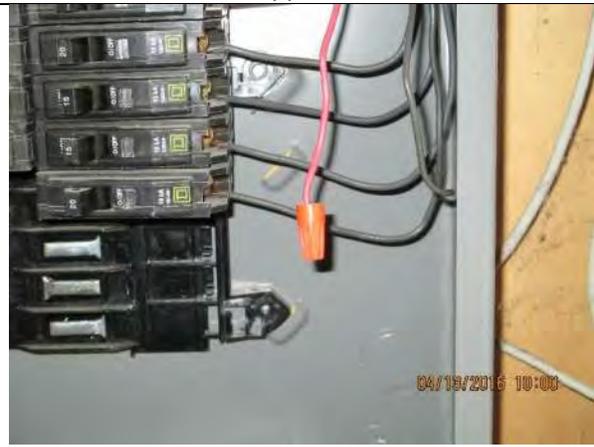
Photo 1: Loose cable near front door

Photo 2: Abandoned box and wires in basement

Photo 3: Unsecured wires in attic

Photo 4: Unsupported box in attic

Photo 5: Loose cable near front porch

Photo 6: Unsecured conductor in basement panel
(MBP installed orange wire nut)

- Electrical wiring survey and correction
 - In several locations within the basement and attic, electrical wires are cut off, disconnected, or have exposed wire ends either inside or outside of an approved junction box or panel. Recommend having a skilled electrician survey the building to locate, identify, safe, or remove electrical wiring that does not meet current code requirements. Temporary wiring should no longer be left in place. Panel directories should be corrected and completed. Please note that this recommendation should be applied to all of the structures.

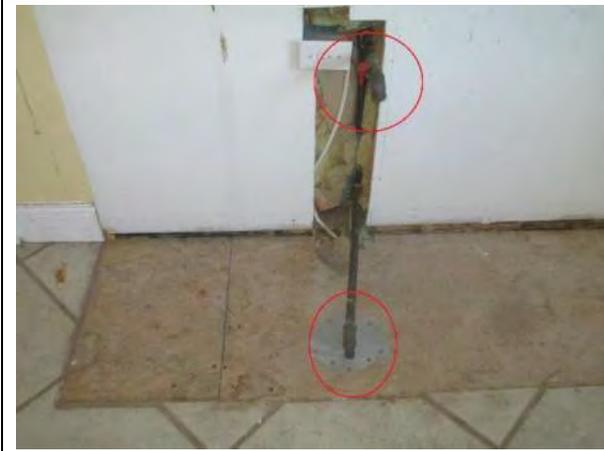
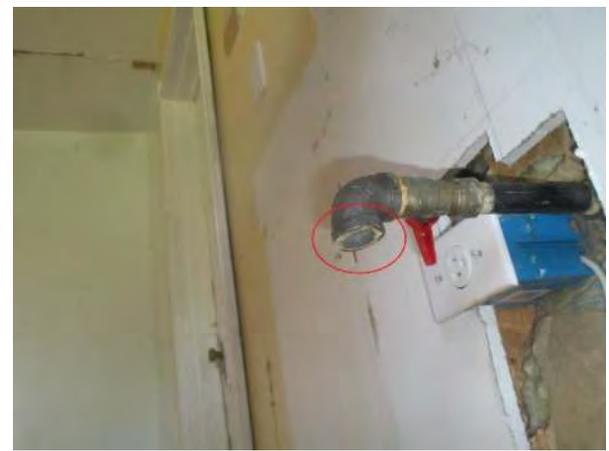
Photo 7: Kitchen gas piping through floor

Photo 8: Kitchen gas piping needs plug

- Kitchen stove gas connection
 - The gas line intended for a stove/oven in the kitchen was turned off when the appliance was removed, however, the line should receive a pipe plug due to long term abandonment. Recommend installing a one-half inch pipe plug to make the abandoned line safe. Additionally, the location of the floor penetration should be reviewed and relocated closer to the wall to allow better appliance selection.

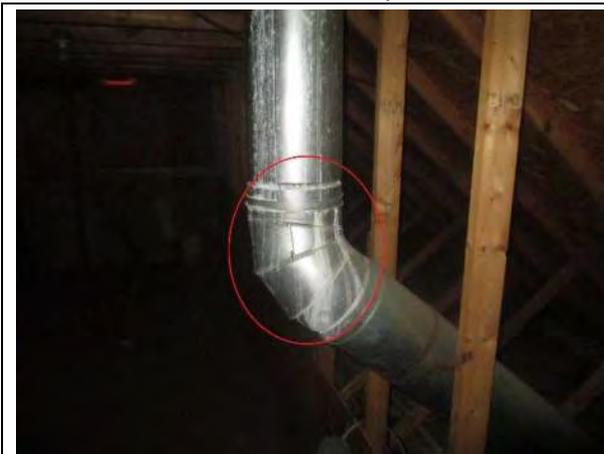
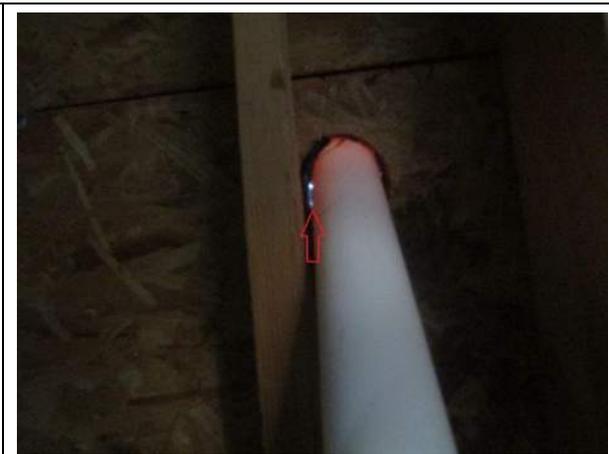
Photo 9: Flue vent with water stains

Photo 10: Plumbing vent with light visible thru roof

- Roof penetrations
 - The gas vent flue and plumbing vent stack roof boots or collars are leaking water into the attic. Water stains are evident on the flue vent and stack vent pipe. Recommend repairing/re-sealing, or replacing roof penetration boots and collars and a review of flashing around the chimney to prevent water infiltration into the attic space.

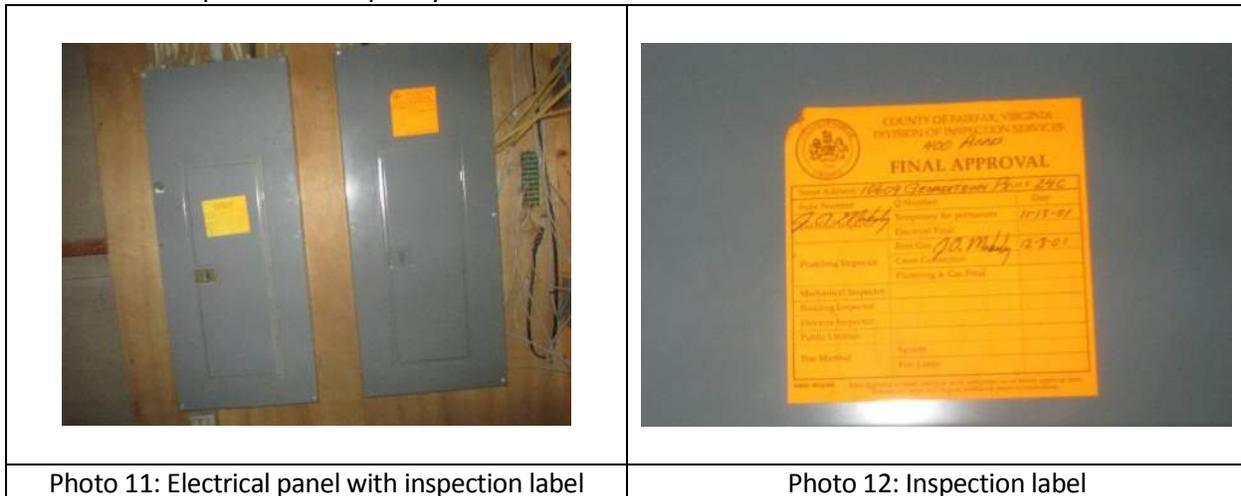
- Code inspection status
 - The inspection stickers noted on the electrical panels show a “temporary” inspection date of 11-13-01 (electric) and 12-3-01 (first gas). MBP recommends that all construction is completed and final inspections are received for all trades prior to occupancy or use of the structure.

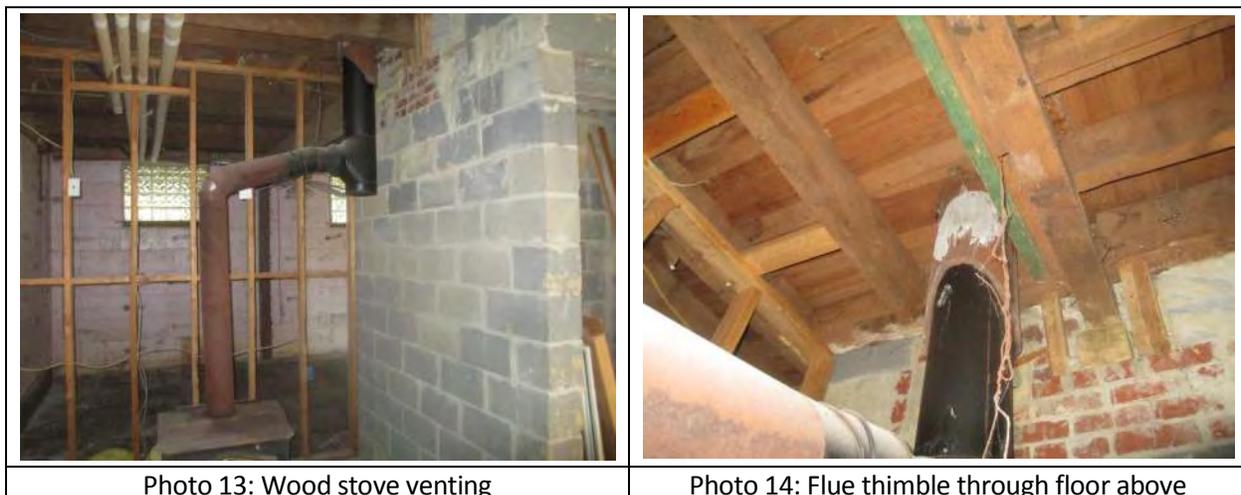
- Basement chimney vent installation
 - The flue vent pipe for the basement wood stove enters a damaged (broken) clay thimble less than 12” from combustible subflooring and floor joists for the first level above. Additionally, it is not clear that the clay thimble is rated for zero clearance with combustible materials as it passes through the floor. Recommend that this chimney flue is abandoned at the basement level and the woodstove is removed. If the chimney is allowed to remain, please review installation with a code official.

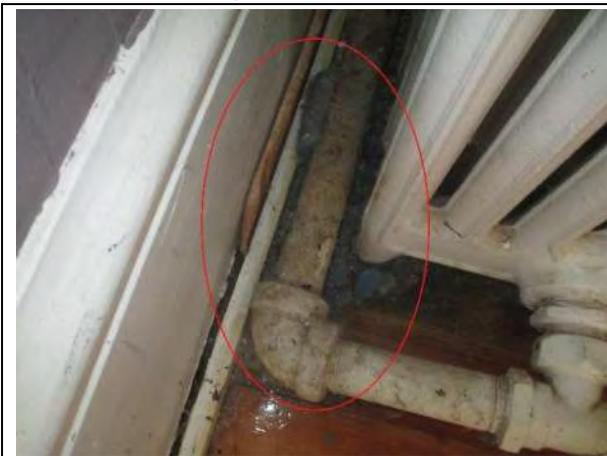
- Radiator care
 - Existing radiators in the building are generally in good condition with three exceptions. One radiator in a second floor bedroom at the southeast corner of the original structure has the remnants of a candle behind the radiator. The wax should be cleaned and removed from around the radiator piping. Future occupants should be warned against placing candles or other materials on the radiators in the future because it could be a fire hazard if the candle is aflame when the radiator is heating and melts the base. Additionally, one of the radiators in the southwest corner of the master bedroom is not connected to piping and the piping is not capped. This piping should be connected or capped to prevent flooding if the hand valve fails in the basement. The spare radiator currently in the second floor hallway should be removed to the basement, out of the hallway and should be mounted on a base or strapped to the wall because of the top-heavy nature of the device. Additionally, the heating system should be brought on-line and tested under pressure to ensure that no leaks exist at any of the radiators.

Photo 15: Candle wax behind radiator

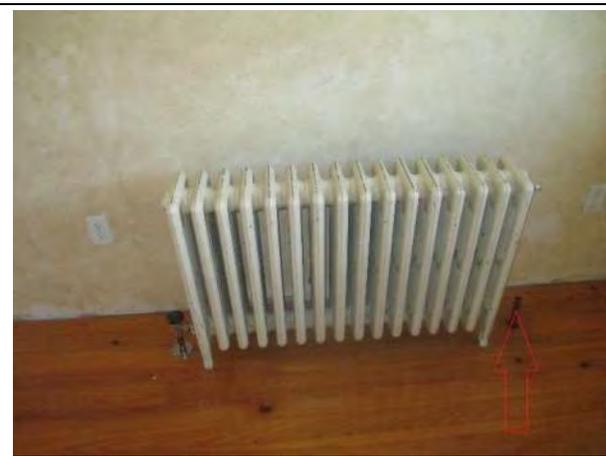
Photo 16: Disconnected radiator

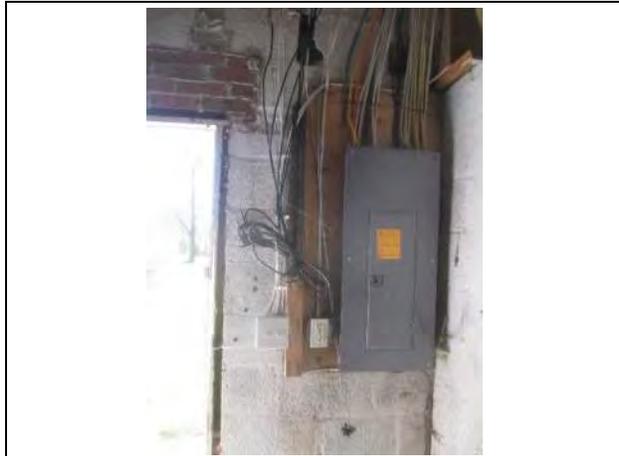
- Similar to the Farm House, the electrical panel in the Garage has an inspection sticker applied to the front of the panel indicating only initial inspections have occurred including temporary electric (8/10/06) and first gas (2/9/07). MBP recommends that all construction is completed and final inspections are received for all trades prior to occupancy or use of the structure.

Photo 17: Electrical panel with inspection label

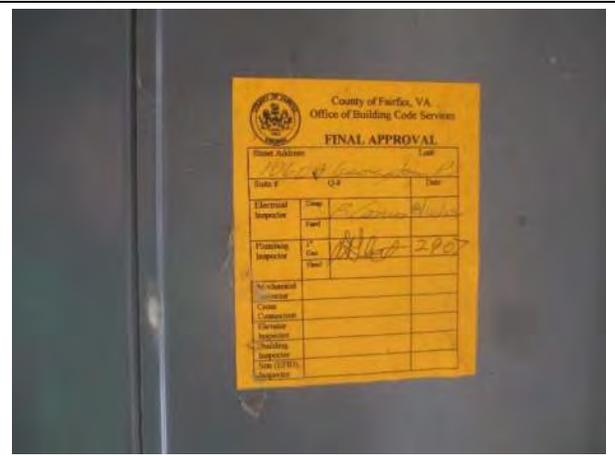
Photo 18: Inspection label

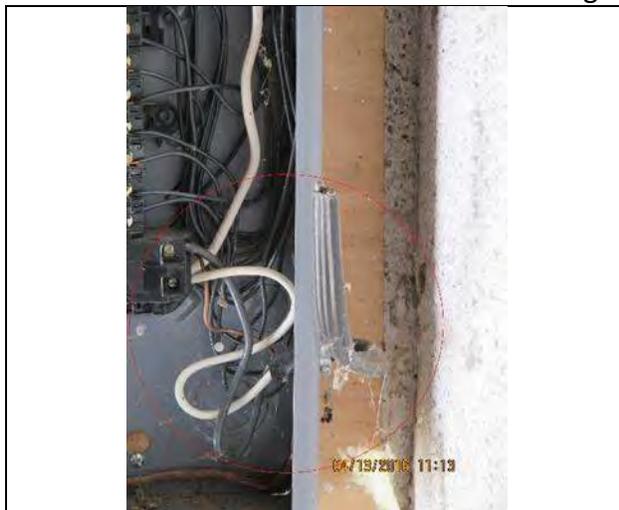
- The bottom right breaker was shut off, but left in place. Wires connected to the breaker extended outside of the enclosure and were cut off, leaving a potential hazard. Recommend removing the wires from the breaker immediately.

Photo 19: Electrical hazard

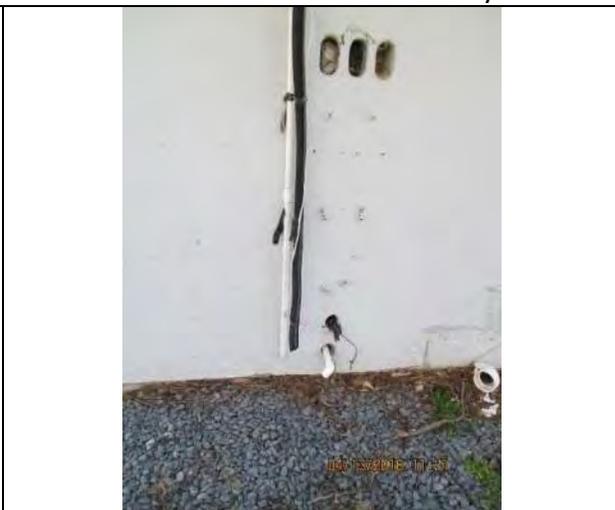
Photo 20: Removed condensing unit

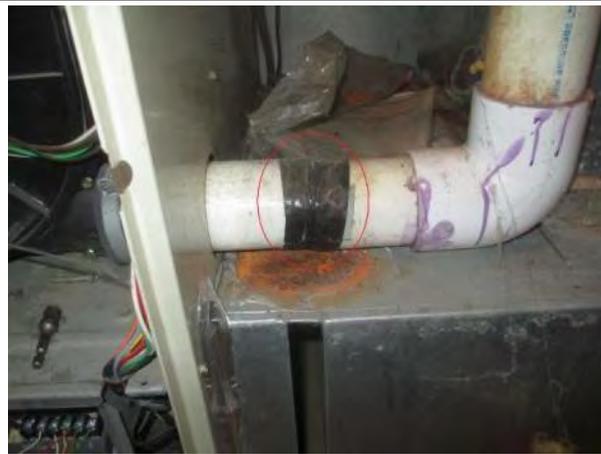
- Gas Furnace (ground floor mechanical room)
The gas supply is turned off at the meter and the unit service valve and the electrical circuit could not be identified or energized during visual observations. The unit operation should be checked by a qualified technician prior to operation. There is some rust and water leakage evident at the exhaust vent connection (lower right PVC pipe). The pipe has been cut and taped back together and the slope back to the unit is

compromised. This taped joint appears to leak. The exhaust pipe is not supported properly between the unit and the exterior wall. One of the pipe clamps at the exhaust connection is unsecured. Long sweep elbows are required on the PVC exhaust piping rather than the short 90 degree elbows currently installed. The condensing unit has been removed and the refrigerant lines are cut. These should be replaced prior to replacing the condensing unit due to moisture and contamination risk. For maximum efficiency, the combustion air inlet should have piping extended to the exterior (note that short 90 degree fittings may be used on the outside air intake if necessary). The condensate pump, necessary for heating and cooling operation, has been removed and is required for operation. All piping penetrations through the exterior CMU wall should be properly sleeved, sealed, and packed.

Photo 21: Taped pipe joint on exhaust

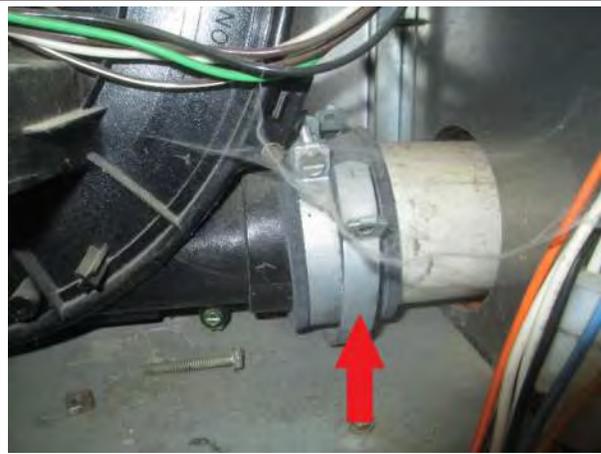
Photo 22: Loose exhaust clamp

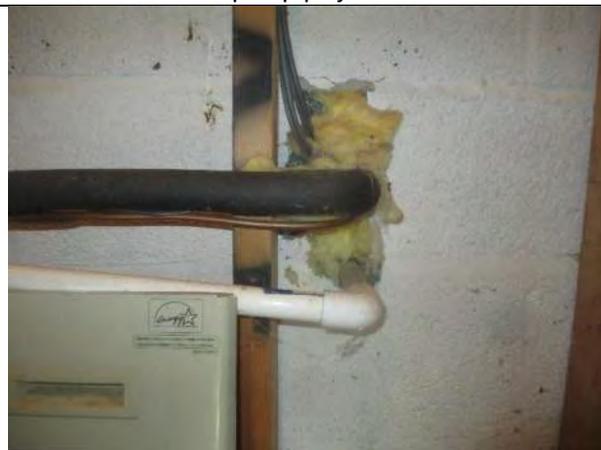
Photo 23: Penetrations not sleeved/sealed (Int.)

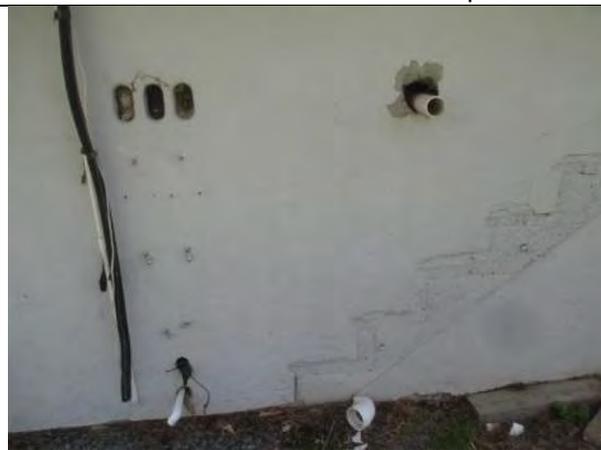
Photo 24: Penetrations not sleeved/sealed (Ext.)

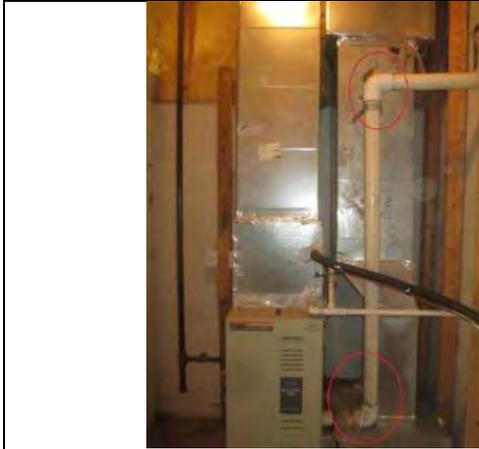
Photo 25: Short 90 fittings on exhaust

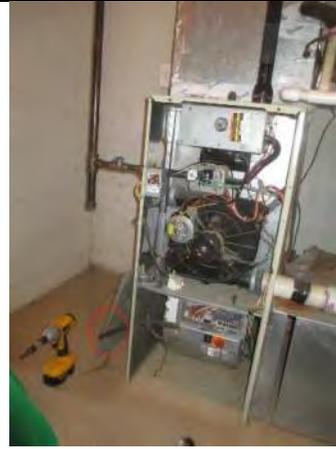
Photo 26: Condensate pump removed (lower left)

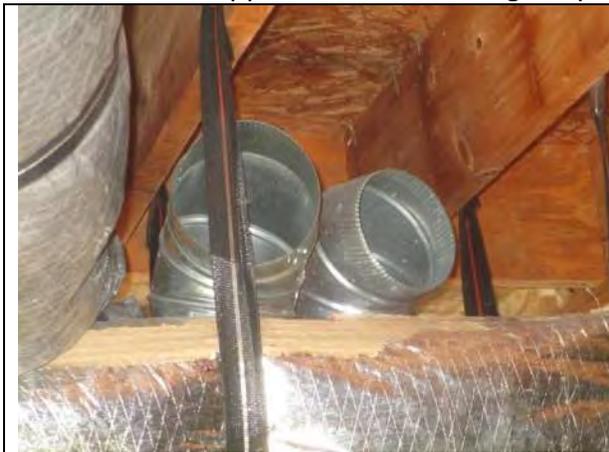
- Lower level ductwork
 - Lower level ductwork appears to have at least two elbows installed that are not connected to diffusers and do not have balancing dampers installed. All ductwork should be connected to diffusers with balancing devices so the system can be balanced. It may be necessary to confirm that holes in the next level floor that appear to have previously served diffusers are properly sealed and supported to floor ratings required.

Photo 27: Duct fittings without dampers/diffusers

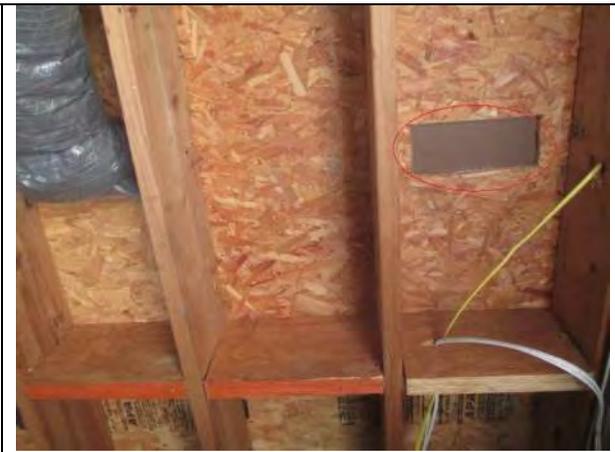
Photo 28: Old floor penetrations

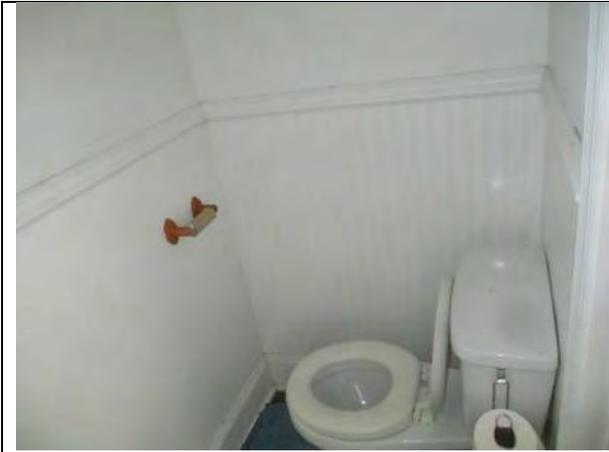
- Upper level facilities
 - Bathrooms, including fixtures and surrounds are largely incomplete and appear to require renovation. Operation of fixtures was not able to be determined due to the water supply being turned off.
 - Selection of wood finish materials within some shower areas is inappropriate due to exposure to moisture.
 - Electrical fixtures are incomplete with several open junction boxes.

Photo 29: Mid-level hall bath toilet

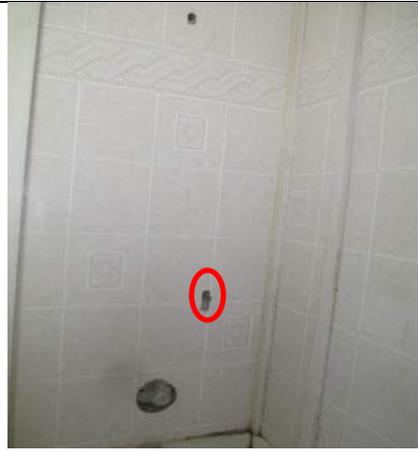
Photo 30: Mid-level hall bath shower enclosure with damage evident

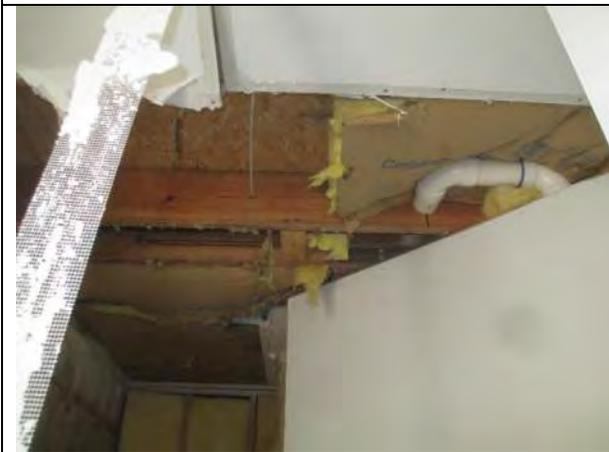
- Past water damage has caused damage to drywall near and around electrical boxes, and may have damaged wiring. A qualified electrician should be employed to review the condition of all fixtures, switches, and cabling.
- The indoor heat pump is in relatively good condition but ductwork should be insulated up to the unit connection boxes and the interior of the unit should be cleaned, including the fan wheel.
- The condensing unit has been removed and the refrigerant lines are cut. These should be replaced prior to replacing the condensing unit due to moisture and contamination risk.

Photo 31: Water damage at mid-level ceilings due to water from floor above

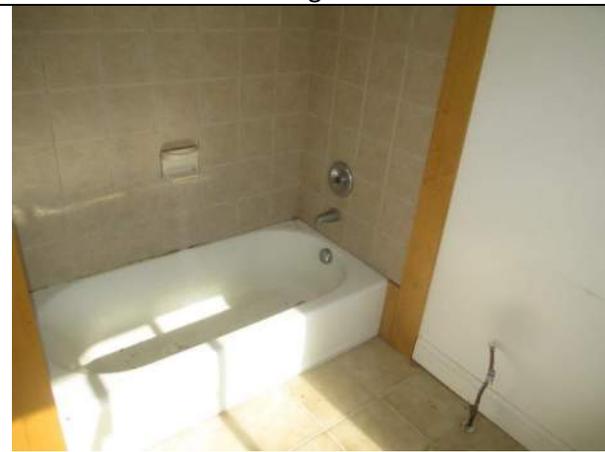
Photo 32: Unfinished bathroom at mid-level (assumed) master suite

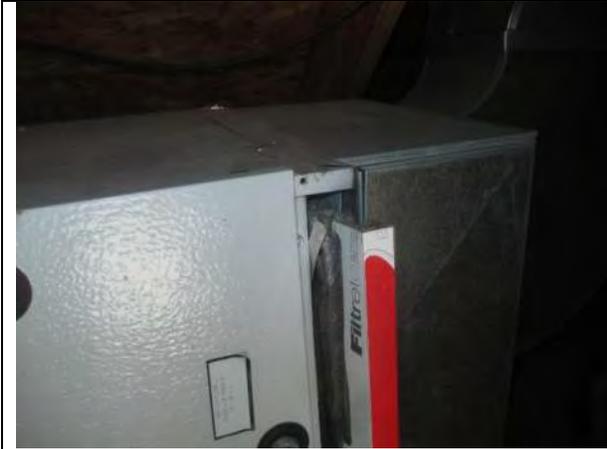
Photo 33: Ill-fitting filter at upper level heat pump unit

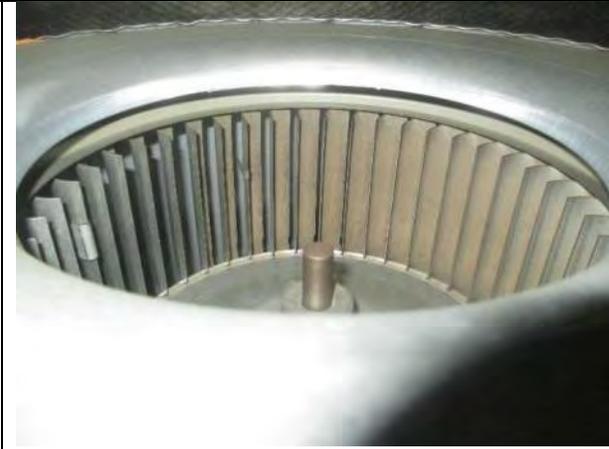
Photo 34: Condition of fan wheel at upper level heat pump unit

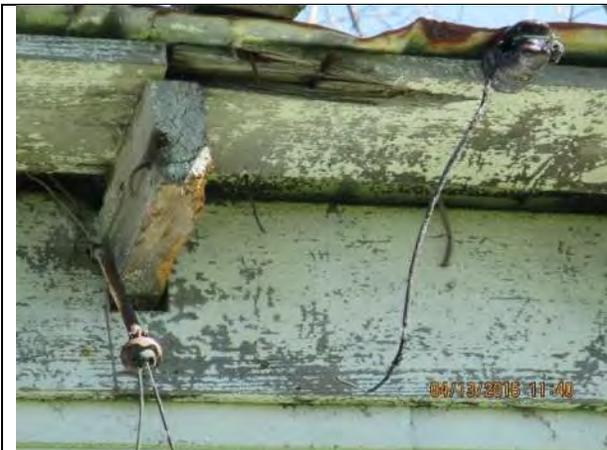
The Equipment Shed is an older structure with only derelict electrical wiring that does not appear to be serviced from the other buildings at this time. Removal of the electrical wiring and fixtures is recommended.

Photo 35: Derelict overhead service

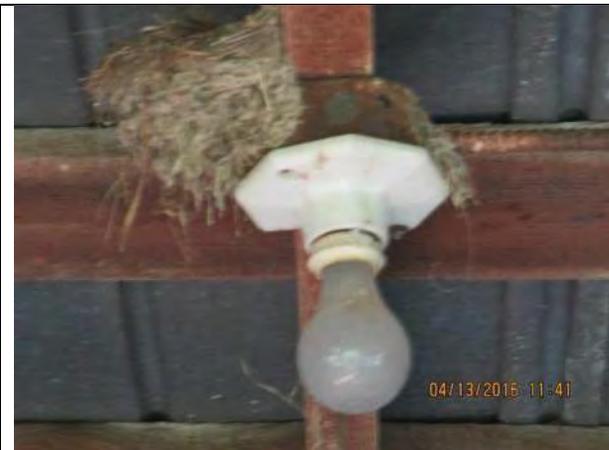
Photo 36: Interior light fixture

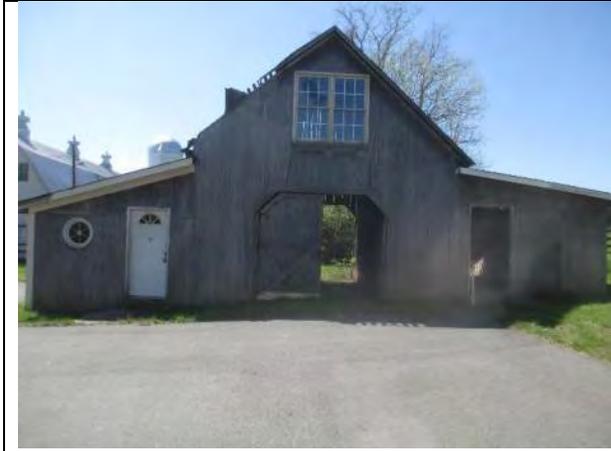
The Crib Barn is an older structure with only minimal electrical circuitry that appears to be provided from the Farm House or Garage. The point of origin could not be determined. The finished portion of the building where the electrical circuits enter is finished and was locked during MBP's observations. Removal of the electrical wiring and fixtures in the open sections of the Crib Barn is recommended.

Photo 37: Crib Barn with finished section at left side

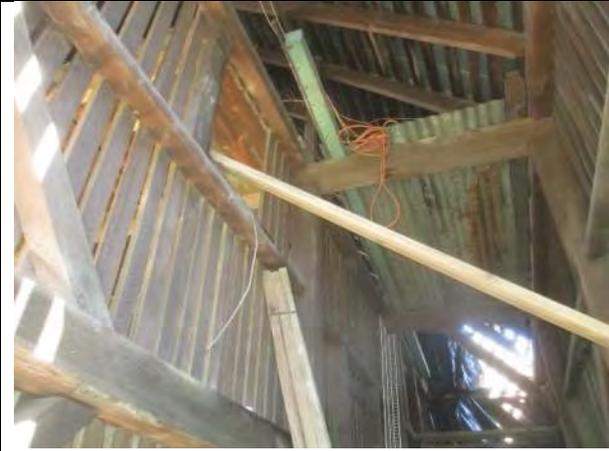
Photo 38: Extension cord for power in unfinished sections

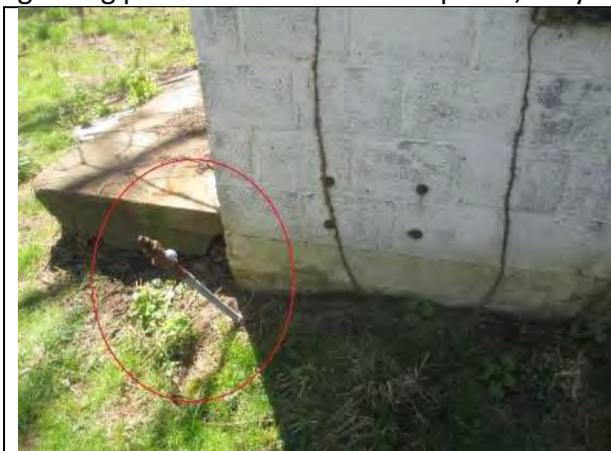
The Milk House is an older structure with only derelict electrical wiring and plumbing systems that does not appear to be serviced from the other buildings at this time. Removal of the gas and plumbing piping and fixtures, electrical wiring, fuse box, and fixtures from the interior is recommended. The utility gas piping extends to the northeast corner of the building and appears damaged where the meter has been removed from the outside of the building. It is recommended that this utility piping be cut and capped below grade, or abandoned at its connection point to prevent further damage and leaks in the future. Ground or lightning protection cables (copper conductors) extend from the room down to head level at the south doorway of the Milk House exterior and should be removed or replaced. If grounding or lightning protection cables are required, they should be engineered for replacement.

Photo 39: Damaged utility gas piping at NE corner

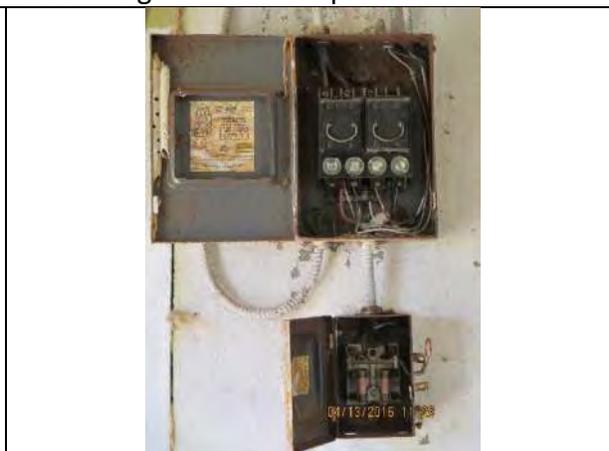
Photo 40: Derelict fuse box and wiring

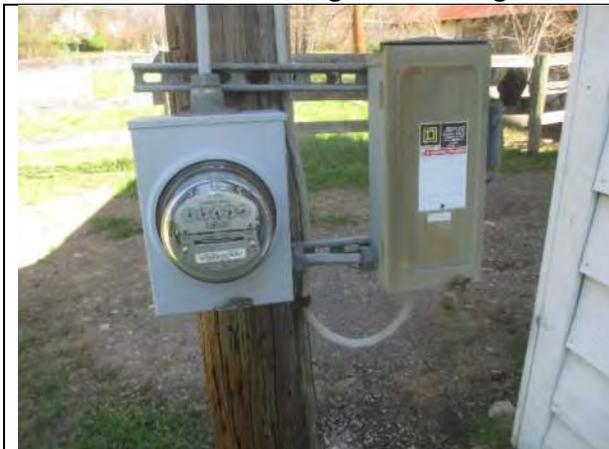
The Dairy Barn is an older structure and was observed to have only a small 60 Amp electrical service from the utility pole at the northwest corner, and a small distribution breaker box on the interior.

Photo 41: 60 Amp service at utility pole (NE corner)

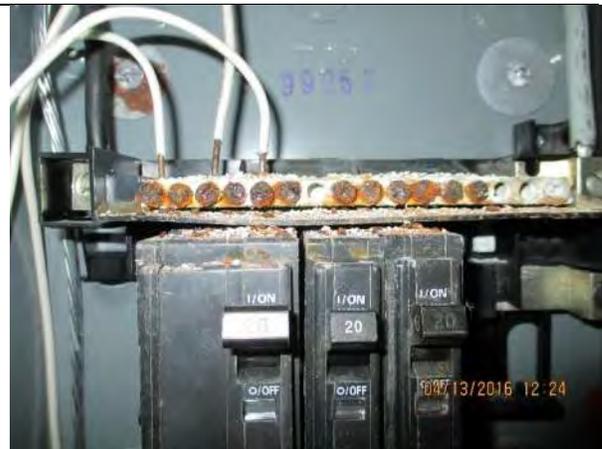
Photo 42: Oxidation/rust at terminations in panel inside the Dairy Barn

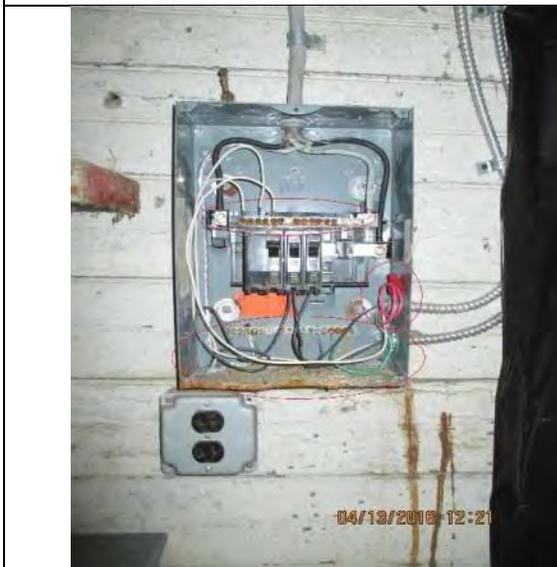
- Electrical wiring
 - The wire to a two pole breaker was disconnected and capped off, but left in place. The wire cable appears to lead to the non-potable well pump circuit and is also disconnected immediately inside the Dairy Barn. This should be rectified by connecting or removing the circuit.

Photo 43: Disconnect well pump circuit

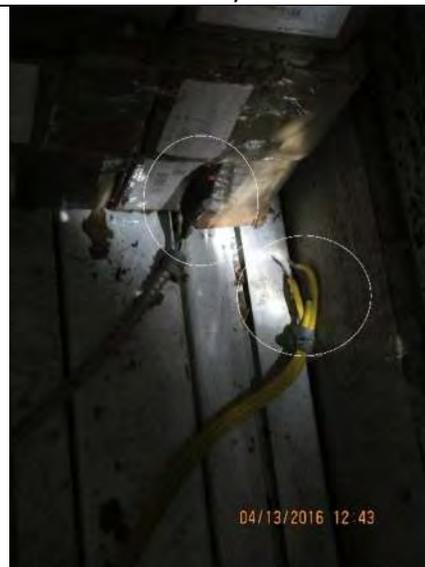
Photo 44: Well pump circuit at exterior wall

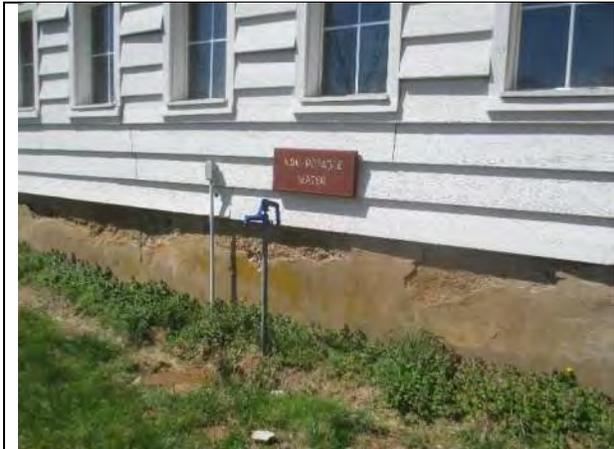
- Water Quality Test
 - Water samples were taken from the outdoor frost proof hydrant located at the east side of the Dairy Barn, which is clearly marked as “non-potable”. Independent laboratory testing indicates the presence of unacceptable levels of Total Coliform Bacteria and Lead. Complete test records are included as Appendix D.

Photo 45: Outdoor hydrant at Dairy Barn

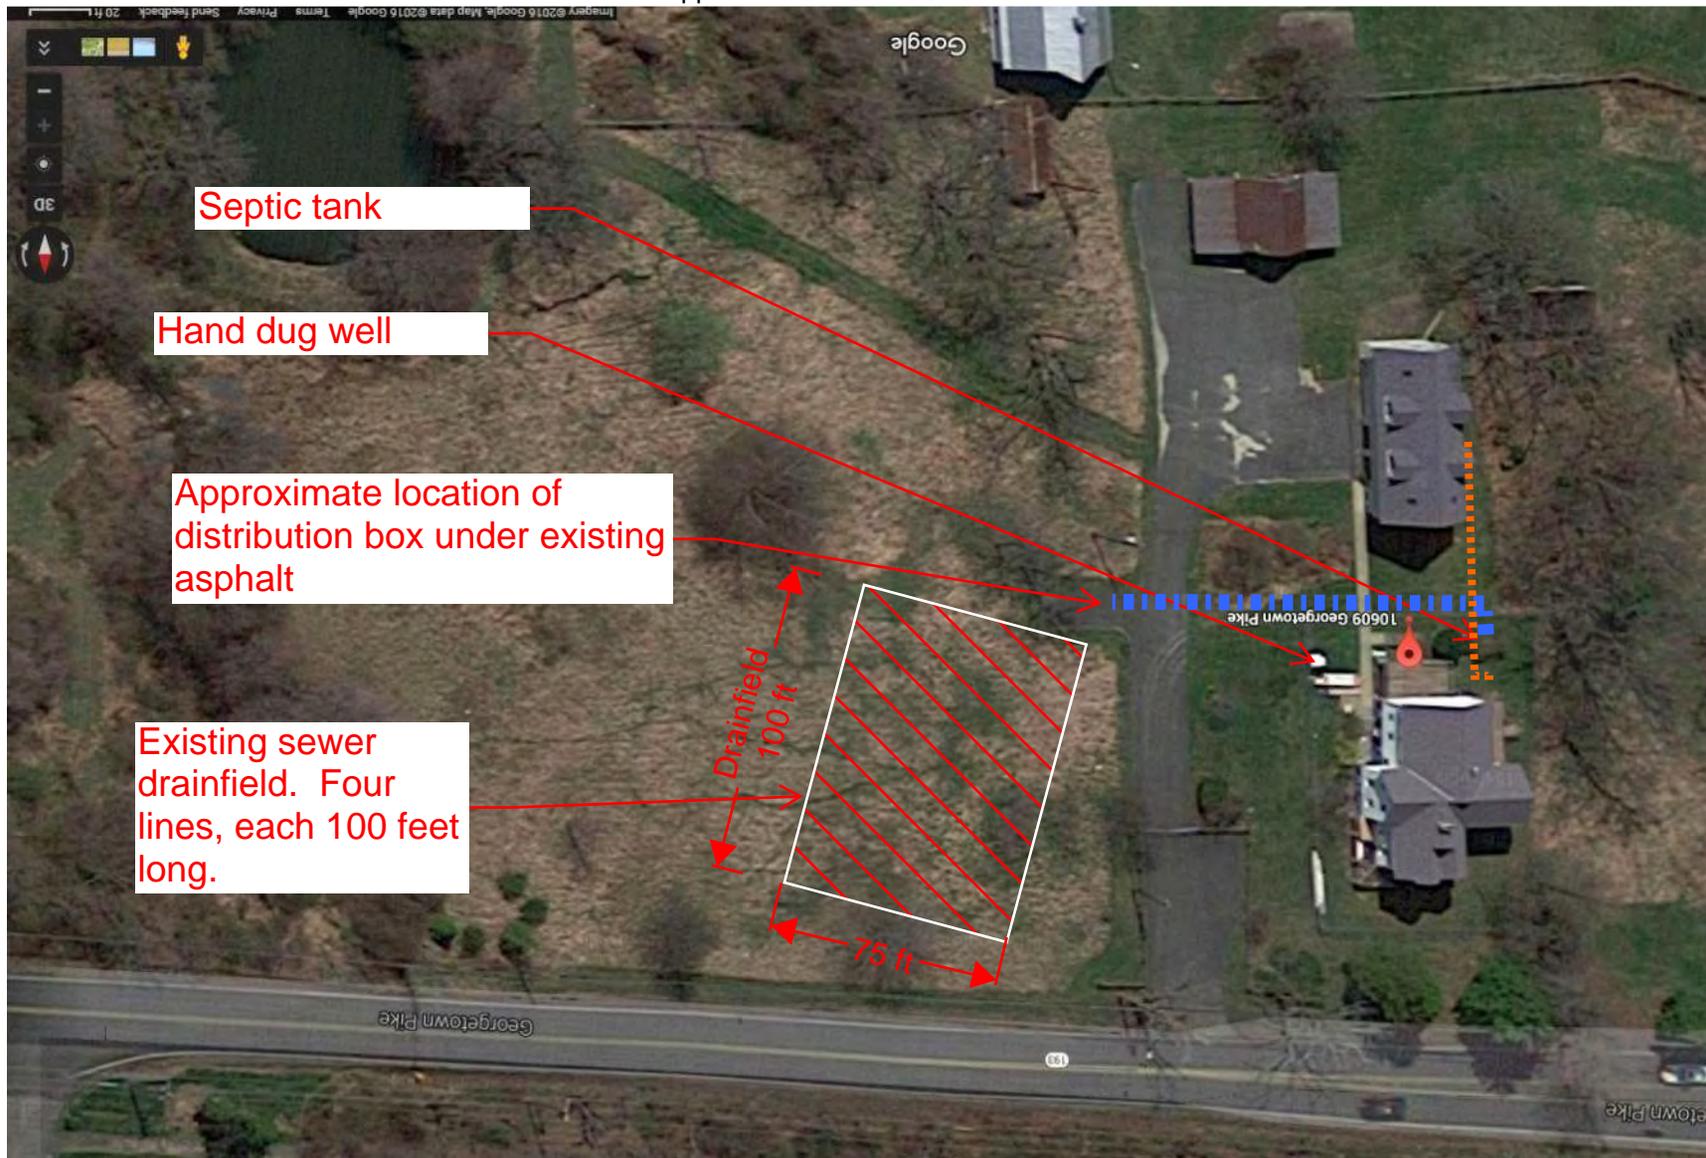
Turner Farmhouse Approximate Drainfield Location

----- Sewer line from Garage to septic tank (shared) recommended for replacement

----- Septic line from tank to distribution box recommended for replacement

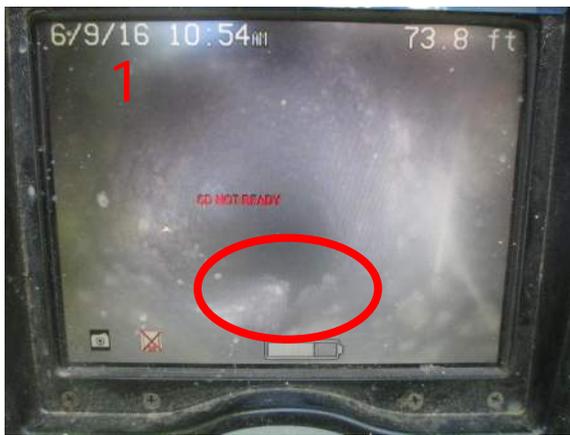
1. Septic pipe between tank and distribution box is broken at 74 feet, immediately west of sidewalk outside existing chain link fence.

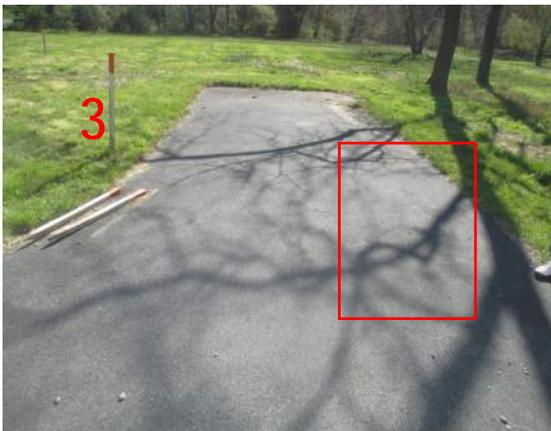
3. Existing parking space east of driveway should be removed. Septic distribution box is located in this area (shown approximate) and would be required to have a traffic rated structure if the parking area remains. Additionally, most local codes require separation between driveways and septic fields.

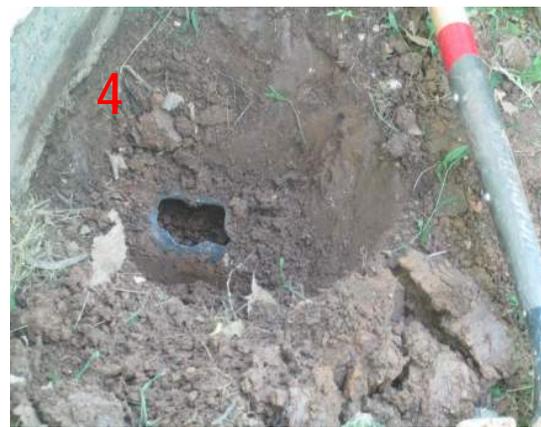
4. Garage sewer line is shown immediately outside west wall of garage. A small existing hole in the top of the pipe was enlarged to allow camera entry because the camera could not be pushed through the cast iron elbow inside the house. The camera could not be pushed more than 18" into the pipe at this location due to corrosion and debris. Recommend replacement of pipe to septic tank.
