MARGARET WHITE HOUSE AND BARN Historic Structure Report

Falls Church, Virginia

Final Report

December 20, 2017
WJE No. 2015.3162.6

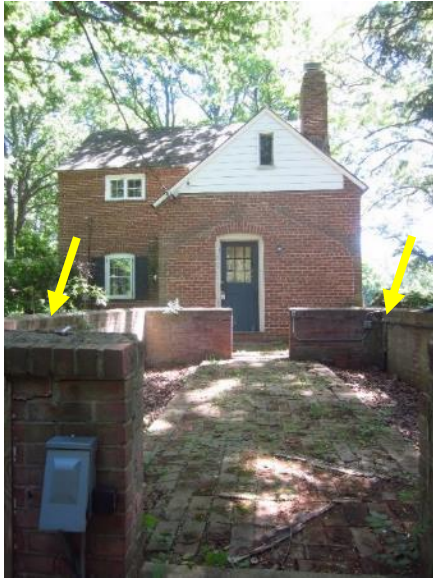
Figure 21. West wing and remains of previous greenhouse.

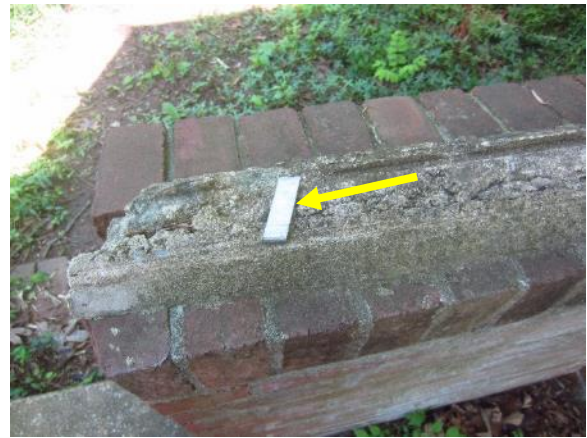
The house can be divided into three main sections: the core, the east wing and the west wing. Notated 1938 and 1958 house drawings are provided in Appendix A. The core is the center of the home and is covered with a gabled roof that runs north-south. This portion is comprised of two above-grade floors and attic space (Figure 19). The east wing of the house is a long, rectangular section with a gabled roof that runs east-west. This portion of the home is also comprised of two above-grade floors and attic space (Figure 20). The west wing is comprised of one above-grade floor and attic space (Figure 21). This attic space at the west wing aligns with the second floor of the rest of the home. The basement is located beneath the core and west wing. Adjacent to the west wing is an area that was previously the greenhouse. The glass has been removed leaving ghosting of the roof outline at the west facade of the house above the kitchen door and a partial height brick knee wall with embedded greenhouse frame anchors and a brick pathway. Along the brick wall are hoses and spigots that were used to water the plants. While the roof of the greenhouse has been removed, the metal clips that previously secured it to the wall still remain (Figure 22).

Figure 22. Metal clips remain embedded in the greenhouse walls

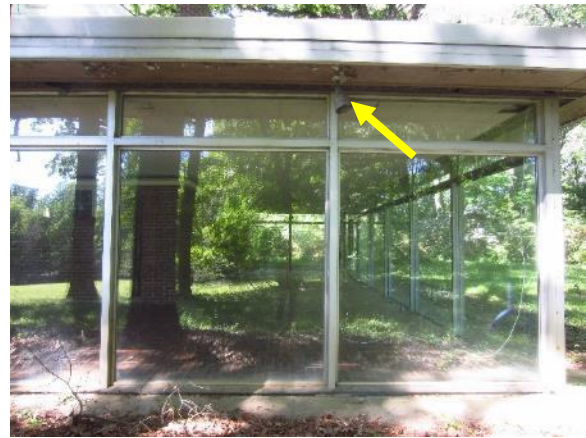
Eight exterior light fixtures were observed at the glass porch soffit (Figure 26 and Figure 40). Per the original 1958 electrical drawings, the fixtures are 150 watt Swivelier #6081 floodlights comprised of aluminum bases connected to the soffit and aluminum swivel hoods. The bulbs are missing from several of the fixtures.

Figure 26. Typical aluminum-framed storefront windows at the glass porch. Note typical floodlight at soffit (yellow arrow).

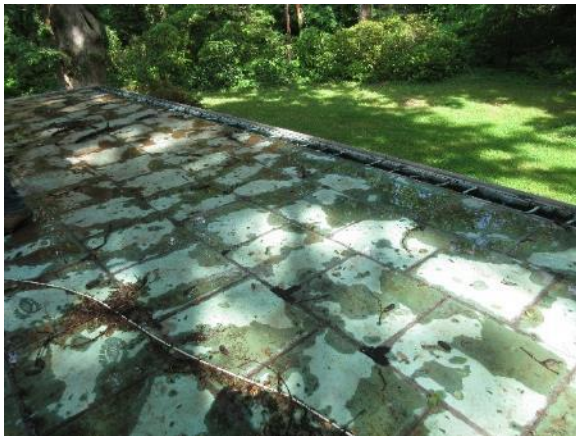
Figure 36. Abandoned fasteners from downspout connections.

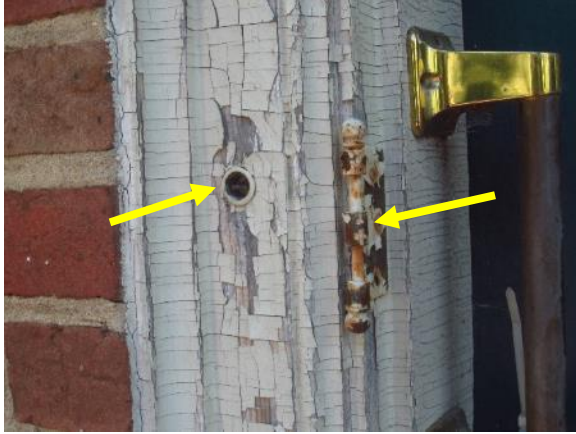
Figure 73. Missing doorbell and abandoned hinges located on frame of west exterior door.

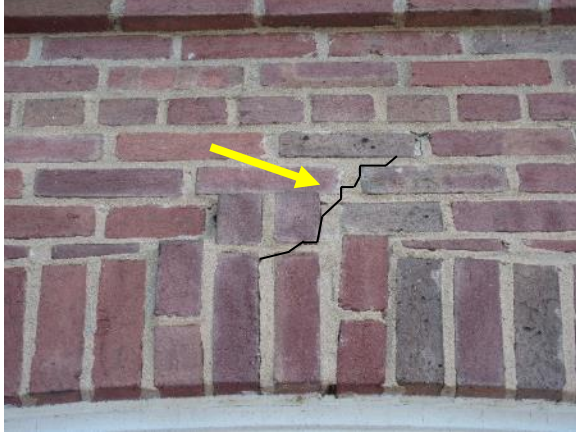
- Cracked mortar joints and/or missing mortar were observed at several discrete locations.
 - The cracking typically had a stepped pattern and was located near edges of the home or at windows (Figure 79).

Figure 79. Stepped cracks in mortar above segmental arch. Crack traced for clarity.

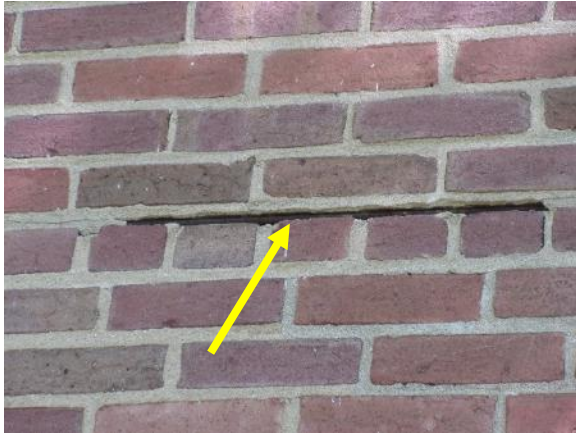
- At one location on the east facade, a vertical crack was observed along the south edge of the building (Figure 80).
 - On the south facade, open and cracked mortar joints were observed along the second floor line, corresponding to embedded metal (Figure 81). Minor surface corrosion was observed on the exposed metal. It is likely that the embedded metal is a steel shelf angle to support the brick units at the second floor.

Figure 81. Cracks in mortar at floor line, revealing minor surface corrosion at steel shelf angle behind.

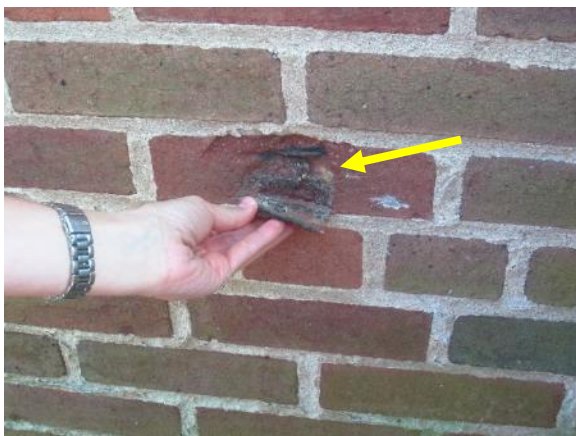
- Missing and cracked joint mortar was also observed on the north chimney (Figure 82).
- Isolated small spalls and cracks were observed at the brick units. The spalls corresponds to an embedded nail that has corroded (Figure 83) and the cracks correspond to the aforementioned vertical crack pattern through the mortar at the southeast corner of the home.

Figure 83. Localized face spall on west facade near exterior door.

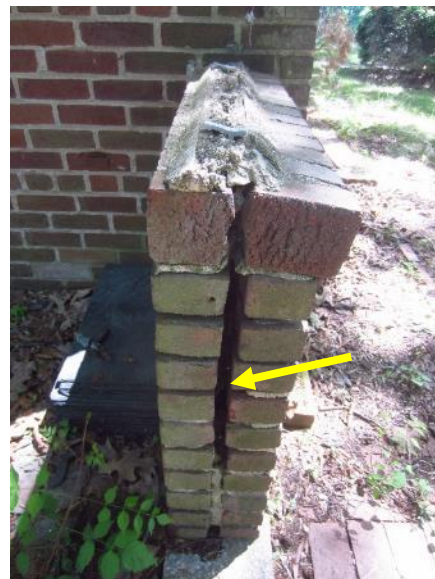
- Multiple forms of deterioration were observed at the greenhouse walls.
 - Several sections of the greenhouse wall are missing mortar in the collar joint, resulting in the wall being out of plumb (Figure 84). Several cracked mortar joints were also observed, which typically had a stepped pattern (Figure 85). A few horizontal cracks along mortar bed joints were also observed (Figure 86).

Figure 84. Missing mortar from greenhouse wall collar joint and bed joints.

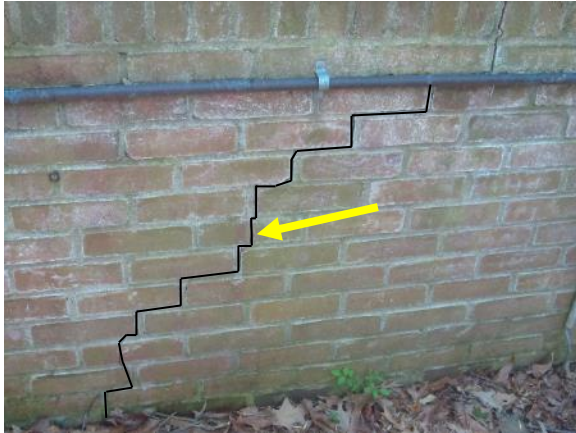
Figure 85. Crack pattern through mortar and brick on greenhouse wall. Crack traced for clarity.

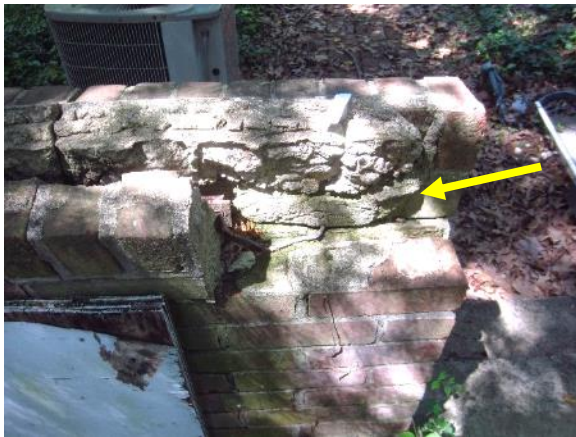
- Several missing or cracked brick units were observed along the greenhouse wall, typically corresponding to the step cracking. Several missing brick units were located at one corner at the west end (Figure 87).

Figure 87. Missing brick units at west end of greenhouse wall.

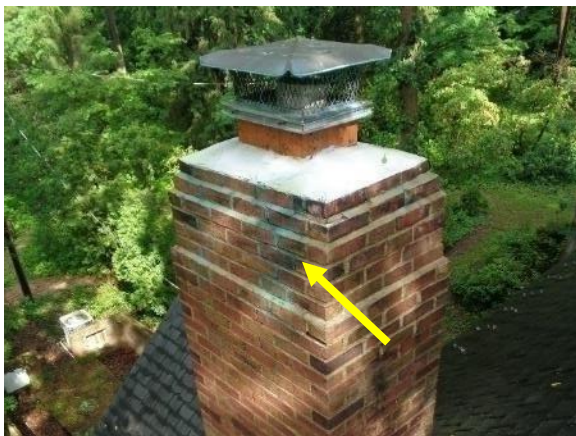
- Copper staining was observed at isolated locations. On the south facade, the staining was associated with abandoned copper elements embedded in the facade (Figure 88). The staining was also observed below the copper chimney caps (Figure 89).

Figure 89. Copper staining due to chimney cap.

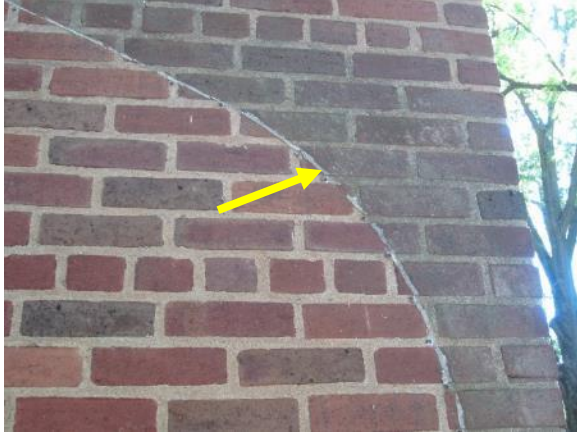
- Surface staining was observed at the brick masonry of both chimney stacks on the home. The staining was dark in color and followed the path of runoff from the chimney cap (Figure 90). Surface staining, residual sealant, and abandoned fasteners were also observed around the outline of the previously attached greenhouse on the west facade (Figure 91).

Figure 91. Surface staining and residual sealant and fasteners around previously-attached greenhouse on west facade.

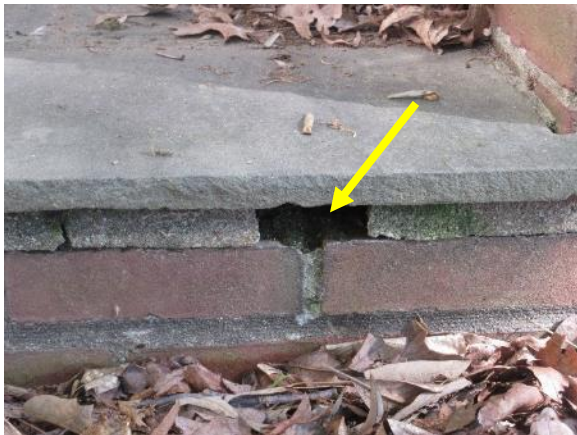
Figure 95. Setting mortar missing from underneath stone paver on front entryway.

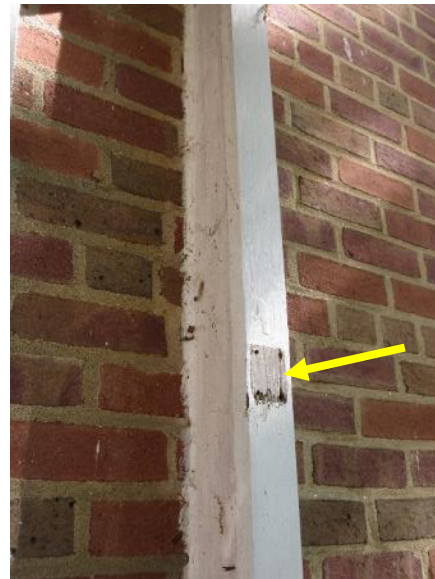
Figure 96. Typical holes in front porch wood post.

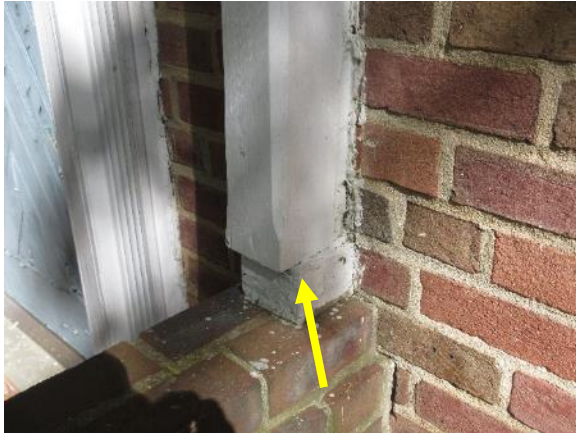
Figure 97. Undersized wood block under wood post at front entryway.

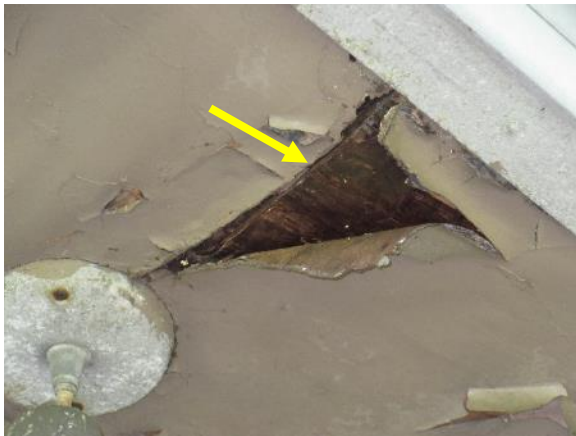
Figure 99. Glass porch soffit sagging from water infiltration.

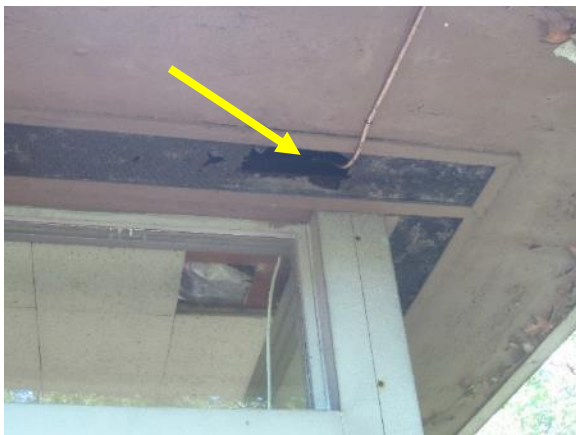
Figure 101. Hole in screen of glass porch soffit with cable fed through opening.

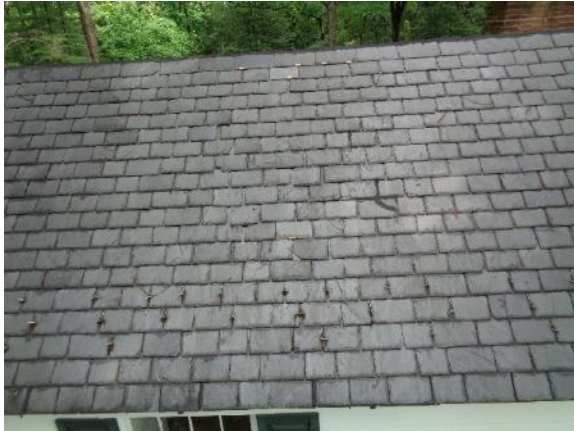
- In general, the slate roofing of the home is in fair condition, but the metal flashings utilized in the slate roof are in poor condition (Figure 103).

Figure 103. View of east portion of slate roof, typical roof condition for entire roof.

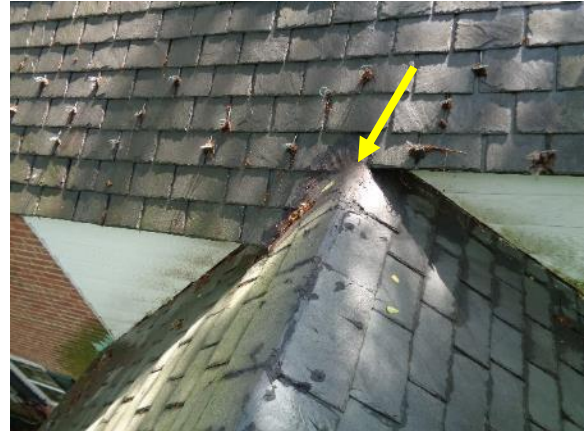
Figure 104. Intersection of west wing roof to main north-south gable roof. Note the repair with mastic at the ridge and meeting point.

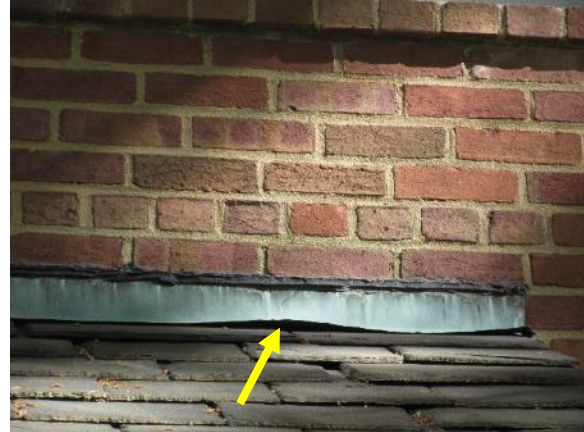
- The copper flashings are beginning to lift up at the edges (Figure 106). Several areas have been patched with mastic (Figure 107).
- The copper cricket flashing at the north chimney exhibits cracked solder joints, loose lap joints and roof cement repair efforts (Figure 108 and Figure 109). This corresponds to water damage observed in Bedroom A.

Figure 106. Warped copper flashing at front entryway roof.

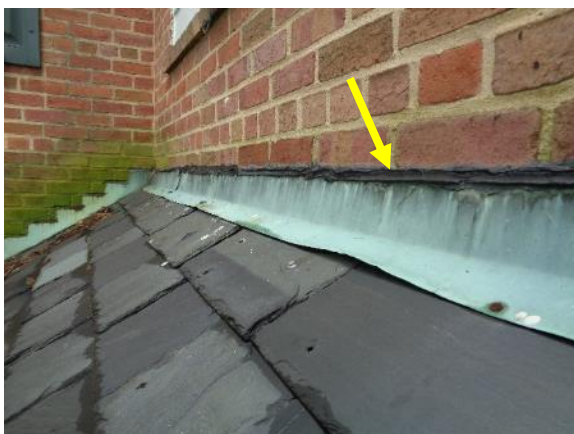
Figure 107. Copper flashing at porch roof. Note the mastic repair at the interface between the copper and the brick masonry.

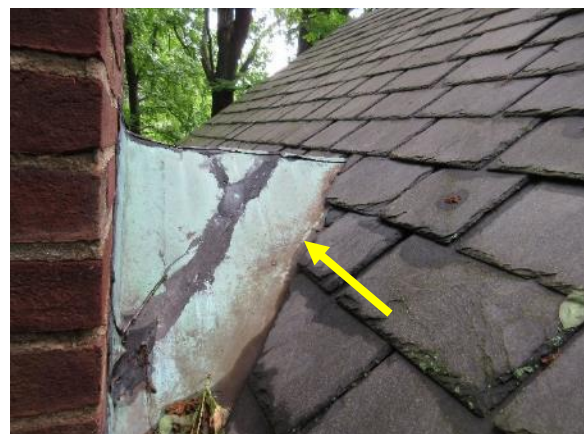
Figure 108. Copper cricket behind north chimney with mastic repairs.

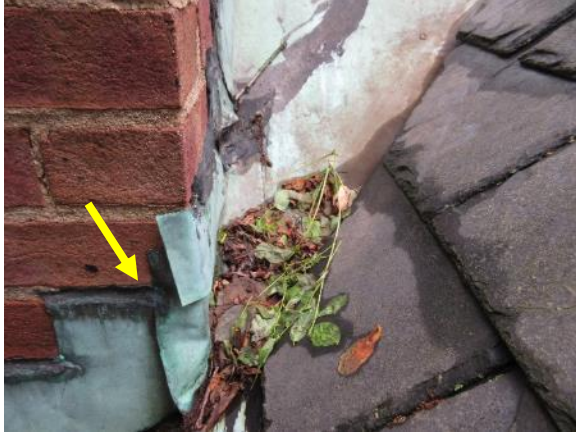
Figure 109. Copper flashing at north chimney. Note the mastic repairs and detached edges.

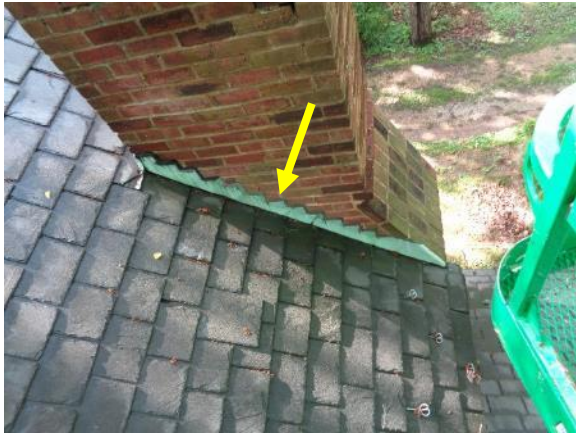
- Ineffective cricket flashing and drainage path were observed between the south chimney and the sloped attic roof (Figure 110 and Figure 111). The south chimney interrupts the rake of the center core slate roof, but no sloped diverter flashing is installed; the copper counterflashing is installed with less than 4-inches vertical rise against the chimney.

Figure 111. Copper chimney flashing on south chimney.

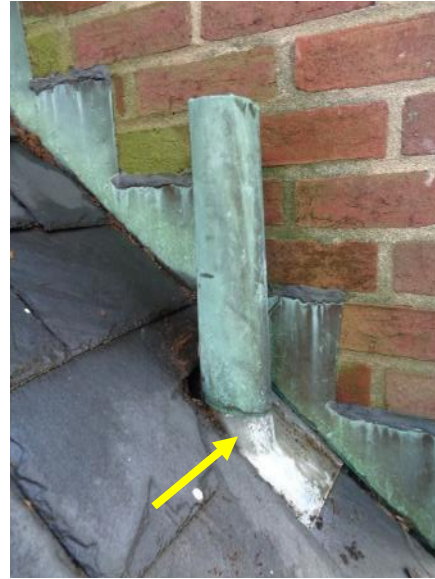
- Vent stack penetrations are detailed with pre-fabricated lead flashing boots (labeled “Monarch Star 2”) and copper counter-flashing, sealed together with roof cement. The seal between the prefabricated boot and the copper counterflashing has failed and is susceptible to snow melt leakage (Figure 112).

Figure 112. Failed copper counterflashing at pre-fabricated lead flashing boot.

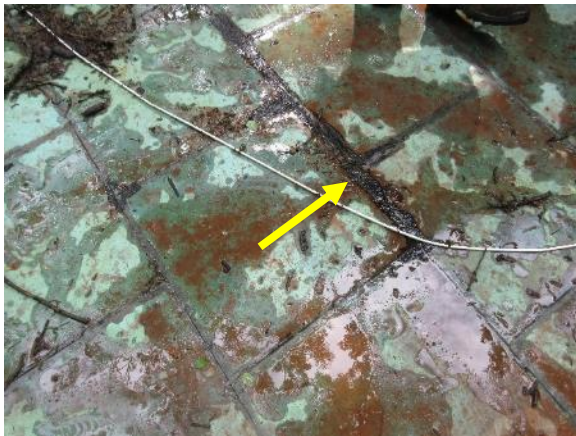
- The copper flat-lock soldered seam roof is in fair-to-poor condition. Many soldered seams between copper panels and alongside the expansion strip are cracked. Several seams have been repaired with mastic (Figure 113 and Figure 114).

Figure 113. Copper flat-lock soldered seam roof. Note the seams that have been repaired with mastic.

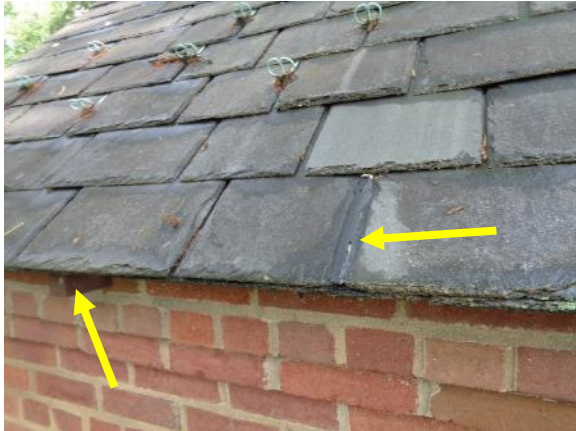
- Hanging gutters are missing from all of the eaves of the steep-slope roofs; the gutters were reportedly removed by the Park Authority (Figure 115). The remnants of cut strap hangers are evident within butt joints of slate shingles in the first course and occasional wood spacer blocks that would have braced the hanging gutters are affixed to the trim.

Figure 115. Cut gutter strap hanger and wood block.

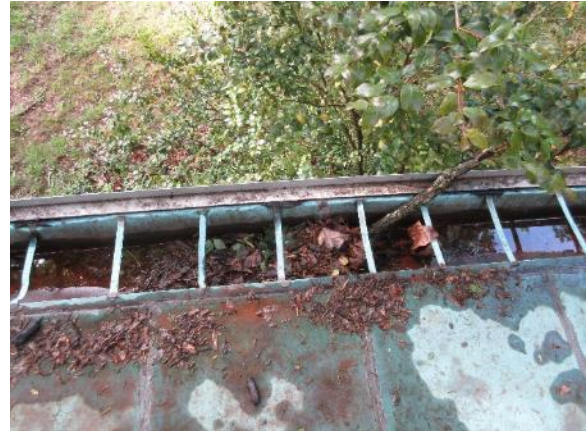
- The gutters are in fair condition, though their function is directly tied to the flat-lock roofing. Currently, the gutters are filled with foliage and debris, which does not allow them to drain (Figure 116).
- Many copper straps installed on the gutters are missing or detached from one side of the gutter (Figure 117).
- Biological growth was observed at multiple locations along the gutter (Figure 118).
- The wood trim under the roofline is in fair condition. Cracked and peeling paint was typically observed along the length of the trim (Figure 119). Trim located above gable end siding has typically been replaced with composite material similar to the siding (Figure 120 and Figure 121).

Figure 116. Glass porch gutters blocked with debris.

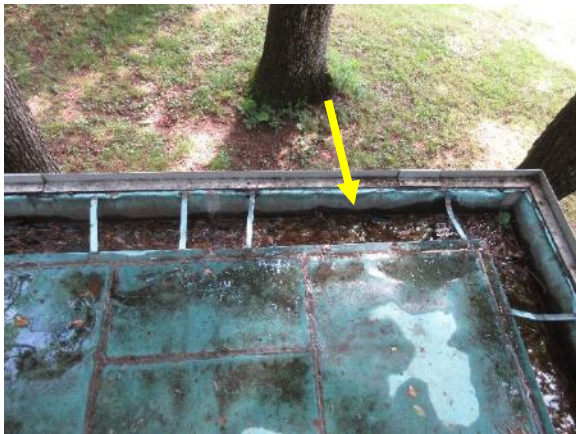
Figure 117. Missing and broken gutter straps along gutter of glass porch.

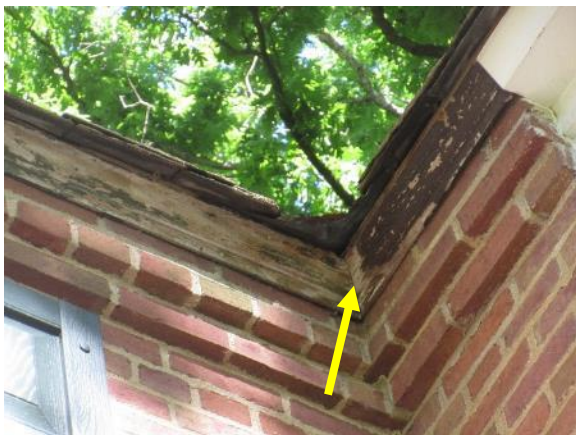
Figure 119. Typical paint deterioration of wood trim underneath roof.

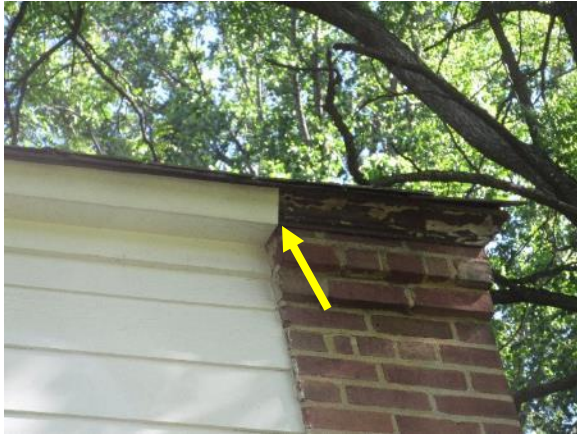
Figure 121. New trim covering old trim (north elevation).

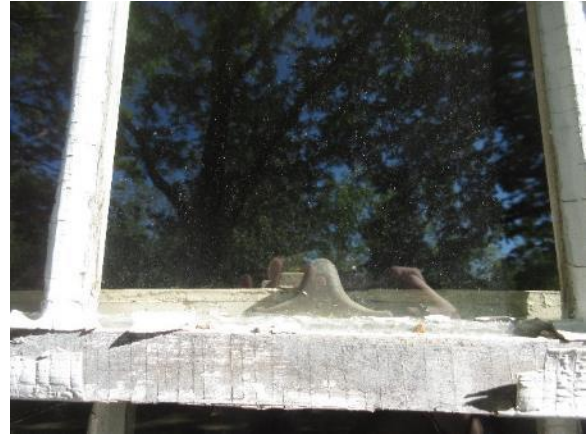
- The upper and/or lower sashes of multiple double hung windows are displaced resulting in window sash locks not being engaged (Figure 122).
- Corrosion of the basement window sashes and frames was observed (Figure 123 and Figure 124). Foliage and dirt accumulation was observed to varying degrees against all basement windows; the basement window well on the north facade is missing the covering grate, resulting in additional foliage build-up against the window (Figure 125).

Figure 122. Typical displaced upper and lower sash on double hung windows.

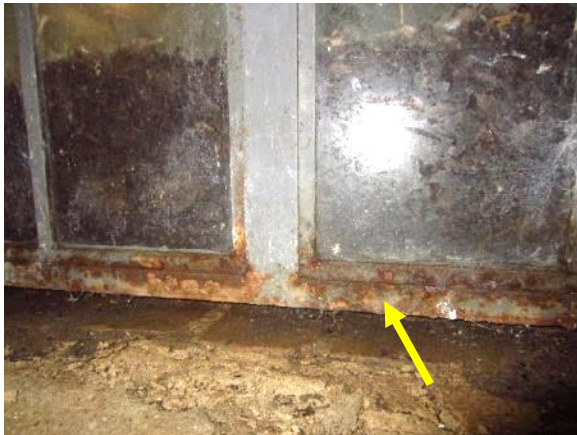
Figure 123. Corroded window casing and sash in basement.

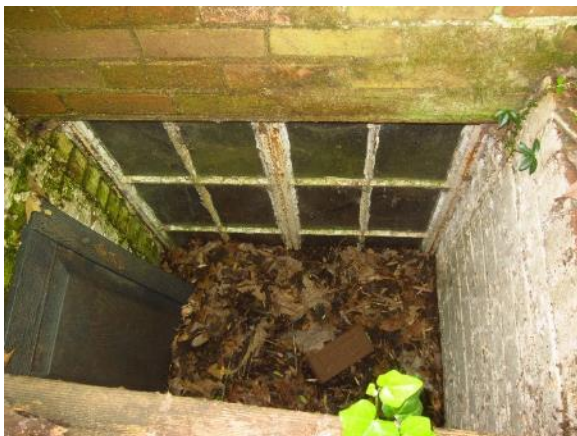
Figure 125. North window with well missing covering grate and debris accumulation. Note miscellaneous shutter stored in window well.

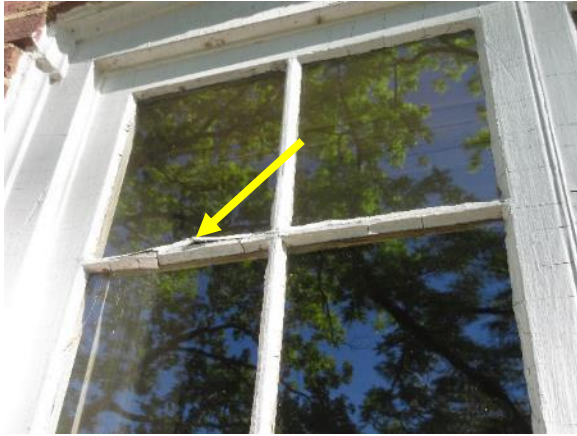
Figure 127. Typical cracked glazing putty at exterior windows.

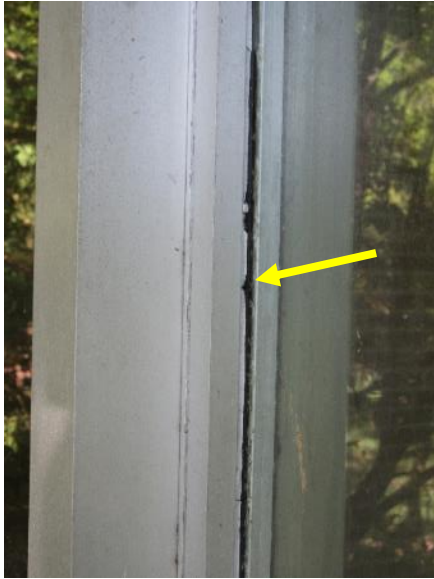
Figure 129. Typical deteriorated sealant at interface between IGU and aluminum framing at glass porch storefront.

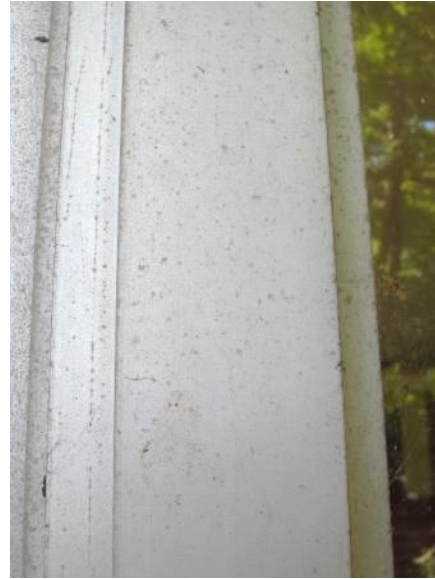
Figure 130. Typical oxidation of glass porch window frame.

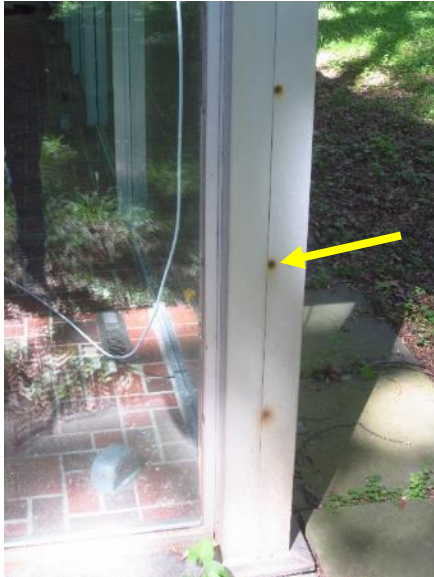
Figure 131. Typical corroding fasteners at glass porch window frame.

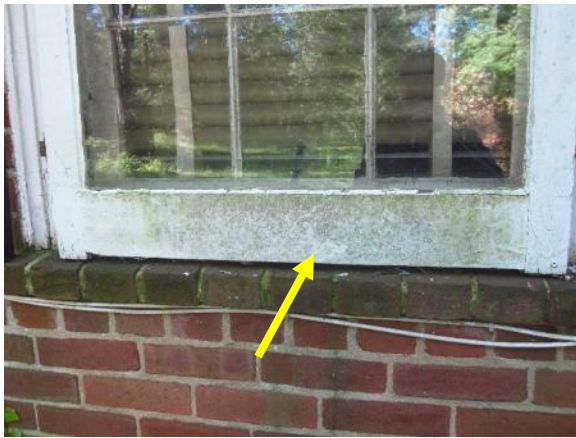
Figure 133. Typical biological growth on storm window and adjacent brick sill.

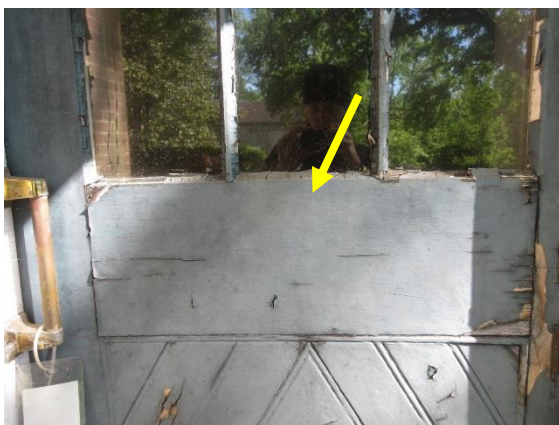
Figure 135. Typical faded and peeling paint at exterior doors.

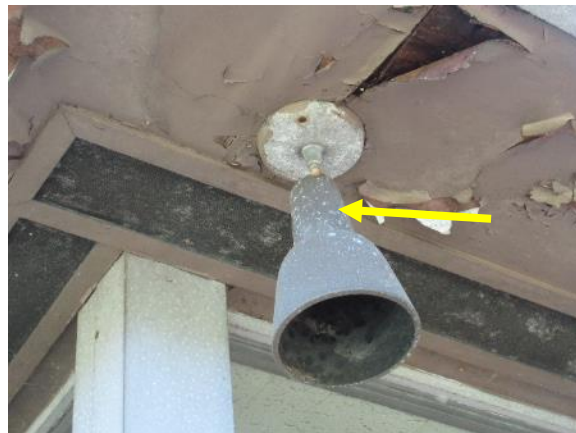
Figure 138. Typical oxidation of exterior glass porch light fixtures.

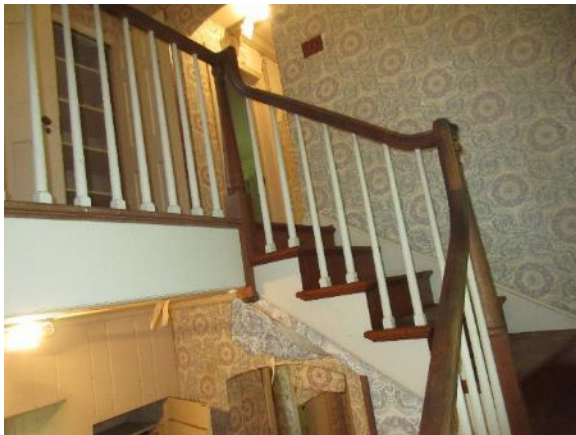
Figure 147. View of landing from staircase.

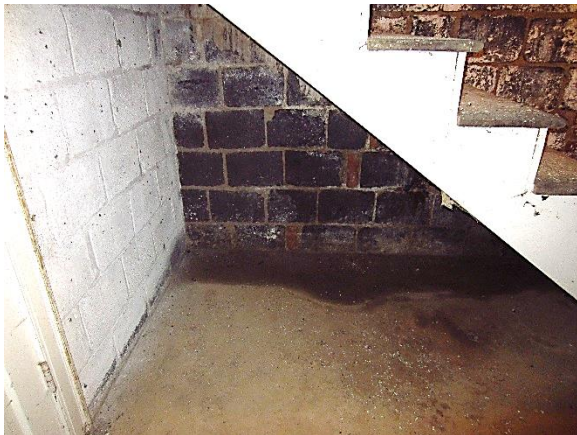
Figure 151. Side view of basement staircase. Note moisture in CMU and edge of slab beyond.

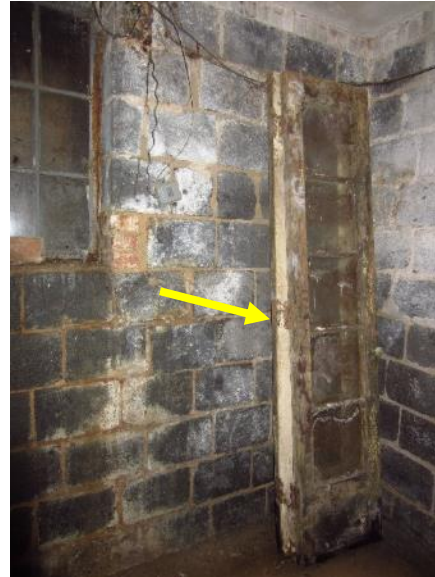
Several window screens and a set of five-paned wood French doors were found in the basement (Figure 158). The door has a metal key escutcheon and a round metal doorknob. The original color could not be discerned due to water damage and microbial growth. The doors appear to have originated from the east doorway between the living room and glass porch that is missing its set of doors.

Figure 158. French doors stored in the basement.

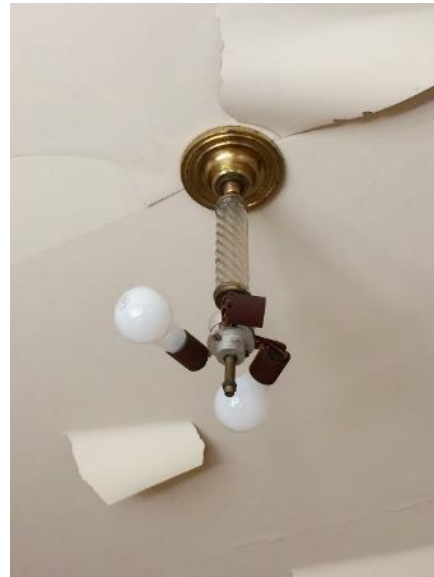
There is one light fixture fixed on the ceiling in the center of the bedroom. It has a circular metal base with two bulbs and the glass globe is missing (Figure 201). This fixture is typical for all bedrooms. Bedroom D has two HVAC vents: one on the north wall and one on the south wall. The vent on the north wall is missing the metal register; however, the register was found in the adjacent first floor bathroom sink (Figure 202). The south wall vent is covered with cardboard and taped over (Figure 203). The outlet and switch plates in bedroom D are all clear plastic except for one outlet plate on the east wall, which is white plastic (Figure 204).

Figure 176. Dining room hanging light fixture. Glass globe and one bulb currently missing.

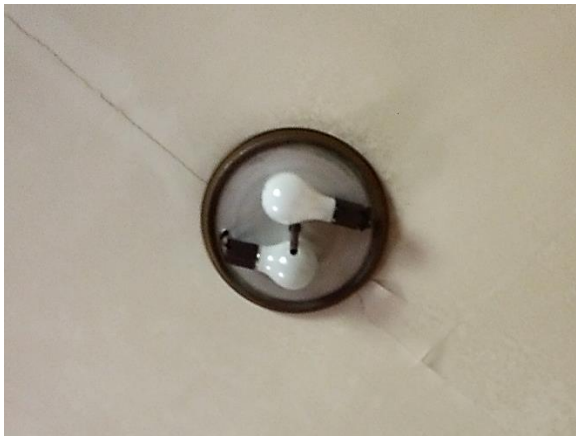
Figure 201. Typical bedroom light fixture with missing glass globe.

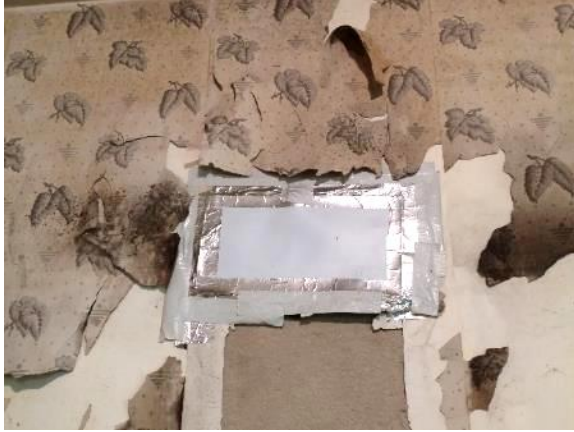
Figure 203. Vent on south wall taped over in Bedroom D.

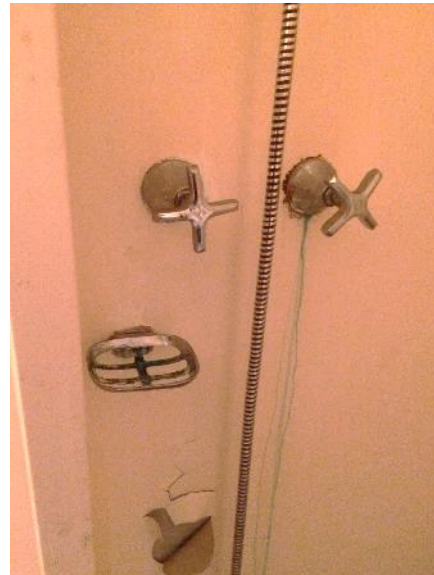
Figure 210. First floor shower faucets and soap holder. Note staining and peeling paint on shower wall.

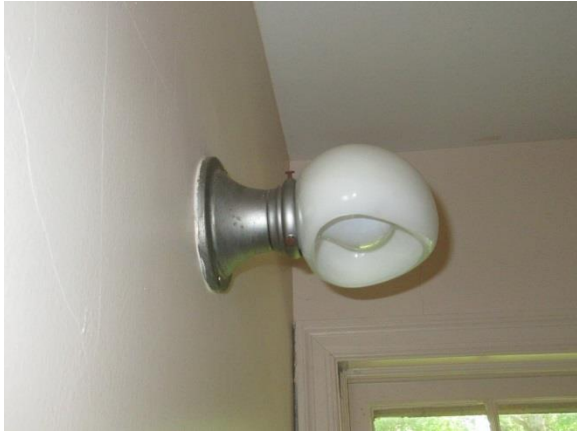
Figure 215. Original light fixture above sink. Typical for all bathrooms.

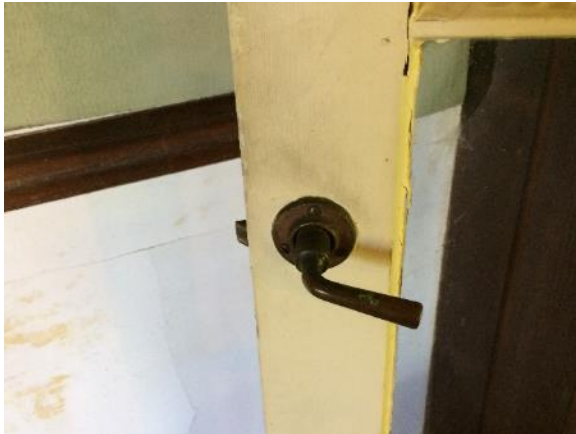
Figure 220. View of east wall of living room and doorway to glass porch. Doors have been removed, but hinges are still in place.

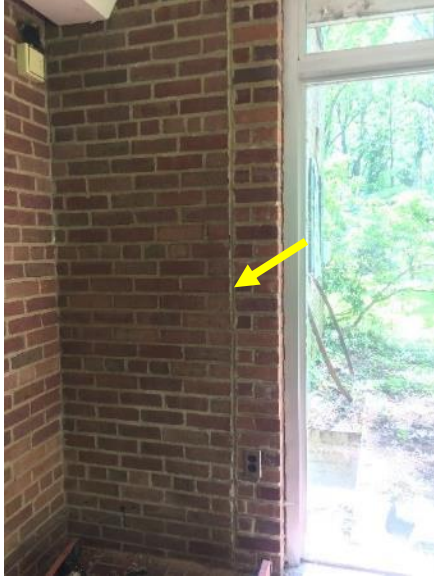
Sections of brick are also present where the storefront assembly interfaces with the original brick facades. On the south wall of the porch a portion of the original porch wall was preserved; this wall was approximately 9 feet wide by 2 feet 7 inches high. An additional brick wall, approximately 2 feet 6 inches wide, was added from the top of the original wall to the aluminum framing of the glass porch (Figure 230). On the west wall a section of brick approximately 8 inches wide and the full height of the porch is present at the transition between the storefront windows and the brick facade (Figure 237). The south and east interior walls of the porch are the original exterior brick face of the home. A “lighting cove” for recessed lighting, made of white pine and painted white, is in place along the top of the interior brick walls (Figure 238). The walls meet square white ceiling tiles at the top that conceal the mechanical equipment above (Figure 239). Per the original 1958 drawings, the tiles are “mechanically suspended acoustic tiles.” A pattern of brick pavers made up of square and rectangular bricks of varying size and color covers the floors (Figure 240).

Figure 237. Southwest corner of glass porch. Note the vertical joint in the masonry between the original brick of the home and the brick added during construction of the glass porch.

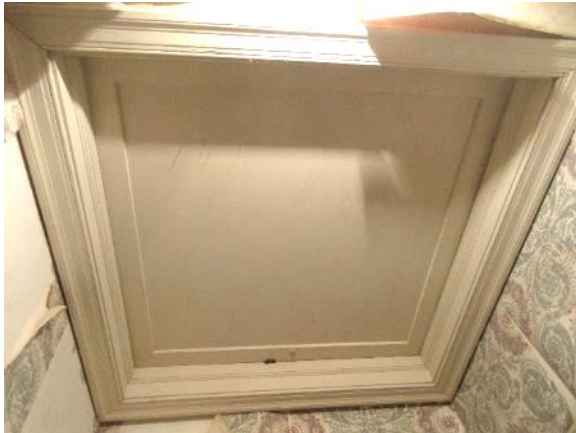
Two bedrooms and one bathroom can be reached through the hallway off the second floor landing. The doorway through the south wall leads to Bedroom C, through the north wall leads to Bathroom B and through the west wall leads to Bedroom B. The finishes in the foyer and landing continue into the hallway. An access hatch is located in the center ceiling of the hallway providing access to the attic (Figure 247). A white switch located on the wall appears to turn on a house fan that is located above the trap door. A light fixture is located east of the access hatch, directly in front of the arched passageway. This fixture has a gold metal base with one bulb and is missing its glass globe.

Figure 247. Access hatch located on the ceiling of the second floor hallway.

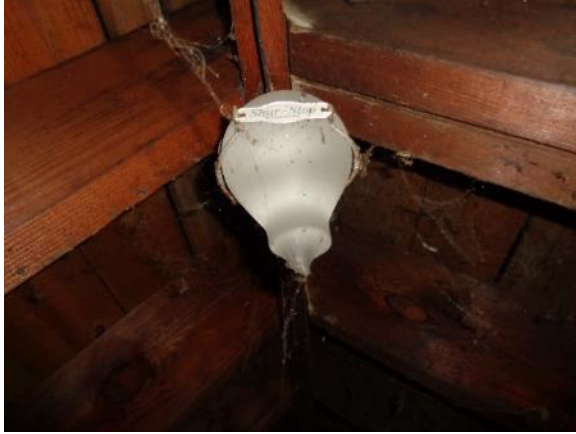
“Shur-Stop” fire grenades are hanging from the ridge beam above the center core (Figure 293). These fire grenades contain toxic extinguishing chemicals, such as carbon tetrachloride, that are intended to release during a fire when the encasing glass is broken due to high temperatures. The chemicals act to smother the fire. The grenades appear original to the home; it is unclear if they would still function as originally designed.

Figure 293. "Sure stop" fire grenades found attached to ridge of attic. These were used to extinguish fires.

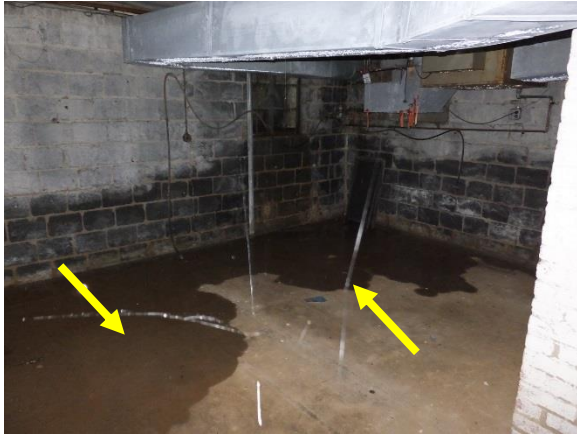
- WJE was on site during a natural rain event and observed significant standing water in the basement (Figure 294). WJE was also on site for several dry weather days during which the foundation wall was consistently damp below the basement window sills (Figure 295). The perimeter of the concrete floor slab was damp as well.

- All of these conditions are common results of prolonged saturation of mass masonry walls. The missing gutters and downspouts, as well as the debris accumulation in the window wells, result in bulk water being directed towards the foundation walls in lieu of away from the walls during natural rain events. The single 12 inch wythe of CMU is very porous in nature and is not capable of serving as a waterproof barrier on its own, particularly in a below-grade application. As the mortar within the CMU joints continues to break down due to prolonged saturation, it will allow an increasing amount of bulk water to penetrate the foundation walls. Additionally, if the mortar deteriorates to the point of substantially decreasing its compressive strength the structural integrity of the foundation wall will be compromised.

Figure 294. Water infiltration in the basement during an active rain event.

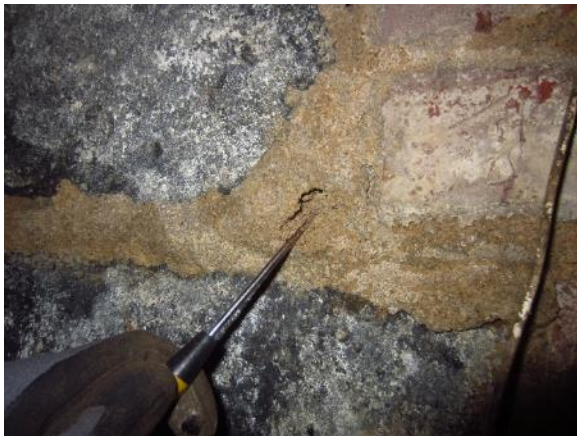
- The mortar throughout the walls was sandy and easily broke apart (Figure 296).
 - Staining, missing and unadhered coating, efflorescence and potential microbial growth were observed along the full perimeter of the CMU foundation walls.

Figure 296. Soft, wet mortar on basement walls.

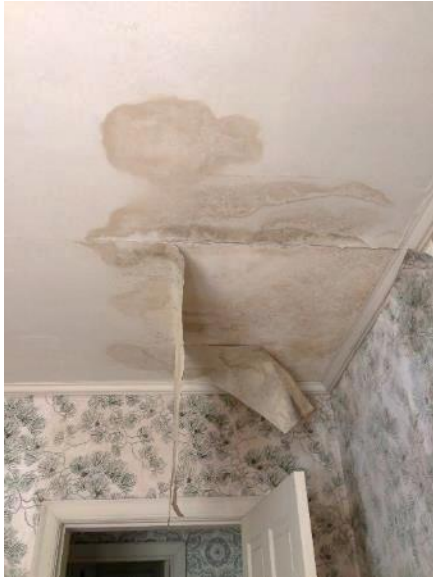
- Extensive water staining and possible microbial growth were observed at the wood framing members, plaster, wallpaper, and wood floors (Figure 298 and Figure 299). Blistering and powdery plaster were also observed.

Figure 298. Staining and peeling of wallpaper on ceiling due to water damage in dining room.

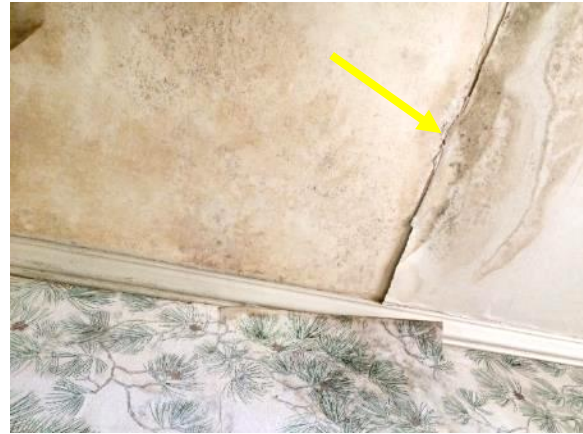
Figure 299. Potential microbial growth at ceiling due to water infiltration in dining room.

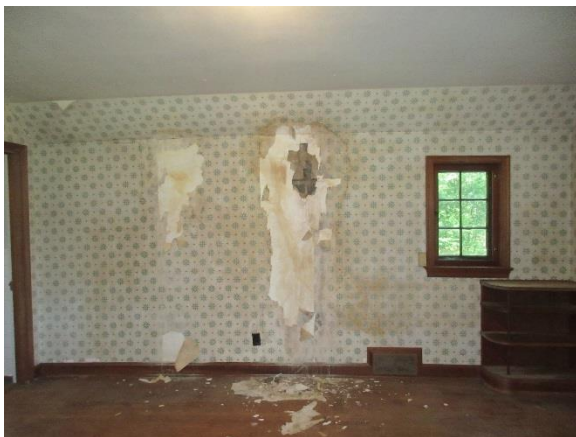
Figure 300. Extensive water staining at plaster, wallpaper and wood floors at north wall in Bedroom A.

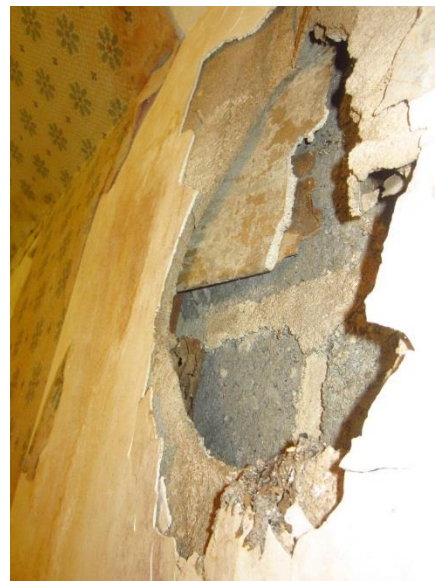
Figure 301. CMU chimney wall and layers of plaster at water damage in Bedroom A.

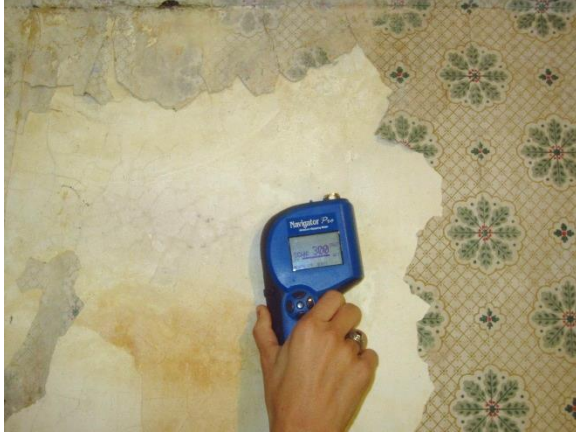
Figure 302. High moisture content detected by the moisture meter (300 out of 300).

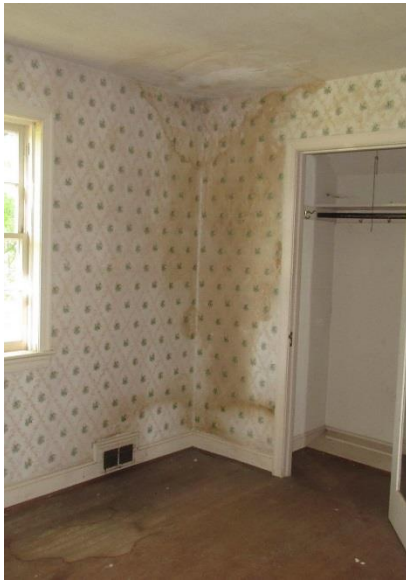
Figure 304. Water staining at plaster and wallpaper in southwest corner of Bedroom C.

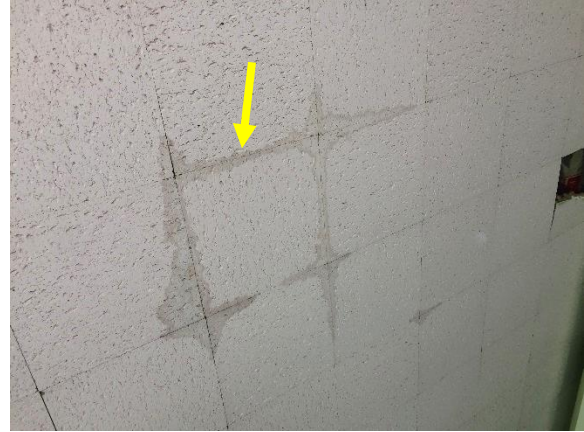
Figure 307. Moisture stains on ceiling tiles in center of glass porch.

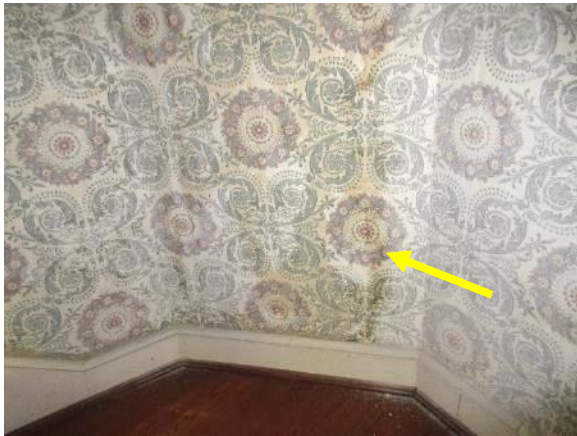
Figure 308. Stained wallpaper as evidence of water infiltration in the main stairwell between the first floor and the second floor.

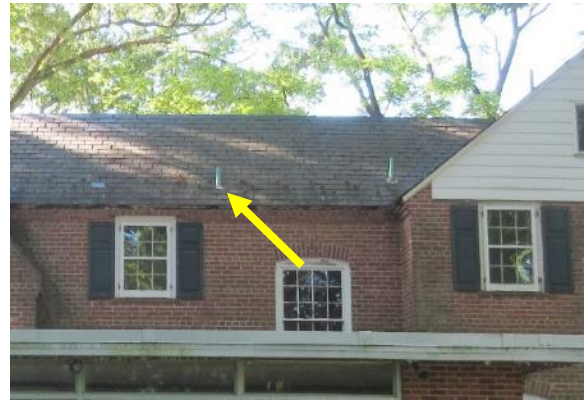
Figure 309. Pipe that penetrates roof above main staircase. This is a potential cause of water infiltration at this location.

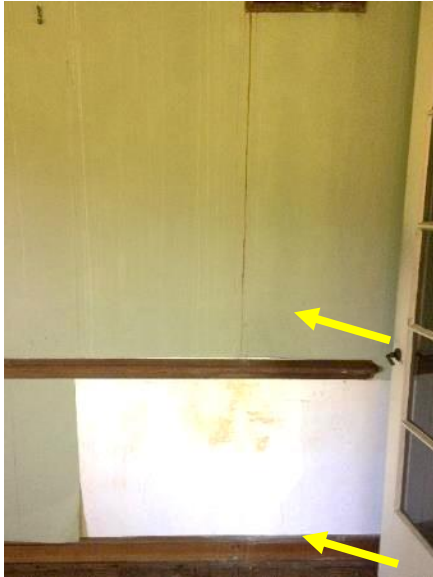
Figure 310. Streaked surface staining and missing wallpaper (living room).

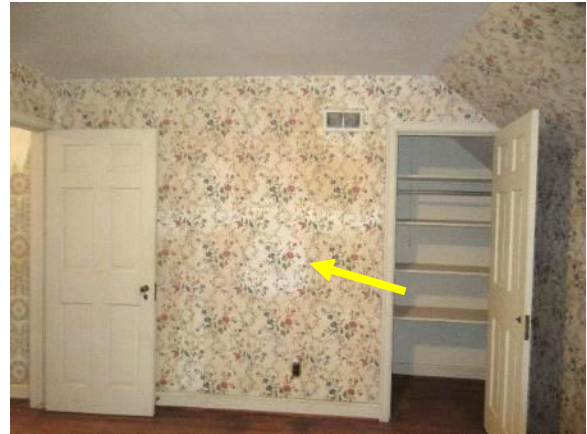
Figure 311. South wall of Bedroom B. Note typical discoloration of wallpaper. The door to the hallway is located on the left.

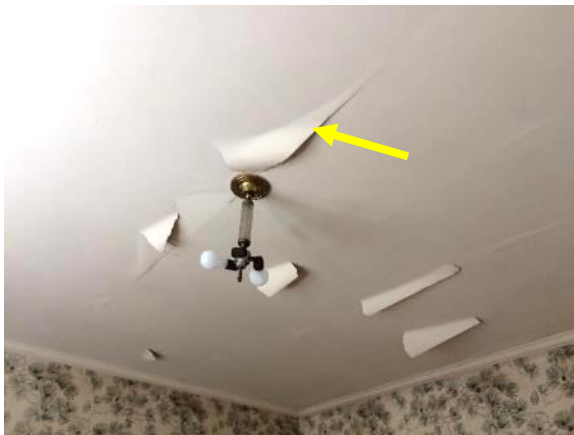
Figure 312. Typical peeling wallpaper on ceiling.

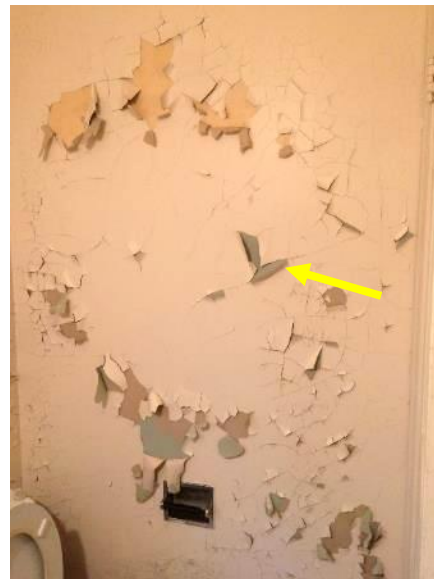
Figure 313. Typical peeling and blistering paint on walls.

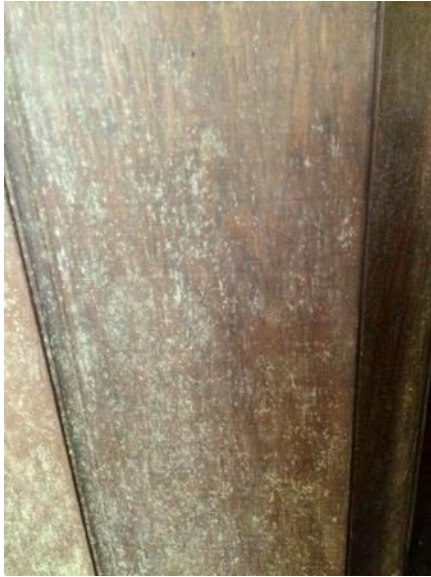
Figure 314. Potential microbial growth on surface of wood paneling in living room.

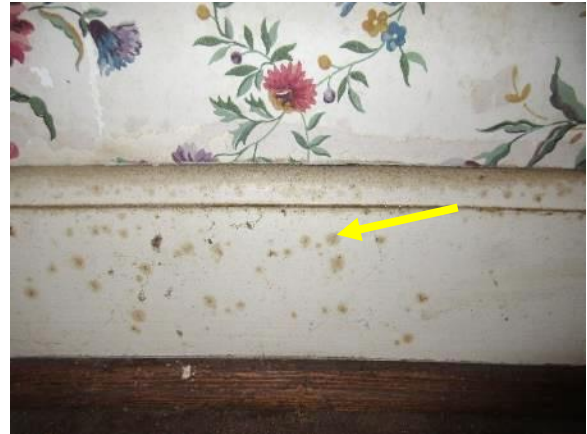
Figure 315. Typical potential microbial growth on baseboard.
