MARGARET WHITE HOUSE AND BARN Historic Structure Report

Falls Church, Virginia

Final Report

December 20, 2017
WJE No. 2015.3162.6

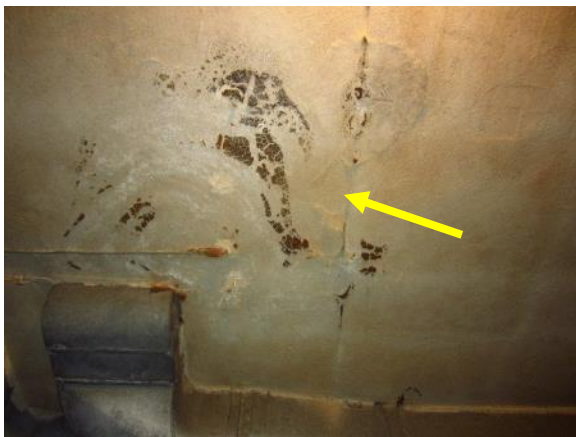
Figure 316. Potential microbial growth on plaster ceiling in basement.

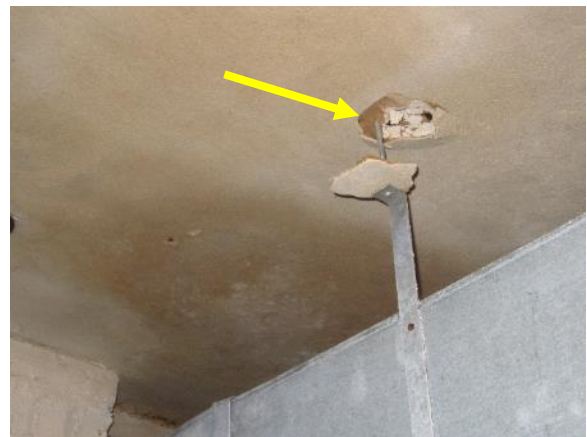
Figure 317. Hole in plaster ceiling of basement from detached ductwork anchorage.

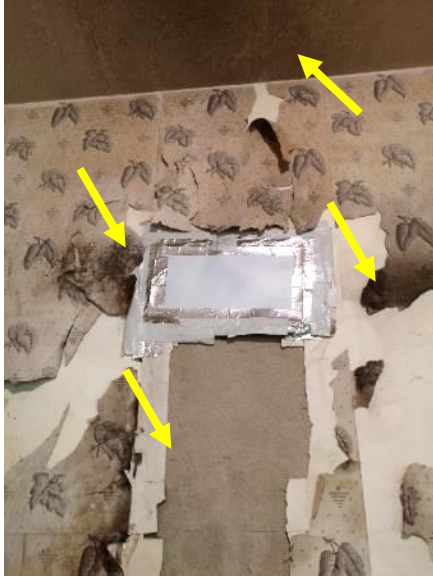
Figure 320. Dark surface staining and peeling/missing wallpaper and plaster around missing vent in Bedroom D.

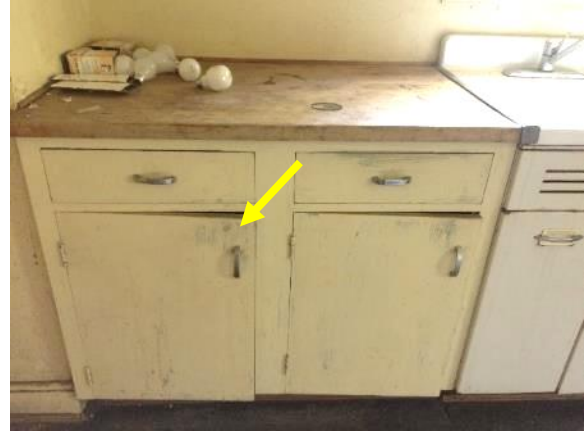
Figure 321. Paint scraped at cabinets in kitchen.

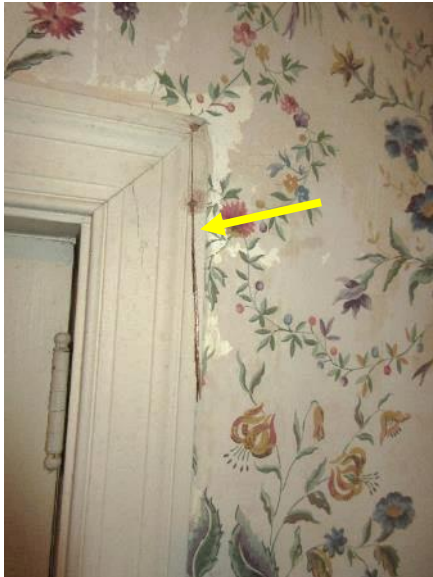
Figure 322. Cracked window casing in Bedroom B.

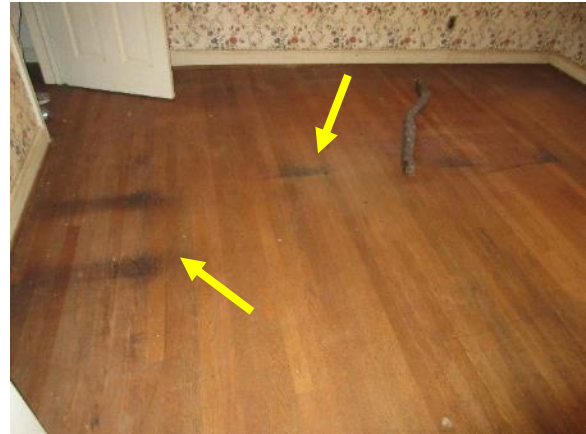
Figure 325. Dark marks on wood floor (Bedroom B).

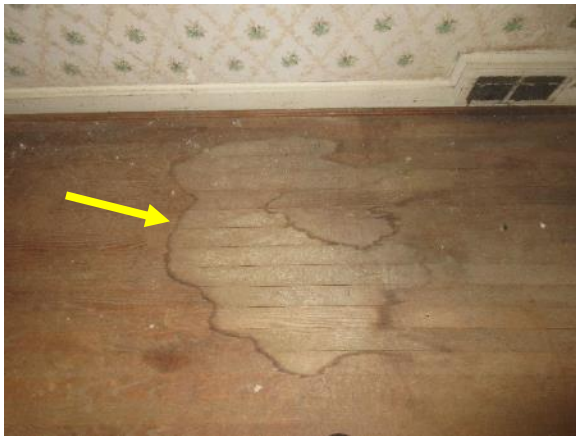
Figure 326. Water stain on wood floor in Bedroom C, not related to locations of exterior water infiltration.

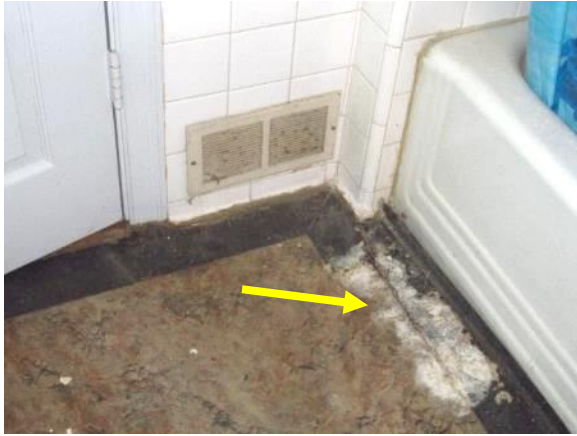
- The linoleum in the kitchen is in poor to fair condition. The floor is cracked or stained in several locations (Figure 327). The linoleum in the first floor bathroom is in good condition with the exception of one tile that is missing. The linoleum in Bathroom A is in poor to fair condition. The floor is cracked and blistering in several locations, primarily below the sink and adjacent to the bathtub (Figure 328). This is likely due to water spillage from the sink and bathtub.

Figure 328. Cracked and blistered linoleum in Bathroom A.

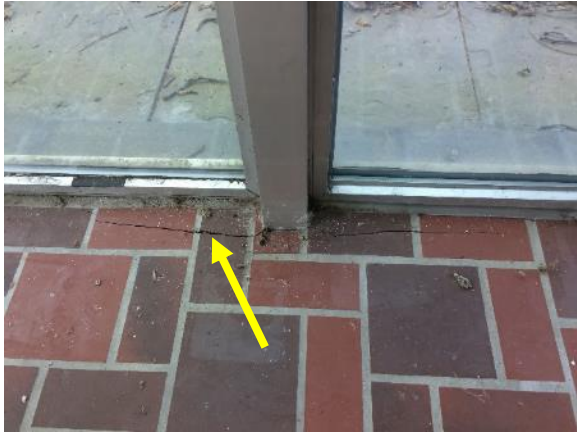
- Isolated brick pavers are cracked in the glass porch. The cracks extend from the base of the aluminum mullions near a corner of the porch (Figure 330). This may be due to unaccommodated thermal expansion and contraction of the aluminum against the pavers.

Figure 330. Cracked brick pavers around aluminum frame in glass porch.

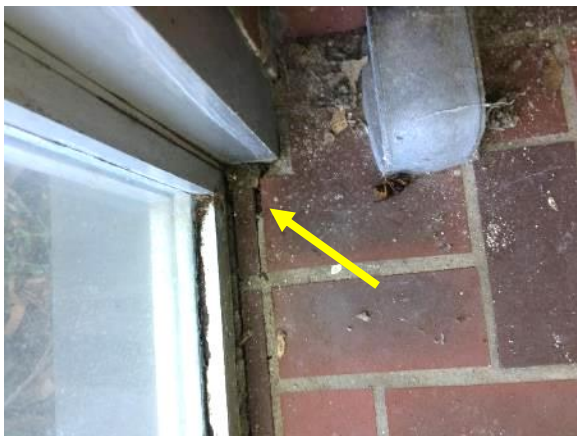
- One brick paver is loose in the glass porch near the east sliding glass door (Figure 331).
- Missing joint mortar was observed between several pavers in the glass porch (Figure 332).

Figure 332. Missing mortar between brick pavers in glass porch.

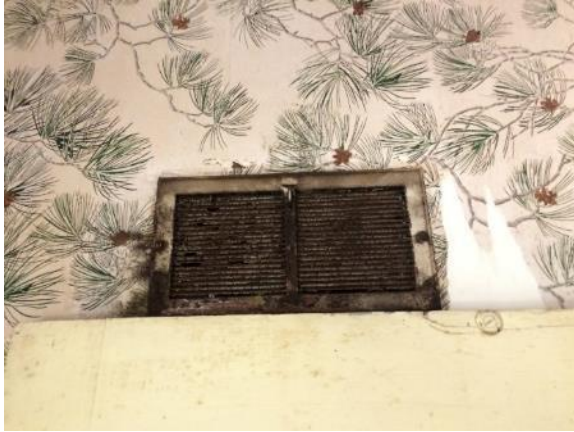
- All of the light fixtures have retained their original light fixture bases; however, many of the glass globes are missing. The bases appear to be in good condition.
- There are original curtains and blinds in Bedroom D and original blinds in the first floor bathroom; however, the curtain and blinds are missing from the windows in the rest of the house. Some of the window frames have abandoned curtain hardware, but many are missing hardware.
- All of the exposed plumbing fixtures that remain in the home visually appear to be in good condition; however, the systems were not tested for functionality.
- Most of the metal vents in the home are blocked with dust. Some of the vents are also corroding (Figure 334).

Figure 334. Typical blocked and corroded vent register.

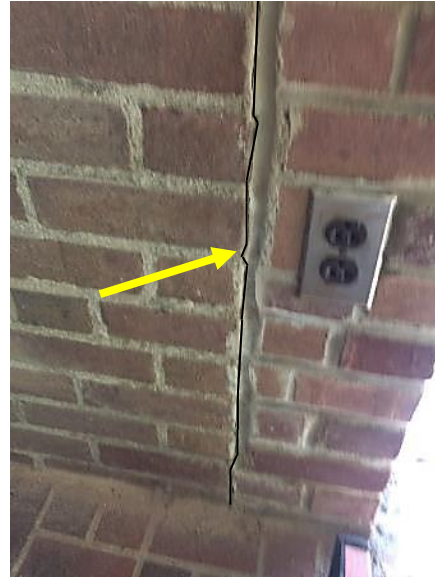
- Bondline failure was observed in the glass porch at both interfaces between the original brick facade and the brick wall of the glass porch (Figure 335).

Figure 335. Bondline failure at interface between original brick facade and glass porch addition. Crack traced for clarity.

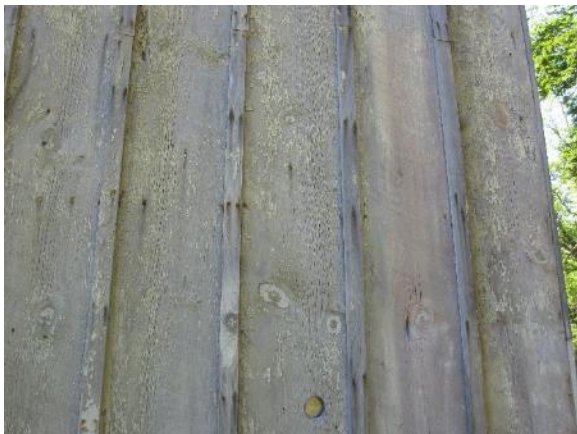
The exterior of the barn is primarily made of a board and batten wood planks (Figure 338). The boards are approximately 12 inches wide and the battens are approximately 1-3/4 inches wide. The wood is typically exposed, but remnants of white coating were observed. A red color can be seen at the top of the boards under the eaves, where weathering and sun exposure has had less of an impact (Figure 339). This may be an indication that the wood was previously stained. Some of the missing knots and other miscellaneous holes in the walls have been patched with copper sheet metal, including a large area at the base of the north side (Figure 340). There is no sign of the removed straw shed roofline in the field of the board and batten siding on the south side.

Figure 338. Typical faded wood color on exterior of barn. Remains of white coating can be seen.

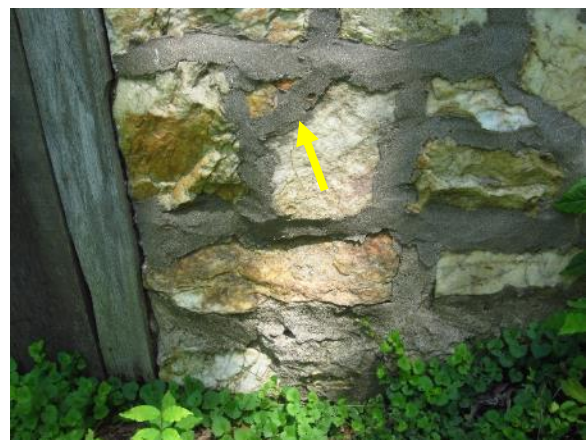
Several vintages of mortar were observed in between the stone units, particularly at the east and west ends, including multiple iterations of what appear to be “face-pointing”¹¹⁰ (Figure 344). Based on the historic photographs, the south basement level was originally open to the exterior with timber posts supporting the main level above (Figure 9). Since the time of the historic photograph (c. 1940), the south basement wall has been infilled with two areas of board and batten wood planks, hinged double doors at the center, and stone columns in between the doors and the infill areas (Figure 337). The joints at these columns appear to have been “face-pointed” with a dark gray mortar (Figure 345).

Figure 345. Dark gray mortar on south side of the barn.

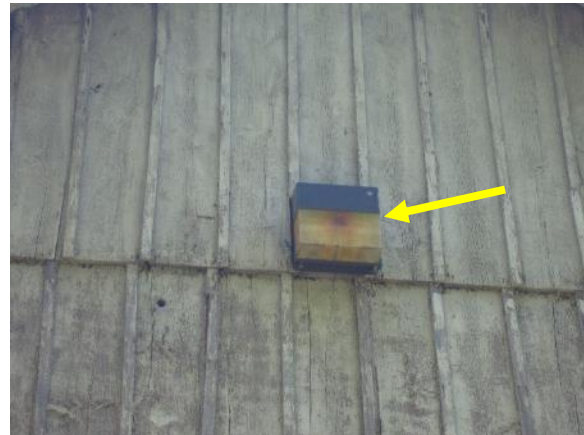
Figure 361. Plastic security light fixture on west end of barn.

- The light fixture located on the west end appears to be in fair condition; the plastic is discolored and likely brittle from exterior exposure. The fixture was not tested for functionality.

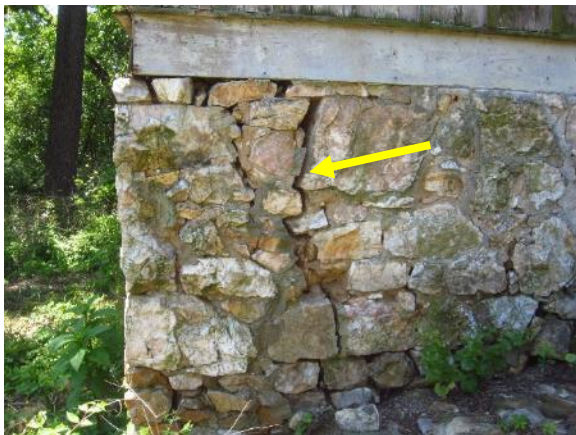
- A portion of the fieldstone foundation is displaced horizontally by approximately 1 inch and vertically by approximately 1/4 inch at the northeast corner of the barn (Figure 362 and Figure 363). The mortar is cracked or missing between the two sides of the crack. Several factors may have contributed to the observed displacement including, but not limited to, differential settlement of the soil below the foundation wall or differential erosion of the soil below the foundation wall. Since the initial displacement and subsequent cracking of the joint mortar occurred, bulk water from natural rain events has been able to flow through the cracks, continually eroding the joint mortar and leading to increased amounts of bulk water infiltration in the basement level. No significant displacement or other related distress were observed in the wood floor or barn structure above.

Figure 362. Displaced stone foundation and cracked mortar on north side.

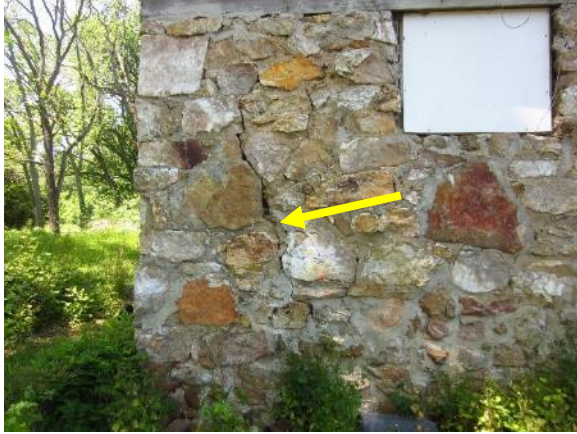
- Large areas of cracked and missing mortar between fieldstones were observed on the east and west ends through all vintages of mortar (Figure 364 and Figure 365). The “face-pointing” mortar is typically thin, cracked and debonded with small holes on the east and west ends of the barn (Figure 366 and Figure 367).

Figure 364. Multiple cracks and missing mortar in mortar of stone foundation at east end.

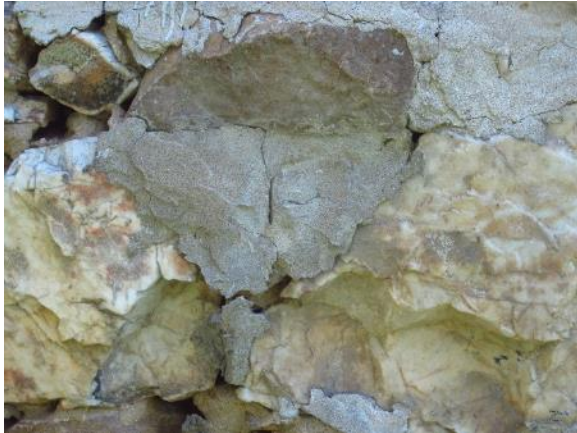
Figure 366. Typical debonded and cracked mortar of foundation walls.

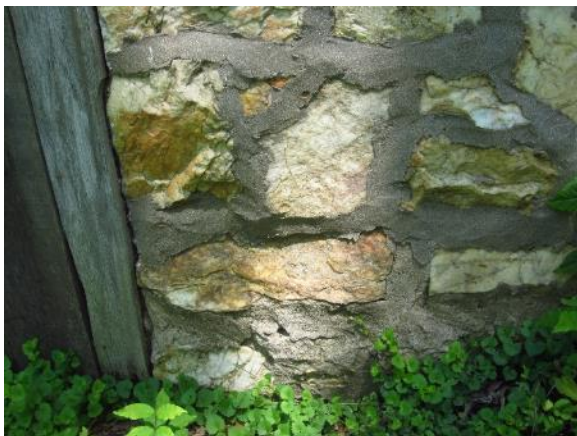
- The mortar is generally in fair condition on the south side (Figure 368). For this reason, as well as the distinctly darker color of the mortar in comparison to the mortar elsewhere in the foundation walls, this mortar was likely installed more recently than the other vintages of mortar.

Figure 368. Mortar in fair condition on south side.

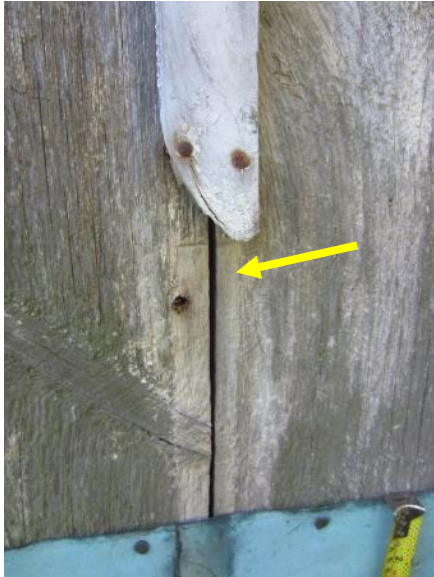
- Several missing or broken battens were observed on both the sides and the ends of the barn (Figure 370). Several battens are partially detached from the barn (Figure 371).

Figure 370. Missing wood batten.

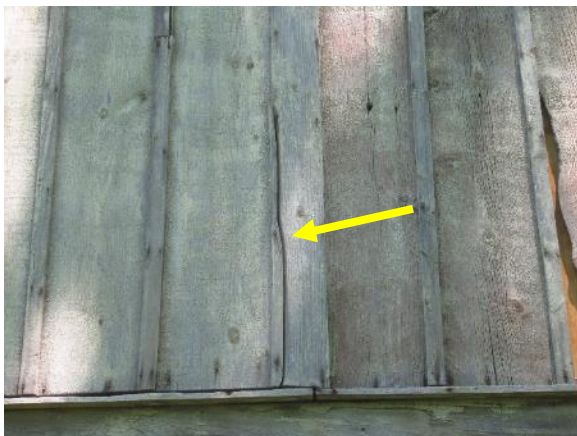
- Multiple holes and cracks in the wood were observed on both the sides and the ends of the barn (Figure 372 and Figure 373). One hole was previously repaired with a wood dutchman (Figure 374). Several holes were previously repaired with copper sheet metal (Figure 375). At one location replacement wood was fastened to the interior to patch the hole (Figure 376).

Figure 372. Split batten on south side.

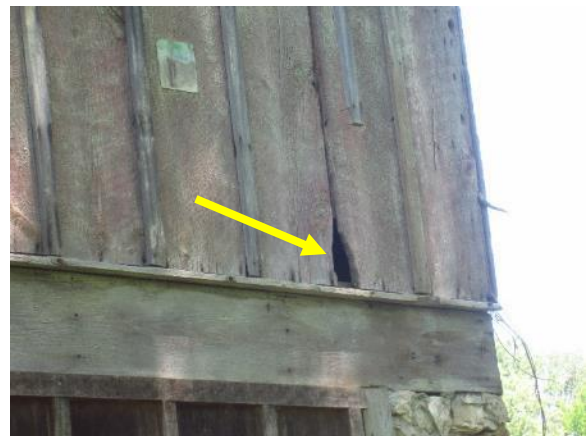
Figure 373. Hole in side of barn on south side.

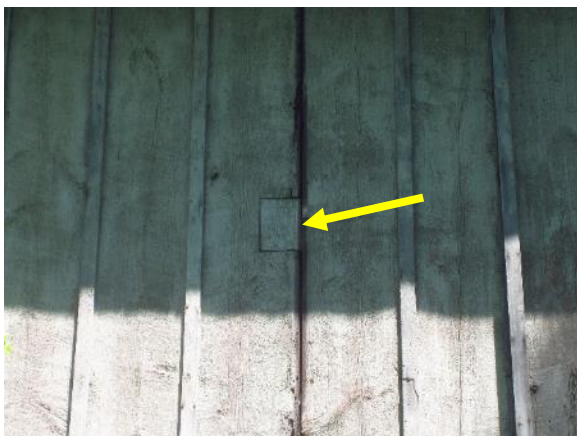
Figure 374. Existing wood dutchman on south side.

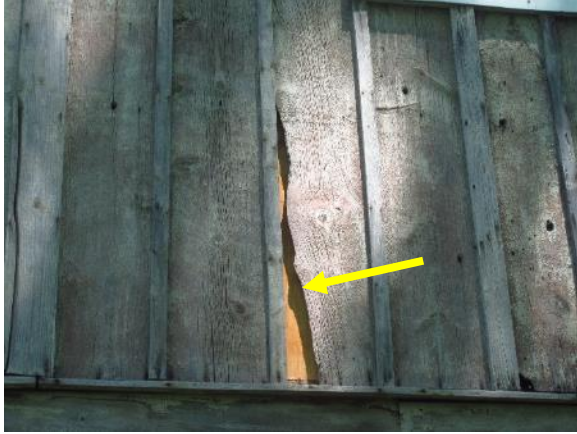
Figure 376. Wood plank attached to interior to cover hole on south side.

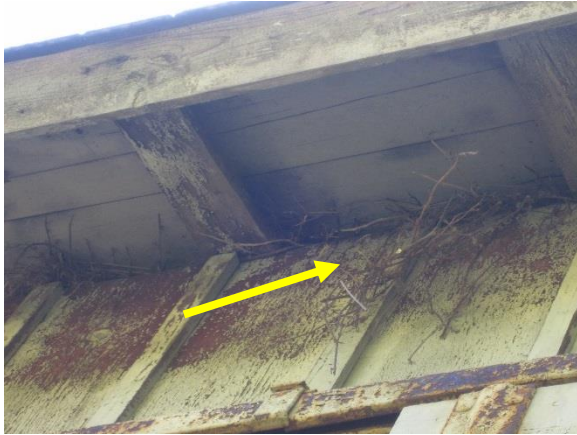
- Numerous hooks and wires are fastened into the wood boards on the west end and south side (Figure 377).
- Vegetation was observed on the wood on the east end and north side, extending under the roof. At the time of our survey the vegetation appeared to be dead (Figure 378).

Figure 378. Vegetation growing from under roof on north side.

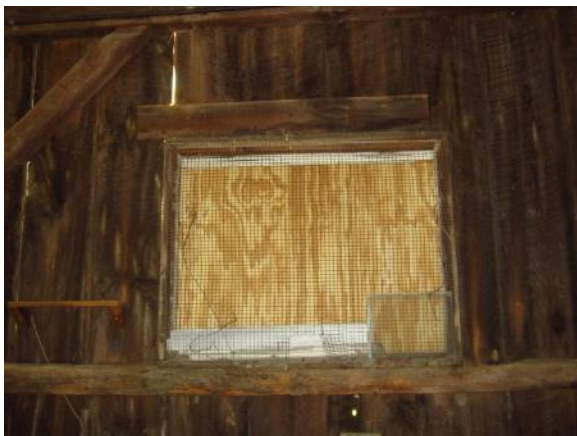
- The windows are in fair to poor condition.
- The entire sash of the main level west window on the south wall is disassembled. Several of the components are stacked in between the plywood on the exterior of the barn and the interior screen (Figure 380). It appears as though some of the components are missing or misplaced.

Figure 380. Missing window sash with several window components stacked between plywood and screen.

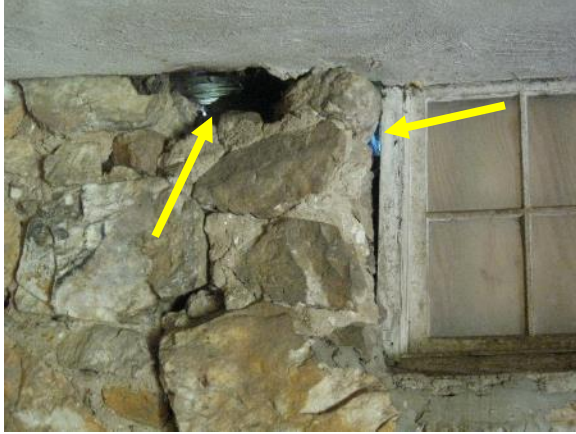
- Approximately 1 inch gaps were observed between the window frames and fieldstone in the basement, indicating that the perimeter of the windows is not sealed to the surrounding foundation wall (Figure 382).

Figure 382. Void between window frame and stone and gap between stone and ceiling.

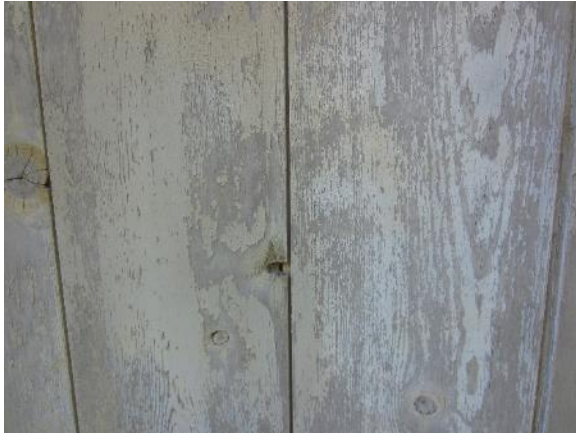
- The double sliding barn doors on the main level are in fair condition. They are operable, but move with some difficulty.
 - Surface corrosion was observed on the metal door tracks and door hardware (Figure 383).
 - Typical coating deterioration, such as cracking and peeling and vegetation was observed (Figure 384 and Figure 385).
- The hinged double doors located at the basement level are in very good condition with slight discoloration and fading of the wood observed.

Figure 384. Typical coating deterioration of sliding door.

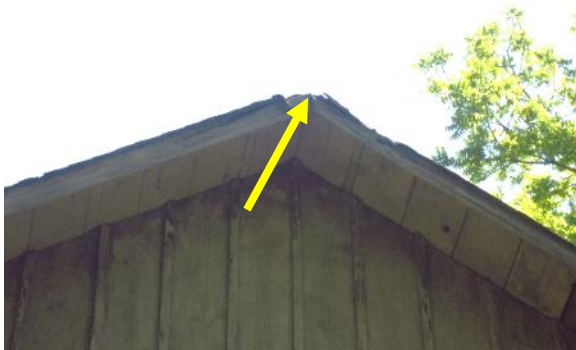
- The asphalt shingle roof is in fair condition consistent with 10 years of in-situ service and a low-middle grade composition shingle.
- Minor sagging was observed along the south side of the roof.
- Several torn shingles were observed at the west end of the roof ridge (Figure 386).
- Multiple replacement wood deck planks were observed underneath the west rake overhang (Figure 387).
- Deteriorated and missing wood was observed along the south eave and east rake overhangs of the barn (Figure 388 and Figure 389).

Figure 386. Missing shingles along ridge of barn at west gable end.

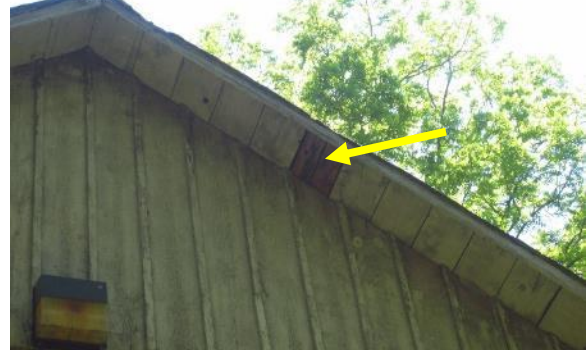
Figure 387. Replacement roof deck plank on west rake overhang.

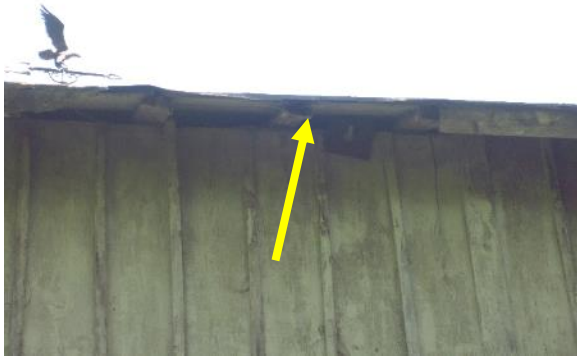
Figure 388. Missing wood along south eave.

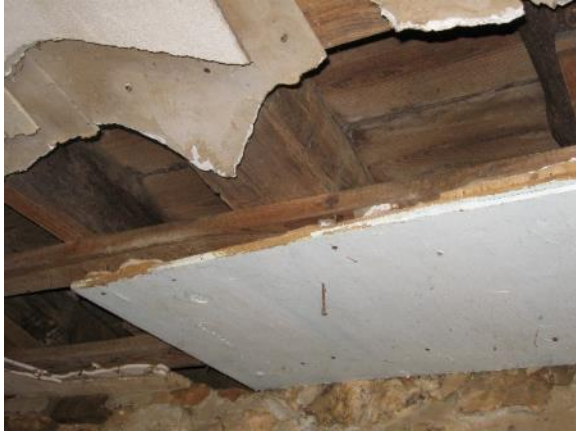
Figure 406. Hole in plaster ceiling of barn basement. The floor boards can be seen through the hole, as well as additional sawn lumber boards used as furring for the plaster.

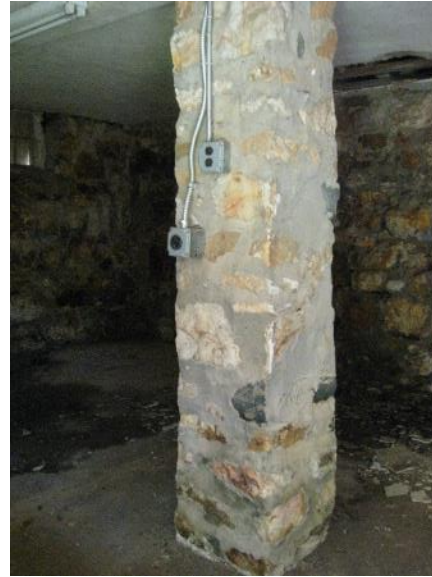
Two stone columns are spaced evenly in the basement and support the floor above (Figure 407). The column joints were previously “face-pointed” with a mortar that matches the “face-pointed” mortar on the south side.

Figure 407. Stone column in basement. Repointing mortar and stone appear to match the south basement wall.

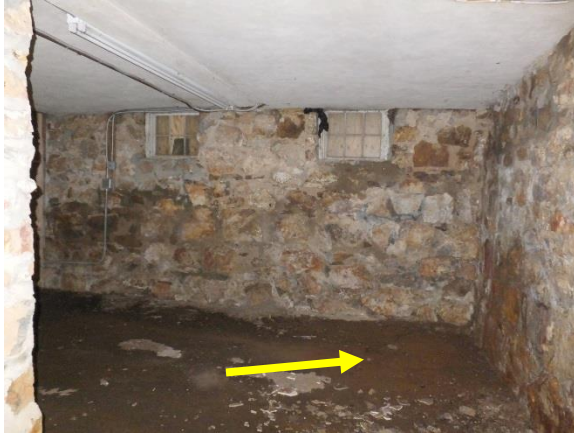
- WJE was on site during a natural rain event and observed significant standing water in the basement level along the north and west foundation walls (Figure 409). Moisture staining remained present on the interior surface of the walls during our survey on a dry day as well (three days following a rain even) (Figure 410). Moisture staining was also observed along the full perimeter of the concrete floor slab (Figure 411).

Figure 409. Standing water in the basement of the barn at the northwest corner during a rain event.

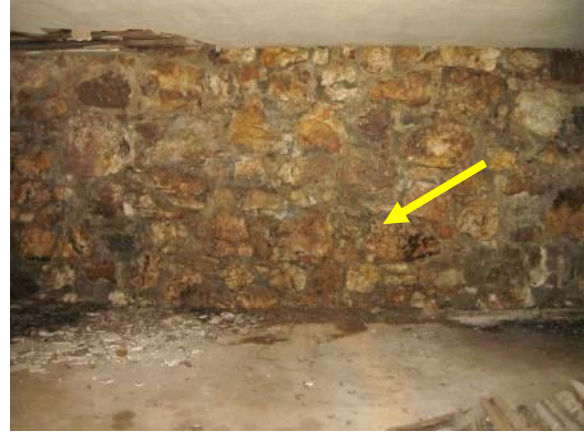
Figure 410. Moisture staining on stone foundation walls in basement.

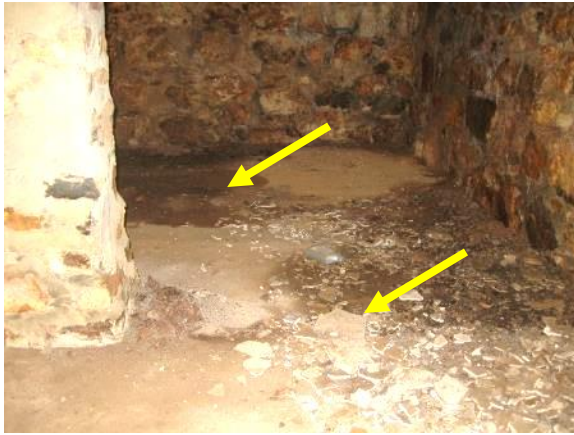
Figure 411. Moisture staining of concrete basement floors. Note plaster remnants on floor.

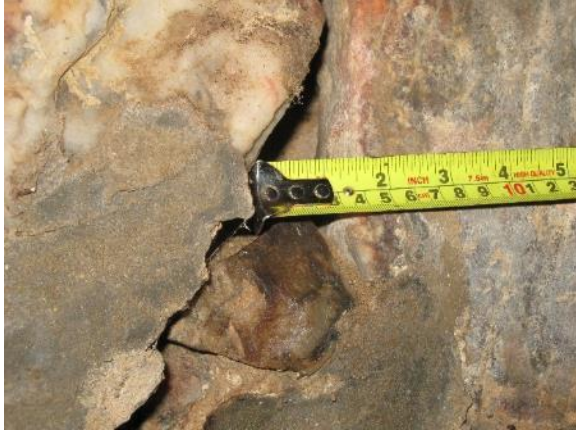
- The mortar on the east, west and north walls is typically cracked and debonded with pin holes. In some locations, the mortar was sandy and easily broke apart (Figure 412). Multiple cracks were observed through the mortar. For example, in the northeast corner of the basement, on the north wall, the vertical and horizontal displacement observed at the exterior is also visible at the interior (Figure 413).

Figure 413. Displaced stone foundation walls and cracked mortar in northeast corner of basement.

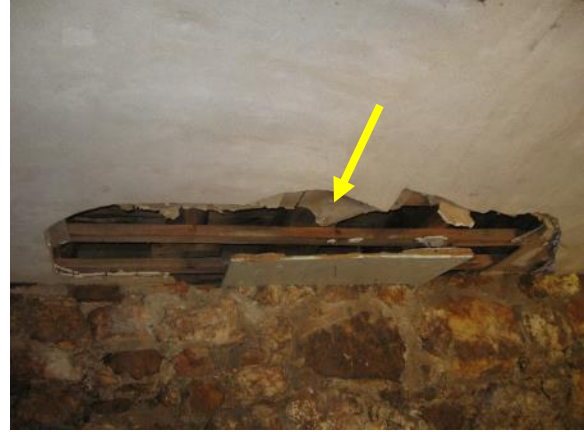
- A large hole was observed in the plaster ceiling of the basement at the center of the north wall (Figure 414). Various pieces of broken plaster and cementitious wall board are scattered on the basement floor below the hole. Surface corrosion was observed on the nails that previously held the wall board in place, which is indicative of moisture exposure (Figure 415). A piece of painted plywood is fastened into the floor joists in the center of the hole as a potential previous repair effort.

Figure 414. Hole in basement ceiling at north wall.

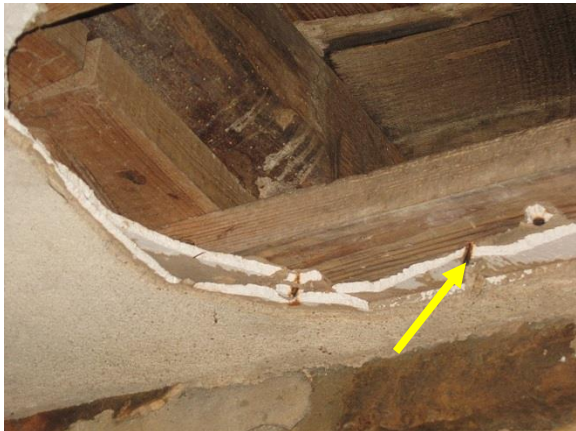
Figure 415. Hole in plaster ceiling at north wall.

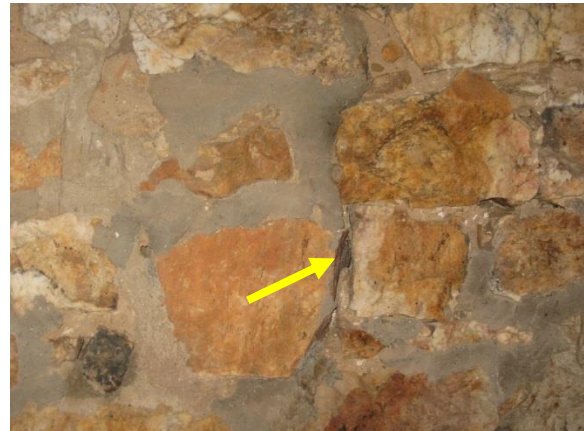
- The “face-pointing” applied to the surface of the joints at the stone columns and interior surface of the foundation walls is poorly tooled and extends over the surface of the stone units significantly (Figure 416).
- The mortar is in fair condition at the interior columns and the south foundation wall.
- The fieldstone units themselves are in good condition.

Figure 416. Typical debonded and missing mortar at interior surface of foundation walls.

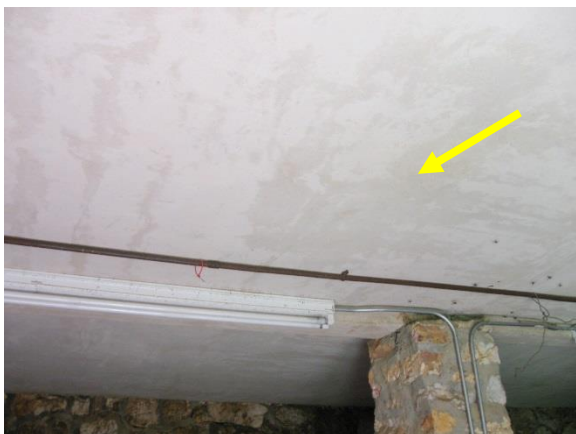
- The plaster ceiling in the basement is generally in good condition with a minor discoloration pattern on the surface (Figure 417). Several holes in the plaster were observed adjacent to the light fixtures to allow for electrical wiring to pass through the ceiling (Figure 418).

Figure 417. View of plaster ceiling in basement. Note the minor staining on the surface.

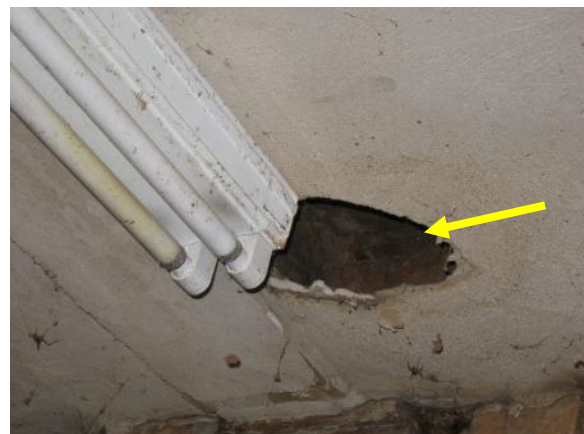
Figure 418. Hole in basement ceiling near east wall.

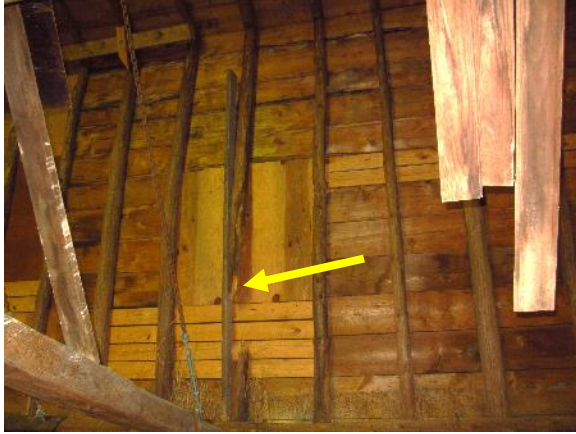
- Several pole rafters have been sistered with dimension lumber on the south half of the roof, including one pole rafter that had failed (Figure 419).
- A partial ridge beam has been added at the center of the roof (Figure 420).

Figure 419. Sistered rafter on southern roof face.

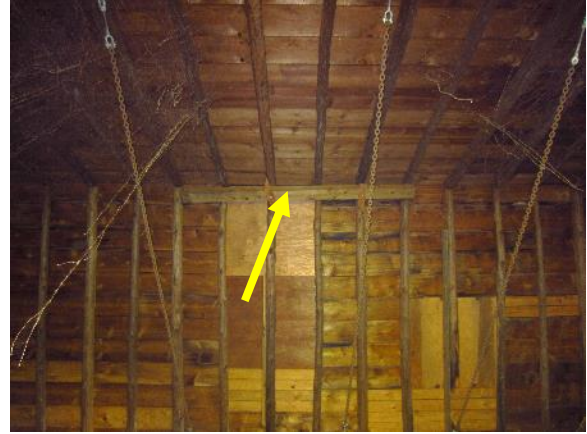
Figure 420. Partial ridge beam nailed in place.
