ASH GROVE Historic Structure Report

Vienna, Virginia

Final Report

December 04, 2017

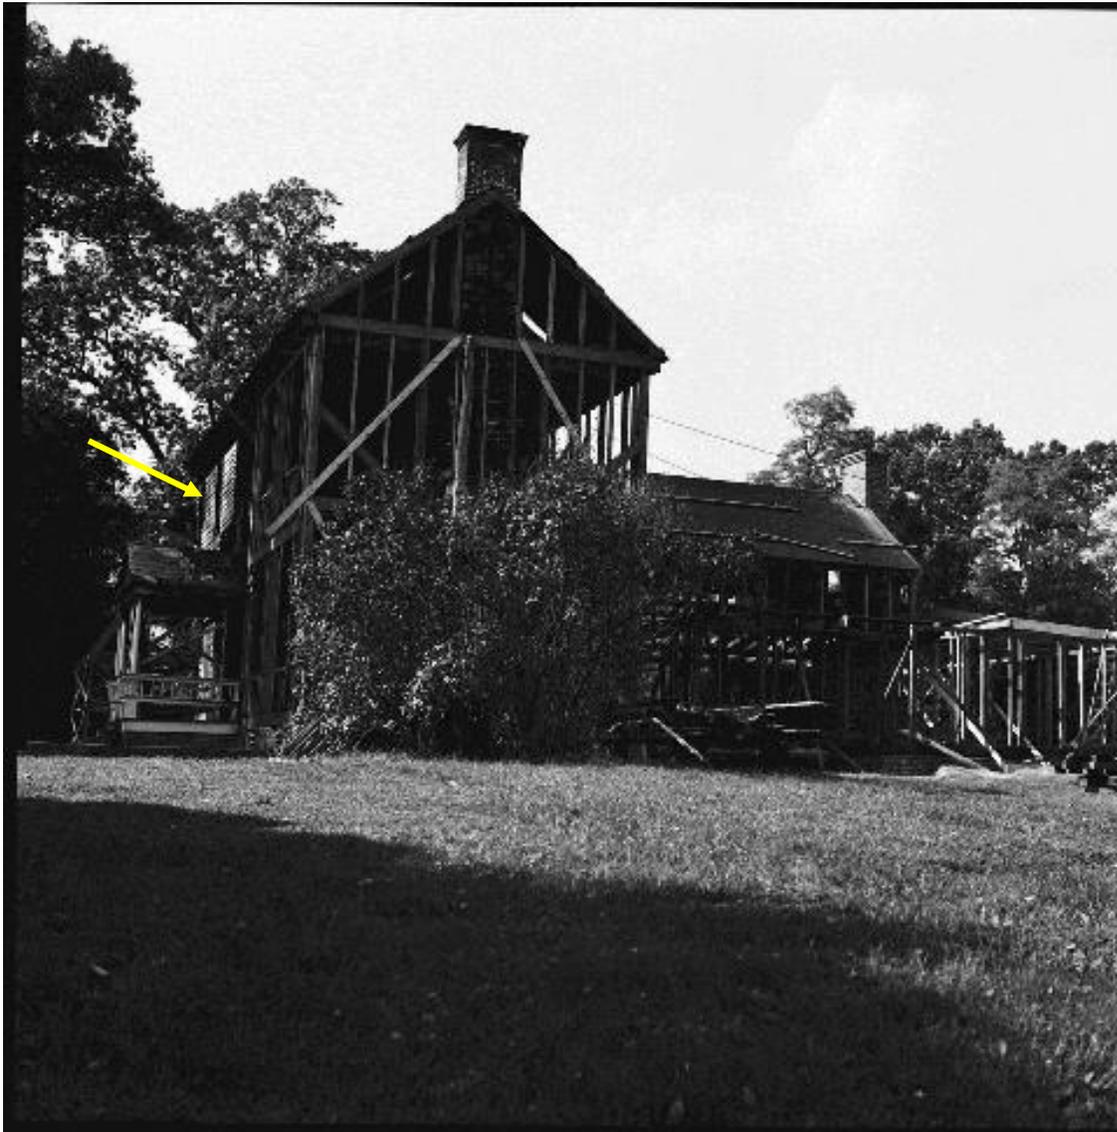
Figure 14. Photograph taken in October 1960 after the fire from the southeast. Note siding still intact along southwest.

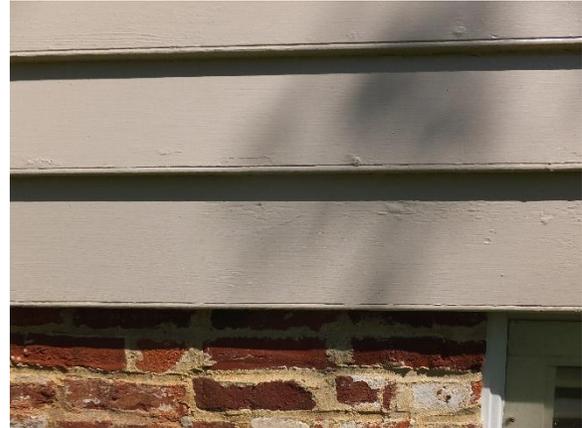
Figure 29. Wood clapboard siding currently obscures the wood members in 2017.

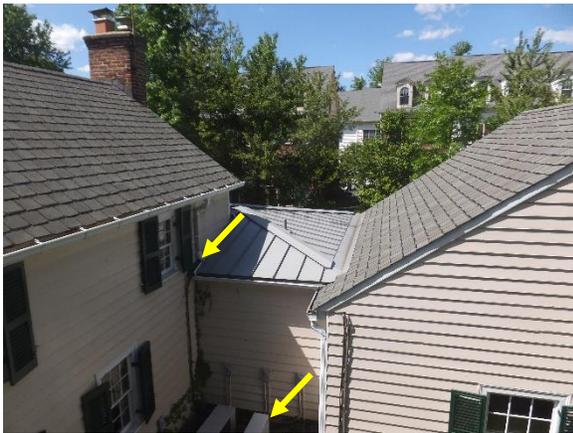
Figure 51. West patio roof interface with central section of the home. Downspout from central section gutter deposits water directly onto patio roof.

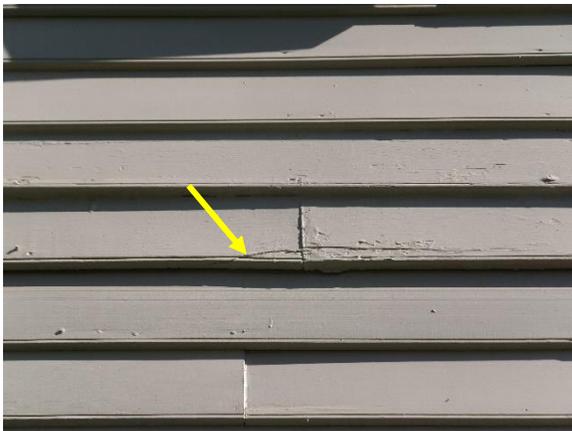
- There are areas of deteriorated siding and fascia boards throughout the facades, most notably near gutters and downspouts (Figure 73). Isolated areas of bubbling paint was observed near the floor of the south portico and east wall. The former may be due to the coating being applied to potentially moist wood while the latter was visibly sagging and holding water (Figure 74). Isolated cracks and minor splits were also observed in the siding (Figure 75).

Figure 74. Area of sagging paint holding water on the east facade.

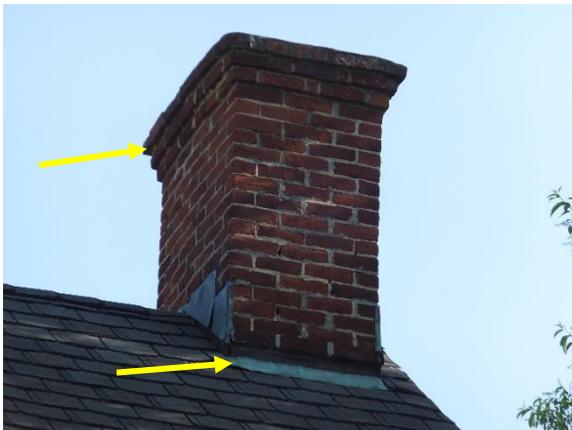
- The chimneys currently do not have any cap flashing. In addition, the flashing at the chimney base is not fully integrated into the roofing assembly (Figure 95). Deteriorated mortar joints were also observed at chimneys.

Figure 95. Chimney with no cap flashing and minimal integration of step flashing at roofing assembly.

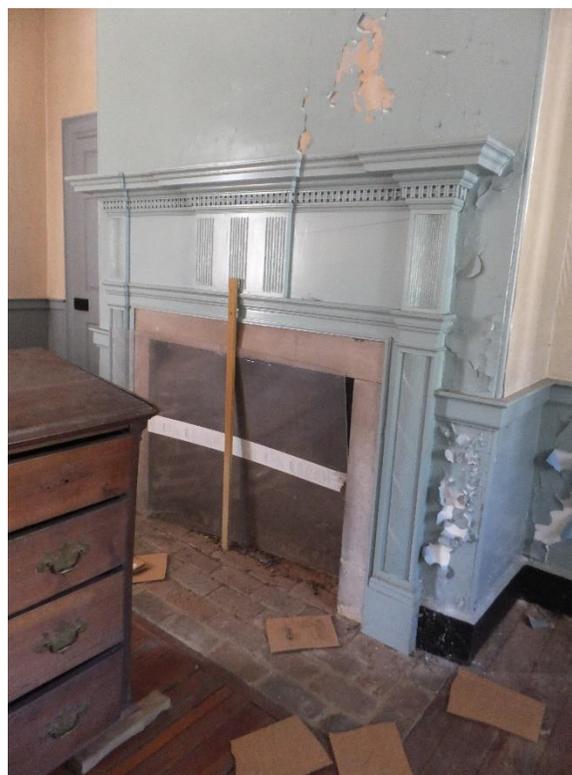
Figure 101. View of the fireplace mantel and surround in room 103 in 2017.

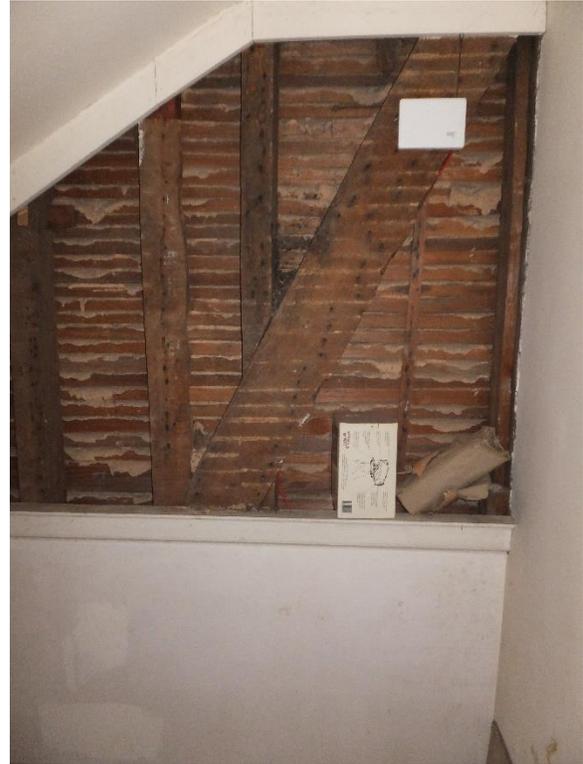
Figure 103. View of the only visible plaster and lathe wall below grand staircase looking west in 2017. Not the same location as the HABS photo.

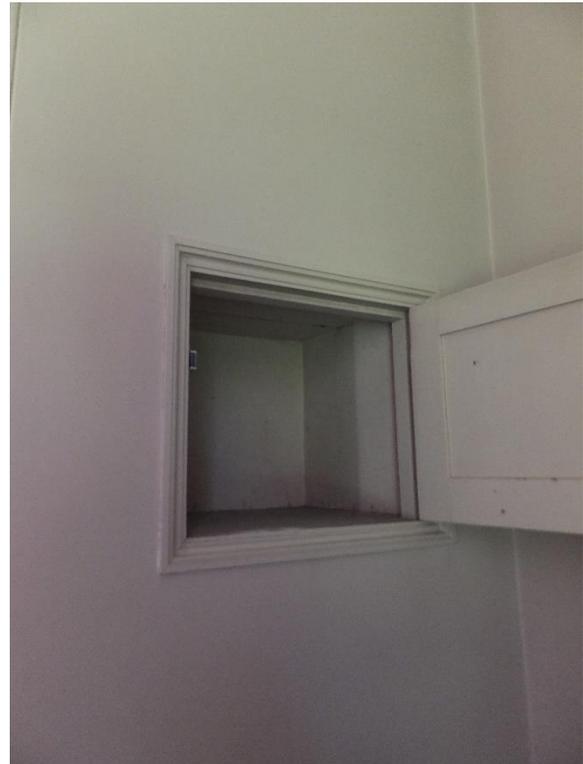
Figure 105. View of the warming cupboard at the south side of the fireplace in room 102 in 2017.

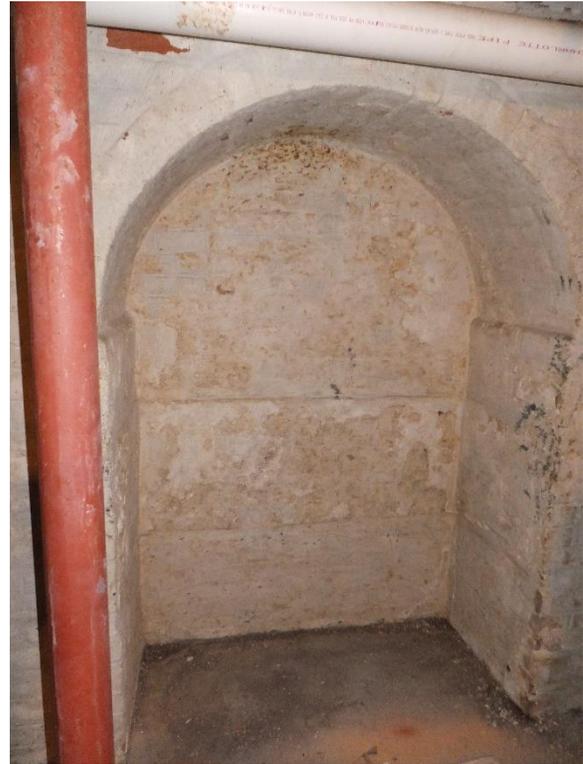
Figure 107. View of the brick masonry arch support for the east fireplace in 2017.

The main access to the basement is gained through the hallway (Room 101) through a door below the staircase. The door is a six-paneled tan painted door with horizontal rim lock and metal doorknob with barrel key still in place. As one opens the door, the backside of the plaster and lathe wall of the east wall of Room 103 is visible. The lathe measures 1-1/4 inches tall with varying space for plaster keys. The stud framing elements visible in this area are 3-1/2 inches deep and of varying widths between 3-1/8 inches to 7 inches. Stairs, that have been replaced recently, lead down to the basement area. Receivers in the masonry wall from the original stairs are still visible and measure 2-1/4 inches by 4-1/4 inches with ghosting from a removed vertical post centered at the stairs. The basement spans east and north with other areas below the first floor inaccessible, as they are unexcavated. Copper flashing has been added along all foundation walls. The brick foundation is approximately 8-1/4 inches thick (2 wythes) and is easily visible throughout the basement, covered with a white impermeable white coating, similar to the coating that has been applied to the brick kitchen structure (Figure 112). Evidence of a previous white coating, which contains calcium carbonate, possibly indicating a lime wash, is visible below areas of flaking impermeable coating. The floors in the basement are poured concrete with steel beams and lally columns (Figure 113). The steel retrofits include cylindrical columns supporting steel I-beams that are placed perpendicular under the wood floor beams. The wood floor beams are spaced 23 inches on center and notched to sit on a timber sill and brick foundation but are most often short of the brick, not allowing the beam to fully bear on the foundation wall as originally designed (Figure 114). There is a considerable amount of insulation packed between floor beams with numerous conduit, ductwork, and the like obscuring full view of the floor beams and underside of the first floor (Figure 115). Ventilation windows are visible at almost all foundation walls with some vertical posts remaining. The posts are diamond shaped measuring 2-1/4 inches wide and are spaced approximately 4 inches on center (Figure 116). Several posts have been removed to accommodate ductwork passing through the window. One can walk through a rough opening dividing this area to move into the east room of the basement. This area has an arched brick masonry support for the east fireplace and stairs leading to the exterior through a storm hatch (Figure 117).

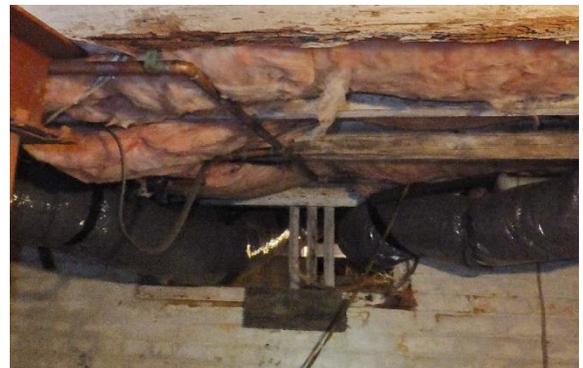
Figure 109. Ventilation window in the basement with view of floor beams and insulation above in 2017.

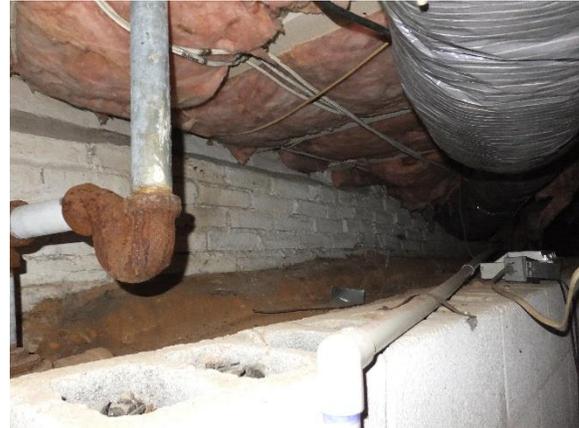
Figure 111. Retrofitted floor beams in the basement below the central section of the house in 2017.

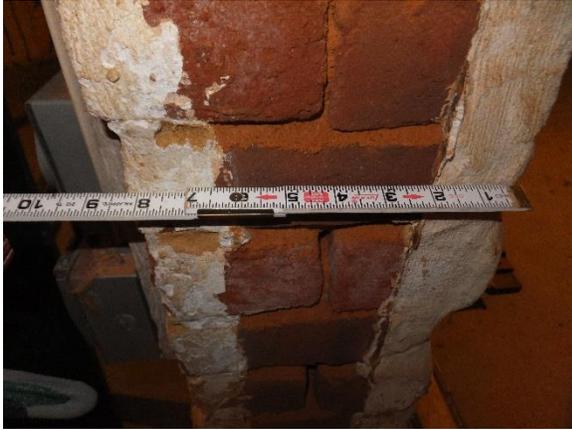
Figure 112. Multi wythe brick wall in the basement with two layers of white coating.

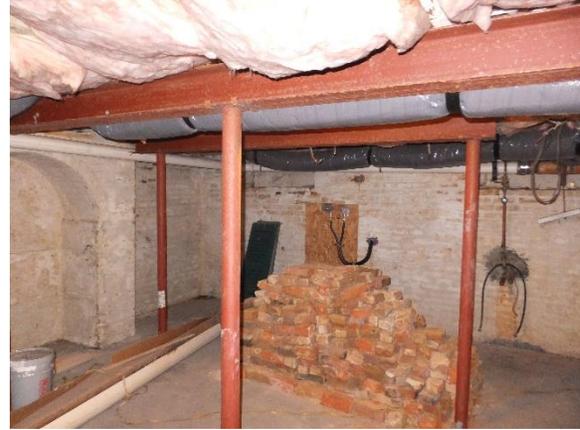
Figure 113. View into the east room of the basement showing poured concrete floors with retrofitted steel beams and lally columns. Brick in photo is from the floor of the meat house.

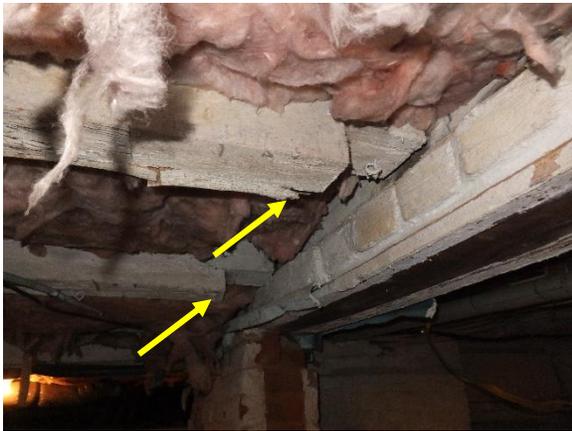
Figure 114. Original floor beams short of original bearing point.

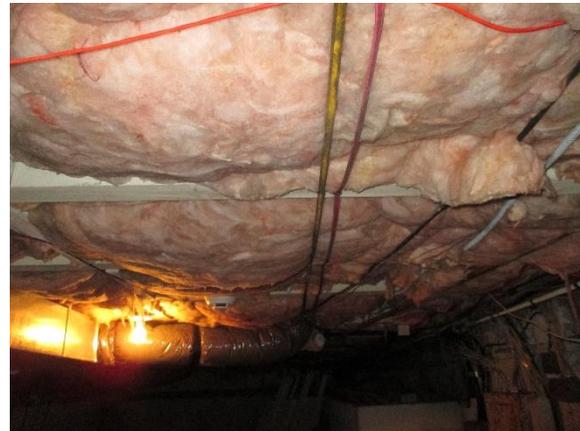
Figure 115. Insulation, wires, ductwork, and conduit obscure the visibility of floor beams in the basement.

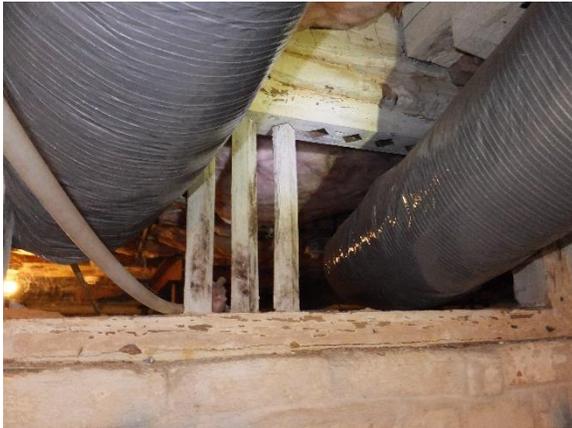
Figure 116. Original ventilation openings that are utilized for mechanical ductwork pathways.

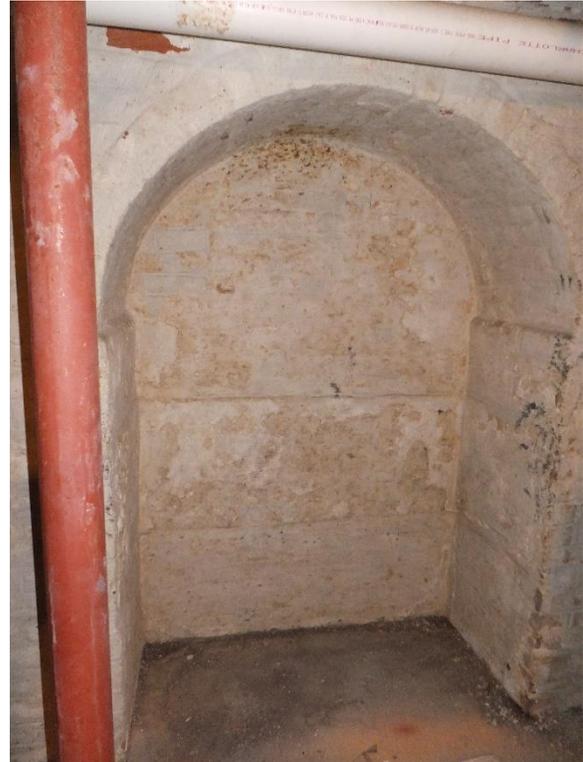
Figure 117. Arched brick masonry support for the east fireplace.

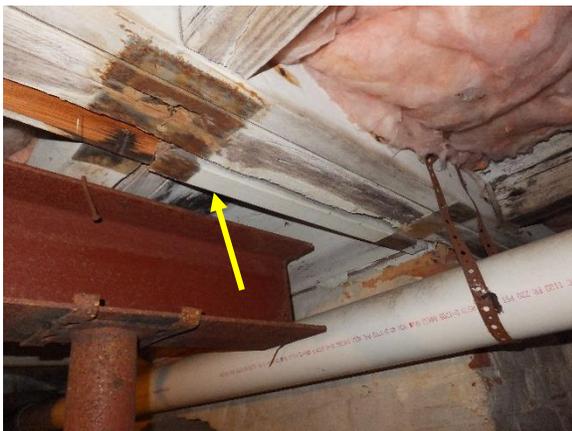
Figure 118. Ghosting of previous supporting columns.

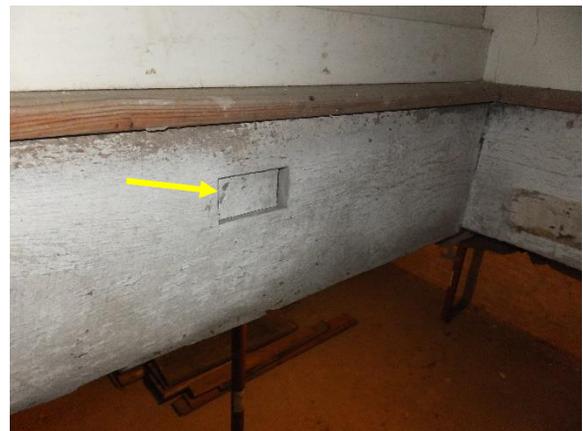
The floor beams below the main section of the house appear to be 3-5/8 inches wide and 12 inches tall, rough hewn and coated white with areas of retrofits, consisting of floor beam replacement and sistered machine cut members. Other columns or supports may have been located in the basement as there is evidence of ghosting from removed members (Figure 118). An example of the sizing and notching of the floor beams can be viewed at the stair well opening member that measures 10-1/2 inches tall and 3-1/2 inches wide (Figure 119). Partial timber sills were observed along the east and west walls of the main

Figure 119. Visible notching of floor beams in the stairwell leading to the basement. Note white coating visible on all structural wood members.

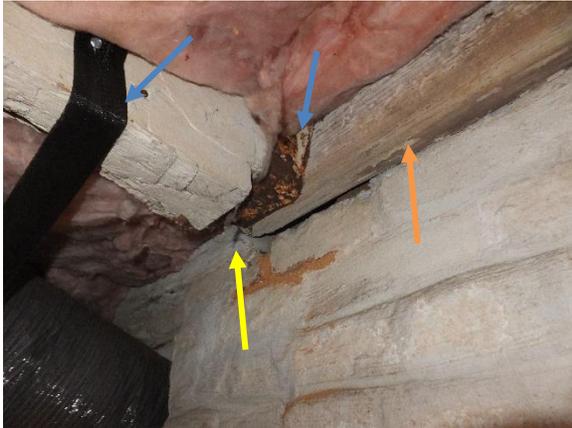
section of the house. The timber sills are no longer continuous and have been cut and partially replaced with machine cut sills (Figure 120).

Figure 120. Original timber sill (yellow arrow) cut short and retrofitted with machine cut sill (orange). Note retrofit strap at the floor beam and strap to mechanical duct (blue).

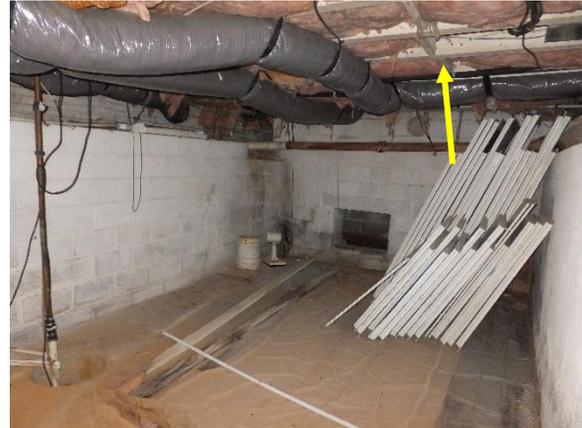
Figure 121. Overview of basement below central section of the home with mostly replaced machine cut floor beams. Note CMU bump-outs and fireplace support.

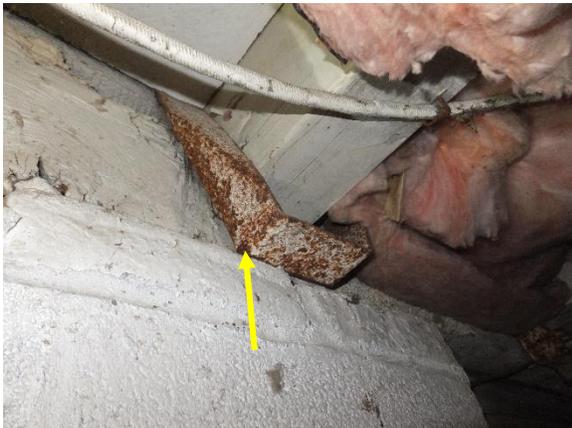
Figure 122. Example of retrofit strap from floor beam to timber sill at the west wall.

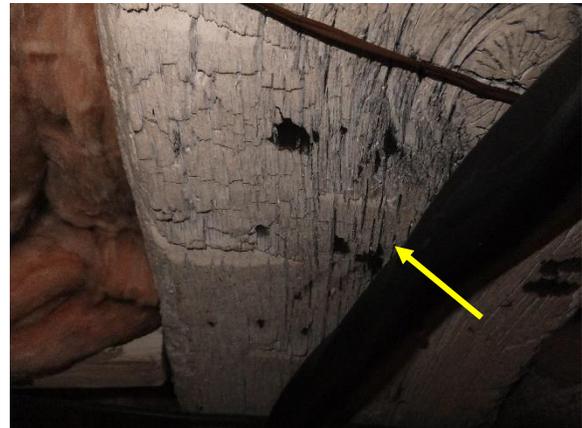
Figure 123. One original rough hewn floor beam remaining below the central section that is charred with a white coating.

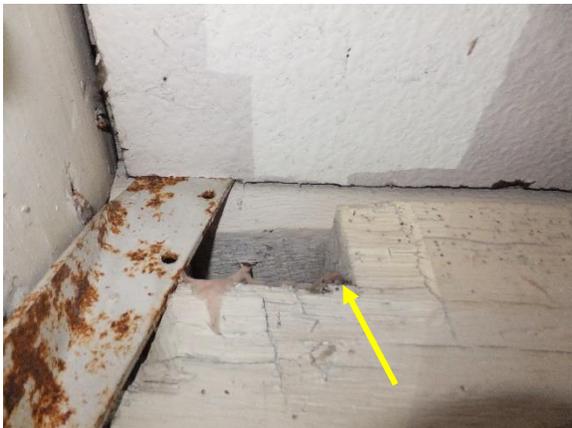
Figure 124. Original timber sill at the west wall with a bearing pocket cut for the floor beams

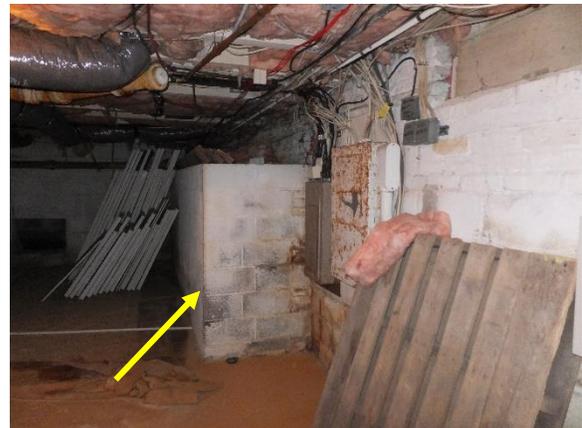
Figure 125. Partial CMU foundation and bump-out at the east wall below the central section of the home.

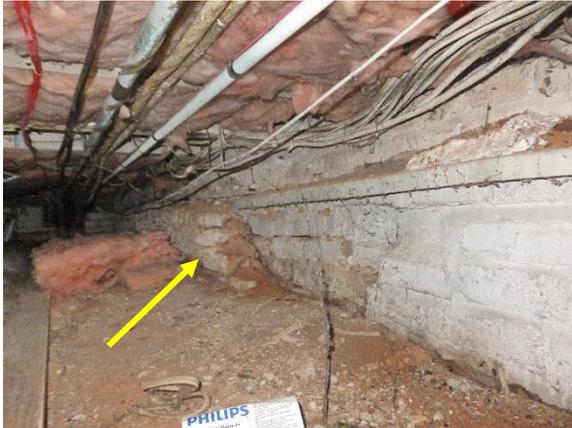
Figure 126. Partially demolished wythe of brick at the east wall.

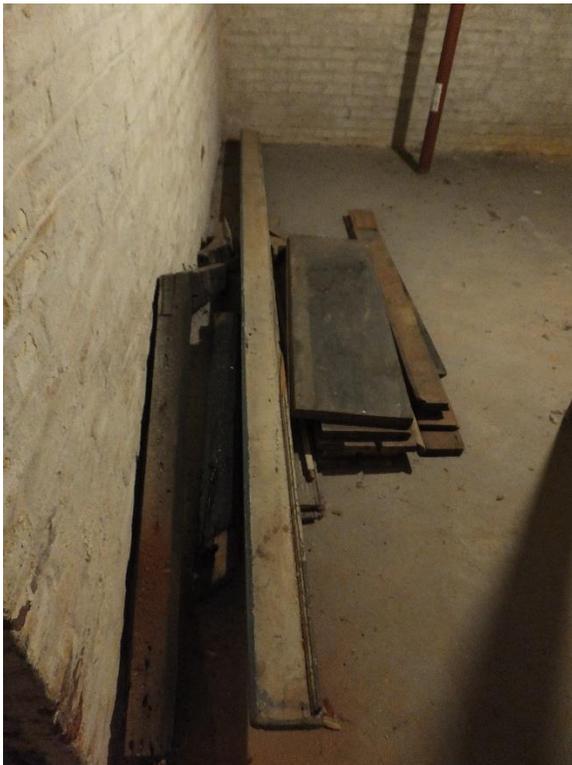
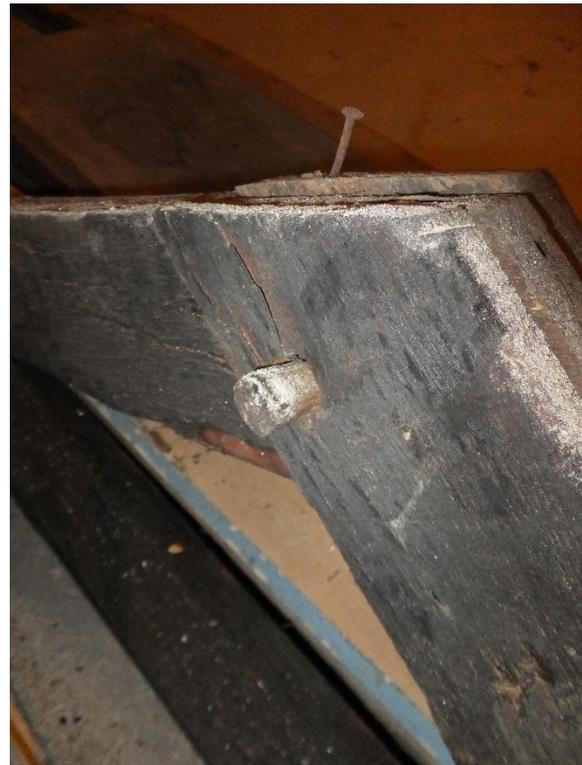
In the basement, several loose materials, original to the home, are stored on the floor. These materials were damaged and removed during the 1960 fire. Of those, a charred partial roof peak shows that the original roofing peak joint was a tongue and fork with single wood dowel design (Figure 128 and Figure 129).

Figure 128. Salvaged materials from the 1960 fire being stored in the basement.

Figure 129. Charred rafters provide a clue to the original tongue and fork with single wood dowel joinery.

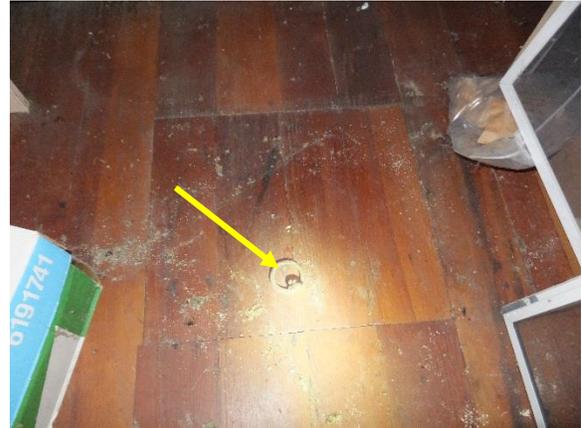
Figure 148. Removed lock mechanism at the closet door in room 102.

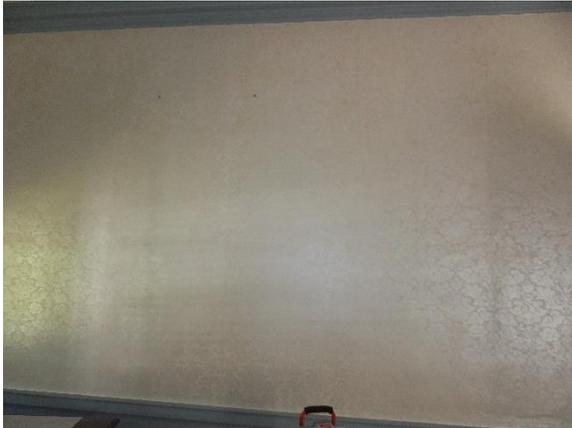
This room features wood floors of random width varying from approximately 3-3/4 to 5-1/2 inches wide that run east to west with evidence of burn marks. Indicating that it was likely salvaged and re-used after the fire (Figure 155). The room also features the same profiled chair rail, window/door trim, and baseboard as the hallway. This room is painted blue up to chair rail with 28-1/2 inch wide ivory damask wallpaper spanning from the chair rail to the plaster cornice. The plaster cornice appears to have the same profiling and general dimensions as represented in the HABS drawings. It was stated in the Works Progress Administration of Virginia Historical Narrative that one room in the house still maintained the original wallpaper. Given the potential extent of the fire in 1960 and the lack of evidence one would see with wallpaper ca. 1790, such as horizontal seams, hanging nails, manufacturer’s marks at the back, and/or typical width of 22 inches or 21 inches as become common widths during this time, the wallpaper does not appear to be original (Figure 156).¹⁶² In addition, one HABS photograph documents the fireplace mantel in this room with floral wallpaper of differing design than what currently exists. Impact to the existing wallpaper was minimized and inspection made only at a location of the paper that was already detached from the wall due to apparent water damage (Figure 157). At an adjacent location of deteriorated wall materials, the wallpaper and associated backing materials were pulled away from the wall to reveal a white gypsum material embedded with corroding metal lath approximately 4 inches tall, spanning above the chair rail along the false door’s south trim (Figure 158). A sandy plaster with course hairs was located above the gypsum and lath (Figure 159). It is likely that the sandy plaster is remnant from the original construction or last application of a plaster pre-1920s, and the gypsum was a later repair. Sandy plaster with a white, possibly gypsum-based, finish coat is also seen at areas of water infiltration where the wallpaper has peeled away from the wall (Figure 160). Walls along the fireplace appear to have wall sheeting, possibly drywall or similar, with the wallpaper applied over the sheeting, as isolated screws were observed penetrating the wallpaper and paint as well as sheeting becoming out of plane at areas of water infiltration (Figure 161).

Figure 155. Wood floors in room 103 with signs of smoke contact.

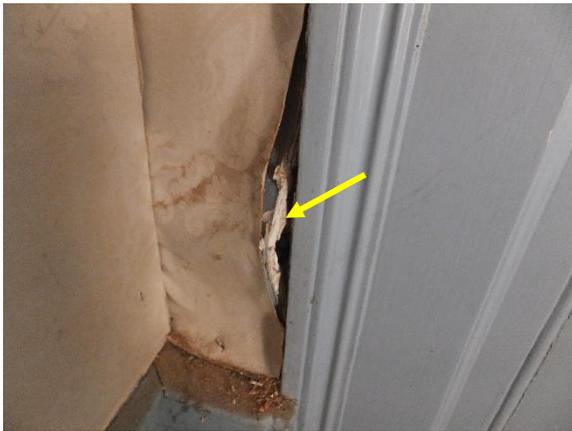
Figure 157. Backside of wallpaper where peeling from wall at the northwest corner of the room.

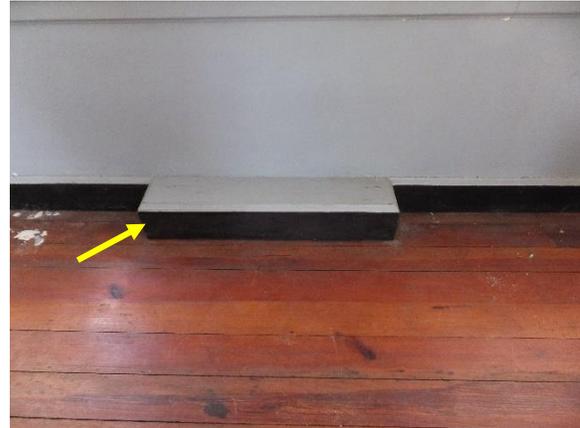
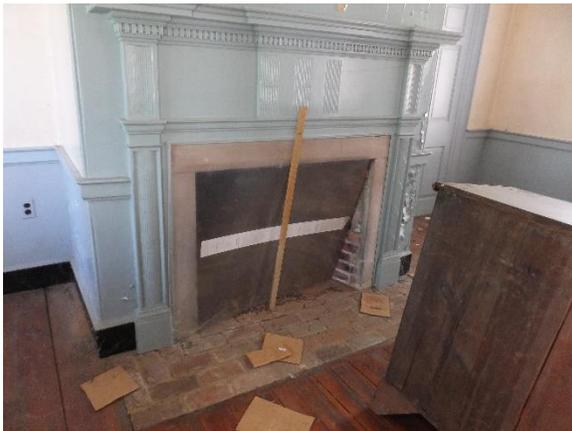
A previous light fixture appears to have been removed at the center of the white plaster ceiling, and the windows have wood blinds and black out shades installed. Two straps were observed penetrating through the north wall between the two windows but the purpose is not clear; however, a slight projection of the wall is located at the floor level below the straps that may have supported a related item (Figure 162 and Figure 163).

Figure 162. Straps penetrating through the north wall.

Figure 163. Projection in north wall at the floor directly below the straps.

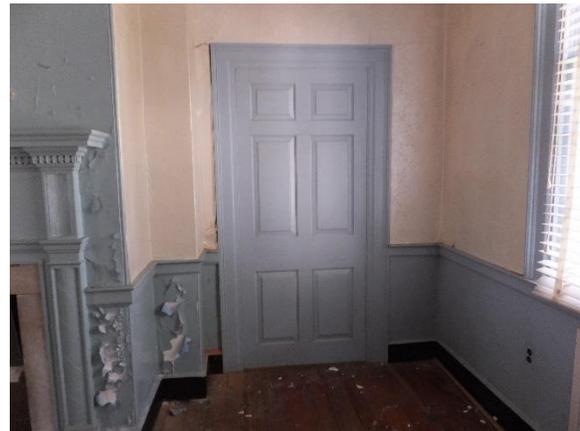
Centered at the west wall is a large fireplace with brick masonry hearth and smooth gray stone surround that is 5-1/2 inches tall at the top and 4 inches wide along the sides (Figure 164). A highly ornamental wood mantelpiece encompasses the stone surround with vertical ribbing wrapped with ribbons leading up to the Firenze of dentils, similar in profile to the exterior cornice, below the mantel. The ribbing above the surround is concave with three central segments of seven flutes at the Firenze. The walls above the mantel are painted the same blue as the rest of the room. The firebox is currently closed off with a piece of acrylic. This fireplace was photographed during the HABS documentation, which shows the fireplace surround unpainted, plaster below the chair rail removed exposing brick, and the area above the mantle having remnants of a floral stripe design, which is not what is currently in place.

Figure 164. Fireplace centered at the west wall.

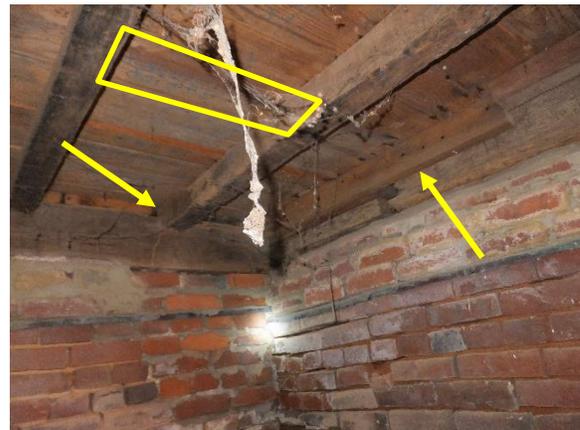
The underside of west closet wood floor was observed from the exterior foundation spall location at the south facade, west corner that revealed writing that says “Parlor” and “Parlor Closet” (Figure 166). This indicates that the floor was removed and reinstalled possibly during the restoration work. Numerous retrofits to the foundation were performed when the floor was removed, such as the installation of copper flashing and replacement/addition of wood members. Original floor beams in this location appear to be rough hewn, possibly through a local saw mill, and notched to meet the brick masonry foundation (Figure 167).

Figure 166. Underside of flooring of west closet viewed from the exterior brick spall area. Writing at the underside indicates “Parlor” and “Parlor Closet”.

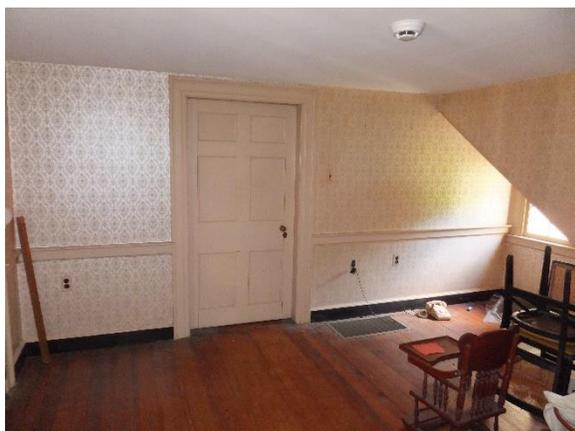
HABS Difference - There is a bump out on the north side of the fireplace that is not reflected on the HABS drawings (Figure 169). The baseboard in this room is the same dimension and profiling as room 102 and does not match what is represented in the HABS drawings.

Figure 169. North bumpout at fireplace not reflected on HABS drawings.

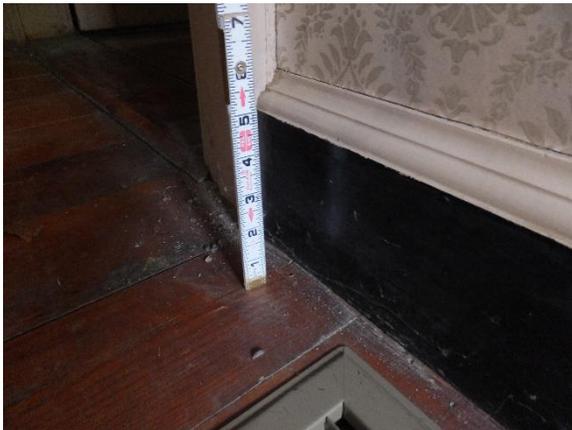
Figure 180. Baseboard height and profiling in room 104 differs than reflected in HABS drawings.

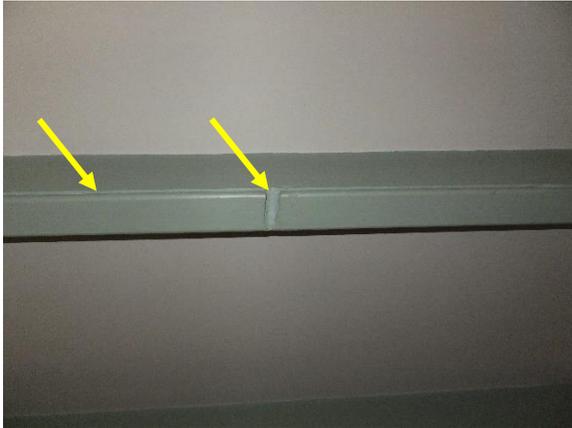
Figure 182. Joists running east to west with bead finish. Note loss of knot.

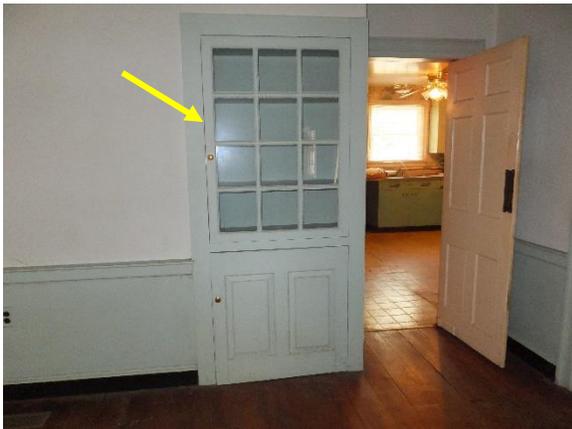
Figure 184. Built in cabinet at the north wall with swing door to the right leading to the kitchen.

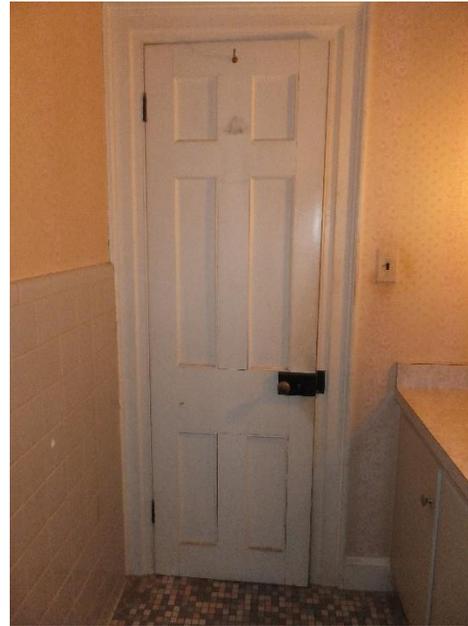
A bathroom has been constructed along the east wall and is accessible through a six-paneled door with horizontal rim lock, metal doorknob, and two 3-1/2 inch tall plain hinges. The floor appears to be un-level as the door is very difficult to open and close. The restroom is not shown on the HABS drawings with the location of the door previously occupied by an original window along the east wall and the space extending eastward towards the garage (Figure 187). The contemporary bathroom contains a built-in sink with a laminate countertop, toilet, linoleum floors, wall-mounted sconces above the vanity, blue tile from the floor to mid height on the walls, tan floral wallpaper to the white painted ceiling, and associated toilet accessories (Figure 188). A 6/6 wood window is located at the east wall, which currently looks into the stairwell of the garage.

Figure 188. View into contemporary bathroom added to room 105.

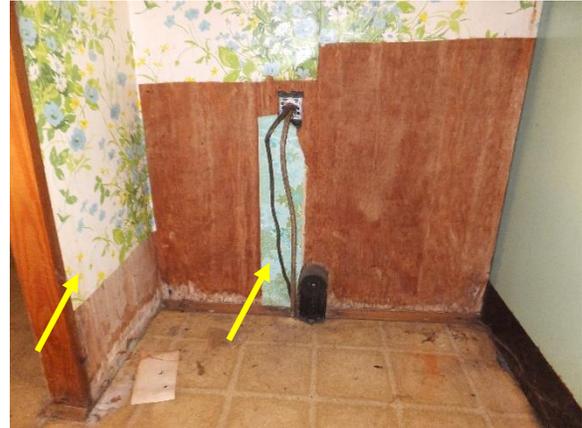
since been removed. The kitchen wall transitions to a floral wallpaper of at least two layers of similar blue flowers (Figure 195). Other kitchen amenities have been removed such as the dishwasher, stove, and a clothes washer and dryer. The washer and dryer appear to have been located along the south wall with large electrical outlets and water resistant wall and floor covering in the corner. A corner of this floor covering is missing, revealing a previous blue “terrazzo” linoleum floor tile. There are areas of 5-1/2 inch tall baseboard in the kitchen of similar profiling as the rest of the house. Two ceiling-mounted dome lights and one ceiling fan are located in the kitchen.

Figure 195. Two floral wallpaper styles observed.

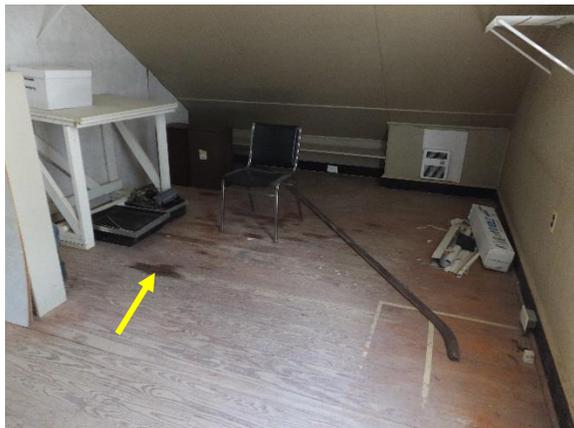
Figure 200. Ceiling of upper garage space follows roofline. Note area of stained wood floor.

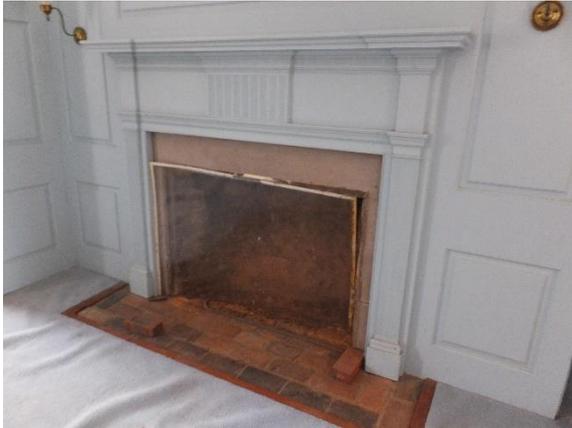
Figure 208. Ornamental fireplace centered at the east wall. Note carpet installed over wood flooring.

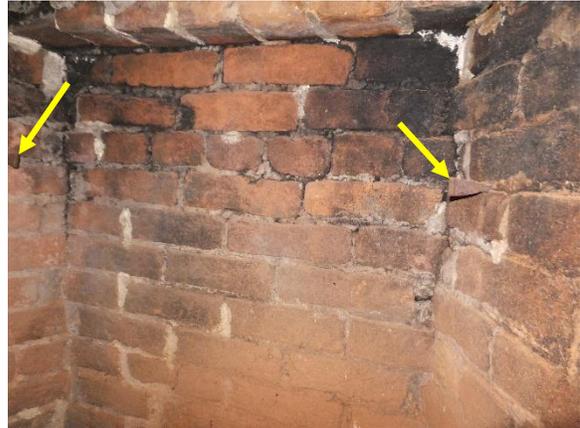
Figure 209. Iron stakes in the firebox embedded in mortar.

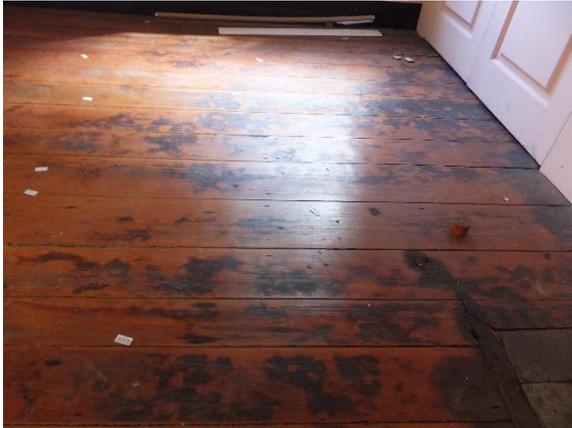
Figure 214. Charring of wood floor in room 203.

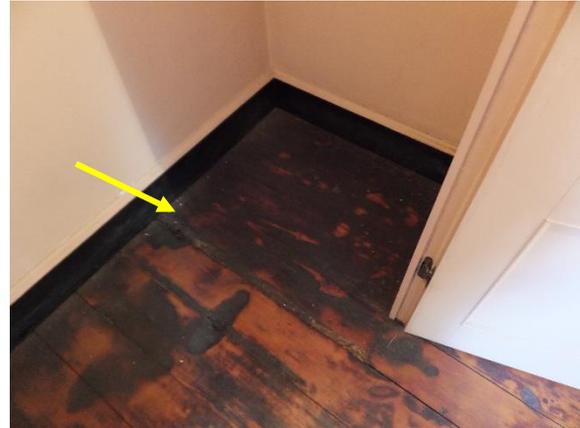
Figure 215. Significantly charred northwest corner of the closet.

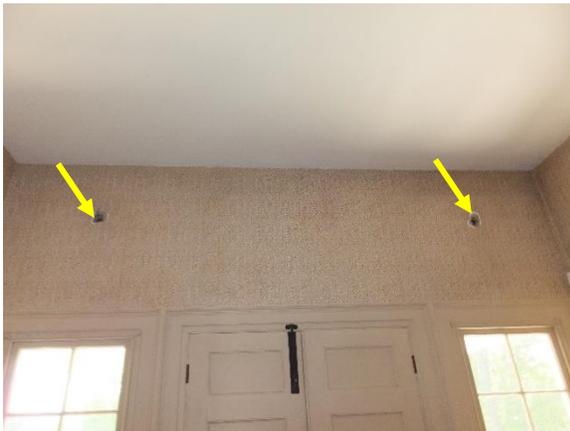
- The plaster and paint have minor deterioration throughout the house including flaking, staining, and hairline cracking as well as manmade holes and penetrations (Figure 247 and Figure 146). While these are primarily aesthetic, there is evidence of considerable water infiltration at the first floor ceilings, east and west walls and at and below most windows (Figure 249 and Figure 250). Some of the cracking associated with water infiltration also occurred with gypsum-salt crystallization (Figure 251). The siding on the house has been repaired and partially replaced recently, which may have stopped the water infiltration source to the ceiling and walls, as materials appeared dry while WJE was onsite. Other wall deterioration also occurred adjacent to exterior mechanical units, which may be due to increasing moisture exposure to the wall surface (Figure 252 and Figure 253). The replacement of the siding may have also stopped the bulk of the water source below the windows, but there were several windows observed to not be fully sitting in the glazing pocket (refer to exterior condition assessment) that still allow the potential for water infiltration. Other cracking observed was associated with change of plane such as at sloped ceilings-to-chimneys (Figure 254 and Figure 255).

Figure 247. Holes in wallpaper and plaster ceiling above the main entry doors.

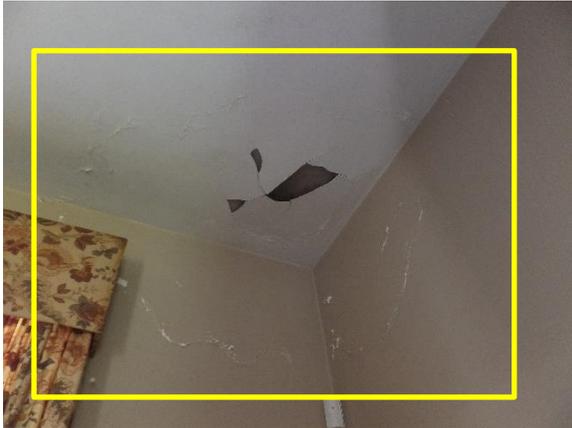
Figure 249. Typical plaster damage at the first floor.

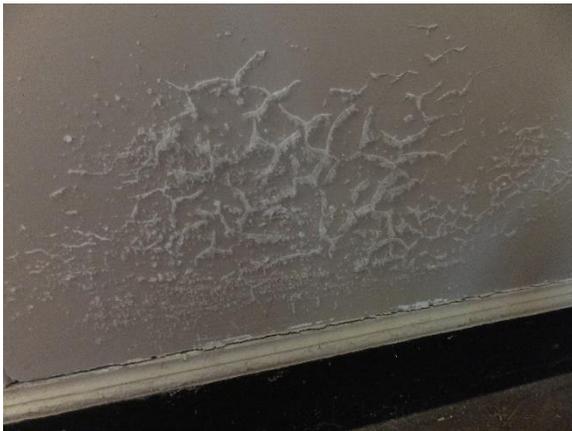
Figure 251. Gypsum salt crystallization of plaster.

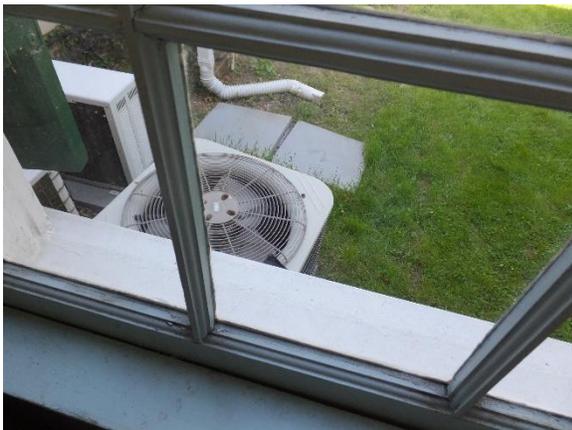
Figure 253. Mechanical units closely located to room 105.

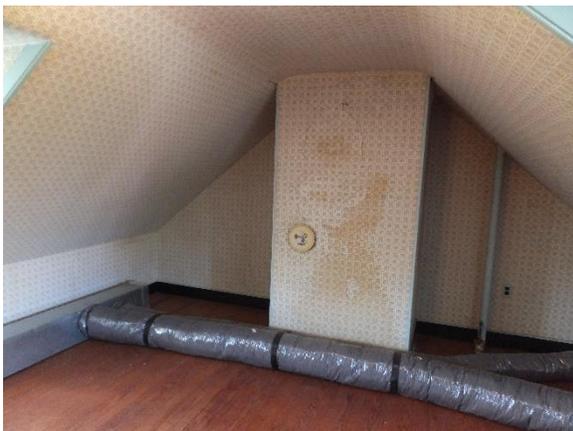
- The wallpaper throughout the home has consistent staining along the seams (Figure 256). The wallpaper in room 103 has unusual speckled staining, which may be associated with moisture drive through the wall with a reaction of the wallpaper glue. The wallpaper at the third floor rooms show water staining along the ceiling, chimney, and walls (Figure 257). As the roofing materials have been recently replaced with asphalt shingles, the source of the water infiltration may have stopped, as materials appeared dry while WJE was onsite.

Figure 257. Typical water staining at the wallpaper at the third floor.

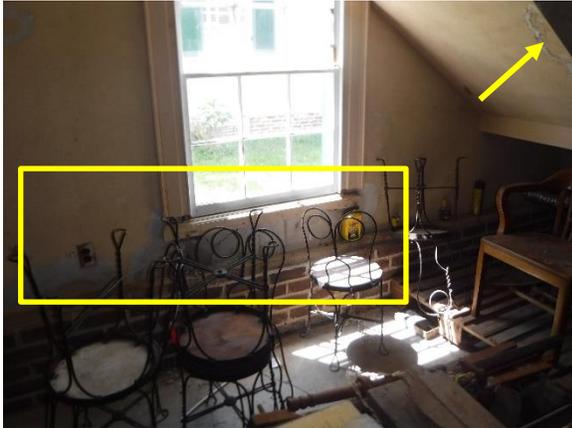
- The stucco in the garage has areas of cracking, water damage, and spalls throughout the space (Figure 259). All of the wall paneling at the garage upper space walls are bowed and warped (Figure 260).

Figure 259. Area of damaged stucco below the window and at the stairs.

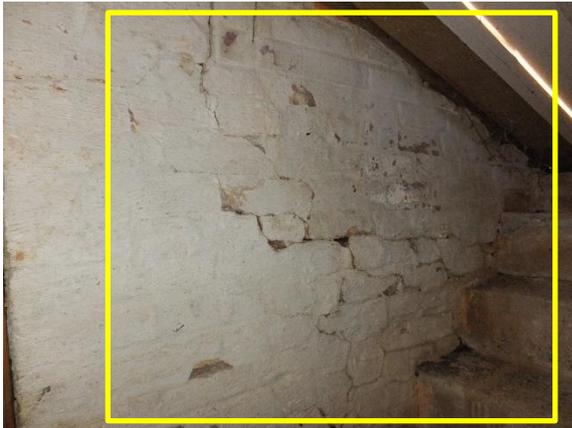
- Cracking in the brick foundation walls was visible in areas where the coating is not intact, as well as at walls leading along the concrete stairs to the storm hatches where a crack in the brick is emanating through the coating. In the hatch stair areas, the wall is bowed out of plane (Figure 263).

Figure 263. Cracking along the stairs leading to storm hatch.

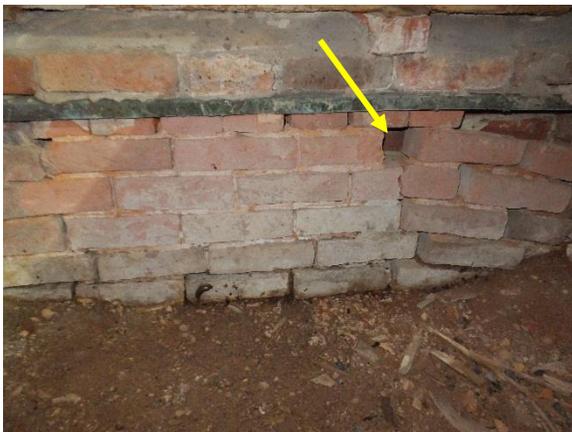
- At the wine storage hatch in room 102, the brick foundation was observed with areas of spalled, loose, and sagging brick (Figure 265 and Figure 266).

Figure 265. Loose and sagging brick at the foundation under room 102's closet.

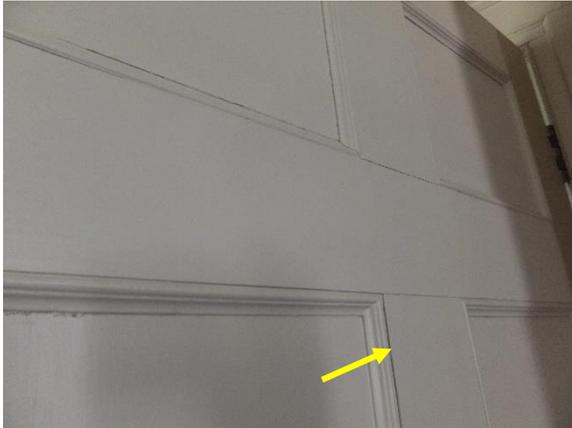
- Slight separation of joinery was observed on doors throughout the home (Figure 267). The built-in cabinet located at the north wall of room 105 has superficial staining at the shelves.
- One of the doors to the closet of room 202 has been removed from the hinges.

Figure 267. Typical separation of door joinery.

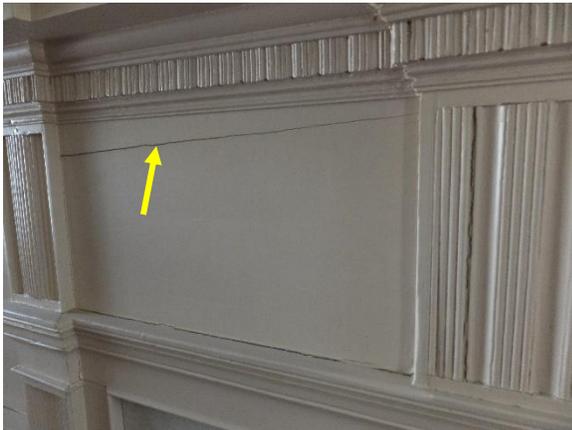
Figure 269. Typical cracking in fireplace ornamentation.

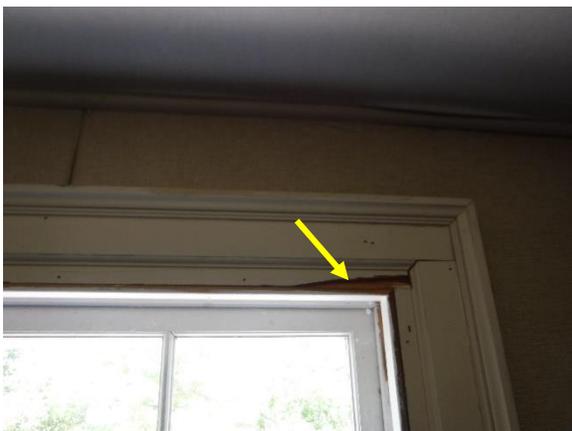
Figure 271. Cracked window trim.

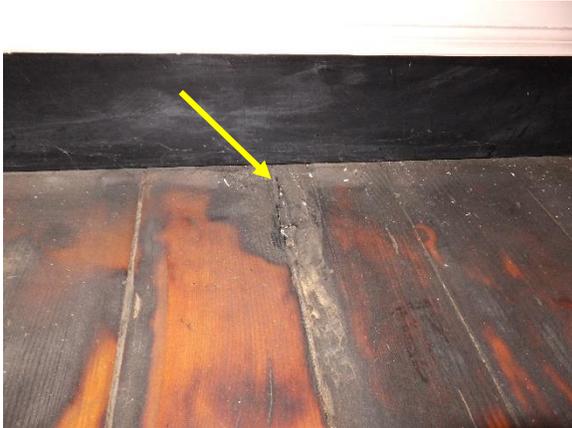
Figure 273. Significant charring of wood floor in room 203.

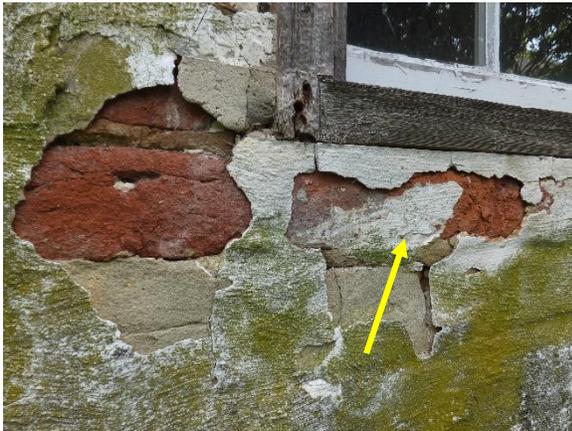
Figure 279. Flaked impermeable coating reveals what appears to be a lime wash.

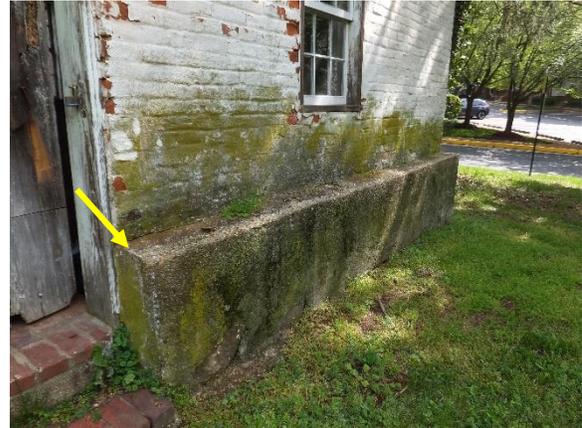
Figure 282. Concrete "buttress".

- The concrete “buttress” is heavily stained from moisture and organic growth.
- The “buttress” has isolated areas of deterioration with cracks, area of delamination, and a spall (Figure 298 and Figure 299).
