ASH GROVE Historic Structure Report

Vienna, Virginia

Final Report

December 04, 2017

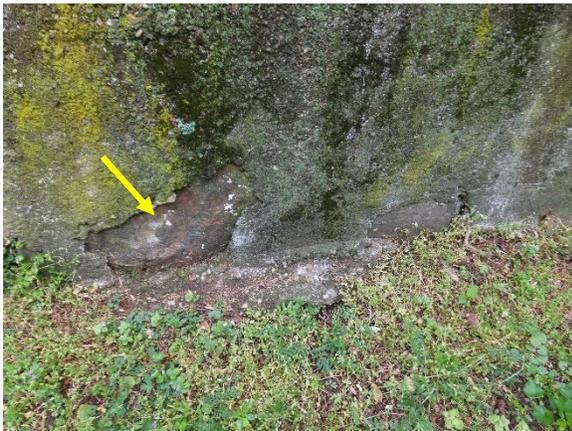
Walls of the kitchen structure are constructed of multi-wythe brick approximately 8-3/4 inches thick, set in a common bond pattern. A white coating has been applied to the exterior and interior of the brick, which has a rough brush texture. At areas of deteriorated coating, a previous white coating was also observed, which appears to contain calcium carbonate (Figure 279). One of the uppermost courses of brick is set at angles to create a dog-toothed cornice just below the eaves (Figure 280). Star anchor plates and associated tie rods are located midspan on the north and south walls and align with floor joists for the second floor (Figure 281). A concrete “buttress” as described by the HABS drawings, encapsulates the exterior first several feet of the exterior wall at grade (Figure 282). It was reported by Fairfax County Park Authority in 2016 that the heavy aggregate parge at the stone foundation had recently been repaired. WJE was able to observe stone in the “buttress” at the south, but was unable to observe stone at one spall location at the northwest corner, which revealed only the larger aggregate in the parge coat (Figure 283 and Figure 284).

Figure 283. Stone visible in an area of delaminated parge coating.

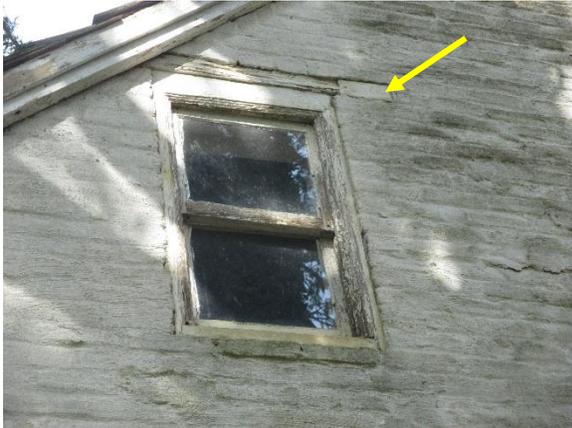
Figure 291. 1/1 wood window at the second floor east facade. Note previous dutchman at lintel.

- Windows typically have flaked coating and deteriorated or missing glazing putty, which allows the wood to become exposed to the elements (Figure 306). The lintels, lower jambs, and sills are particularly exposed and appear to be deteriorated with rot and likely loss of cellulose and lignin in the wood’s inner structure. (Figure 307). A partial wood dutchman was observed at the lintel of the east window (Figure 308).

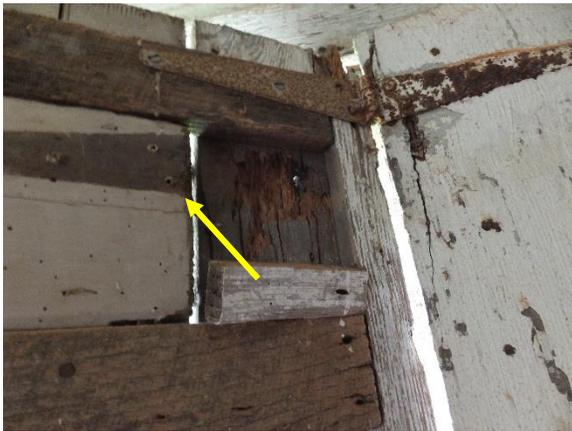
Figure 297. Ghosting of previous straps at batten that has been cut short.

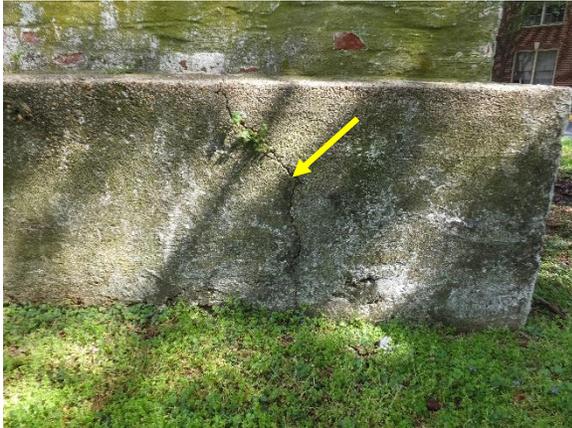
- The concrete “buttress” is heavily stained from moisture and organic growth.
- The “buttress” has isolated areas of deterioration with cracks, area of delamination, and a spall (Figure 298 and Figure 299).

Figure 298. Vertical crack in “buttress”.

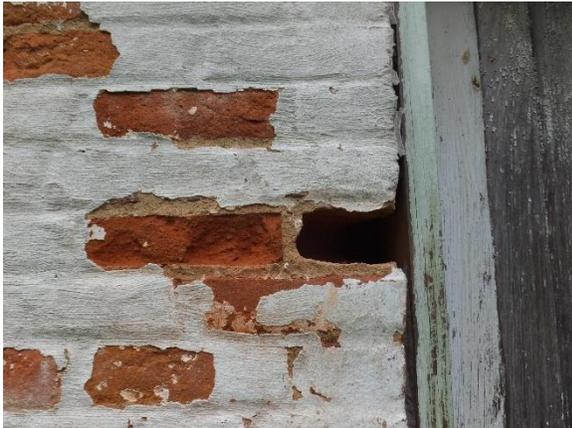
- There are numerous brick face spalls and deterioration throughout the facades. It appears that the existing coating applied is impermeable, which does not allow moisture that may be behind the coating to dry. The vapor drive has subsequently created delamination of the coating with associated brick and mortar deterioration. In masonry construction, the mortar should be designed to be softer than the brick such that it can accommodate expansion and contraction. Deteriorated areas of the coating, spalls in the brick, and deteriorated mortar joints are typically related throughout the structure (Figure 302 and Figure 303).

Figure 302. Flaked impermeable coating with related brick face spalls and missing brick.

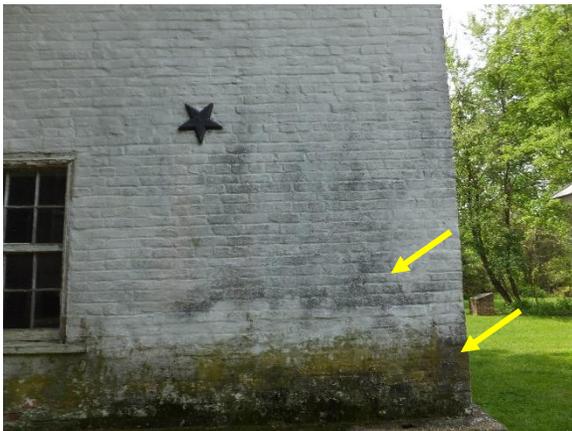
- There are areas of dark staining along the facade (Figure 304).

Figure 304. Biological growth staining throughout the facades.

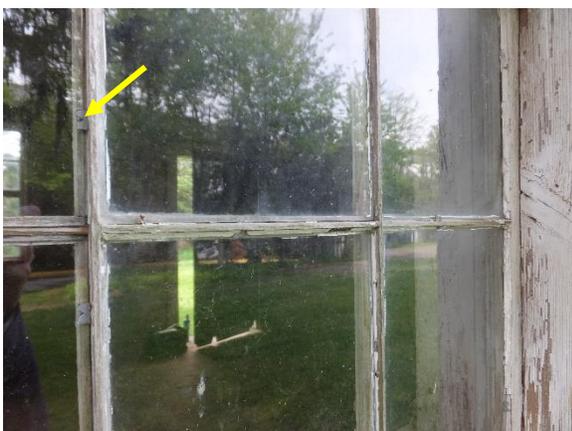
Figure 306. Complete loss of glazing putty with glazing points exposed at the north window.

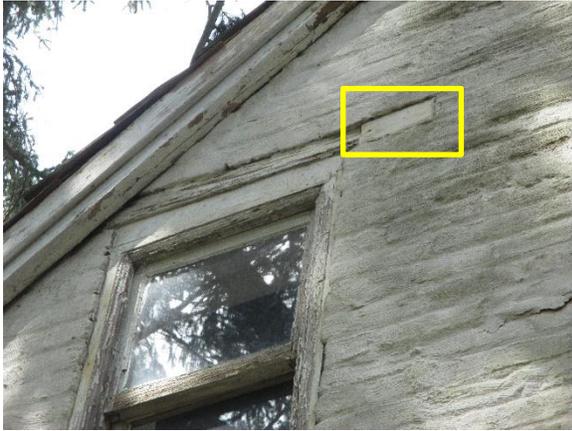
Figure 308. Partial wood dutchman at the east facade window lintel.

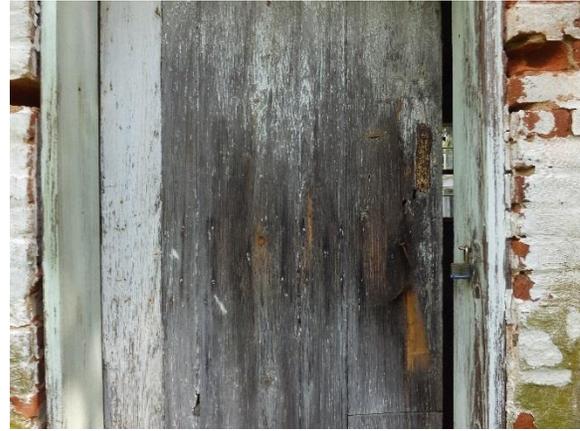
- The entry door coating has mostly faded, exposing the wood and lintel. The wood is partially missing along the bottom of the door with soft wood along this area and at the lower jambs. The wrought iron hardware appears to have been previously coated, which is mostly flaked with signs of corrosion of the metal (Figure 309).

Figure 309. Exposed wood and wrought iron hardware at the board and batten door.

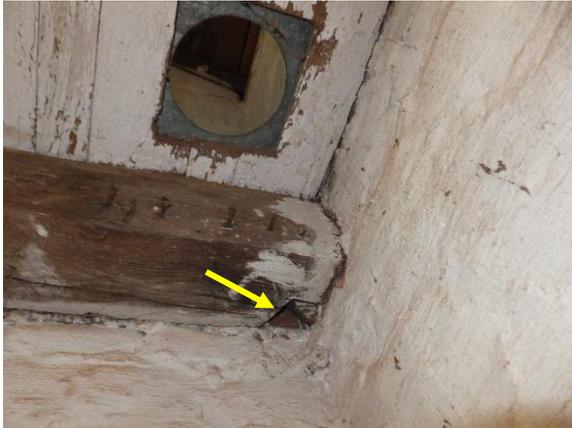
Figure 317. Triangular cut in beam #8 at west wall.

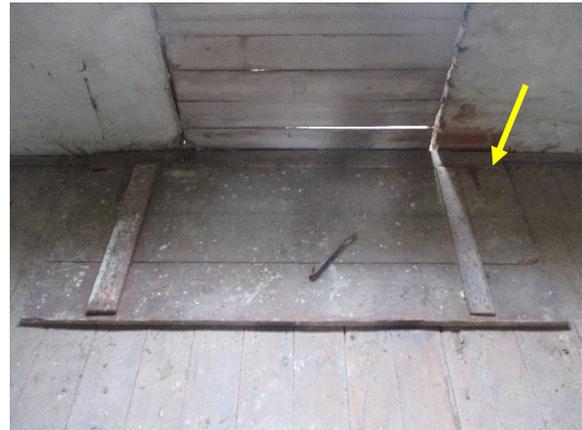
A board and batten hatch at the stairs divides the first floor from the second floor loft (Figure 320). The second floor is open with tongue and groove wood floors of varying width between 4-1/2 inches and 6-1/2 inches running east-west with a brick firebox and wood mantel located at the east wall. At the center of the floor, a 10 foot by 5 foot section of the flooring members are more narrow with 2-1/2 inch wide members to the south and 6-1/2 inch members to the north (Figure 321). The 10 inch tall and 11 inch wide white painted wood mantel spans the width of the chimney and does not appear to be original, with the ornamentation below the shelf constructed of three strips of cyma recta profiled pieces built on top of one another and fastened by small nails to create depth and support for the shelf (Figure 322). The firebox opening measures approximately 23 inches wide, 25 inches tall, and 18 inches deep. The firebox opening is supported by a jack arch (Figure 323).

Figure 320. Board and batten hatch between the first and second floors.

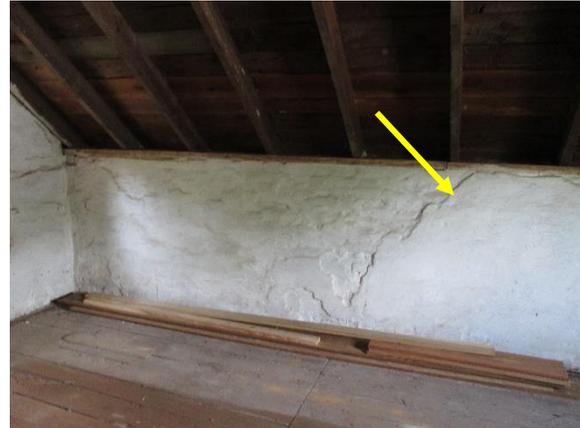
Windows are located at the east and west gable ends providing the only light into the space. The brick walls are approximately 4 feet tall with the same white coating observed at the exterior with the exception of an application of a thicker material on portions of brick, which appears to be a parge coat (Figure 324). The parge coat is behind the existing coating, which inhibits further understanding of the product and application; however, it appears that the parge covered all brick at this level, but had delaminated from brick in several areas. The most recent coating was then applied over exposed brick and whatever remained of this parge.

Figure 324. Partial parge coating observed at the second floor.

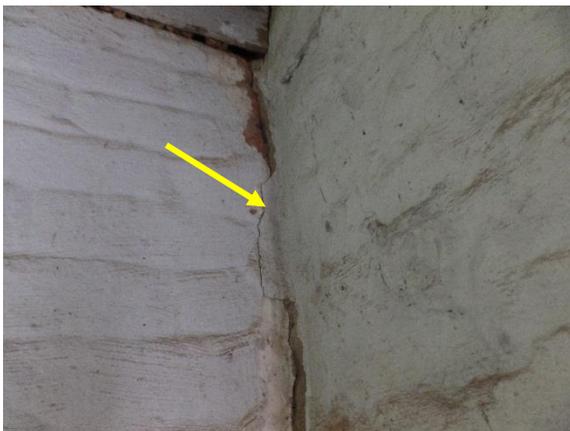
- The white coating on the brick is flaking with related brick spalls similar to what was observed at the exterior. Additional cracks in the masonry were observed at the corner of the masonry oven and south wall at the first floor, at beam connections, and in the field of the wall (Figure 326 and Figure 327). The latter is primarily located at the west wall where the exterior cracking is through all wythes and is visible at the interior (Figure 328 and Figure 329). Cracking is also visible at the second floor primarily at the south wall where the parge coating is in place (Figure 330). The extent of crack to the brick cannot be fully observed with the parge in place.

Figure 326. Vertical cracking at wall to chimney interface.

- Monitor existing cracks to determine if the building is still moving by placing a crack gauge at the major cracks at the east and west ends of the structure, and engage a structural engineer to evaluate the structure.

- Perform crack monitoring, removal of the interior coating, and subsequent brick repairs in coordination with the exterior brick repair work.
- Replace spalled brick and reinstall mortar joints where needed.

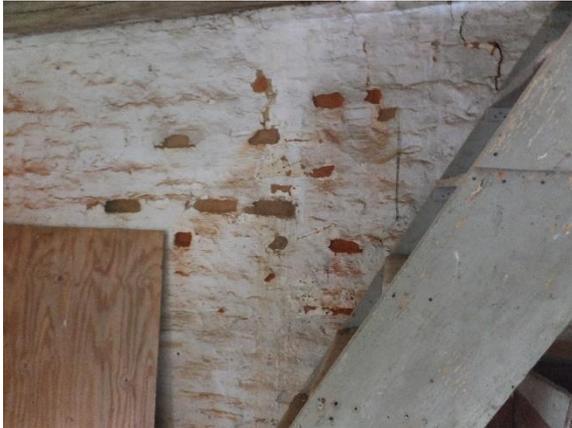
Figure 328. Flaked coating with cracked and spalled brick at the west wall.

- Perform trial repairs to gently remove the impermeable coating at the interior and exterior of the structure. The coating is not allowing the brick to breathe, which leads to the spalling and loss of the brick. Care should be taken to remove the coating without further impacting the brick. Once the coating has been removed, evaluate the exposed brick condition. The walls will require selective repointing with a natural cement mortar where needed and brick replacement at units that have significant spalling or are cracking. The replacement materials should be sensitive to the fact that the mortar should be softer than the brick. The existing brick may have lost strength with the impermeable coating in place.

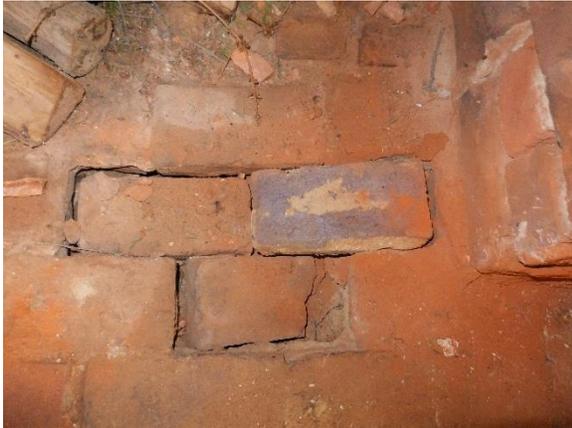
- There is an area of three loose brick at the lower level floor, rather the hearth, adjacent to the fireplace. The bricks were removed by hand, revealing loose dirt and rubble below the floor (Figure 332 and Figure 333).
- The wood floor at the second floor appeared to be wet. Moisture readings were taken and resulted in relatively high levels. The rafters above were also tested, which resulted in high levels. This indicates that the roof is leaking and may not have adequate flashing at the ridge and/or proper protection at the wood shingles as they are uncoated.

Figure 332. Loose brick in the floor adjacent to firebox.

- Remove loose brick and install additional fill material as needed to ensure proper support for the floor area. Prepare brick by removing any attached old mortar and reinstall in floor.

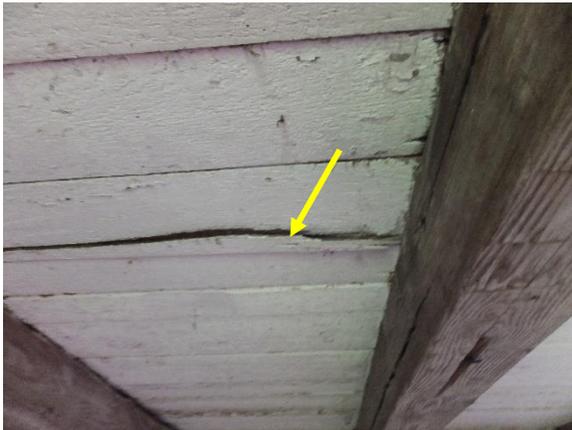
- The underside of the second floor was observed to have splintering between beams #6 and #7 (Figure 334).
- Rafters at the east and west are not fully bearing on the nailer plate. There does not appear to be related stress to rafters; however, this may be indicative of how the building's roof is performing in relation to wind uplift or potentially related to the settling of the building, which may explain the cracking that has occurred at the east and west walls (Figure 335).

Figure 334. Splintered wood at the underside of the second floor.

- Repair the splintering at the underside of the floor.
- Engage in structural engineer to evaluate rafters in coordination with cracking at the east and west walls.
