Ellmore Farmhouse Historic Structure Report

Prepared by:
Shaffer, Wilson, Sarver & Gray, PC

Prepared for:
Fairfax County Park Authority

May 12, 2011 - Final

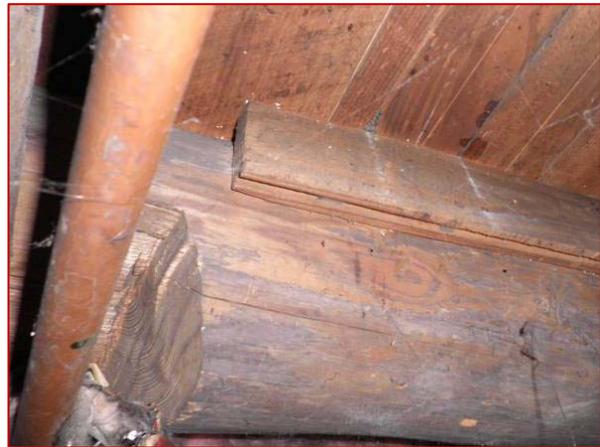
Two features are especially noteworthy. While it has not been proven, it is possible that Mary Ellmore constructed the house using yellow pine lumber sawn at the nearby saw mill of her brother-in-law, M. A. Hutchison. Round logs that were sawn flat at the top and hewn at the joinery connections remain as original first-floor rafters.

Image 3.2: Yellow Pine Log First-Floor Joists

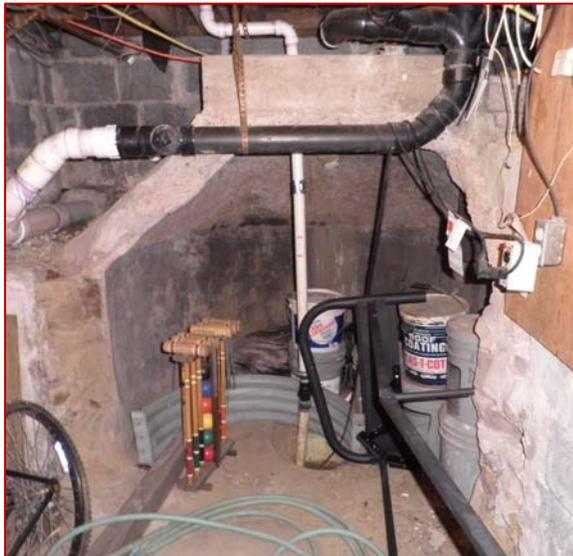
Secondly, the Ellmore farmhouse had an early septic system. The septic tank, which would have been out in the yard originally, is exposed in the cellar under an addition. It was constructed of stone and concrete.

Image 3.3: Original Septic Tank

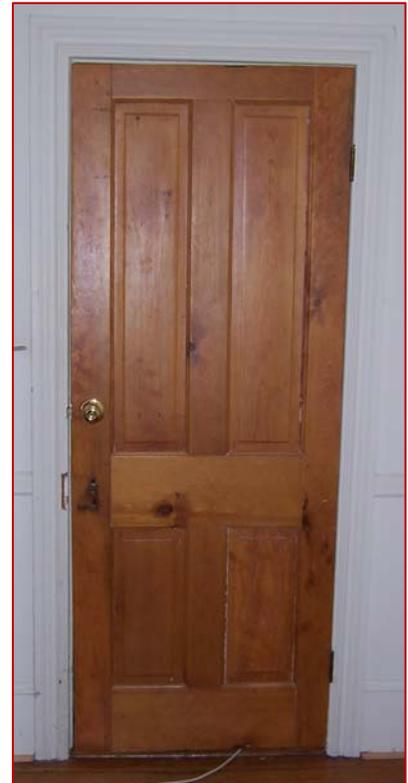
Image 3.4: Original Door D103, Similar to Other Original Doors

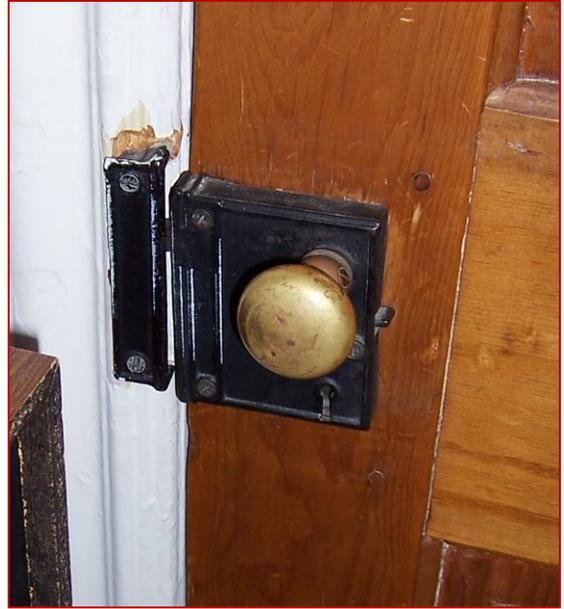
Image 3.5: Original Upright Rim Lock on Door D103 at Bedroom 102

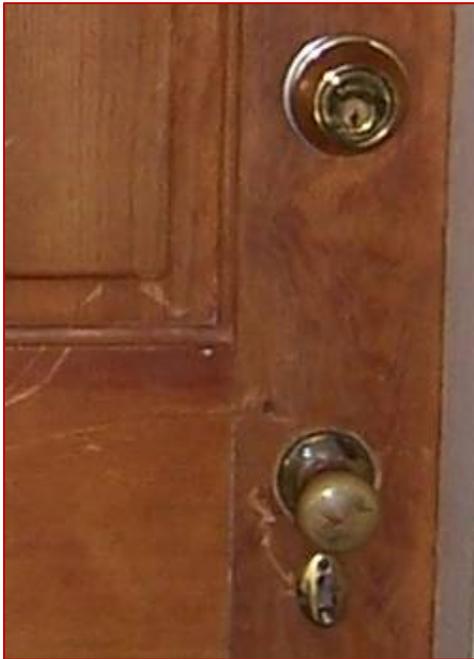
Image 3.6: Door Hardware on Door D103 at Bedroom 102

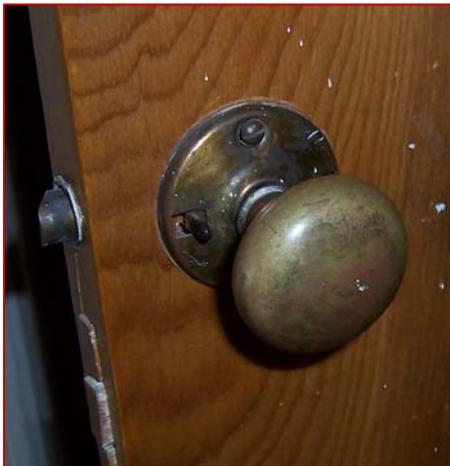
Image 3.7: Brass Knob on Closet Door D206, Bedroom Side

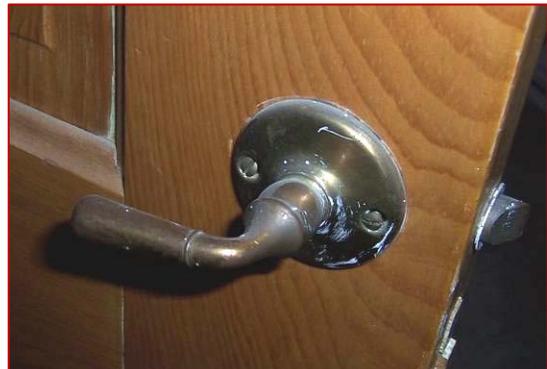
Image 3.8: Brass Lever Handle on Closet Door D206, Closet Side

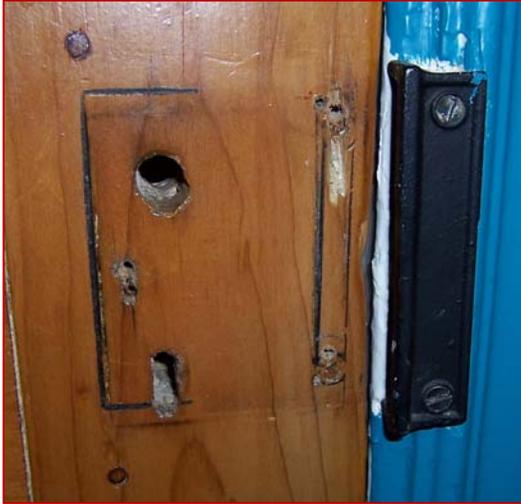
Some of the original door hardware remains on the door in Bedroom 203 (D207). This door now serves as a closet door but was originally the bedroom door to the hall. The hall was later enclosed to create the closet. This explains why this door had an upright rim lock rather than a brass knob/brass lever handle similar to what exists on the closet door in Bedroom 202.

Image 3.9: Upright Rim Lock Keeper on Door D207 in Bedroom 203

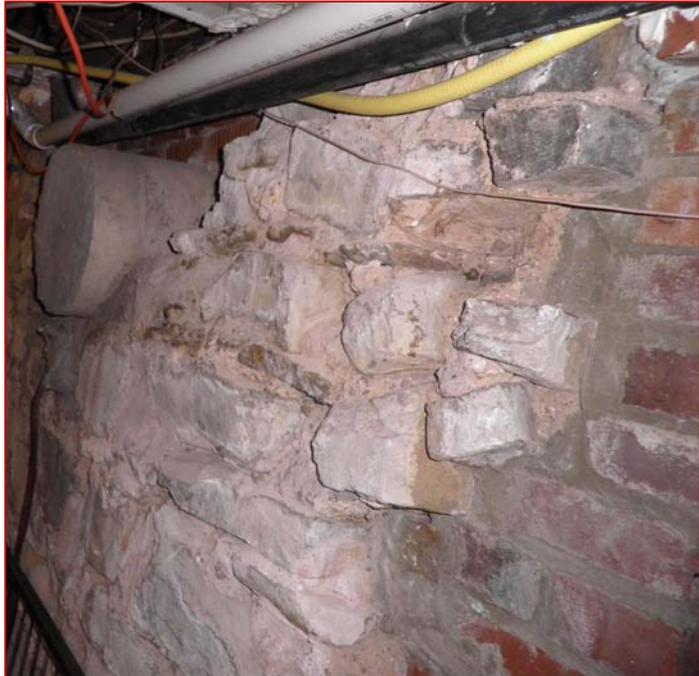
Image 3.18: Original Foundation Cellar Wall That Has Been Modified

The first major addition has basement retaining walls made of the concrete masonry units. Corner repair of the original rubble stone basement walls was achieved using brick masonry. When the earth was excavated away from the original cellar wall to expand the cellar, cement-based mortar was used to patch between the uneven and projecting stones that were thereby exposed.

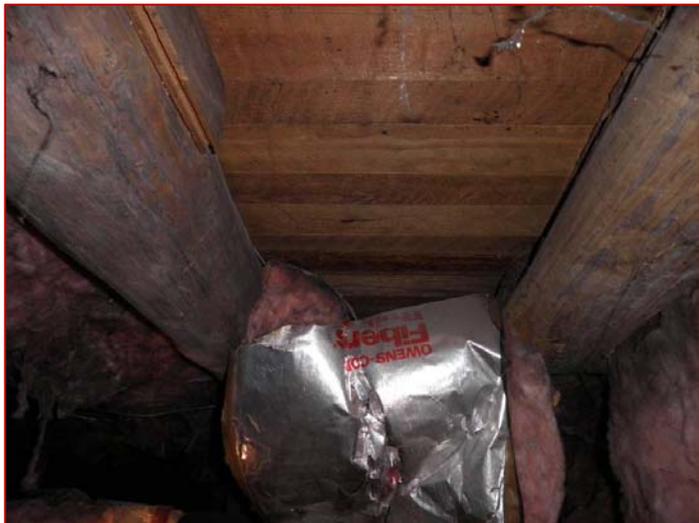
The first-floor framing in the front portion of the original house is made of +/- 6” diameter wood timber log joists supported on fieldstone rubble foundation walls and a ladder-type, wood truss-shaped intermediate supports.

The round log timbers, spaced approximately two feet on center, are supported on the front and rear foundation walls. Intermediate supports are constructed of +/- 7”x7” wood lumber running perpendicular to floor joists, and connected together in a ladder truss shape using varying dimensions (4”x4” to 6”x6”) of wood blockings spaced from 2 to 4 feet apart. The intermediate ladder truss is supported on masonry stone piers.

Image 3.21: Log Joists in Original Portion of House

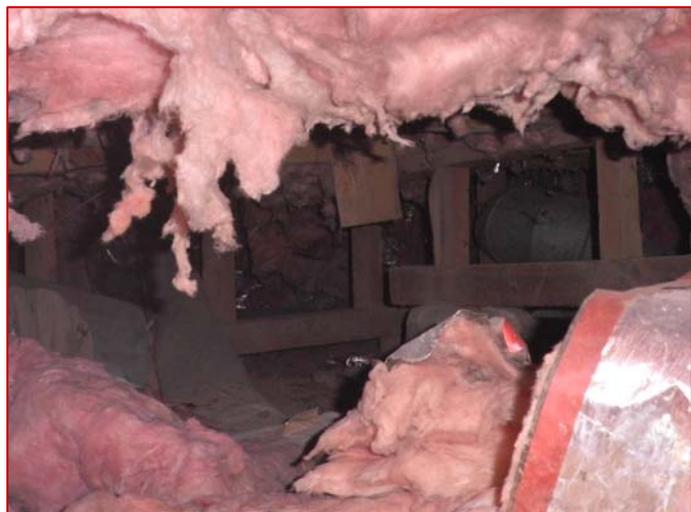
Image 3.22: Intermediate Ladder Truss Supports

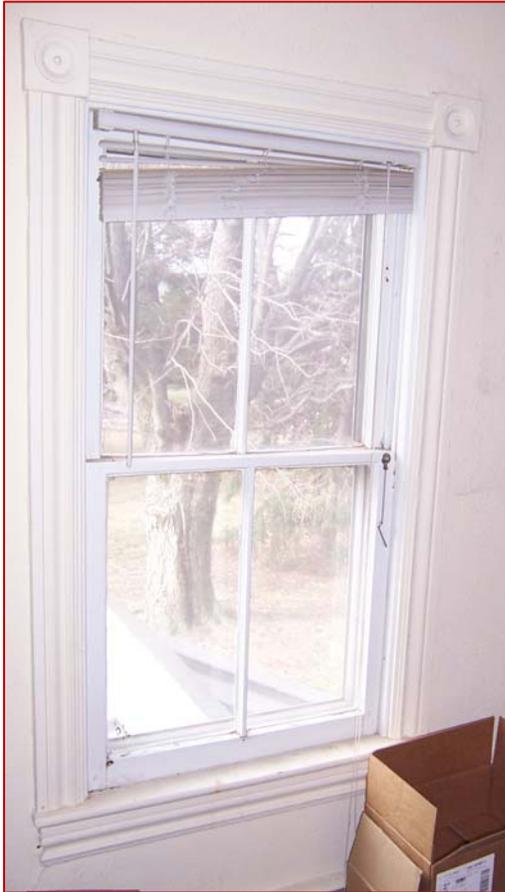
The windows are typically double-hung wood widows with sashes containing 2 lites over 2 lites. The corner blocks in the Hall 200 and Bedroom 201 were later modifications.

*Image 3.29: Corner Blocks Added Later
(W202)*

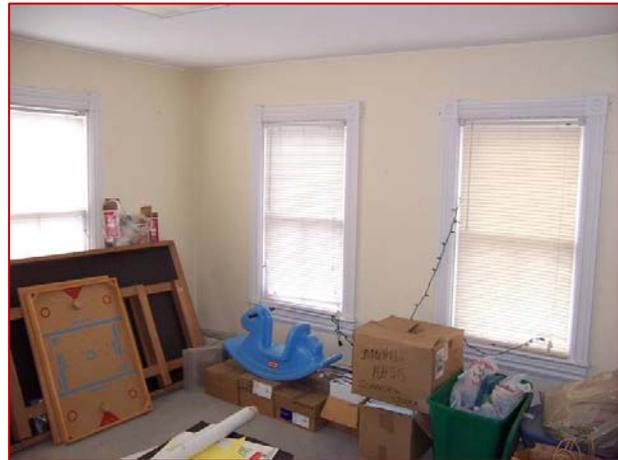
Image 3.46: Bedroom 201

The window trim and stools are original, though the decorative corner blocks were added later. The door into the room is a modern flush wood door within a modern door assembly.

Recommendations: Patch and finish existing damaged area of ceiling in Bedroom 201 to match adjacent area.

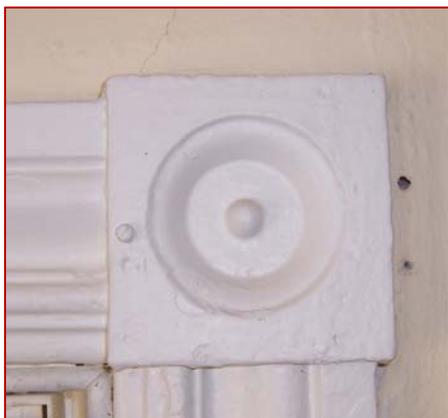
Image 3.47: Corner Block Added Later

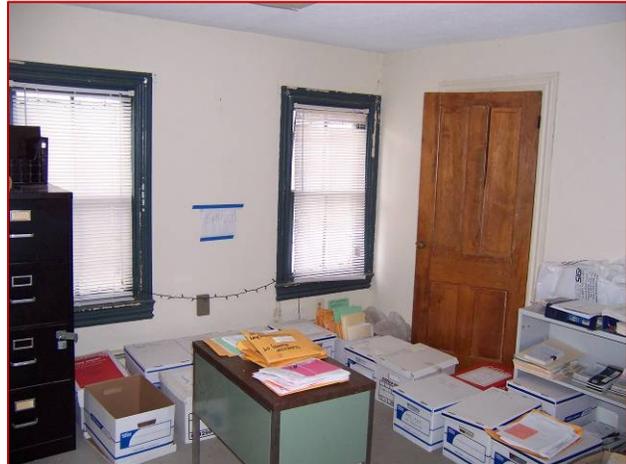
Image 3.48: Bedroom 202

The window trim and stools are original. Some of the window sash is also original. The trim appears to have been originally stained. The closet door is original. It is currently stained, though it had been painted at one time. The hardware is original.

Recommendations: Reinstall dislocated wood base and patch wall hole in Bedroom 202.

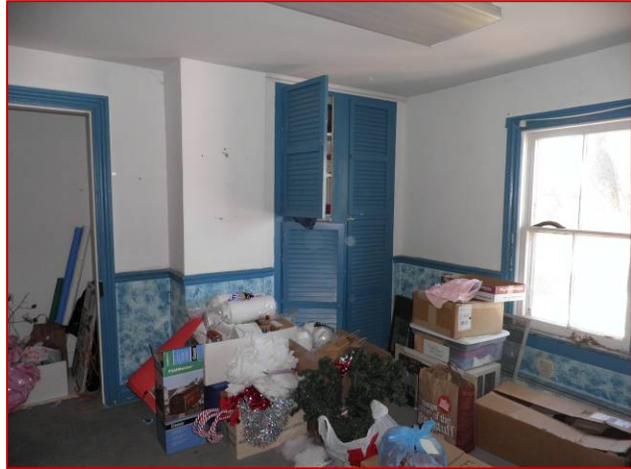
Image 3.49: Bedroom 203

The door for Closet 207 (D207) is original. This was the original passageway into the Bedroom 203. The hardware that remains is original. There is an early light switch in the closet that likely served the hallway lights.

The windows have original trim. The window stool is a plain wood board, rather than the more intricate millwork seen in the other original bedrooms. The trim was originally stained.

Recommendations: Patch damaged wall paper cover and paint to match adjacent surface on wall of the closet in Bedroom 203.

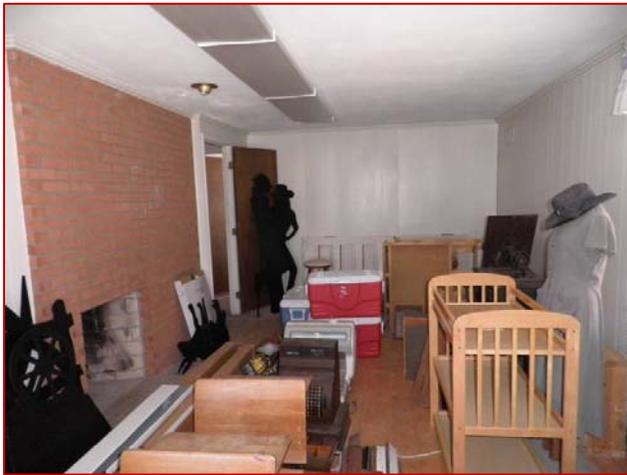
Image 3.51: Office 209

Office 209 and Office 210 were constructed as a second major addition, and have similar construction materials. A small hallway connects the two rooms. There is a step up from this connecting hallway to Hall 200. Baseboard heaters extend along all of the exterior walls, though they are in poor condition. There are two diffusers high on the rear exterior walls.

Recommendations: Replace damaged ceiling area in the closet of second floor Office 209 with like material.

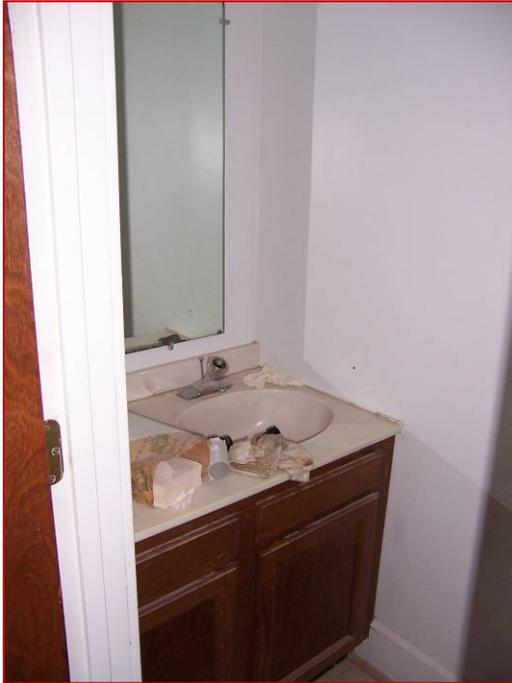
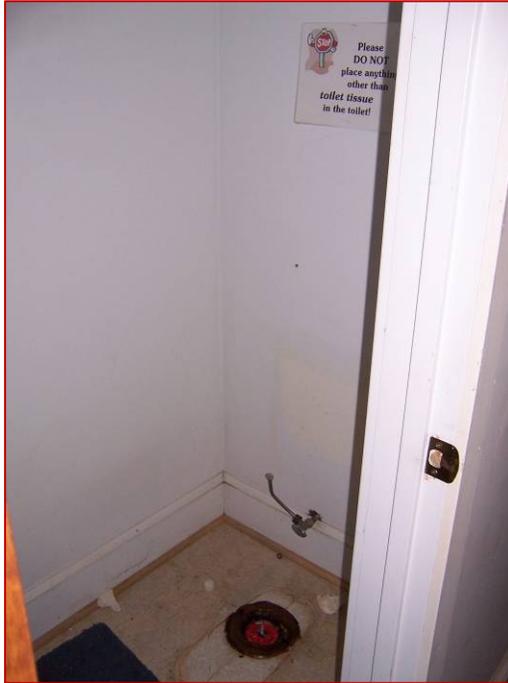
Image 3.53: Lavatory in Toilet Room 211

Image 3.54: Previous Location of Toilet

The toilet room was constructed using modern material. The water closet has been removed. A water fountain in Hall 200 adjacent to the toilet room was also removed.

Recommendations: Remove vanity top, base cabinet, mirror on wall and toilet accessories in addition to capping toilet drain pipe and patching floor in second floor toilet room 211. Install carpeting and a closet shelf.

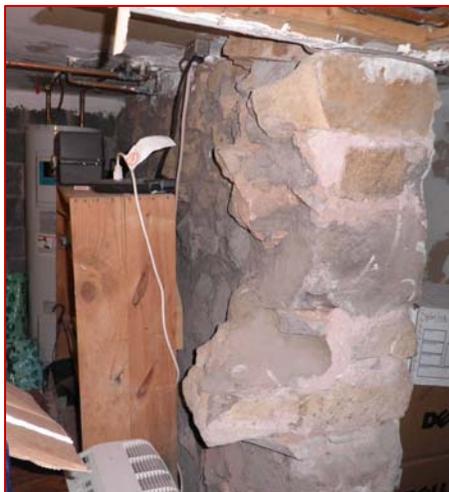
2. Since a cellar access hatch is not shown in an early photo, it is believed that the hatch was located on the southeastern side of the cellar.
3. The stones at the termination of the stone wall dividing rooms B01 and B02 are dressed. They only appear to be broken off in the area where the retaining wall would have extended up to grade.

Image 3.59: Stone Wall At Original Cellar Access

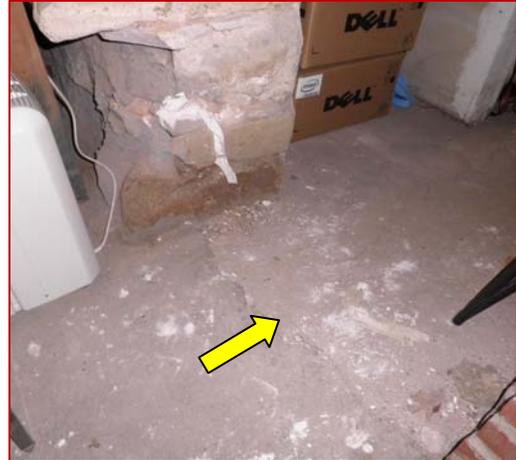
4. The concrete pour for the original cellar extends beyond the face of the stone wall.

Image 3.60: Joint of Two Concrete Pours

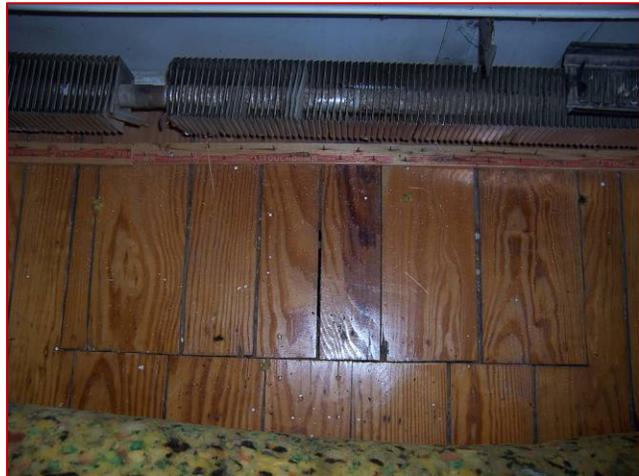
5. The interior-end chimney was removed and floor boards infilled the opening. This is evident in the floor of Bedroom 201 (22" x 13 1/4").
6. Wall plaster at the exterior wall in the area of the removed chimney shows a later plaster patch; probably plaster over wire lath.

Image 3.61: Infill at Previous Chimney Flue in Bedroom 201

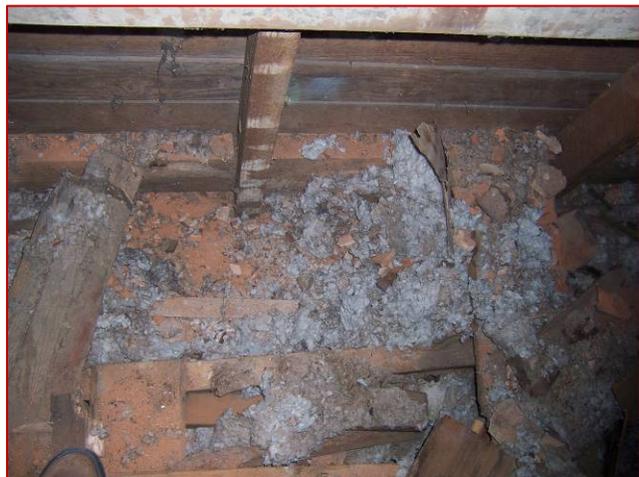
7. There is brick dust and brick fragments in the attic where the chimney was removed. In addition, there is evidence of mortar on the stud where the brick chimney abutted the exterior wall.

Image 3.62: Brick Fragments and Mortar on the Nearby Stud

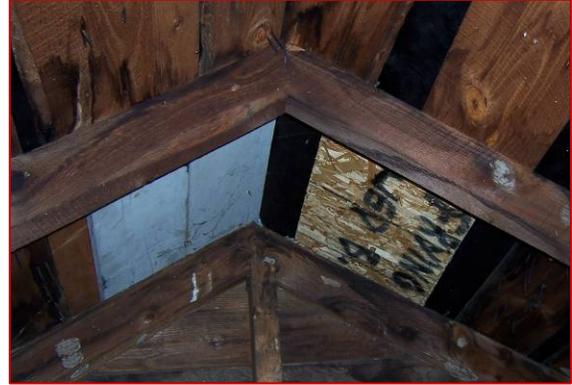
8. The original roof sheathing indicates that the roof was patched after the chimney was removed.

Image 3.63: Roof Patch at Earlier Chimney Location

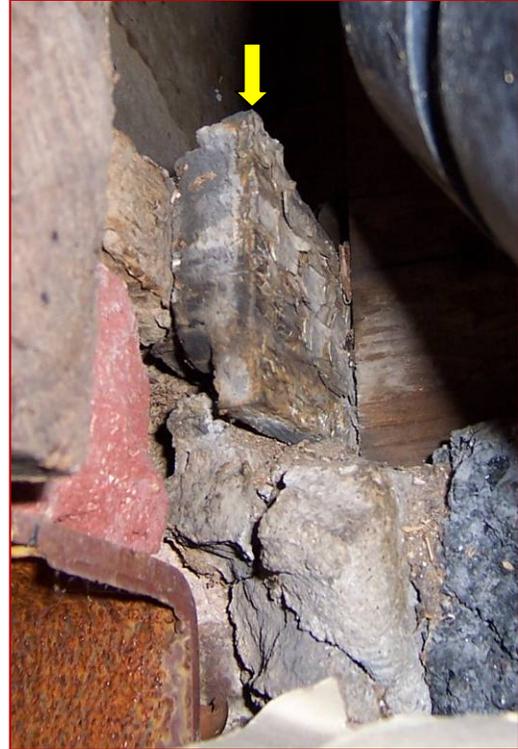
14. A fragment of the siding was observed in the basement between the first-floor joists. This siding would have been located on the back of kitchen wing.

Image 3.65: Exterior Siding Observed Where the Joists for the Rear Stairs Attach to the Back of the House at the Kitchen

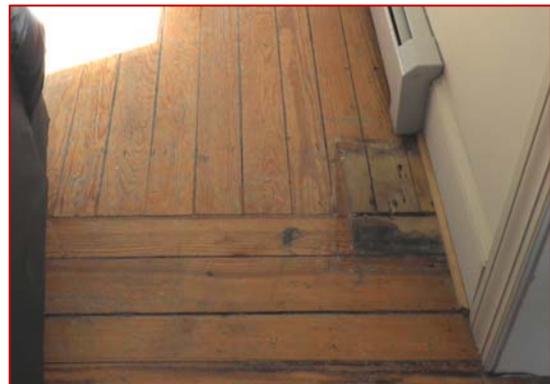
15. There are indications of an original wall separating the central hallway from the living room on the wood flooring. In two locations, one close to the exterior wall near the entry foyer and the other one on same axis next to the opposite wall of the living room, that exhibit the location of posts in that the area beneath the posts wasn't stained and there are nail holes.
16. The first floor wood joists in the center hall area are made of dimensional lumber running from side to side the width of the hallway.
17. Wood floor boards in the center hall run from front to back.

Image 3.66: Post Location at Original Center Hall Wall

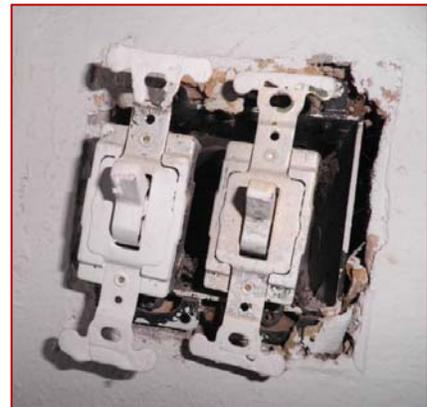
22. The door trim on inside of Closet 207 is the original decorative wood trim.
23. There is a double light switch on the wall adjacent to Bedroom 202 that may have operated hallway fixtures on the first and second floors. The wiring is old.
24. The original door opening into Bedroom 202 was infilled with gypsum wallboard and the baseboard does not have the original profile.
25. The wall at the original door opening extends into the room for the length of the landing, likely so that additional width would be achieved in the hallway.

Image 3.67: Light Switches in Closet 207.

Recommendations: Cover the abandoned old recessed double electric light switches with clear acrylic shielding cover.

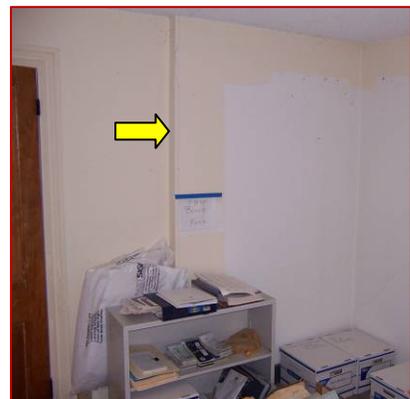
Image 3.68: Wall Extends Into Bedroom 202 to Increase Original Width of Hallway

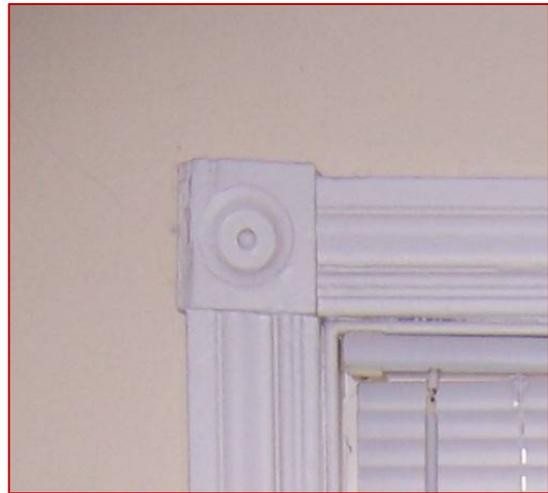
The windows in Bedroom 201 and Hall 200 have molded wood trim with corner blocks as opposed to the windows in Bedroom 202 and Bedroom 203 that do not have corner blocks. The corner blocks may have been added at a later date, based on the poor quality craftsmanship of the installation. Had the window trim been cut prior to being attached to the wall, it is more likely that the cut would be square.

Image 3.69: Window Trim Cut on an Angle, Rather than Square, for Installation of Corner Block

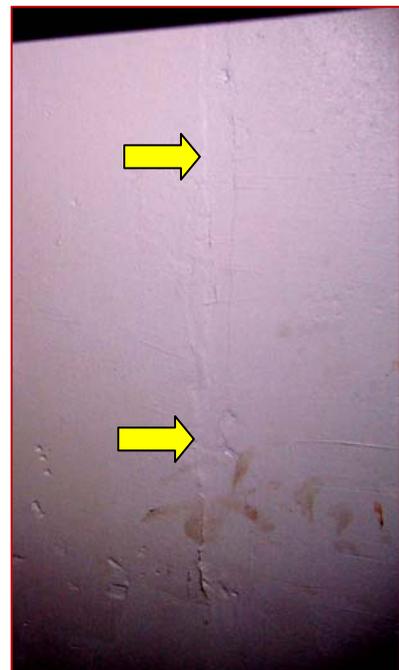
30. Window W225, as shown on sheet D3 in Appendix D, was infilled. The patching is evident on the rear wall of Closet 205.

Image 3.70: Patching at Original Window W225

Recommendations: Patch holes and damaged areas of the wall in Closet 205.

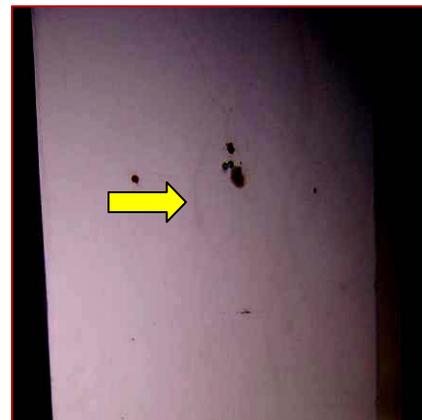
- 35. The chimney in Bedroom 201 was removed and the floor infilled. The ceiling was patched with metal lath and plaster.
- 36. The original flue opening in the plaster-covered chimney in Bedroom 203 has been patched.

Image 3.72: Patched Flue Penetration in Bedroom 203

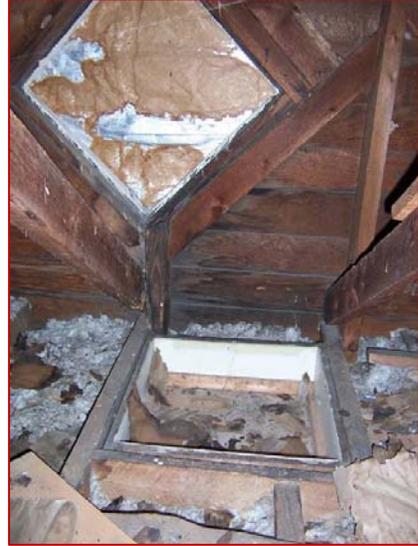
37. The framing is evident in the attic.

Image 3.73: Framing for Original Attic Access

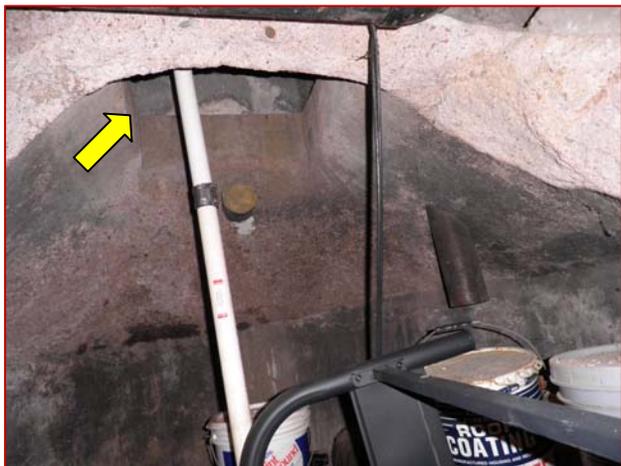
39. The remnant of the septic tank in the cellar indicates that an indoor bathroom was existing prior to construction of the first major addition, since the first major addition was constructed on top of the septic tank. There is a square opening in the top of the tank that was no longer easily accessed once the floor was constructed above.

Image 3.74: Opening at Top of Septic Tank

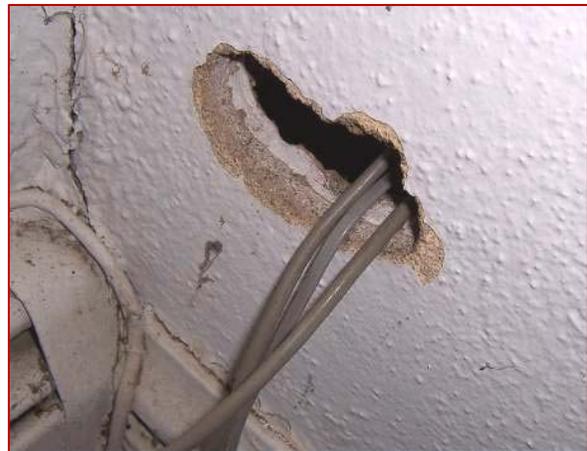
41. The back of Closet 205 is from the original period of construction while the other side of the wall in Bedroom 204 was constructed as a result of the first major addition. The closet side of the wall is plaster over wood lath and on the opposite side of the stud wall there is a cementitious plaster over gypsum lath.

Image 3.76: Plaster of Gypsum Lath

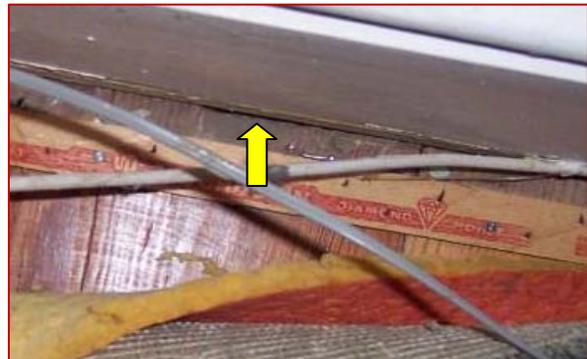
42. The floor boards do not bear of the last joist at the wall, as evidenced by a gap; therefore, they must bear on a subfloor.

Image 3.77: Floor Boards Over a Subfloor

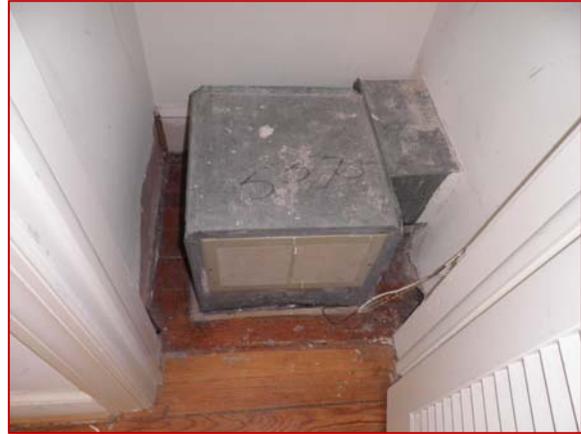
At some time during the Smith ownership, Mason Smith Jr. installed central air conditioning. It is conjectured that he created the closet under the first-floor stairs as a room for the duct work. As a result, the door into the bedroom needed to be relocated, thus creating door location D102 at the foot of the stairs.

Image 3.78: Ductwork in Closet at Stairs

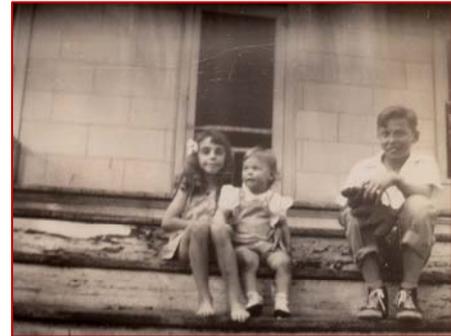
The exterior of the house may have been covered with asbestos-panel shingles. It was later clad with the existing prefinished aluminum siding.

Image 3.79: Mid-20th Century Asbestos-Panel Shingles

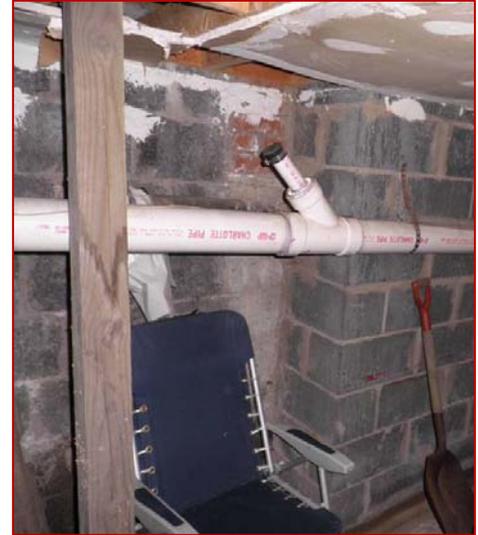
45. The foundation for the chimney uses a different CMU from the cellar walls built during the first major addition. Also, there cellar wall was patched with brick after construction of the chimney foundation.

Image 3.80: Rear Chimney Foundation

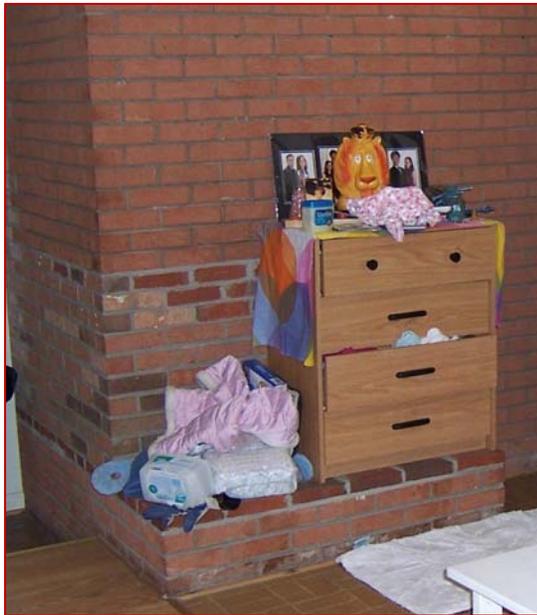
At a later time, the firebox on the family room side was infilled and a new firebox was opened on the opposite side.

The brick used to modify the chimney to infill the existing firebox and create a new firebox is a different color than the original chimney brick.

Image 3.81: Brick Infill at Family Room Hearth

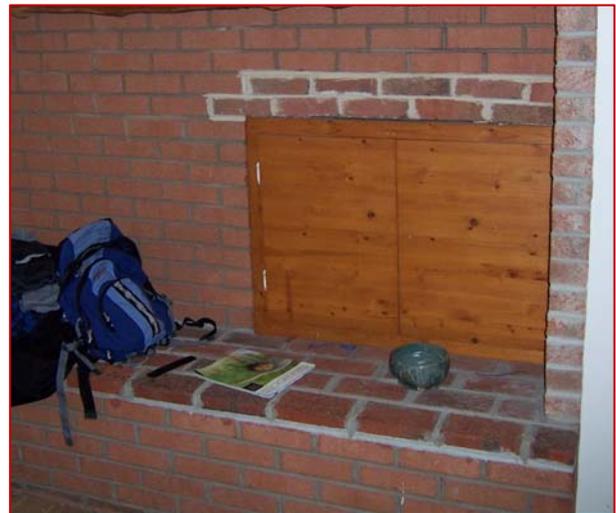
Image 3.82: Modifications for New Fire Box in Bedroom 107

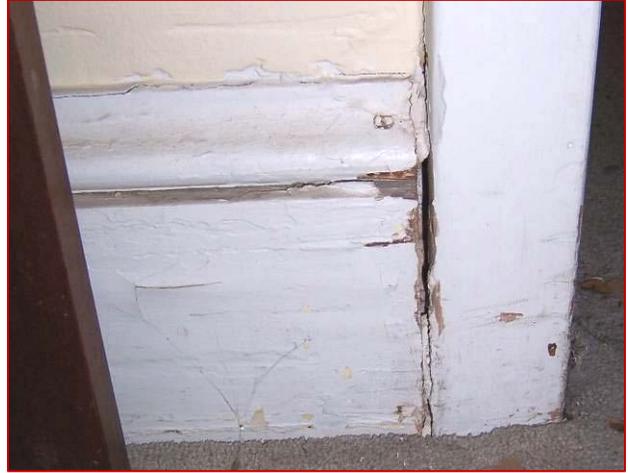
48. The original baseboard and base molding was cut and then visibly nailed back down through the molding.

Image 3.83: Re-nailed Baseboard and Base Molding

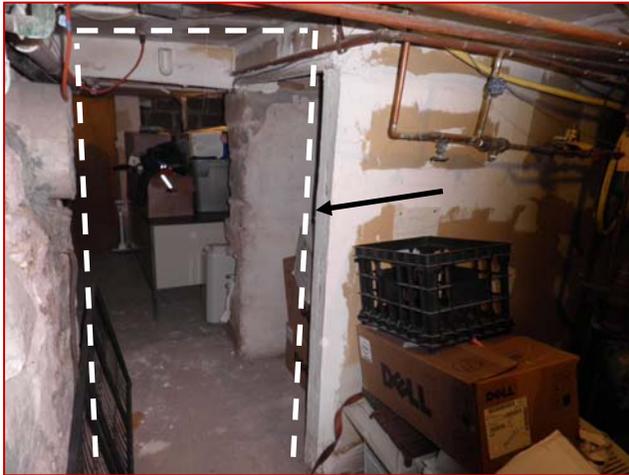
Issue: There are 2x6 joists under the rear area of the kitchen that are undersized because a bearing wall that bisects the joists at the front of the kitchen does not extend all the way back to the rear of the kitchen. The undersized joists are indicated by the number 2 in a circle in the sketch below.

Image 4.4: Rear Joists Below Kitchen

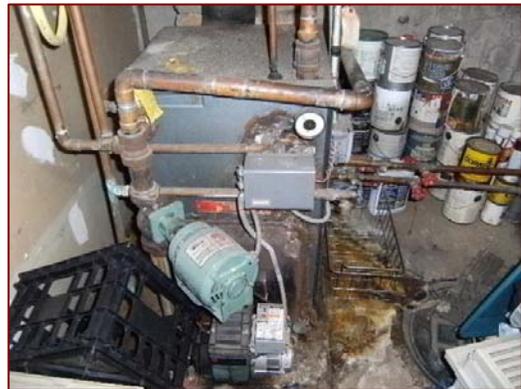
Image 4.11: Oil-fired Hydronic Boiler

Heating water is pumped through uninsulated copper piping throughout the house to floor-mounted radiators in a series layout. There are two thermostats on the first floor and two thermostats on the second floor, however there are only three hydronic zone valves controlling three heating zones. It is unknown if the controls are operational.

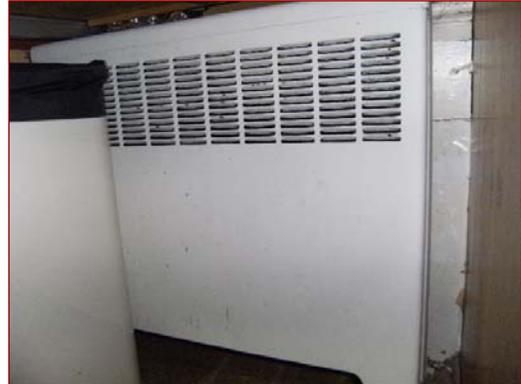
Image 4.13: Freestanding Floor Radiator in Kitchen

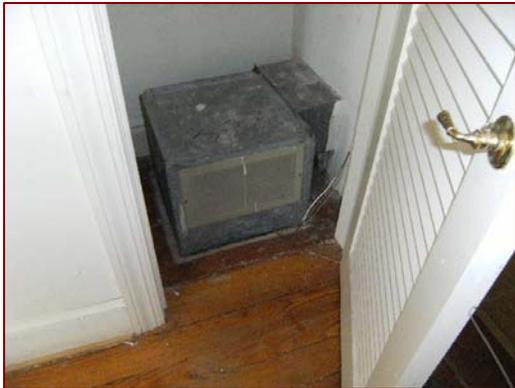
There are fireplaces located throughout the house which are not in use. The tenants are currently using electric space heaters throughout the first floor to provide heat. The basement has ducts that drop into the crawl space and resurface in the family room closet. During the survey there was no sign of an HVAC unit; the purpose of the ducts is unknown.

Image 4.14: Ductwork in Closet112

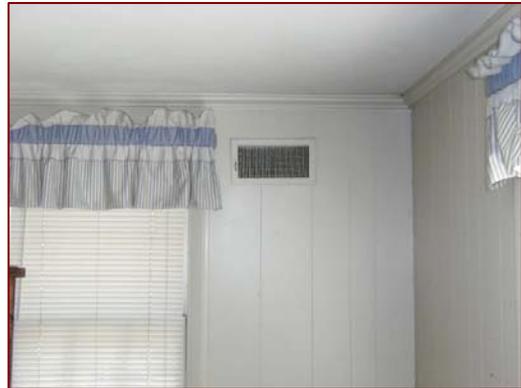
There are several wall grilles installed in the house on the first and second floors. The purpose/function of these grilles is unknown since they do not stack from floor to floor and there was no ductwork found connected to them.

Image 4.15: Wall Grille

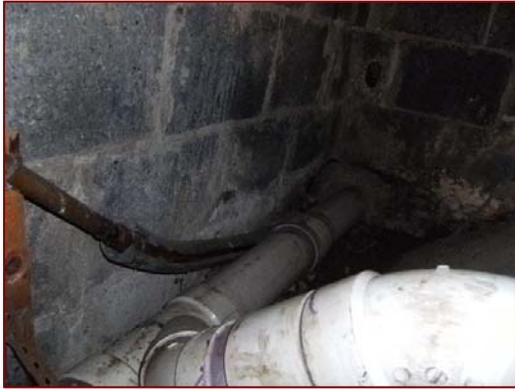
The existing utility-provided domestic water service enters the house through the basement wall adjacent to the sanitary sewer. Copper domestic water piping in the basement distributes water to the plumbing fixtures. Sanitary sewer is connected to the utility and not a septic system. The sanitary sewer piping is comprised of cast iron, PVC, and ABS piping. It appears that it may have once been connected to a septic system and some of the piping is abandoned in place.

Image 4.16: Sanitary Sewer Piping

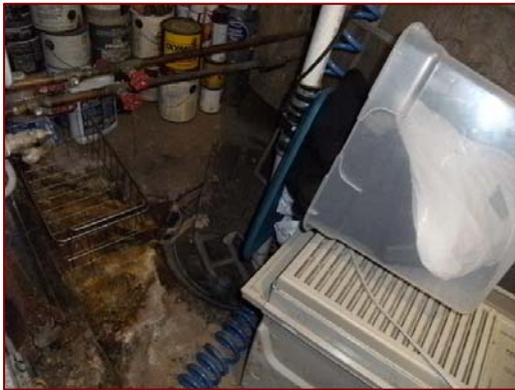
The basement has two sump pumps along with floor drains. The sump pumps are located on opposite sides of the basement and discharge out of the Southeast side of the house to an open yard inlet.

Image 4.18: Sump Pump Within Floor Drain

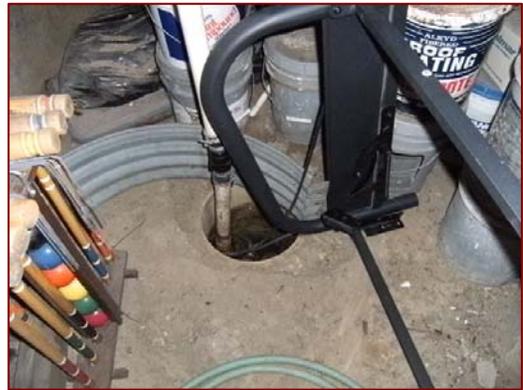
Image 4.19: Sump Pump Within Floor Drain

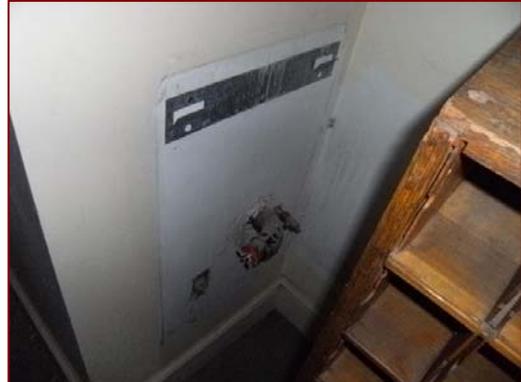
Image 4.21: Earlier Location of Drinking Fountain

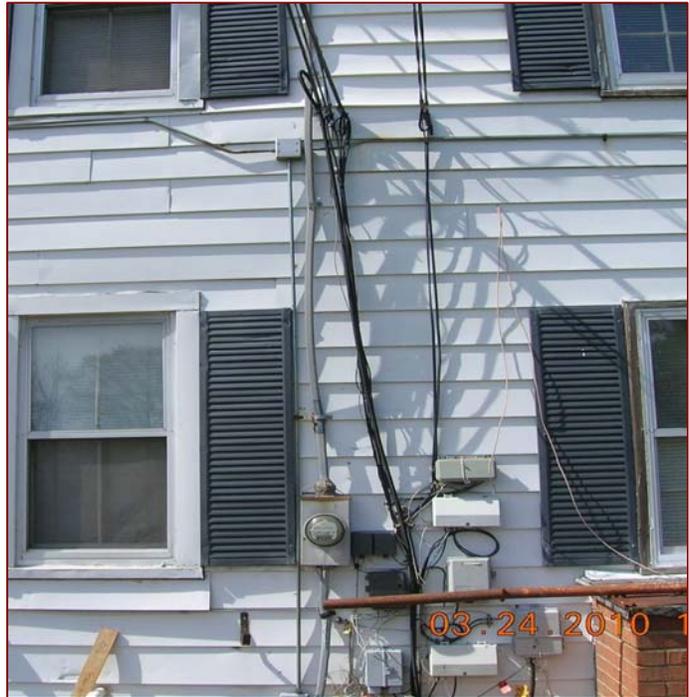
The house is served by a overhead secondary distribution with a secondary voltage of 120/240 volts, single phase, 3-wire from a pole mounted utility transformer at east side of the property ~ 100 feet from the house. This pole is one of three bringing electrical service from West Ox Road to the Visitor’s Center located north of the property. In addition to the electric line the pole also supports telephone, cable and fiber lines all of which terminate on the east side of the building. Some of the equipment appears to have been abandon in place.

Image 4.22: Exterior Electrical Service Entrance

The power line is run separately from the other conductors approximate 15 feet above the ground. The guy line from the power is supported by an eyelet screwed into the side of the building between the windows, approximately 18” from the closest window which is a violation of the National Electric Code (NEC).

There is no weather head to protect the service conductors and terminations where the utility conductors are spliced to a USE cable. The USE cable is not in conduit but attached directly to the building which is also a violation of the NEC. The USE cable runs down the side of the building to the electrical meter. This is acceptable for residential use but commercial services should be in conduit.

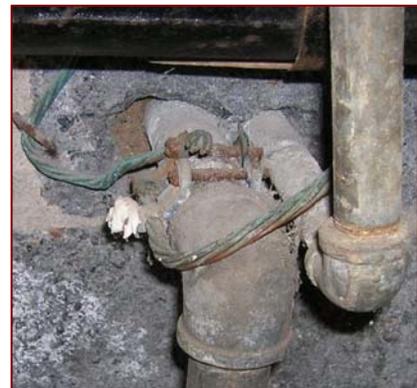
A ground wire connects several of the communications/fiber cables to the electric meter housing, but no ground wire to a ground rod was found. A ground rod is required by the NEC. A ground wire is connected to the domestic water pipe entrance and the panelboard providing buildings ground. The connection is rusted and should be cleaned and reconnected.

Image 4.23: Ground Connection

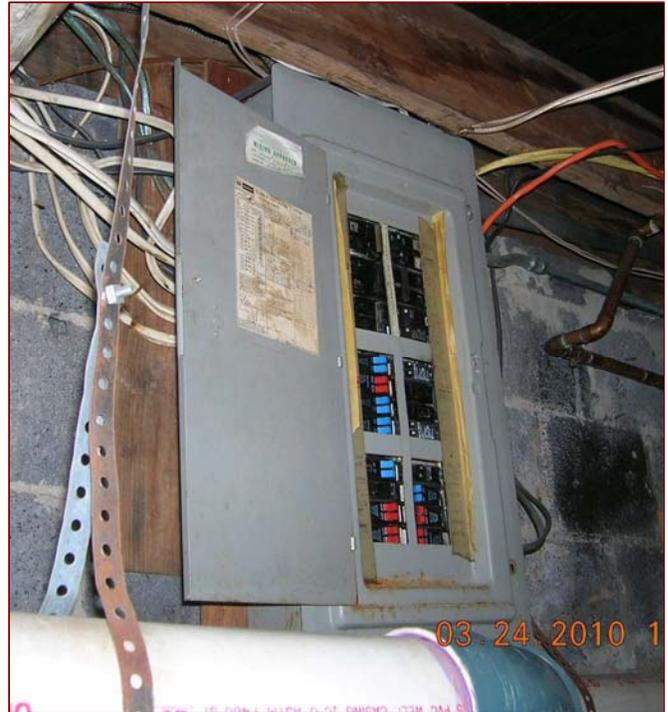
Once in the building, the service cable is attached to the bottom of the rafters and runs to the only panelboard in the building. The panelboard is located on a side wall approximately ten feet from the exterior wall. This location is in violation of the NEC which requires a service disconnecting means within five feet of the service's entrance into the building. The panelboard does contain main circuit breakers which qualify as the service disconnecting means. It also contains a dozen double circuit breakers, is very old and is at the end of its useful life. A waste pipe runs directly underneath the panelboard which is a violation of the NEC. The basement room where the panelboard is located has a very low ceiling and does not meet the requirements of the National Electric Code.

Image 4.24: Basement Panelboard

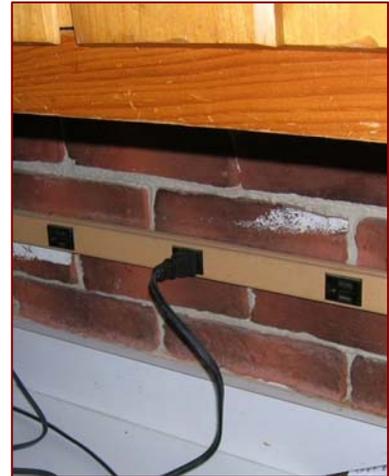
Image 4.25: Kitchen ‘Wiremold’;

A surface mounted ‘Wiremold’ strip is mounted underneath the counter in the kitchen and appears supply the only receptacles at the counter. The NEC requires two 20A circuits in residential kitchens and it appears only one is furnished. Two receptacles are not required if the building is changed to commercial use.

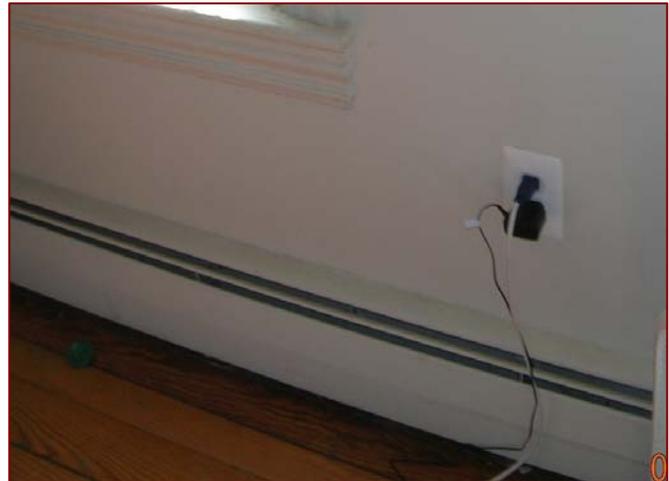
In several rooms electric baseboard heaters are installed continuously at exterior walls with receptacles are installed above the baseboard. This is an NEC violation.

Image 4.26: Receptacle above Baseboard

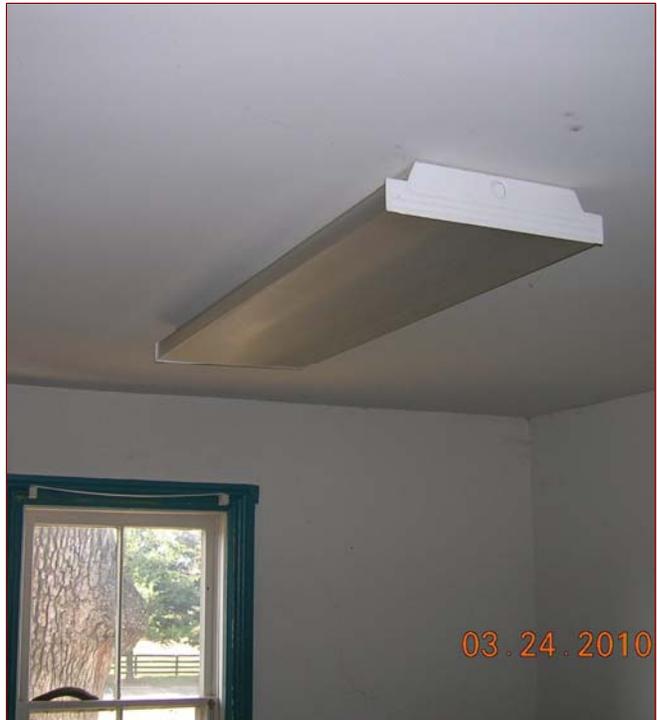
Image 4.27: Surface Mounted Light Fixture

- Salvage and reuse existing light fixtures in the basement and where possible throughout the house.
- Replace existing light fixtures in the kitchen.
- Install surface mounted fluorescent fixtures in proposed office space.
- Install compact fluorescent bulbs in closet and basement porcelain screw-in lamp holders.
- Replace exterior flood lights with HID fixtures with photocell and time clock.
