Mt. Vernon Recreation Center

Facility Condition Assessment and Life Cycle Cost Analysis

Fairfax County Park Authority

Prepared by: Hughes Group Architects
October 24, 2014

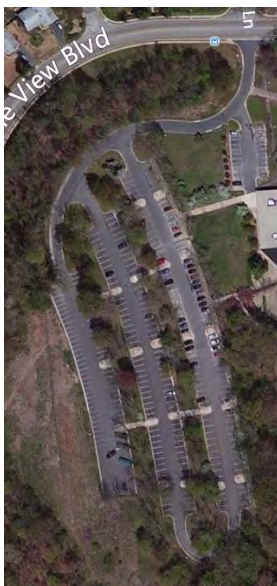
| ASSESSMENT REPORT | | | | |
|---|---|---|---|---|
| ASSESSMENT DESCRIPTION: Although the public parking lots lack significant damages, the asphalt pavement surface, and concrete steps and curbs seem to be wearing down as normal and nearing the end of their useful life. Additionally, striping is worn out. | | | | |

| BUILDING SYSTEMS - SITE | | | | | | | | | | | |
|---|--|---|---|---|---|---|---|---|---|---|---|
| S.4 | Replace parking lot asphalt and concrete curbs and restripe parking lot. | C | 3 | 2 | 1 | LS | 35/15 | - | ✓ | 15 | \$ 219,918.63 |

| ASSESSMENT REPORT | | | | |
|---|---|---|---|---|
| RECOMMENDATION: Replace all concrete curbs and asphalt pavement of public parking lots with new materials and restripe parking lot. Also, repair edges of concrete steps which have broken off and/or have become significantly worn. | | | | |

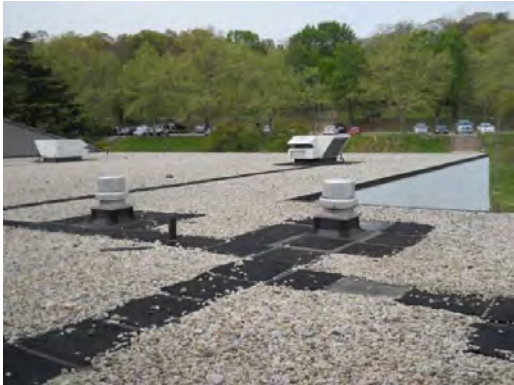
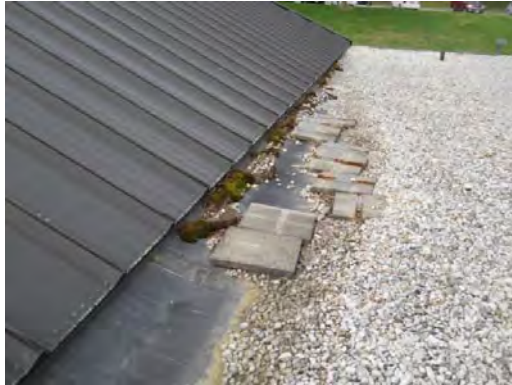
| ASSESSMENT REPORT | | | | |
|---|---|---|---|---|
| ASSESSMENT DESCRIPTION: Existing walkway pads appeared in satisfactory condition. The life expectancy of the roof walkway pads is 20 years, the same as for the main roof membrane and were probably replaced in 1997. Even though the pads appear in satisfactory condition, they are close to exceeding their life expectancy. | | | | |

| BUILDING SYSTEMS – BUILDING ENVELOPE (cont'd) | | | | | | | | | | | |
|---|--|---|---|---|---|---|---|---|---|---|---|
| E.1D | Replace roof walkway pads | C | 3 | 3 | 1 | LS | 17/20 | - | ✓ | 18 | \$ 4,438.65 |

| ASSESSMENT REPORT | | | | |
|---|---|---|---|---|
| RECOMMENDATION: Completely remove and replace the existing walkway pads with new pads when the new roofing membrane is installed. | | | | |

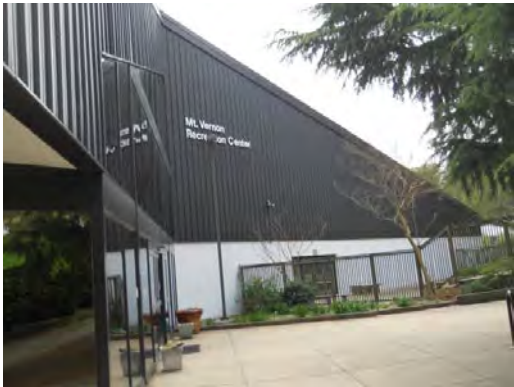
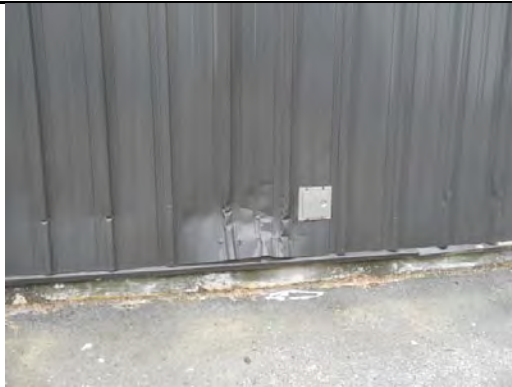
| ASSESSMENT REPORT | | | | |
|--|---|--|---|---|
| ASSESSMENT DESCRIPTION: Overall the metal wall panels are in good condition. Little sign of wear is evident. | | | | |

| BUILDING SYSTEMS – BUILDING ENVELOPE (cont'd) | | | | | | | | | | | |
|---|--|---|---|---|---|---|---|---|---|---|---|
| E.2A | Clean and re-paint metal wall panels that show deterioration | C | 3 | 1 | 1 | LS | 18/30 | ✓ | - | 15 | \$ 3,604.11 |

| ASSESSMENT REPORT | | | | |
|--|---|--|---|---|
| RECOMMENDATION: Where deterioration has occurred, these areas should be cleaned and painted to match. | | | | |

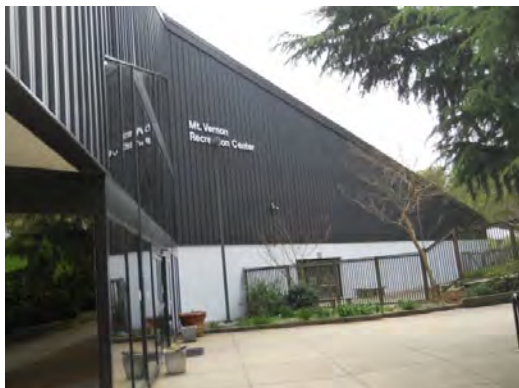
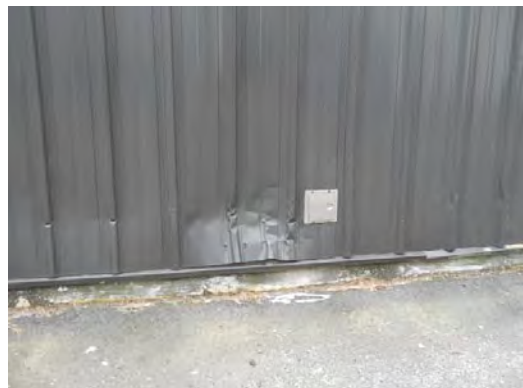
Insulated metal fascia panels are installed above the CMU wall construction. The metal panels are in good condition with only minor areas that need attention. Metal panels near the service entrance of the Pool area show signs of damage due to traffic, but the damage appears to be cosmetic only. For aesthetic reasons, those damaged panels can be replaced.

| ASSESSMENT REPORT | | | | |
|--|---|---|---|---|
| ASSESSMENT DESCRIPTION: Metal panels near the service entrance of the Pool Facility show signs of damage due to traffic, but the damage appears to be cosmetic only. | | | | |

| BUILDING SYSTEMS – BUILDING ENVELOPE (cont'd) | | | | | | | | | | | |
|---|--|---|---|---|---|---|---|---|---|---|---|
| E.2B | Replace damaged metal wall panels at Pool area service entrance | C | 3 | 3 | 1 | LS | 18/30 | ✓ | - | 15 | \$ 9,027.45 |

| ASSESSMENT REPORT | | | | |
|--|---|---|---|---|
| RECOMMENDATION: Replace damaged metal wall panels at Pool Facility’s service entrance. | | | | |

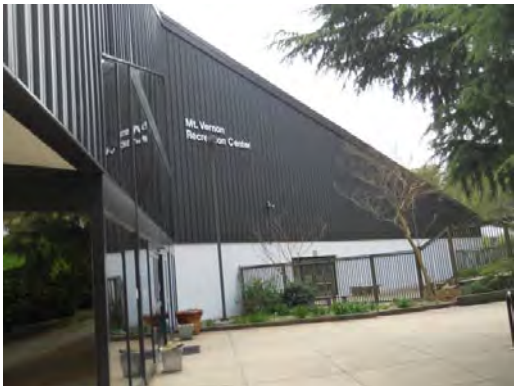
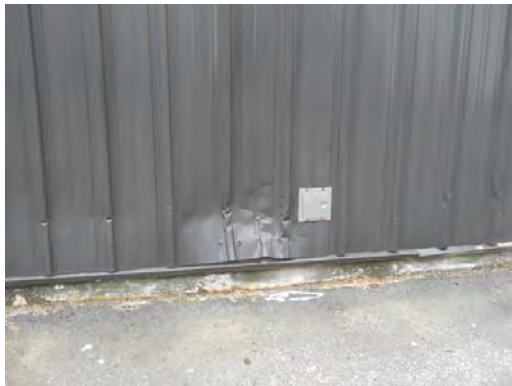
| ASSESSMENT REPORT | | | | |
|--|---|---|---|---|
| ASSESSMENT DESCRIPTION: Metal Panels: Overall the metal wall panels are in good condition. Little sign of wear is evident. | | | | |

| ASSESSMENT REPORT | | | | |
|--|---|---|---|---|
| RECOMMENDATION: Pipe bollards are recommended at service areas where automobiles or equipment may contact low metal panels. | | | | |

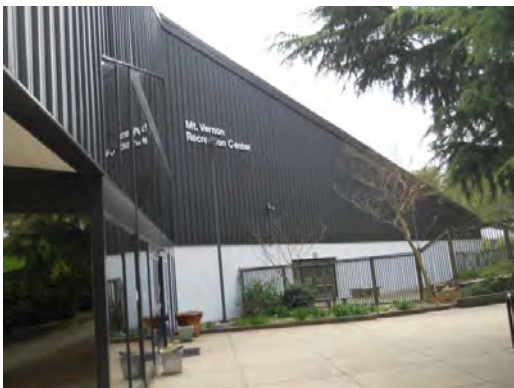
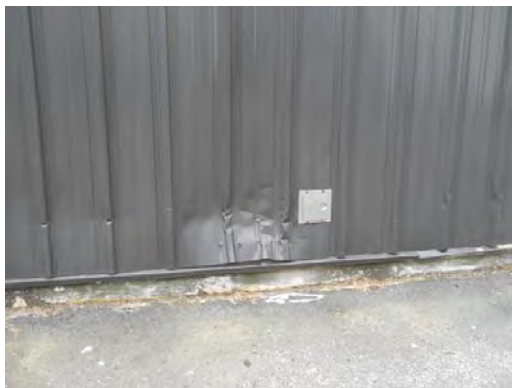
| ASSESSMENT REPORT | | | | |
|--|---|---|---|---|
| ASSESSMENT DESCRIPTION: Overall the metal wall panels are in good condition. The cladding system is about halfway through its expected life cycle. | | | | |

| BUILDING SYSTEMS – BUILDING ENVELOPE (cont'd) | | | | | | | | | | | |
|---|--|---|---|---|---|---|---|---|---|---|---|
| E.2K | Replace metal wall panel system | B | 4 | 3 | 1 | LS | 18/30 | - | ✓ | 27 | \$ 221,000.00 |

| ASSESSMENT REPORT | | | | |
|--|---|---|---|---|
| RECOMMENDATION: Anticipate complete replacement of the metal wall panel system at the end of its expected life cycle. | | | | |

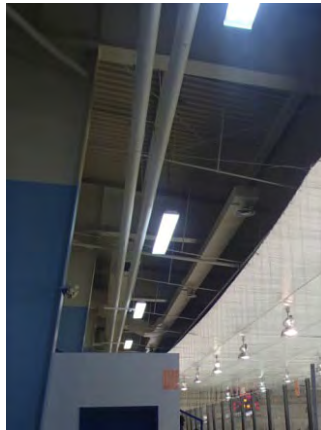
| ASSESSMENT REPORT | | | | |
|--|---|---|---|---|
| ASSESSMENT DESCRIPTION: Acoustics within the Ice Rink are poor. | | | | |

| BUILDING SYSTEMS – INTERIOR FINISHES | | | | | | | | | | | |
|---|---|---|---|---|---|---|---|---|---|---|---|
| F.3A | In Ice Rink area, replace low-E ceiling with a foil & bubble finished low-E ceiling | B | 4 | 4 | 1 | LS | 19/10 | - | ✓ | 15 | \$ 12,655.56 |

| ASSESSMENT REPORT | | | | |
|--|---|---|---|---|
| RECOMMENDATION: Although the low-E ceiling over ice rink is in very good shape with no separation at seams or at connections to the ceiling, we recommend replacing the existing ceiling with a modified low-E ceiling system with foil and bubble finish to improve acoustical quality. | | | | |

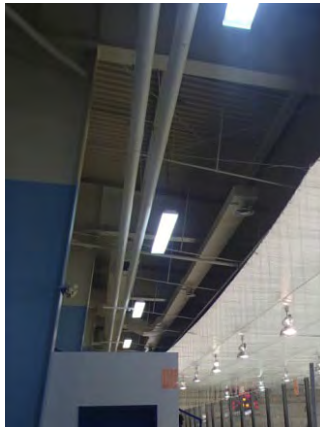
| ASSESSMENT REPORT | | | | |
|--|---|---|---|---|
| ASSESSMENT DESCRIPTION: Acoustics within the Ice Rink are poor. | | | | |

| ASSESSMENT REPORT | | | | |
|--|---|---|---|---|
| RECOMMENDATION: Provide acoustic panels on the walls of the Ice Rink. | | | | |

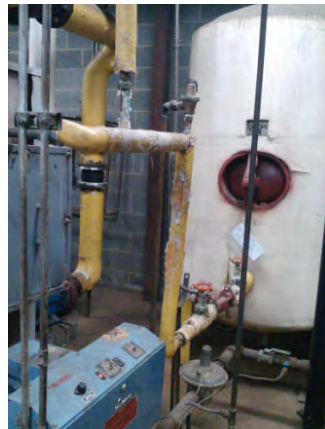
The condition of the pool water heater was surveyed as part of the mechanical systems assessment. The boiler was installed in 1983. Although it is still operational, like the other main mechanical systems, it has reached the end of its expected useful life. It is recommended for the pool heater burner and boiler to be replaced as soon as possible.

| ASSESSMENT REPORT | | | | |
|---|---|---|---|---|
| ASSESSMENT DESCRIPTION: Boiler B-1 and associated piping and insulation show signs of advanced wear and leakage. The useful life of the boiler is 30 years, which has been exceeded by 5 years. Further, given the severity of the chemical buildup on the exterior of the piping, we are concerned about how the water chemistry was maintained over the life of the boiler. | | | | |

| ASSESSMENT REPORT | | | | |
|---|---|---|---|---|
| RECOMMENDATION: Replace the existing boiler with a new boiler. Replace the piping and pump within the mechanical room, and evaluate the demolished piping to determine if further system demolition is required. | | | | |

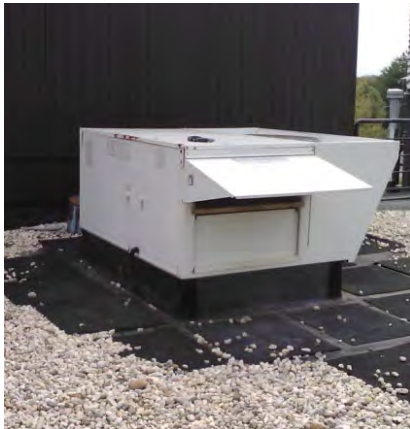
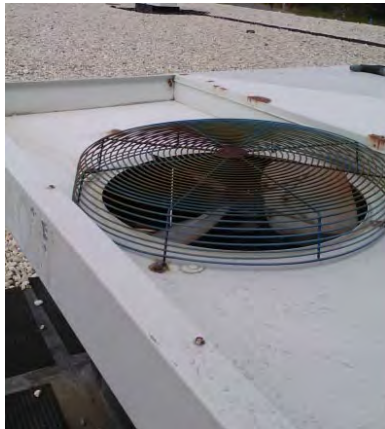
| ASSESSMENT REPORT | | | | |
|--|---|---|---|---|
| ASSESSMENT DESCRIPTION: Rooftop Unit RTU-1 is nearing the end of its serviceable life. | | | | |

| ASSESSMENT REPORT | | | | |
|--|---|---|---|---|
| RECOMMENDATION: Preparations should be made for replacement of this rooftop unit within the next two years. Replacement will include controls, flexible duct connectors, re-piping of the gas train, and piping of the condensate drain to the nearest storm drain (not done for the current installation). If the Facility anticipates that the area served by this RTU will be modified within the next 12 years, then the ductwork may be kept in place and cleaned. If the intent is to maintain the current space configuration beyond the next 12 years, then the ductwork should be replaced with the unit. | | | | |

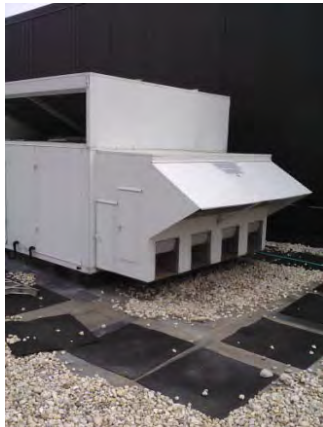
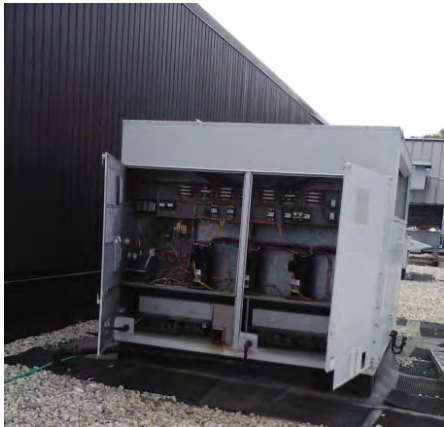
| ASSESSMENT REPORT | | | | |
|--|---|---|---|---|
| ASSESSMENT DESCRIPTION: Rooftop Unit RTU-2 is nearing the end of its serviceable life. | | | | |

| ASSESSMENT REPORT | | | | |
|--|---|---|---|---|
| RECOMMENDATION: Preparations should be made for replacement of this rooftop unit within the next two years. Replacement will include controls, flexible duct connectors, re-piping of the gas train, and piping of the condensate drain to the nearest storm drain (not done for the current installation). If the Facility anticipates that the area served by this RTU will be modified within the next 12 years, then the ductwork may be kept in place and cleaned. If the intent is to maintain the current space configuration beyond the next 12 years, then the ductwork should be replaced with the unit. | | | | |

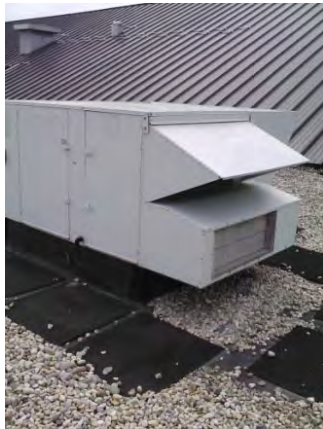
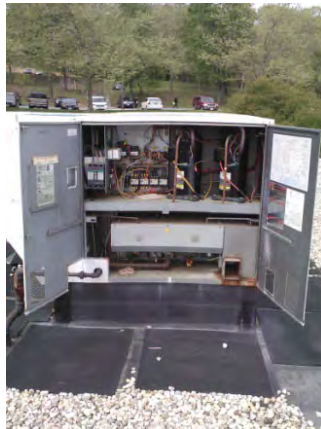
| ASSESSMENT REPORT | | | | |
|--|---|---|---|---|
| ASSESSMENT DESCRIPTION: Rooftop Unit RTU-3 is nearing the end of its serviceable life. | | | | |

| ASSESSMENT REPORT | | | | |
|--|---|---|---|---|
| RECOMMENDATION: Preparations should be made for replacement of this rooftop unit within the next two years. Replacement will include controls, flexible duct connectors, re-piping of the gas train, and piping of the condensate drain to the nearest storm drain (not done for the current installation). If the Facility anticipates that the area served by this RTU will be modified within the next 12 years, then the ductwork may be kept in place and cleaned. If the intent is to maintain the current space configuration beyond the next 12 years, then the ductwork should be replaced with the unit. | | | | |

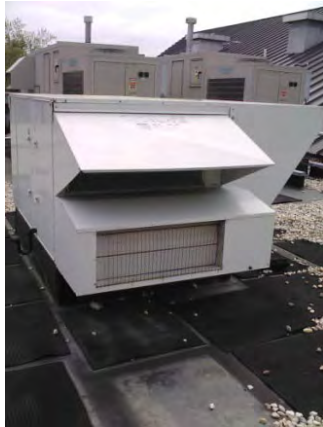
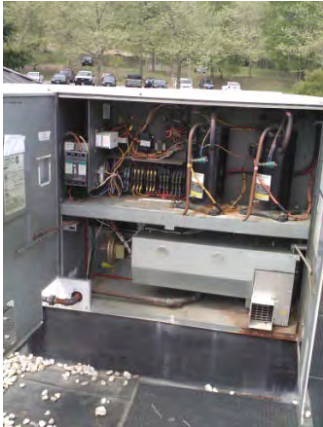
| ASSESSMENT REPORT | | | | |
|--|---|---|---|---|
| ASSESSMENT DESCRIPTION: Rooftop Unit RTU-4 is nearing the end of its serviceable life. | | | | |

| ASSESSMENT REPORT | | | | |
|--|---|---|---|---|
| RECOMMENDATION: Preparations should be made for replacement of this rooftop unit within the next two years. Replacement will include controls, flexible duct connectors, re-piping of the gas train, and piping of the condensate drain to the nearest storm drain (not done for the current installation). If the Facility anticipates that the area served by this RTU will be modified within the next 12 years, then the ductwork may be kept in place and cleaned. If the intent is to maintain the current space configuration beyond the next 12 years, then the ductwork should be replaced with the unit. | | | | |

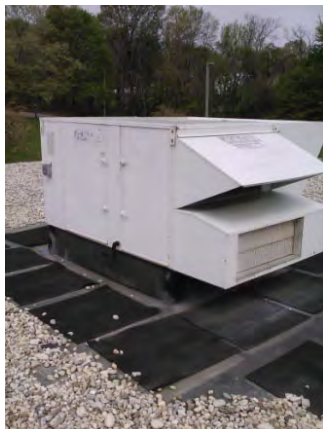
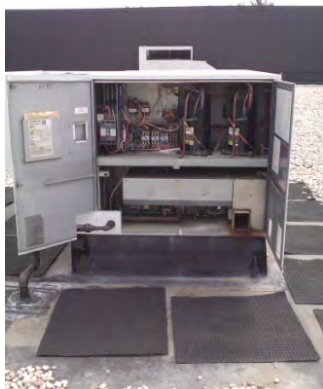
| ASSESSMENT REPORT | | | | |
|--|---|---|---|---|
| ASSESSMENT DESCRIPTION: Rooftop Unit RTU-5 is nearing the end of its serviceable life. | | | | |

| ASSESSMENT REPORT | | | | |
|--|---|---|---|---|
| RECOMMENDATION: Preparations should be made for replacement of this rooftop unit within the next two years. Replacement will include controls, flexible duct connectors, re-piping of the gas train, and piping of the condensate drain to the nearest storm drain (not done for the current installation). If the Facility anticipates that the area served by this RTU will be modified within the next 12 years, then the ductwork may be kept in place and cleaned. If the intent is to maintain the current space configuration beyond the next 12 years, then the ductwork should be replaced with the unit. | | | | |

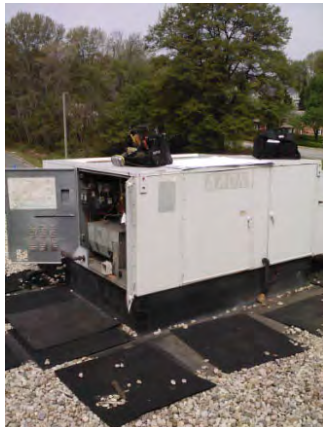
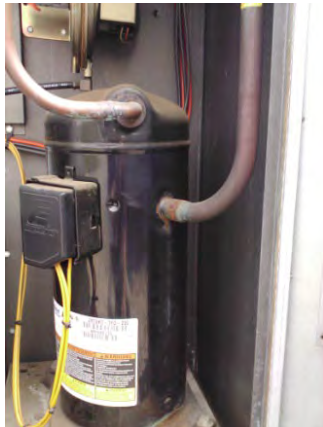
| ASSESSMENT REPORT | | | | |
|--|---|---|---|---|
| ASSESSMENT DESCRIPTION: Rooftop Unit RTU-6 is nearing the end of its serviceable life. | | | | |

| ASSESSMENT REPORT | | | | |
|--|---|---|---|---|
| RECOMMENDATION: Preparations should be made for replacement of this rooftop unit within the next two years. Replacement will include controls, flexible duct connectors, re-piping of the gas train, and piping of the condensate drain to the nearest storm drain (not done for the current installation). If the Facility anticipates that the area served by this RTU will be modified within the next 12 years, then the ductwork may be kept in place and cleaned. If the intent is to maintain the current space configuration beyond the next 12 years, then the ductwork should be replaced with the unit. | | | | |

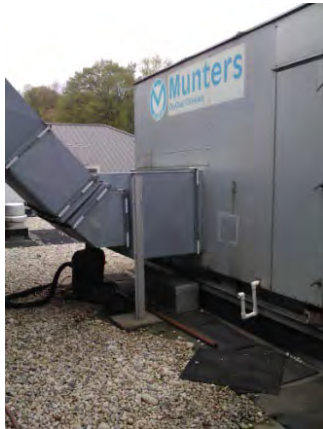
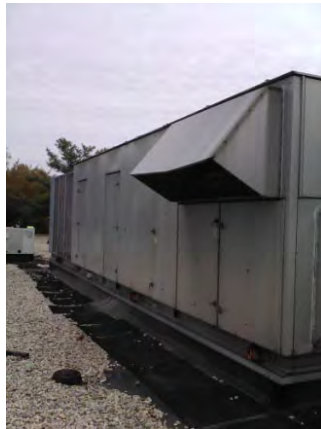
| ASSESSMENT REPORT | | | | |
|---|---|---|---|---|
| ASSESSMENT DESCRIPTION: Makeup Air Unit MAU-1 is nearing the end of its serviceable life. | | | | |

| ASSESSMENT REPORT | | | | |
|---|---|---|---|---|
| RECOMMENDATION: Preparations should be made for replacement of this makeup air unit within the next two years. Replacement will include controls, flexible duct connectors, re-piping of the gas train, and piping of the condensate drain to the nearest storm drain (not done for the current installation). If the Facility anticipates that the area served by this MAU will be modified within the next 12 years, then the ductwork may be kept in place and cleaned. If the intent is to maintain the current space configuration beyond the next 12 years, then the ductwork should be replaced with the unit. | | | | |

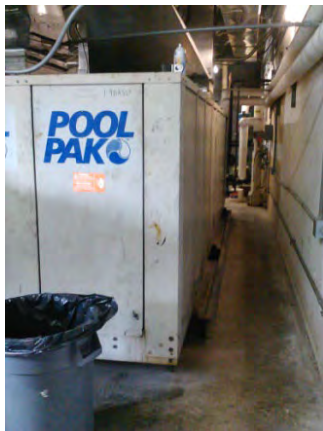
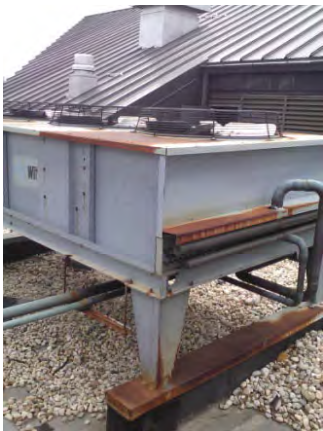
| ASSESSMENT REPORT | | | | |
|--|---|---|---|---|
| ASSESSMENT DESCRIPTION: Pool Energy Recovery Unit PRU-2 and associated Outdoor Condensing Unit ACCOU-2 are nearing the end of their serviceable lifespan. | | | | |

| ASSESSMENT REPORT | | | | |
|--|---|---|---|---|
| RECOMMENDATION: Preparations should be made for replacement of this makeup air unit within the next two years. Replacement will include controls, flexible duct connectors, hot water piping and circulator pump, refrigerant piping, and exhaust fan. If the Facility anticipates that the area served by this PRU will be modified within the next 12 years, then the ductwork may be kept in place and cleaned. If the intent is to maintain the current space configuration beyond the next 12 years, then the ductwork should be replaced with the unit. Also, the 40x30 outside air duct should be reinforced to eliminate the bellowing, and provided with additional support to eliminate the swaying of the duct. | | | | |

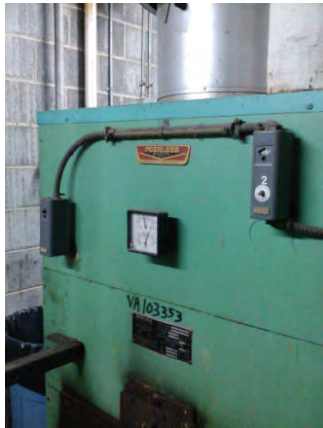
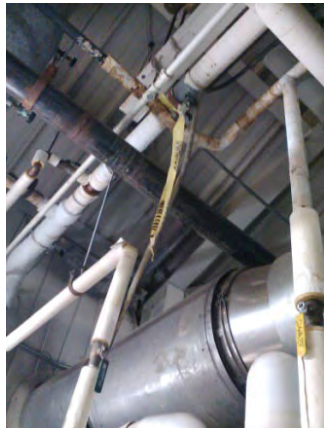
| ASSESSMENT REPORT | | | | |
|--|---|---|---|---|
| ASSESSMENT DESCRIPTION: Boiler B-2 (pool water heater) and associated pumps, piping and insulation show signs of wear and leakage. | | | | |

| ASSESSMENT REPORT | | | | |
|--|---|---|---|---|
| RECOMMENDATION: Replace the existing boiler with a new boiler. Replace the piping and pump within the mechanical room, and evaluate the demolished piping to determine if further system demolition is required. | | | | |

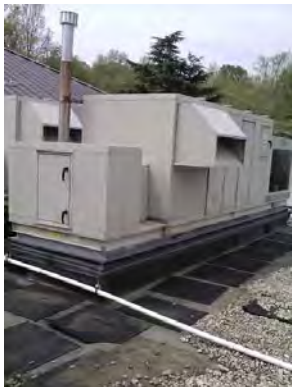
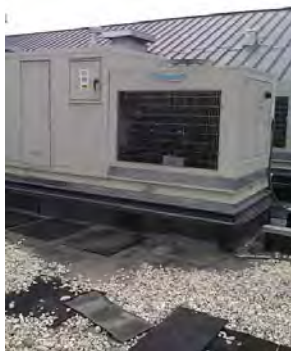
| ASSESSMENT REPORT | | | | |
|--|---|---|---|---|
| ASSESSMENT DESCRIPTION: Reports from FCPA staff indicate that Energy Recovery Unit ERU-1 serving the locker rooms does an inadequate job of cooling and dehumidifying the space. Conditions observed in the locker room during a survey on 6/17/14 could be qualitatively assessed as “comfortable”. | | | | |

| ASSESSMENT REPORT | | | | |
|--|---|---|---|---|
| RECOMMENDATION: This unit was installed in 2008 as a replacement for the unit installed during the 1995 renovations. The occasional nature of the equipment issue suggests that it is related to the unit controls. The unit is only six years old and has an anticipated remaining service life of 14 years. At the very least, we would recommend that this unit be commissioned, and inspected by a controls contractor for proper operation. However, as the remainder of the mechanical systems are generally in poor condition and require full replacement, any major renovation plans should include replacing these units as well rather than an attempted repair. Therefore, the cost provided is for full replacement. | | | | |

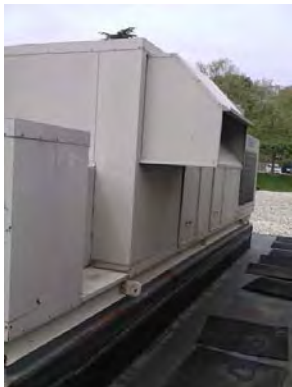
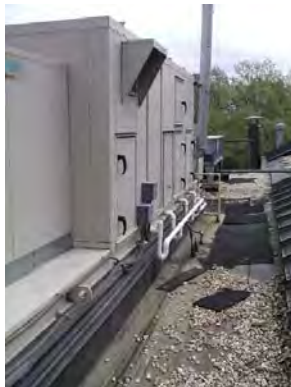
| ASSESSMENT REPORT | | | | |
|--|---|---|---|---|
| ASSESSMENT DESCRIPTION: Reports from FCPA staff indicate that Energy Recovery Unit ERU-2 serving the locker rooms does an inadequate job of cooling and dehumidifying the space. Conditions observed in the locker room during a survey on 6/17/14 could be qualitatively assessed as “comfortable”. | | | | |

| ASSESSMENT REPORT | | | | |
|--|---|---|---|---|
| RECOMMENDATION: This unit was installed in 2008 as a replacement for the unit installed during the 1995 renovations. The occasional nature of the equipment issue suggests that it is related to the unit controls. The unit is only six years old and has an anticipated remaining service life of 14 years. At the very least, we would recommend that this unit be commissioned, and inspected by a controls contractor for proper operation. However, as the remainder of the mechanical systems are generally in poor condition and require full replacement, any major renovation plans should include replacing these units as well rather than an attempted repair. Therefore, the cost provided is for full replacement. | | | | |

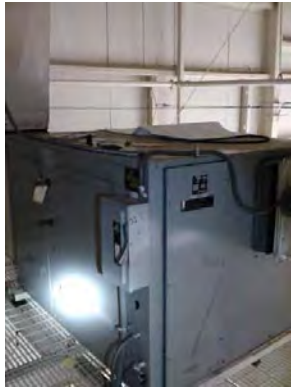
| ASSESSMENT REPORT | | | | |
|--|---|---|---|---|
| ASSESSMENT DESCRIPTION: Dehumidification Unit DH-1 is nearing the end of its serviceable life. | | | | |

| ASSESSMENT REPORT | | | | |
|--|---|---|---|---|
| RECOMMENDATION: Preparations should be made for replacement of this unit within the next two years. Replacement will include controls, flexible duct connectors, and piping of the condensate drain to the nearest storm or sanitary drain. The ductwork may be kept in place and cleaned. | | | | |

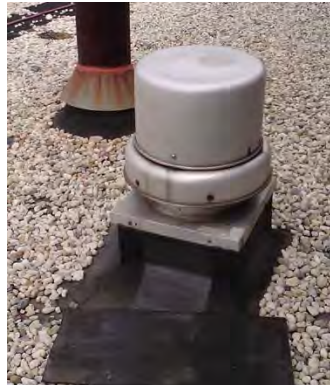
| ASSESSMENT REPORT | | | | |
|--|---|---|---|---|
| ASSESSMENT DESCRIPTION: Boiler room exhaust fan MF-1 is nearing the end of its serviceable life. Additionally, this fan exhibits significant vibration and rattling. | | | | |

| ASSESSMENT REPORT | | | | |
|--|---|---|---|---|
| RECOMMENDATION: Preparations should be made for replacement of this unit within the next two years. Replacement will include controls (speed controls and refrigerant leak detection), flexible duct connectors, and new ductwork. | | | | |

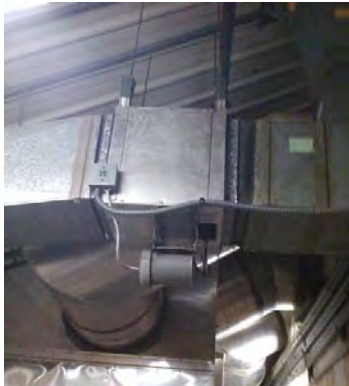
| ASSESSMENT REPORT | | | | |
|--|---|---|---|---|
| ASSESSMENT DESCRIPTION: Inline Exhaust Fan EF-2 was installed without a belt guard. | | | | |

| ASSESSMENT REPORT | | | | |
|--|---|---|---|---|
| RECOMMENDATION: Provide new belt guard for the existing fan to ensure personnel are protected from exposed rotating parts. | | | | |

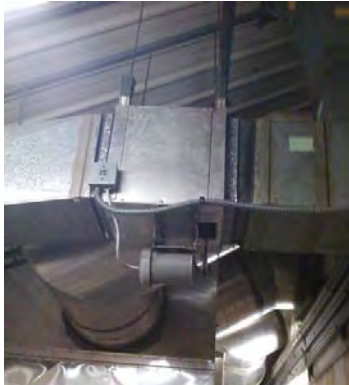
| ASSESSMENT REPORT | | | | |
|---|---|---|---|---|
| ASSESSMENT DESCRIPTION: Inline Exhaust Fan EF-2 is nearing the end of its serviceable life. | | | | |

| ASSESSMENT REPORT | | | | |
|---|---|---|---|---|
| RECOMMENDATION: Replace inline exhaust fan at the end of its service life. | | | | |

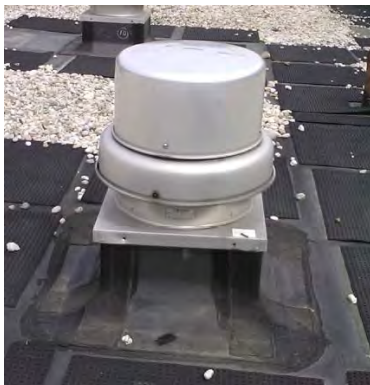
| ASSESSMENT REPORT | | | | |
|---|---|---|---|---|
| ASSESSMENT DESCRIPTION: Powered Roof Ventilator EF-3 exhibits slight rattling and vibration and is nearing the end of its serviceable life. | | | | |

| ASSESSMENT REPORT | | | | |
|---|---|---|---|---|
| RECOMMENDATION: At the very least, we would recommend that the services of a factory service representative be enlisted to perform required maintenance (belt replacement, grease bearings, etc.). However, as the remainder of the mechanical systems are generally in poor condition and require full replacement, any major renovation plans should include replacing these units as well, rather than an attempted repair. Therefore, the cost provided is for full replacement of EF-3 at the end of its service life. | | | | |

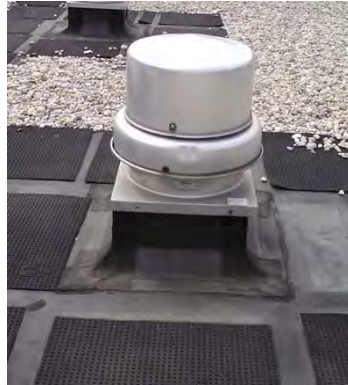
| ASSESSMENT REPORT | | | | |
|---|---|---|---|---|
| ASSESSMENT DESCRIPTION: Powered Roof Ventilator EF-4 exhibits slight rattling and vibration and is nearing the end of its serviceable life. | | | | |

| ASSESSMENT REPORT | | | | |
|---|---|---|---|---|
| RECOMMENDATION: At the very least, we would recommend that the services of a factory service representative be enlisted to perform required maintenance (belt replacement, grease bearings, etc.); and would further recommend that this fan be rebalanced by a certified Testing and Balancing firm due to the strong odors present in the room served by this fan. However, as the remainder of the mechanical systems are generally in poor condition and require full replacement, any major renovation plans should include replacing these units as well, rather than an attempted repair. Therefore, the cost provided is for full replacement of EF-4 at the end of its service life. | | | | |

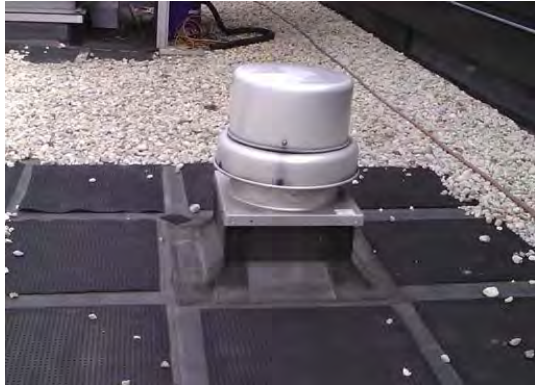
| ASSESSMENT REPORT | | | | |
|--|---|---|---|---|
| ASSESSMENT DESCRIPTION: Powered Roof Ventilator EF-5 exhibits slight rattling and vibration and is nearing the end of its serviceable life. | | | | |

| ASSESSMENT REPORT | | | | |
|--|---|---|---|---|
| RECOMMENDATION: At the very least, we would recommend that the services of a factory service representative be enlisted to perform required maintenance (belt replacement, grease bearings, etc.); and would further recommend that this fan be rebalanced by a certified Testing and Balancing firm due to the strong odors present in the Team Room served by this fan. However, as the remainder of the mechanical systems are generally in poor condition and require full replacement, any major renovation plans should include replacing these units as well, rather than an attempted repair. Therefore, the cost provided is for full replacement of EF-5 at the end of its service life. | | | | |

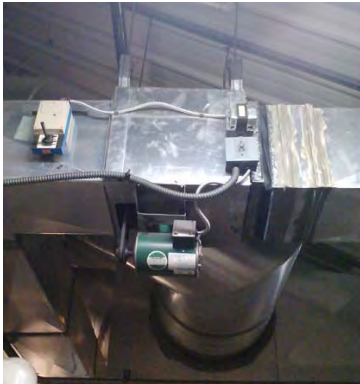
| ASSESSMENT REPORT | | | | |
|--|---|---|---|---|
| ASSESSMENT DESCRIPTION: Supply Fan SF-1 was installed without a belt guard. | | | | |

| ASSESSMENT REPORT | | | | |
|--|---|---|---|---|
| RECOMMENDATION: Provide new belt guard for the existing fan to ensure personnel are protected from exposed rotating parts. | | | | |

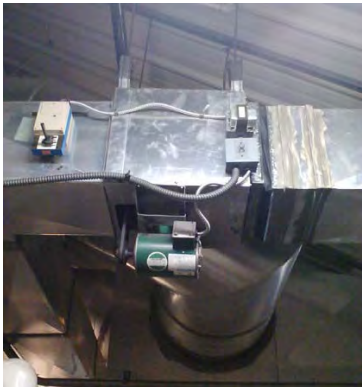
| ASSESSMENT REPORT | | | | |
|---|---|---|---|---|
| ASSESSMENT DESCRIPTION: Supply Fan SF-1 is nearing the end of its serviceable life. | | | | |

| ASSESSMENT REPORT | | | | |
|---|---|---|---|---|
| RECOMMENDATION: Replace Supply Fan SF-1 at the end of its serviceable life. | | | | |

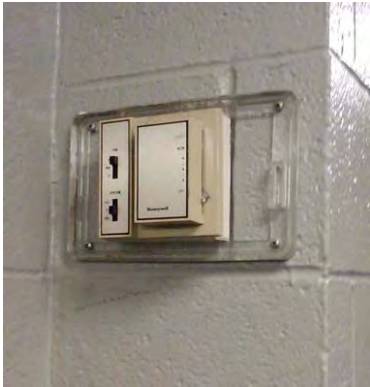
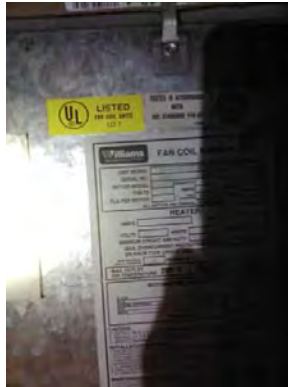
| ASSESSMENT REPORT | | | | |
|---|---|---|---|---|
| ASSESSMENT DESCRIPTION: Fan Coil Unit FCU-1 is nearing the end of its serviceable life. | | | | |

| ASSESSMENT REPORT | | | | |
|---|---|---|---|---|
| RECOMMENDATION: Preparations should be made for replacement of this fan coil unit within the next two years. Replacement will include controls, flexible duct connectors, ductwork, and re-piping of the hot water train. | | | | |

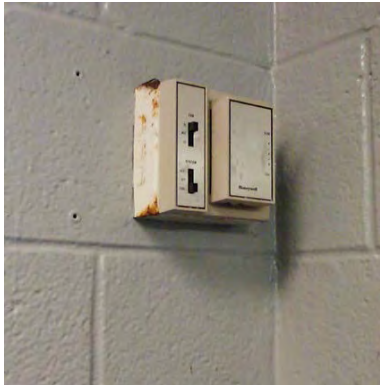
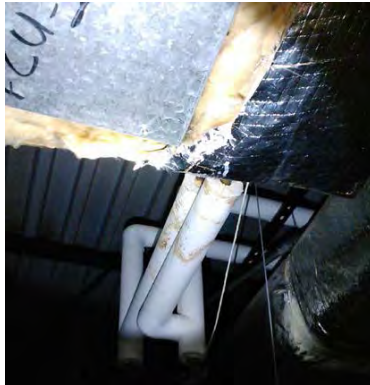
| ASSESSMENT REPORT | | | | |
|---|---|---|---|---|
| ASSESSMENT DESCRIPTION: Fan Coil Unit FCU-2 is nearing the end of its serviceable life. | | | | |

| ASSESSMENT REPORT | | | | |
|---|---|---|---|---|
| RECOMMENDATION: Preparations should be made for replacement of this fan coil unit within the next two years. Replacement will include controls, flexible duct connectors, ductwork, and re-piping of the hot water train. | | | | |

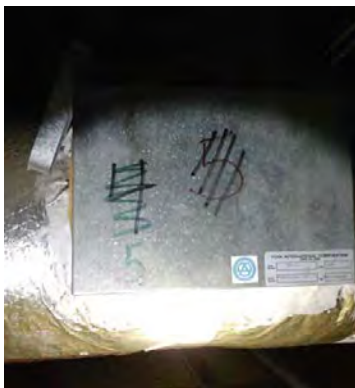
| ASSESSMENT REPORT | | | | |
|---|---|---|---|---|
| ASSESSMENT DESCRIPTION: The air terminal units serving RTU-2 are nearing the end of their serviceable lives. | | | | |

| ASSESSMENT REPORT | | | | |
|---|---|---|---|---|
| RECOMMENDATION: Preparations should be made for replacement of this fan coil unit within the next two years. Replacement will include thermostats. | | | | |

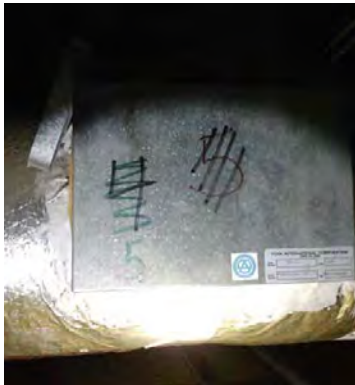
| ASSESSMENT REPORT | | | | |
|---|---|---|---|---|
| ASSESSMENT DESCRIPTION: Some of the ductwork serving RTU-2 is missing insulation. | | | | |

| ASSESSMENT REPORT | | | | |
|---|---|---|---|---|
| RECOMMENDATION: Insulate areas of ductwork where insulation has fallen off, and provide with new vapor barrier. | | | | |

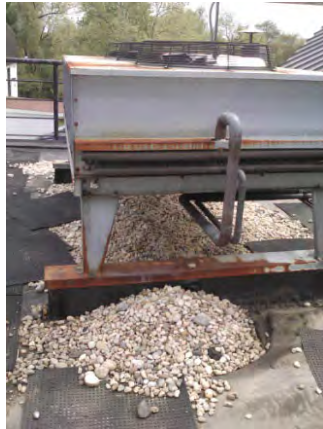
| ASSESSMENT REPORT | | | | |
|---|---|---|---|---|
| ASSESSMENT DESCRIPTION: Outdoor Condensing Unit ACCOU-1 associated with Pool Energy Recovery Unit PRU-1 is showing signs of weathering and rusting. ACCOU-1 was not energized during the survey, so no observations could be made regarding its operation; however, ACCOU-1 is nearing the end of its serviceable life. | | | | |

| ASSESSMENT REPORT | | | | |
|---|---|---|---|---|
| RECOMMENDATION: Preparations should be made for replacement of this outdoor condensing unit within the next two years. | | | | |

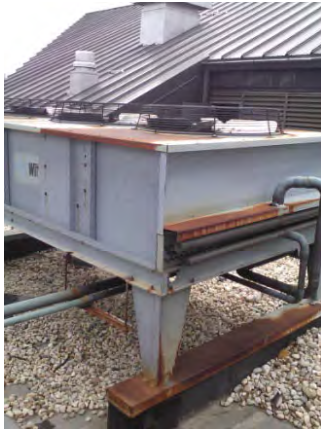
| ASSESSMENT REPORT | | | | |
|---|---|---|---|---|
| ASSESSMENT DESCRIPTION: Outdoor Condensing Unit ACCOU-2 associated with Pool Energy Recovery Unit PRU-2 is showing signs of weathering and rusting. ACCOU-2 was not energized during the survey, so no observations could be made regarding its operation; however, ACCOU-2 is nearing the end of its serviceable life. | | | | |

| ASSESSMENT REPORT | | | | |
|---|---|---|---|---|
| RECOMMENDATION: Preparations should be made for replacement of this outdoor condensing unit within the next two years. | | | | |

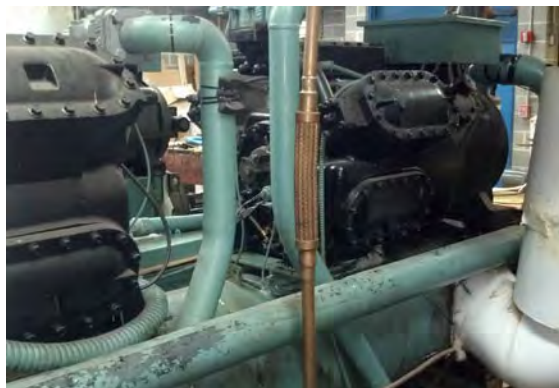
| ASSESSMENT REPORT | | | | |
|--|---|---|---|---|
| ASSESSMENT DESCRIPTION: Although they are nearing the end of their expected life cycle, the four York compressors and two chillers seem to be operating well to maintain the ice sheet to industry tolerances. | | | | |

| ASSESSMENT REPORT | | | | |
|--|---|---|---|---|
| RECOMMENDATION: Preparations should be made for replacement of this equipment in the next five years. | | | | |

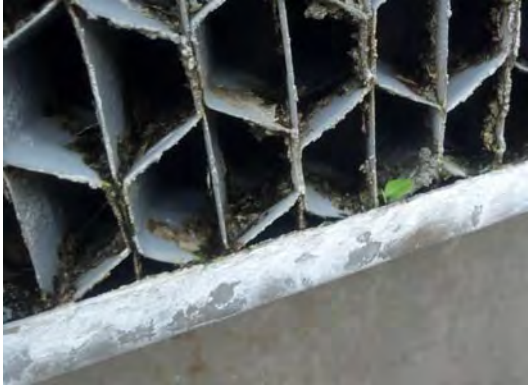
| ASSESSMENT REPORT | | | | |
|---|---|---|---|---|
| ASSESSMENT DESCRIPTION: The inside of each of the two cooling towers appears to be in very good shape. However, there is considerable algae growth and calcium deposits on the outside. | | | | |

| ASSESSMENT REPORT | | | | |
|---|---|---|---|---|
| RECOMMENDATION: Look at water treatment history to determine if more algaecide is needed and descale units (preferably every year before winter). Water treatment documents were not available at the time of the assessment. | | | | |

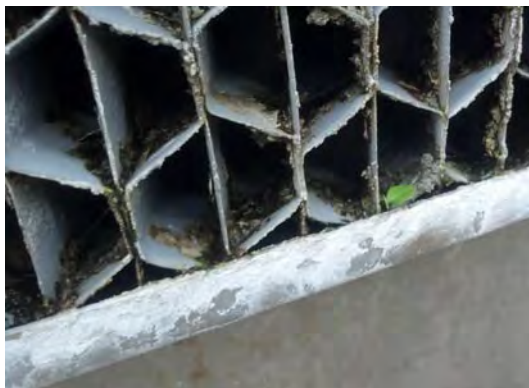
| ASSESSMENT REPORT | | | | |
|--|---|---|---|---|
| ASSESSMENT DESCRIPTION: While currently operating fine without any major maintenance issue reported from operations staff, the two cooling towers are nearing the end of their serviceable life. | | | | |

| ASSESSMENT REPORT | | | | |
|--|---|---|---|---|
| RECOMMENDATION: Preparations should be made to replace these cooling towers in the next five years. | | | | |

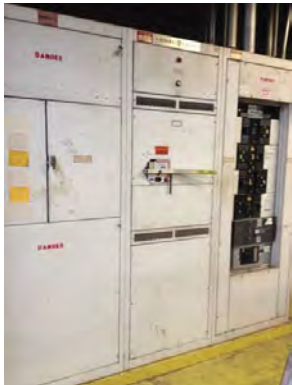
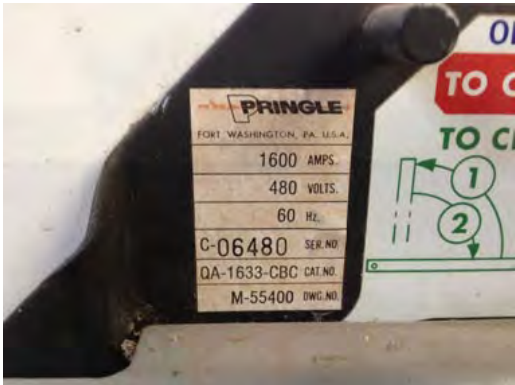
| ASSESSMENT REPORT | | | | |
|---|---|---|---|---|
| ASSESSMENT DESCRIPTION: Switchboard Main Switch, CT and Incoming Lugs: This is original equipment from 1970s. Useful life expectancy is 30 years. Benfield Electric report from 2012 indicates critical need to tighten lugs and clean dust and dirt accumulation in the remainder of the compartments (safety hazard). | | | | |

| ASSESSMENT REPORT | | | | |
|---|---|---|---|---|
| RECOMMENDATION: The non-moving parts can be maintained in a routine maintenance program. The main fusible Pringle switch and ground fault relay operation can be tested, but these are well beyond their expected life and we recommend replacement. | | | | |

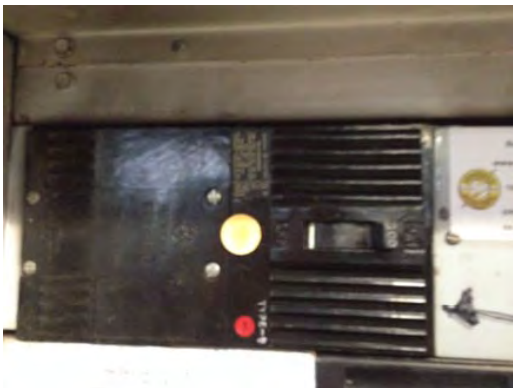
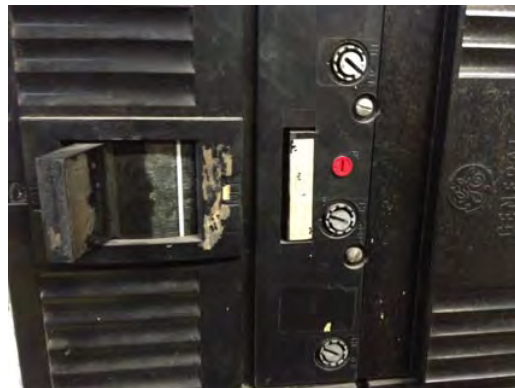
| ASSESSMENT REPORT | | | | |
|---|---|---|---|---|
| ASSESSMENT DESCRIPTION: Switchboard Distribution Breakers: This is mostly original equipment from 1970s. Useful life expectancy is 30 years. However, two of the breakers have been replaced in recent years and we'd expect the remainder would need to be replaced. | | | | |

| ASSESSMENT REPORT | | | | |
|---|---|---|---|---|
| RECOMMENDATION: Replace the 100 amp, 60 amp, and (2) 300 amp, and 400 amp 3 pole breakers and provide permanent labeling of all the feeder breakers. Tighten the bus bars inside the section and thoroughly clean the interior. | | | | |

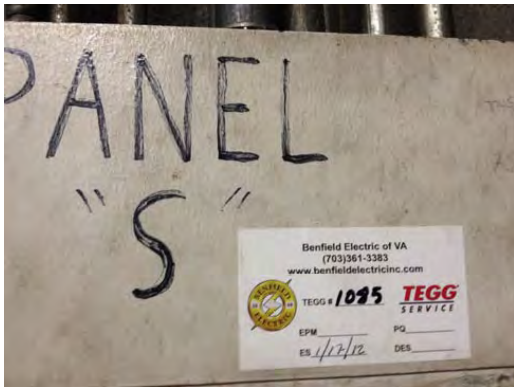
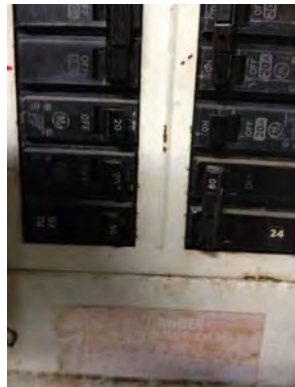
| ASSESSMENT REPORT | | | | |
|--|---|---|---|---|
| ASSESSMENT DESCRIPTION: Panels S, MLO, 100 amp, 120/208 volt, 36 poles: This is an original panel that has outlived its useful life. It serves house loads. | | | | |

| ASSESSMENT REPORT | | | | |
|--|---|---|---|---|
| RECOMMENDATION: Replace with new panel and confirm and tag all existing circuits. New branch circuit breakers to serve all existing loads. Reconnect to source and to all branch circuits. | | | | |

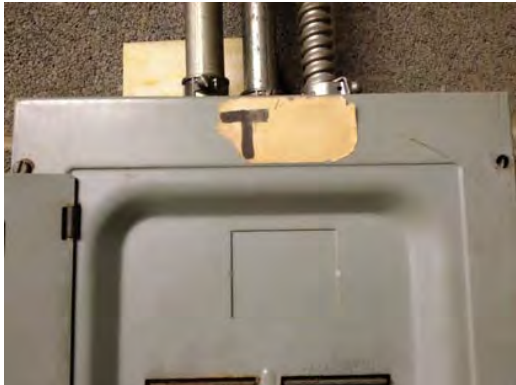
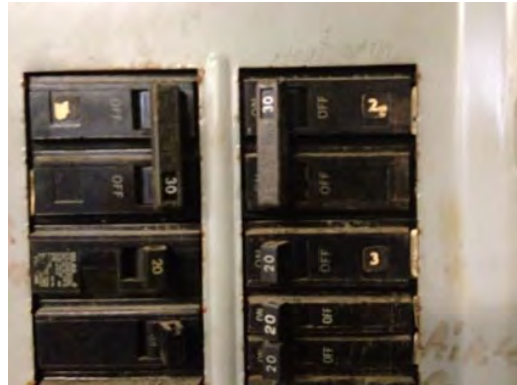
| ASSESSMENT REPORT | | | | |
|---|---|---|---|---|
| ASSESSMENT DESCRIPTION: Panels T, MLO, 100 amp, 120/208 volt, 12 poles: This is a newer load center (non-commercial grade electrical panel) that we believe is not a properly matched solution for this Facility. It also has early signs of corrosion (rust). It serves house loads. | | | | |

| ASSESSMENT REPORT | | | | |
|---|---|---|---|---|
| RECOMMENDATION: Replace with new panel and confirm and tag all existing circuits. New branch circuit breakers to serve all existing loads. Reconnect to source and to all branch circuits. | | | | |

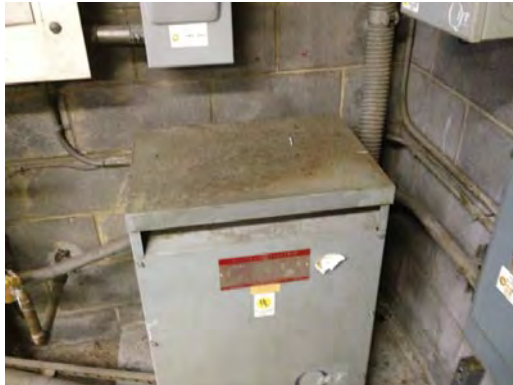
| ASSESSMENT REPORT | | | | |
|---|---|---|---|---|
| ASSESSMENT DESCRIPTION: Dry type step down transformer that converts 480 volt power to 120/208 volt power. This appears to be original equipment. Typically transformers last 30 or more years but given the conditions of the Compressor Room (hot and humid), this transformer should be replaced as it is showing signs of exterior corrosion. | | | | |

| ASSESSMENT REPORT | | | | |
|---|---|---|---|---|
| RECOMMENDATION: Replace with new 45 KVA transformer of the same general ratings. | | | | |

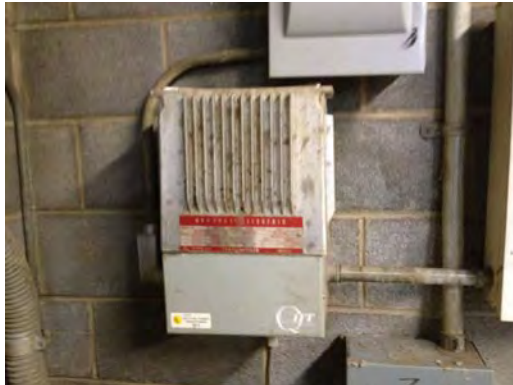
| ASSESSMENT REPORT | | | | |
|--|---|---|---|---|
| ASSESSMENT DESCRIPTION: Dry type step down transformer that converts 480 volt power to 120/208 volt power. This appears to be original equipment. Typically transformers last 30 or more years but given the conditions of the Mechanical Room (hot and humid), this transformer should be replaced it is showing signs of exterior corrosion. | | | | |

| ASSESSMENT REPORT | | | | |
|--|---|---|---|---|
| RECOMMENDATION: Replace with new 7.5 KVA transformer of the same general ratings. | | | | |

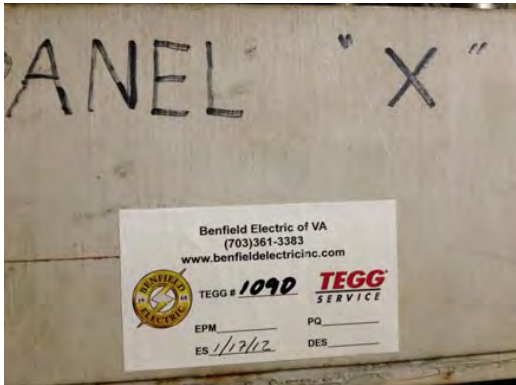
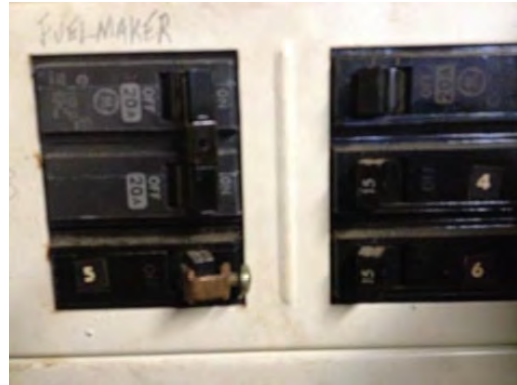
| ASSESSMENT REPORT | | | | |
|--|---|---|---|---|
| ASSESSMENT DESCRIPTION: Panel X, MLO, 60 amp, 120/240 volt, single phase, 12 poles. This is an original panel that has outlived its useful life. It serves house life safety loads. | | | | |

| ASSESSMENT REPORT | | | | |
|--|---|---|---|---|
| RECOMMENDATION: Replace with new panel and confirm and tag all existing circuits. New branch circuit breakers to serve all existing loads. Reconnect to source and to all branch circuits. | | | | |

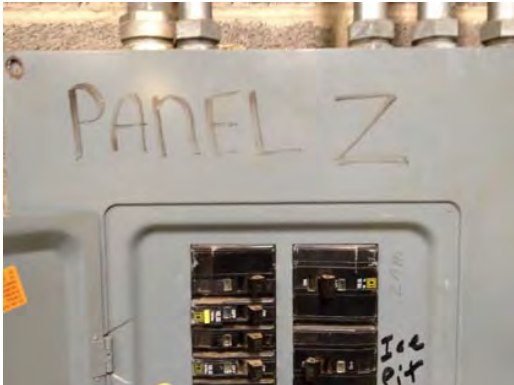
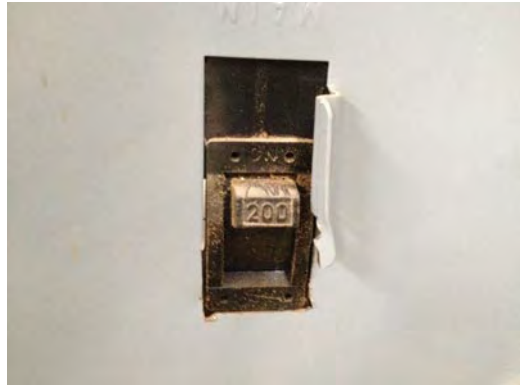
| ASSESSMENT REPORT | | | | |
|--|---|---|---|---|
| ASSESSMENT DESCRIPTION: Panel Z, MLO, 200 amp, 120/208 volt, 40 poles. This is a newer load center (non-commercial grade electrical panel) that we believe is not a properly matched solution for this facility. It also is missing exterior fasteners. It serves house loads. | | | | |

| ASSESSMENT REPORT | | | | |
|--|---|---|---|---|
| RECOMMENDATION: Replace with new panel and confirm and tag all existing circuits. New branch circuit breakers to serve all existing loads. Reconnect to source and to all branch circuits. | | | | |

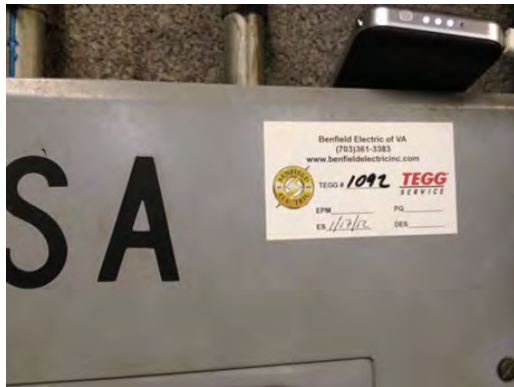
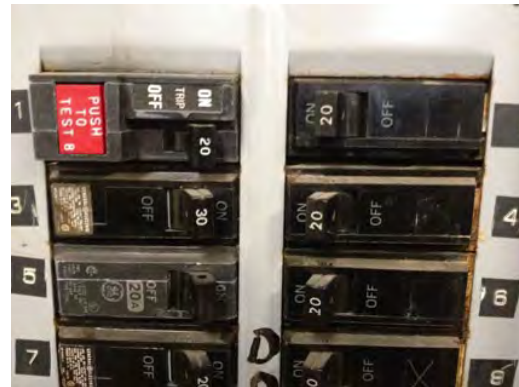
| ASSESSMENT REPORT | | | | |
|--|---|---|---|---|
| ASSESSMENT DESCRIPTION: Panel SA, MLO, 125 amp, 120/208 volt, single phase, 18 poles. This is a newer panel, but exhibits rust damage in many areas. It serves house loads. | | | | |

| ASSESSMENT REPORT | | | | |
|--|---|---|---|---|
| RECOMMENDATION: Replace with new panel and confirm and tag all existing circuits. New branch circuit breakers to serve all existing loads. Reconnect to source and to all branch circuits. | | | | |

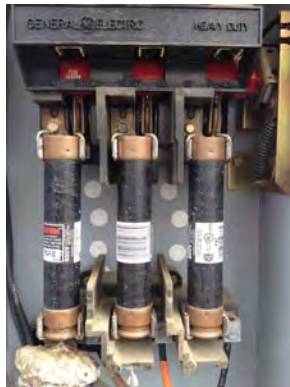
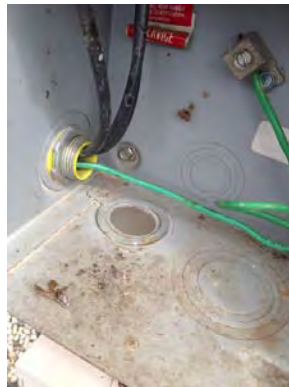
| ASSESSMENT REPORT | | | | |
|---|---|---|---|---|
| ASSESSMENT DESCRIPTION: The disconnect for roof mounted equipment ACCOU-2 has a missing knock out on its bottom surface which has allowed the infiltration of wasps whose nest could cause a failure. | | | | |

| ASSESSMENT REPORT | | | | |
|---|---|---|---|---|
| RECOMMENDATION: Provide a permanent knock-out cover. Should be done very soon to avoid possible damage to the system. | | | | |

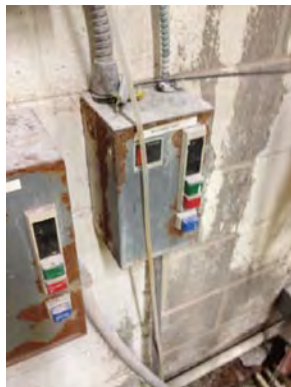
| ASSESSMENT REPORT | | | | |
|---|---|---|---|---|
| ASSESSMENT DESCRIPTION: The starters for the pool pump equipment are severely corroded and could possibly fail. | | | | |

| ASSESSMENT REPORT | | | | |
|---|---|---|---|---|
| RECOMMENDATION: Provide new starters for main pool and for back wash pump. | | | | |

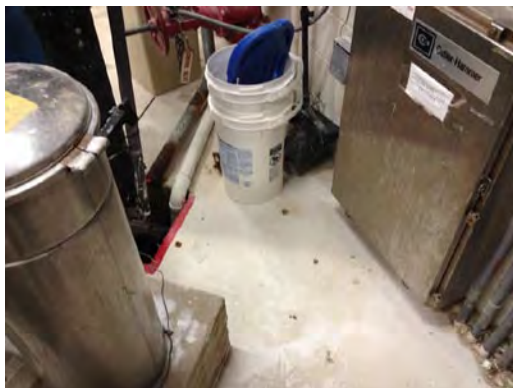
| ASSESSMENT REPORT | | | | |
|---|---|---|---|---|
| ASSESSMENT DESCRIPTION: Filter canister pad impinges on Code required 3 feet of clearance in front of panel. | | | | |

| ASSESSMENT REPORT | | | | |
|---|---|---|---|---|
| RECOMMENDATION: No solution possible without removal of canister pad. Rework of filter room as part of Aquatics recommendations should free up space for code compliant installation. | | | | |

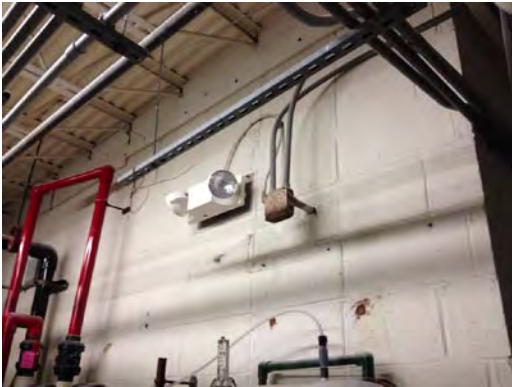
| ASSESSMENT REPORT | | | | |
|--|---|---|---|---|
| ASSESSMENT DESCRIPTION: Corrosion of existing original era equipment and conduits is rapidly deteriorating electrical system and is becoming a safety concern. | | | | |

| ASSESSMENT REPORT | | | | |
|--|---|---|---|---|
| RECOMMENDATION: Replace all metal conduit with PVC. Replace Nema 1 enclosures with Nema 4 enclosures and metal outlet and switch boxes with heavy duty plastic or nylon boxes. | | | | |

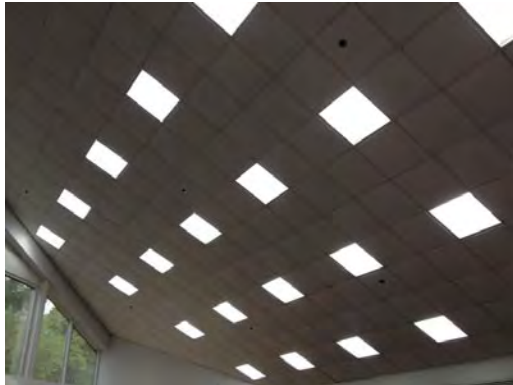
| ASSESSMENT REPORT | | | | |
|---|---|---|---|---|
| ASSESSMENT DESCRIPTION: Lighting fixtures throughout the Building are not meeting current IECC watts per square foot requirements nor are they controlled in a manner that meets IECC requirements. IECC has no enforcement mechanism that would force compliance. However substantial energy saving could be realized with a total replacement. | | | | |

| ASSESSMENT REPORT | | | | |
|---|---|---|---|---|
| RECOMMENDATION: Do a phased replacement of all lighting in the Facility except for new LED lighting in the Pool. This would include the parking pole fixtures as well. FCPA guidelines would require the use of LED fixtures wherever possible. Special consideration would be given to the lighting in the main lobby (pictured) that would provide not only illumination but also drama and interest. LED linear pendants would be considered in this area. Also we believe that all emergency egress battery backs and battery backed exit signs should be replaced. | | | | |

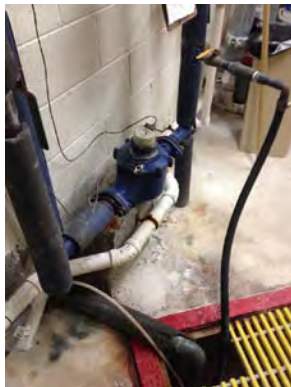
| ASSESSMENT REPORT | | | | |
|---|---|---|---|---|
| ASSESSMENT DESCRIPTION: Domestic water backflow preventer is not installed per Code. Need to upgrade to RPZ ASPE 1013. | | | | |

| ASSESSMENT REPORT | | | | |
|---|---|---|---|---|
| RECOMMENDATION: Install new RPZ ASPE 1013 in lieu of existing arrangement. An even better solution would be to remove this critical installation from this room to prevent corrosion issues. Recommend installation of new water service at alternative location. | | | | |

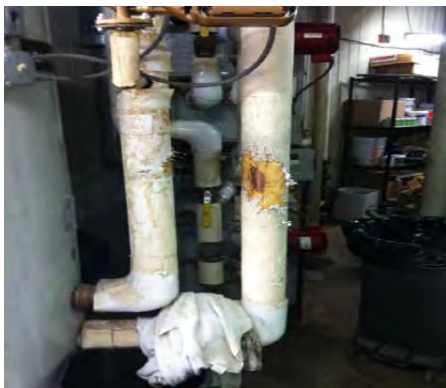
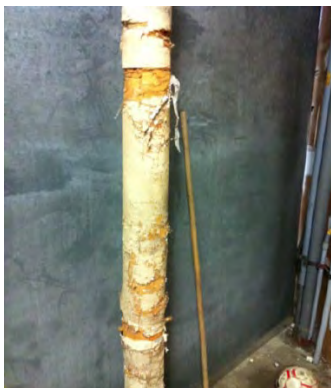
| ASSESSMENT REPORT | | | | |
|--|---|---|---|---|
| ASSESSMENT DESCRIPTION: Domestic water pipe insulation damaged or missing in many locations. | | | | |

| ASSESSMENT REPORT | | | | |
|--|---|---|---|---|
| RECOMMENDATION: Replace all damaged domestics water pipe insulation; and add new pipe insulation where it is currently missing. | | | | |
