Mt. Vernon Recreation Center

Facility Condition Assessment and Life Cycle Cost Analysis

Fairfax County Park Authority

Prepared by: Hughes Group Architects
October 24, 2014

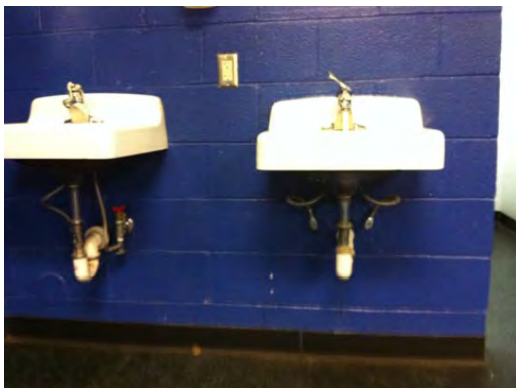
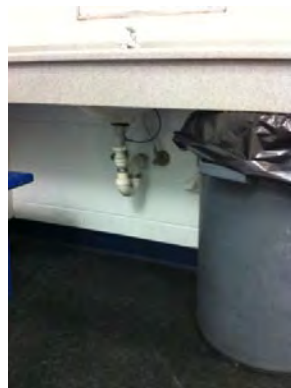
| ASSESSMENT REPORT | | | | |
|--|---|---|---|---|
| ASSESSMENT DESCRIPTION: Damaged and missing sink insulation. | | | | |

| ASSESSMENT REPORT | | | | |
|--|---|---|---|---|
| RECOMMENDATION: Replace sink trap insulation and add new sink insulation where it is currently missing. This is important to meet ADA requirements. | | | | |

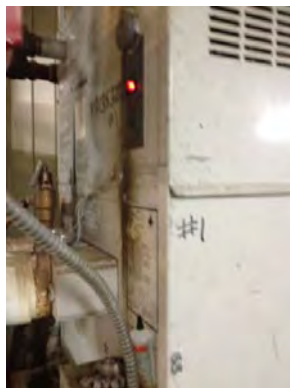
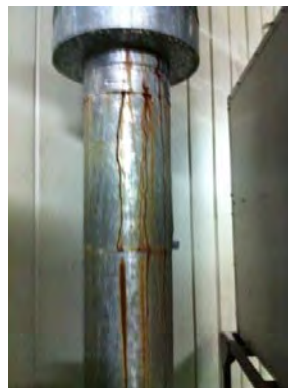
| ASSESSMENT REPORT | | | | |
|--|---|---|---|---|
| ASSESSMENT DESCRIPTION: Water heater at Mechanical Room beyond useful life. Associated flue is rusty. | | | | |

| ASSESSMENT REPORT | | | | |
|--|---|---|---|---|
| RECOMMENDATION: Replace with new water heater, associated pumps and flue. Flue is nearly rusted through at size transition. | | | | |

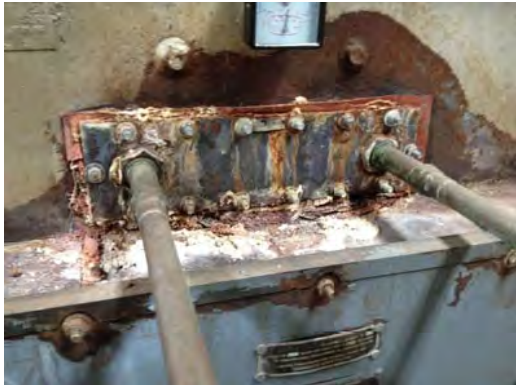
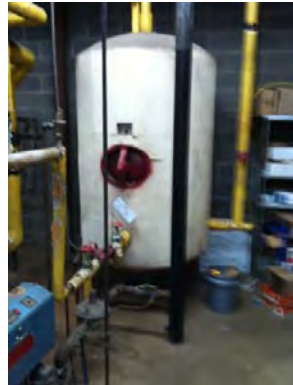
| ASSESSMENT REPORT | | | | |
|---|---|---|---|---|
| ASSESSMENT DESCRIPTION: Old hot water generator and immersion coil, storage tank beyond life expectancy. | | | | |

| ASSESSMENT REPORT | | | | |
|---|---|---|---|---|
| RECOMMENDATION: Replace old water heater generator, immersion coil, storage tank and associated pumps with new. Efficiency will be increased by Code mandated higher efficiency model. Hot water generator referenced in other reports. | | | | |

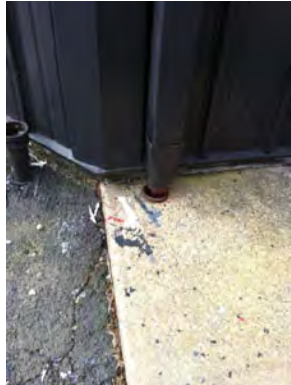
| ASSESSMENT REPORT | | | | |
|--|---|---|---|---|
| ASSESSMENT DESCRIPTION: Downspouts do not connect properly to underground storm stub up. | | | | |

| ASSESSMENT REPORT | | | | |
|--|---|---|---|---|
| RECOMMENDATION: Provide downspout boot connection at downspouts | | | | |

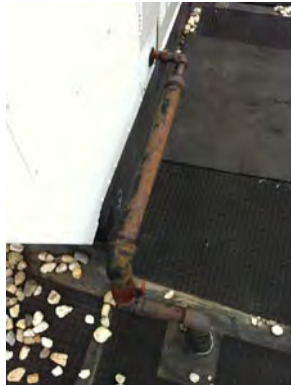
| ASSESSMENT REPORT | | | | |
|---|---|---|---|---|
| ASSESSMENT DESCRIPTION: Gas piping paint is peeling and/or pipe is rusting. | | | | |

| ASSESSMENT REPORT | | | | |
|---|---|---|---|---|
| RECOMMENDATION: Remove rust and old paint, for nine roof top equipment locations; repaint with appropriate exterior grade paint. Replacement of gas piping has been factored into the replacement costs to replace individual HVAC equipment and other systems which utilize natural gas. | | | | |

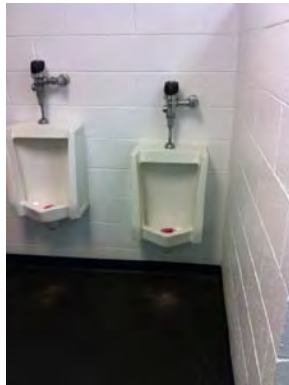
| ASSESSMENT REPORT | | | | |
|--|---|---|---|---|
| ASSESSMENT DESCRIPTION: During our assessment, we analyzed and evaluated of the overall conditions of the plumbing fixtures. The existing fixtures do not meet Code for water savings. Many of the existing fixtures have been retrofitted with auto flush and auto sensor flow but, in general, all plumbing fixtures are nearing the end of their life span. | | | | |

| ASSESSMENT REPORT | | | | |
|--|---|---|---|---|
| RECOMMENDATION: Make provisions for new lavatories, urinals, EWCs and water closets compliant with current ADA and IPC requirements. New fixtures should have 120V auto sensor technology (per FCPA standard) and not battery powered sensors as they have been currently retrofitted. | | | | |

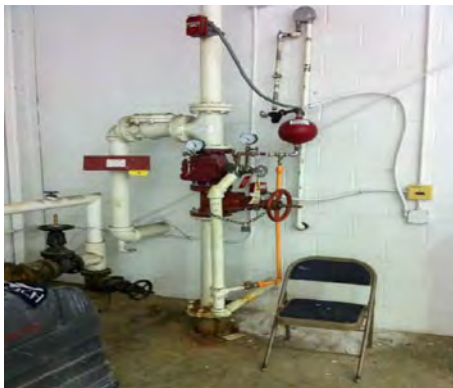
| ASSESSMENT REPORT | | | | |
|--|---|---|---|---|
| ASSESSMENT DESCRIPTION: Ice Rink and the remainder of the original building fire protection water service are without back flow prevention. | | | | |

| ASSESSMENT REPORT | | | | |
|--|---|---|---|---|
| RECOMMENDATION: Provide back flow prevention at fire protection water service (Current Code requirement). Any new substantial work in building such as an addition would require this upgrade. Current code does not make upgrade necessary in existing buildings, however the backward flow of water from the in-building sprinkler lines could present a health issue. | | | | |

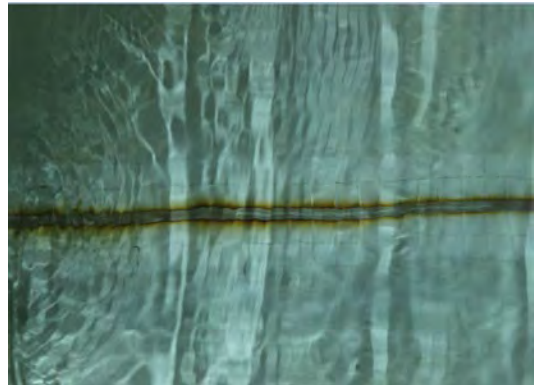
| ASSESSMENT REPORT | | | | |
|---|--|---|---|---|
| ASSESSMENT DESCRIPTION: The submerged pool plaster finish is pitted, chipped and etched. Staining was noted around floor inlets. The pool operator reported that the pool finish is approximately 3 years old. The operator added that the pool has been refinished several times in its life, without removal of the existing finishes. The inconsistencies in the pool surface due to pitting and etching could pose a safety hazard to feet and other skin surface that come in contact with the pool finish. The expansion joints are lined by tile on each side. The expansion joint caulk is heavily stained on the edges. The stain color is consistent with oxidized iron and appears to be coming from the caulk material or corrosion of pool steel below the joint. The consistency of the stain along the entire length of each joint points more towards a joint material failure than corrosion of the pool steel. | | | | |

| ASSESSMENT REPORT | | | | |
|---|--|---|---|---|
| RECOMMENDATION: <ul style="list-style-type: none">Remove existing finishes, provide manufacturer's recommended bonding agent, and refinish the pool with quartz aggregate type finish. If staining is from the source water, WTI recommends a 12"x12" pattern of white tile around each inlet to make these areas easier to clean.Remove joint filler materials, review steel integrity.Provide pool chemical resistant joint filler materials. | | | | |

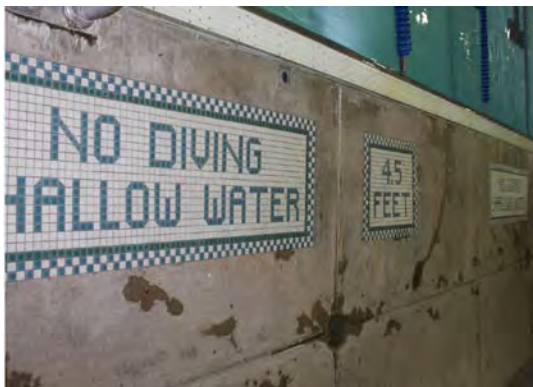
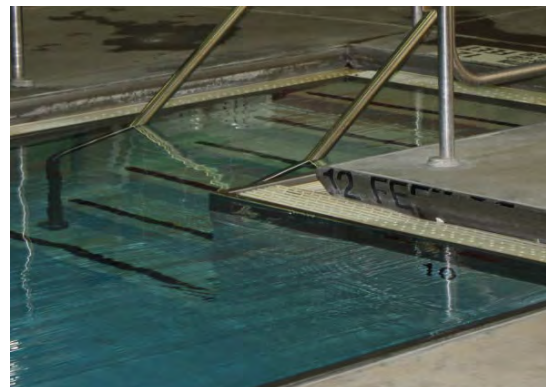
The wall and deck depth markers are in good to excellent service condition.

- The wall depth markers on the pool gutter consist of vinyl stick on numbers and letters. These were in good condition for the most part. A few stick on numbers and letters need to be replaced. Additionally, tile depth markers have been added below the water line.

- Add depth markers at beach entry and adjacent swimming area.
- Survey the pool depth to confirm depth markers are accurate after several years of pool refinishing.

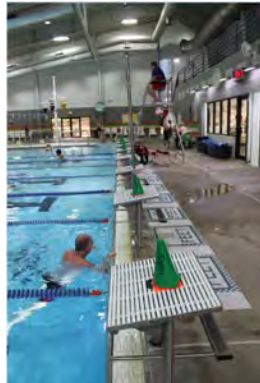
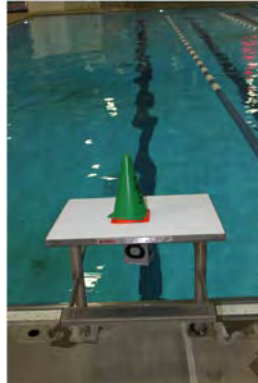
| ASSESSMENT REPORT | | | | |
|---|---|---|---|---|
| ASSESSMENT DESCRIPTION: There are eight starting platforms located on the pool deck. They are located in water depths ranging from 4.5 feet to 12 feet according to the depth markers. The blocks are in good condition, with minor corrosion of the stainless steel components. The blocks appeared to be very sturdy, with no movement noted. | | | | |

| ASSESSMENT REPORT | | | | |
|---|---|---|---|---|
| RECOMMENDATION: Survey the pool empty to verify the pool water depth at the blocks is consistent with the governing swimming body (NFHSA, USA, NCAA) that is utilized at the pool. If pool depth is inadequate, then starting platforms shall be removed. Otherwise, observe condition daily. | | | | |

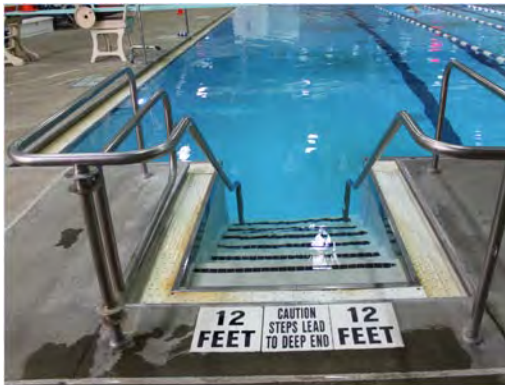
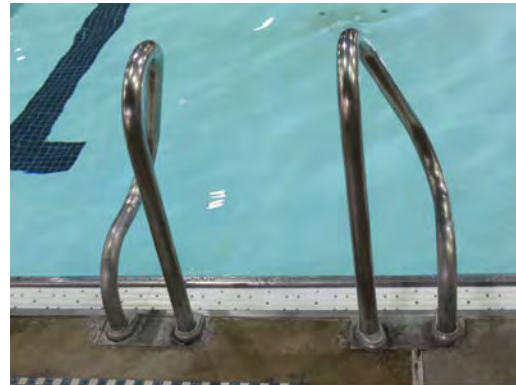
The deep end stairs are 48" wide with a width between the rails of 35". The riser height is 9" for all risers except the riser that terminates at the gutter's edge, which is only 4". 69.1-2-10.B.2 requires the stairs to be compliant with VUSBC. A patron at the facility indicated that the inconsistency of the top riser was troublesome as a user. The railing on the stair is in good condition with mild to moderate corrosion on surface of the stainless steel. The left hand side of the rail included unusual flange type pieces in the vertical support that may be from a previous repair.

Revise stair riser heights such that all are uniform.

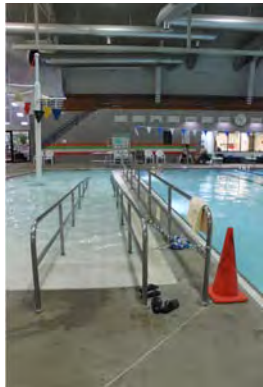
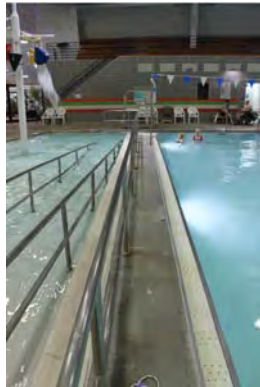
| ASSESSMENT REPORT | | | | |
|--|---|---|---|---|
| ASSESSMENT DESCRIPTION: The pool is over 300 linear feet in perimeter, which means that at least two accessible means of entry shall be provided. The primary means must be a lift or sloped entry. The ramp in the beach entry is 40 feet long and terminates in 36" of water. The width between the rails is 37.25" and the railing height is 33.25". The Section 1009.3.2 of the 2010 ADA standards requires, "at least one <u>landing shall be located 24 inches minimum and 30" maximum</u> below the stationary water level." Based on the field measurements, the existing ramp is non-compliant with the requirement for a landing and therefore cannot count toward the two means of accessible entry required. Modification of the ramp would be challenging and would require either modifying the entire beach entry area or providing a peninsula wall between the ramp and beach entry. Additional means of accessible entry are missing at the swimming pool. The Operator verbally indicated that they were in process of securing an ADA compliant lift. A hydraulic connection is already in place at the pool deck for the future lift. | | | | |

| ASSESSMENT REPORT | | | | |
|--|---|---|---|---|
| RECOMMENDATION: <ul style="list-style-type: none">Survey the pool when empty to confirm exact dimensions of sloped entry and rail spacing dimensions.Install ADA lift as primary means of ADA entry. Lift must comply with 1009.2 of the 2010 ADA Standards. | | | | |

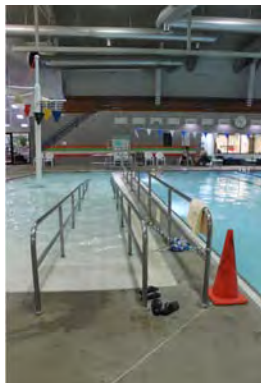
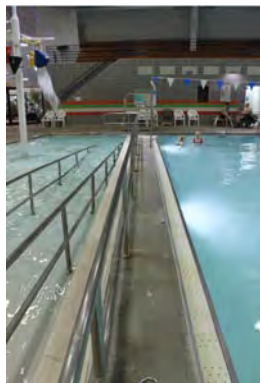
| ASSESSMENT REPORT | | | | |
|--|---|---|---|---|
| ASSESSMENT DESCRIPTION: The pool is over 300 linear feet in perimeter, which means that at least two accessible means of entry shall be provided. The primary means must be a lift or sloped entry. The ramp in the beach entry is 40 feet long and terminates in 36" of water. The width between the rails is 37.25" and the railing height is 33.25". The Section 1009.3.2 of the 2010 ADA standards requires, "at least one <u>landing shall be located 24 inches minimum and 30" maximum</u> below the stationary water level." Based on the field measurements, the existing ramp is non-compliant with the requirement for a landing and therefore cannot count toward the two means of accessible entry required. Modification of the ramp would be challenging and would require either modifying the entire beach entry area or providing a peninsula wall between the ramp and beach entry. Additional means of accessible entry are missing at the swimming pool. The Operator verbally indicated that they were in process of securing an ADA compliant lift. A hydraulic connection is already in place at the pool deck for the future lift. When the lift is in place, the pool will still be missing a secondary compliant means of ADA access. | | | | |

| ASSESSMENT REPORT | | | | |
|--|---|---|---|---|
| RECOMMENDATION: <ul style="list-style-type: none">Install secondary means of ADA entry. A hydraulic lift compliant with 1009.2 is recommended. | | | | |

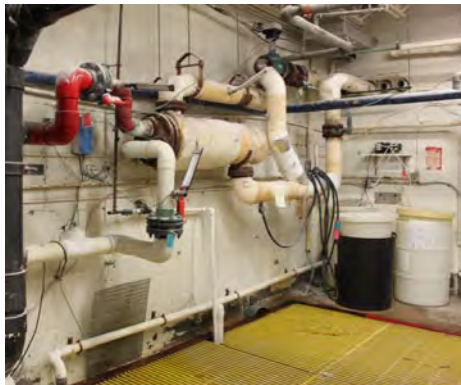
| ASSESSMENT REPORT | | | | |
|--|---|---|---|---|
| ASSESSMENT DESCRIPTION: The pool utilized a heat exchanger with a building heat system to maintain water temperature. The operator reported that they are able to maintain pool temperature. The heat exchanger is fully evaluated in the building mechanical scope of the report. The exterior of the heat exchanger showed heavy corrosion. The pool water side connections of the heat exchanger appear to be PVC, but were painted so that the type of PVC could not be noted. | | | | |

| ASSESSMENT REPORT | | | | |
|--|---|---|---|---|
| RECOMMENDATION: Replace pool water piping with CPVC or Copper pipe. Defer to the Mechanical section of report for recommendations on the pool heat exchanger. | | | | |

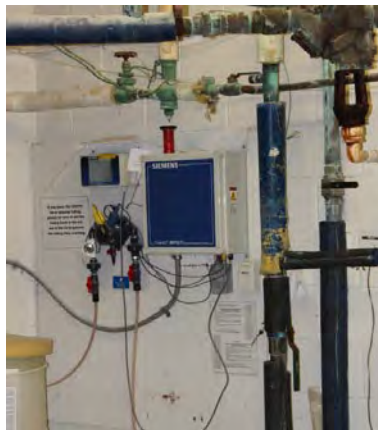
| ASSESSMENT REPORT | | | | |
|--|--|---|---|---|
| ASSESSMENT DESCRIPTION: The pool chemical controller is a Siemens Impact chemical controller. The Impact controller has been discontinued by the manufacturer and is currently serviced with "new old parts". Maintaining and servicing the chemical controller will become more difficult as time goes on. It is currently operating well, appears in good condition, and is interlocked via the manufacturer's flow cell. | | | | |

| ASSESSMENT REPORT | | | | |
|--|--|---|---|---|
| RECOMMENDATION: <ul style="list-style-type: none">• Provide a secondary, electrical interlock direct to the filtration pump such that if the filtration pump is off, chemical cannot feed, even if the flow cell is reading flow.• Replace the chemical controller, as necessary, when parts are no longer available for service. | | | | |

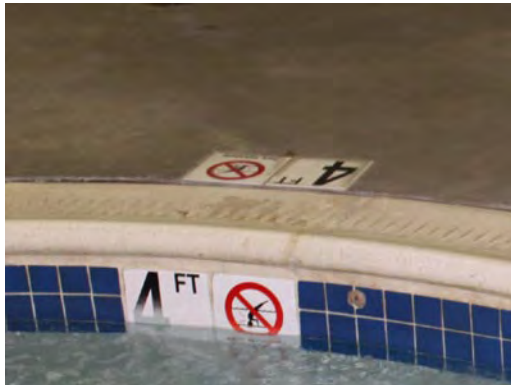
| ASSESSMENT REPORT | | | | |
|---|--|---|---|---|
| ASSESSMENT DESCRIPTION: The spa includes two pair of deck and wall depth markers. The depth markers are slip-resistant tile and indicate 4FT water depth and include the international "no diving" symbol. Other than discoloration, the depth markers are in good condition. | | | | |

| ASSESSMENT REPORT | | | | |
|---|--|---|---|---|
| RECOMMENDATION: <ul style="list-style-type: none">• Provide a deep cleaning• Anticipate replacement in 12 years | | | | |

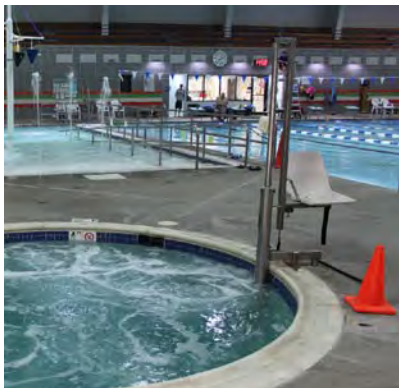
| ASSESSMENT REPORT | | | | |
|---|---|---|---|---|
| ASSESSMENT DESCRIPTION: The one required means of accessible entry into the spa is provided by a hydraulically powered pool lift. The lift is functional and in good service condition. | | | | |

| ASSESSMENT REPORT | | | | |
|---|---|---|---|---|
| RECOMMENDATION: Status quo. Anticipate replacement in 12 years. | | | | |

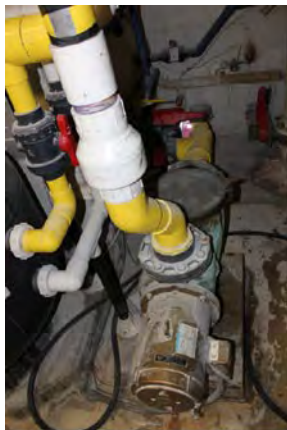
| ASSESSMENT REPORT | | | | |
|---|---|---|---|---|
| ASSESSMENT DESCRIPTION: The spa pool filtration pump is a Pac-Fab (Pentair) CMK-75, self-priming commercial bronze swimming pool pump with integral strainer. There were no pressure gauges installed on the suction side of the pump, so the operating flow could not be pinpointed on the manufacturer's design curve. The flow meter reading was approximately 260 GPM, design flow rate on the drawings is 205 GPM. The pump body was moderately corroded. | | | | |

| ASSESSMENT REPORT | | | | |
|---|---|---|---|---|
| RECOMMENDATION: <ul style="list-style-type: none">• Install pressure gauges in the suction and discharge PVC flange connections for compliance with chapter 69.1 and so that pump performance can be evaluated.• Adjust pump to design flow rate, unless there is operational justification for the higher flow rate. | | | | |

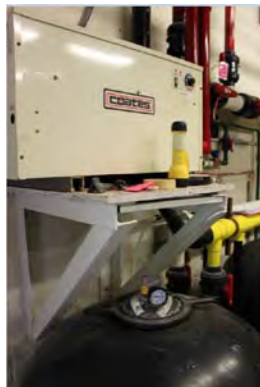
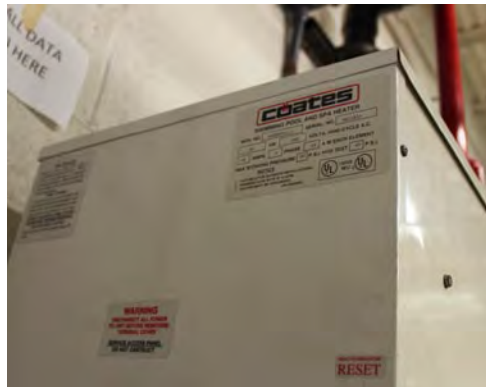
| ASSESSMENT REPORT | | | | |
|---|---|---|---|---|
| ASSESSMENT DESCRIPTION: The spa pool heater is an electric swimming pool and spa heater manufactured by Coates, model number 34836PHS-3. The operator reports that the spa heater has been working well and maintaining heat. | | | | |

| ASSESSMENT REPORT | | | | |
|---|---|---|---|---|
| RECOMMENDATION: Status quo. Anticipate replacement in 12 years. | | | | |

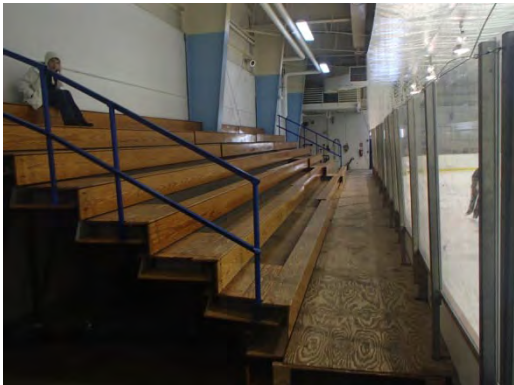
| ASSESSMENT REPORT | | | | |
|---|---|---|---|---|
| ASSESSMENT DESCRIPTION: There are two sets of wall-mounted telescopic wooden bleachers that were installed in the '70s during the original construction of the Ice Rink Facility. The age and condition of the bleachers are past there useable life span. There are visible spots of splinters. At the base of the bleachers, little children can access underneath the seats, which is a liability hazard. Additional boards were added to cover the gap between the dasher boards and bleachers. The bleachers are not ADA compliant either and would not meet code for bleachers today. | | | | |

| ASSESSMENT REPORT | | | | |
|---|---|---|---|---|
| RECOMMENDATION: Replace current system with a new ADA compliant wall-mounted telescopic aluminum bleacher system with plastic covers on seating. | | | | |

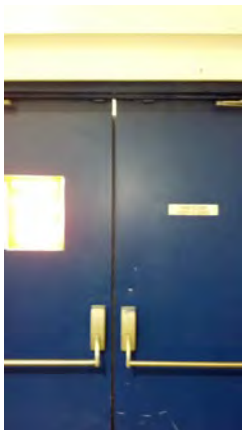
| ASSESSMENT REPORT | | | | |
|---|---|---|---|---|
| ASSESSMENT DESCRIPTION: Weather stripping on each exterior door has been compromised. Every exterior door in the rink section of the building is missing some part of its weather stripping. This might seem to be minor, but the envelope of an ice rink building is very important to reduce energy costs, reduce humidity and provide great ice quality. During the spring and summer months these small openings to the outside environment add unneeded load to the entire refrigeration system. | | | | |

| ASSESSMENT REPORT | | | | |
|---|---|---|---|---|
| RECOMMENDATION: Replace all weather stripping between doors and on their bottoms. | | | | |
