PHYSICIAN'S RESIDENCE

HISTORIC STRUCTURE REPORT

PROPERTY DESCRIPTION, ASSESSMENT, AND RECOMMENDATIONS

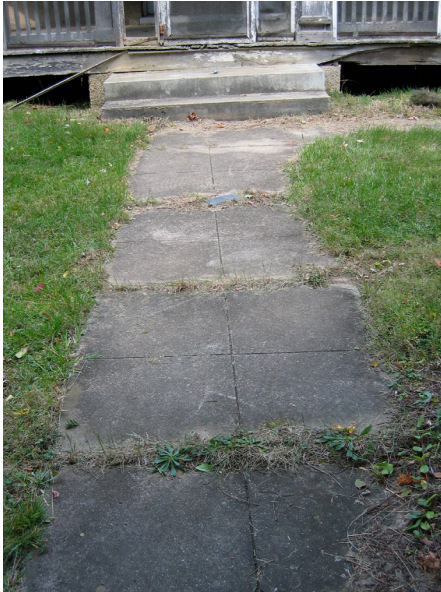
Figure 3.5 The concrete front walk is in need of general maintenance.

The driveway is in fair condition, however, there is no parking area for the house or handicap access. Most of the sidewalks are overgrown and show settlement or deterioration.

Provide new sidewalks as required for handicap access to rear of the building from the new parking area. Replace selected sidewalks as needed.

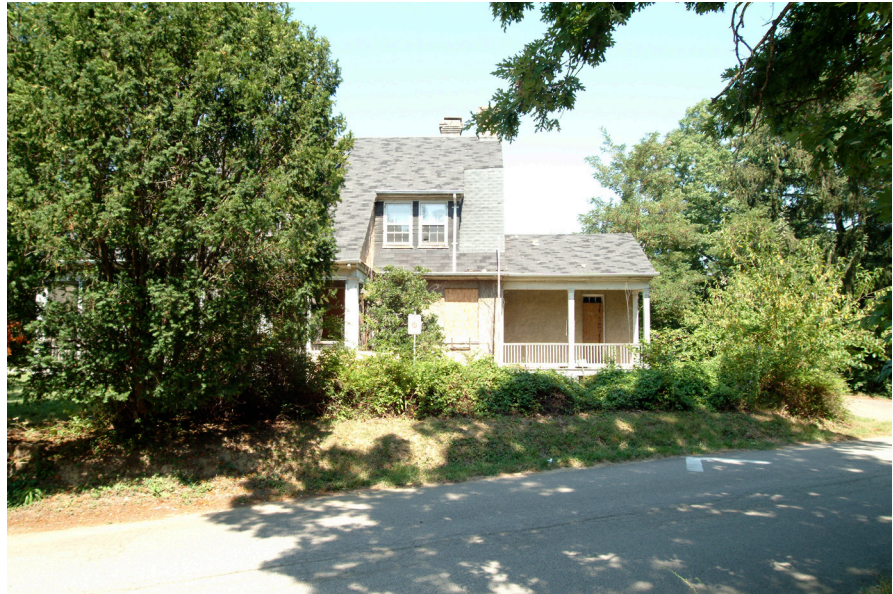
Figure 3.8 A hedge extends from the yews at the front walk entrance to more upright forms at the entrance to the driveway.

At the eastern driveway entrance, a number of tree saplings have taken root and detract from the formality of the hedge planting. (Figure 3.8)

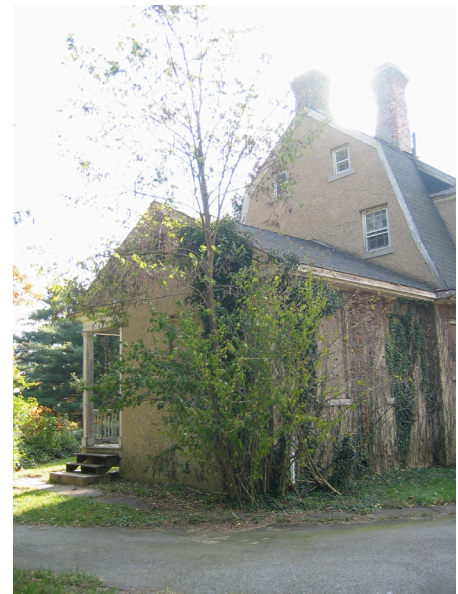
Figure 3.10 A Rose of Sharon is planted too close to the corner of the office wing of the house.

Provide tree work and pruning as necessary to retain existing mature trees. Provide screening for parking lots. Replace plantings in front of the building. Remove the Rose of Sharon at the northeast corner of the office wing, as it will likely have an adverse effect on the building if it continues to grow. (Figure 3.10).

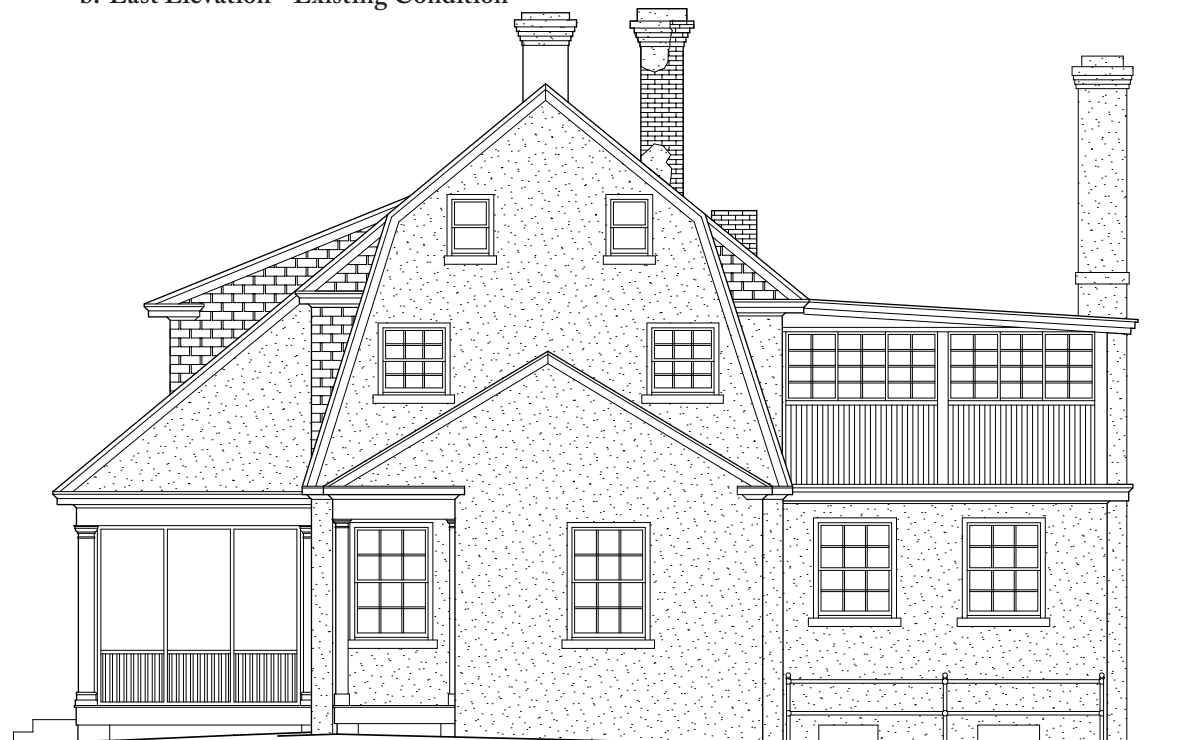
Figure 3.19 The east elevation drawing shows the deteriorated of the chimneys.

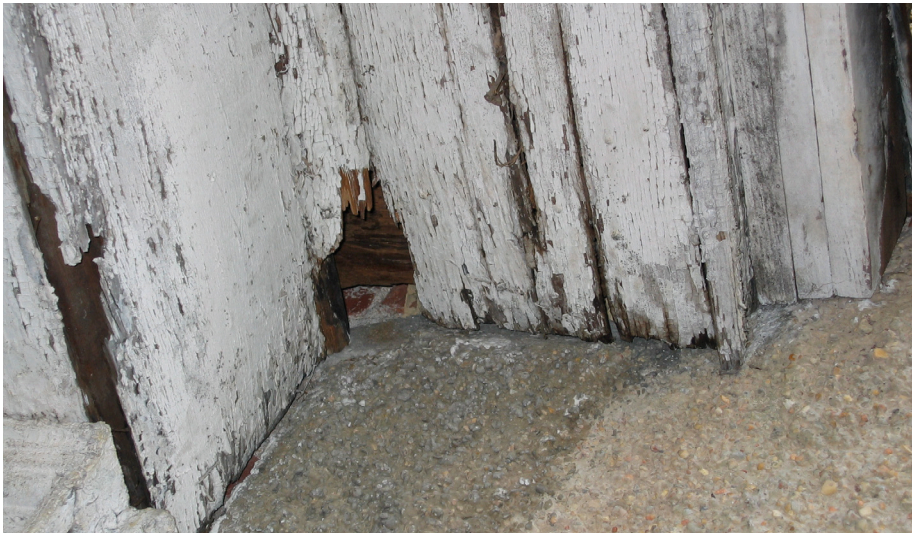
Figure 3.23 This view shows the original brick beneath stucco and that the stucco stops at the wood trim, and that therefore the stucco was a later addition.

The condition of the stucco is good. The condition of the brick is not known, but suspect that deteriorated condition may have led to stucco covering.

Remove vine growth (Figure 3.24), clean stucco finish, and repair as needed as part of any exterior rehabilitation.

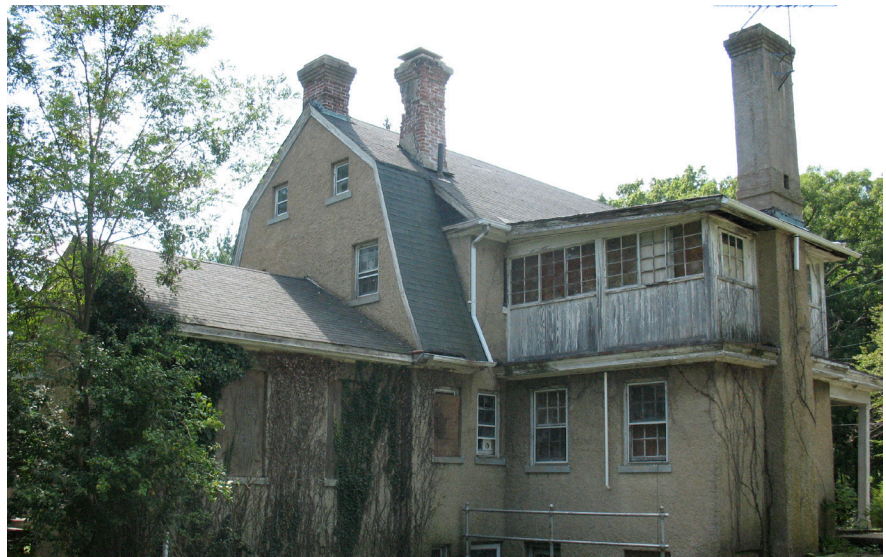
Much of this stucco is deteriorating, as well as the brick underneath (Figure 3.32). The kitchen chimney retains the highest level of stucco finish of the four chimneys.

Figure 3.29 Three of the four chimneys for the house are shown above.

Remove unstable sections of the chimneys. Rebuild the chimneys using, in part, any salvaged chimney brick that is in good condition. The new chimney should use the same detailing as the original. Provide chimney flashing in coordination with roof replacement. For the missing chimney, rebuild as shown on the drawings in this report. Remove extension to chimney at the sunroom if the sunroom is removed. Recoat portions of exposed brick chimneys with stucco to match existing.

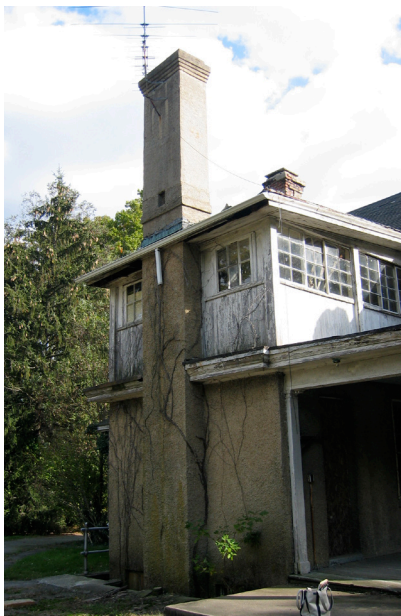
Figure 3.30 The kitchen chimney features a band above the sunroom roof line that shows where the chimney was extended after that addition.

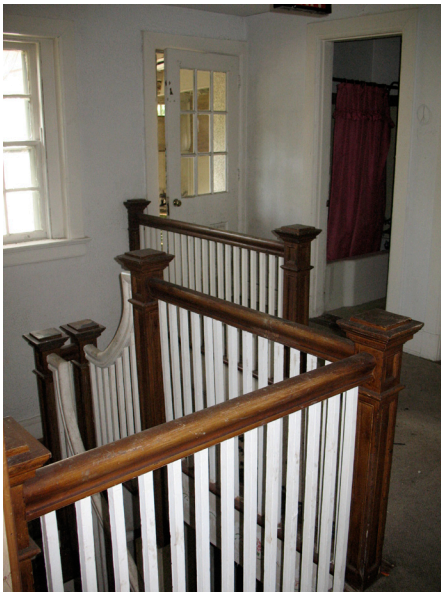
Figure 3.64 The stair hall on the second floor has a well-preserved Colonial Revival balustrade, posts, and railing.

The narrow u-shaped stair from the first to the second floor begins on the west wall of the hall (Room 102). Also an open string stair, it has a square oak newel post with recessed panels and trim that evokes a stylized classical column. An oval rail caps the narrow, square balusters. Posts, of the same description as the newel post, mark each turn of the stair and the balustrade intersections around the stair opening on the second floor (Figure 3.64).

The main and attic stairs are in good to fair condition.

The risers and balusters for the main stair should be repainted. Paint should be removed from the handrail to return the railing to its original appearance.

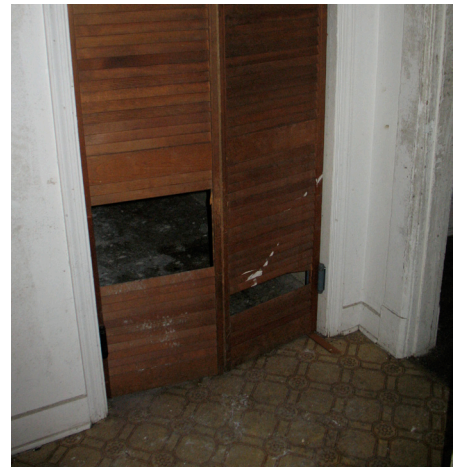
The concrete basement floors are in good condition. The drains were not tested. The sheet vinyl flooring and carpeting are in poor condition and were not removed for inspection of the surfaces underneath. Exposed wood floors appear to be in good condition. Limited observed areas of damage include holes for radiator piping.

Figure 3.66 Patterned vinyl flooring is found in the pantry and kitchen areas.

Sheet vinyl flooring should be removed and replaced with a ceramic tile floor. Ceramic tile in Room 109 can be retained or replaced with a new finish appropriate to the building.

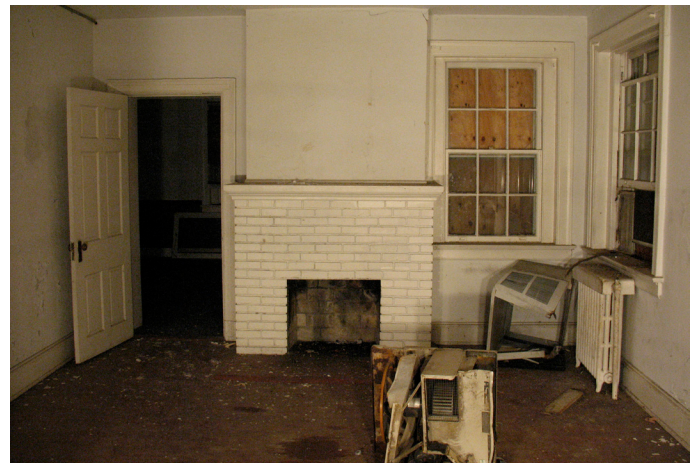
Figure 3.69 Wood tongue-and-groove floors are typical on the first and second floors.

Wood floors should be retained. Damaged areas should be repaired with matching materials. The floors should be refinished as part of any rehabilitation.

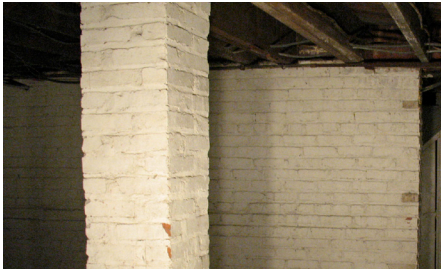
Figure 3.70 Painted brick and exposed joists are found in Rooms 002 and 004.

In the basement, Rooms 001 (Figure 3.71) and 003 have brick walls that have been parged with a portland cement mix. Rooms 002 and 004 (Figure 3.70) have painted brick walls, and Room 003 has plaster walls. Room 001 has a fiberboard ceiling. All other rooms have exposed joist ceilings, with every three to four joists doubled.

Finished wall and ceiling surfaces in the basement are in poor condition. Spalling of paint and parging and mold growth is evident due to moisture infiltration and rising damp. The fiberboard ceiling in Room 001 may contain asbestos.

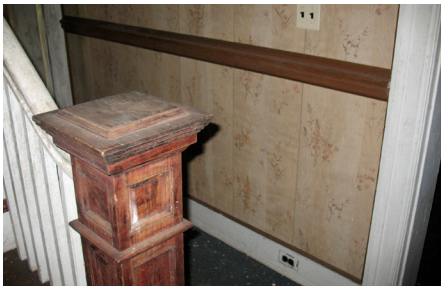
Figure 3.72 Patterned pressed board paneling is found in the hall, Room 102.

On the first floor, rooms typically have painted plaster walls and ceilings. In Room 102 (Figure 3.72) there is pressed wood paneling on both the east and west walls. In Room 108, there is non-original chair rail with pressed board paneling below. In Room 109, a fiberboard product has been applied over the plaster walls. A laminate type wallboard has been installed on the walls in the pantry (Room 106). A glossy backsplash material was installed over the wallboard between the countertop and the upper cabinets in the kitchen (Room 104). Most wall and ceiling surfaces are in good to fair condition with the exception of the kitchen (Room 104) and pantry (Room 106) ceilings, which appear to have water damage.

On the first and second floors, there is peeling paint on some ceilings, peeling wallpaper in Room 201, and a failing ceiling in Room 207. Other surfaces show cracked plaster that is, in part, due to vandalism. There is water damage in Room 104. On the second floor, there was sporadic mold observed due to water damage. Pressboard paneling and wallpaper are in fair to poor condition.

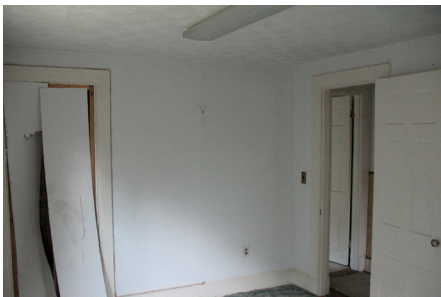
Figure 3.73 Plaster is the typical wall and ceiling finish on the first and second floor.

On the second floor, most walls retain their original plaster finishes (Figure 3.73). The upstairs bath has a chair rail with plaster below and wallpaper above and a tiled tub surround that is not original.

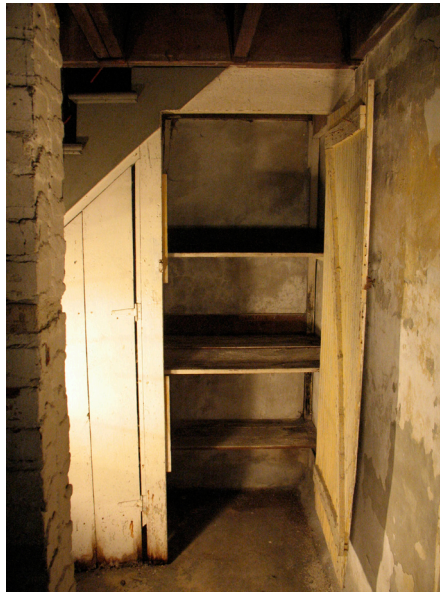
Figure 3.74 The understair closet in the basement has a vertical board door.

Retain existing original doors. Adjust, prepare and paint as required. Replace the doors between Rooms 105 and 106 with a single door. In instances where new doors are needed, match them to the existing six-panel stile-and-rail doors.

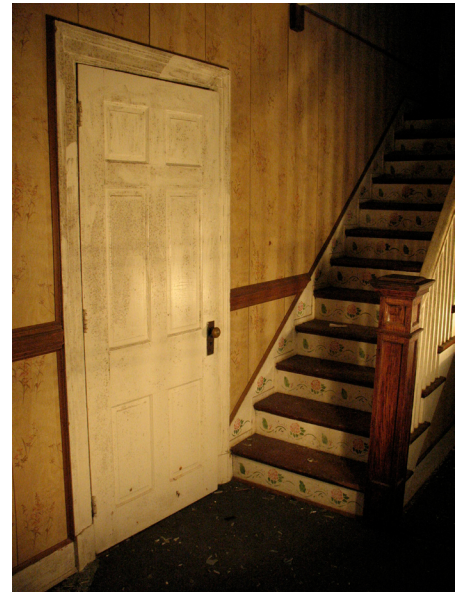
Interior doors (Figure 3.75) are predominantly of six-panel construction and are of a Colonial Revival style that is consistent with the date of construction for the house. The door between Rooms 103 and 105 (Figure 3.76) is unusual in that it is partially glazed. The under-stair closet in the basement has a vertical board door (Figure 3.74) with a diagonal cross-brace.

Figure 3.75 A typical six-panel door is located between Rooms 101 and 102.

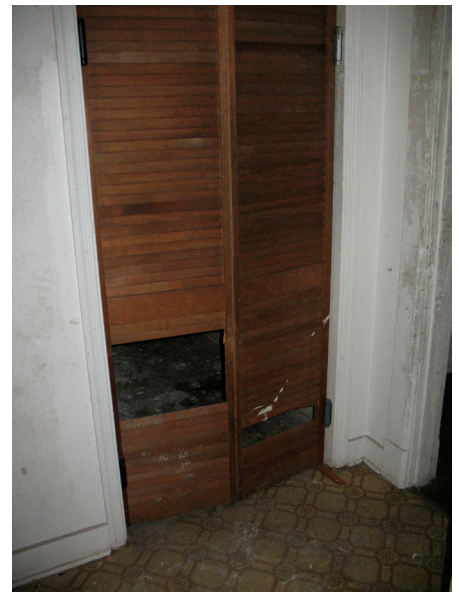
There is a door missing between Rooms 102 and 103. The louvered swinging doors between Rooms 105 and 106 (Figure 3.77) are not original to the building.

Most doors are in good condition. There is peeling paint and mold growth in some locations. The louvered door between Rooms 105 and 106 is in poor condition.

Figure 3.77 Louvered doors are located between Rooms 105 and 106.

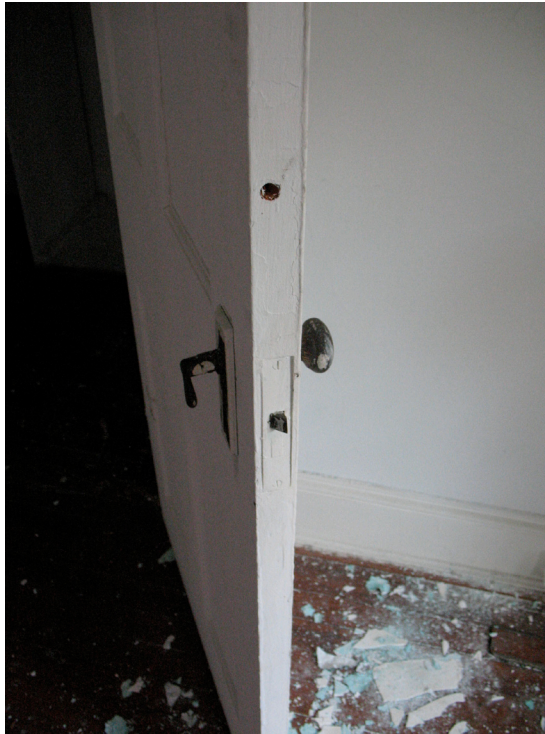
Figure 3.81 Original door hardware is found on some original doors.

Save, refurbish and consolidate original door hardware for use in rooms without public functions. Provide new lever hardware as required to meet ADA requirements.

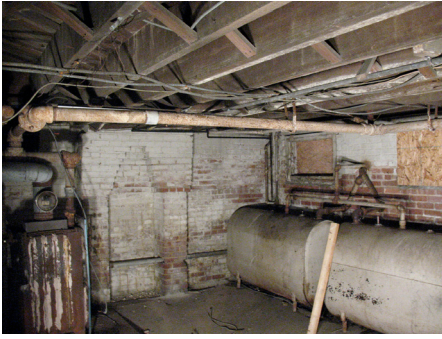
Figure 3.82 The outdated heating plant for the house is located in Room 004.

Heat for the building was provided by a radiator system with the boiler located in the basement. There are two oil tanks and a boiler located in Room 004 (Figure 3.82). The house retains its original radiators (Figure 3.84). Exposed radiator piping, as well as plumbing piping, can be seen in the basement of the building. The building does not have a central air-conditioning system. Window air-conditioning units were removed from many openings as a part of the process of mothballing and securing the building.

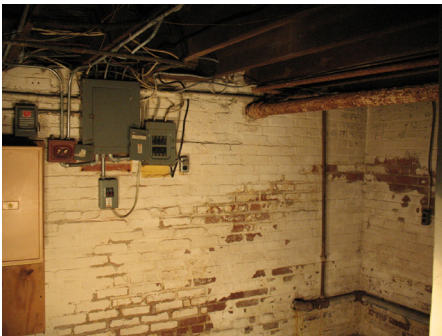
Figure 3.83 The panel box for the electrical service to the house is pictured above.

The electrical system (Figure 3.83) appears to date from mid-twentieth century with many alterations. It can be assumed that it does not have the capacity to support the updated HVAC system proposed in this report. Exposed surface-mounted conduit has been used for fairly recent electrical alterations. No examples of historically significant light fixtures exist in the building. Fluorescent fixtures (Figure 3.84) are not original or appropriate to the building.

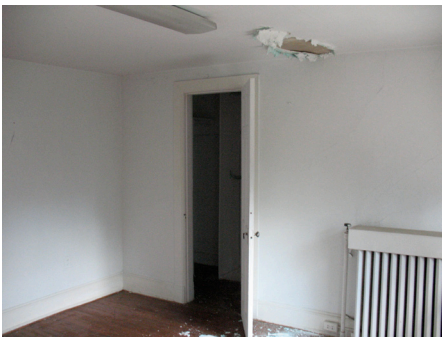
Figure 3.84 Later florescent light fixture and original radiators are located throughout the house.

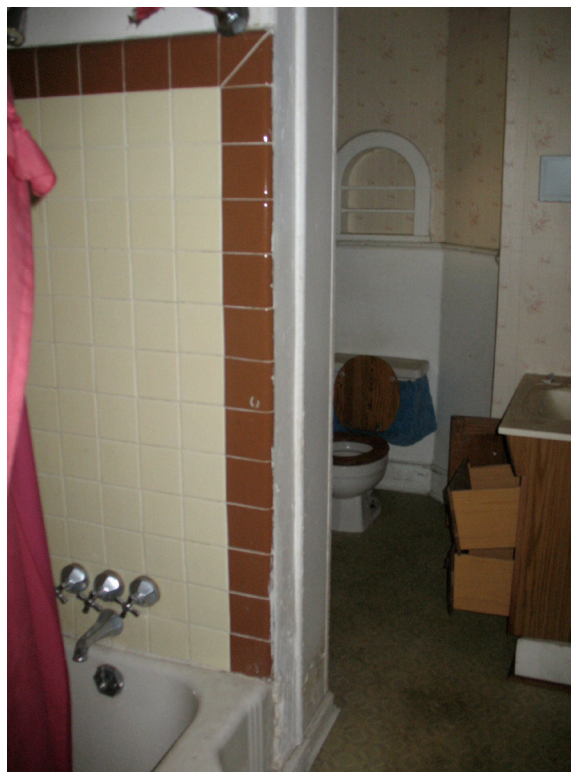
The toilets (Figure 3.85) and sinks are outdated. The bathtub (Figure 3.86) in Room 208 could be considered for reuse.

Figure 3.86 Room 208 has mid- to late-twentieth century tile and a bathtub from the same period.
