LAUREL HILL HOUSE

Historic Structure Report and Treatment Options

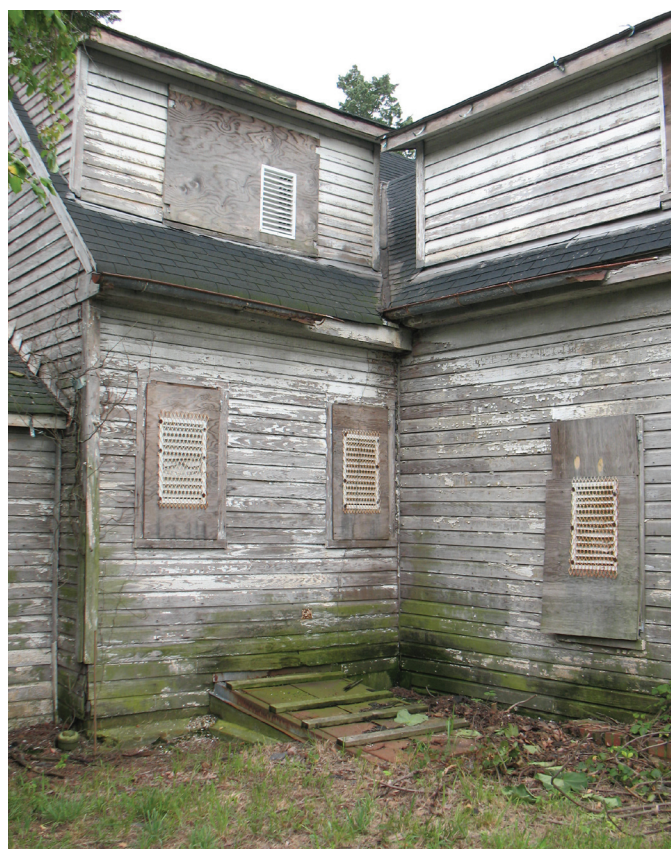
The windows are typically double-hung wood sash windows with some casements seen in the one-story additions. Few of the original six-over-six sash windows remain. They were replaced with two-over-two windows, possibly at the time the rear addition was added. While the windows are covered with vented plywood, their condition varies from fair to poor (X7, X8, X9, X10 and X12).

Close-up detail of building from northeast side that shows beveled siding on the dormers and German siding on the wall of the original house and addition. (X9)

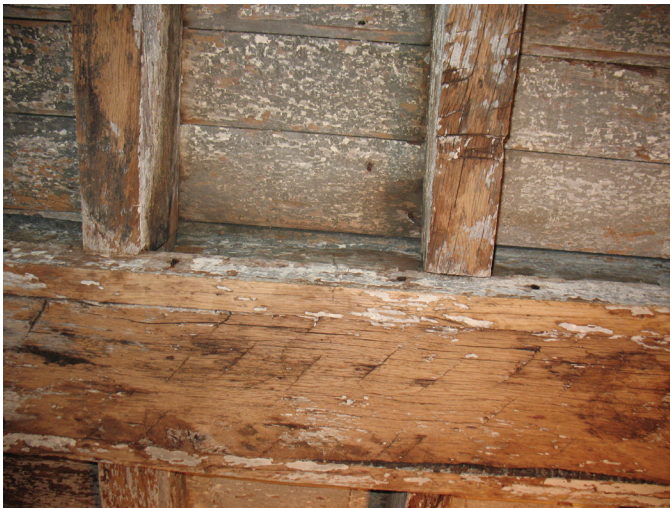
Basement detail of original sawn floor joists, hand-hewn summer beam and plank floor above. (B01-1)

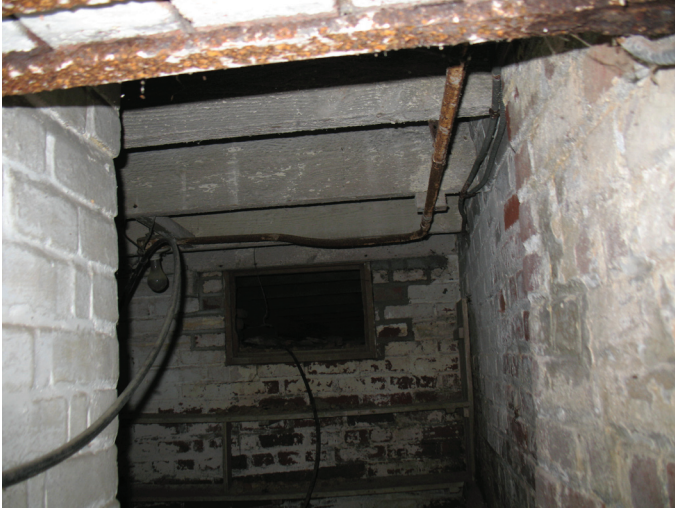
This prison-era brick is used for the foundation under the east chimney, for foundation repairs and alterations, piers, and for the coal room (B01-7) and the north areaway. In addition, it was used for the foundation of the additions made during that period of time.

Basement view of access to crawl space below rear (north) addition. (B01-7)

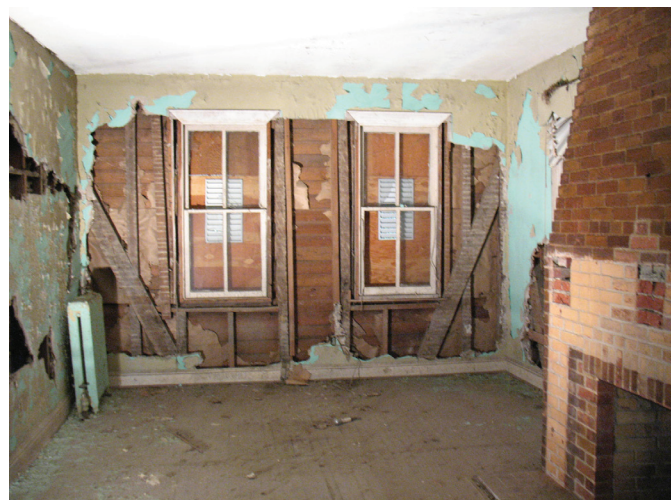
The plaster has been removed on most of the south wall to expose the original braced timber frame (101-2). Insect damage can be seen in this wood framing. Rosin paper is visible between the wood framing and the exterior siding.

View of west wall with braced timber frame exposed. (101-2)

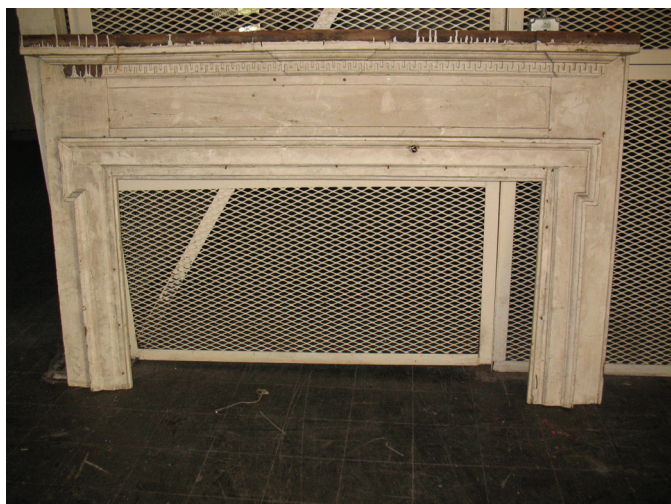
This room was part of the original section of the house and has been heavily altered. Most prominently in this room, the original fireplace has been removed and replaced with a large pyramid-shaped fireplace built of exposed penitentiary-era brick (101-1). A classically designed mantel was reportedly removed from this room and is currently in storage (101-3). A 4" x 4" ceramic tile hearth has replaced the original.

This mantel was removed from Room 101. (101-3)

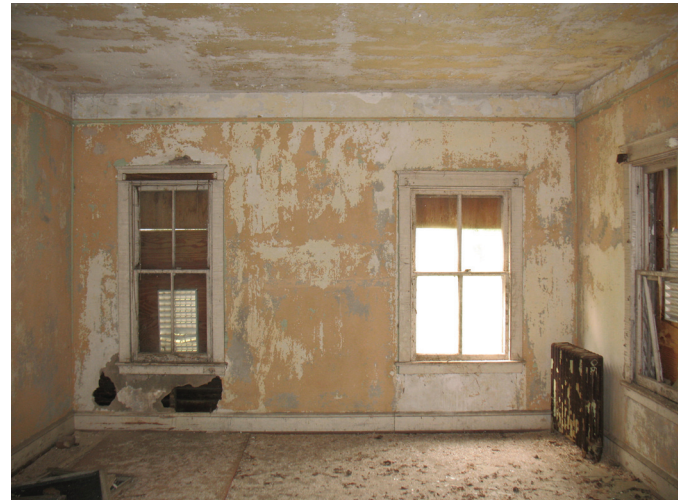
The rear addition features a classical cornice at the eaves (X7). A historic photo (H-4) circa 1920s, shows an exterior door on the north side of the rear addition along with shed dormers. A window later replaced this door and the resulting patches can still be seen in the siding. This door may have been moved to the covered location under the porch after it was built.

View of windows on north side of rear addition. Note indications in base and plaster of right window being converted from door to window. (102-2)

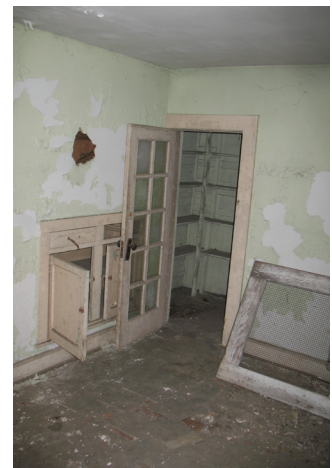
An interesting built-in cabinet in the southwest corner of the room has settled toward the damaged area in the floor (106-1). There is another built-in cabinet, probably dating from the early twentieth century adjacent to the chimney (106-2). This chimney has been boxed in such a way that it is not visible to the room.

View of Room 106 facing pantry closet to north. (106-2)

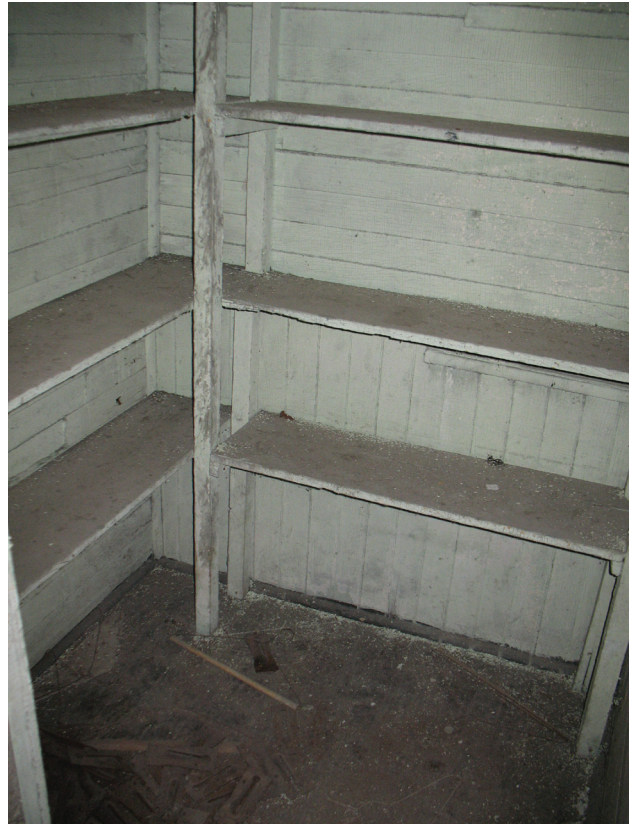
A glass door with ten panes of glass leads into this pantry closet. This room is finished with horizontal and vertical tongue-and-groove boards and is outfitted with painted wood shelving. The overall condition of the room is fair to good (107-1).

View of the interior of the pantry closet, Room 107, adjacent to Room 106. (107-1)

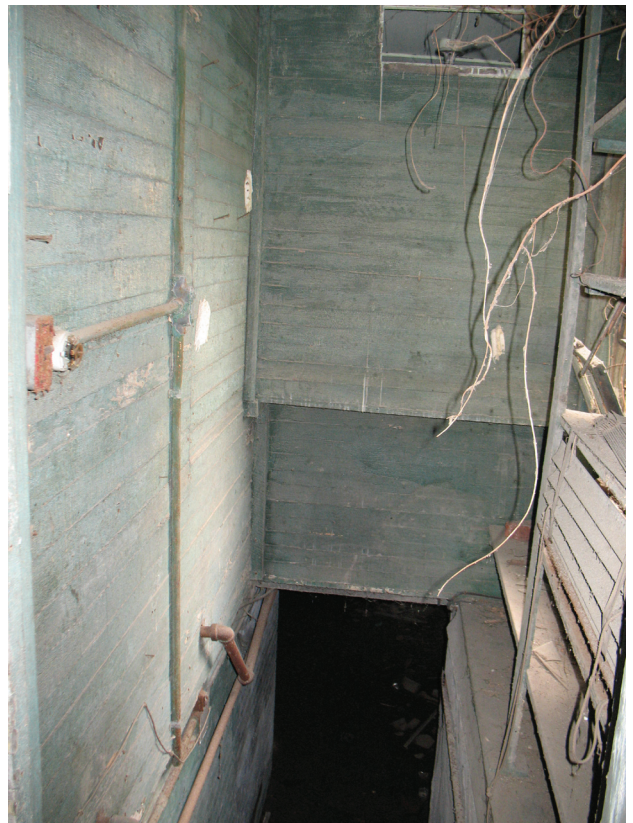
The stair to the basement has brick steps and foundation walls that utilize the penitentiary-era bricks. The walls and ceiling are a tongue-and-groove beaded board similar to the boards used in the pantry (108-1).

View of board wall finish in stair. (108-1)

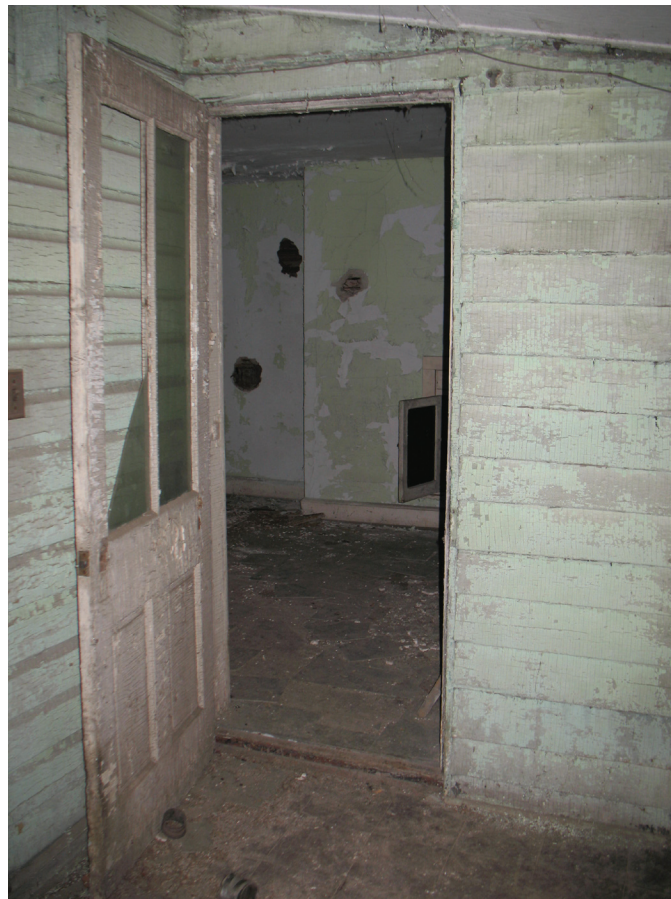
This foyer appears to be an enclosed porch. It has a variety of wall finishes. The west wall is finished with what is likely the original clapboard siding on the exterior wall of the house. German siding is used on the south wall (109-1). The east wall is plaster and the ceiling is finished with painted hardboard with lattice strips covering the joints. The north wall is finished with tongue-and-groove beaded-board.

View into room 106 from room 109. Note German and clapboard siding on the south and west walls, respectively. (109-1)

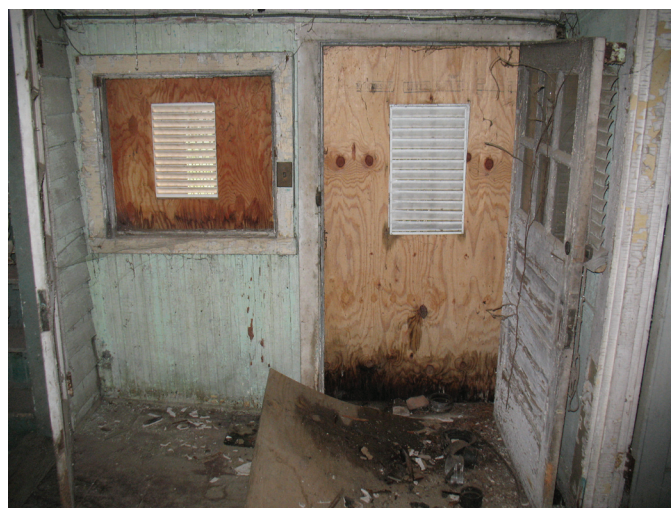
View of exterior door and tongue-and-groove wood wall finish. (109-2)

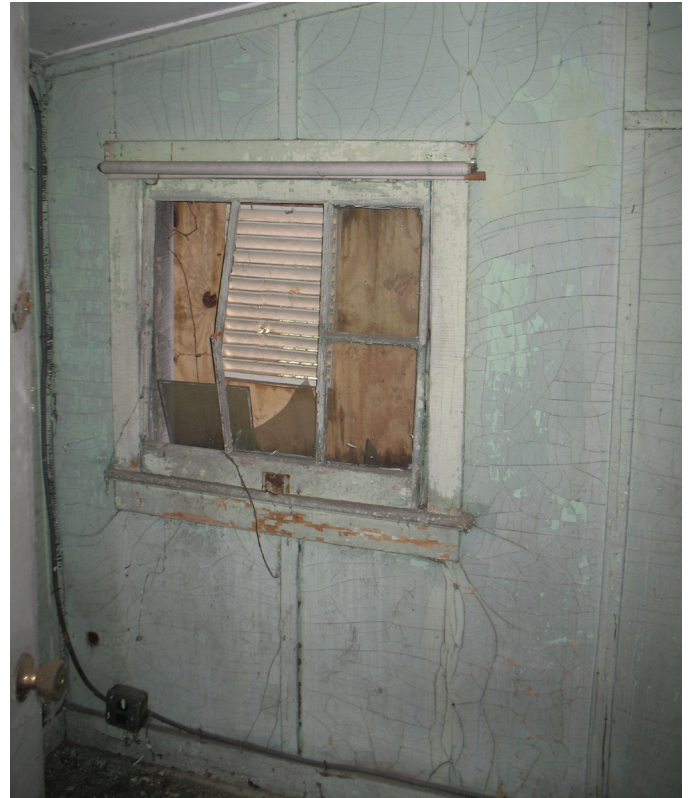
View of casement window and hardboard wall finish. (110-1)

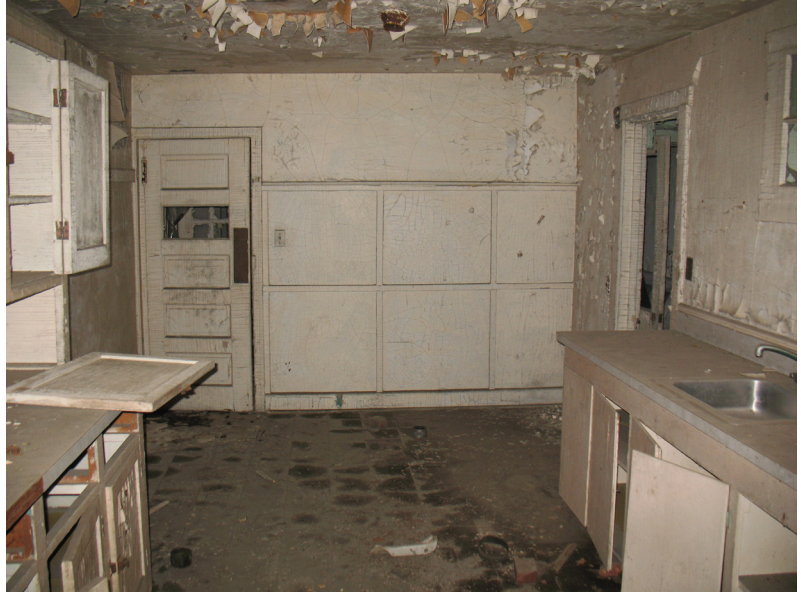
View toward west end of kitchen showing finishes dating from mid-twentieth century. (112-1)

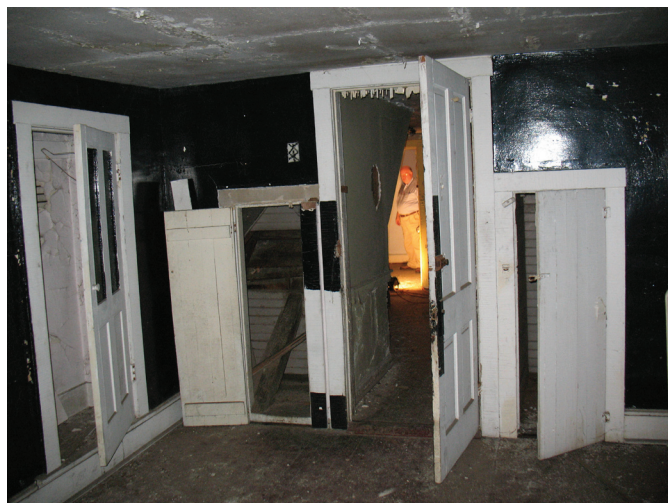
According to a suggestion from the Laurel Hill Committee, this room may have been used as a “safe room” during the prison era. The extra bolts seen at the entrance door and the dark color of paint may be evidence of this use.

View toward entrance door of Room 202. (202-1)

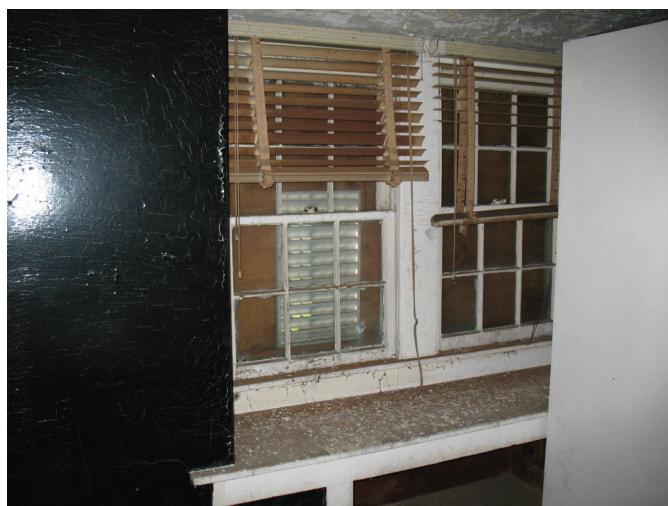
View of windows in shed dormer in Room 202. (202-2)

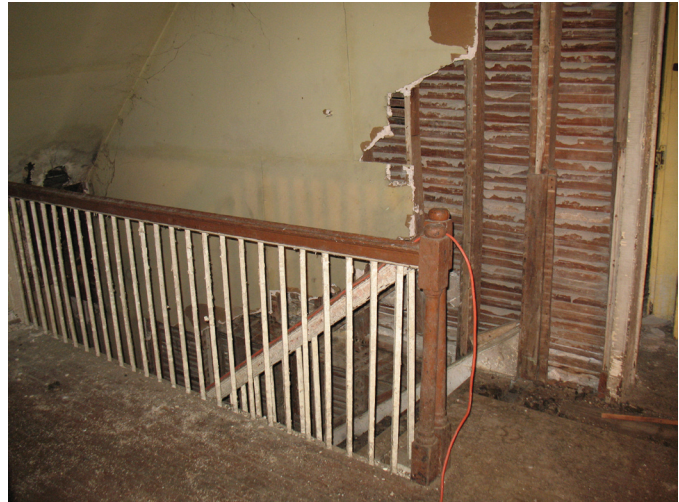
View of likely original railing in second floor hall. Note double newel post. (203-1)
