3 Subwatershed Condition and Plan Action

3.1 Introduction

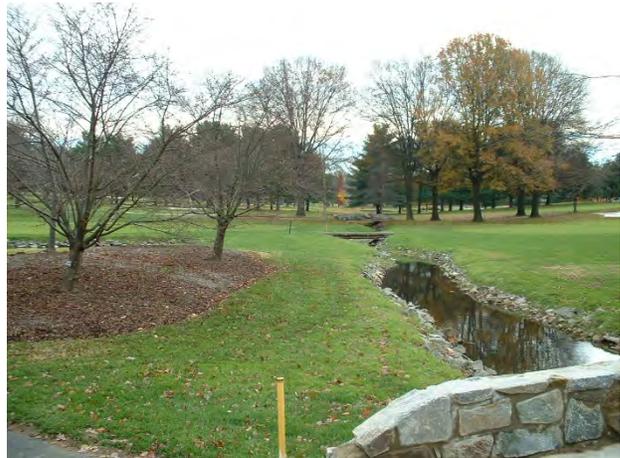
- *Extreme (10)*– Impervious/commercial area is in close proximity to the stream. Stream banks may be modified or engineered. Stream character (bank/bed stability; sediment deposition, and/or light penetration) is obviously degraded by adjacent use.
- *Severe (7)* – Some impervious and/or turf only up to bank and water. There is very little vegetation aside from turf within the 25-foot zone. There may be a home site very close to stream. The stream character is probably degraded by adjacent use.
- *Moderate (5)* – Buffer encroachment is mostly from residential uses and lawn. There is some vegetation within the 25-foot zone, but very little aside from turf within the remainder of the 100-foot zone. The stream character may be changed slightly by adjacent use.
- *Minor (2)* – The vegetated buffer primarily consists of native meadow. (Not Grazed)

Poor Condition

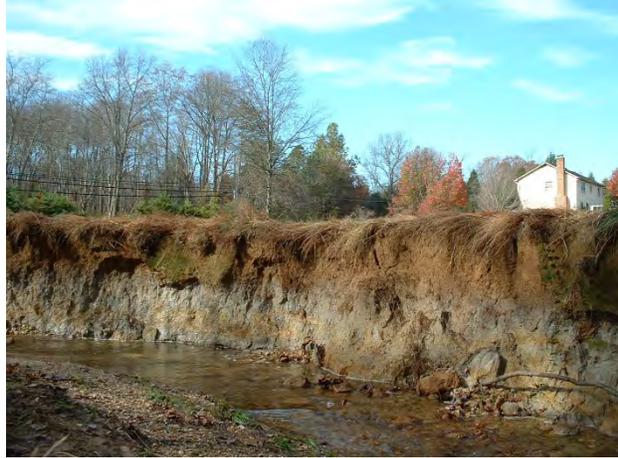
Areas of Erosion (*scale of 0 – 10*): These are areas of active erosion that are at least 2 – 3 feet high. The height and length, in feet, of erosion and impact scores are recorded separately for each bank separately.

- *Extreme (10)* – Impending threat to structures or infrastructure
- *Severe (7)* – Large area of erosion that is damaging property and causing obvious instream degradation. Eroding bank is generally five feet or greater in height.

Poor Condition

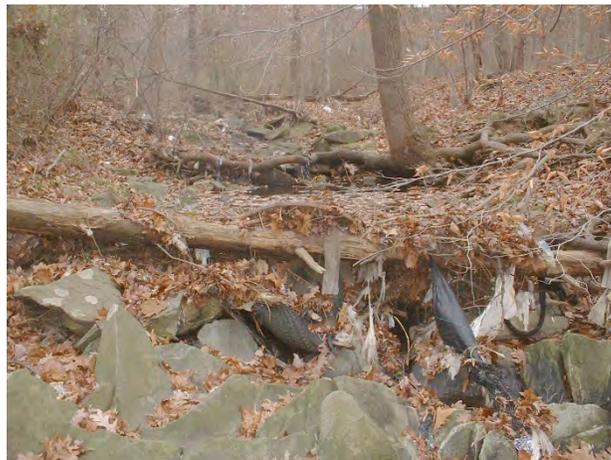
Obstructions (*scale of 0 – 10*): Obstructions that are causing erosion problems or are causing flooding of manmade structures are recorded. Beaver dams are included as obstructions but are scored as zero impact unless significant bank damage is evident. Notation is also made concerning the obstructions impact on fish passage.

Poor Condition

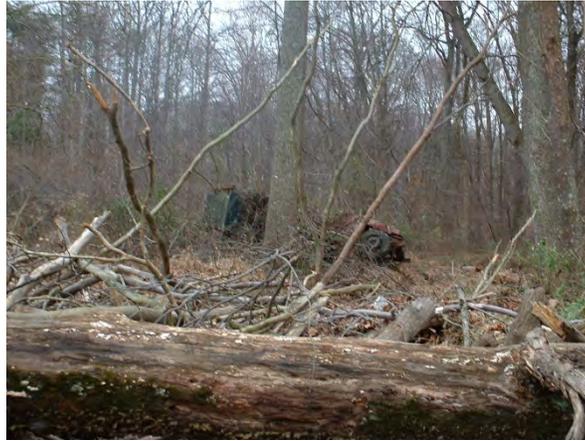
Dump Sites (*scale of 0 – 10*): Dump sites include all areas where inappropriate materials have been disposed. Yard waste and other organic debris is included if it is directly in the stream.

Poor Condition

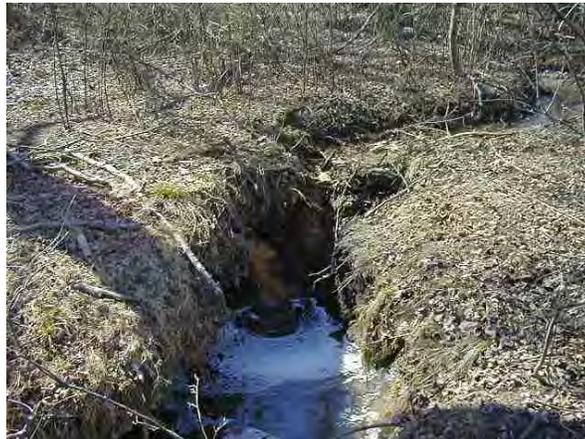
Head Cuts (*scale of 0 – 10*): A head cut is an erosional feature in which a sudden change in stream bed elevation occurs resulting in a small waterfall feature. Flow over the headcut results in a lowering of the stream bed elevation on the downstream side. The headcut will migrate upstream creating a deeper channel as it progresses. Only active head cuts were recorded.

Poor Condition

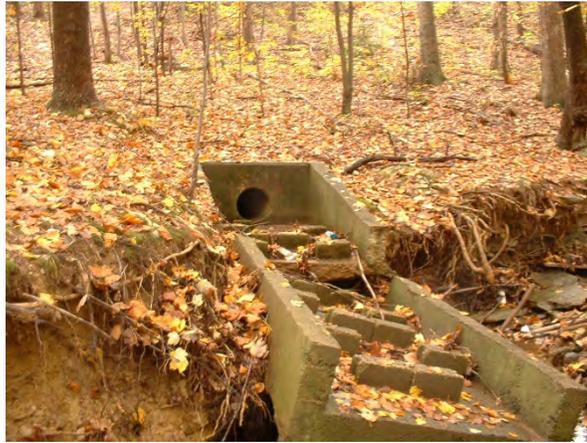
Pipes and Drainage Ditches (*scale of 0 – 10*): All drainage pipes and ditches were recorded. Information on each includes size and distance from channel, material, discharge (if present), and source of discharge (if known). The impact score assigned refers to the impact that the pipe or ditch has on the stream channel.

Poor Condition

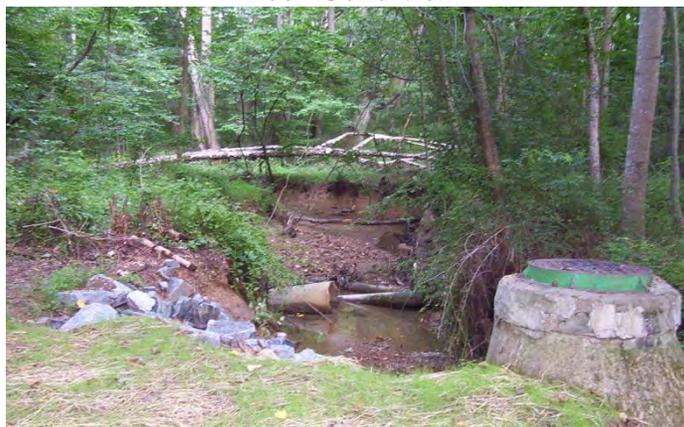
Public Utility Lines (*scale of 0 – 20*): This includes all exposed utility lines and manholes. Information on utility type was also collected if known.

Poor Condition

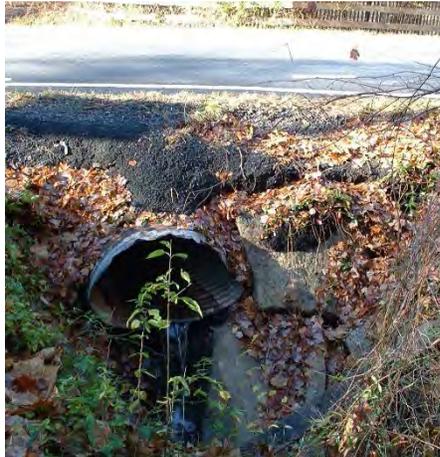
Road and Other Crossings (*scale of 0 – 10*): All stream crossings, including foot bridges and man made fords were included. Information on upstream and downstream structural integrity and blockages was also included.

Poor Condition

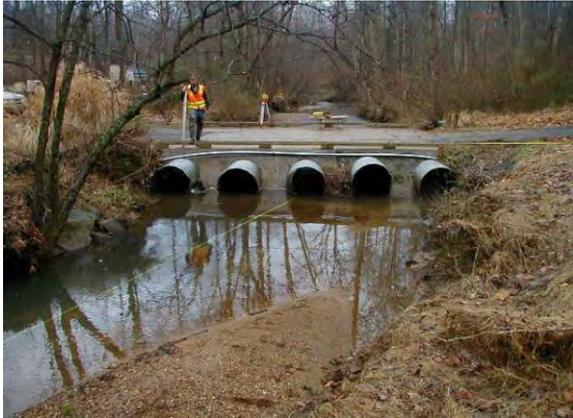
Culvert # 65 (Photo 3.6) overtopped for all events. From the photos, it appears that culvert #65 has recently been reconstructed and functions as a stream ford. This crossing is also a residential access road with a functional classification of "local". It should not be overtopped by storms more frequent than the 10-year event.

Photo 3.6 Captain Hickory Mainstem at End of Fringe Tree Road

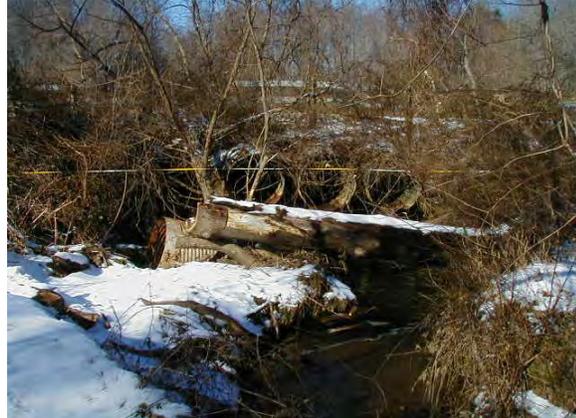
Culvert #69 (Photo 3.7) overtopped for the 50- and 100-year events. This is a residential access road with a classification of "local," requiring the culvert to pass the 10-year event.

Photo 3.7 Unnamed Tributary at Sunnybrook Drive.

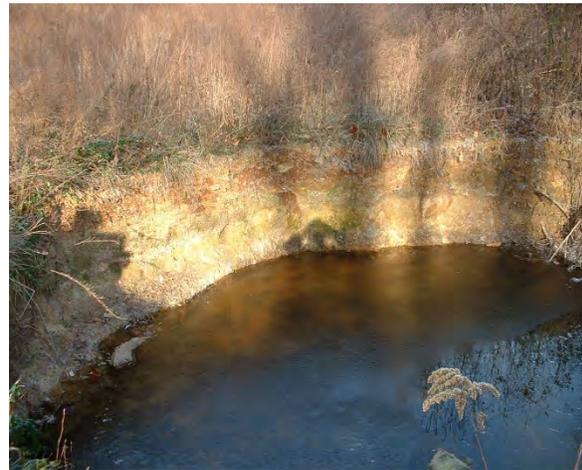
Photo 3.10 Erosion located near confluence of Dog Run with Piney Run (DFDG001.E001).

- S02 This reach has active widening, unstable banks, and erosion. It is located in the downstream portion of Dog Run near the confluence with Piney Run (Photo 3.10)
- S78 This eastern reach is in an area with missing buffer and erosion problems combined. This stream has poor habitat (Photo 3.8 and 3.9).
- S79 This reach has missing buffer on both the left and right banks along with poor habitat. Channel disturbance in the form of channelization is also an issue on this reach (Photo 3.11).

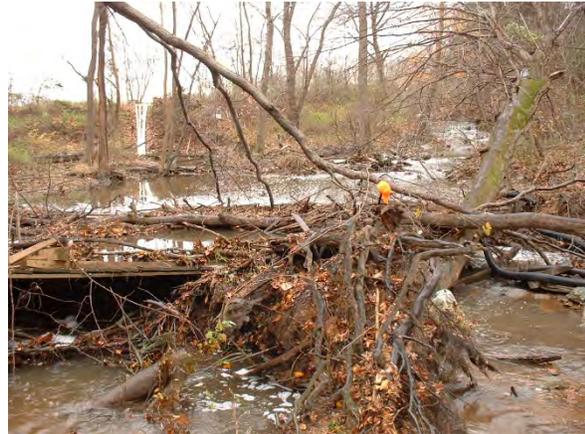
Photo 3.13 Obstruction located near the intersection of Walker Road with Manning Street (DFPR001.T001).

There are 11 obstruction locations within the Piney Run subwatershed, all of which are restricting fish passage. Many of the obstructions were beaver dams and are located in the central portion of the subwatershed on tributaries and on the mainstem. One obstruction is located at the very downstream end of the mainstem and is blocking fish passage. The site is shown in Photo 3.13 and is a candidate stream restoration site S83.

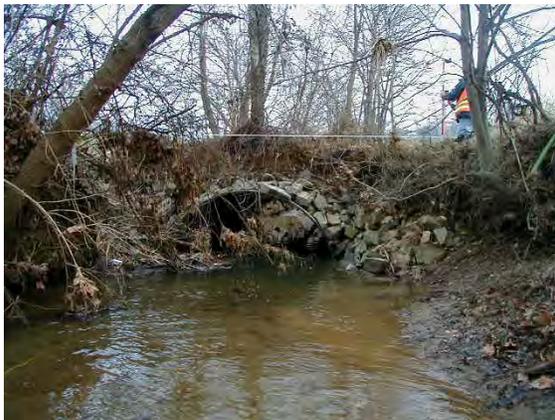
Culvert #59 (Photo 3.32) overtopped for all events. Leesburg Pike is a primary road, which is required to pass the 25-year event.

Photo 3.32 Lower Difficult Run Mainstem at Leesburg Pike

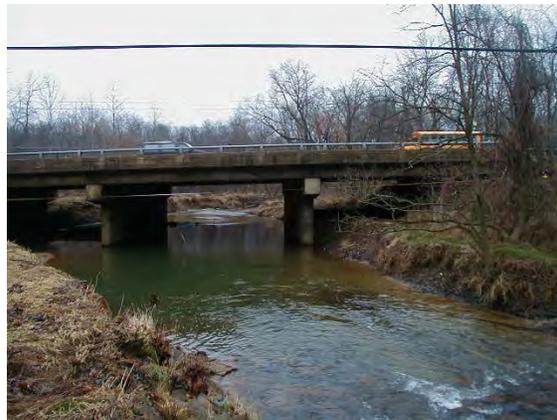
Culvert #72 (Photo 3.33) overtopped for all events also. Leigh Mill Road carries through traffic and is thus considered a primary road. Primary roads should pass the 25-year event.

Photo 3.33 Lower Difficult Run Mainstem at **ents**
Leigh Mill Road

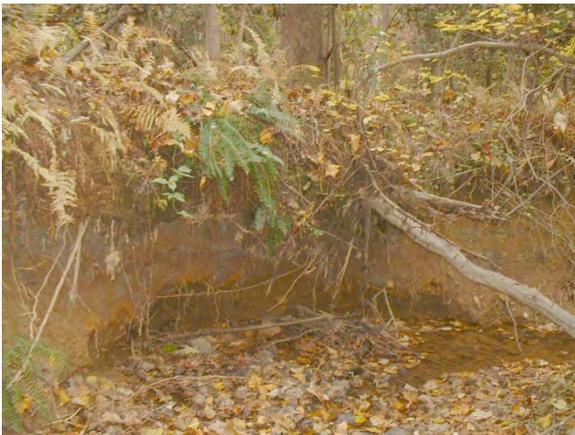
There are 28 points along the stream that are blocked by trees, debris and sediment. Eleven of these are severe enough to be obstructing fish passage. Two are shown below in Photos 3.50 and 3.51 and are near stream restoration candidate sites S135 and S11, respectively.

Photo 3.50 Obstruction just upstream of Lake Fairfax to the west of Aldenham Lane (DFCR013.T001).

- S49 This reach has severe erosion with unstable banks and buffer deficiency. Both have moderate potential for restoration.
- S92 The Stream Physical Assessment noted this reach, which is directly downstream of S99, has extreme erosion with moderate restoration potential along with active widening. (Photo 3.50)

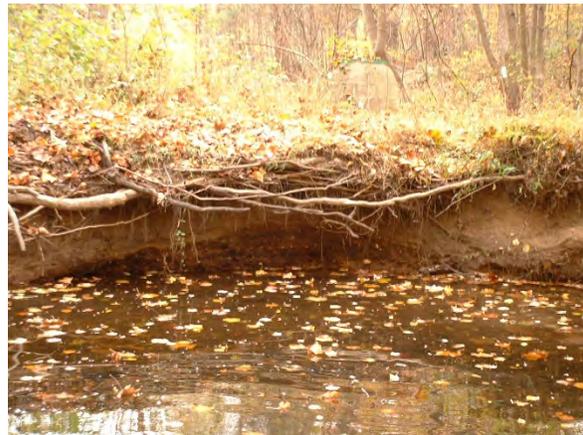
Photo 3.51 Obstruction upstream of Lake Fairfax located near Park Overlook Drive (DFCR015.T001).

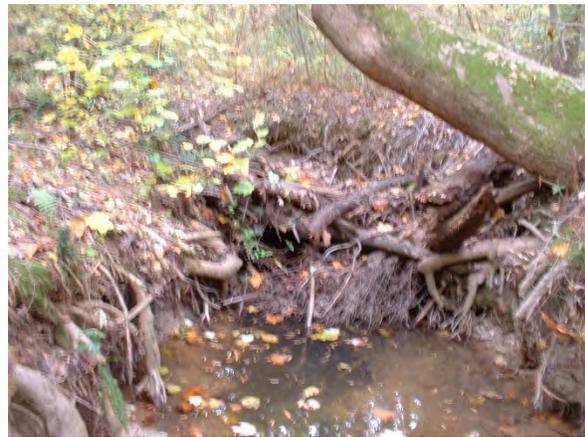
There are ten stream blockages, primarily comprised of downed trees. Eight of these blockages are likely restricting movement of fish within the stream system and can block passage. Only one obstruction is thought to have a severe impact. This obstruction of trees and debris is located on an upstream reach near Stirrup Road, upstream of the candidate stream restoration area S26 (see Photo 3.68).

Photo 3.68 Obstruction of trees and debris near Stirrup Road. (DFGL008.T001)

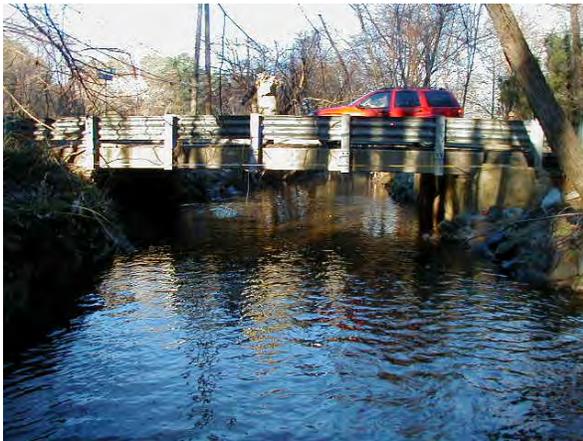
Culvert #28 (Photo 3.82) overtopped for all events. As Beulah Road is a through road, it can be classified as a primary road. This means that it must pass the 25-year event.

Photo 3.82 Wolftrap Creek Mainstem at Beulah Road.

- F28 The bridge on Beulah Road that passes over Wolftrap Creek overtops for all events. Beulah Road is classified as a primary road, so it must pass the 25-year event (Photo 3.82).
- F48 The culvert that flows Wolftrap Creek under Creek Crossing Road overtops for all events. Creek Crossing is a primary road, so it must pass the 25-year event (Photo 3.83).
- F49 The culvert under Old Courthouse Road that passes Wolftrap Creek also overtops for all events. Old Courthouse Road is classified as a primary road, so it must pass the 25-year event (Photo 3.84).

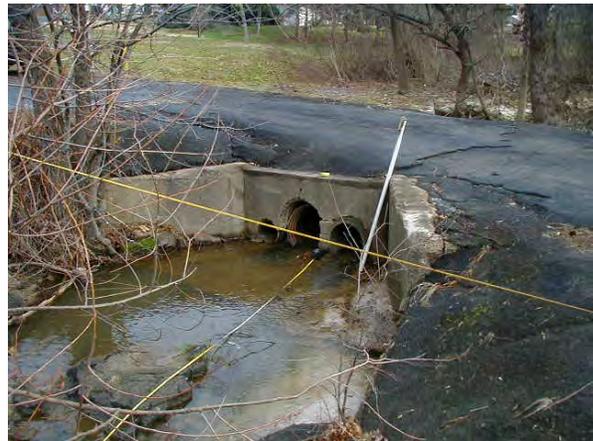
Culvert #48-A (Photo 3.83) overtopped for all events. Creek Crossing Road can also be used as a through road, so it too can be classified as a primary road. Primary roads must pass the 25-year event.

Photo 3.83 Wolftrap Creek Tributary at Creek Crossing Road.

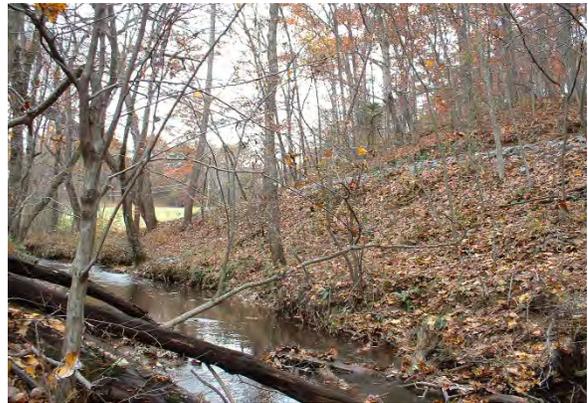
Photo 3.99 Severe buffer encroachment (in background) Little Difficult Run Stream Valley Park, directly south of Stuart Mill Road on the mainstem (DFLD011.B001)

- S114 Erosion located on the mainstem of Little Difficult Run, directly east of Colt Run Road in the Roan Stallion Estates subdivision (Photo 3.97).
- S115 Stream Physical Assessment found erosion and riparian buffer problems north of the terminus of Hollybrook Place in the Hollybrook subdivision (Photo 3.95)
- S116 Buffer encroachment on the mainstem of Little Difficult Run along Stuart Mill Road in the Difficult Stream Valley Park (Photo 3.99).

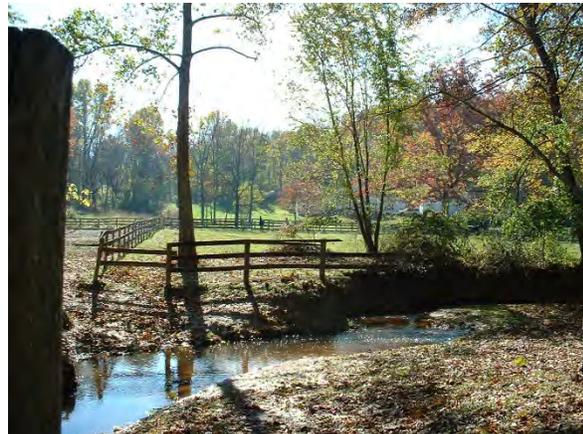
Photo 3.101 Buffer impact in the Hollybrook community, directly north of the terminus of Hollybrook Place, mainstem of Little Difficult Run (DFLD003.B002).

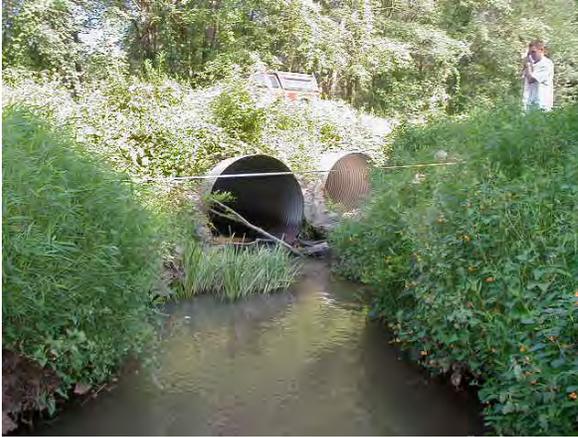
Photo 3.102 Little Difficult Run at Stuart Mill Road

Culvert #3 (Photo 3.102) overtopped for all events except the one-year. Stuart Mill Road can be considered a primary road, which requires it to pass the 25-year event.

- F03 The bridge carrying Stuart Mill Road over the Mainstem of Little Difficult Run overtops for all events except the 1-year storm. It is required to pass the 25-year event (Photo 3.102).
- F06 The culvert conveying Mainstem of Little Difficult Run under Colt Run Road overtops for all events. It is required to pass the 10-year event (Photo 3.103).

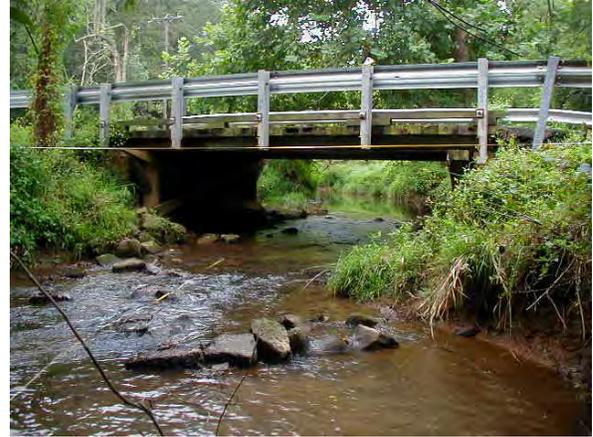
Photo 3.103 Little Difficult Run at Colt Run Road

Culvert #6 (Photo 3.103) overtopped for all events. Colt Run Road is a residential access road, classified as local, requiring the culvert to pass the 10-year event. This culvert is candidate site F06.

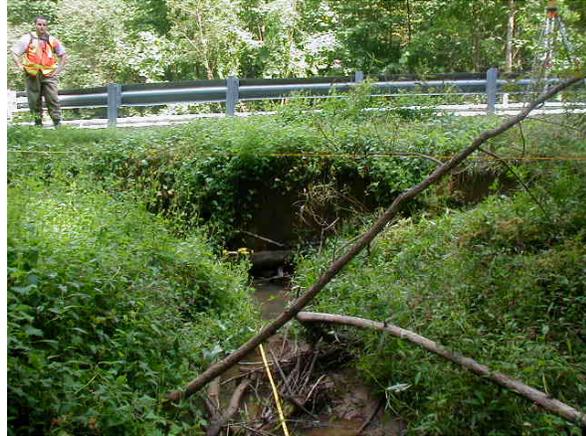
Photo 3.107 Little Difficult Run mainstem at Fox Mill Road South

Culvert #16 (Photo 3.107) overtopped for all events except the one and two-year. Fox Mill Road, also mentioned above, can be considered a primary road and must pass the 25-year event.

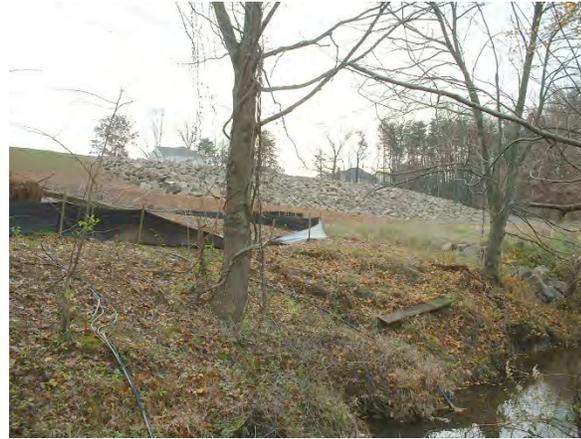
Photo 3.122 Buffer impact located northwest of Timber Lake, in the Timber Lake subdivision (DFSF005.B001).

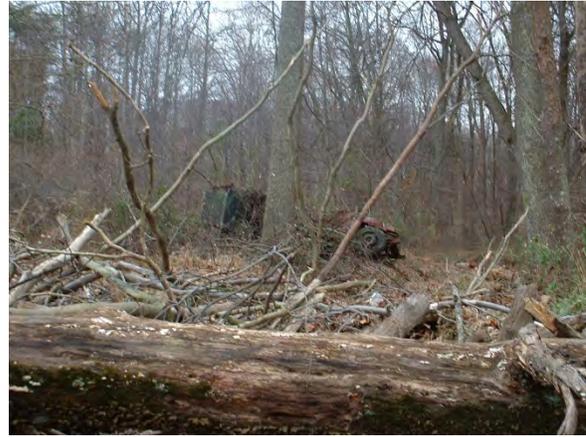
Photo 3.141 Dumpsite located between Oakton Road and Waples Mill Road. DFDF042.M001

- There is one dumpsite, a place where trash is deposited illegally, located between Oakton Road and Waples Mill Road. The site is located along the streambank within the floodplain and was assigned an impact score of seven, indicating that the site is greater than 2,500 square feet in size and may be active (Photo 3.141). This is candidate site S132.

- S132 The Stream Physical Assessment showed channel widening, poor habitat, and lack of buffer through this reach. A large dumpsite is also present at the site (Photo 3.141).

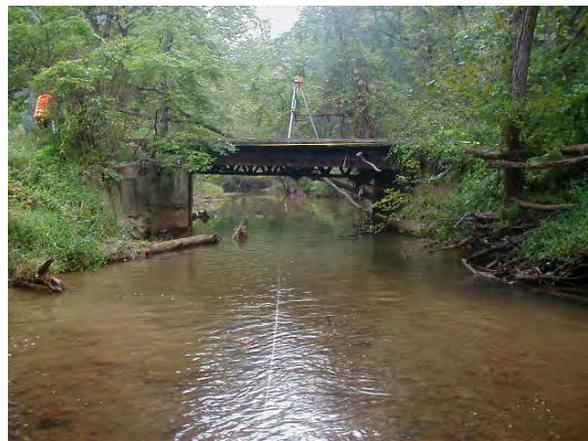
Photo 3.151 Difficult Run Mainstem at Hunters Valley Road

Culvert #22 (Photo 3.151) overtopped for all events except the one-year. Hunters Valley Road is a local access road used by resident to get to abutting properties and is not used for through traffic. This is not a candidate site.
