Difficult Run Watershed Management Plan

**Volume 1: Watershed Plan
February 2007**

*Fairfax County Department of
Public Works and
Environmental Services*

Prepared By:
KCI Technologies Inc.

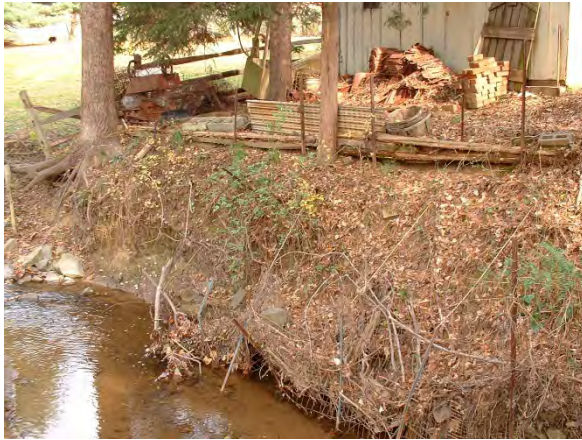
Sixty-three percent of the stream length is moderately unstable, indicating that there is high erosion potential during high flow events. There are five specific erosion locations that are impacting the stream integrity. The points are characterized by raw, actively eroding banks that are degrading the instream habitat and may be damaging property. Four of the five points are considered severe and should be addressed. All of these erosion points have high restoration potential. Photos of two of the more serious erosion areas are located below. Photo 3.3 is located at candidate site S54 and Photo 3.4 was taken at candidate site S76.

Photo 3.3 Erosion on the right bank of Captain Hickory Run near the end of Constellation Drive (DFCH010.E001)

- S54 The Stream Physical Assessment survey indicated that bank stability was low, the channel was incised, and habitat was poor to very poor. (Photo 3.3)

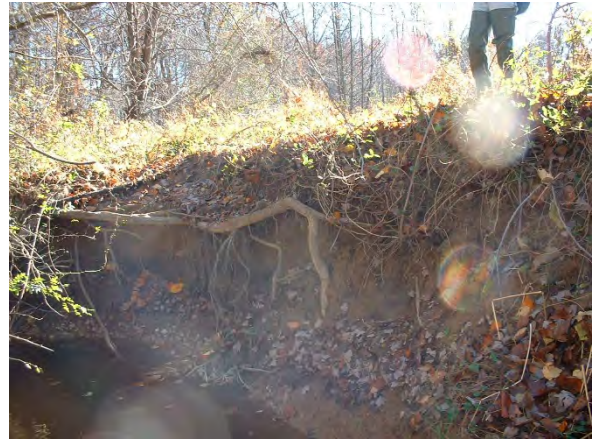
Photo 3.3 Erosion on Captain Hickory Run along Milburn Street (DFCH012.E002).

- S76 This site at the end of Milburn Street is severely eroded, as shown in Photo 3.2 and Photo 3.4.
- S77 This site has a significant amount of buffer encroachment, along with an area of erosion. Additionally, there is an earthen berm, which is blocking the stream and may be a fish blockage (Photo 3.5).

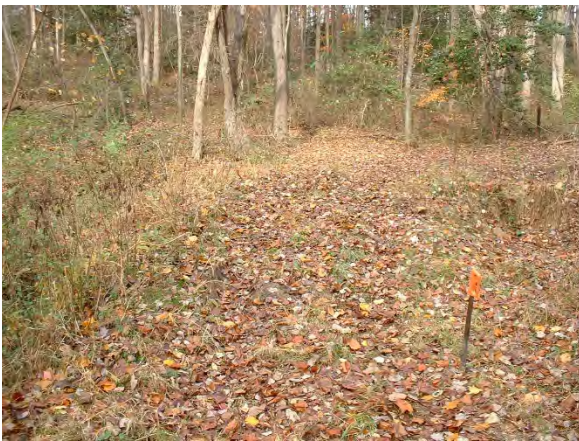
Photo 3.5 Earthen berm located in the upper reaches of Captain Hickory Run near Thunderhill Court (DFCH009.T001)

There are two obstruction locations within the subwatershed both of which are restricting fish passage between habitats and possibly during migration. One obstruction is an earthen **berm** (used to block or redirect surface water flow) with an impact score of moderate to severe, indicating that it may be causing damage to stream (see Photo 3.5). This berm is located on a tributary just east of Walker Road near Thunderhill Court and is at candidate site S77.

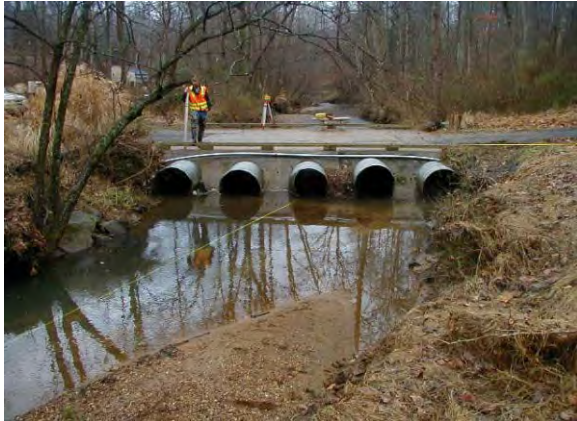
Culvert # 65 (Photo 3.6) overtopped for all events. From the photos, it appears that culvert #65 has recently been reconstructed and functions as a stream ford. This crossing is also a residential access road with a functional classification of "local". It should not be overtopped by storms more frequent than the 10-year event.

Photo 3.6 Captain Hickory Mainstem at End of Fringe Tree Road

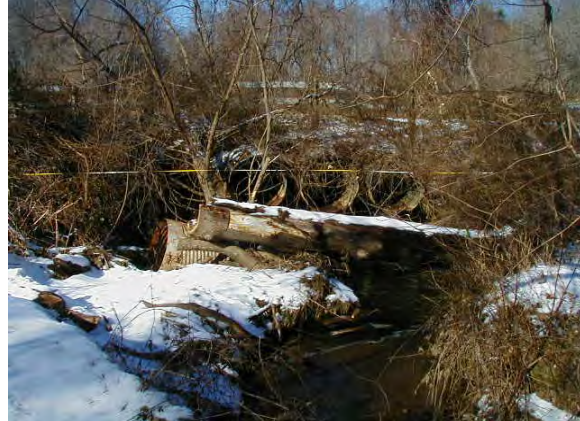
Culvert #69 (Photo 3.7) overtopped for the 50- and 100-year events. This is a residential access road with a classification of "local," requiring the culvert to pass the 10-year event.

Photo 3.7 Unnamed Tributary at Sunnybrook Drive.

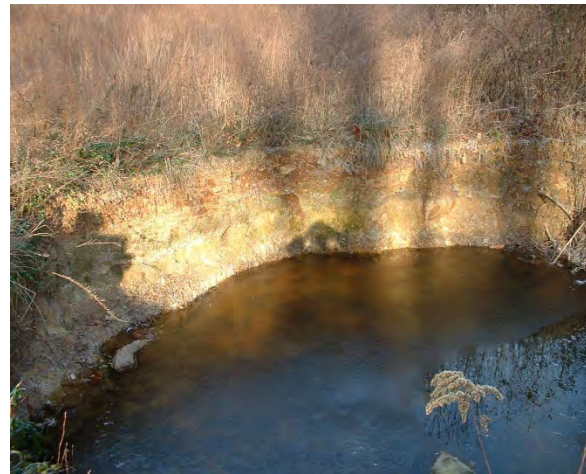
The entire stream length of Dog Run is characterized by moderately unstable banks with high erosion potential during **floods** as in Type II and III channels. Two specific erosion locations were located that are impacting the stream system. The first is located south of Georgetown Pike and east of Kimberly Place, and is 1,800 linear feet on the outer bends (see Photo 3.9). The eroding area is causing instream degradation, may be damaging property and is a stream restoration candidate site S78. The second erosion location (Photo 3.10) is on the most downstream reach near the confluence with Piney Run. It is 50 linear feet in length, has instream degradation, and is also a stream restoration candidate site S02.

Photo 3.10 Erosion located near confluence of Dog Run with Piney Run (DFDG001.E001).

- S02 This reach has active widening, unstable banks, and erosion. It is located in the downstream portion of Dog Run near the confluence with Piney Run (Photo 3.10)
- S78 This eastern reach is in an area with missing buffer and erosion problems combined. This stream has poor habitat (Photo 3.8 and 3.9).
- S79 This reach has missing buffer on both the left and right banks along with poor habitat. Channel disturbance in the form of channelization is also an issue on this reach (Photo 3.11).

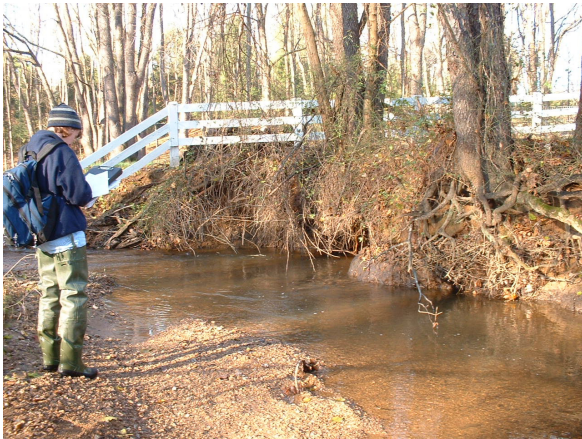
Fifty-seven percent of the assessed stream length had at least one bank that was considered moderately unstable, with high erosion potential during **floods**. There is one specific erosion location comprising 2,800 linear feet that is damaging property and causing instream habitat degradation. It is located on the mainstem of Piney Run in the downstream end of the subwatershed. A portion of the erosion is shown in Photo 3.12. The site has high restoration potential and is a candidate stream restoration site S05.

Photo 3.12 Erosion just south of Eisenhower Lane (DFPR005.E001).

- S05 The Stream Physical Assessment survey found this site was found to have Poor habitat and erosion resulting in unstable banks (Photo 3.12).
- S80 The Stream Physical Assessment found that there are long reaches with limited buffer due to lawn encroachment on both sides of the channel (3200 feet along one reach).
- S81 Also located at a confluence, the reported that this site had active widening on the mainstem and a severely deficient buffer with moderate restoration potential on the tributary (Photo 3.14).
- S82 The Stream Physical Assessment survey noted significant trash and debris at the dumpsite located north of Springvale Court (Photo 3.15).
- S83 The Stream Physical Assessment survey found an obstruction located at the very downstream end of Piney Run (Photo 3.13).

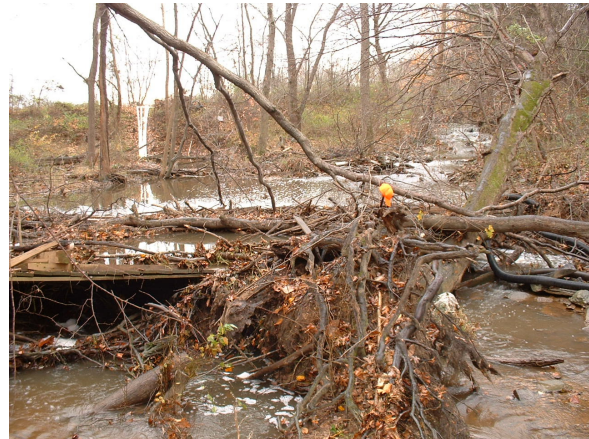
Photo 3.13 Obstruction located near the intersection of Walker Road with Manning Street (DFPR001.T001).

There are 11 obstruction locations within the Piney Run subwatershed, all of which are restricting fish passage. Many of the obstructions were beaver dams and are located in the central portion of the subwatershed on tributaries and on the mainstem. One obstruction is located at the very downstream end of the mainstem and is blocking fish passage. The site is shown in Photo 3.13 and is a candidate stream restoration site S83.

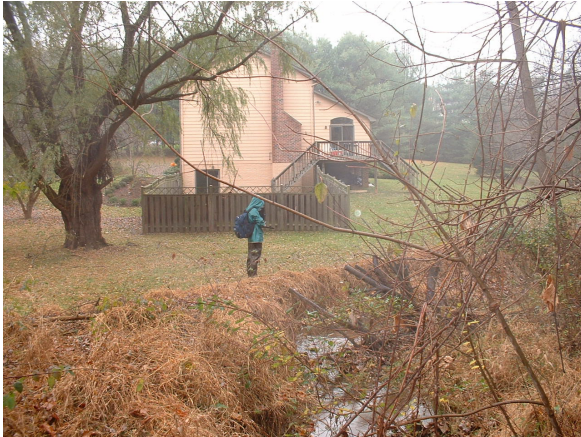
Photo 3.14 Example of deficient buffer located south of Good Spring Avenue (DFPR009.B003).

- A specific buffer encroachment area is located along a tributary between Riva Ridge Drive and Springvale Road and extends for approximately 350 feet. An example area is shown in Photo 3.14. The reach is a candidate stream restoration site S81.
- One dumpsite was reported in the Piney Run subwatershed. It is located just north of Springvale Court. It contains non-toxic material, and does not appear to be used often. However, clean up would definitely be beneficial. The site is a candidate stream restoration site S82 and is shown in Photo 3.15.

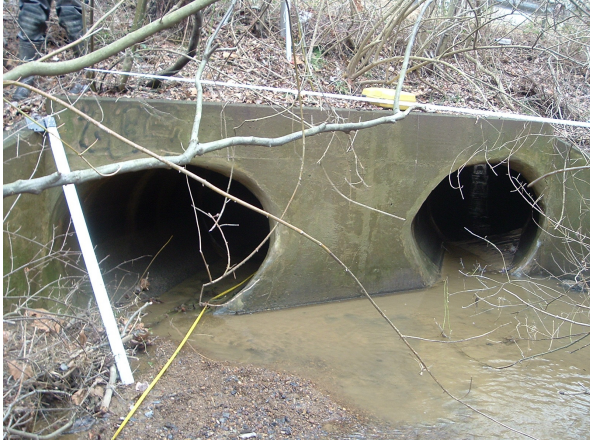
Photo 3.16 Piney Run Tributary at Riva Ridge Drive.

Culvert #64 (Photo 3.16) overtopped for the 50- and 100-year events. Riva Ridge Drive can be classified as a local road, so it must pass the 10-year event, which it does. This is not considered a candidate site

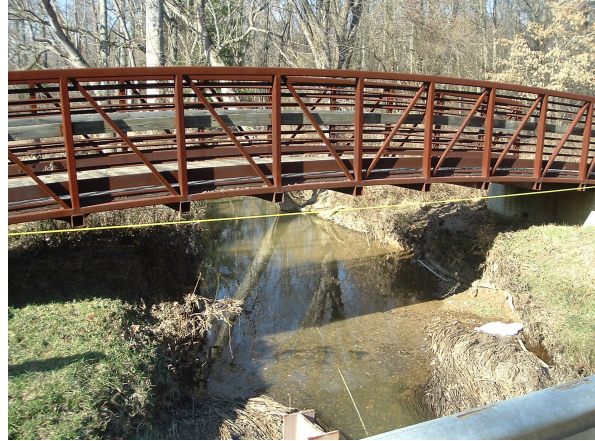
Photo 3.17 Piney Run Mainstem at the footbridge by Springvale Road.

Culvert #67-A (Photo 3.17) overtopped for the 50- and 100-year events. A footbridge is not a public road and has no requirements for overtopping. This is not considered a candidate site.

- F67A The footbridge upstream of Springvale Road overtops for the 50- and 100-year events (Photo 3.17).
- F67B The bridge on Springvale Road overtopped for all events except the one- and two-year. This is a primary road, so it is required to pass the 25-year event (Photo 3.18).
- F77 The bridge at Walker Road overtops for events less frequent than the 5-year event. This is a primary road, so it must pass the 25-year event (Photo 3.20).
- F78B The driveway pad next to Manning Street overtops for all events (Photo 3.21).

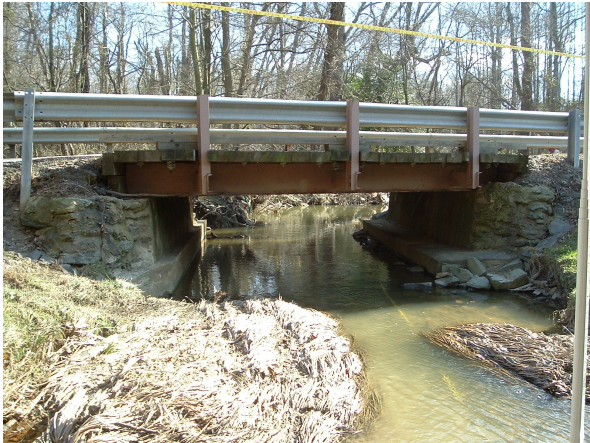
Photo 3.18 Piney Run Mainstem at Springvale Road

Culvert #67-B (Photo 3.18) overtopped for events less frequent than the 2-year event. Springvale Road carries through traffic and so is considered a primary road, which must pass the 25-year event.

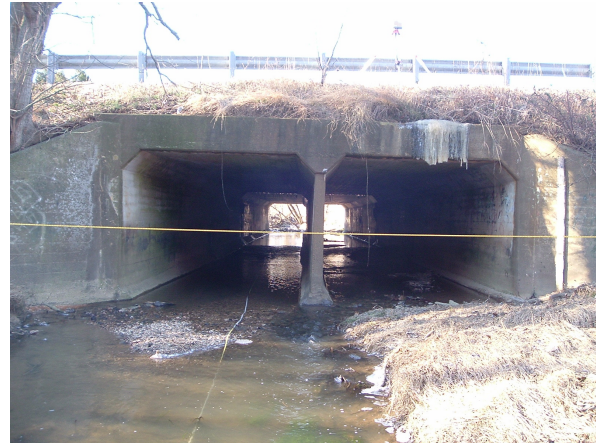
Photo 3.19 Piney Run Mainstem at Leesburg Pike

Culvert #68-A (Photo 3.19) overtopped for the 50 and 100-year events. Primary roads like Leesburg Pike are required to pass the 25-year event. This is not considered a candidate site.

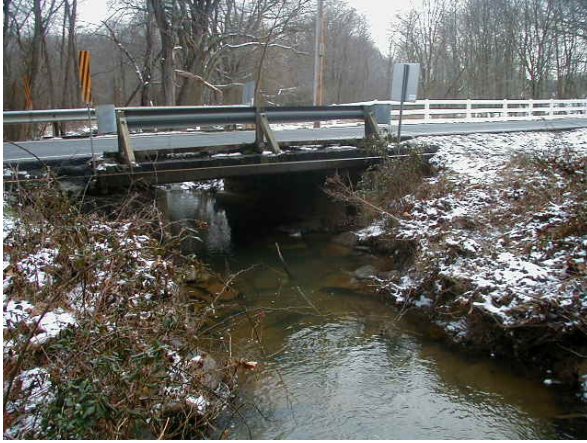
Photo 3.20 Piney Run Mainstem at Walker Road

Culvert #77 (Photo 3.20) overtopped for events less frequent than the five-year event. Walker Road is also considered a primary road that is required to pass the 25-year event.

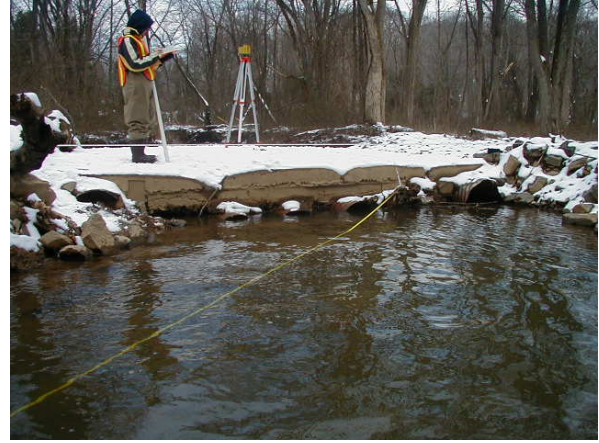
Photo 3.21 Piney Run Mainstem at the driveway pad by Manning Street

Culvert #78-B (Photo 3.21) overtopped for all events. The driveway pad next to Manning Street is not a public road and is therefore not subject to overtopping requirements. This is not considered a candidate site.

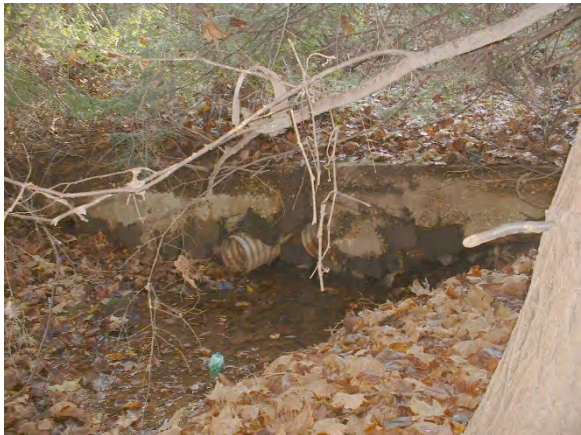
The storm drainage system connects the developed portions of the land to the stream system. Stormwater outfalls are located where the stormwater system ends and the natural channel begins. Outfalls may be sources of pollutants and excessive stormflow from pipes can cause erosion at the outfall and downstream. Field crews located 15 **outfall** pipes discharging into the Lower Difficult Run subwatershed during the Stream Physical Assessment. All were within 200 feet of the channel, and ranged in size from 12 to 18 inches. Stormwater from all of the pipes was causing at least minor to moderate erosion. Two pipes were identified with erosion downstream and some undermining of the structures. They are shown below in Photos 3.22 and 3.23.

Photo 3.22 Erosion at outfall pipe located near Mill Creek Landing (DFDF003.P001).

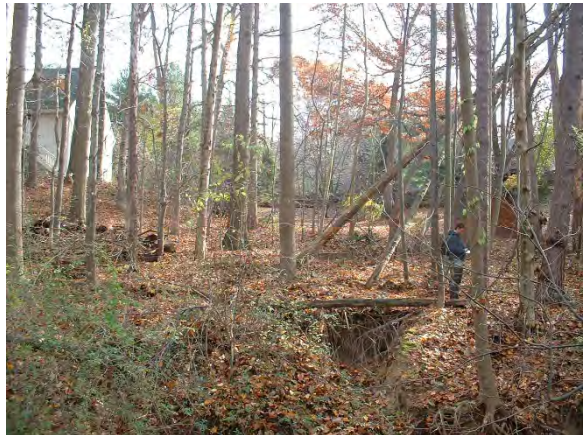
Photo 3.23 Erosion at outfall pipe located off of Hidden Creek Drive (DFDF020.P004).

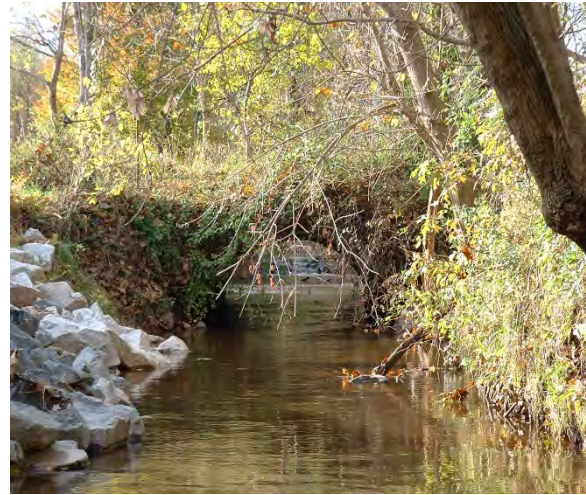
Photo 3.25 Upstream and downstream bank erosion at Leesburg Pike (DFCR001.C001).

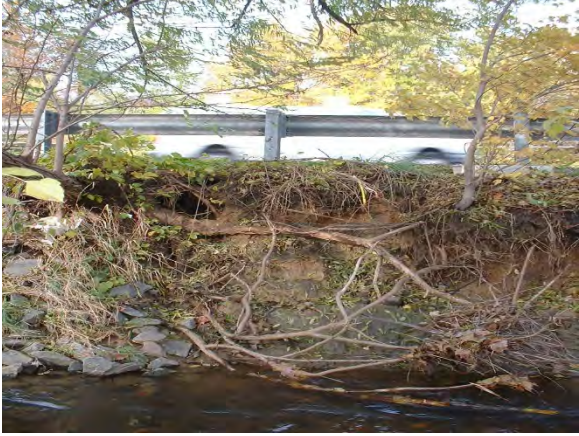
erosion sites (nine points) were having a severe impact on the stream channel, instream habitat or infrastructure. Several of the erosion areas have a high restoration potential. Two of the areas with the highest restoration potential are shown in Photos 3.26 and 3.27, which are candidates for stream restoration S85 and S84 respectively.

Photo 3.26 Severe erosion that could pose a threat to road safety along Route 7 to the east of Carpers Farm Way (DFCR001.E001).

- S85 The Colvin Run tributary has severe erosion (Photo 3.26) that could impact the safety of Carpers Farm Way and is missing buffer on both sides of the stream.

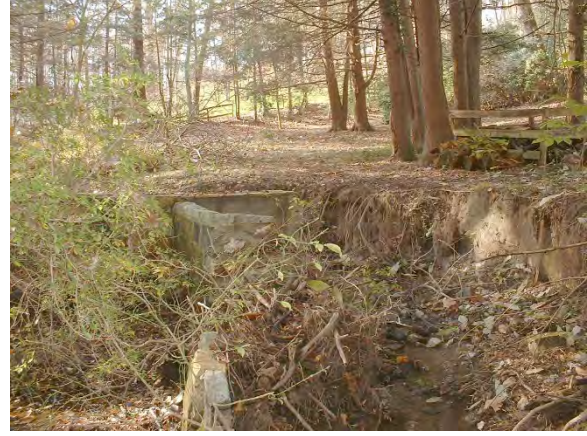
Photo 3.27 Erosion located between Old Dominion Drive and Georgetown Pike (DFDF011.E001).

- S84 A tributary of the Difficult Run mainstem is identified as having localized severe erosion with a high restoration potential and buffer encroachment by adjacent lawns between Old Dominion Drive and Georgetown Pike (Photo 3.27).

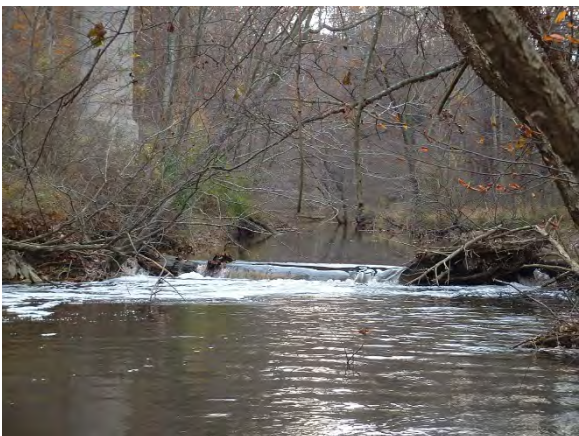
There are 10 obstruction sites located within the Lower Difficult Run subwatershed, most of which are trees and debris. Six of the obstruction sites are thought to be impacting fish movement within the stream. Of these six, one of the sites is on a downstream reach of the mainstem of Difficult Run (Photo 3.28) and has the potential for impacting a large majority of the entire Difficult Run watershed, as this is the only way for fish to get upstream to the rest of the watershed. This site is candidate site S86.

Photo 3.28 Stream blockage located near Old Dominion Drive (DFDF002.T002).

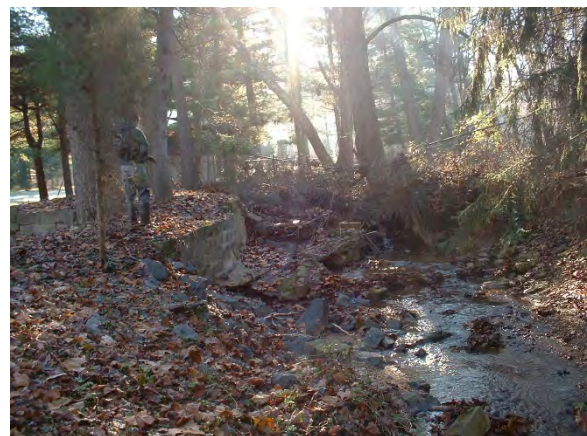
A second site impacting fish passage is located at the downstream end of one of the longer tributaries to mainstem Difficult Run (Photo 3.29). This site is candidate site S86.

Photo 3.29 Stream blockage near Ramey Lane cul-de-sac (DFDF019.T001).

- S86 The Stream Physical Assessment identified an obstruction affecting fish passage (Photo 3.29), which could possibly affect the entire Difficult Run watershed.

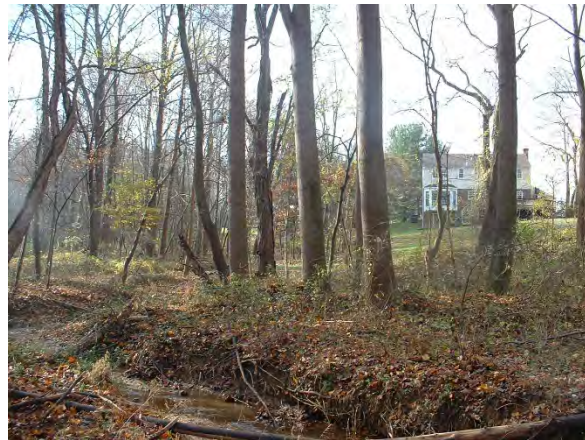
Photo 3.30 Buffer impact on a tributary west of Hidden Creek Drive (DFDF020.B001).

- S88 The stream between Hidden Creek Drive and Forestville Drive was identified during the assessment as having a severe obstruction, a pipe with moderate erosion and 800 feet of erosion with “moderate” restoration potential, and missing buffer over approximately half of the reach (Photo 3.30).

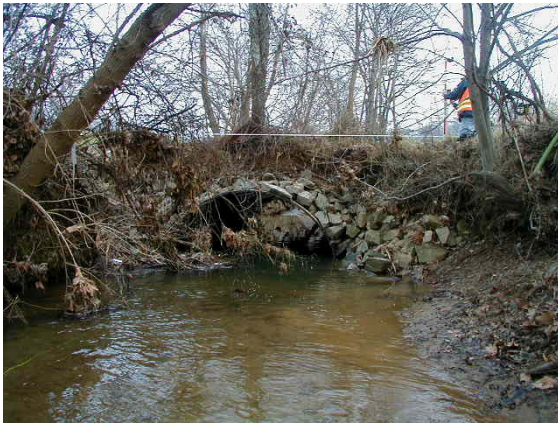
Photo 3.31 Lower Difficult Run Mainstem along Leesburg Pike

Culvert #58 (Photo 3.31) overtopped for all events. From the photos, this culvert appears to be under a gravel drive, possibly a driveway or access road, and will be classified as a local road. Local roads are required to pass the 10-year event.

- F58 The crossing along Leesburg Pike was overtopped for all events. Since it is classified as a local road, the culvert should pass the 10-year event (Photo 3.31).
- F59 The crossing of Leesburg Pike was overtopped for all events. Classified as a primary road, this bridge should pass the 25-year event (Photo 3.32).
- F72 The bridge on Leigh Mill Road overtopped for all events. It is also classified as a primary road, so it must pass the 25-year event (Photo 3.33).

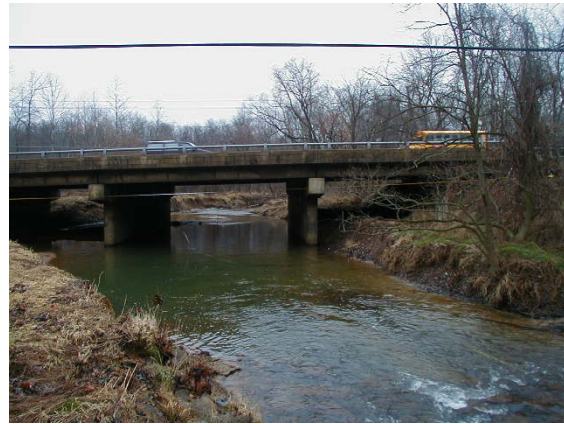
Photo 3.32 Lower Difficult Run Mainstem at Leesburg Pike

Culvert #59 (Photo 3.32) overtopped for all events. Leesburg Pike is a primary road, which is required to pass the 25-year event.

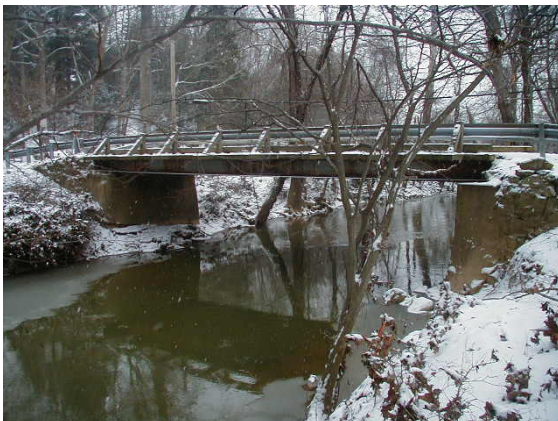
Photo 3.33 Lower Difficult Run Mainstem at Leigh Mill Road

Culvert #72 (Photo 3.33) overtopped for all events also. Leigh Mill Road carries through traffic and is thus considered a primary road. Primary roads should pass the 25-year event.

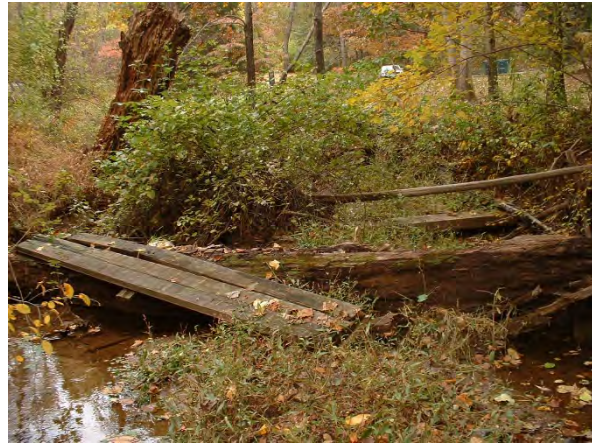
There was one stream blockage made up of trees and debris that appeared to be restricting fish movement. The obstruction also has the potential to create **flooding** problems under high flow conditions. The obstruction is shown in Photo 3.35 and is a candidate site for restoration S90.

Photo 3.35 Obstruction at the northern end of Sharpers Run near the confluence with Rocky Run between the Bryan Pond and Peacock Station communities (DFSP001.T001).

S90 The Stream Physical Assessment identified this site as having buffer and erosion problems along with active widening. There is also a stream blockage at this site (Photo 3.35, 3.36).

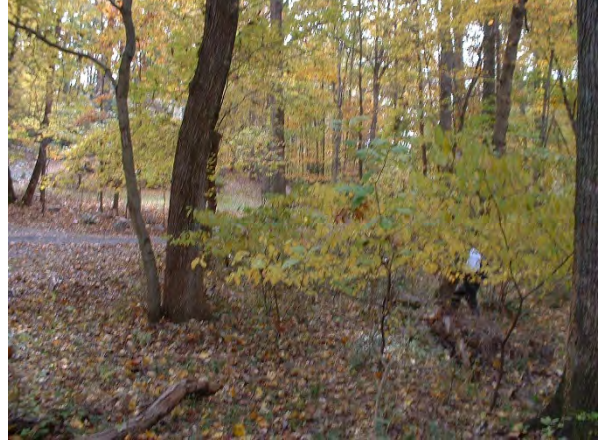
Photo 3.36 Buffer encroachment between Rocky Run Road and Cedrus Lane (DFSP001.B004).

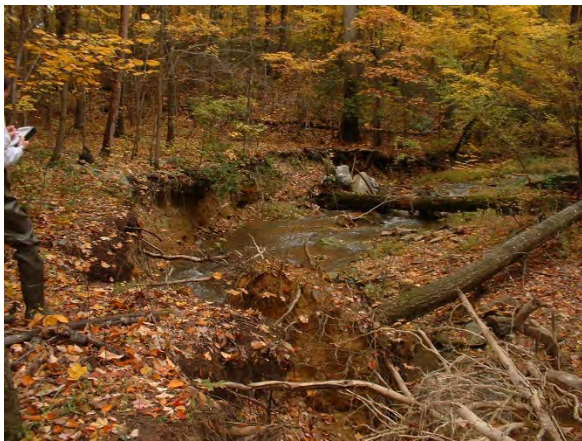
Channel incision was especially notable on several tributaries to Rocky Run and on a segment of the mainstem of Rocky Run in the central portion of the subwatershed. Field crews noted and photographed five erosion points that were having a severe impact on Rocky Run and its tributaries. Four of these erosion points are located on the mainstem of Rocky Run and one on a minor tributary in the upper reaches of Rocky Run. An example is shown in Photo 3.38, which is stream restoration candidate site S92.

Photo 3.38 Significant erosion on the mainstem between Woodside Drive and Orlo Drive (DFRR013.E001).

- S91 The Stream Physical Assessment identified this site as having severe erosion all with moderate restoration potential near Bellview Road.
- S92 This site was identified as having significant erosion and a deficient buffer, where houses are built close to the stream (Photo 3.38).
- S93 This site, located near the culvert at Towlston Road, was identified as having a deficient buffer, again because of the proximity to houses.

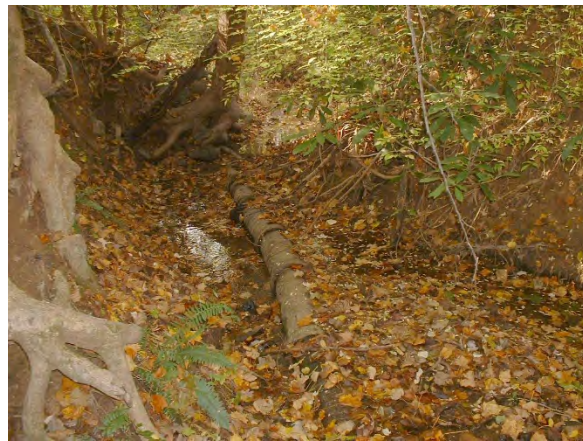
Photo 3.39 Exposed utility located northeast of Old Dominion Drive near Tebbs Lane.

There was one utility pipe of an unknown type in reach on a tributary to Rocky Run as shown in Photo 3.39. This utility pipe is partially buried and did not appear to be causing erosion in the stream channel.

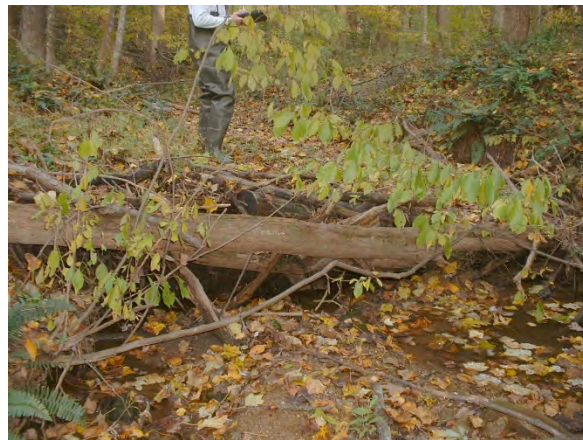
There were 16 sites along the stream within the subwatershed where trees and debris were obstructing flow. Of these, nine were considered significant enough to affect fish passage and three of the 16 had a greater than moderate impact. Photo 3.40 shows a representative blockage on a Rocky Run tributary that may be impeding fish passage.

Photo 3.40 Obstruction located between Tebbs Lane and Cilicia Street (DFRR001.T002).

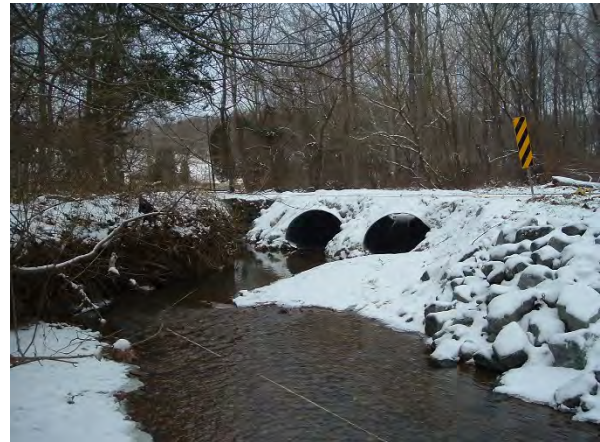
Photo 3.42 Culvert 75 at Bellview Road on Rocky Run mainstem.

Culvert #75 (Photo 3.42) overtopped for all events except the one and two-year. Bellview Road is a primary road and so must pass the 25-year event.

- F75 The crossing at Bellview Road overtopped for 5-year and greater events. To meet standards, however, it must pass the 25-year event because it is a primary road (Photo 3.42).
- F76 The bridge on Towlston Road, a primary road, overtopped for all events except the one-year. This bridge must pass the 25-year event to meet requirements (Photo 3.43).
- F79 The crossing at Old Dominion Drive overtopped for 25, 50, and 100-year events. Old Dominion Drive is classified as a primary road, so it must pass the 25-year event (Photo 3.44).

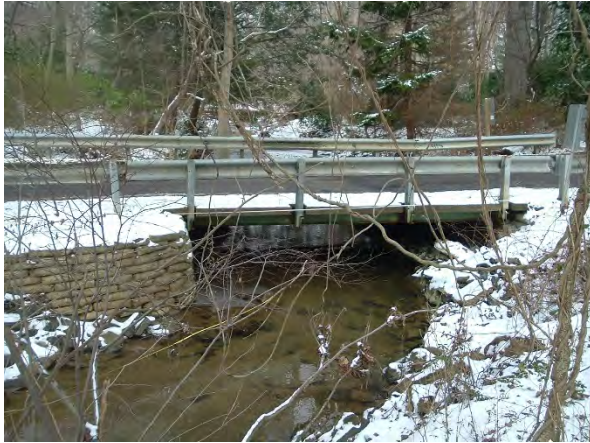
Photo 3.43 Culvert 76 on Rocky Run mainstem at Old Towlston Road

Culvert #76 (Photo 3.43) overtopped for all events except for the one-year. Primary roads, the classification for Towlston Road, must pass the 25-year event.

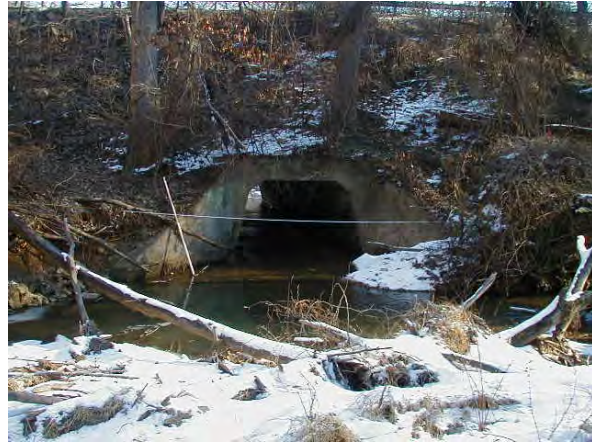
Photo 3.44 Culvert 79 on Rocky Run mainstem at Old Dominion Drive

Culvert #79 (Photo 3.44) overtopped for the 25, 50, and 100-year events. Old Dominion Drive allows through traffic and is classified as a primary road. This means it must pass the 25-year event.

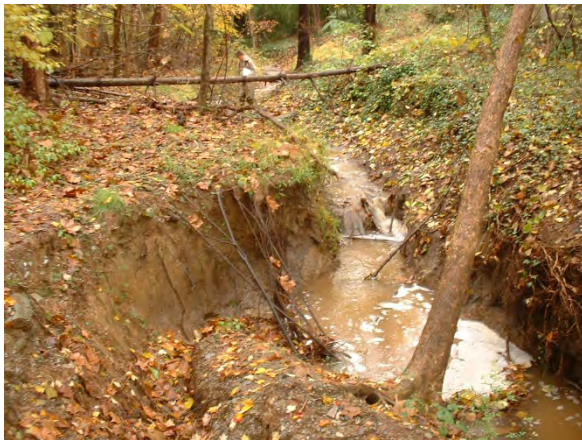
Photo 3.46 Erosion located on a tributary to Colvin Run between Buttermilk Lane and Hunt Club Road (DFCR012.E002)

In the stream reaches that are experiencing erosion, much of the erosion is occurring on the outer banks of bends. Several severe erosion locations exist in the Colvin Run subwatershed. Most of these areas have a good restoration potential. Photos of a few of the more serious erosion problems are shown in Photos 3.46 through 3.49. These example sites are all candidate sites for stream restoration (S98, S93, S96, S92 respectively).

- S98 The stream flows directly into Lake Fairfax and is extremely eroded with moderate restoration potential. (Photo 3.47)
- S99 This site has missing buffer that is considered severe. It has the most severe impact from the missing buffer and the highest potential for restoration.
- S135 The Stream Physical Assessment located a failing outfall where the flow is causing severe bank erosion and potentially unsafe conditions (Photo 3.45 and 3.51).
- S136 The Stream Physical Assessment identified several outfalls in disrepair, obstructions, and severe stream bank erosion along this reach. (Photo 3.46)

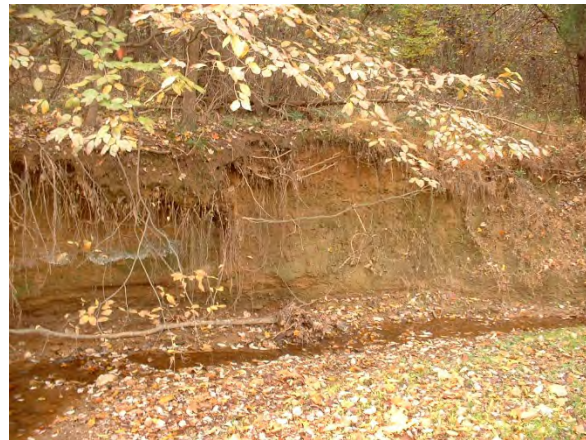
Photo 3.47 Erosion located on reach just west of Hunter Mill Road near Little Run Farm Court (DFCR008.E001)

- S93 This is another site with the most severe erosion combined with the highest restoration potential as defined by field crews. (Photo 3.47)
- S94 The Stream Physical Assessment showed this stream as having active widening.

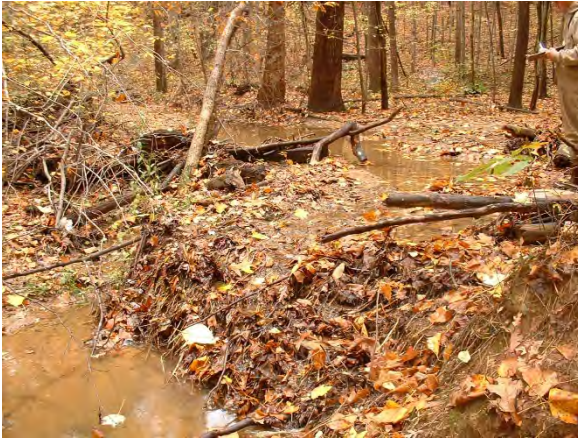
Photo 3.48 Erosion on a tributary to mainstem Colvin Run near Mount Sunapee Road (DFCR006.E002).

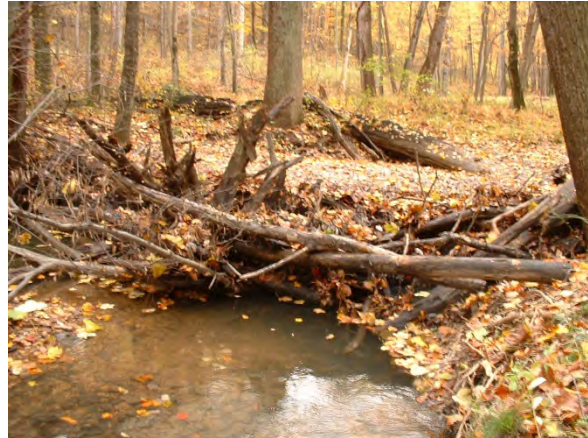
Photo 3.49 Erosion on mainstem Colvin Run downstream of Lake Fairfax before Colvin Run crosses under Hunter Mill Road (DFCR009.E001).

- S95 This site has severe to extreme erosion with moderate restoration potential along with active widening.
- S96 This reach, as well as the reach downstream around the D12 site, has severe erosion with moderate potential for restoration. (Photo 3.49)

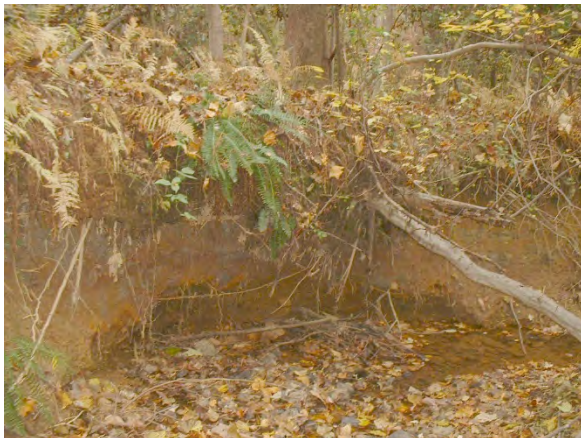
There are 28 points along the stream that are blocked by trees, debris and sediment. Eleven of these are severe enough to be obstructing fish passage. Two are shown below in Photos 3.50 and 3.51 and are near stream restoration candidate sites S135 and S11, respectively.

Photo 3.50 Obstruction just upstream of Lake Fairfax to the west of Aldenham Lane (DFCR013.T001).

- S49 This reach has severe erosion with unstable banks and buffer deficiency. Both have moderate potential for restoration.
- S92 The Stream Physical Assessment noted this reach, which is directly downstream of S99, has extreme erosion with moderate restoration potential along with active widening. (Photo 3.50)

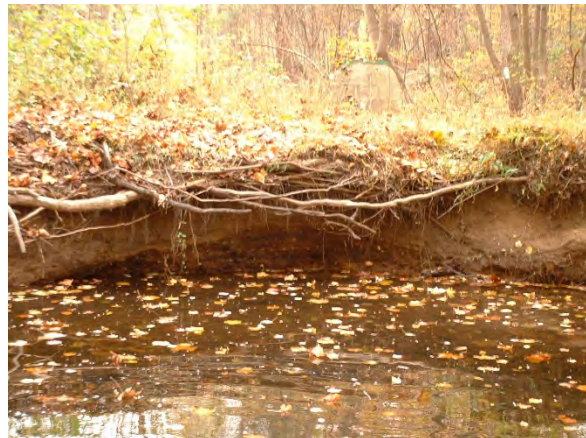
Photo 3.51 Obstruction upstream of Lake Fairfax located near Park Overlook Drive (DFCR015.T001).

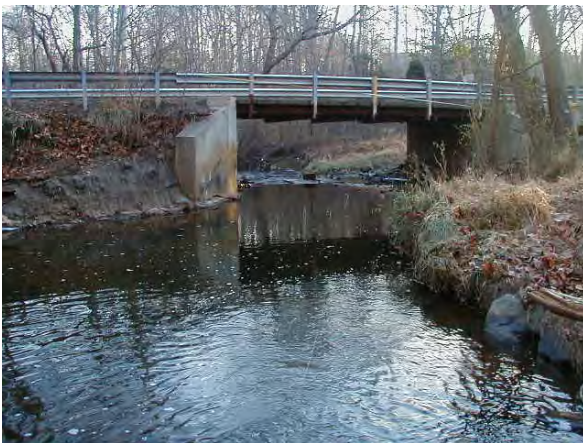
Photo 3.52 Colvin Run Mainstem at Hunter Mill Road

Culvert #40 (Photo 3.52) overtopped for events less frequent than the 10-year. The road this bridge is on, Hunter Mill Road is classified as a primary road. This requires it to pass the 25-year event.

- F40 The bridge over Colvin Run on Hunter Mill Road overtops for flows less frequent than the 25-year event. Primary roads must pass the 25-year event. (Photo 3.52)
- F41 The culvert under Lake Fairfax Drive overtops for all events. Local roads must pass the 10-year event. (Photo 3.53)
- F57 The culvert under Carpers Farm Way overtops with existing conditions for all the modeled events. Local roads must pass the 10-year event. (Photo 3.54)

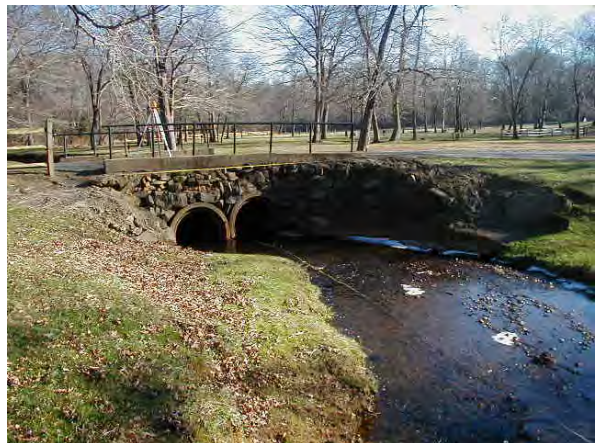
Photo 3.53 Colvin Run Mainstem at Lake Fairfax Drive

Culvert #41 (Photo 3.53) overtopped for all events. Lake Fairfax Drive is used as a local road to access Lake Fairfax Park. This requires it to pass the 10-year event.

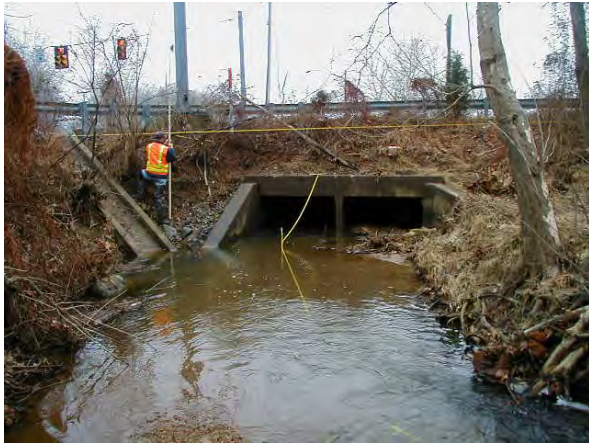
Photo 3.54 Colvin Run Mainstem at Carpers Farm Way

Culvert #57 (Photo 3.54) overtopped for events less frequent than the 2-year. Carpers Farm Way is a local road, which means it must pass the 10-year event.

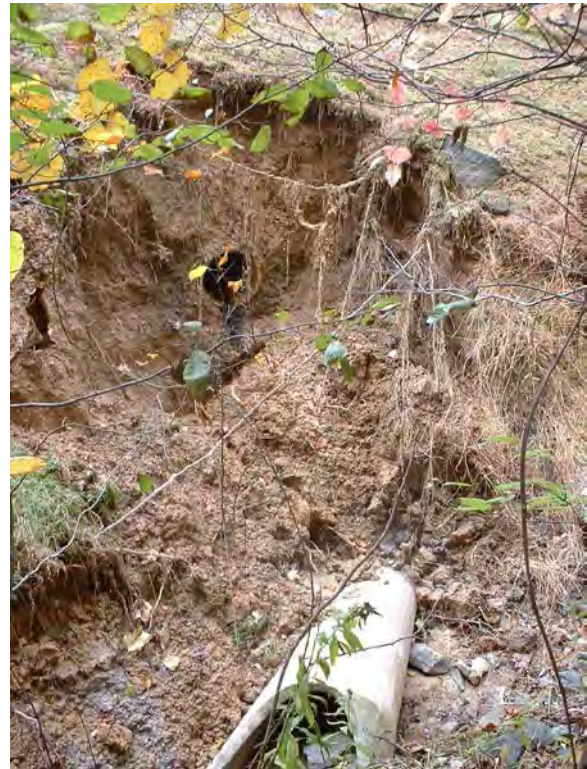
A 16-inch concrete pipe is located south of the Dulles Access and Toll Road near Alexander Bell Drive. Severe erosion is occurring where the pipe segments have separated (Photo 3.55). A second outfall, located just downstream, is an 18-inch pipe located 75 feet from the channel as shown in Photo 3.56. These two outfalls together make up a candidate restoration site S101.

Photo 3.55 Severe erosion and pipe segment separation at a 16-inch outfall located near Alexander Bell Drive (DFSB006.P006).

- S25 The stream has signs of erosion considered severe but with a high potential for restoration (Photo 3.58).
- S101 There are outfall pipes that are causing major erosion and have the potential to destroy existing parking lots and sanitary sewers (Photo 3.55, 3.56 and 3.60).
- S102 There are utility lines in the stream that erosion has unearthed (Photo 3.57).
- S103 There is erosion that is considered severe with a high potential for restoration at this site. It is located directly upstream of site S25 (Photo 3.59 and 3.61).

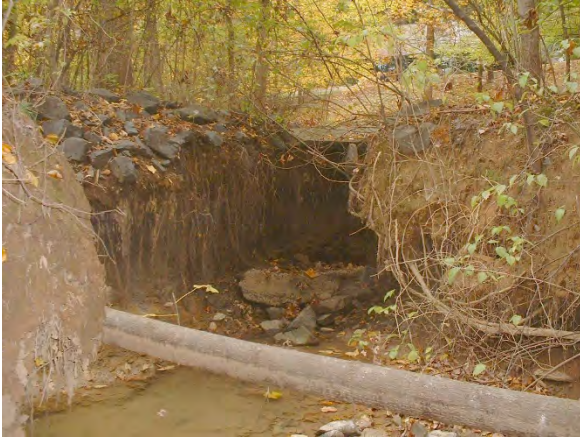
Photo 3.56 An 18-inch outfall causing severe erosion located downstream of the outfall shown in Photo 4.1 (DFSB006.P005).

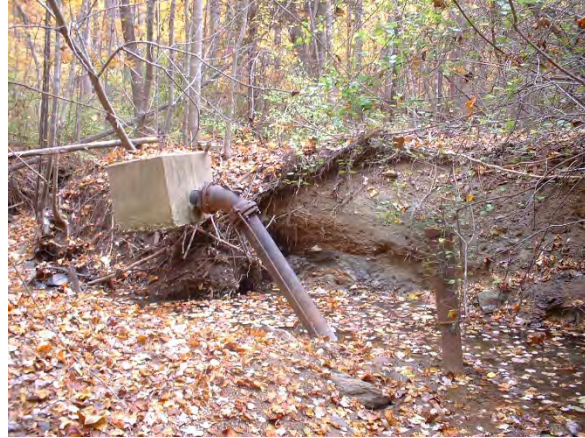
The third outfall lies within the stream channel, and is located south of Sunrise Valley Drive and just east of Barton Hill Road (Photo 3.57). This site is identified a potential restoration site (S102) due to the severe erosion.

Photo 3.57 Pipe located south of Sunrise Valley Drive and just east of Barton Hill Road. Major erosion around the structure is evident (DFSB006.P003).

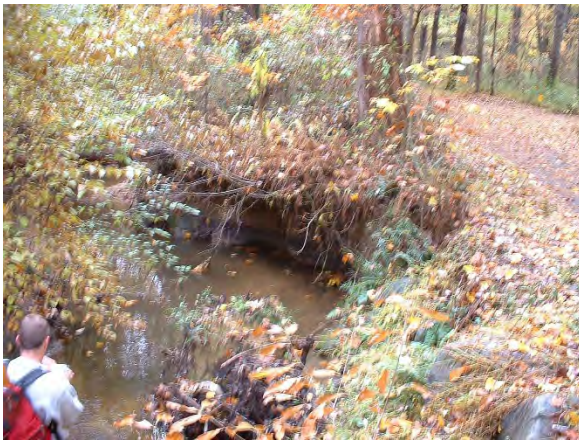
- Channel **substrate** throughout the subwatershed is made up of gravel and sand.
- The majority of the stream banks were moderately unstable which can lead to stream erosion during high flows and **flood** events. There were 125 linear feet of erosion noted that were having an extreme impact on the stream with a potential threat to property and infrastructure. One of these points is located on a tributary to Snakeden Branch near the tributary's confluence with the mainstem and is shown in Photo 3.58. This site is potential stream restoration site S25.

Photo 3.58 Erosion located south of South Lakes Drive (DFSB012.E001).

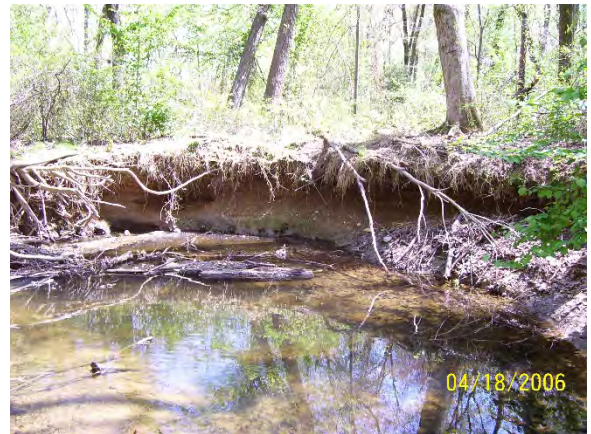
- The other two areas of erosion are on a single reach approximately 500 feet from one another. These are located on the mainstem of Snakeden Branch upstream of Lake Audubon. This potential stream restoration site S103, shown in Photo 3.59

Photo 3.59 Erosion located between Old Trail Drive and Millenium Lane (DFSB015.E001).

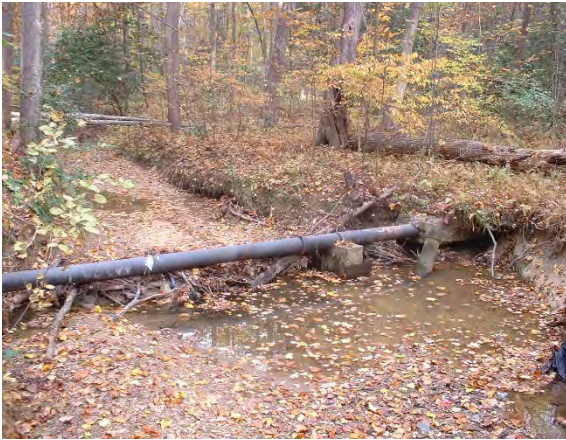
Photo 3.60 Exposed sanitary utility line crossing stream (DFSB006.U002).

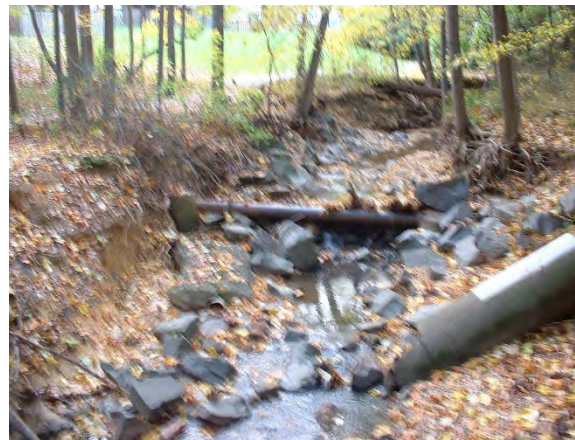
- There are nine stream blockages, primarily trees. Four of these blockages are likely restricting fish passage. The worst obstruction is located at the confluence of the two upstream tributaries near Tanbark Drive and is a potential stream restoration site. All other stream obstructions were considered to have less significant and were not considered further for study.
- There are four sanitary lines either crossing the stream or within the stream banks that were exposed and causing erosion problems and/or an obstruction during higher flows.
- The sanitary line near Robert Fulton Drive is in severe disrepair and is a potential stream restoration site.
- The utility at the end of Wilder Point Road is shown in Photo 3.60 and is a potential stream restoration site.
- The utility at the southern end of Mossy Creek Lane is shown in Photo 3.61 and is also a potential stream restoration site.

Photo 3.61 Exposed utility at the southern end of Mossy Creek Lane.

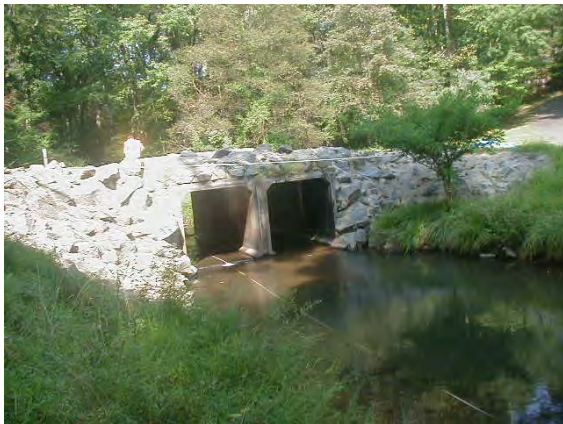
Culvert #10 (Photo 3.62) overtopped for all events except the one-year. This is a local road, and so is required to pass the 10-year event.

Photo 3.62 Snakeden Branch Mainstem at Hunters Den Lane

- F10 The culvert at Hunters Den Lane overtopped for all events except the one-year. This is a local road, so it must pass the 10-year event (Photo 3.62).
- F11 The bridge on Hunter Station Road overtops for all events. Hunter Station Road is a primary road that should pass the 25-year event (Photo 3.63).

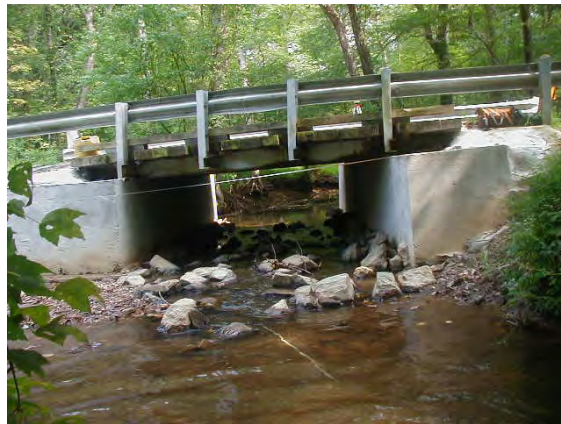
Culvert #11 (Photo 3.63) overtopped for all events. Hunter Station Road is a primary road, uses mainly for through traffic. It is therefore required to pass the 25-year event.

Photo 3.63 Snakeden Branch Mainstem at Hunter Station Road

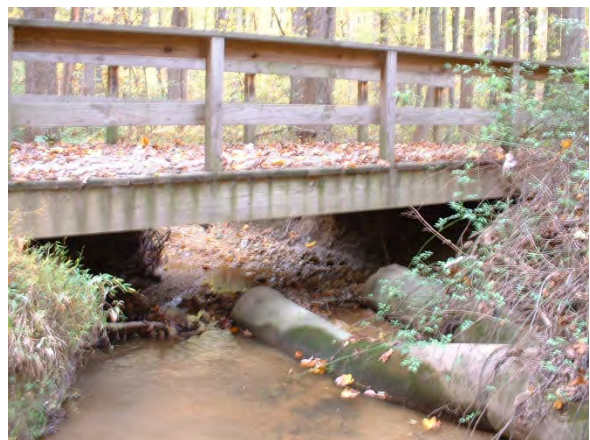
Stream crossings, such as bridges and culverts are often locations of erosion and flooding. The combination of aging structures and frequently high stormwater levels can cause downstream stream stability problems and habitat impairment. Seventeen of the 21 stream crossings in The Glade subwatershed are wooden footbridges. All but two crossings have very little impact on stream character. The two with more significant impact are wooden footbridges where the flow is creating moderate bank erosion. The erosion was not significant enough to warrant further study or restoration. The crossings are shown in Photos 3.64 and 3.65.

Photo 3.65 Wooden bridge where stream flow is causing moderate erosion. Located just west of Steeplechase Drive (DFGL008.C001).

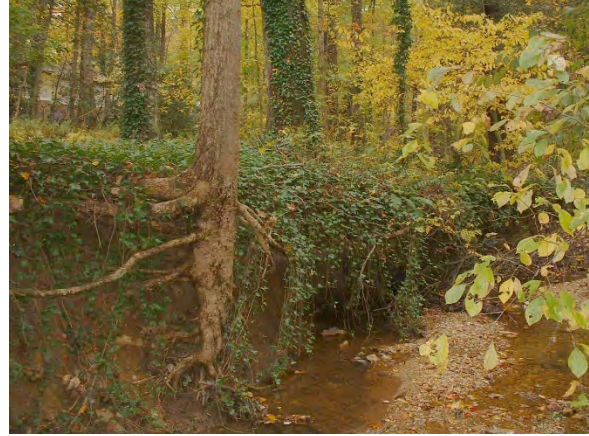
Photo 3.66 Located north of Lawyers Road between Pegasus Lane and Charlestown Lane (DFGL005.E001).

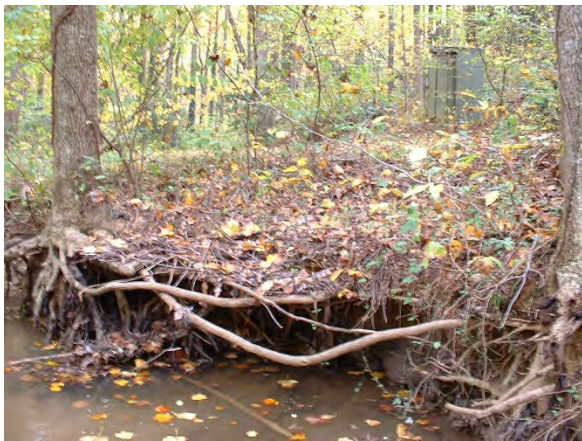
There were only two specific erosion locations noted in the subwatershed. Both were considered to be of moderate impact. These are located just downstream of a candidate stream restoration site S26. An example of the erosion is shown in Photo 3.67.

Photo 3.67 Erosion north of Lawyers Road near Pinoak Lane (DFGL006.E001)

S26 The Stream Physical Assessment identified a significant portion of the stream, including this reach, which has erosion causing unstable banks (Photo 3.67).

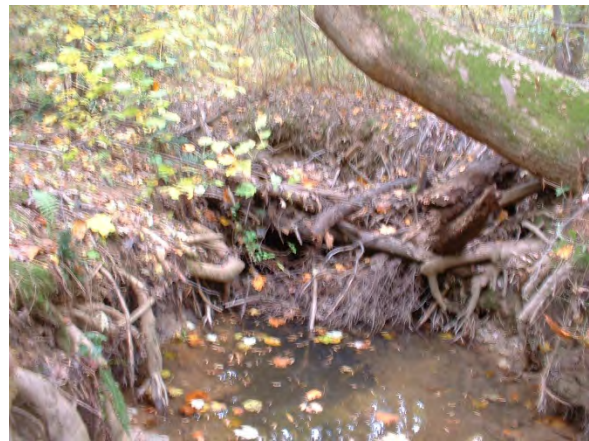
There are ten stream blockages, primarily comprised of downed trees. Eight of these blockages are likely restricting movement of fish within the stream system and can block passage. Only one obstruction is thought to have a severe impact. This obstruction of trees and debris is located on an upstream reach near Stirrup Road, upstream of the candidate stream restoration area S26 (see Photo 3.68).

Photo 3.68 Obstruction of trees and debris near Stirrup Road. (DFGL008.T001)
