Difficult Run Watershed Management Plan

**Volume 1: Watershed Plan
February 2007**

*Fairfax County Department of
Public Works and
Environmental Services*

Prepared By:
KCI Technologies Inc.

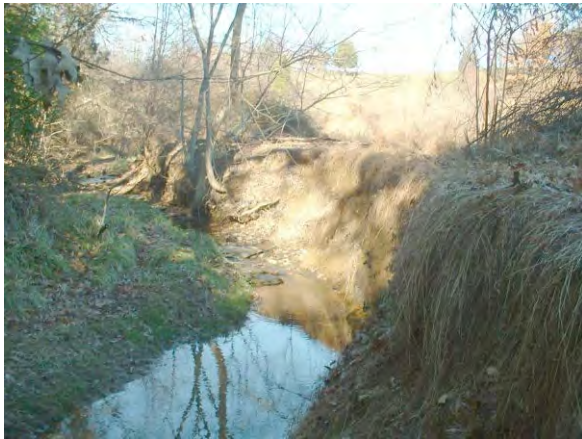
There were 11 points of erosion noted in Middle Difficult Run. The combined length of the erosion points is approximately 6,660 feet (1.3 miles). Two of the 11 erosion points are having a severe impact on stream condition. They are shown here in Photos 3.70 and 3.71. The former is located at Candidate Site S56.

Photo 3.70 Eroding channel located between Brittenford Drive and Hunt Country Lane (DFDF049.E002).

- S56 The Stream Physical Assessment found severe bank erosion at this site, and the catchment has the second highest runoff volume in the subwatershed (Photo 3.70).
- S105 The Stream Physical Assessment found a residential oil tank that should be removed from the stream. The catchment has average runoff and below average pollutant loading (Photo 3.74).
- S106 Stream Physical Assessment inspections showed areas of unstable streambanks, incision, and deficient buffer in this area (Photo 3.76).
- S107 This site has better than average conditions for the subwatershed for runoff flows and pollutant loads. The Stream Physical Assessment identified this site as having deficient buffer and widening.

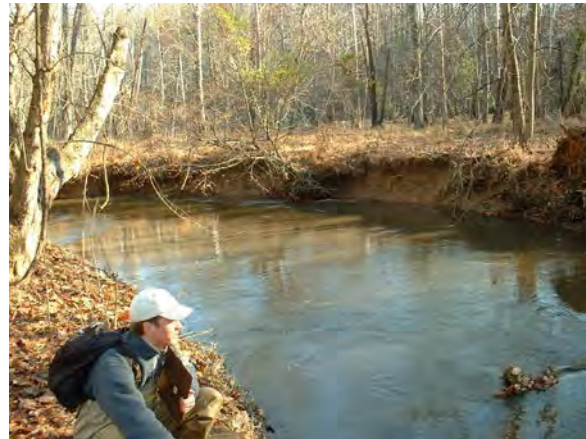
Photo 3.71 Erosion on the mainstem of Difficult Run at the end of Tamarack Drive (DFDF008.E001).

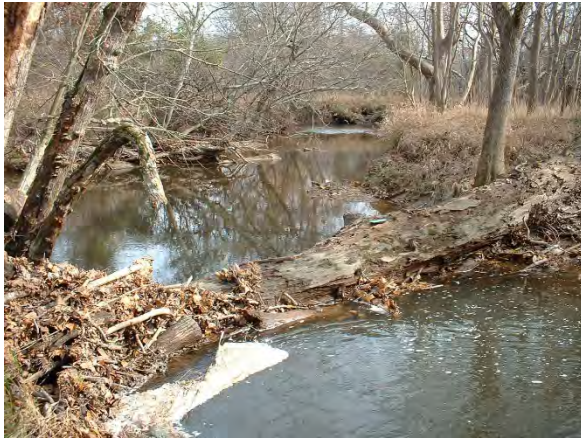
Photo 3.72 Obstruction on the mainstem located in Tamarack Park (DFDF007.T002).

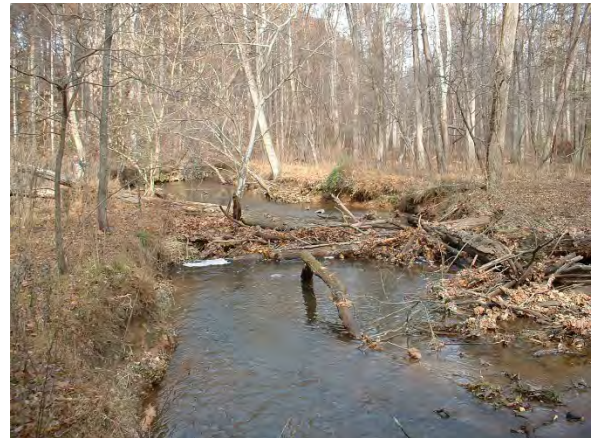
Photo 3.73 Obstruction to fish passage on the mainstem located at the terminus of Montafia Lane, Sun Valley subdivision, directly west of Sun Valley Park (DFDF007.T001).

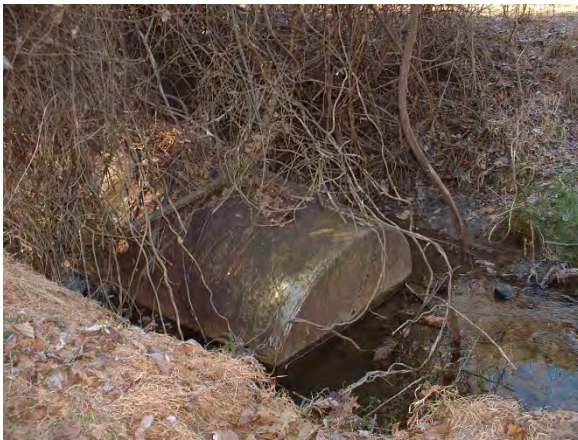
was located in the stream and contained a residential oil tank. Although the dumpsite was not active, clean up would definitely be a benefit to the stream quality. The tank is shown in Photo 3.74 and is at candidate site S105.

Photo 3.74 Residential oil tank located in a tributary near Asoleado Lane (DFDF055.M001).

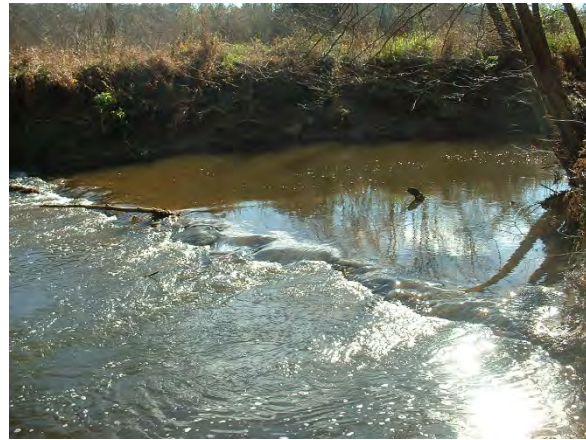
- There was one sanitary line that was crossing the stream and partially buried (see Photo 3.75). Although the line was exposed in some parts, it was stabilized and anchored to the banks.

Photo 3.75 Utility at the downstream end of the subwatershed near Valley Creek Lane (DFDF005.U001).

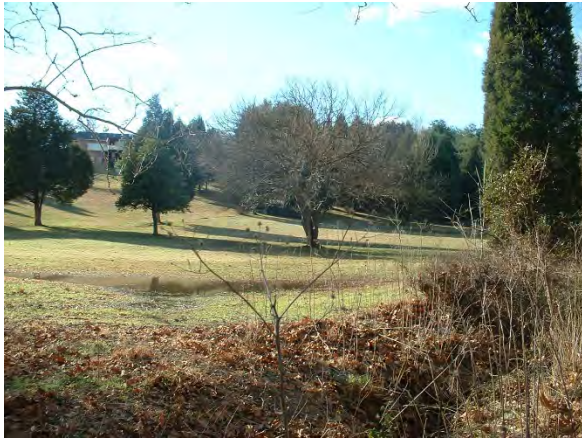
Photo 3.76 Buffer impact south of Windy Knoll Lane (DFDF053.B001).

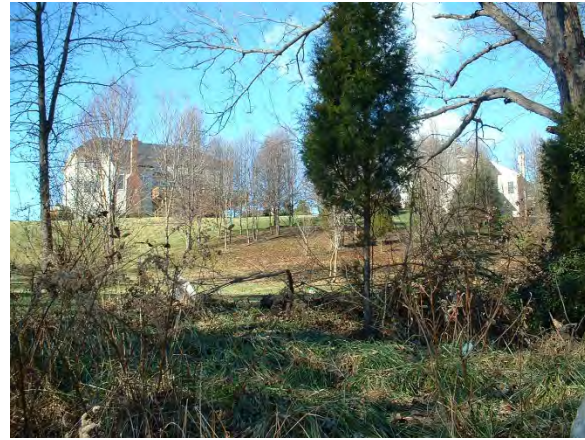
Photo 3.77 2000 feet of buffer impact upstream of Brittenford Road (DFDF050.B002).

S108 Inadequate buffer and stream erosion are both problems at this site. The catchment has the highest runoff volume and peak discharge in the subwatershed (Photo 3.77).

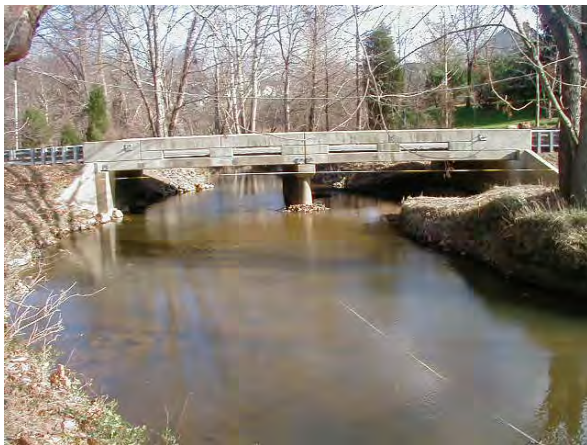
Culvert #29 (Photo 3.78) overtopped for all events. Browns Mill Road is a local road, so it is required to pass the 10-year flow.

Photo 3.78 Difficult Run Mainstem at Browns Mill Road.

F29 The Browns Mill Road Bridge overtops for all events. Since it is classified as a local road, the bridge should pass the 10-year event (Photo 3.78).

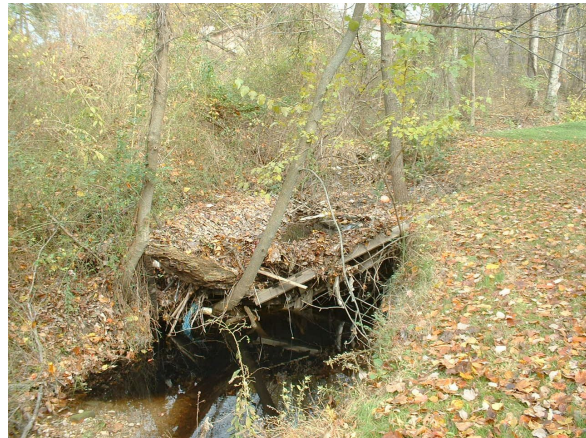
- There were five stream blockages, primarily trees. Four of these blockages are likely restricting fish movement within the stream system. All stream obstructions were having a significant impact on stream condition. Photo 3.79 shows an obstruction that is candidate site S124.

Photo 3.79 A severe obstruction located upstream of Chain Bridge Road near Echols Street (DFWC028.T001).

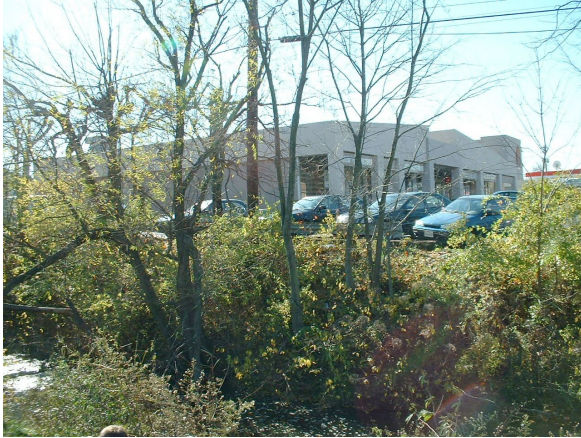
- 7,725 feet of the buffer encroachment is having a significant impact on the stream condition and habitat quality. Photos of an example are shown below in Photos 3.80 and 3.81 that are located at candidate site S123.
- Most (66 percent) of the total buffer encroachment has good restoration potential.

Photo 3.80 Buffer encroachment with high impact near Maple Avenue. (DFWC019.B002).

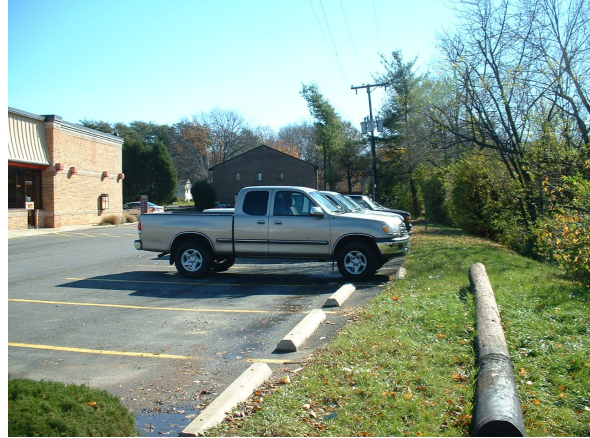
Photo 3.81 Buffer impact near Maple Avenue (DFWC019.B001).

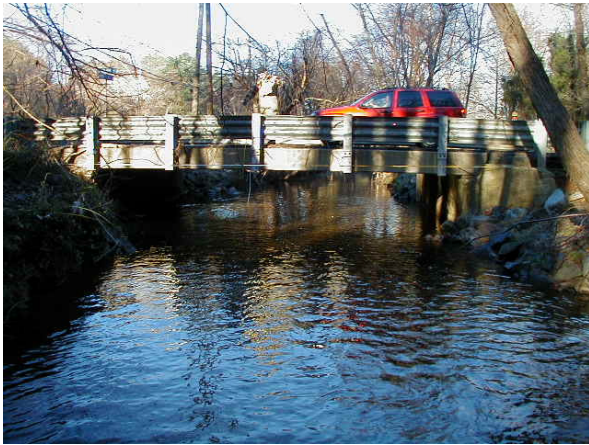
Culvert #28 (Photo 3.82) overtopped for all events. As Beulah Road is a through road, it can be classified as a primary road. This means that it must pass the 25-year event.

Photo 3.82 Wolftrap Creek Mainstem at Beulah Road.

- F28 The bridge on Beulah Road that passes over Wolftrap Creek overtops for all events. Beulah Road is classified as a primary road, so it must pass the 25-year event (Photo 3.82).
- F48 The culvert that flows Wolftrap Creek under Creek Crossing Road overtops for all events. Creek Crossing is a primary road, so it must pass the 25-year event (Photo 3.83).
- F49 The culvert under Old Courthouse Road that passes Wolftrap Creek also overtops for all events. Old Courthouse Road is classified as a primary road, so it must pass the 25-year event (Photo 3.84).

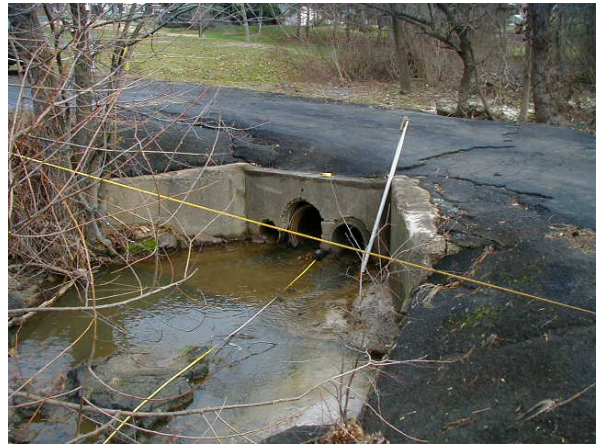
Culvert #48-A (Photo 3.83) overtopped for all events. Creek Crossing Road can also be used as a through road, so it too can be classified as a primary road. Primary roads must pass the 25-year event.

Photo 3.83 Wolftrap Creek Tributary at Creek Crossing Road.

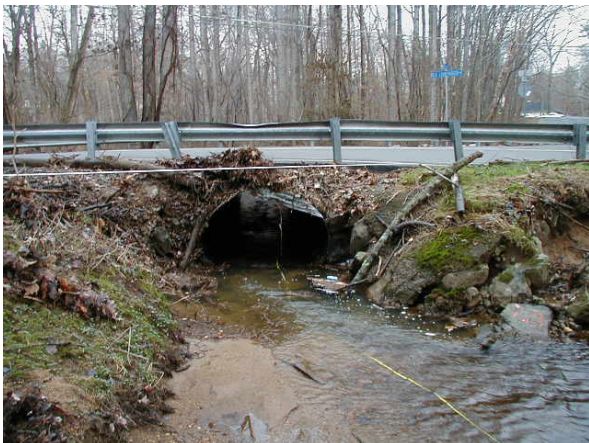
Culvert #49 (Photo 3.84) also overtopped for all events. Classified as a primary road, Old Courthouse Road is required to pass the 25-year event.

Photo 3.84 Wolftrap Creek Mainstem at Old Courthouse Road.

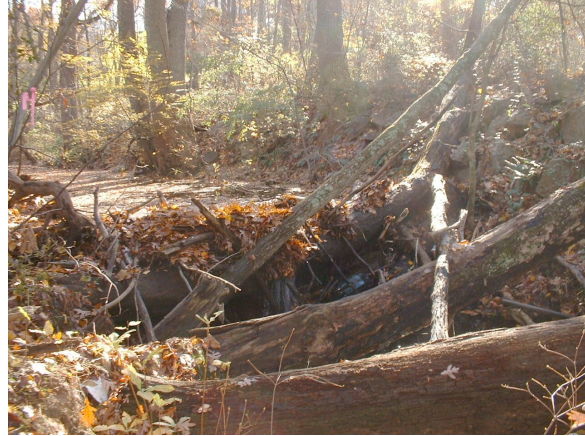
There was only one stream blockage, comprised of trees and debris, at the time of the assessment. The obstruction was causing some streambed erosion and was likely restricting fish passage. The area is shown in Photo 3.85 and is candidate site S109.

Photo 3.85 Stream blockage with a severe impact on the stream (DFOR701.T001).

S109 The Stream Physical Assessment survey identified a blockage in the stream that possibly inhibits fish passage (Photo 3.85).

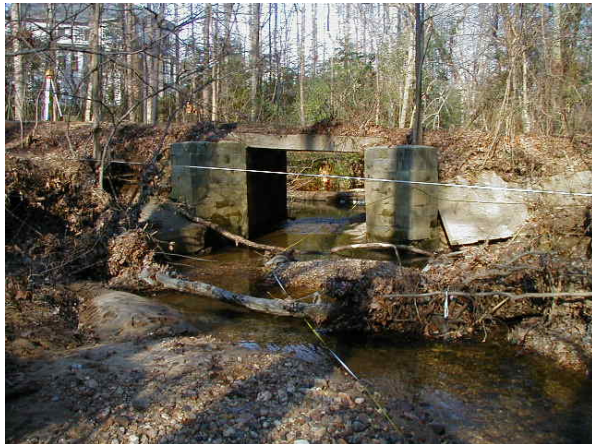
Culvert #47 (Photo 86) overtopped for all events except for the one and two-year. This road can be classified as a local road since there is no through traffic. Local roads must be able to pass the 10-year event.

Photo 3.86 Crossing at Northern Neck Drive (DFOR701.T001).

- F47 The crossing at Northern Neck Drive overtopped for 5-year and greater events. Northern Neck Drive is classified as a local road, so it must pass the 10-year storm (Photo 3.86).

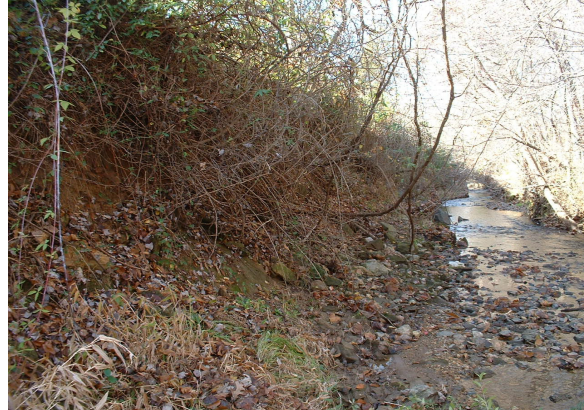
The majority (93 percent) of the channel has a gravel **substrate**. The remaining portions are primarily silt and sand. All of the reaches are Type III, which is indicative of an actively widening stream channel. There was one erosion point of moderate to severe erosion of approximately 300 feet. It is candidate site S110 and is shown in Photo 3.87. Refer to DFPB_3 for the stream classifications.

Photo 3.87 Streambank erosion just upstream from confluence with Difficult Run, west of Fosbak Drive (DFPB002.E001)

- S110 The Stream Physical Assessment survey indicated that there was severe streambank erosion just upstream from confluence with Difficult Run, west of Fosbak Drive (Photo 3.87).
- S111 During the Stream Physical Assessment, field crews noted an exposed sanitary line that should be examined and corrected (Photo 3.89).
- S112 During the Stream Physical Assessment survey, riparian buffer was noted as being encroached upon by lawns and pavement. The Stream Physical Assessment survey indicated that streambank erosion was severe or extreme, channel was widening, and habitat was Poor to Very Poor.
- S134 The site is located downstream of and within catchments with high runoff volume and near obstructions identified during the Stream Physical Assessment (Photo 3.88).

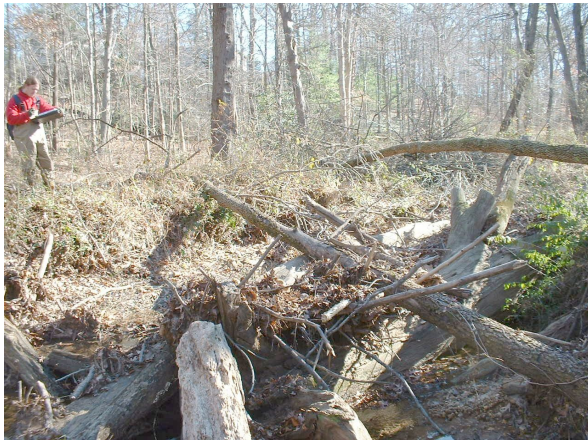
Photo 3.88 Obstruction point, mostly trees and debris, at the end of Corsica Street. (DFPB015.T001).

All of the eight stream blockages were made up of trees and debris. Some had additional concrete and sediment. One-half of the obstructions had only minor impacts on the stream, causing some erosion. Thirty-eight percent of the obstructions were causing a greater impact on the stream condition. The example shown in Photo 3.88 is candidate site S134.

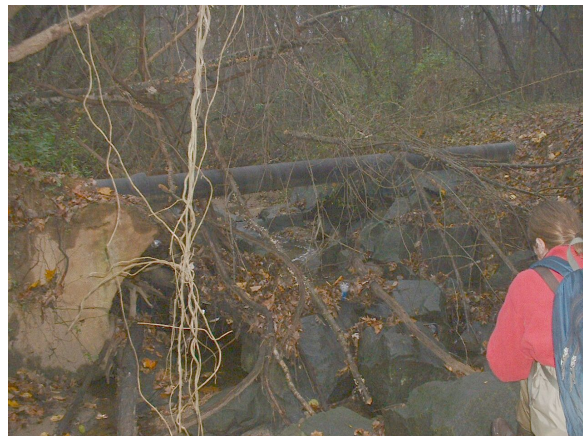
Photo 3.89 Sanitary line crossing the stream above the baseflow (DFPB010.U001).

There was one sanitary line of approximately 10" that was crossing the stream above the base flow. The sanitary line is shown above in Photo 3.89 and is candidate site S111. Much of the stream length (74 percent) has high erosion potential during **flood** events.

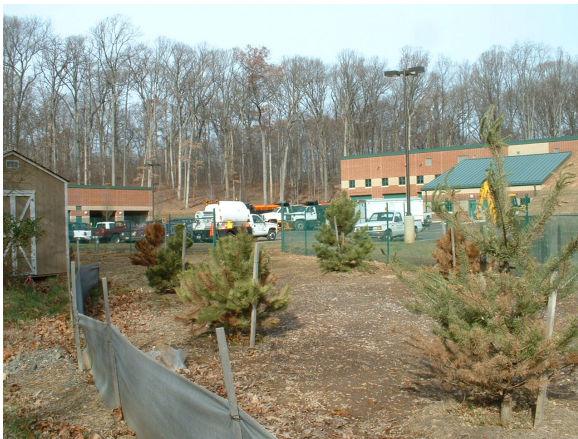
- There is 35,400 feet, approximately 42 percent of the total stream length, of **riparian buffer** encroachment (this length includes left and right banks combined). Of this, 25,550 feet (72 percent) is lawn, and 2,300 (6.5 percent) is pavement. The remaining buffer encroachment area is some combination of lawn, meadow, trees and pavement. Eighty-two percent of the buffer encroachment length has no or low restoration potential due to existing infrastructure, however; 18 percent of the length has moderate to high restoration potential. Most of the percent of the buffer encroachment had only minimal impact, suggesting that the stream character may be changed slightly by adjacent use. Two of the areas with pavement buffer encroachment appear to present a greater impact and are shown in Photo 3.90 and 3.91.

Photo 3.90 Buffer impact in North Side Park (DFPB024.B002).

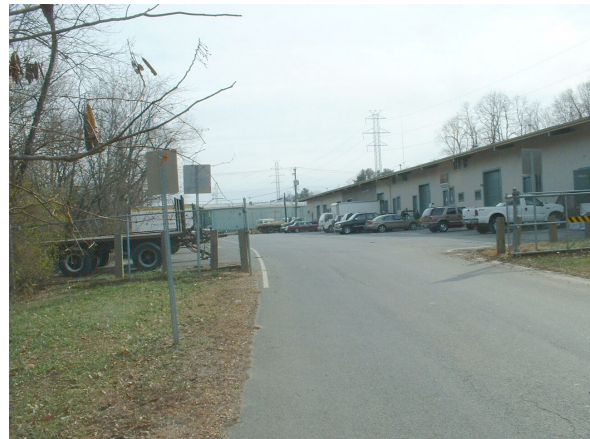
Photo 3.91 Buffer impact in the Somerset community at the end of Mill Street (DFPB024.B003).

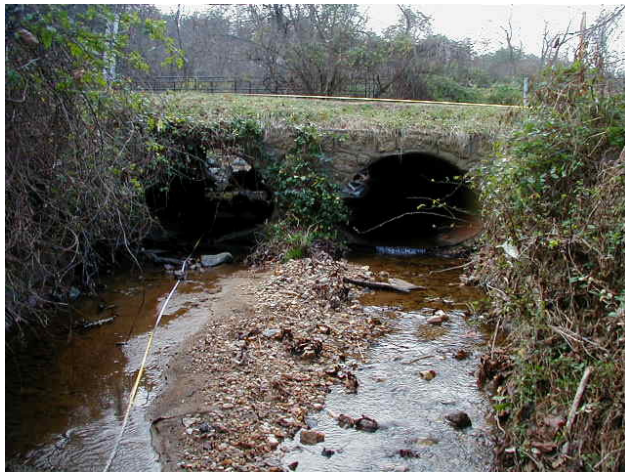
Photo 3.92 Piney Branch tributary at Lawyers Road.

Culvert #25-A (Photo 3.92) overtopped for the 25, 50, and 100-year events. Lawyers Road has a classification of “primary,” which requires the culvert to pass the 25-year event.

- F25A The crossing of Lawyer's Road was overtopped for 25-year and greater events. Since it is classified as a primary road, the culvert should pass the 25-year event (Photo 3.92).

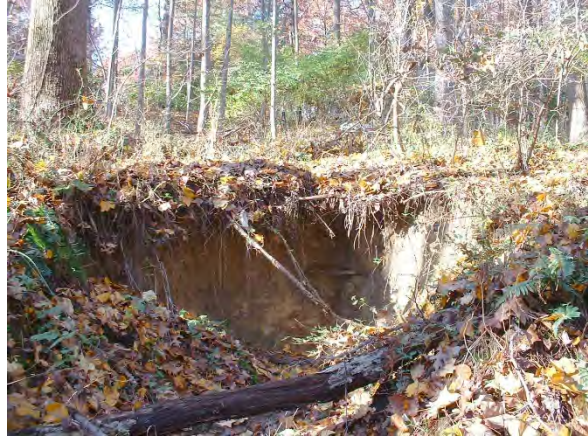
The storm drainage system connects the developed portions of the land to the stream system. Stormwater outfalls are located where the stormwater system ends and the natural channel begins. Outfalls may be sources of pollutants and excessive stormflow from pipes can cause erosion at the outfall and downstream. During the Stream Physical Assessment, field crews located 11 **outfall** pipes discharging into the Little Difficult Run subwatershed. Most of the pipes were causing minor or no erosion to the streambed or banks; however, one pipe discharging from a neighborhood road was creating major erosion.

Photo 3.93 Pipe near the end of Checkerberry Court near Blue Smoke Trail (DFLD014.P001)

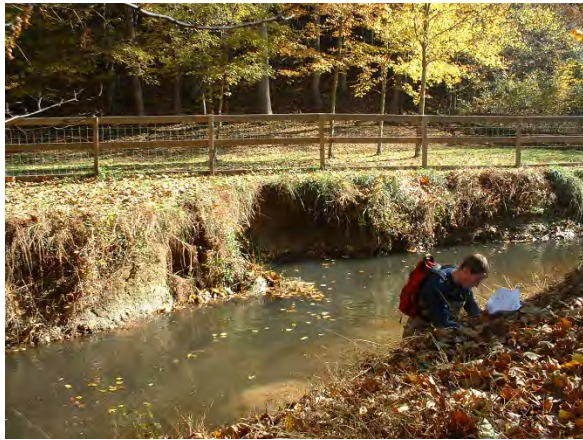
Photo 3.95 Eroding bank directly north of the terminus of Hollybrook Place in the Hollybrook subdivision (DFLD004.E001).

- S114 Erosion located on the mainstem of Little Difficult Run, directly east of Colt Run Road in the Roan Stallion Estates subdivision (Photo 3.97).
- S115 Stream Physical Assessment found erosion and riparian buffer problems north of the terminus of Hollybrook Place in the Hollybrook subdivision (Photo 3.95)
- S116 Buffer encroachment on the mainstem of Little Difficult Run along Stuart Mill Road in the Difficult Stream Valley Park (Photo 3.99).

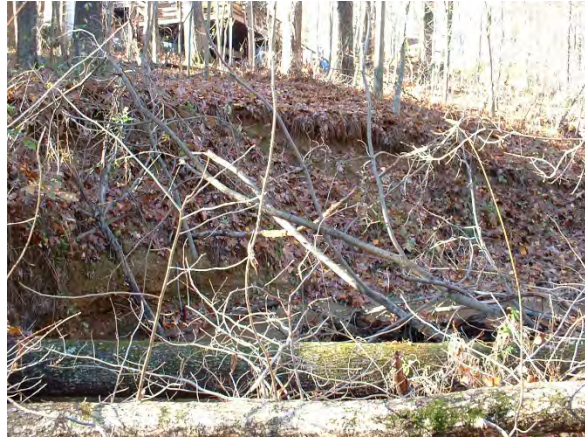
Photo 3.96 Erosion area at the end of Millstream Court, in Little Difficult Run Stream Valley Park (DFLD024.E001).

- S36 There are significant riparian buffer impacts over 1,000 feet in length in the Little Difficult Run Stream Valley Park directly east of Mill Road and Stuart Mill Road (Photo 3.100).
- S65 The reach between two overtopping culverts (culvert 13 and culvert 30) is exhibiting poor bank stability and has several crossing impacts.
- S113 Erosion area at the end of Millstream Court, in Little Difficult Run Stream Valley Park (Photo 3.96).

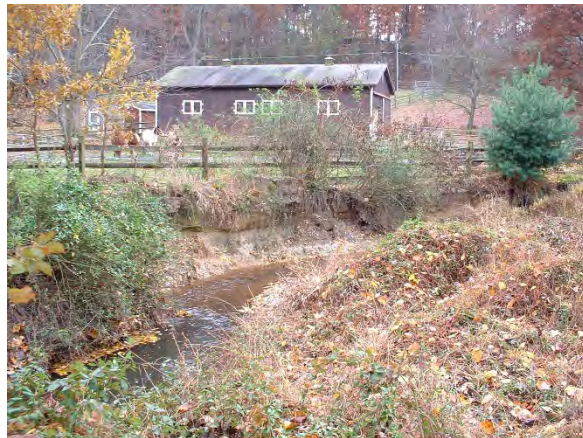
Photo 3.97 Erosion located on the mainstem of Little Difficult Run, directly east of Colt Run Road in the Roan Stallion Estates subdivision (DFLD013.E001).

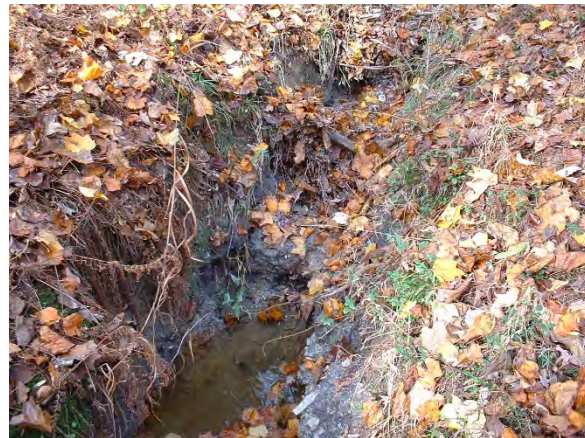
Photo 3.98 Headcut located northwest of Fox Mill District Park in the Fox Mill Woods subdivision. Directly east of the intersection of Steeplechase Drive and Aintree Lane (DFLD023.H001).

slight potential for erosion at flood stages. There were four specific stream erosion points noted in the Little Difficult Run subwatershed. The combined length of the erosion points is approximately 230 feet. Three of the erosion points are considered severe indicating that erosion may be damaging property and causing instream degradation. All erosion points are considered to have moderate to high restoration potential. These erosion points are shown in Photos 3.95 to 3.97. Photo 3.95 is candidate site S115, 3.96 is candidate site S113, and 3.97 is candidate site S114. There was one **headcut** identified as having a significant impact with a height of 2.5 feet (Photo 3.98).

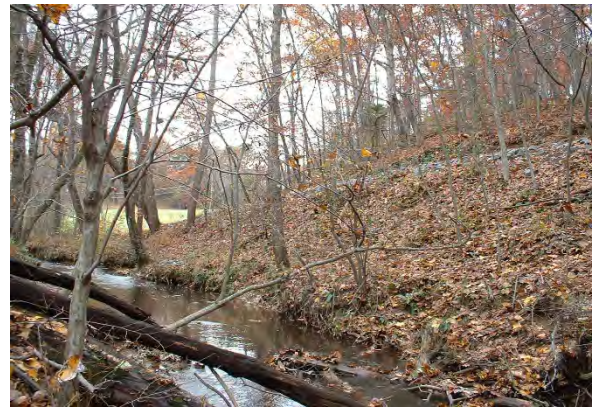
Photo 3.99 Severe buffer encroachment (in background) Little Difficult Run Stream Valley Park, directly south of Stuart Mill Road on the mainstem (DFLD011.B001)

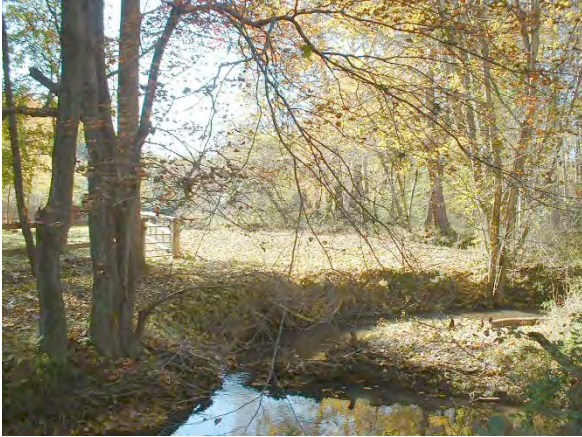
Photo 3.100 Buffer encroachment in the Little Difficult Run Stream Valley Park. Directly east of Mill Road and Stuart Mill Road (DFLD003.B001).

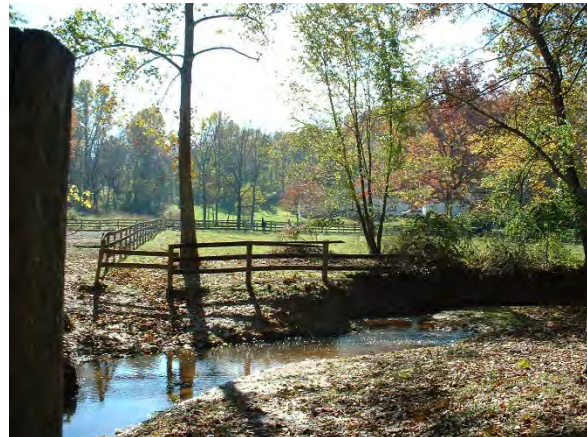
- Of the assessed reaches, 60 percent have fair habitat for aquatic insects and fish, 29 percent have good habitat, and 21 percent have poor habitat.
- There are 14,450 feet of **riparian buffer** encroachment in the subwatershed (this length includes left and right banks combined). Of this total, 9,900 feet (69 percent) is a combination of **pervious** surfaces, 1,050 feet (7 percent) is a combination of different impervious surfaces, and the remaining 3,500 feet (24 percent) is some combination of impervious and pervious surfaces. Photos 3.99 above (which is candidate site S116) and 3.100 (which is candidate site S36) and 3.101 below show examples of buffer encroachment.

Photo 3.101 Buffer impact in the Hollybrook community, directly north of the terminus of Hollybrook Place, mainstem of Little Difficult Run (DFLD003.B002).

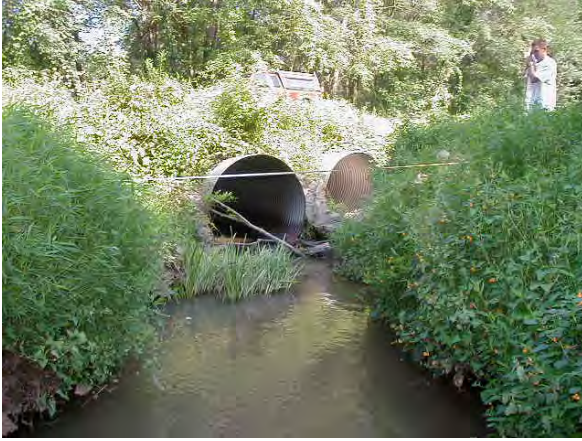
Photo 3.102 Little Difficult Run at Stuart Mill Road

Culvert #3 (Photo 3.102) overtopped for all events except the one-year. Stuart Mill Road can be considered a primary road, which requires it to pass the 25-year event.

- F03 The bridge carrying Stuart Mill Road over the Mainstem of Little Difficult Run overtops for all events except the 1-year storm. It is required to pass the 25-year event (Photo 3.102).
- F06 The culvert conveying Mainstem of Little Difficult Run under Colt Run Road overtops for all events. It is required to pass the 10-year event (Photo 3.103).

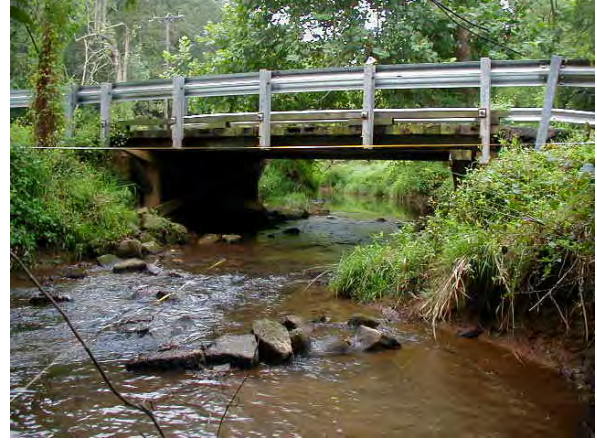
Photo 3.103 Little Difficult Run at Colt Run Road

Culvert #6 (Photo 3.103) overtopped for all events. Colt Run Road is a residential access road, classified as local, requiring the culvert to pass the 10-year event. This culvert is candidate site F06.

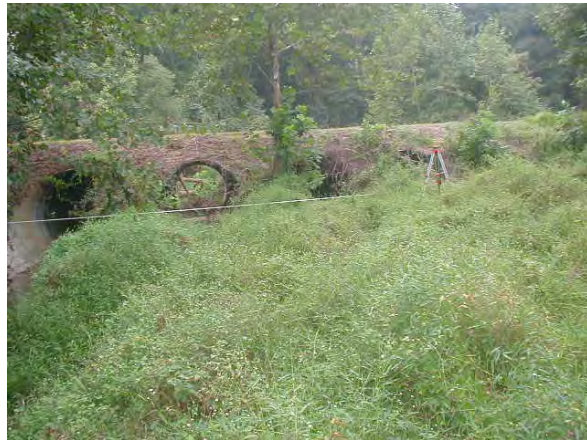
Photo 3.104 Little Difficult Run tributary at Polo Pointe Drive.

Culvert #12 (Photo 3.104) overtopped for the 25, 50, and 100-year events. The culvert at Polo Pointe Drive, a local road, is required to pass the 10-year event. This culvert is not a candidate site.

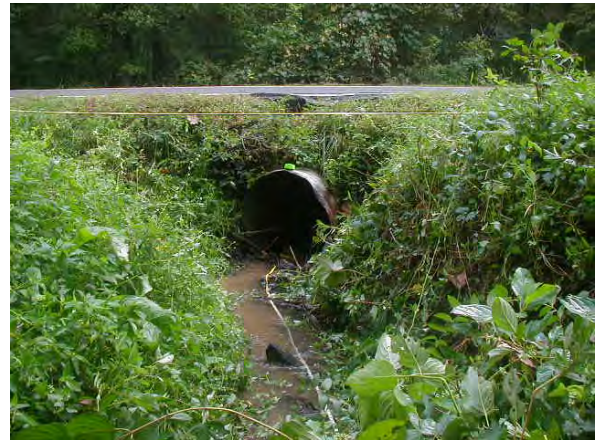
Photo 3.105 Little Difficult Run mainstem at Fox Mill Road North

Culvert #13 (Photo 3.105) overtopped for all events except the one-year. Fox Mill Road is a primary road, and is therefore required to pass the 25-year event.

- F13 The culvert conveying a tributary of Little Difficult Run under Fox Mill Road overtops for all events except the 1-year storm. It is required to pass the 25-year event (Photo 3.105).
- F15B The culvert conveying Little Difficult Run under Stuart Mill Road overtops for all events except the 1-year and 2-year storms. It is required to pass the 25-year event (Photo 3.106).
- F16 The culvert conveying a tributary of Little Difficult Run under Fox Mill Road overtops for all events except the 1-year and 2-year storms. It is required to pass the 25-year event. (Photo 3.107).
- F30 The culvert conveying a tributary of Little Difficult Run under Thoroughbred Road overtops for all events except the 1-year and 2-year storms. It is required to pass the 20-year event (Photo 3.108).

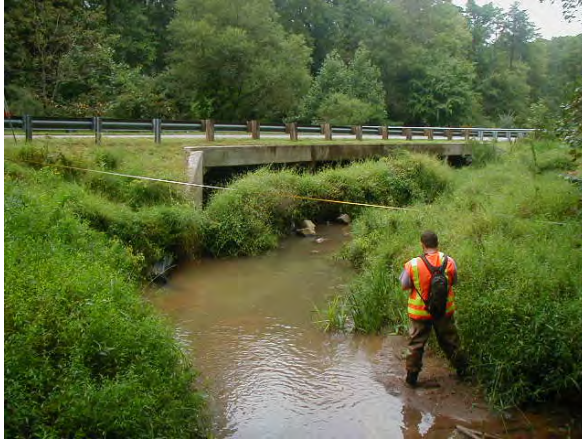
Photo 3.106 Little Difficult Run mainstem at Stuart Mill Road

Culvert #15-B (Photo 3.106) overtopped for all events except the one and two-year. Stuart Mill Road, as mentioned above, can be considered a primary road, requiring it to pass the 25-year event.

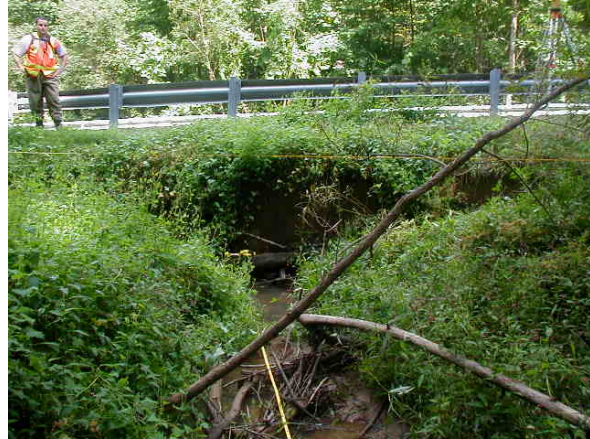
Photo 3.107 Little Difficult Run mainstem at Fox Mill Road South

Culvert #16 (Photo 3.107) overtopped for all events except the one and two-year. Fox Mill Road, also mentioned above, can be considered a primary road and must pass the 25-year event.

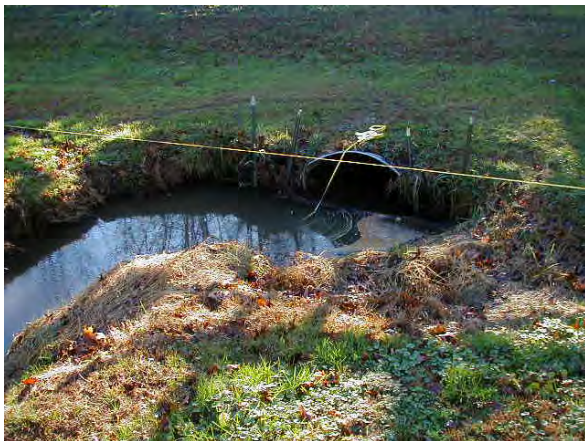
Photo 3.108 Little Difficult Run tributary at Westwood Hills Drive

Culvert #30 (Photo 3.108) overtopped for all events except the one and two-year. The

culvert at Westwood Hills Drive, a local road, is expected to pass the 10-year event.

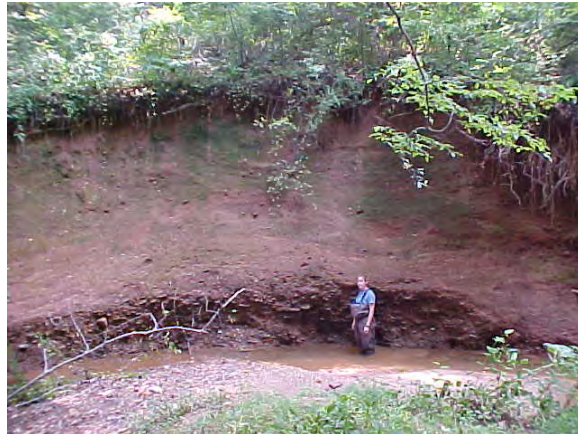
The **substrate** material found in Angelico Branch is a mix of silt, sand and gravel. The entire length of Angelico Branch is characterized as Type III, indicative of an unstable channel that is actively widening in response to changes in stream flow. Most of the stream between Lawyers Road and Whippoorwill Road is severely eroded, shown in Photo 3.110. This site is candidate site S117. Refer to DFAB_3 for the stream classifications.

Photo 3.110 Severe erosion located just west of Whippoorwill Road (DFAB001.E001)

- S117 The Stream Physical Assessment survey noted severe erosion just west of Whippoorwill Road (Photo 3.110). The reach also was identified as having erosion problems and active widening.
- S118 This site was identified in the Stream Physical Assessment survey as having erosion problems and active widening, along with a deficient buffer.

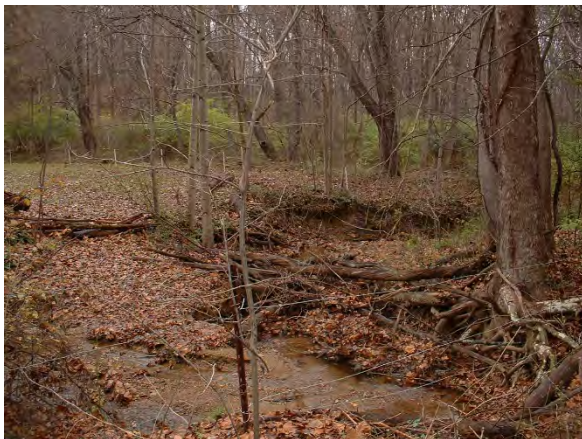
There were three locations along Angelico Branch where field crews noted obstructions. All obstructions were restricting fish passage and can lead to flooding and stream erosion. Two of these are shown in Photos 3.111 and 3.112.

Photo 3.111 Obstruction located just west of Whippoorwill Road (just downstream of erosion shown in Photo 3.2) (DFAB001.T001)

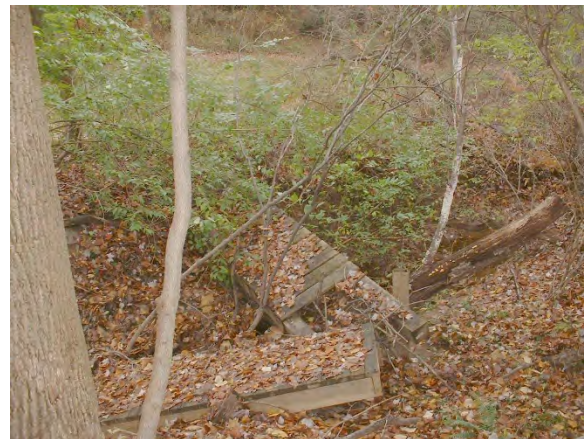
Photo 3.112 Obstruction located just south of East Hunter Valley Road (DFAB002.T002)

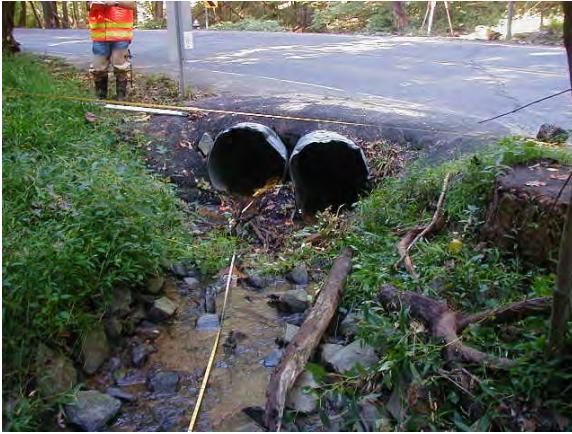
*Photo 3.113 Angelico Branch
at Lawyers Road*

Culvert #19 (Photo 3.113) overtopped for all events except the 1-year. Lawyers Road is a primary road, which should allow the 25-year event to pass.

- F19 This culvert overtops with existing conditions for all rainfall events from 2- to 100-year; however, it should pass the 25-year event to meet County standards (Photo 3.113).

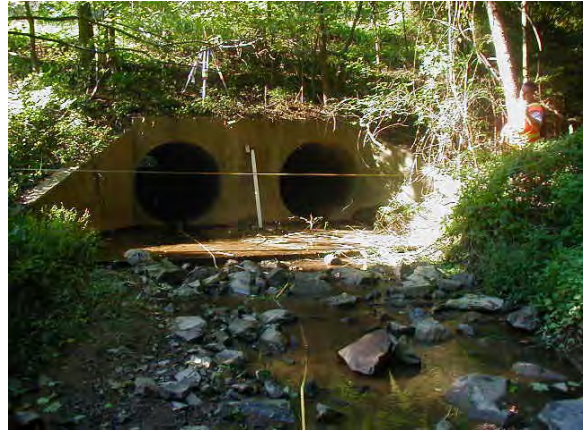
*Photo 3.114 Angelico Branch
at Cedar Pond Drive*

Culvert #20 (Photo 3.114) overtopped for the 50 and 100-year events. This is a residential access road, which can be classified as local, and is required to pass beneath it the 10-year event. This culvert is not considered a candidate site.

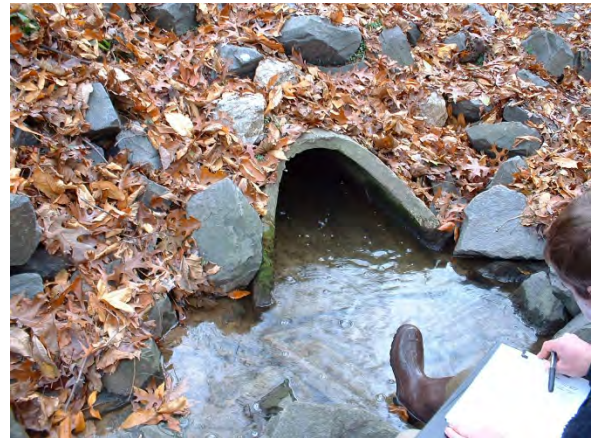
Photo 3.116 Concrete circular crossing located in the Clarke's Landing Subdivision between Timberline Drive and the Difficult Run Stream Valley Park (DFSF0002.C001)

There were four severe erosion points of approximately 200 feet noted in the subwatershed by field crews. In all four cases, the restoration potential was high. Photos of the four points are show in Photos 3.116 to 3.119. Photo 3.116 is candidate site S121, Photo 3.118 is candidate site S119, and Photos 3.119 and 3.120 are candidate site S120.

- S121 The Stream Physical Assessment survey showed this to be a severely eroded reach of a tributary to South Fork Run. (Photo 3.116)
- S122 The Stream Physical Assessment survey showed this reach of a tributary to South Fork Run is heavily eroded and has a deficient stream buffer.

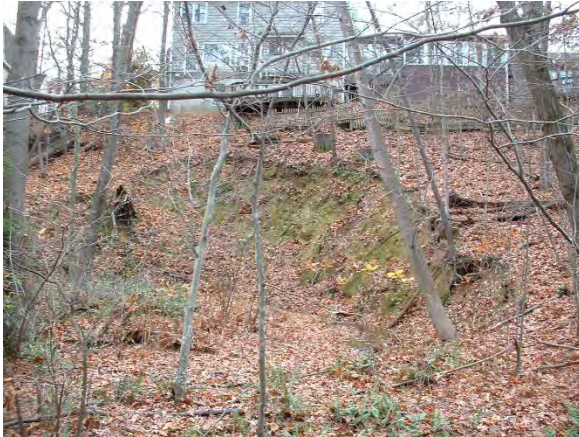
Photo 3.118 Eroding bank located in the southern edge of the Difficult Run Stream Valley Park in the Clarke's Landing subdivision directly north of the terminus of Timberline Court (DFSF002.E001).

- S119 The Stream Physical Assessment survey indicated an area of severe erosion, along with active channel widening (Photo 3.118)
- S120 This reach of South Fork Run near the crossing of Fox Mill Road is heavily eroded and has no stream buffer. (Photos 3.119, 3.120)

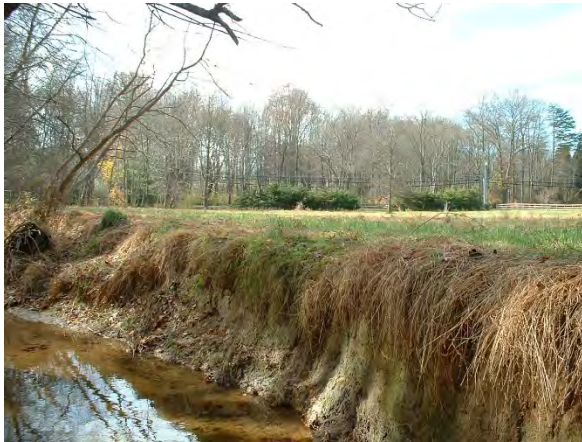
- Four reaches, or 37 percent of the buffer encroachment length, are having a severe impact on the stream. Examples of two of these reaches are shown below in Photos 3.120 and 3.121.

Photo 3.121 Severe buffer impact on the mainstem of South Fork Run, directly north of the intersection of Fox Mill Road (SR 665) and Deerfield Drive in the Brians Hill Estates subdivision (DFSF007.B002).

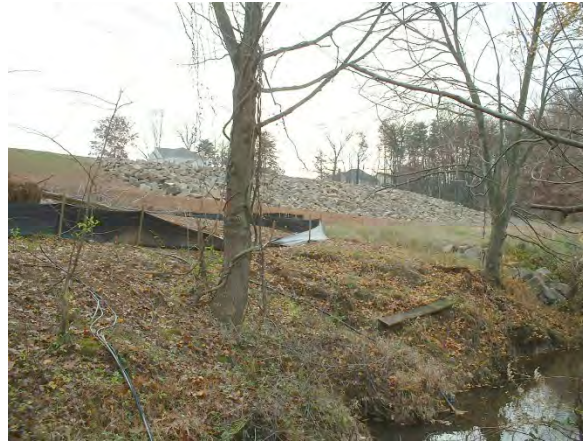
Photo 3.122 Buffer impact located northwest of Timber Lake, in the Timber Lake subdivision (DFSF005.B001).

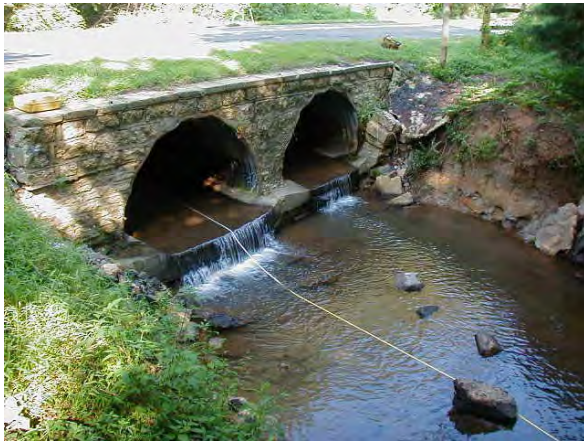
Culvert #4 (Photo 3.123) overtopped for the 10-year and greater events. This is classified as a primary road and should not be overtopped by storms more frequent than the 25-year event.

Photo 3.122 South Fork Run Mainstem at Fox Mill Road

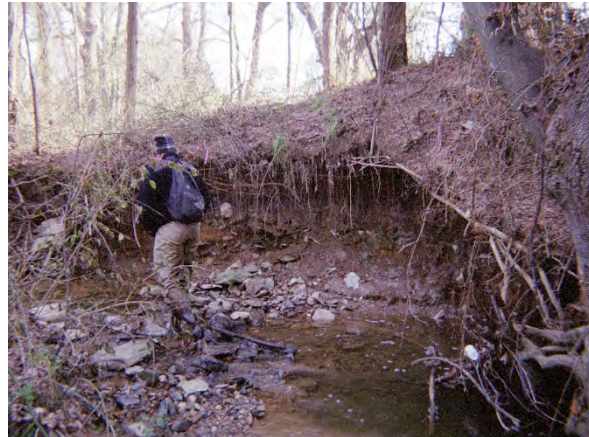
Photo 3.123 Erosion point on a tributary off of the mainstem of Rocky Branch. East of Oakton Ridge Court in the Oakton Mill Estate subdivision (DFRB010.E001)

Eighty-one percent of the stream length was classified as moderately unstable with high erosion potential during flood events. Seventeen percent of the stream length was moderately stable with only slight potential for erosion at flood stages. Several of the erosion points are shown in Photos 3.123 to 3.126. Photos 3.123, 3.127 and 3.130 are candidate site S127. Photos 3.125 and 3.126 are candidate site S128. Photo 3.128 is candidate site S128. Candidate site S130 is shown in Photos 3.124 and 3.131.

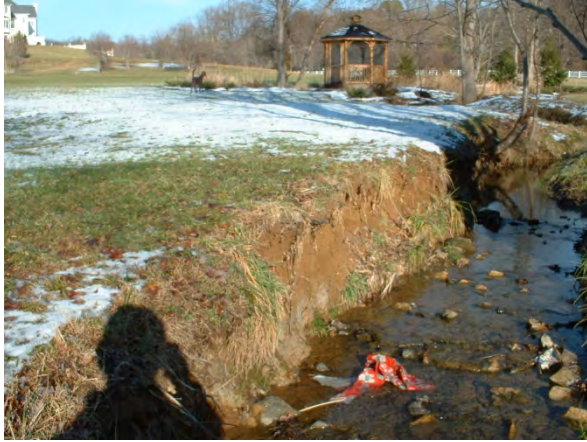
Photo 3.124 Erosion point on the west side of Hunter Mill Road at the intersection with Conejo Land (DFRB012.E001).

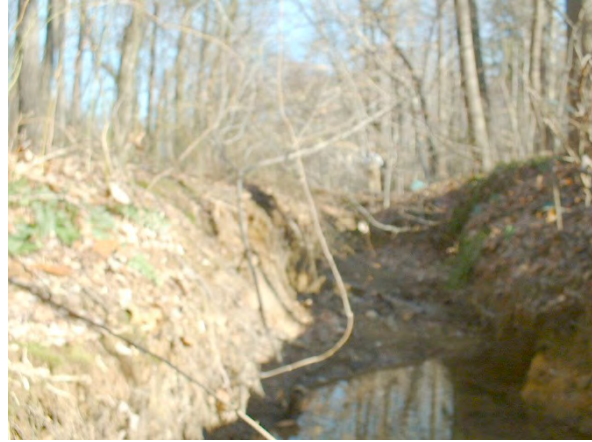
Photo 3.125 On a tributary northwest of the cul-de-sac of Westhurst Court in the Windsong community. (DFRB015.E001).

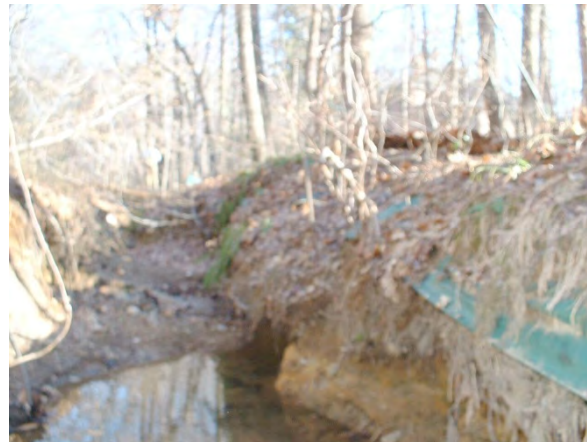
Photo 3.126 On a tributary northwest of the cul-de-sac of Westhurst Court in the Windsong community. (DFRB015.E002).

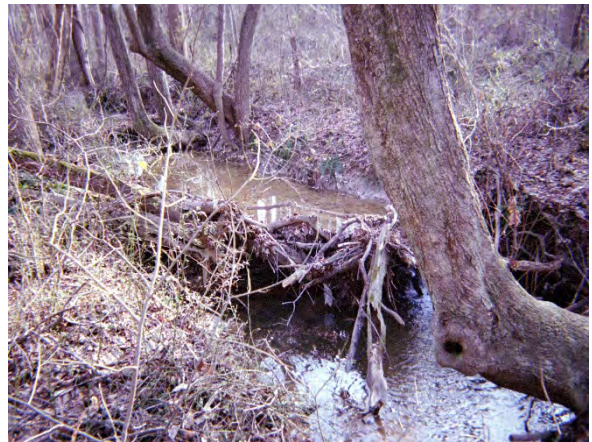
Photo 3.127 Obstruction on a tributary to Rocky Branch, directly east of Oakton Ridge Court in the Oakton Mill Estates (DFRB010.T001).

There were eight stream blockages made up mostly of trees and debris. Twenty-five percent of the obstructions appeared to be restricting fish passage. Sixty-three percent of the obstructions were causing moderate erosion to the stream. One obstruction was causing greater than moderate erosion. This one is shown above in Photo 3.127 (candidate site S128)

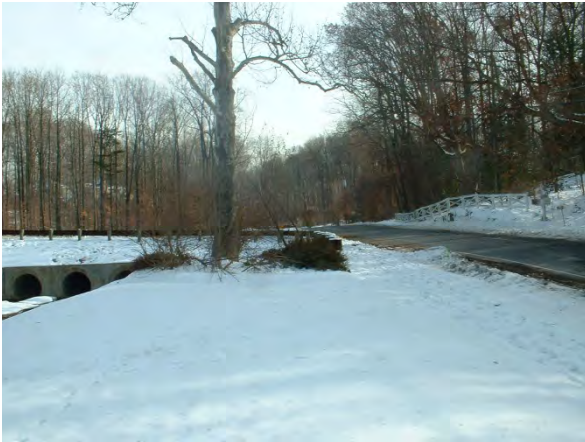
Photo 3.128 Buffer impairment south of Miller Road in the Flint Hill Lower and Middle Campus (DFRB004.B001)

S127 The Stream Physical Assessment identified poor habitat, 2700 feet of buffer impact and over 1,000 linear feet of erosion along Miller Road (Photo 3.128).

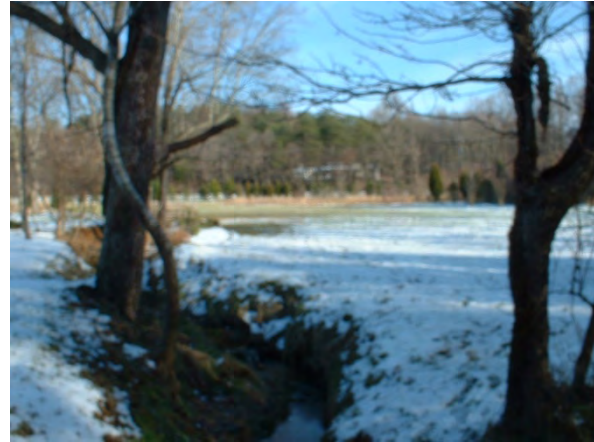
Photo 3.131 West side of Hunter Mill Road, south of intersection with Conejo Lane (DFRB012.B001)

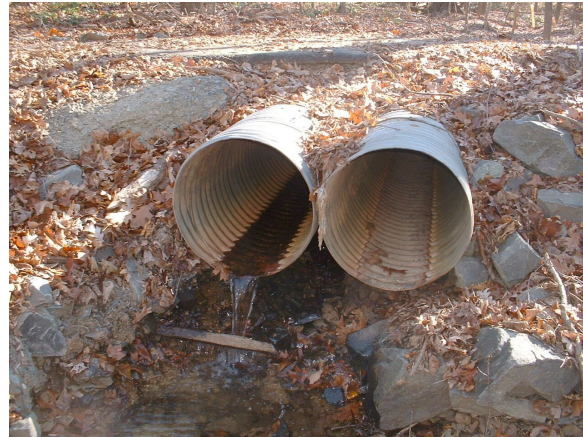
Physical Assessment identify 108 crossings in the Upper Difficult Run subwatershed. Two crossings were having a significant impact on stream condition or instream habitat. The crossings are pipe culverts that have adequate structural condition but could be improved to enhance stream integrity and avoid future problems. These are located between Blenheim Drive and Lochinver Lane and between Lochinver Lane and Lakenheath Way. Erosion at the downstream end of the culvert between Lochinver Lane and Lakenheath Way can be seen in Photo 3.133.

Photo 3.133 Pipe culvert between Lochinver Lane and Lakenheath Way.

- D33 (Catchment DFDF8701) Runoff and water quality from this area are better than average for the subwatershed, and somewhat worse than average for all of Difficult Run. Streambanks are unstable and the mainstem of Difficult Run shows severe erosion impacts downstream of the site (Photo 3.133).

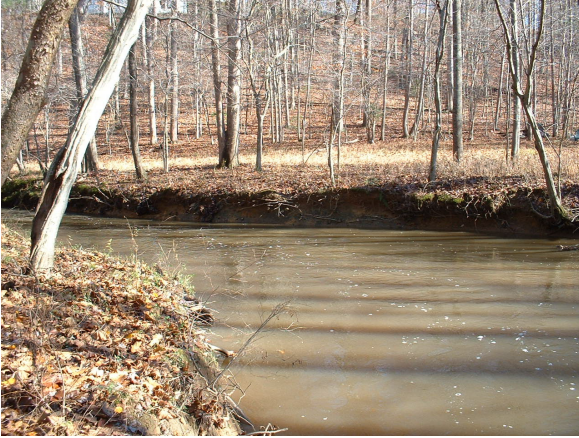
Two of the more severe areas with the highest restoration potential are located in the northern portion of the subwatershed. These are shown in Photos 3.134 and 3.135. Photo

Photo 3.134 Erosion noted by field crews just east of Hunters Crest Way (DFDF009.E001).

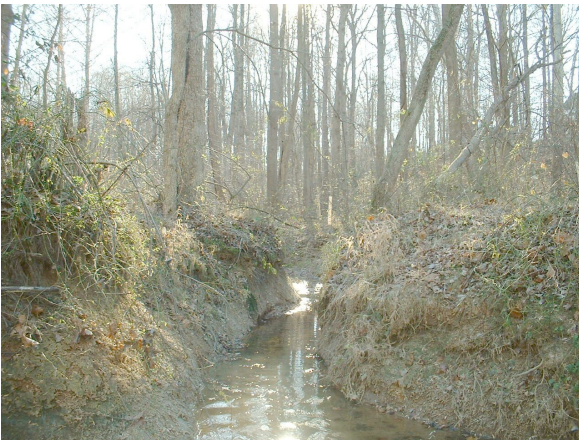
Photo 3.136 Area of extreme erosion with moderate restoration potential. This area is located near the end of Blenheim Drive (DFDF029.E001).

- S37 From the Stream Physical Assessment, this reach showed severe erosion and Poor or Very Poor habitat (Photo 3.136 and 3.137).
- S38 From the Stream Physical Assessment, this reach showed severe to extreme erosion, channel widening, a degraded buffer and Poor or Very Poor habitat (Photo 3.140).
- S44 From the Stream Physical Assessment, this reach was described as unstable, with a widening channel and Poor or Very Poor habitat.
- S45 The Stream Physical Assessment showed unstable banks, Poor habitat, and lack of buffer through this reach.
- S46 From the Stream Physical Assessment, this reach was described as unstable, with a widening channel and Poor or Very Poor habitat.

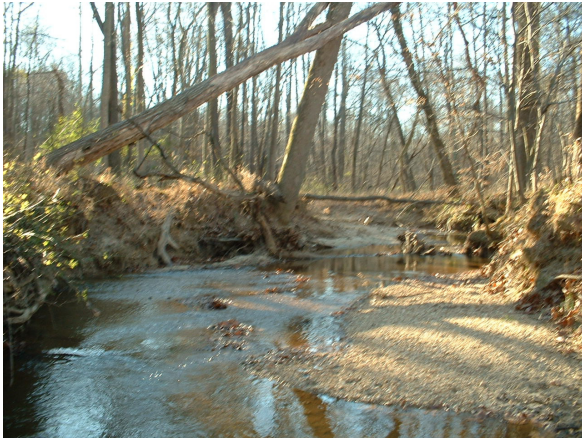
Photo 3.137 Severe erosion with moderate restoration potential located near the end of Lapham Drive (DFDF028.E001).

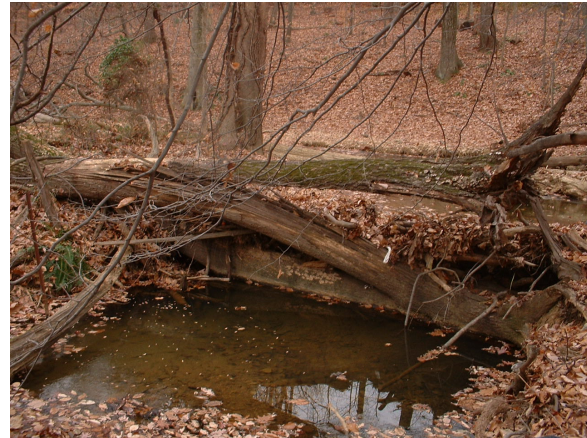
There are 37 obstructions, such as fallen trees or debris, located within the Upper Difficult Run subwatershed. All of the obstructions are thought to be restricting fish passage. Twenty-three of these obstructions were assigned an impact score of extreme, indicating that the obstruction is causing significant erosion problems or potential for **flooding** that could damage infrastructure. At these points the stream is at least 75 percent blocked, usually by trees, debris and sediment. Examples of two sites that have an extreme impact on stream integrity are shown in Photos 3.138 and 3.139 below.

Photo 3.138 Stream blockage located between Oakton Road and Waples Mill Road (DFDF042.T001).
