Difficult Run Watershed Management Plan

**Volume 1: Watershed Plan
February 2007**

*Fairfax County Department of
Public Works and
Environmental Services*

Prepared By:
KCI Technologies Inc.

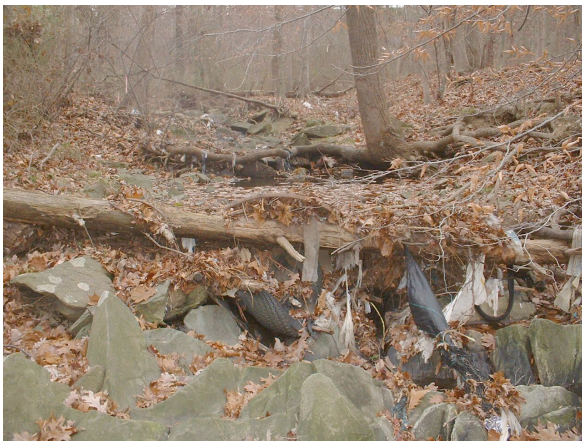
Photo 3.139 Stream blockage located upstream of the area shown in Photo 3.139 (DFDF043.T002).

Eight of the most severe blockages are located on the Difficult Run mainstem in the central portion of the subwatershed. Removal of these blockages would allow easier fish passage to the more upstream portion of mainstem Difficult Run and upstream tributaries.

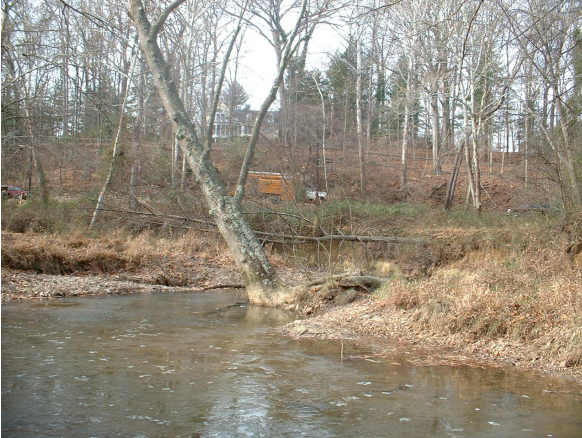
- There are 15 miles of buffer encroachment (this length includes left and right banks combined); of this total 44 percent is a combination of lawn and grasses, 41 percent is any combination of pavement and grasses/forbs/lawn, and 3 percent is pavement. Seventy-eight percent of the total length of buffer encroachment was having a severe impact and degrading the stream character. Photo 3.140 shows a roadway buffer encroachment along the mainstem. This is candidate site S38.

Photo 3.140 Roadway buffer encroachment near Waples Mill Road (DFDF034.B001).

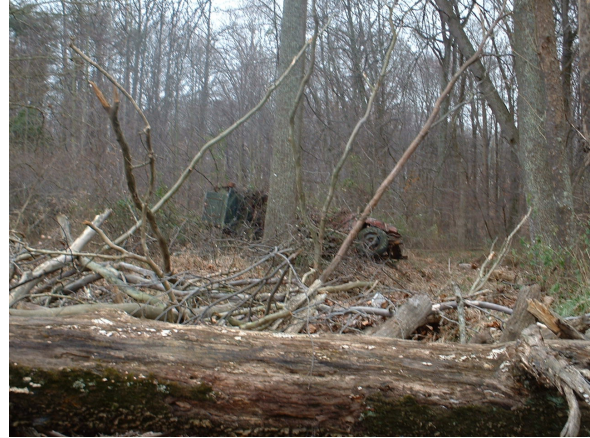
Photo 3.141 Dumpsite located between Oakton Road and Waples Mill Road. DFDF042.M001

- There is one dumpsite, a place where trash is deposited illegally, located between Oakton Road and Waples Mill Road. The site is located along the streambank within the floodplain and was assigned an impact score of seven, indicating that the site is greater than 2,500 square feet in size and may be active (Photo 3.141). This is candidate site S132.

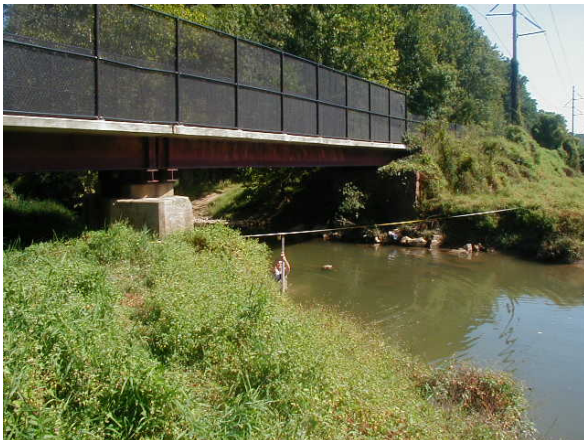
Culvert #21 (Photo 3.142) overtopped for the 50 and 100-year events. As this is not a roadway traveled by cars and does not overtop more frequently, it is not considered a

Photo 3.142 Difficult Run Mainstem at W&OD Trail

candidate site.

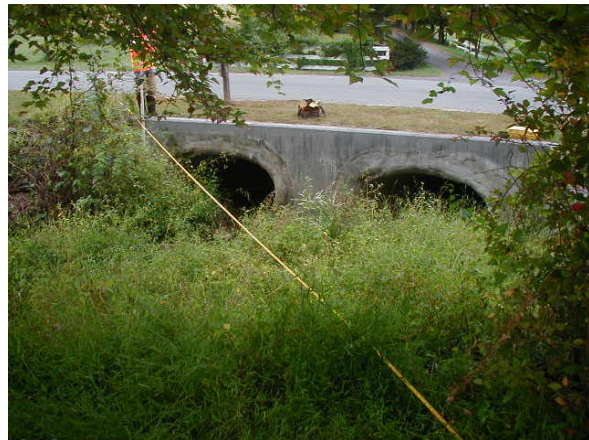
Photo 3.143 Difficult Run Tributary at Valley Road

Culvert #23 (Photo 3.143) overtopped for the 25, 50, and 100-year events. Valley Road is a local street, used by residents to access houses. Local roads are required to pass only the 10-year event, so this culvert is also not a candidate site.

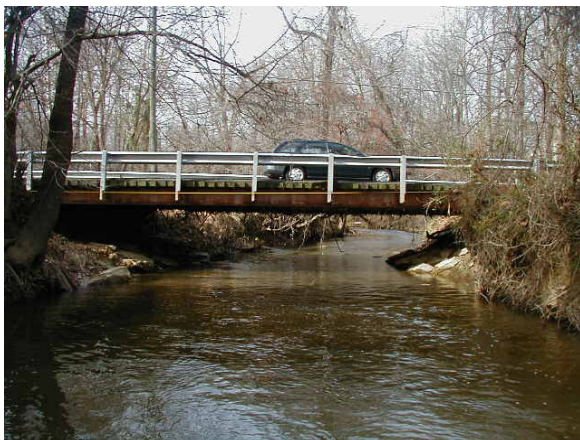
Photo 3.144 Difficult Run Mainstem at Hunter Mill Road

Culvert #27 (Photo 3.144) overtopped for all events. Hunter Mill Road is a primary road, used for through traffic flow. Crossings classified as primary roads are required to pass the 25-year event.

- F27 The culvert carrying the mainstem under Hunter Mill Road overtopped for all events. Since Hunter Mill Road is a primary road, the culvert must pass the 25-year event (Photo 3.144).
- F31 The culvert under Pine Tree Drive overtopped for all events. Since this is a local road, the culvert required to pass the 10-year event (Photo 3.145).
- F32 This culvert overtopped for all events except the one and two-year. As Waples Mill Road can be considered a primary road, it must pass the 25-year event (Photo 3.146).
- F33 This culvert was overtopped for the 25, 50, and 100-year events. Again, Waples Mill Road is considered a primary road, used for through traffic flow. It must pass the 25-year event (Photo 3.147).
- F34 The culvert under Valley Road overtopped for all events except the one-year. Valley Road is a local road, so the culvert must pass the 10-year event (Photo 3.148).

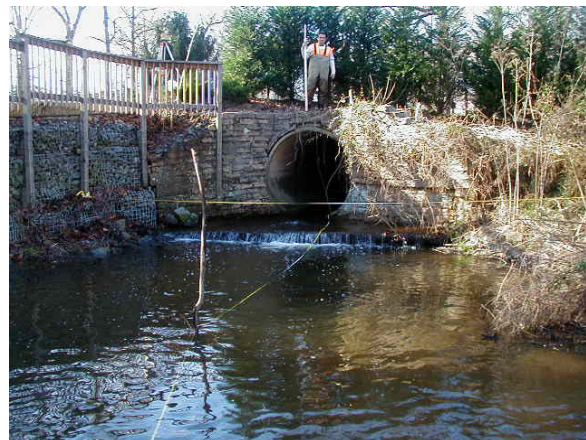
Photo 3.145 Difficult Run Tributary at Pine Tree Drive

Culvert #31 (Photo 3.145) overtopped for all events. Pine Tree Drive is a local road, so it is required to pass the 10-year event.

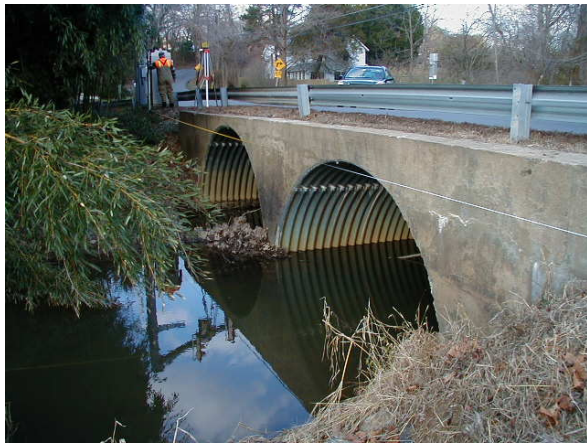
Culvert #32 (Photo 3.146) overtopped for all events except the one and two-year. As Waples Mill Road can be considered a primary road, it must pass the 25-year event.

Photo 3.146 Difficult Run Mainstem at Waples Mill Road DS

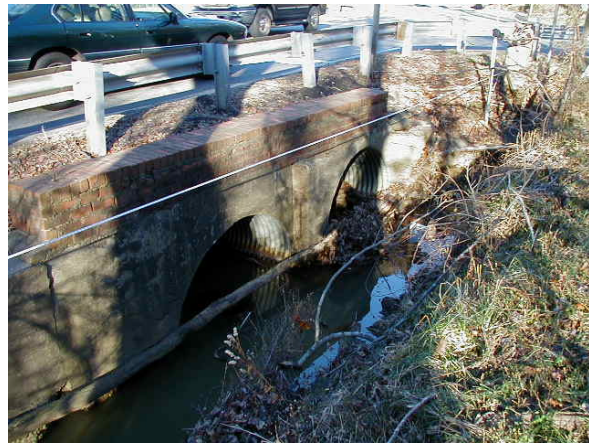
Culvert #33 (Photo 3.147) overtopped for the 25, 50, and 100-year events. Again, Waples Mill Road is considered a primary road, used for through traffic flow. It must pass the 25-year event.

Photo 3.147 Difficult Run Tributary at Waples Mill Road US

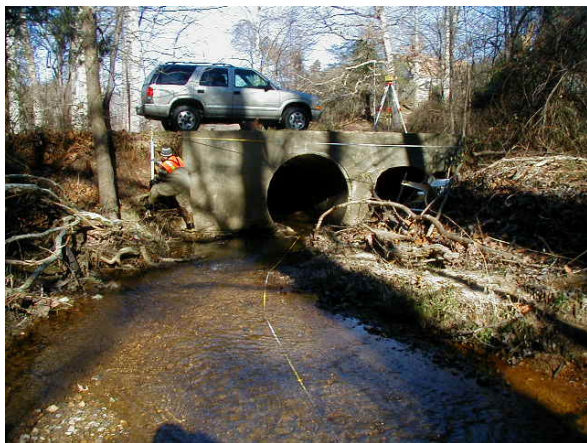
Photo 3.148 Difficult Run Mainstem at Valley Road

Culvert #34 (Photo 3.148) overtopped for all events except the one-year. Valley Road is a local road, not used for through traffic. Local roads are required to pass the 10-year event.

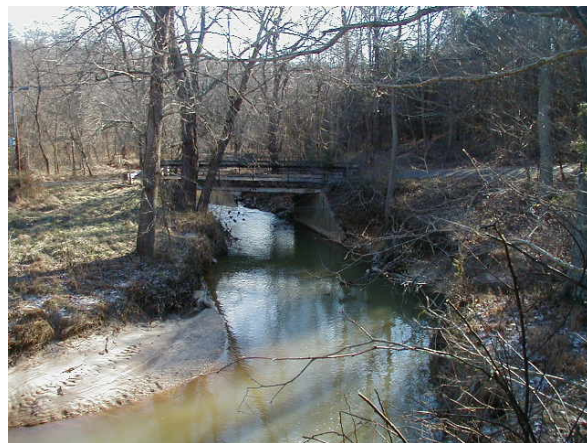
Photo 3.149 Difficult Run Mainstem at Vale Road

Culvert #38-A (Photo 3.149) overtopped for all events except the one and two-year. As this is a footbridge and is not a roadway traveled by cars, it is not considered a candidate site.

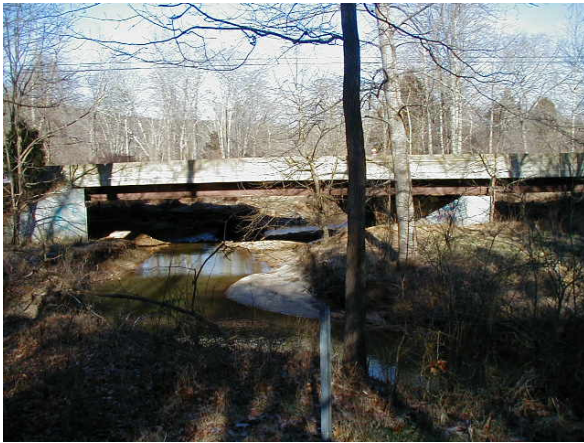
Culvert #38-B (Photo 3.150) overtopped for the 100-year event. Vale Road is a primary road and is thus required to pass the 25-year event. This site is not considered a candidate site.

Photo 3.150 Difficult Run Mainstem at Vale Road

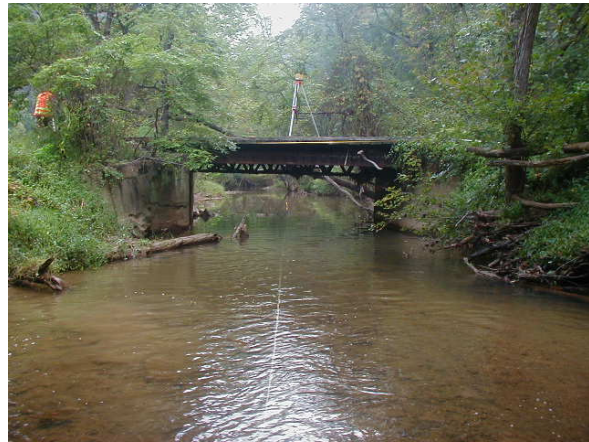
Culvert #22 (Photo 3.151) overtopped for all events except the one-year. Hunters Valley Road is a local access road used by resident to get to abutting properties and is not used for through traffic. This is not a candidate site.

Photo 3.151 Difficult Run Mainstem at Hunters Valley Road
