Chapter 3: Subwatershed Conditions

3.1 Upper Popes Head Subwatershed

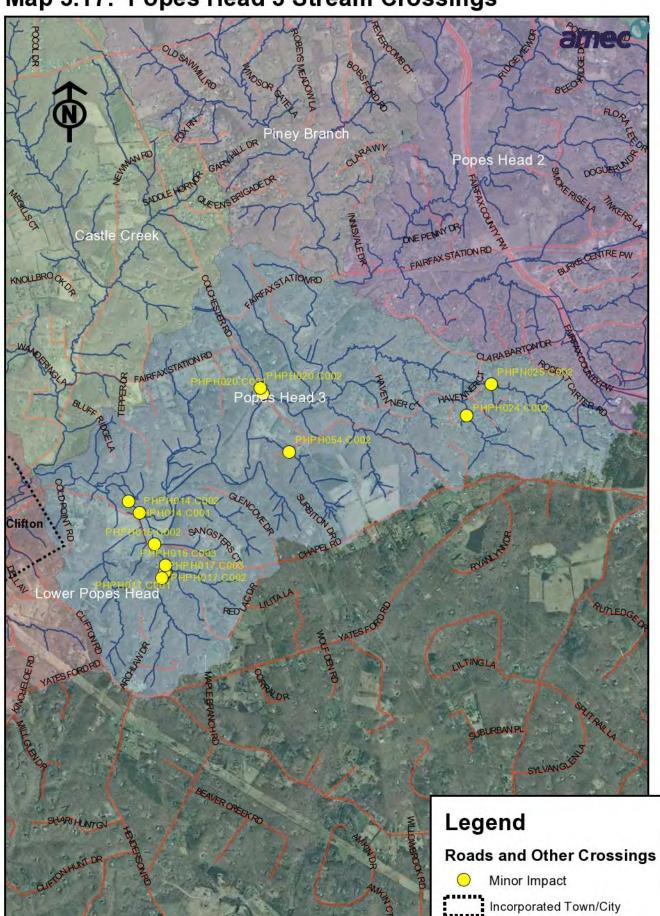
- Havenner Court and Blackburn Ford Drive: A 15-foot wooden footbridge (PHPH024.C002) has a minor impact on the same tributary.
- Colchester Road: A 1.5-foot, two barrel CMP culvert (PHPH020.C001) has a minor impact on the main stem, as shown in Photo 3.14. To the south, an 18-foot diameter circular CMP culvert (PHPH020.C002) has a minor impact on the main stem.

- Stonecrest Lane: A three-foot by four-foot diameter, two barrel elliptical CMP culvert (PHPH054.C002) has a minor impact on the main stem.
- Chapel Road: A 75-foot iron bridge (PHPH014.C001) has a minor impact on the main stem, as show in Photo 3.15. To the southeast, a 50-foot iron bridge (PHPHC014.C002) has a minor impact on the main stem. To the south, a two-foot diameter circular CMP culvert (PHPH015.C002) has a minor impact on the main stem. To the south, three circular CMP culverts (PHPH017.C001, PHPH017.C002, PHPH017.C003) have minor impacts on the main stem. Two of the culverts are fourfeet in diameter, and the remaining culvert is three-feet in diameter.

Photo 3.15 An iron bridge(PHPH014.C001) at Chapel Road has a minor impact on the stream

Photo 3.14 A double barrel culvert (PHPH020.C001) near Colchester Road has a minor impact on the stream
