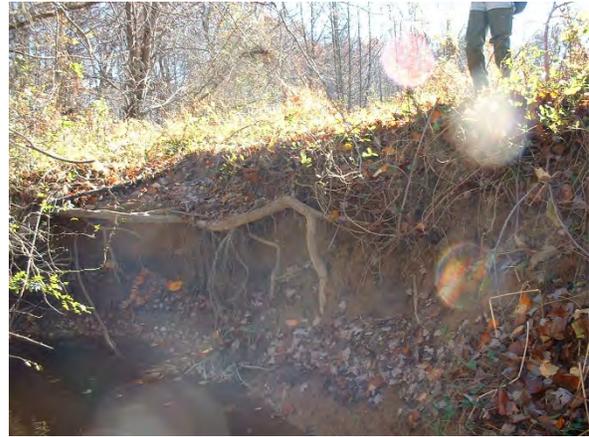
Sixty-three percent of the stream length is moderately unstable, indicating that there is high erosion potential during high flow events. There are five specific erosion locations that are impacting the stream integrity. The points are characterized by raw, actively eroding banks that are degrading the instream habitat and may be damaging property. Four of the five points are considered severe and should be addressed. All of these erosion points have high restoration potential. Photos of two of the more serious erosion areas are located below. Photo 3.3 is located at candidate site S54 and Photo 3.4 was taken at candidate site S76.

*Photo 3.3 Erosion on Captain Hickory Run along Milburn Street (DFCH012.E002).*

- S76 This site at the end of Milburn Street is severely eroded, as shown in Photo 3.2 and Photo 3.4.
- S77 This site has a significant amount of buffer encroachment, along with an area of erosion. Additionally, there is an earthen berm, which is blocking the stream and may be a fish blockage (Photo 3.5).

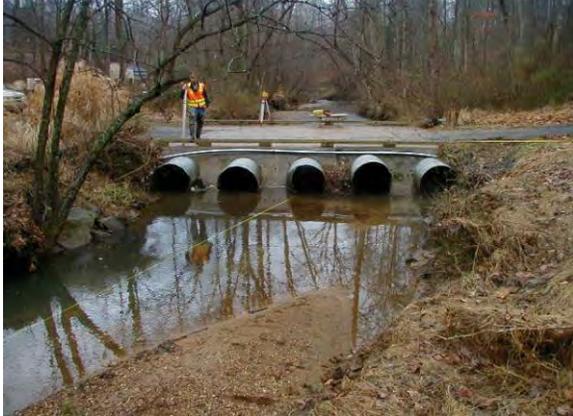
Culvert # 65 (Photo 3.6) overtopped for all events. From the photos, it appears that culvert #65 has recently been reconstructed and functions as a stream ford. This crossing is also a residential access road with a functional classification of "local". It should not be overtopped by storms more frequent than the 10-year event.

*Photo 3.6 Captain Hickory Mainstem at End of Fringe Tree Road*

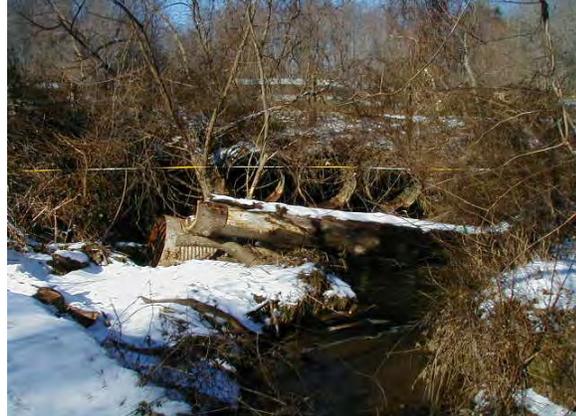
Culvert #69 (Photo 3.7) overtopped for the 50- and 100-year events. This is a residential access road with a classification of "local," requiring the culvert to pass the 10-year event.

*Photo 3.7 Unnamed Tributary at Sunnybrook Drive.*

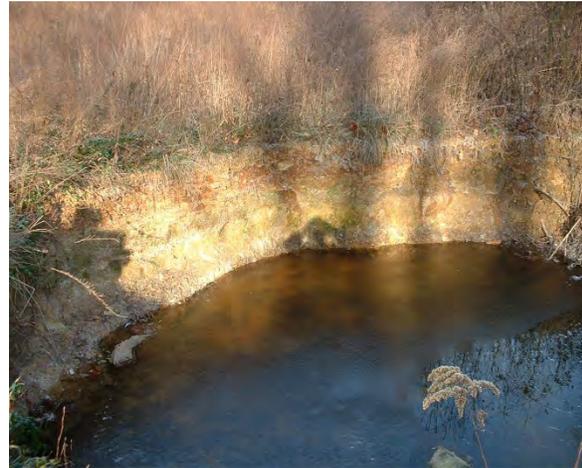
*Photo 3.10 Erosion located near confluence of Dog Run with Piney Run (DFDG001.E001).*

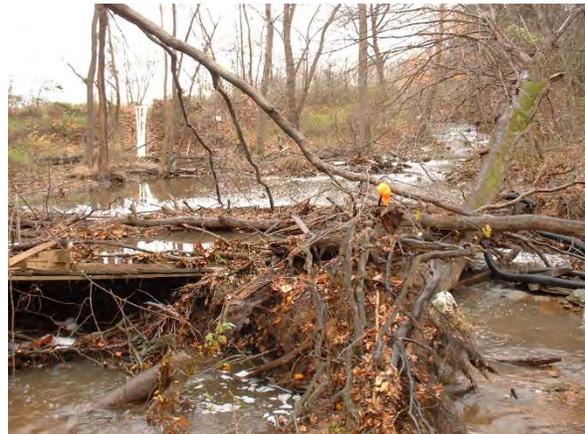
*Photo 3.13 Obstruction located near the intersection of Walker Road with Manning Street (DFPR001.T001).*

There are 11 obstruction locations within the Piney Run subwatershed, all of which are restricting fish passage. Many of the obstructions were beaver dams and are located in the central portion of the subwatershed on tributaries and on the mainstem. One obstruction is located at the very downstream end of the mainstem and is blocking fish passage. The site is shown in Photo 3.13 and is a candidate stream restoration site S83.

- S05 The Stream Physical Assessment survey found this site was found to have poor habitat and erosion resulting in unstable banks (Photo 3.12).
- S80 The Stream Physical Assessment found that there are long reaches with limited buffer due to lawn encroachment on both sides of the channel (3200 feet along one reach).
- S81 Also located at a confluence, the reported that this site had active widening on the mainstem and a severely deficient buffer with moderate restoration potential on the tributary (Photo 3.14).
- S82 The Stream Physical Assessment survey noted significant trash and debris at the dumpsite located north of Springvale Court (Photo 3.15).
- S83 The Stream Physical Assessment survey found an obstruction located at the very downstream end of Piney Run (Photo 3.13).

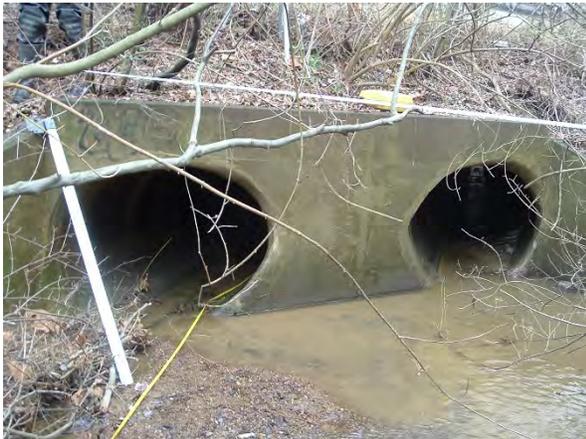
Culvert #64 (Photo 3.16) overtopped for the 50- and 100-year events. Riva Ridge Drive can be classified as a local road, so it must pass the 10-year event, which it does. This is not considered a candidate site

*Photo 3.16 Piney Run Tributary at Riva Ridge Drive.*

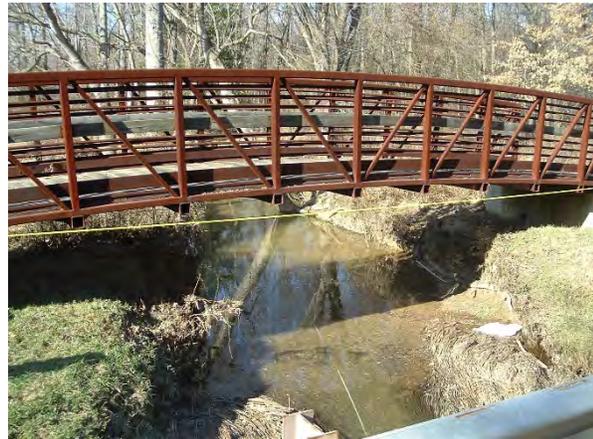
Culvert #67-A (Photo 3.17) overtopped for the 50- and 100-year events. A footbridge is not a public road and has no requirements for overtopping. This is not considered a candidate site.

*Photo 3.17 Piney Run Mainstem at the footbridge by Springvale Road.*

- F67A The footbridge upstream of Springvale Road overtops for the 50- and 100-year events (Photo 3.17).
- F67B The bridge on Springvale Road overtopped for all events except the one- and two-year. This is a primary road, so it is required to pass the 25-year event (Photo 3.18).
- F77 The bridge at Walker Road overtops for events less frequent than the 5-year event. This is a primary road, so it must pass the 25-year event (Photo 3.20).
- F78B The driveway pad next to Manning Street overtops for all events (Photo 3.21).

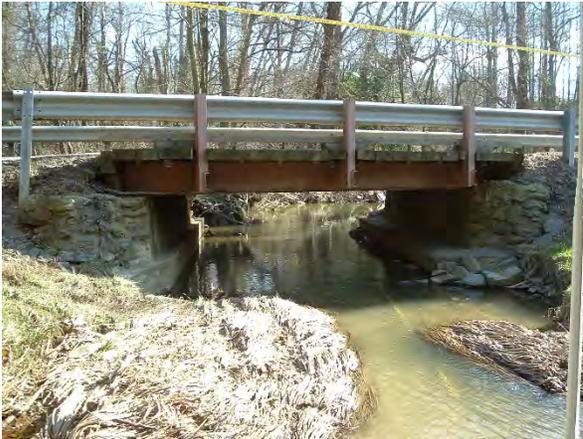
Culvert #67-B (Photo 3.18) overtopped for events less frequent than the 2-year event. Springvale Road carries through traffic and so is considered a primary road, which must pass the 25-year event.

*Photo 3.18 Piney Run Mainstem at Springvale Road*

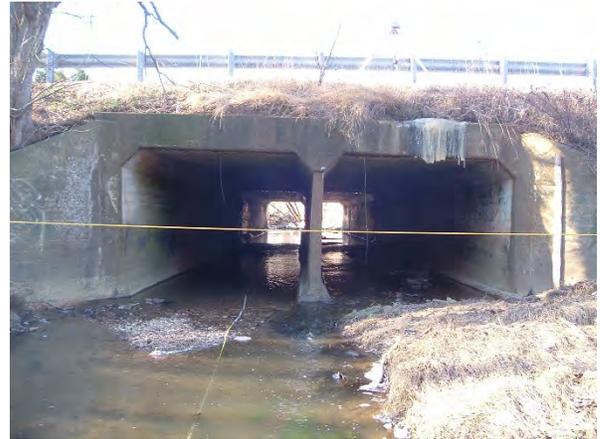
Culvert #68-A (Photo 3.19) overtopped for the 50 and 100-year events. Primary roads like Leesburg Pike are required to pass the 25-year event. This is not considered a candidate site.

*Photo 3.19 Piney Run Mainstem at Leesburg Pike*

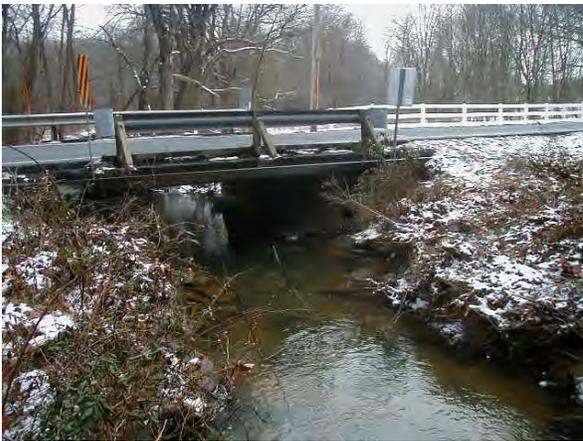
Culvert #77 (Photo 3.20) overtopped for events less frequent than the five-year event. Walker Road is also considered a primary road that is required to pass the 25-year event.

*Photo 3.20 Piney Run Mainstem at Walker Road*

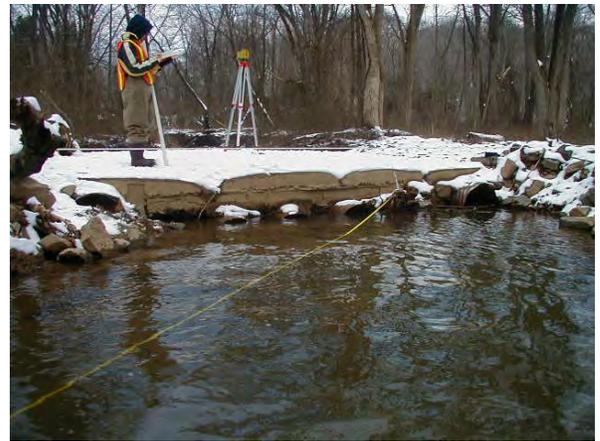
Culvert #78-B (Photo 3.21) overtopped for all events. The driveway pad next to Manning Street is not a public road and is therefore not subject to overtopping requirements. This is not considered a candidate site.

*Photo 3.21 Piney Run Mainstem at the driveway pad by Manning Street*

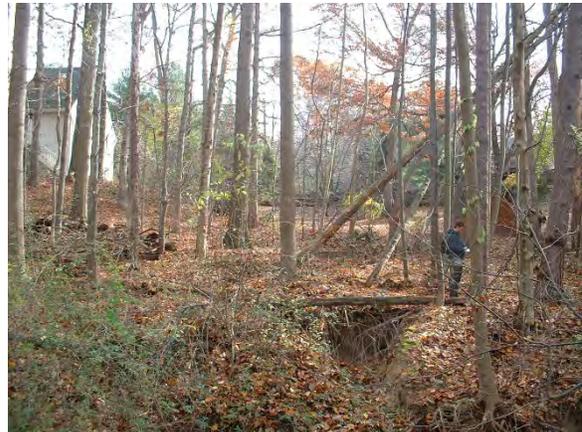
The storm drainage system connects the developed portions of the land to the stream system. Stormwater outfalls are located where the stormwater system ends and the natural channel begins. Outfalls may be sources of pollutants and excessive stormflow from pipes can cause erosion at the outfall and downstream. Field crews located 15 **outfall** pipes discharging into the Lower Difficult Run subwatershed during the Stream Physical Assessment. All were within 200 feet of the channel, and ranged in size from 12 to 18 inches. Stormwater from all of the pipes was causing at least minor to moderate erosion. Two pipes were identified with erosion downstream and some undermining of the structures. They are shown below in Photos 3.22 and 3.23.

*Photo 3.23 Erosion at outfall pipe located off of Hidden Creek Drive (DFDF020.P004).*

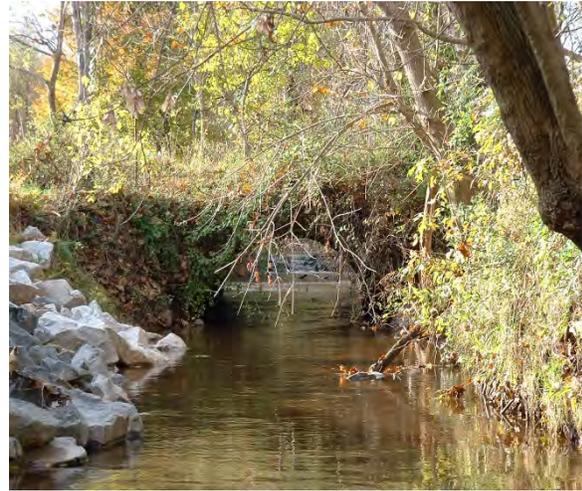
*Photo 3.25 Upstream and downstream bank erosion at Leesburg Pike (DFCR001.C001).*

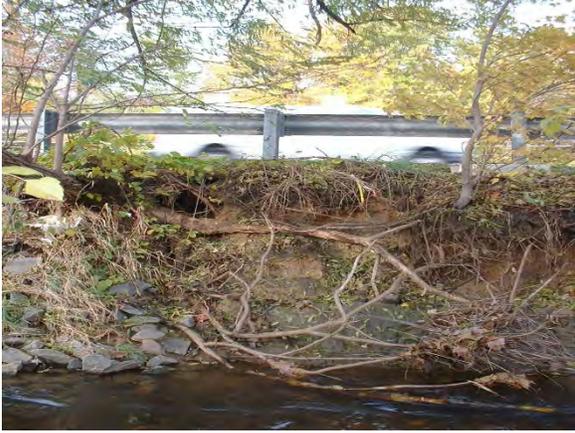
erosion sites (nine points) were having a severe impact on the stream channel, instream habitat or infrastructure. Several of the erosion areas have a high restoration potential. Two of the areas with the highest restoration potential are shown in Photos 3.26 and 3.27, which are candidates for stream restoration S85 and S84 respectively.

*Photo 3.26 Severe erosion that could pose a threat to road safety along Route 7 to the east of Carpers Farm Way (DFCR001.E001).*

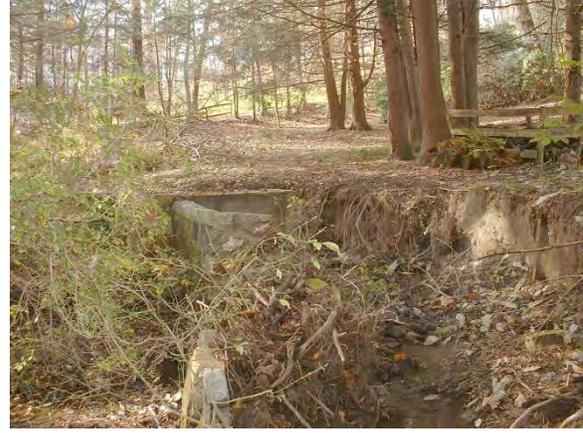
*Photo 3.27 Erosion located between Old Dominion Drive and Georgetown Pike (DFDF011.E001).*

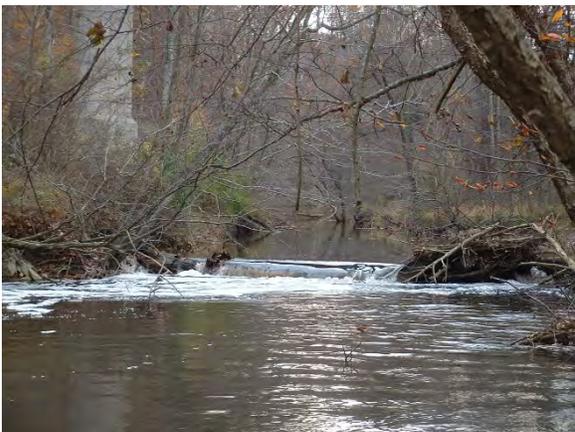
There are 10 obstruction sites located within the Lower Difficult Run subwatershed, most of which are trees and debris. Six of the obstruction sites are thought to be impacting fish movement within the stream. Of these six, one of the sites is on a downstream reach of the mainstem of Difficult Run (Photo 3.28) and has the potential for impacting a large majority of the entire Difficult Run watershed, as this is the only way for fish to get upstream to the rest of the watershed. This site is candidate site S86.

*Photo 3.28 Stream blockage located near Old Dominion Drive (DFDF002.T002).*

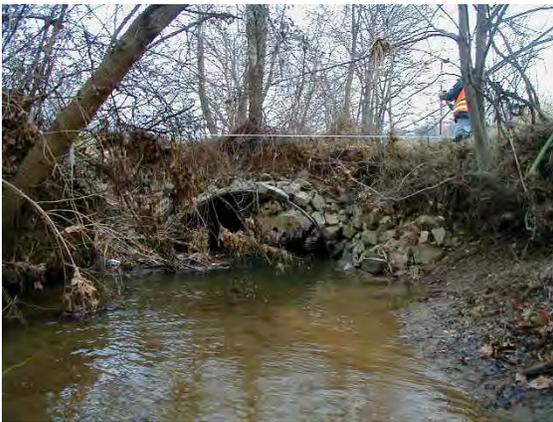
Culvert #59 (Photo 3.32) overtopped for all events. Leesburg Pike is a primary road, which is required to pass the 25-year event.

*Photo 3.32 Lower Difficult Run Mainstem at Leesburg Pike*

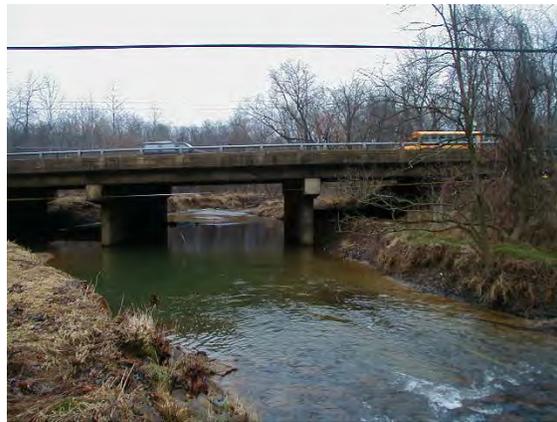
Culvert #72 (Photo 3.33) overtopped for all events also. Leigh Mill Road carries through traffic and is thus considered a primary road. Primary roads should pass the 25-year event.

Photo 3.33 Lower Difficult Run Mainstem at **ents**  
Leigh Mill Road

- F58 The crossing along Leesburg Pike was overtopped for all events. Since it is classified as a local road, the culvert should pass the 10-year event (Photo 3.31).
- F59 The crossing of Leesburg Pike was overtopped for all events. Classified as a primary road, this bridge should pass the 25-year event (Photo 3.32).
- F72 The bridge on Leigh Mill Road overtopped for all events. It is also classified as a primary road, so it must pass the 25-year event (Photo 3.33).

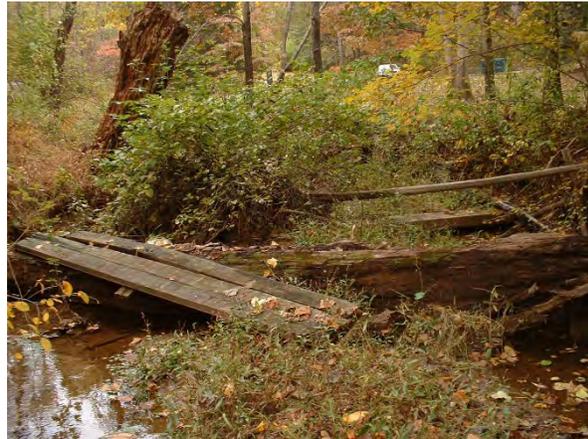
There was one stream blockage made up of trees and debris that appeared to be restricting fish movement. The obstruction also has the potential to create **flooding** problems under high flow conditions. The obstruction is shown in Photo 3.35 and is a candidate site for restoration S90.

*Photo 3.35 Obstruction at the northern end of Sharpers Run near the confluence with Rocky Run between the Bryan Pond and Peacock Station communities (DFSP001.T001).*

S90 The Stream Physical Assessment identified this site as having buffer and erosion problems along with active widening. There is also a stream blockage at this site (Photo 3.35, 3.36).

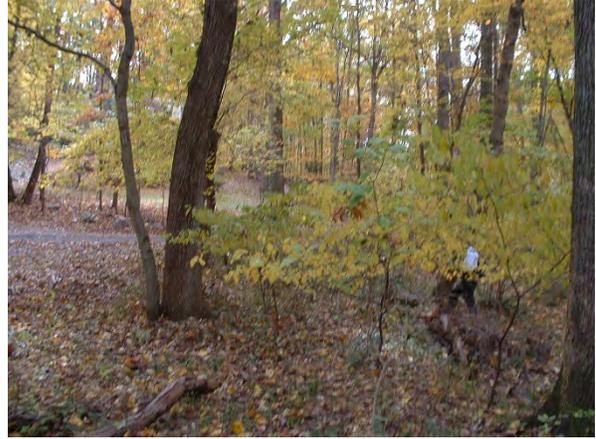
*Photo 3.36 Buffer encroachment between Rocky Run Road and Cedrus Lane (DFSP001.B004).*

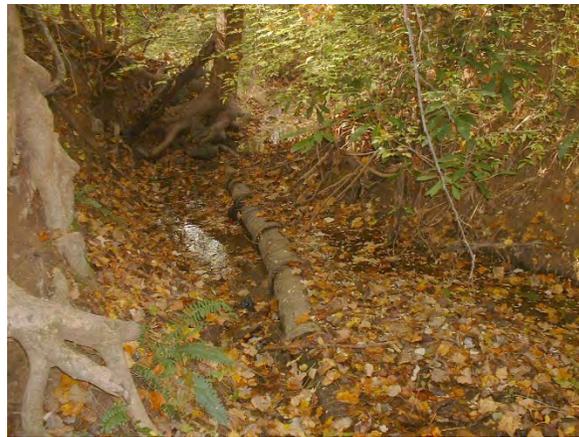
*Photo 3.39 Exposed utility located northeast of Old Dominion Drive near Tebbs Lane.*

There was one utility pipe of an unknown type in reach on a tributary to Rocky Run as shown in Photo 3.39. This utility pipe is partially buried and did not appear to be causing erosion in the stream channel.

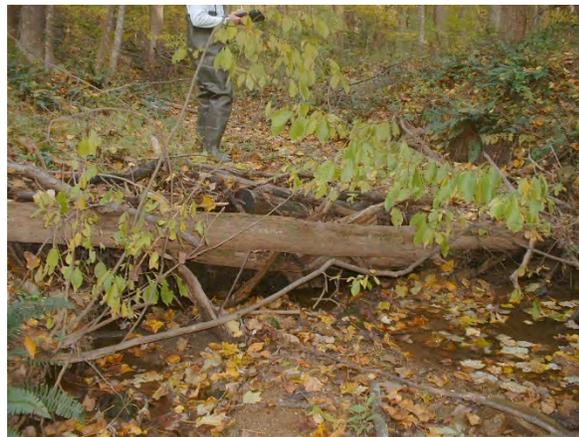
There were 16 sites along the stream within the subwatershed where trees and debris were obstructing flow. Of these, nine were considered significant enough to affect fish passage and three of the 16 had a greater than moderate impact. Photo 3.40 shows a representative blockage on a Rocky Run tributary that may be impeding fish passage.

*Photo 3.40 Obstruction located between Tebbs Lane and Cilicia Street (DFRR001.T002).*

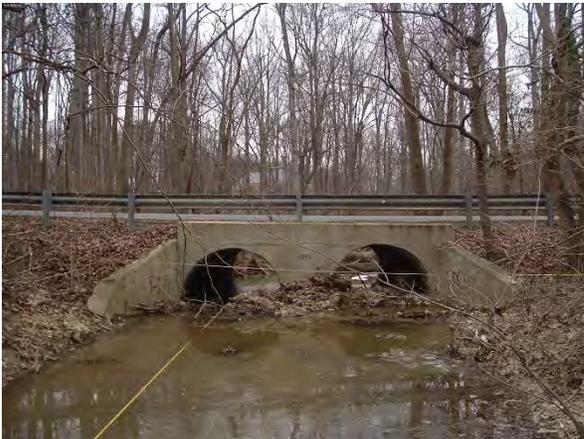
Culvert #74 (Photo 3.41) overtopped for the 25, 50, and 100-year events. Since Brook Road does not allow through traffic, it is classified as a local road, which has to pass the 10-year

*Photo 3.41 Culvert 74 at Brook Road on Rocky Run mainstem.*

flow. Since it does pass the 10-year flow, this culvert is not considered a candidate site.

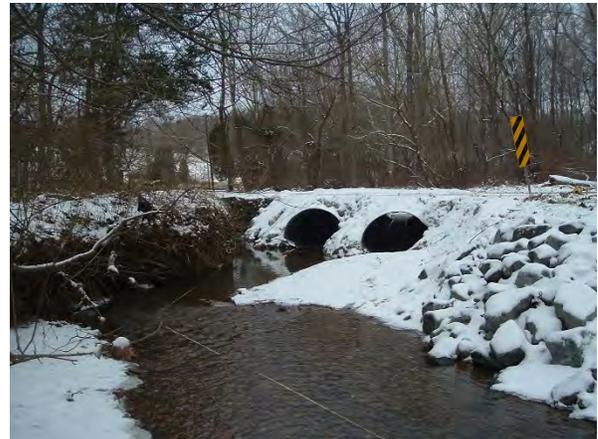
*Photo 3.42 Culvert 75 at Bellview Road on Rocky Run mainstem.*

Culvert #75 (Photo 3.42) overtopped for all events except the one and two-year. Bellview Road is a primary road and so must pass the 25-year event.

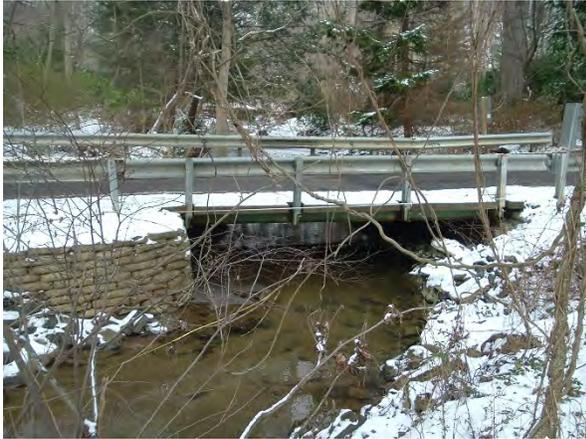
Culvert #76 (Photo 3.43) overtopped for all events except for the one-year. Primary roads, the classification for Towlston Road, must pass the 25-year event.

*Photo 3.43 Culvert 76 on Rocky Run mainstem at Old Towlston Road*

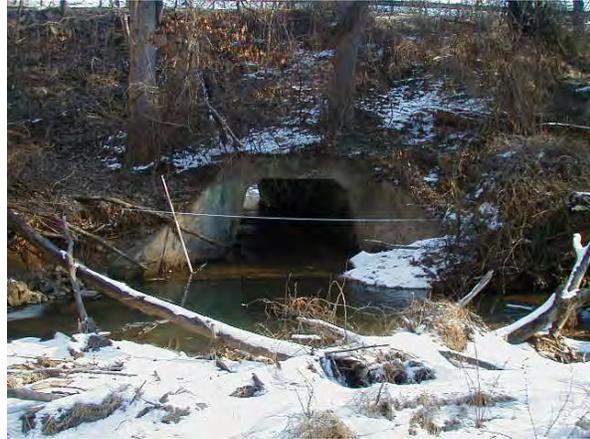
Culvert #79 (Photo 3.44) overtopped for the 25, 50, and 100-year events. Old Dominion Drive allows through traffic and is classified as a primary road. This means it must pass the 25-year event.

*Photo 3.44 Culvert 79 on Rocky Run mainstem at Old Dominion Drive*

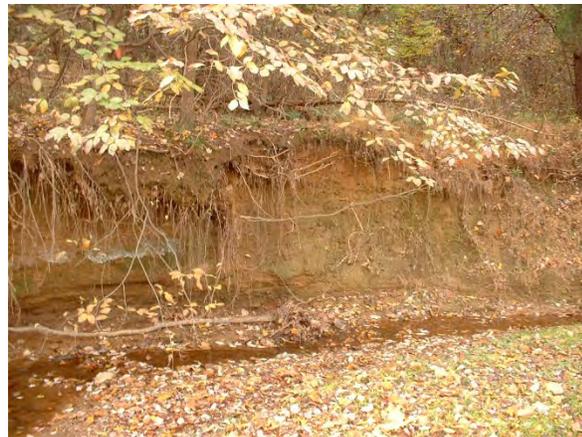
*Photo 3.47 Erosion located on reach just west of Hunter Mill Road near Little Run Farm Court (DFCR008.E001)*

In the stream reaches that are experiencing erosion, much of the erosion is occurring on the outer banks of bends. Several severe erosion locations exist in the Colvin Run subwatershed. Most of these areas have a good restoration potential. Photos of a few of the more serious erosion problems are shown in Photos 3.46 through 3.49. These example sites are all candidate sites for stream restoration (S98, S93, S96, S92 respectively).

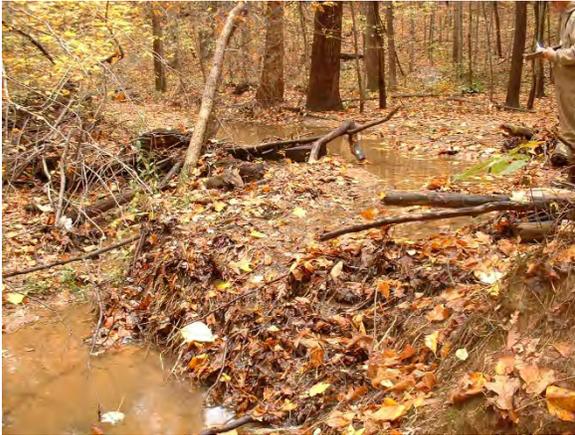
*Photo 3.48 Erosion on a tributary to mainstem Colvin Run near Mount Sunapee Road (DFCR006.E002).*

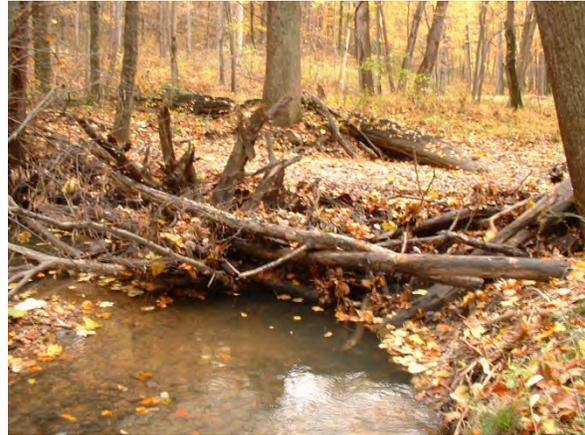
*Photo 3.49 Erosion on mainstem Colvin Run downstream of Lake Fairfax before Colvin Run crosses under Hunter Mill Road (DFCR009.E001).*

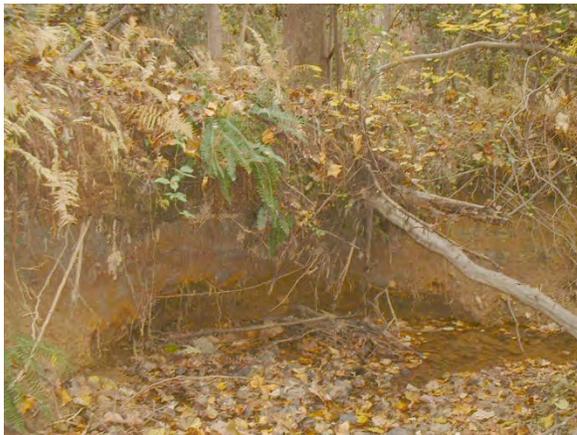
There are 28 points along the stream that are blocked by trees, debris and sediment. Eleven of these are severe enough to be obstructing fish passage. Two are shown below in Photos 3.50 and 3.51 and are near stream restoration candidate sites S135 and S11, respectively.

*Photo 3.50 Obstruction just upstream of Lake Fairfax to the west of Aldenham Lane (DFCR013.T001).*

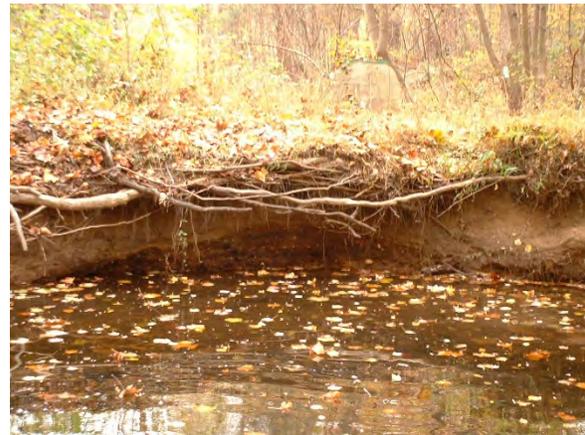
*Photo 3.51 Obstruction upstream of Lake Fairfax located near Park Overlook Drive (DFCR015.T001).*

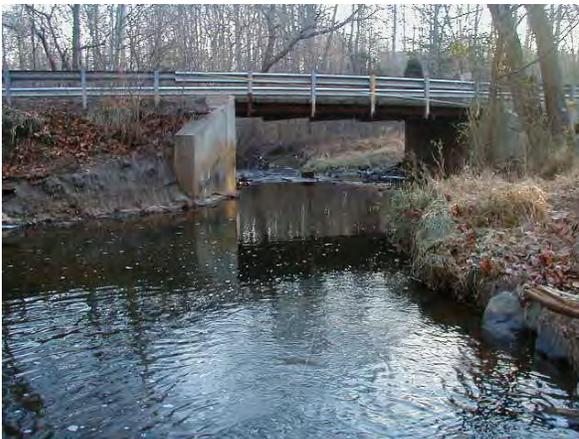
Culvert #40 (Photo 3.52) overtopped for events less frequent than the 10-year. The road this bridge is on, Hunter Mill Road is classified as a primary road. This requires it to pass the 25-year event.

*Photo 3.52 Colvin Run Mainstem at Hunter Mill Road*

- F40 The bridge over Colvin Run on Hunter Mill Road overtops for flows less frequent than the 25-year event. Primary roads must pass the 25-year event. (Photo 3.52)
- F41 The culvert under Lake Fairfax Drive overtops for all events. Local roads must pass the 10-year event. (Photo 3.53)
- F57 The culvert under Carpers Farm Way overtops with existing conditions for all the modeled events. Local roads must pass the 10-year event. (Photo 3.54)

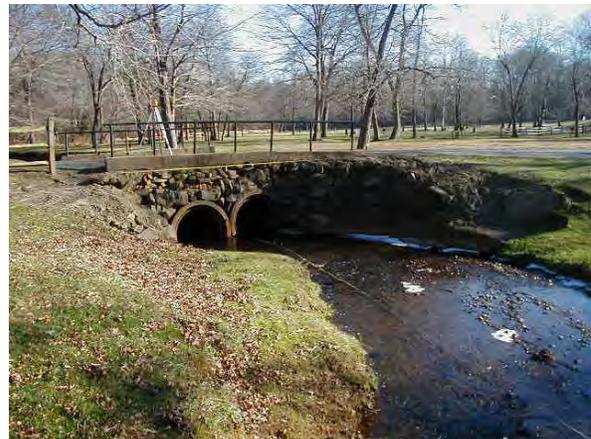
Culvert #41 (Photo 3.53) overtopped for all events. Lake Fairfax Drive is used as a local road to access Lake Fairfax Park. This requires it to pass the 10-year event.

*Photo 3.53 Colvin Run Mainstem at Lake Fairfax Drive*

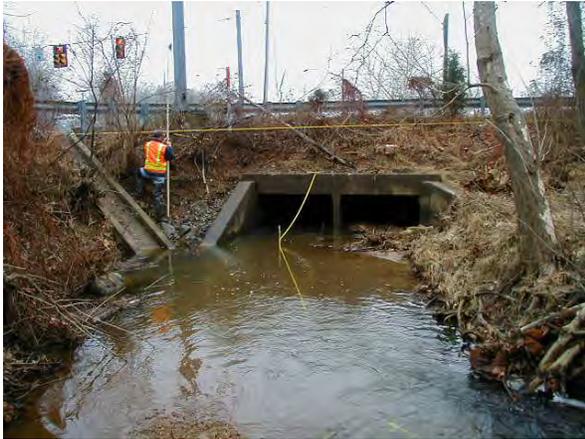
Culvert #57 (Photo 3.54) overtopped for events less frequent than the 2-year. Carpers Farm Way is a local road, which means it must pass the 10-year event.

*Photo 3.54 Colvin Run Mainstem at Carpers Farm Way*

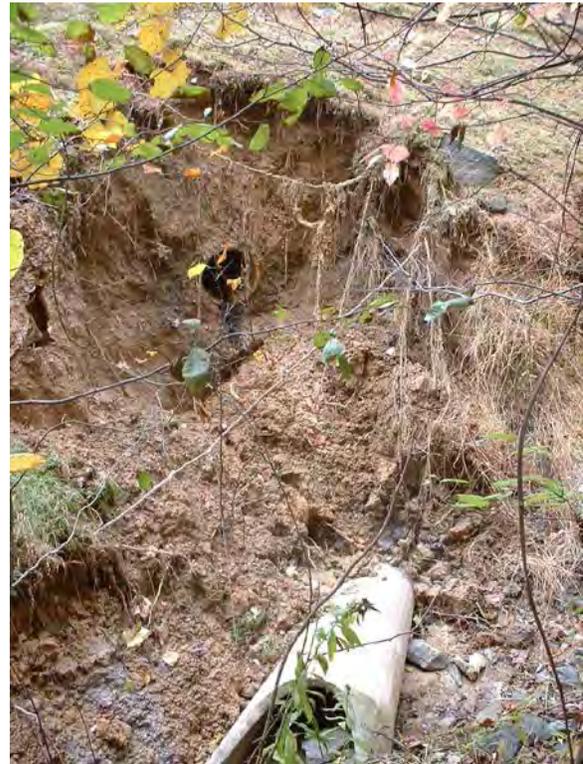
A 16-inch concrete pipe is located south of the Dulles Access and Toll Road near Alexander Bell Drive. Severe erosion is occurring where the pipe segments have separated (Photo 3.55). A second outfall, located just downstream, is an 18-inch pipe located 75 feet from the channel as shown in Photo 3.56. These two outfalls together make up a candidate restoration site S101.

*Photo 3.55 Severe erosion and pipe segment separation at a 16-inch outfall located near Alexander Bell Drive (DFSB006.P006).*

- S25 The stream has signs of erosion considered severe but with a high potential for restoration (Photo 3.58).
- S101 There are outfall pipes that are causing major erosion and have the potential to destroy existing parking lots and sanitary sewers (Photo 3.55, 3.56 and 3.60).
- S102 There are utility lines in the stream that erosion has unearthed (Photo 3.57).
- S103 There is erosion that is considered severe with a high potential for restoration at this site. It is located directly upstream of site S25 (Photo 3.59 and 3.61).

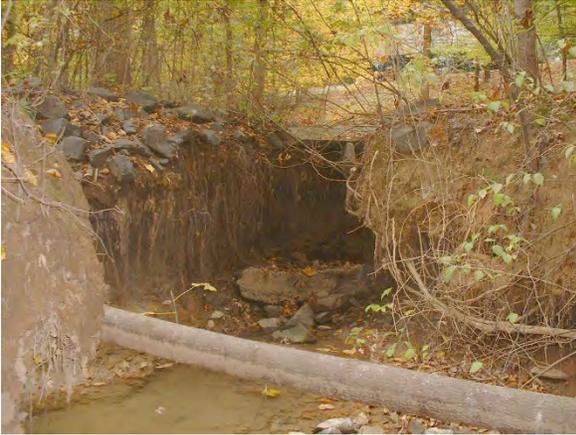
*Photo 3.56 An 18-inch outfall causing severe erosion located downstream of the outfall shown in Photo 4.1 (DFSB006.P005).*

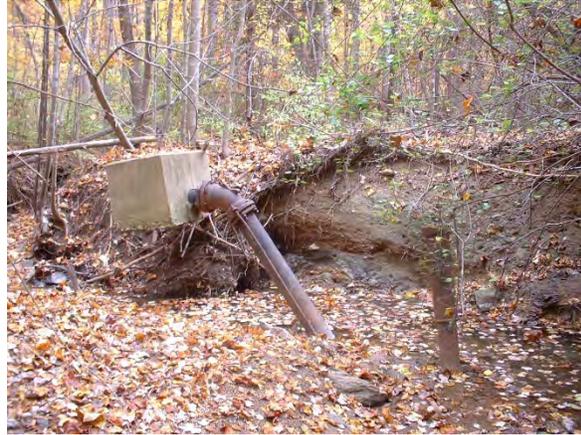
The third outfall lies within the stream channel, and is located south of Sunrise Valley Drive and just east of Barton Hill Road (Photo 3.57). This site is identified a potential restoration site (S102) due to the severe erosion.

*Photo 3.57 Pipe located south of Sunrise Valley Drive and just east of Barton Hill Road. Major erosion around the structure is evident (DFSB006.P003).*

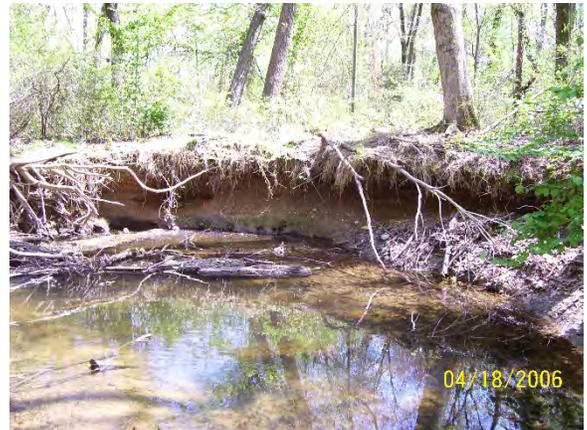
- The other two areas of erosion are on a single reach approximately 500 feet from one another. These are located on the mainstem of Snakeden Branch upstream of Lake Audubon. This potential stream restoration site S103, shown in Photo 3.59

*Photo 3.59 Erosion located between Old Trail Drive and Millenium Lane (DFSB015.E001).*

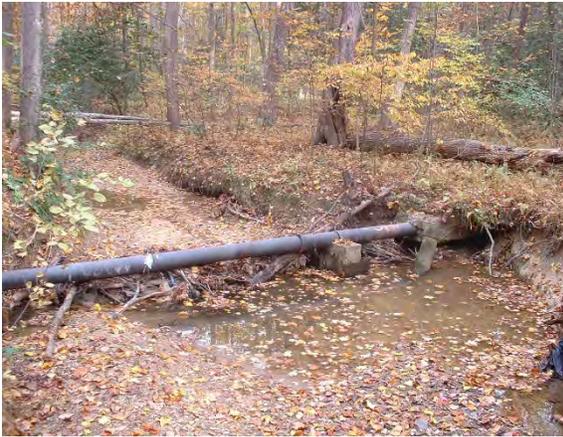
Photo 3.60 Exposed sanitary utility line crossing stream (DFSB006.U002).

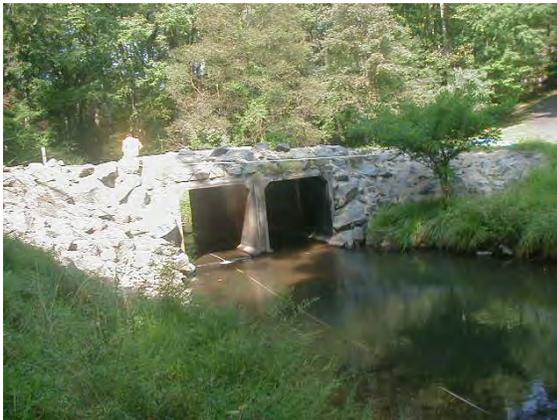
Culvert #10 (Photo 3.62) overtopped for all events except the one-year. This is a local road, and so is required to pass the 10-year event.

*Photo 3.62 Snakeden Branch Mainstem at Hunters Den Lane*

- F10 The culvert at Hunters Den Lane overtopped for all events except the one-year. This is a local road, so it must pass the 10-year event (Photo 3.62).
- F11 The bridge on Hunter Station Road overtops for all events. Hunter Station Road is a primary road that should pass the 25-year event (Photo 3.63).

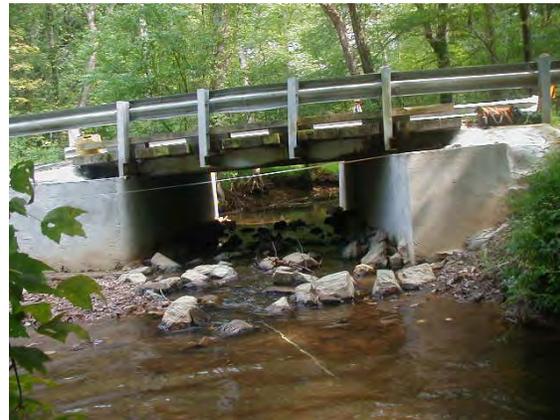
Culvert #11 (Photo 3.63) overtopped for all events. Hunter Station Road is a primary road, uses mainly for through traffic. It is therefore required to pass the 25-year event.

*Photo 3.63 Snakeden Branch Mainstem at Hunter Station Road*

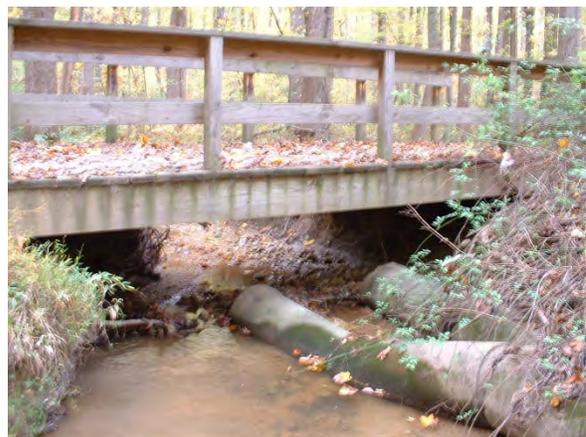
Stream crossings, such as bridges and culverts are often locations of erosion and flooding. The combination of aging structures and frequently high stormwater levels can cause downstream stream stability problems and habitat impairment. Seventeen of the 21 stream crossings in The Glade subwatershed are wooden footbridges. All but two crossings have very little impact on stream character. The two with more significant impact are wooden footbridges where the flow is creating moderate bank erosion. The erosion was not significant enough to warrant further study or restoration. The crossings are shown in Photos 3.64 and 3.65.

*Photo 3.65 Wooden bridge where stream flow is causing moderate erosion. Located just west of Steeplechase Drive (DFGL008.C001).*

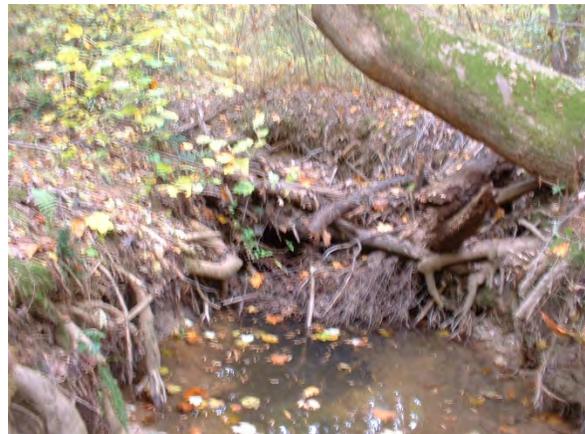
*Photo 3.68 Obstruction of trees and debris near Stirrup Road. (DFGL008.T001)*

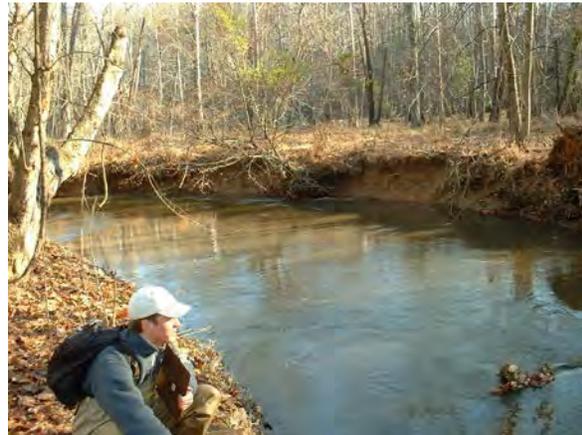
There were 11 points of erosion noted in Middle Difficult Run. The combined length of the erosion points is approximately 6,660 feet (1.3 miles). Two of the 11 erosion points are having a severe impact on stream condition. They are shown here in Photos 3.70 and 3.71. The former is located at Candidate Site S56.

*Photo 3.71 Erosion on the mainstem of Difficult Run at the end of Tamarack Drive (DFDF008.E001).*

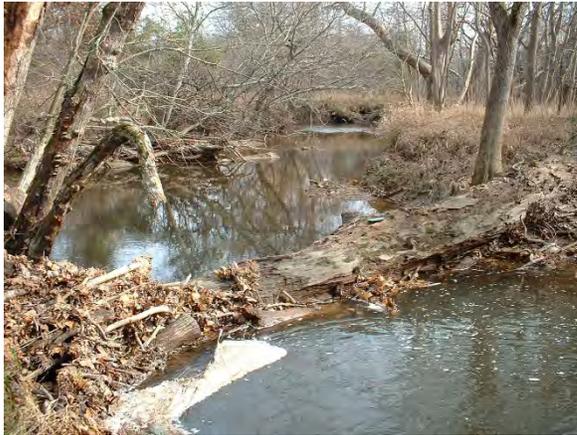
- Of the assessed reaches, 82 percent have fair habitat for aquatic insects and fish, 14 percent is considered poor, and 4 percent is good.
- There are 12 stream blockages, primarily composed of trees and debris. Eight of these blockages are likely restricting movement of fish in the stream system between habitats and for migration. Three of these obstructions have a more significant impact on stream integrity. Two of them are shown below in Photos 3.72 and 3.73.

*Photo 3.72 Obstruction on the mainstem located in Tamarack Park (DFDF007.T002).*

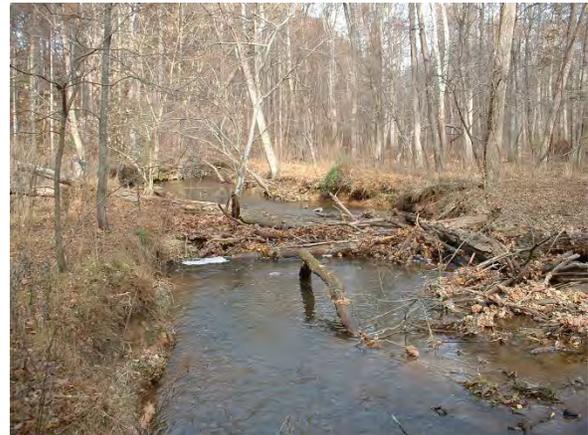
*Photo 3.73 Obstruction to fish passage on the mainstem located at the terminus of Montafia Lane, Sun Valley subdivision, directly west of Sun Valley Park (DFDF007.T001).*

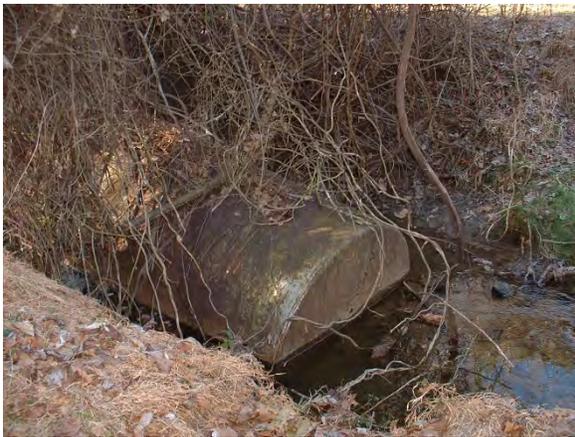
was located in the stream and contained a residential oil tank. Although the dumpsite was not active, clean up would definitely be a benefit to the stream quality. The tank is shown in Photo 3.74 and is at candidate site S105.

*Photo 3.74 Residential oil tank located in a tributary near Asoleado Lane (DFDF055.M001).*

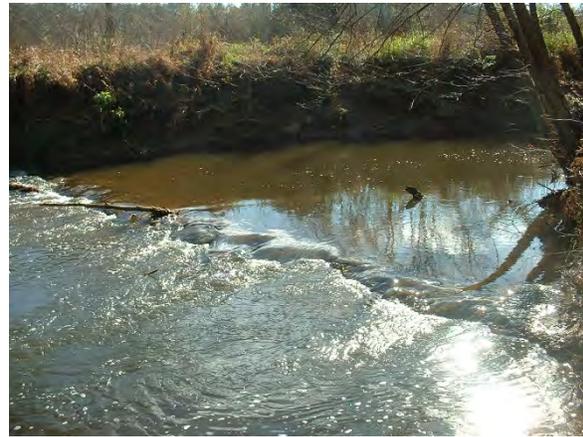
- There was one sanitary line that was crossing the stream and partially buried (see Photo 3.75). Although the line was exposed in some parts, it was stabilized and anchored to the banks.

*Photo 3.75 Utility at the downstream end of the subwatershed near Valley Creek Lane (DFDF005.U001).*

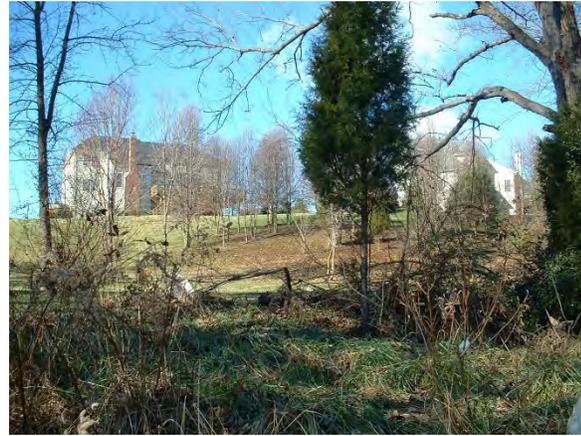
*Photo 3.77 2000 feet of buffer impact upstream of Brittenford Road (DFDF050.B002).*

S108 Inadequate buffer and stream erosion are both problems at this site. The catchment has the highest runoff volume and peak discharge in the subwatershed (Photo 3.77).

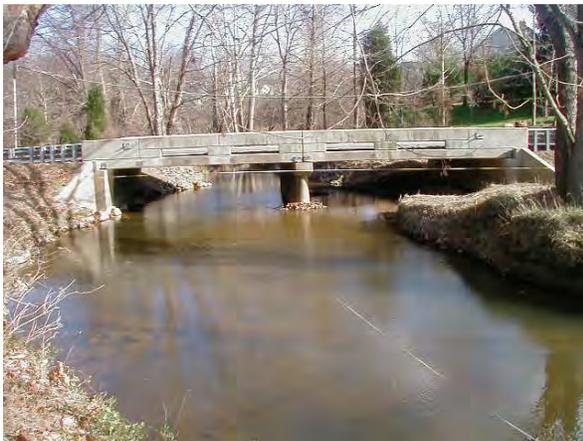
Culvert #29 (Photo 3.78) overtopped for all events. Browns Mill Road is a local road, so it is required to pass the 10-year flow.

*Photo 3.78 Difficult Run Mainstem at Browns Mill Road.*

F29 The Browns Mill Road Bridge overtops for all events. Since it is classified as a local road, the bridge should pass the 10-year event (Photo 3.78).

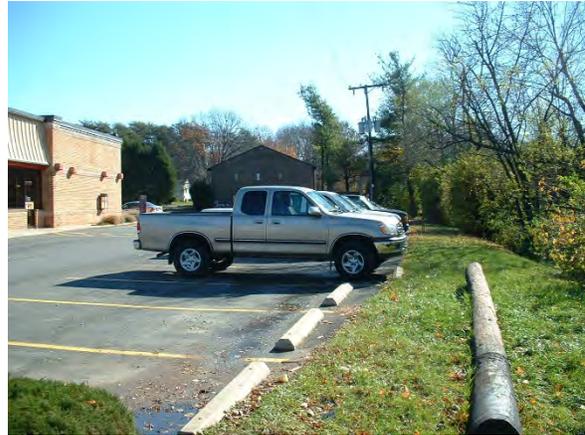
- 7,725 feet of the buffer encroachment is having a significant impact on the stream condition and habitat quality. Photos of an example are shown below in Photos 3.80 and 3.81 that are located at candidate site S123.
- Most (66 percent) of the total buffer encroachment has good restoration potential.

Photo 3.81 Buffer impact near Maple Avenue (DFWC019.B001).

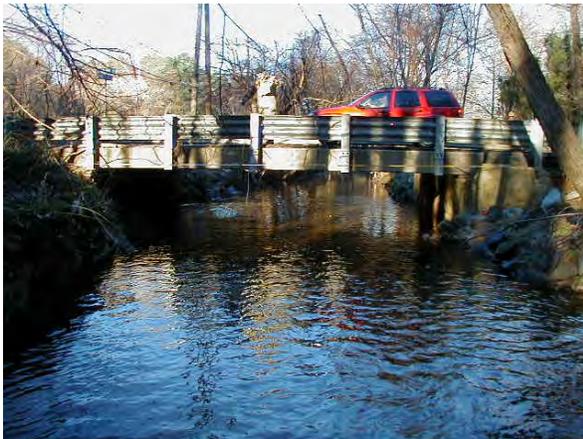
Culvert #28 (Photo 3.82) overtopped for all events. As Beulah Road is a through road, it can be classified as a primary road. This means that it must pass the 25-year event.

Photo 3.82 Wolftrap Creek Mainstem at Beulah Road.

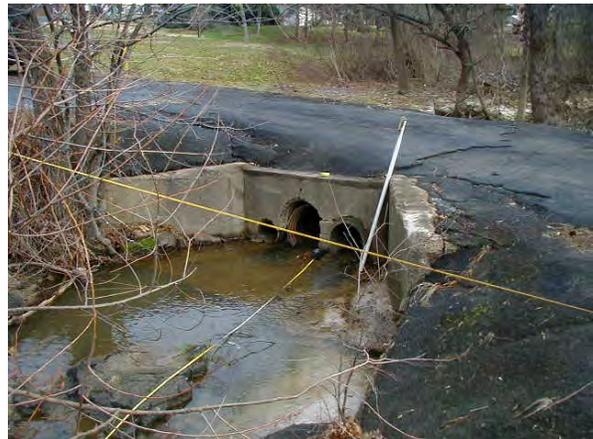
Culvert #48-A (Photo 3.83) overtopped for all events. Creek Crossing Road can also be used as a through road, so it too can be classified as a primary road. Primary roads must pass the 25-year event.

Photo 3.83 Wolftrap Creek Tributary at Creek Crossing Road.

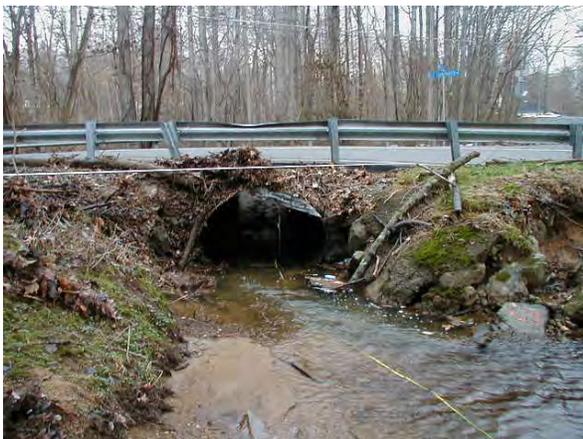
Culvert #49 (Photo 3.84) also overtopped for all events. Classified as a primary road, Old Courthouse Road is required to pass the 25-year event.

Photo 3.84 Wolftrap Creek Mainstem at Old Courthouse Road.

- F28 The bridge on Beulah Road that passes over Wolftrap Creek overtops for all events. Beulah Road is classified as a primary road, so it must pass the 25-year event (Photo 3.82).
- F48 The culvert that flows Wolftrap Creek under Creek Crossing Road overtops for all events. Creek Crossing is a primary road, so it must pass the 25-year event (Photo 3.83).
- F49 The culvert under Old Courthouse Road that passes Wolftrap Creek also overtops for all events. Old Courthouse Road is classified as a primary road, so it must pass the 25-year event (Photo 3.84).

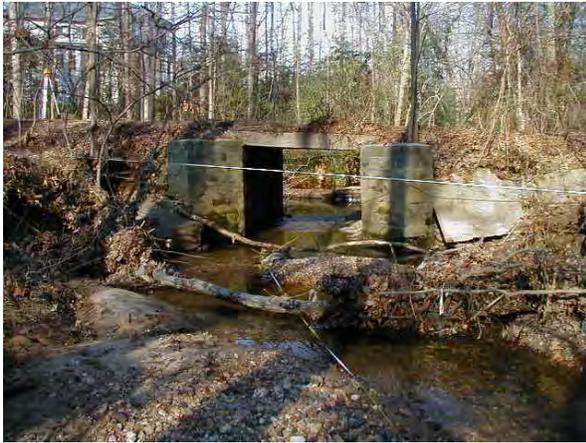
Culvert #47 (Photo 86) overtopped for all events except for the one and two-year. This road can be classified as a local road since there is no through traffic. Local roads must be able to pass the 10-year event.

*Photo 3.86 Crossing at Northern Neck Drive (DFOR701.T001).*

F47 The crossing at Northern Neck Drive overtopped for 5-year and greater events. Northern Neck Drive is classified as a local road, so it must pass the 10-year storm (Photo 3.86).

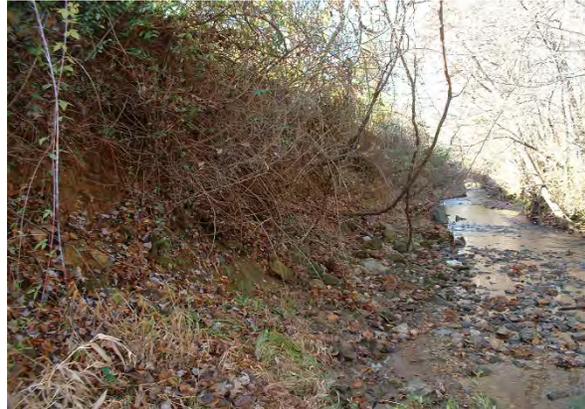
The majority (93 percent) of the channel has a gravel **substrate**. The remaining portions are primarily silt and sand. All of the reaches are Type III, which is indicative of an actively widening stream channel. There was one erosion point of moderate to severe erosion of approximately 300 feet. It is candidate site S110 and is shown in Photo 3.87. Refer to DFPB\_3 for the stream classifications.

*Photo 3.87 Streambank erosion just upstream from confluence with Difficult Run, west of Fosbak Drive (DFPB002.E001)*

- S110 The Stream Physical Assessment survey indicated that there was severe streambank erosion just upstream from confluence with Difficult Run, west of Fosbak Drive (Photo 3.87).
- S111 During the Stream Physical Assessment, field crews noted an exposed sanitary line that should be examined and corrected (Photo 3.89).
- S112 During the Stream Physical Assessment survey, riparian buffer was noted as being encroached upon by lawns and pavement. The Stream Physical Assessment survey indicated that streambank erosion was severe or extreme, channel was widening, and habitat was poor to very poor.
- S134 The site is located downstream of and within catchments with high runoff volume and near obstructions identified during the Stream Physical Assessment (Photo 3.88).

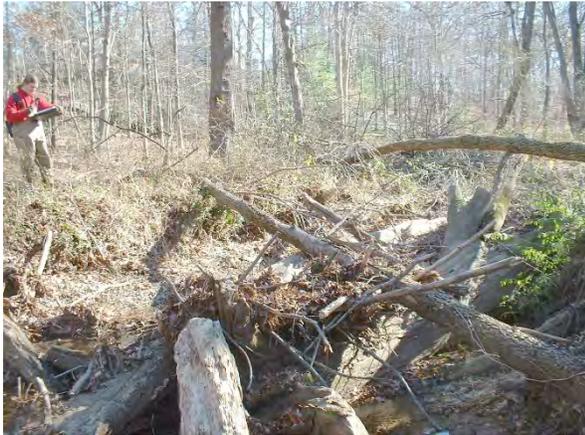
*Photo 3.88 Obstruction point, mostly trees and debris, at the end of Corsica Street. (DFPB015.T001).*

All of the eight stream blockages were made up of trees and debris. Some had additional concrete and sediment. One-half of the obstructions had only minor impacts on the stream, causing some erosion. Thirty-eight percent of the obstructions were causing a greater impact on the stream condition. The example shown in Photo 3.88 is candidate site S134.

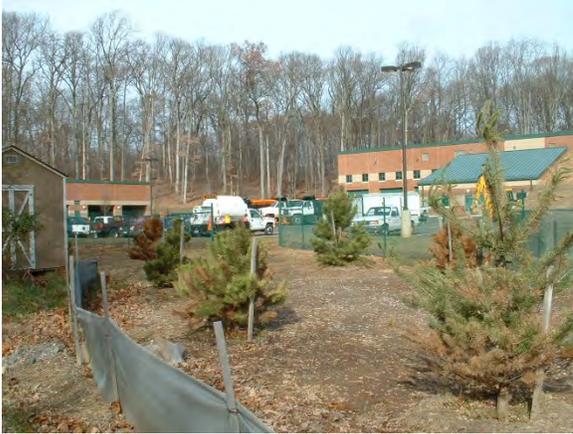
- There is 35,400 feet, approximately 42 percent of the total stream length, of **riparian buffer** encroachment (this length includes left and right banks combined). Of this, 25,550 feet (72 percent) is lawn, and 2,300 (6.5 percent) is pavement. The remaining buffer encroachment area is some combination of lawn, meadow, trees and pavement. Eighty-two percent of the buffer encroachment length has no or low restoration potential due to existing infrastructure, however; 18 percent of the length has moderate to high restoration potential. Most of the percent of the buffer encroachment had only minimal impact, suggesting that the stream character may be changed slightly by adjacent use. Two of the areas with pavement buffer encroachment appear to present a greater impact and are shown in Photo 3.90 and 3.91.

*Photo 3.90 Buffer impact in North Side Park (DFPB024.B002).*

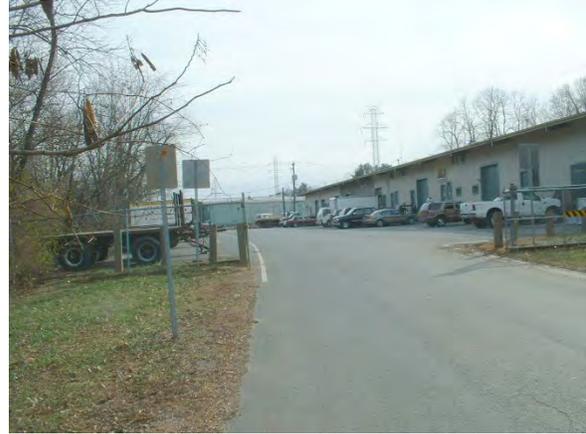
*Photo 3.91 Buffer impact in the Somerset community at the end of Mill Street (DFPB024.B003).*

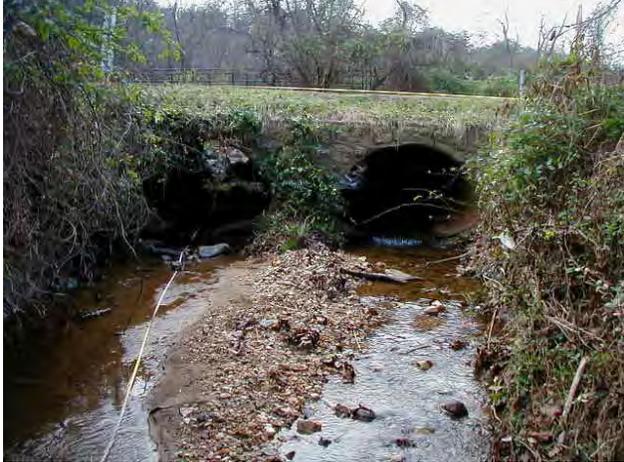
Culvert #25-A (Photo 3.92) overtopped for the 25, 50, and 100-year events. Lawyers Road has a classification of “primary,” which requires the culvert to pass the 25-year event.

*Photo 3.92 Piney Branch  
tributary at Lawyers Road.*

- F25A The crossing of Lawyer's Road was overtopped for 25-year and greater events. Since it is classified as a primary road, the culvert should pass the 25-year event (Photo 3.92).

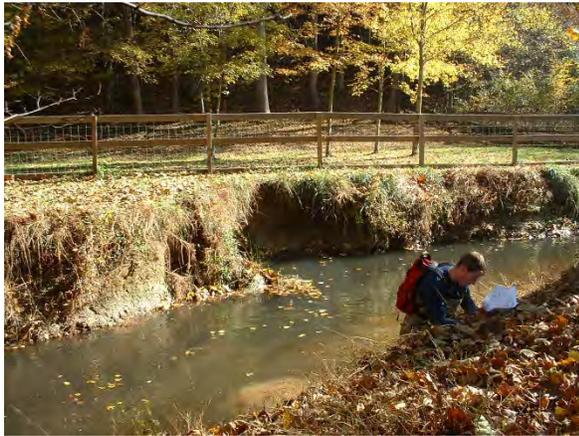
*Photo 3.95 Eroding bank directly north of the terminus of Hollybrook Place in the Hollybrook subdivision (DFLD004.E001).*
