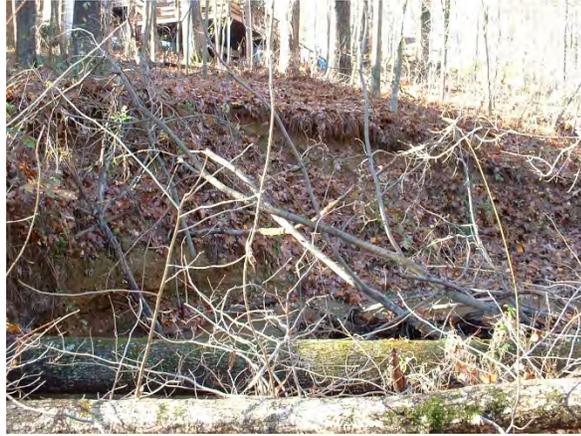
*Photo 3.96 Erosion area at the end of Millstream Court, in Little Difficult Run Stream Valley Park (DFLD024.E001).*

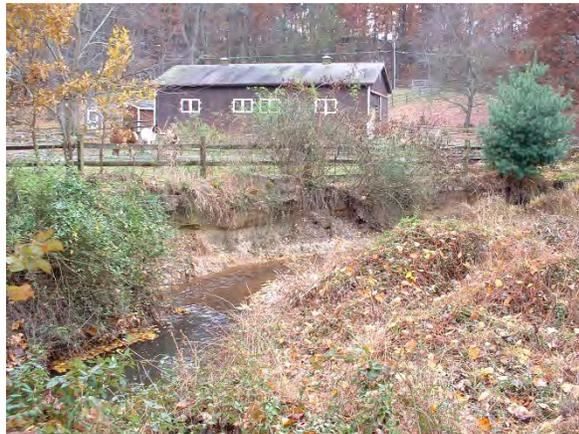
*Photo 3.97 Erosion located on the mainstem of Little Difficult Run, directly east of Colt Run Road in the Roan Stallion Estates subdivision (DFLD013.E001).*

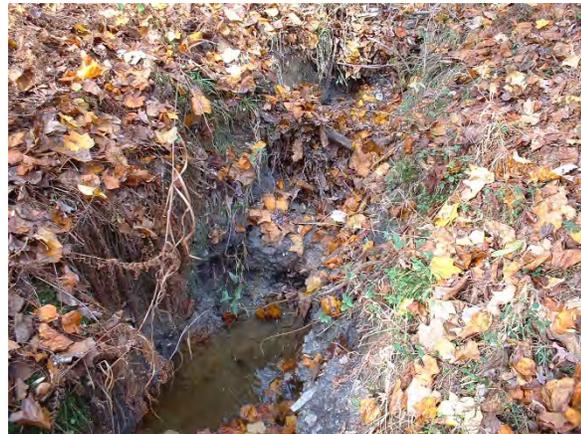
*Photo 3.98 Headcut located northwest of Fox Mill District Park in the Fox Mill Woods subdivision. Directly east of the intersection of Steeplechase Drive and Aintree Lane (DFLD023.H001).*

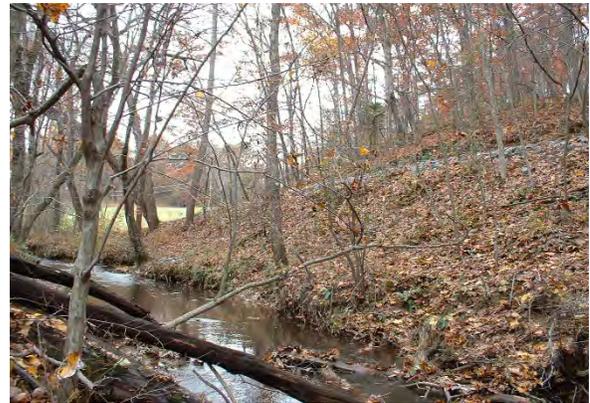
- Of the assessed reaches, 60 percent have fair habitat for aquatic insects and fish, 29 percent have good habitat, and 21 percent have poor habitat.
- There are 14,450 feet of **riparian buffer** encroachment in the subwatershed (this length includes left and right banks combined). Of this total, 9,900 feet (69 percent) is a combination of **pervious** surfaces, 1,050 feet (7 percent) is a combination of different impervious surfaces, and the remaining 3,500 feet (24 percent) is some combination of impervious and pervious surfaces. Photos 3.99 above (which is candidate site S116) and 3.100 (which is candidate site S36) and 3.101 below show examples of buffer encroachment.

*Photo 3.99 Severe buffer encroachment (in background) Little Difficult Run Stream Valley Park, directly south of Stuart Mill Road on the mainstem (DFLD011.B001)*

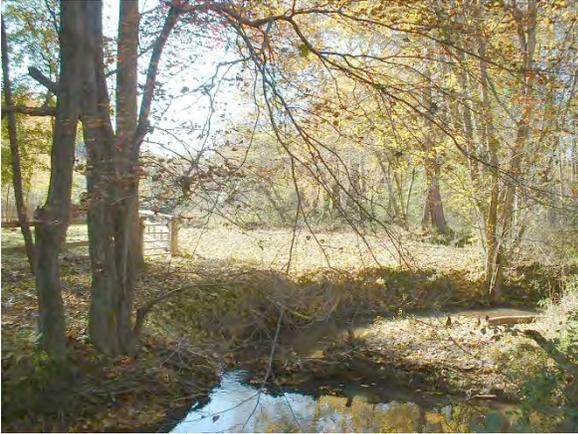
*Photo 3.100 Buffer encroachment in the Little Difficult Run Stream Valley Park. Directly east of Mill Road and Stuart Mill Road (DFLD003.B001).*

- S36 There are significant riparian buffer impacts over 1,000 feet in length in the Little Difficult Run Stream Valley Park directly east of Mill Road and Stuart Mill Road (Photo 3.100).
- S65 The reach between two overtopping culverts (culvert 13 and culvert 30) is exhibiting poor bank stability and has several crossing impacts.
- S113 Erosion area at the end of Millstream Court, in Little Difficult Run Stream Valley Park (Photo 3.96).

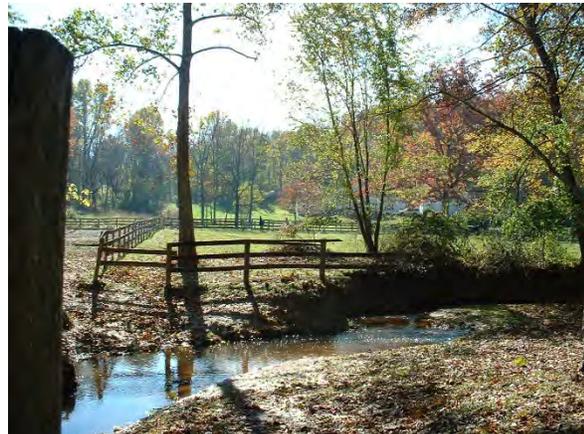
*Photo 3.101 Buffer impact in the Hollybrook community, directly north of the terminus of Hollybrook Place, mainstem of Little Difficult Run (DFLD003.B002).*

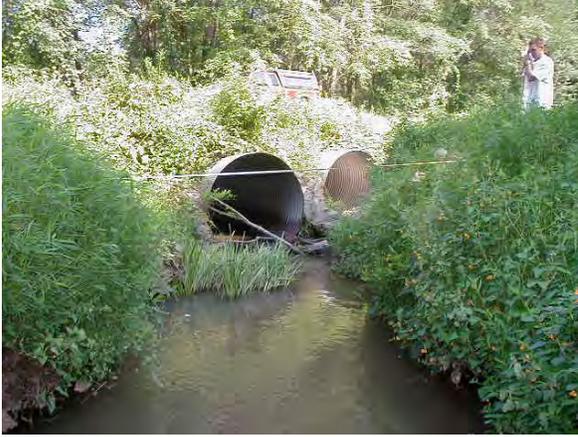
Culvert #3 (Photo 3.102) overtopped for all events except the one-year. Stuart Mill Road can be considered a primary road, which requires it to pass the 25-year event.

*Photo 3.102 Little Difficult Run at Stuart Mill Road*

- F03 The bridge carrying Stuart Mill Road over the Mainstem of Little Difficult Run overtops for all events except the 1-year storm. It is required to pass the 25-year event (Photo 3.102).
- F06 The culvert conveying Mainstem of Little Difficult Run under Colt Run Road overtops for all events. It is required to pass the 10-year event (Photo 3.103).

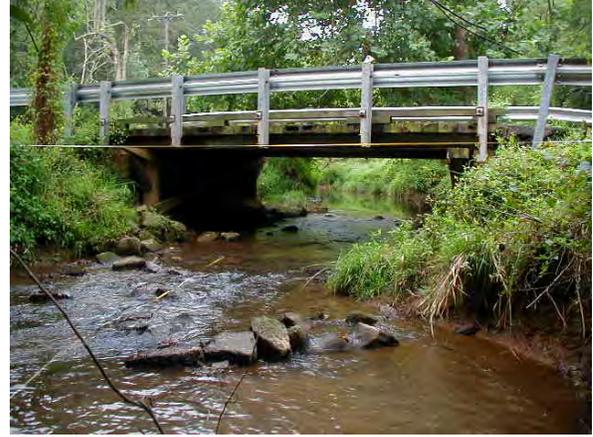
Culvert #6 (Photo 3.103) overtopped for all events. Colt Run Road is a residential access road, classified as local, requiring the culvert to pass the 10-year event. This culvert is candidate site F06.

*Photo 3.103 Little Difficult Run at Colt Run Road*

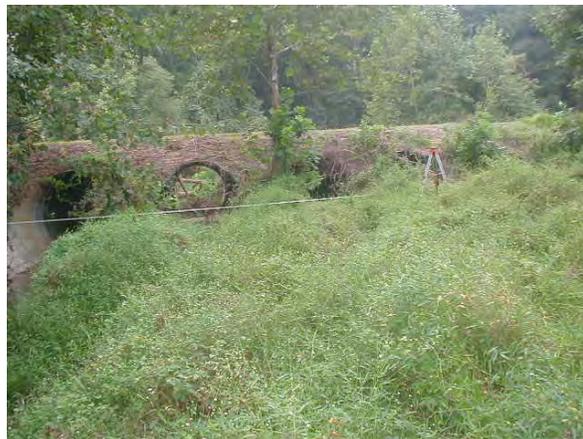
Culvert #12 (Photo 3.104) overtopped for the 25, 50, and 100-year events. The culvert at Polo Pointe Drive, a local road, is required to pass the 10-year event. This culvert is not a candidate site.

*Photo 3.104 Little Difficult Run tributary at Polo Pointe Drive.*

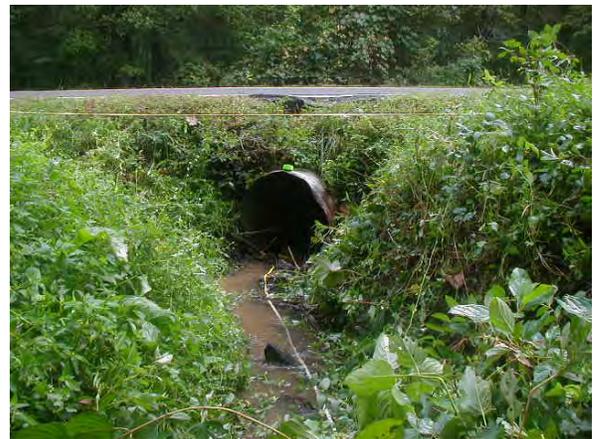
Culvert #13 (Photo 3.105) overtopped for all events except the one-year. Fox Mill Road is a primary road, and is therefore required to pass the 25-year event.

*Photo 3.105 Little Difficult Run mainstem at Fox Mill Road North*

- F13 The culvert conveying a tributary of Little Difficult Run under Fox Mill Road overtops for all events except the 1-year storm. It is required to pass the 25-year event (Photo 3.105).
- F15B The culvert conveying Little Difficult Run under Stuart Mill Road overtops for all events except the 1-year and 2-year storms. It is required to pass the 25-year event (Photo 3.106).
- F16 The culvert conveying a tributary of Little Difficult Run under Fox Mill Road overtops for all events except the 1-year and 2-year storms. It is required to pass the 25-year event. (Photo 3.107).
- F30 The culvert conveying a tributary of Little Difficult Run under Thoroughbred Road overtops for all events except the 1-year and 2-year storms. It is required to pass the 20-year event (Photo 3.108).

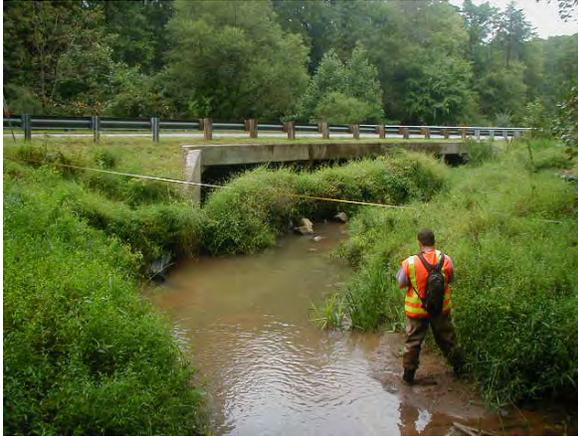
Culvert #15-B (Photo 3.106) overtopped for all events except the one and two-year. Stuart Mill Road, as mentioned above, can be considered a primary road, requiring it to pass the 25-year event.

*Photo 3.106 Little Difficult Run mainstem at Stuart Mill Road*

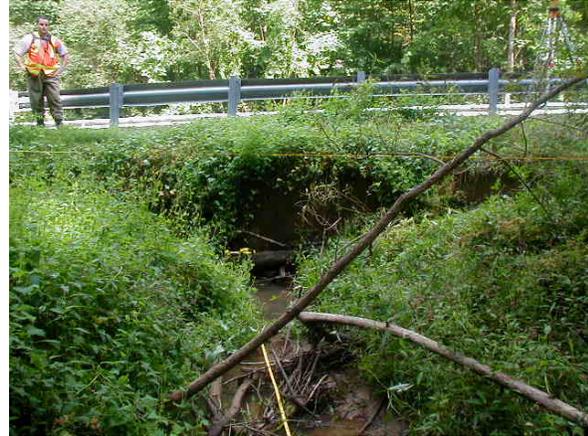
Culvert #16 (Photo 3.107) overtopped for all events except the one and two-year. Fox Mill Road, also mentioned above, can be considered a primary road and must pass the 25-year event.

*Photo 3.107 Little Difficult Run mainstem at Fox Mill Road South*

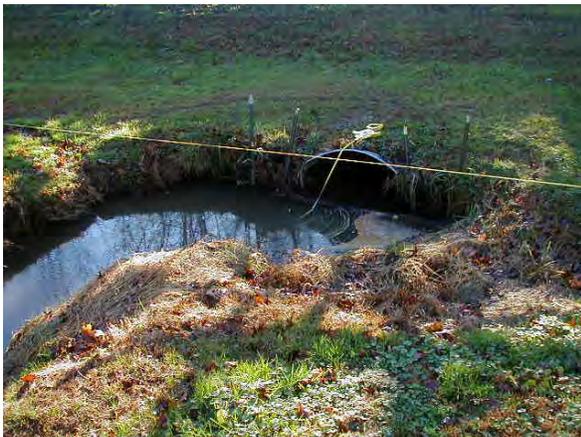
Culvert #30 (Photo 3.108) overtopped for all events except the one and two-year. The

culvert at Westwood Hills Drive, a local road, is expected to pass the 10-year event.

*Photo 3.108 Little Difficult Run tributary at Westwood Hills Drive*

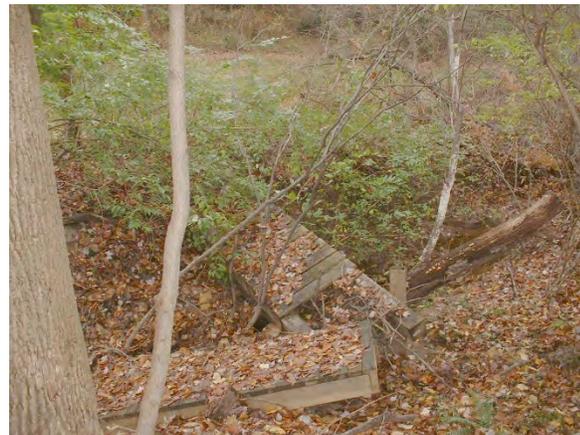
There were three locations along Angelico Branch where field crews noted obstructions. All obstructions were restricting fish passage and can lead to flooding and stream erosion. Two of these are shown in Photos 3.111 and 3.112.

*Photo 3.112 Obstruction located just south of East Hunter Valley Road (DFAB002.T002)*

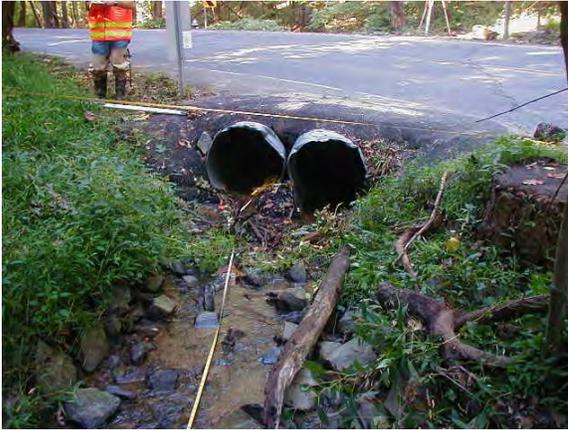
Culvert #19 (Photo 3.113) overtopped for all events except the 1-year. Lawyers Road is a primary road, which should allow the 25-year event to pass.

*Photo 3.113 Angelico Branch  
at Lawyers Road*

- F19 This culvert overtops with existing conditions for all rainfall events from 2- to 100-year; however, it should pass the 25-year event to meet County standards (Photo 3.113).

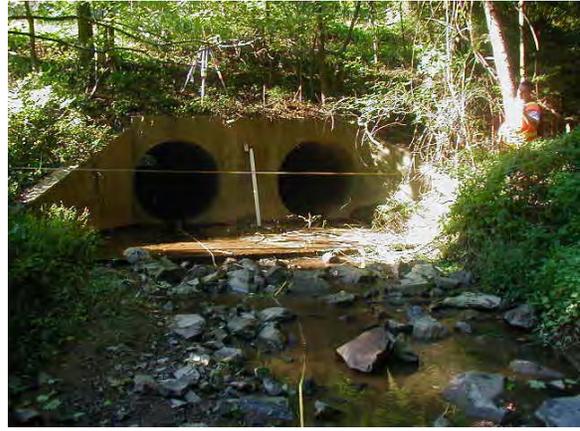
Culvert #20 (Photo 3.114) overtopped for the 50 and 100-year events. This is a residential access road, which can be classified as local, and is required to pass beneath it the 10-year event. This culvert is not considered a candidate site.

*Photo 3.114 Angelico Branch  
at Cedar Pond Drive*

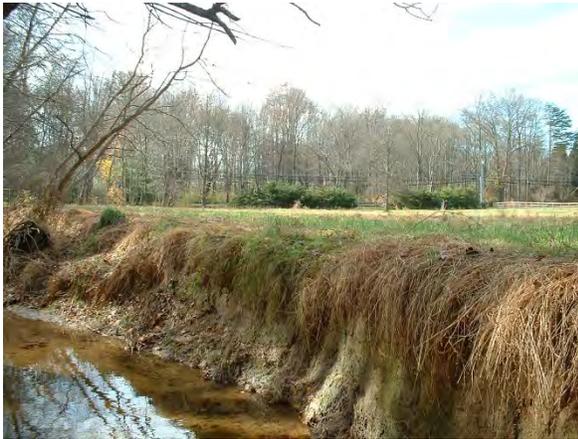
*Photo 3.121 Severe buffer impact on the mainstem of South Fork Run, directly north of the intersection of Fox Mill Road (SR 665) and Deerfield Drive in the Brians Hill Estates subdivision (DFSF007.B002).*

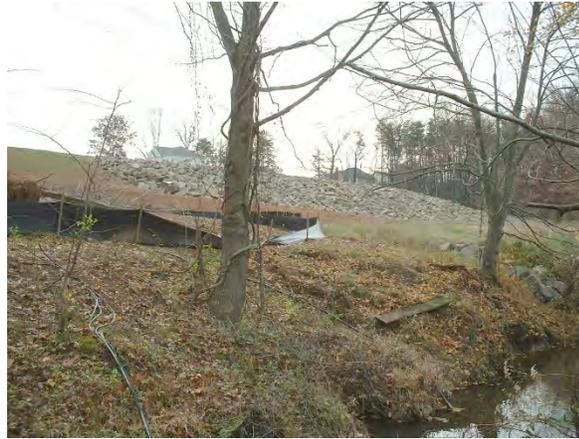
*Photo 3.122 Buffer impact located northwest of Timber Lake, in the Timber Lake subdivision (DFSF005.B001).*

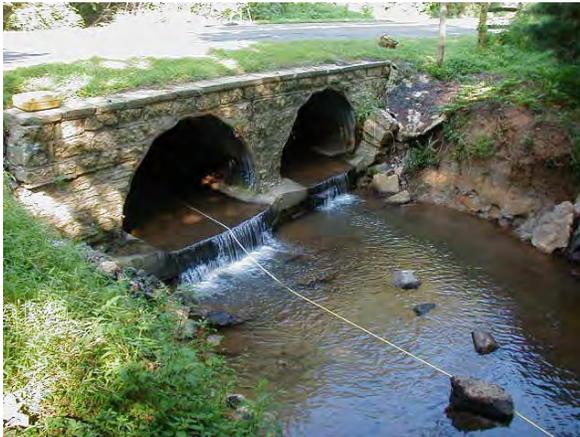
Culvert #4 (Photo 3.123) overtopped for the 10-year and greater events. This is classified as a primary road and should not be overtopped by storms more frequent than the 25-year event.

*Photo 3.122 South Fork Run Mainstem at Fox Mill Road*

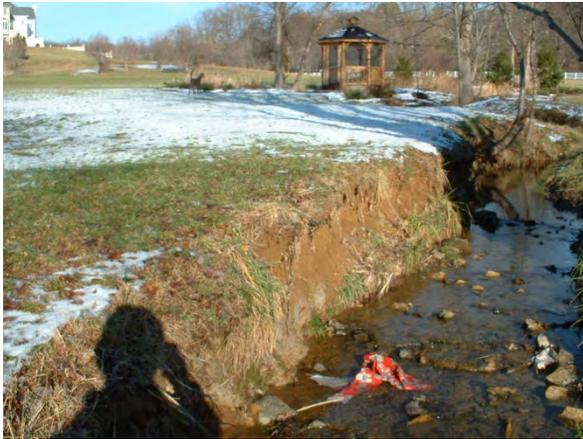
*Photo 3.124 Erosion point on the west side of Hunter Mill Road at the intersection with Conejo Land (DFRB012.E001).*

- S128 The entire length from the confluence with Difficult Run to the headwaters has a combination of bank erosion, poor habitat and a widening channel. The reach traverses the Oakton Mill Estates, Miller Heights, and Windsong Communities (Photos 3.123, 3.127 and 3.130).
- S129 A small tributary to one of the major Rocky Branch tributaries with poor habitat, low bank stability, and approximately 400 linear feet of severe erosion (Photo 3.125 and 3.126).
- S130 The Stream Physical Assessment located approximately 1,000 feet of buffer encroachment in the Hunter Hills community. The reach appears to be on an agricultural land use (Photo 3.129).
- S131 The Stream Physical Assessment identified the reach as having poor bank stability, poor habitat, buffer impacts, eroding banks and several crossings (Photo 3.124 and 3.131).

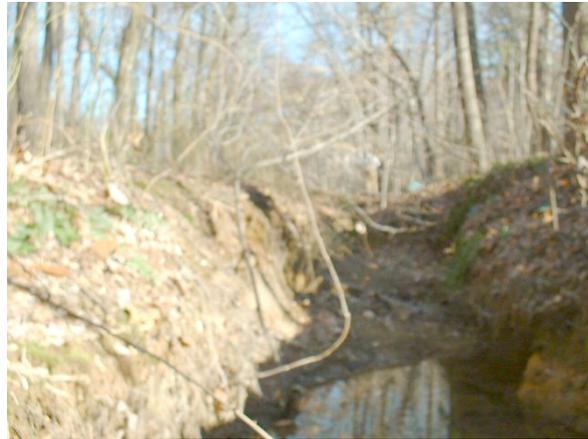
*Photo 3.125 On a tributary northwest of the cul-de-sac of Westhurst Court in the Windsong community. (DFRB015.E001).*

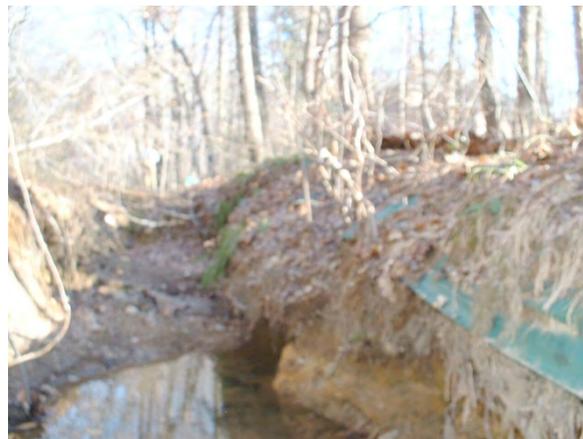
*Photo 3.126 On a tributary northwest of the cul-de-sac of Westhurst Court in the Windsong community. (DFRB015.E002).*

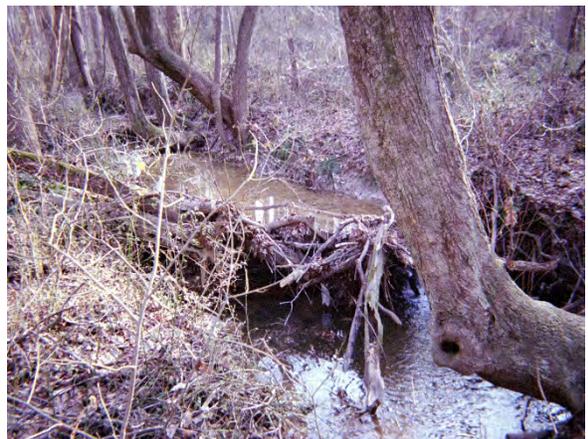
*Photo 3.127 Obstruction on a tributary to Rocky Branch, directly east of Oakton Ridge Court in the Oakton Mill Estates (DFRB010.T001).*

There were eight stream blockages made up mostly of trees and debris. Twenty-five percent of the obstructions appeared to be restricting fish passage. Sixty-three percent of the obstructions were causing moderate erosion to the stream. One obstruction was causing greater than moderate erosion. This one is shown above in Photo 3.127 (candidate site S128)

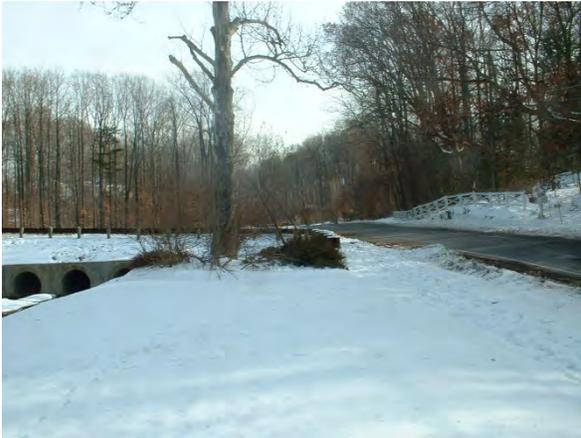
*Photo 3.128 Buffer impairment south of Miller Road in the Flint Hill Lower and Middle Campus (DFRB004.B001)*

S127 The Stream Physical Assessment identified poor habitat, 2700 feet of buffer impact and over 1,000 linear feet of erosion along Miller Road (Photo 3.128).

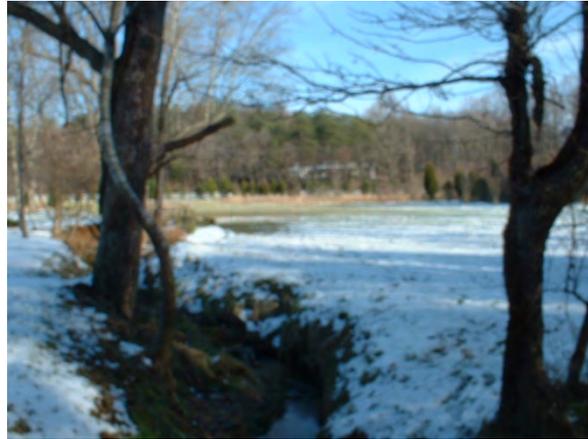
*Photo 3.131 West side of Hunter Mill Road, south of intersection with Conejo Lane (DFRB012.B001)*

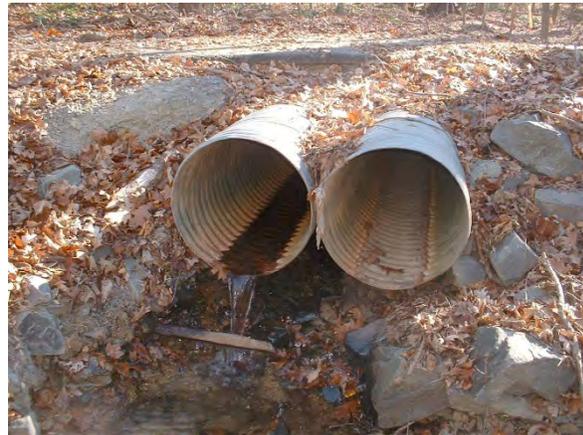
crossings are pipe culverts that have adequate structural condition but could be improved to enhance stream integrity and avoid future problems. These are located between Blenheim Drive and Lochinver Lane and between Lochinver Lane and Lakenheath Way. Erosion at the downstream end of the culvert between Lochinver Lane and Lakenheath Way can be seen in Photo 3.133.

*Photo 3.133 Pipe culvert between Lochinver Lane and Lakenheath Way.*

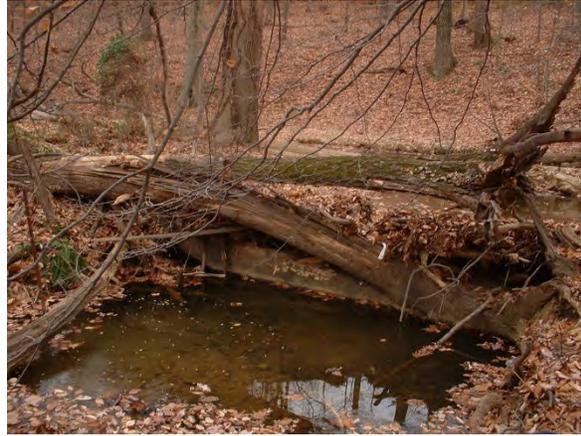
There are 37 obstructions, such as fallen trees or debris, located within the Upper Difficult Run subwatershed. All of the obstructions are thought to be restricting fish passage. Twenty-three of these obstructions were assigned an impact score of extreme, indicating that the obstruction is causing significant erosion problems or potential for **flooding** that could damage infrastructure. At these points the stream is at least 75 percent blocked, usually by trees, debris and sediment. Examples of two sites that have an extreme impact on stream integrity are shown in Photos 3.138 and 3.139 below.

*Photo 3.138 Stream blockage located between Oakton Road and Waples Mill Road (DFDF042.T001).*

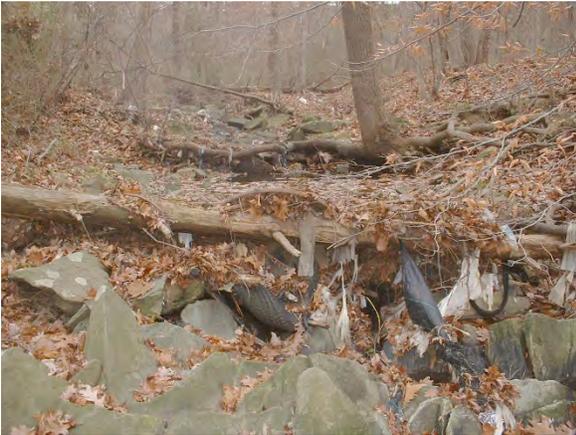
*Photo 3.139 Stream blockage located upstream of the area shown in Photo 3.139 (DFDF043.T002).*

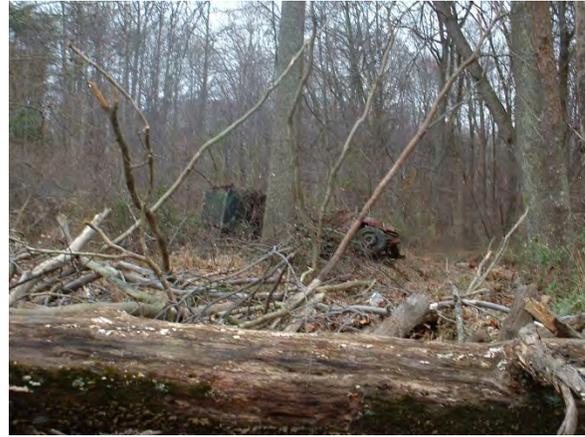
*Photo 3.141 Dumpsite located between Oakton Road and Waples Mill Road. DFDF042.M001*

- There is one dumpsite, a place where trash is deposited illegally, located between Oakton Road and Waples Mill Road. The site is located along the streambank within the floodplain and was assigned an impact score of seven, indicating that the site is greater than 2,500 square feet in size and may be active (Photo 3.141). This is candidate site S132.

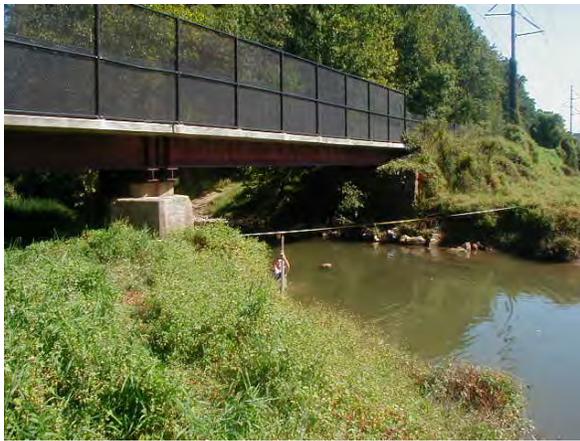
*Photo 3.142 Difficult Run Mainstem at W&OD Trail*

Culvert #21 (Photo 3.142) overtopped for the 50 and 100-year events. As this is not a roadway traveled by cars and does not overtop more frequently, it is not considered a

candidate site.

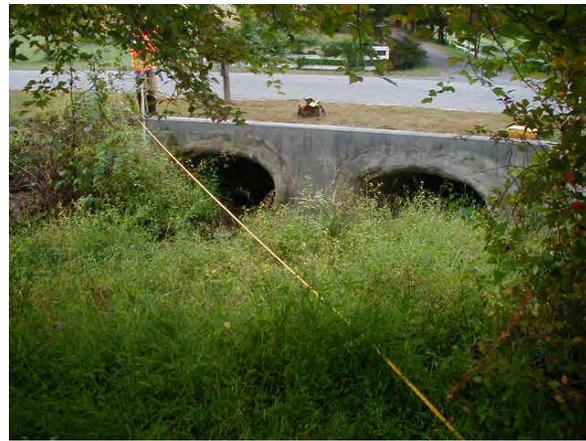
*Photo 3.143 Difficult Run Tributary at Valley Road*

Culvert #23 (Photo 3.143) overtopped for the 25, 50, and 100-year events. Valley Road is a local street, used by residents to access houses. Local roads are required to pass only the 10-year event, so this culvert is also not a candidate site.

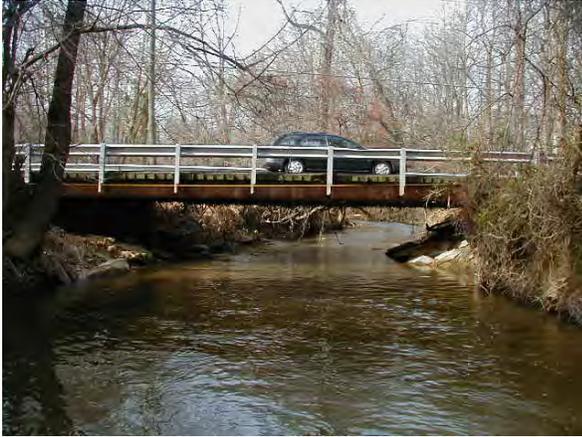
*Photo 3.144 Difficult Run Mainstem at Hunter Mill Road*

Culvert #27 (Photo 3.144) overtopped for all events. Hunter Mill Road is a primary road, used for through traffic flow. Crossings classified as primary roads are required to pass the 25-year event.

- F27 The culvert carrying the mainstem under Hunter Mill Road overtopped for all events. Since Hunter Mill Road is a primary road, the culvert must pass the 25-year event (Photo 3.144).
- F31 The culvert under Pine Tree Drive overtopped for all events. Since this is a local road, the culvert required to pass the 10-year event (Photo 3.145).
- F32 This culvert overtopped for all events except the one and two-year. As Waples Mill Road can be considered a primary road, it must pass the 25-year event (Photo 3.146).
- F33 This culvert was overtopped for the 25, 50, and 100-year events. Again, Waples Mill Road is considered a primary road, used for through traffic flow. It must pass the 25-year event (Photo 3.147).

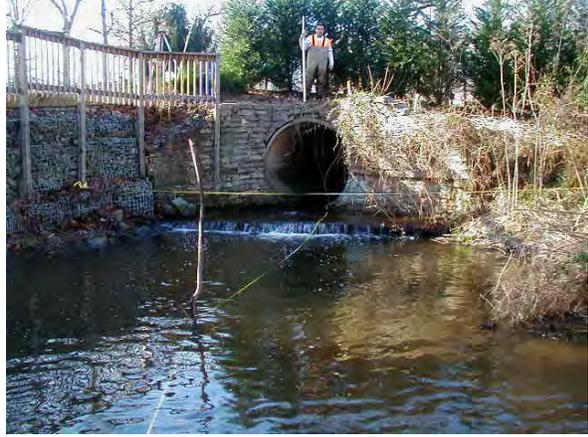
*Photo 3.145 Difficult Run Tributary at Pine Tree Drive*

Culvert #31 (Photo 3.145) overtopped for all events. Pine Tree Drive is a local road, so it is required to pass the 10-year event.

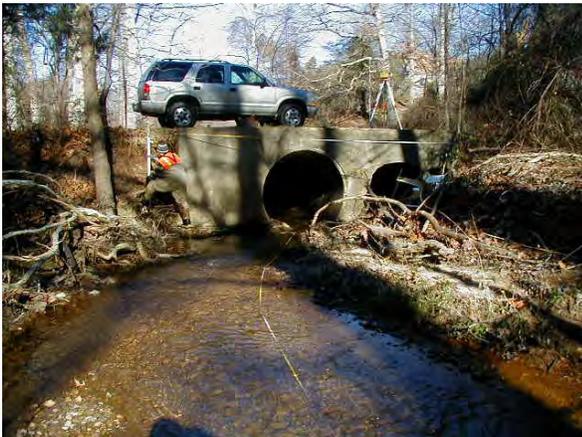
*Photo 3.148 Difficult Run Mainstem at Valley Road*

Culvert #34 (Photo 3.148) overtopped for all events except the one-year. Valley Road is a

local road, not used for through traffic. Local roads are required to pass the 10-year event.

F34 The culvert under Valley Road overtopped for all events except the one-year. Valley Road is a local road, so the culvert must pass the 10-year event (Photo 3.148).

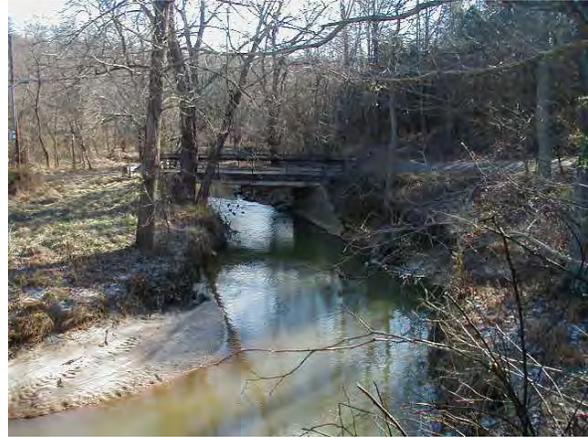
*Photo 3.149 Difficult Run Mainstem at Vale Road*

Culvert #38-A (Photo 3.149) overtopped for all events except the one and two-year. As this is a footbridge and is not a roadway traveled by cars, it is not considered a candidate site.

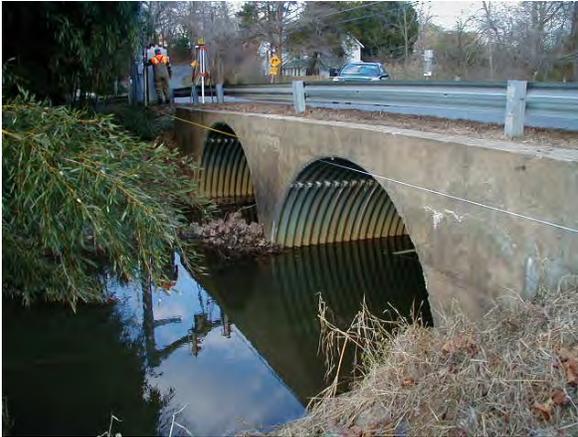
*Photo 3.146 Difficult Run Mainstem at Waples Mill Road DS*

Culvert #32 (Photo 3.146) overtopped for all events except the one and two-year. As Waples Mill Road can be considered a primary road, it must pass the 25-year event. Culvert

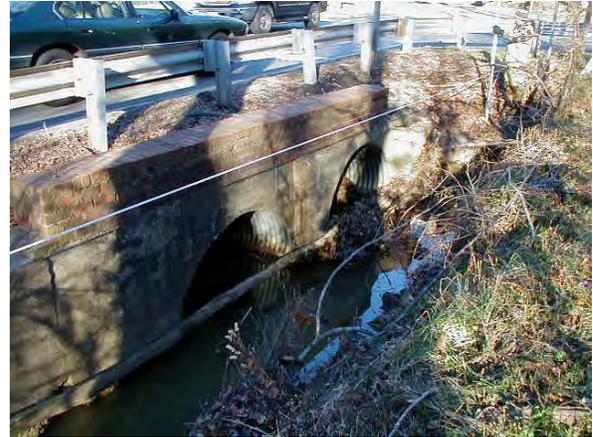
*Photo 3.147 Difficult Run Tributary at Waples Mill Road US*

#33 (Photo 3.147) overtopped for the 25, 50, and 100-year events. Again, Waples Mill Road is considered a primary road, used for through traffic flow. It must pass the 25-year event.

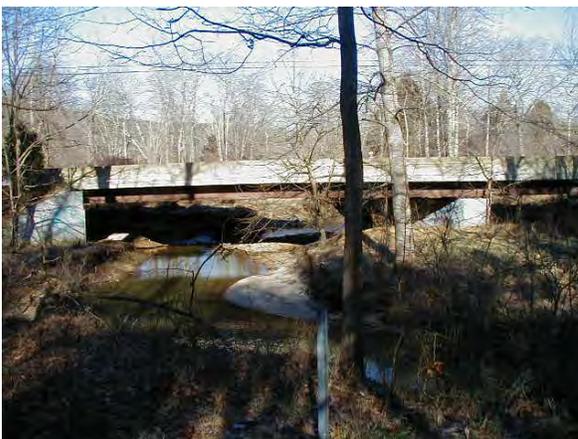
*Photo 3.150 Difficult Run Mainstem at Vale Road*

Culvert #38-B (Photo 3.150) overtopped for the 100-year event. Vale Road is a primary road and is thus required to pass the 25-year event. This site is not considered a candidate site.

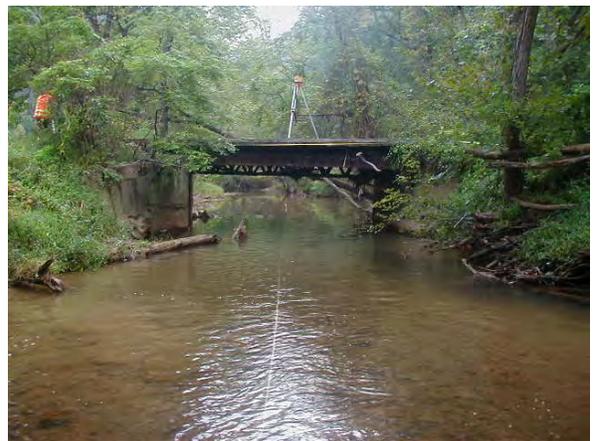
*Photo 3.151 Difficult Run Mainstem at Hunters Valley Road*

Culvert #22 (Photo 3.151) overtopped for all events except the one-year. Hunters Valley Road is a local access road used by resident to get to abutting properties and is not used for through traffic. This is not a candidate site.
