## Chapter 3: Subwatershed Condition

### 3.1 North Little Hunting Creek Subwatershed

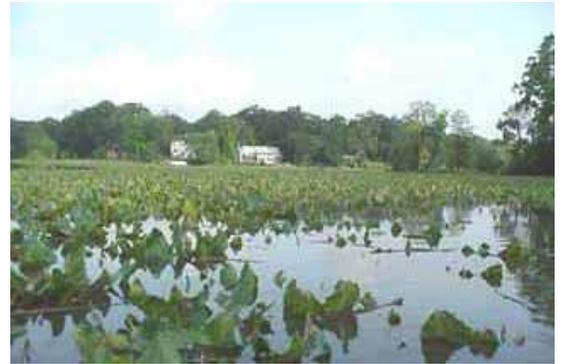
The South Little Hunting Creek Subwatershed contains the southern portion of Little Hunting Creek, seen in Photo 3.9, and South Branch, a tributary of Little Hunting Creek located on the east side of the creek. Other smaller streams are located on the west side of the subwatershed and discharge directly into Little Hunting Creek as shown on Map 3.5. The South Little Hunting Creek Subwatershed’s condition is summarized as follows.

Photo 3.9 Tidal portion of Little Hunting Creek

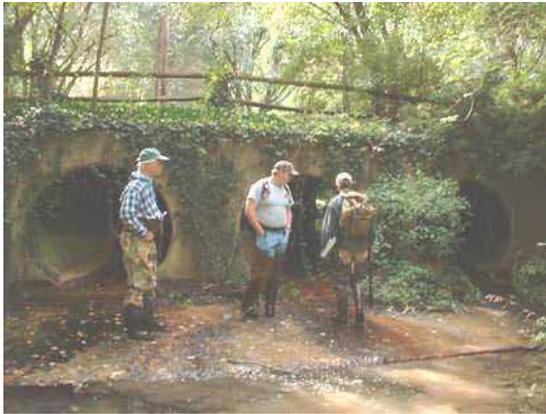
- Davenport Street: Three 60-inch (diameter) corrugated metal pipe culverts with minor stream bed erosion of two-foot height were observed downstream of the pipe as shown in Photo 3.30.

Photo 3.30 Triple 60" corrugated metal pipe culverts located under Davenport Street

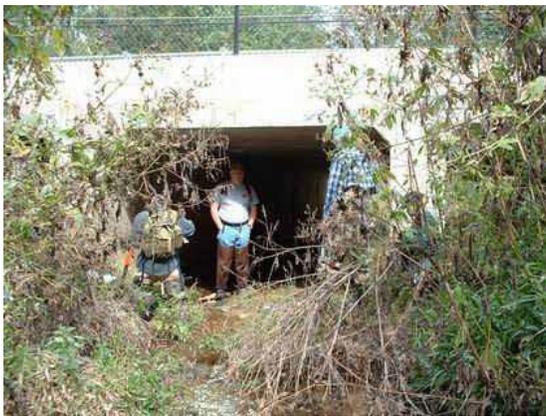
- Sherwood Hall Lane: Two 72-inch (diameter) corrugated metal pipe culverts have no impact on the stream as shown in Photo 3.31.
- Collingwood Road: Five 12-foot by eight-foot box culverts, shown in Photo 3.32, cause minor stream bed erosion upstream of the crossing.
- Collingwood Road: Four 10-foot by 15-foot concrete box culverts, shown in Photo 3.33, with sedimentation upstream of the crossing, are causing a moderate impact on the stream.
- Stacey Road: Four elliptical, five-foot by three-foot corrugated metal pipe culverts are causing minor downstream bed erosion.

Photo 3.32 Five 12' x 8' concrete box culverts located under Collingwood Road to convey North Branch main stem flows

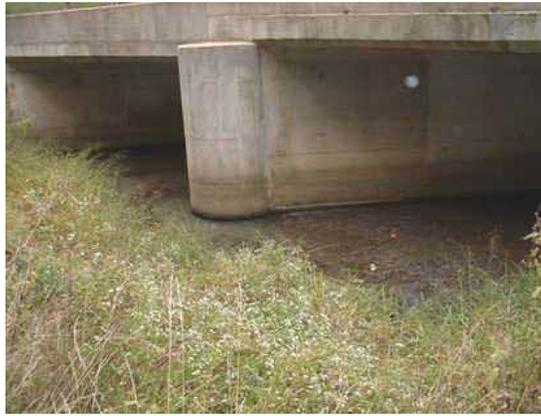
Photo 3.33 Four 10' x 15' concrete box culverts located under Collingwood Road to convey flows of the eastern tributary

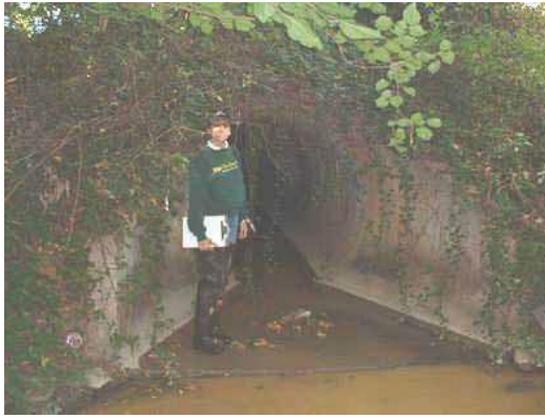
Fifteen concrete pipe outfalls discharge to North Branch and its tributaries. They range in size from 12 to 72 inches in diameter. Photo 3.34 shows a 60-inch concrete pipe outfall located at the headwaters of the tributary LHN001 to North Branch. Discharges from the majority of pipe outfalls are causing only minor erosion and their locations are shown on Map 3.14. Downstream of the confluence with Paul Spring Branch, a small ditch with an 18-inch width discharges into the stream and causes moderate erosion (shown in Photo 3.35).

Photo 3.34 A 60" diameter concrete pipe outfall at the headwaters of the tributary to North Branch

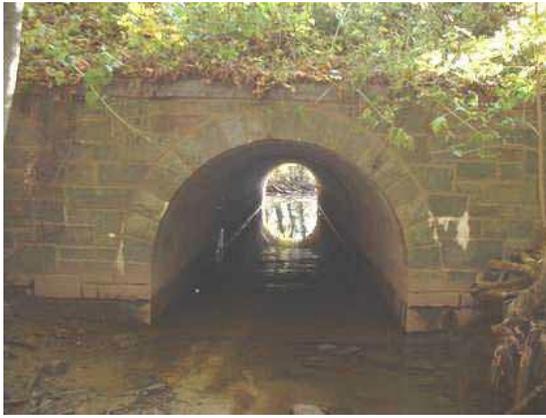
The developed areas such as the Waynewood subdivision have storm drain systems that discharge directly into the Potomac River. The major road crossings include a seven-foot by six-foot concrete arch culvert under the George Washington Memorial Parkway (shown in Photo 3.41). This crossing is free of sediment, trash, and obstructions and causes no impact

Photo 3.41 Concrete arch culvert of size 7' by 6' located under George Washington Memorial Parkway

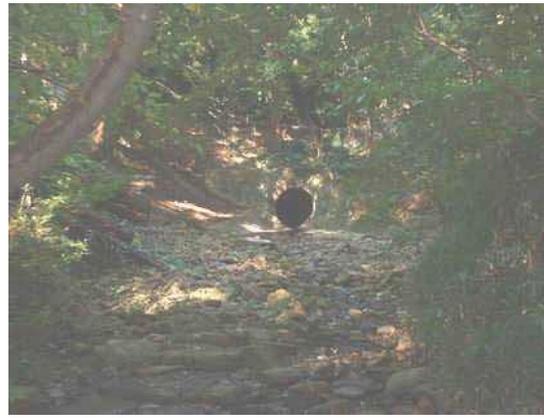
Photo 3.42 Concrete pipe outfall located west of Eaglebrook Court

on the stream. A 66-inch (diameter) concrete pipe discharges into one of the streams in the East Potomac portion of the subwatershed without causing any erosion (shown in Photo 3.42). There are no private or public stormwater management facilities in this subwatershed.
