Massey Building Condition Assessment

Facilities Management Department

March 26, 2010

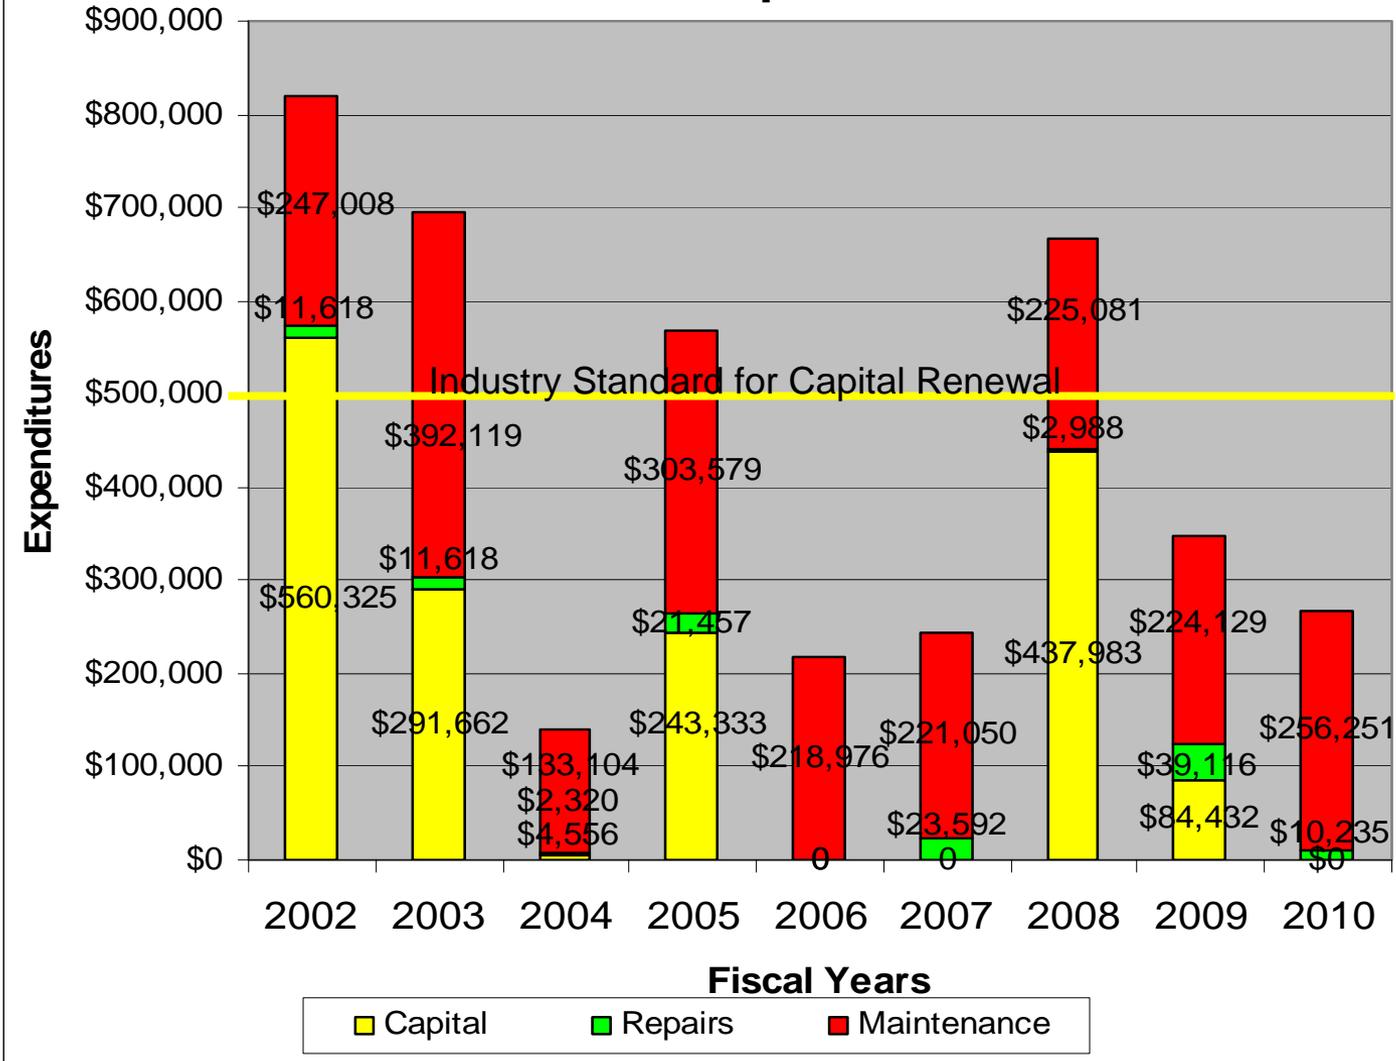
Massey Building - Capital, Repairs, and Maintenance Expenditures

*Industry standard for capital renewal reinvestment is currently 2% of replacement value. Based on average replacement value of \$150 per square foot, capital renewal requirements of \$3.00 per square foot would be required to meet industry standards.
