# 6630 Holland Street McLean, Virginia

RESOURCE PROTECTION AREA (RPA) ENCROACHMENT EXCEPTION #129-WRPA-005-1 &  
WATER QUALITY IMPACT ASSESSMENT #129-WQ-001-3

SECTION 118-6-9, GENERAL RESOURCE PROTECTION AREA ENCROACHMENT REQUEST

APPLICANT REPRESENTED BY TNT ENVIRONMENTAL, INC.

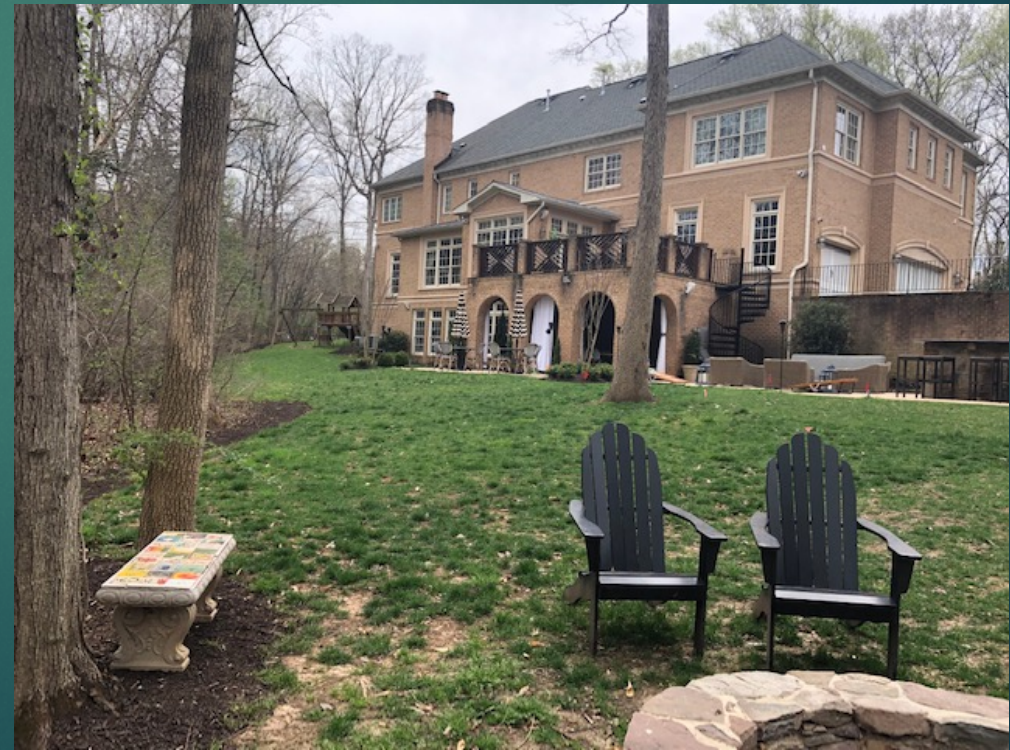
- ▶ Notice of Violation (# 201803030) issued on 3/6/2019 for 1,042 SF of RPA disturbance associated with an unpermitted patio and masonry grill.
- ▶ This application proposes to remove approximately 331 SF of patio and install 2 planter boxes to increase water quality leaving the site.
  - ▶ Approximately 750 SF of the patio are proposed to remain.
- ▶ The fire pit will also be removed.

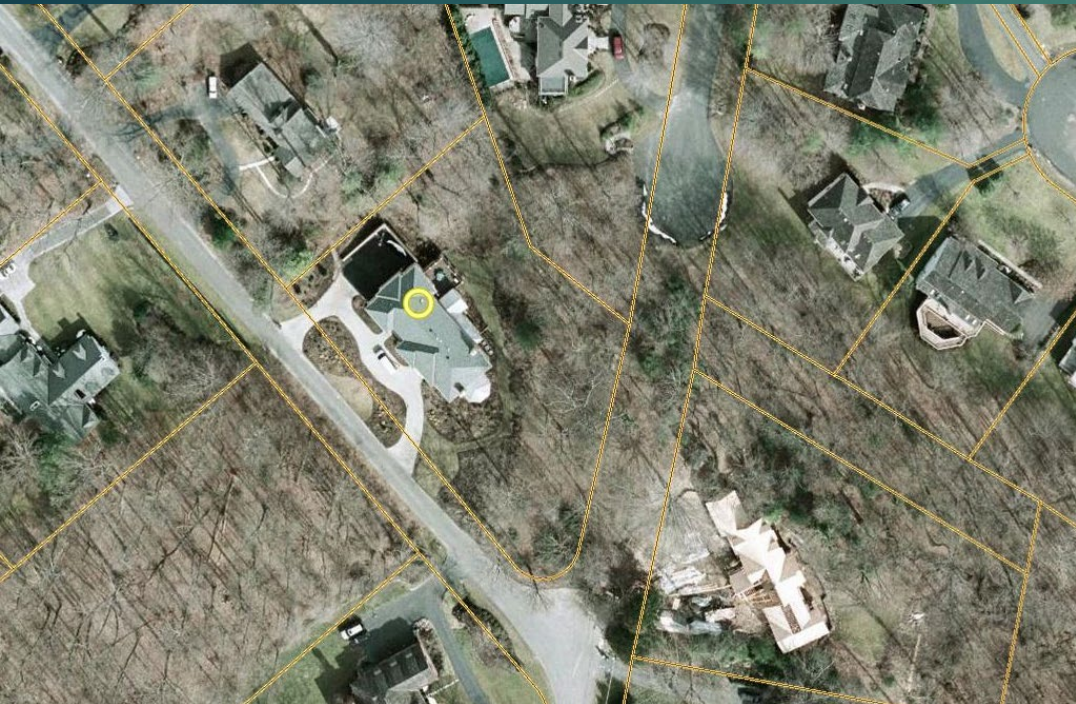
2007 Aerial Per Fairfax County JADE

- ▶ Per historic aerial imagery, vegetation removal (~3,444 SF) in the RPA occurred on the property between 2007 and 2009. This vegetation removal was completed by the previous owner(s) of the property, Stuart and Regina Solomon who purchased the property in 2006.

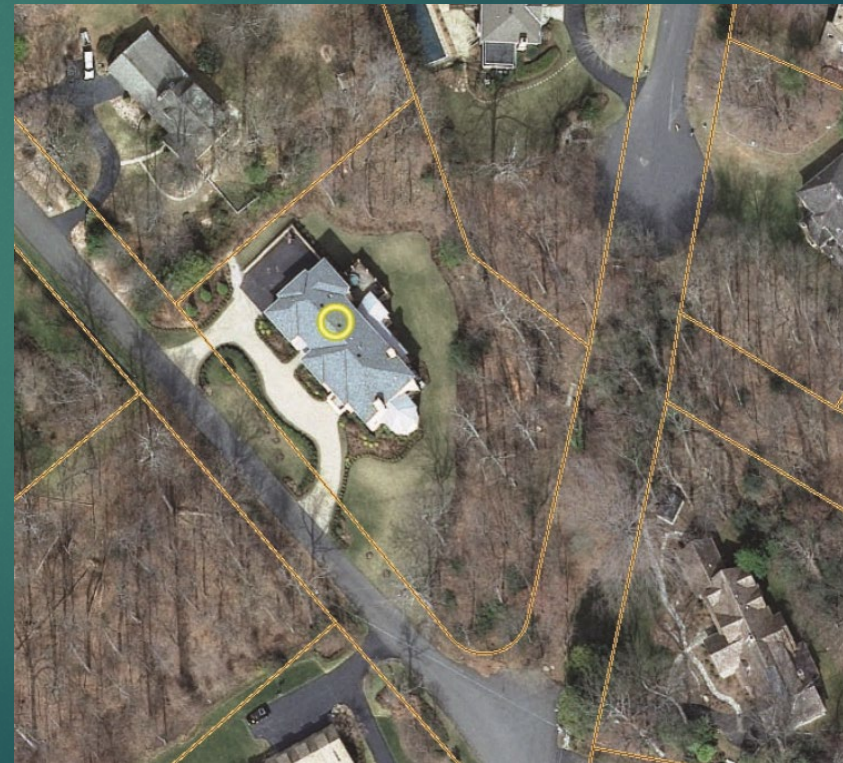
2009 Aerial Per Fairfax County JADE

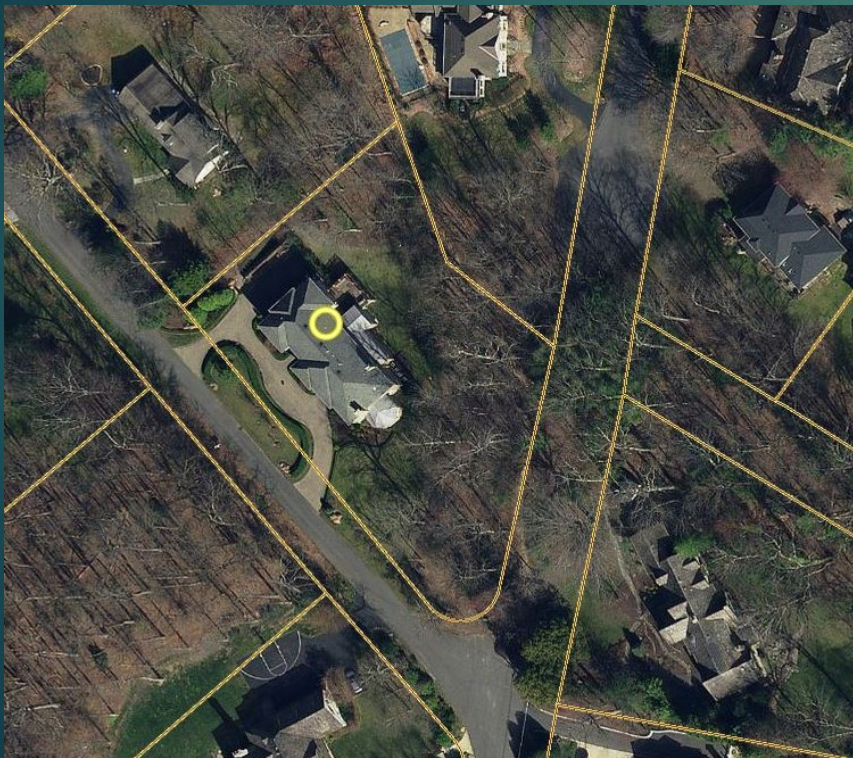
2017 Aerial Per Fairfax County JADE

- ▶ Mr. and Mrs. Bergoglio (the applicants) purchased the property in January 2016.
- ▶ Additional vegetation (2,684 SF) removal and the construction of the existing patio and grill in the RPA occurred between 2017 and 2019 associated with the Notice of Violation received by the applicants

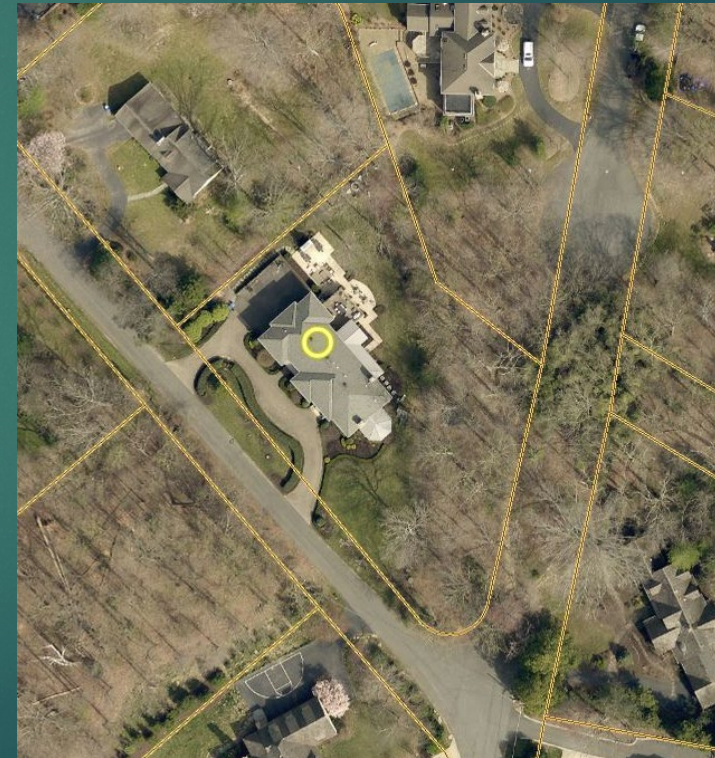
2019 Aerial Per Fairfax County JADE

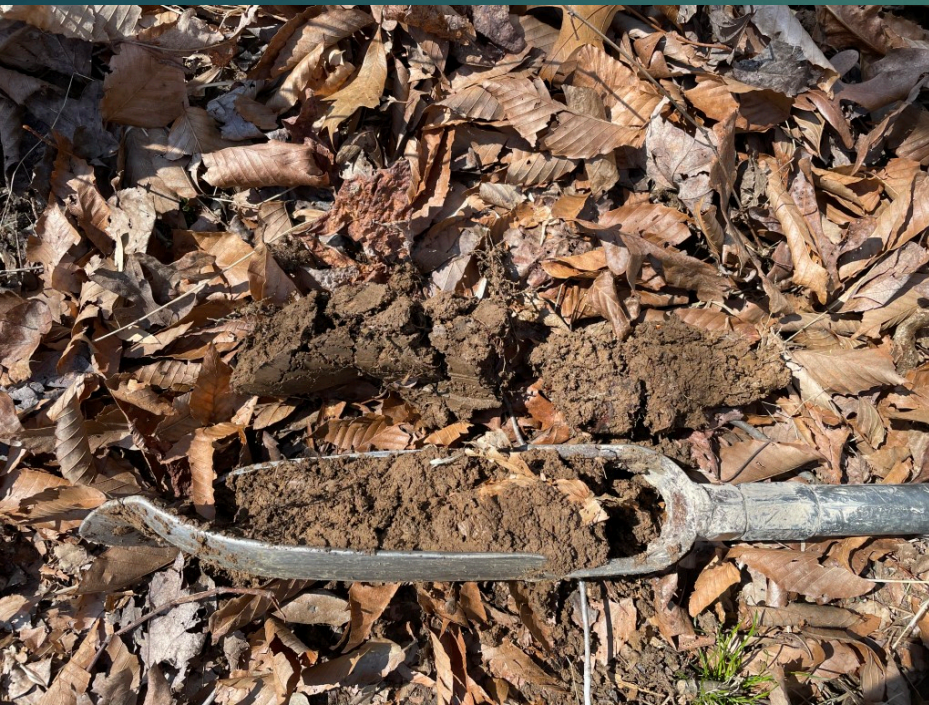
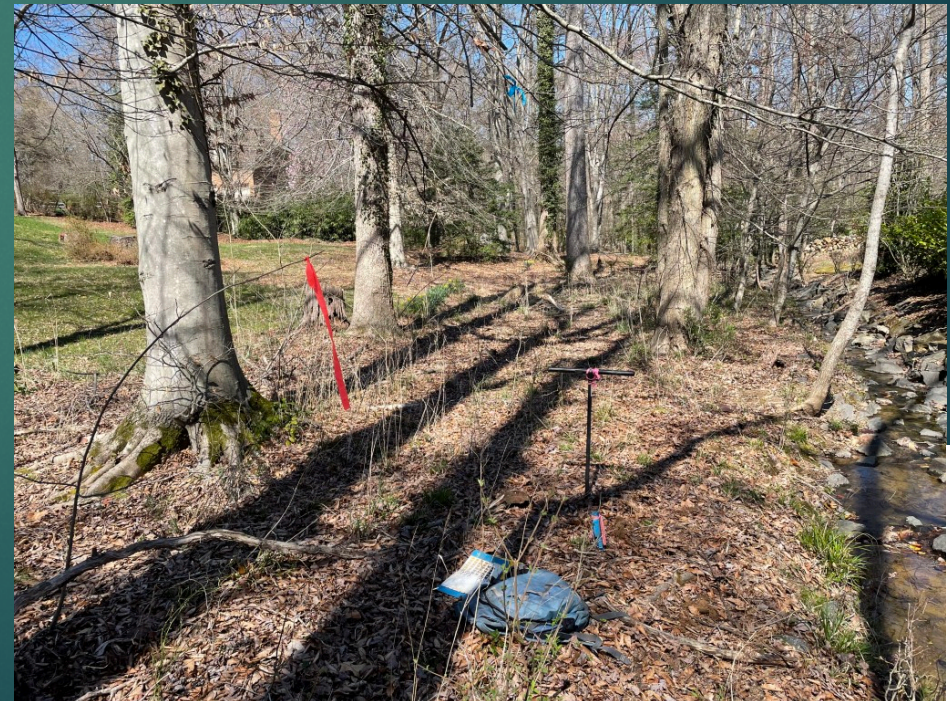
- ▶ The potential wetland noted on the adjacent property is not a wetland. There is no dominance of hydrophytic vegetation. American beech (Facultative Upland Plants (FACU)), white oak (FACU) and Japanese honeysuckle (FACU) are shown to dominate this area. No hydric soils were observed (10YR 4/4 from 0-14”).
- ▶ The applicant has no issue providing the requisite data demonstrating the lack of wetlands in this location.

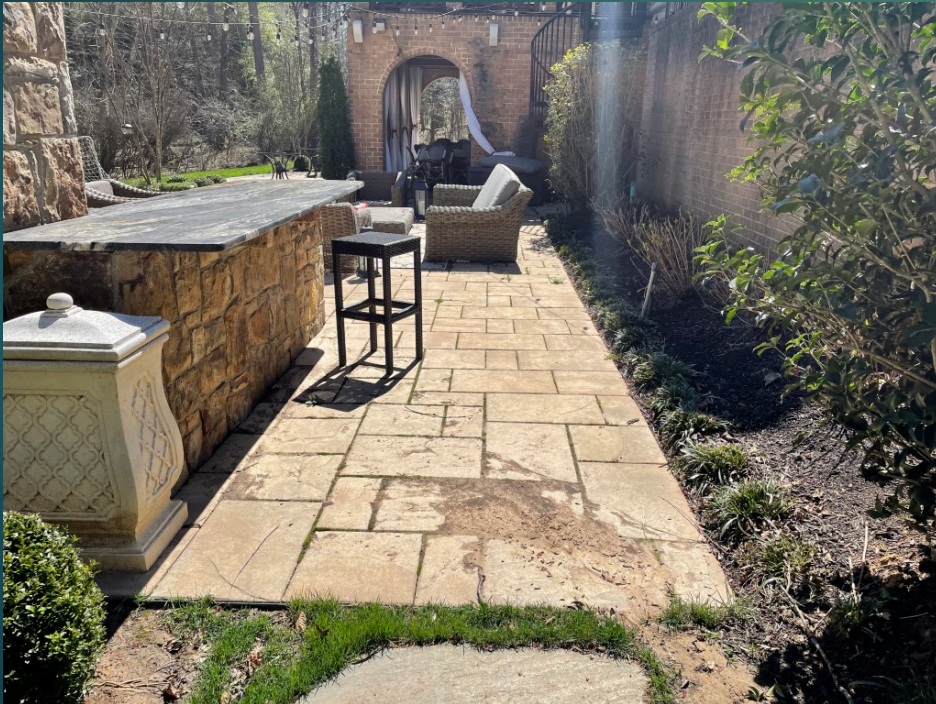
View of portion of patio to be removed

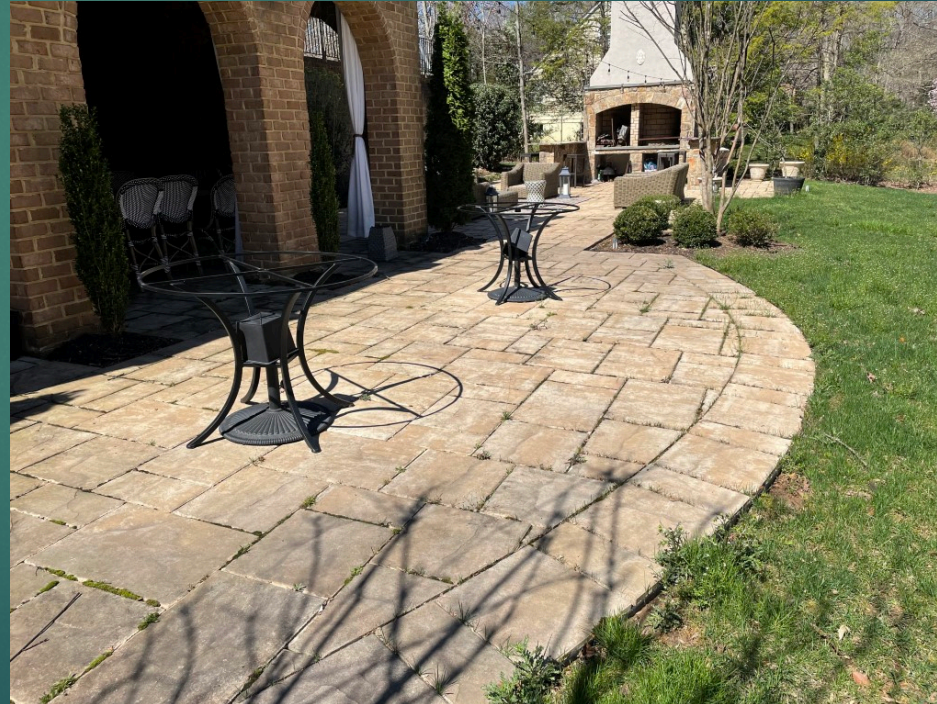
View of portion of patio to be removed
