Turner Farmhouse Preliminary Historic Structure Report

Prepared for:
Fairfax County Park Authority

Prepared by:
Shaffer, Wilson, Sarver & Gray, PC

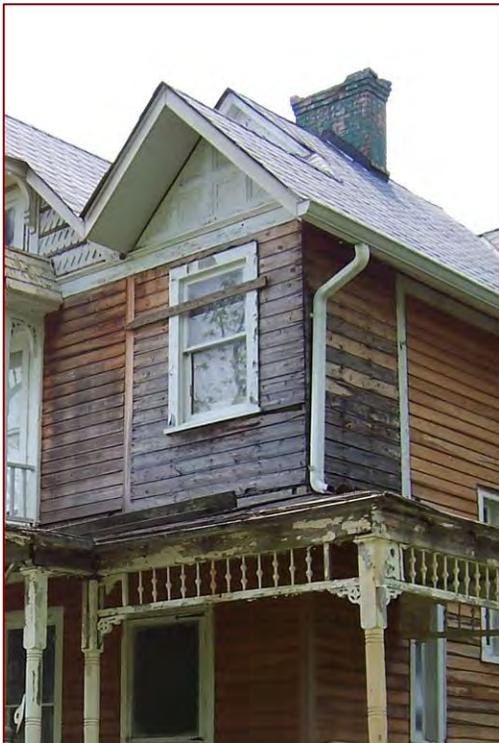
- Integral recessed second-story porch. Originally the house had a recessed second-story covered porch. It was later enclosed.

Image 2.12: Section of House Originally a Recessed Covered Porch

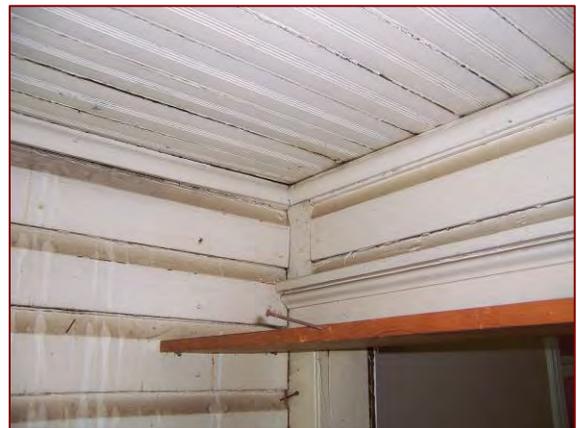
Image 2.13: Original Exterior Siding and Wood Porch Roof Within Enclosed Porch

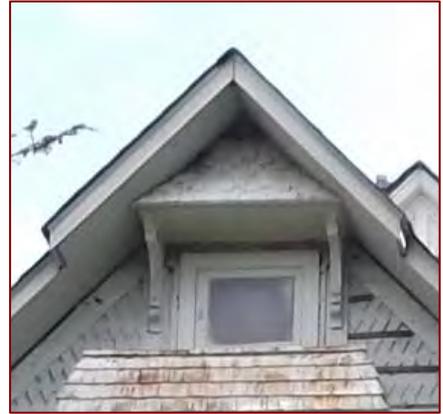
- Triangular-shaped window hood in top of gable extends forward and is bracketed. The square-butt shingles are irregularly staggered on the hood.

Image 2.19: Projecting Bracketed Hood

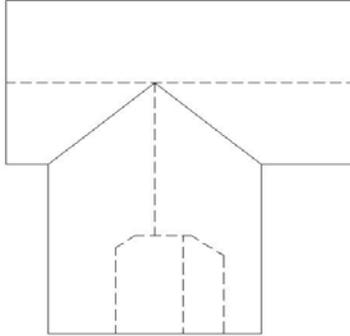
Image 2.24: Original Roof Plan

The original layout of the house is depicted by the following roof plan.

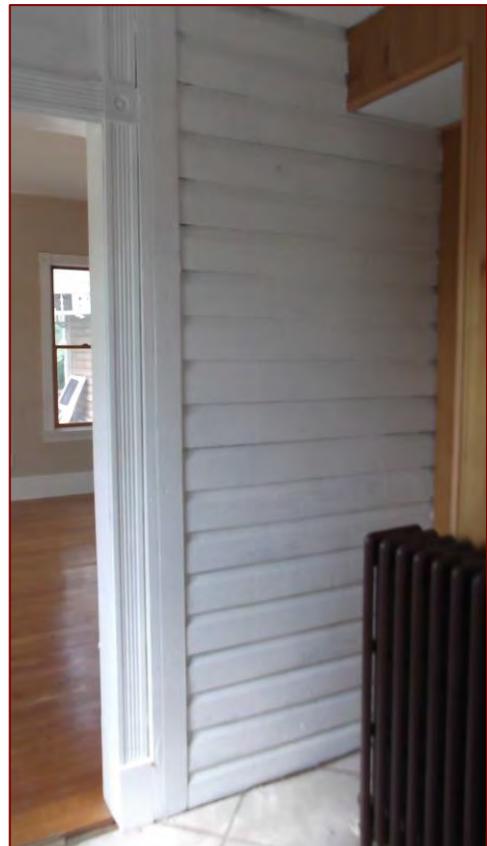
Image 2.25: Original Exterior Wall as Seen From the Kitchen

The original exterior siding for the rear of the house is visible in the kitchen. The original house ended where the siding terminates at the doorway in the following photo.

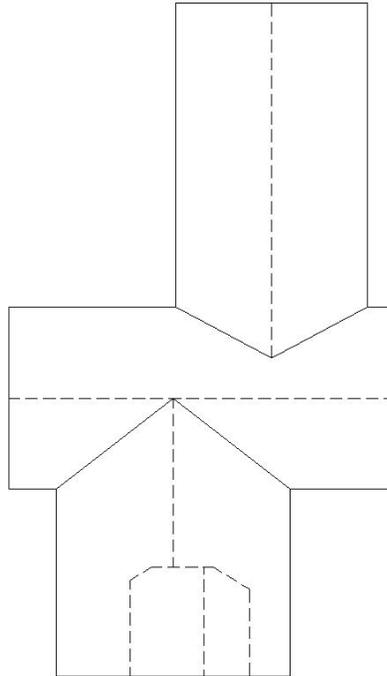
Image 2.26: Ca. 1930 Roof Plan

Around 1930, a 1-story addition was constructed onto the rear of the house. This addition was much narrower than the rear addition on the house today. The space contained the existing bathroom (Room 105) and perhaps a small kitchen. A septic field was located east of the house.

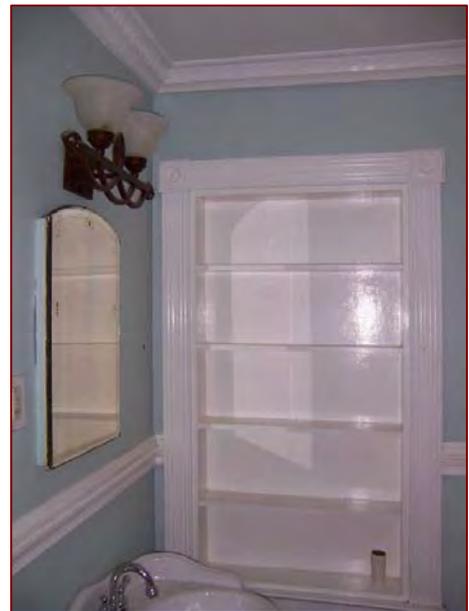
The bathroom had an exterior window, which is no longer functional due to a later rear addition expansion to the west.

Image 2.27: Bathroom 105

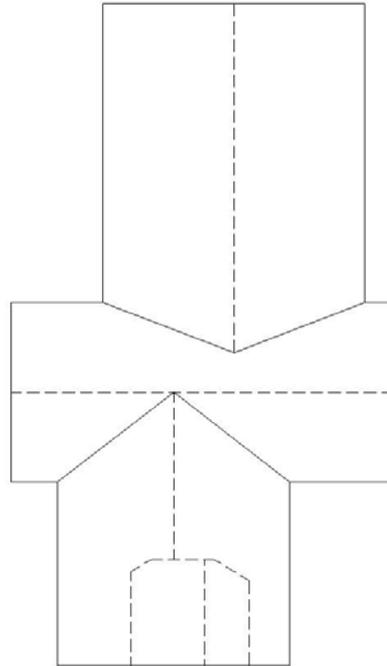
Image 2.28: Ca. 1937 Roof Plan

The rear addition was enlarged by moving the eastern wall further east as depicted in the following roof plan. The addition was also likely now 1 ½ stories. Rear stairs were added to allow access to a new second floor toilet room. A bedroom was also likely added on the second floor.

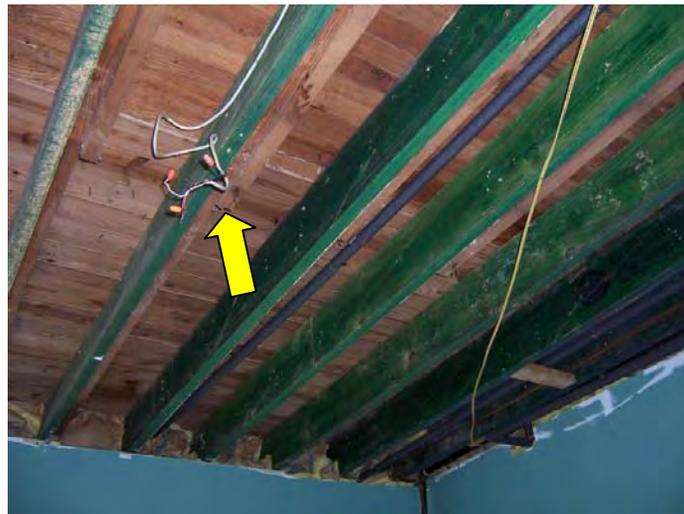
Evidence of the expansion can be observed in the cellar ceiling joists. As can be seen in the following photo, the original ceiling rafters did not extend all the way to the existing eastern wall. New joists were sistered to the old joists in order to widen the structure.

Image 2.29: Yellow Arrow Points to End of One of the Original Joists

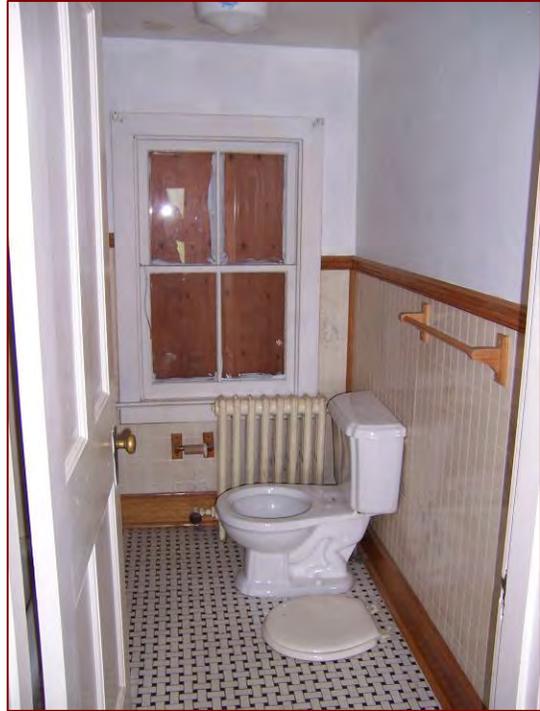
Similar to the first floor bathroom, the second floor toilet room had an exterior window, which is no longer functional due to a later rear addition expansion to the west.

Image 2.30: Second Floor Toilet (Room 206)

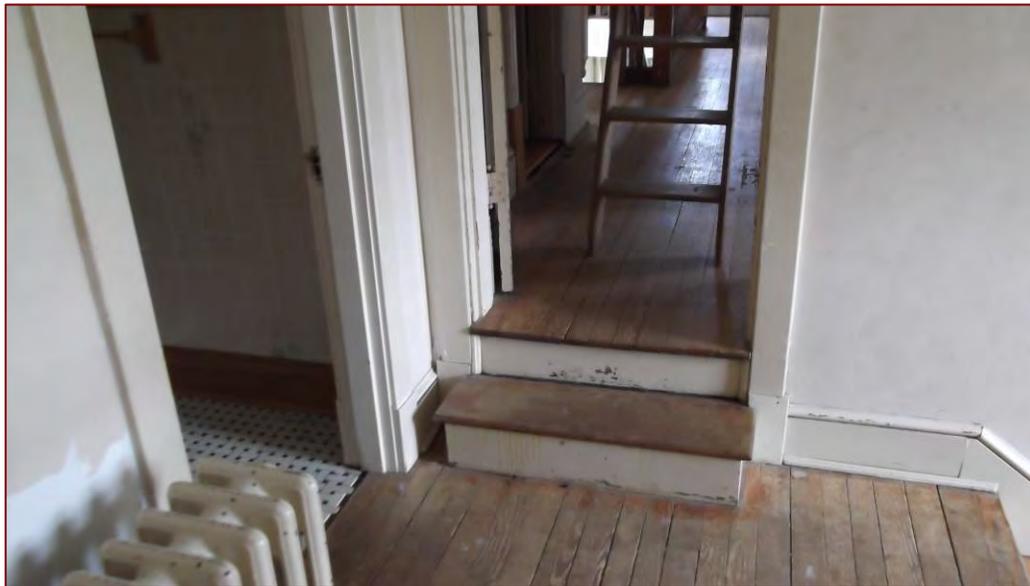
The roof line was not raised; therefore, the second floor of the addition was lower than the second floor of the original house in order to have enough head clearance on the second floor of the addition. As a result, stairs were installed between the addition and the original second floor hall.

Image 2.31: Stairs from Second-Floor of the Addition to the Second Floor of the Original House

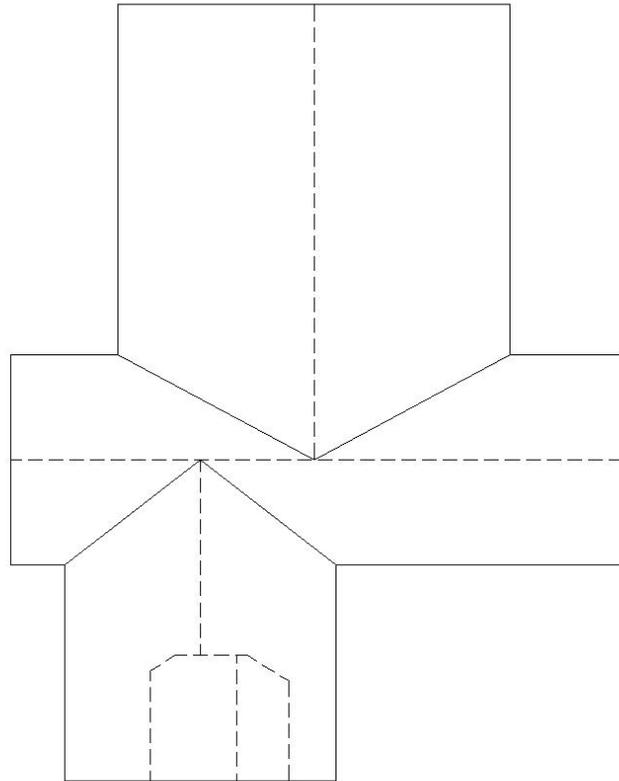
Image 2.32: Ca. 2002 Roof Plan

Possibly around 2002, the rear addition was expanded to the west and the parlor (Room 106) was lengthened. The roof line of the addition was also raised to meet the roof line of the original house. This provided additional ceiling height for the second floor of rear addition.

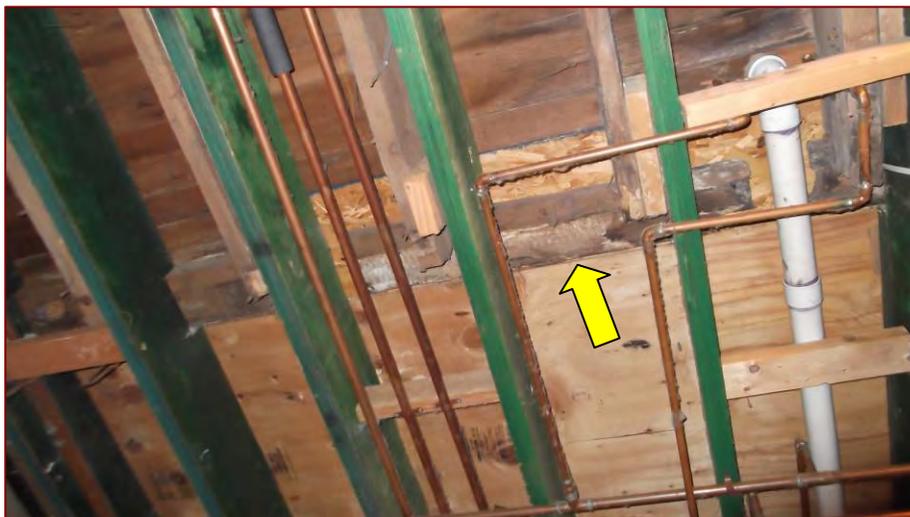
Evidence exists to show the expansion area of the rear addition. The original sill plate for the ca. 1930 addition is visible from the Utility Room (Room B04). New floor joists were added that extended the entire length of the addition. The subfloor of the expansion area is plywood.

Image 2.33: Utility Room Ceiling Joists. Yellow Arrow Points to Original Sill Plate of First Rear Addition, Plywood Shown in Photo is the Subfloor for the ca. 2002 Expansion

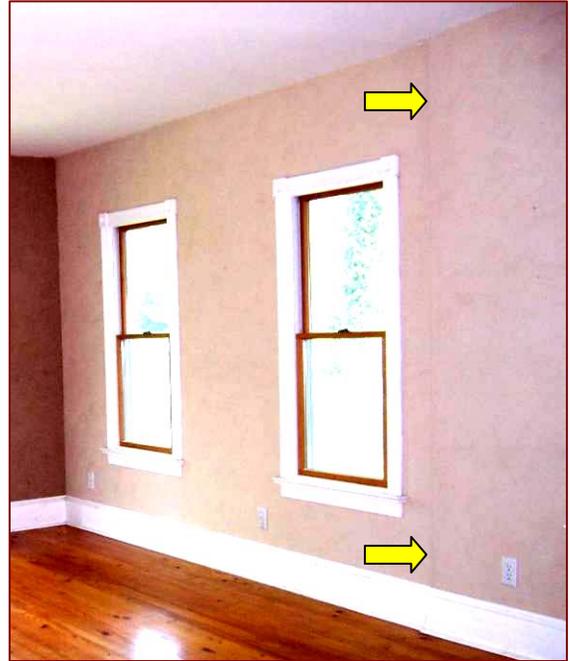
The first floor parlor was also likely expanded at this time. The location of a jog in the wall suggests the location of the original end of the house.

Image 2.34: Yellow Arrows Point to Original End of House in Parlor (Room 106)

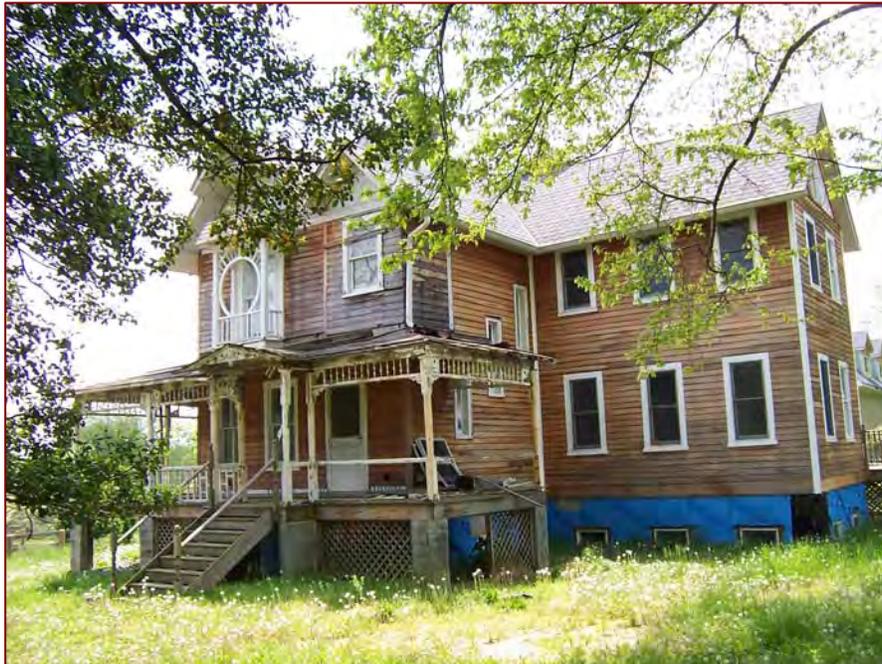
The house was likely raised at this time in order to provide additional ceiling height in the cellar. This allowed for the addition of windows to provide light into the cellar.

Image 2.35: House Raised Approximately Four Feet

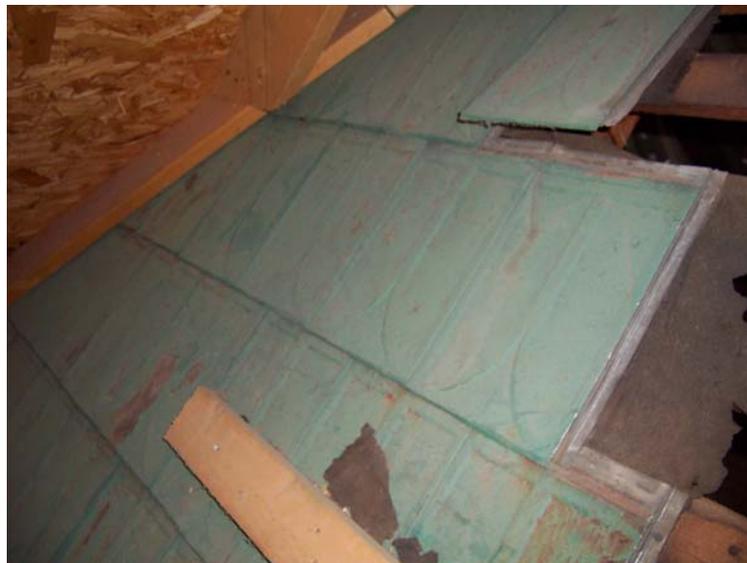
Cove-lap siding originally clad the exterior of the building. The roof, which is now covered with asphalt shingles, at one time had embossed metal shingles over felt construction paper attached to the original 1x3 skip boards. Some of the earlier shingles are visible in the attic. Existing nail holes and even remaining bent nails point to the fact that there must have been another roofing prior to the metal shingle roofing. The frequency of the nail holes suggest that the original roofing was wood shingle.

Image 3.1: Early Metal Shingles

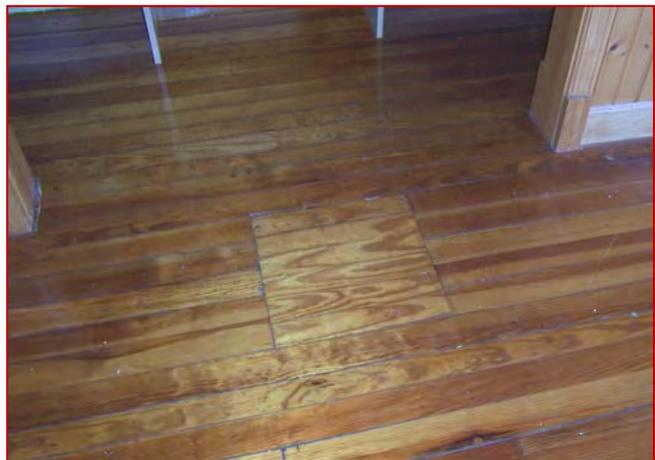
Fireplaces heated the living room (Room 101) and formal dining room (Room 102). Transfer grills in the first floor ceilings near these fireplaces provided heat to Bedroom 201 and Bedroom 202. The transfer grills are indicated by variances in the flooring where floor boards later infilled the grill. The transfer grill may have been infilled when steam radiator heat was installed in the house. No evidence was observed of how the parlor was originally heated.

Image 3.2: Location of Transfer Grill in Bedroom 202

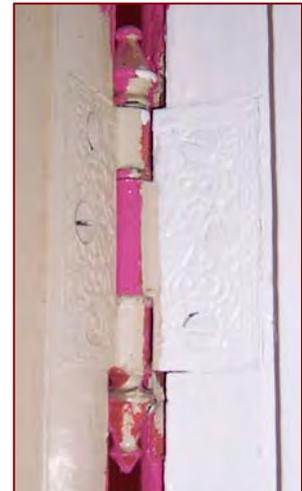
Door and window hardware is decorative. Examples include decorative steeple-tipped hinges.

Image 3.3: Decorative Steeple-Tipped Hinge

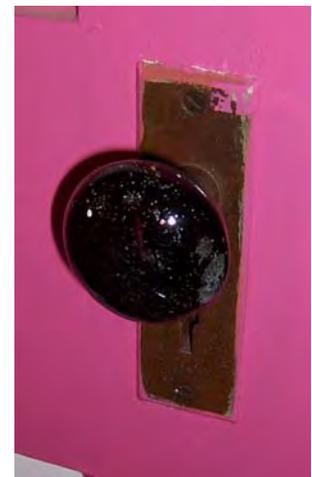
Several of the doors have original clay knobs.

Image 3.4: Clay Doorknob

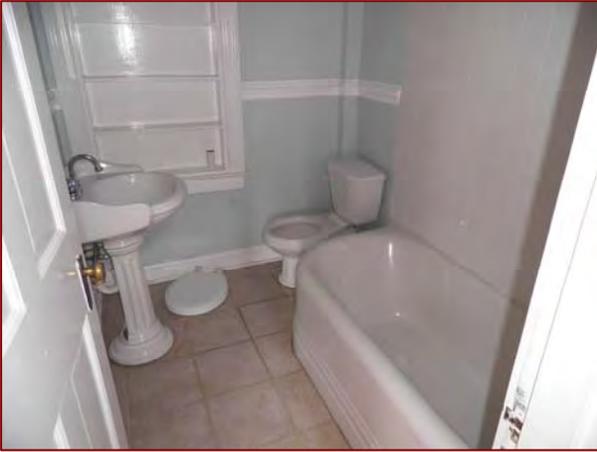
The bathtub and mirror in Bathroom 105 are original.

Image 3.5: Original Bathtub in Room 105

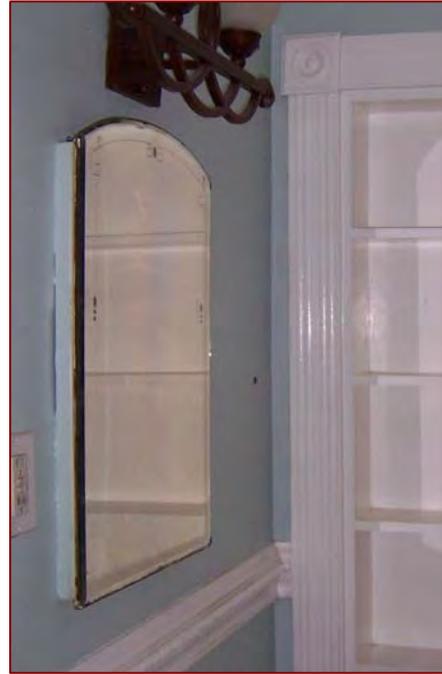
*Image 3.6: Original Mirrored
Medicine Cabinet in Room 105*

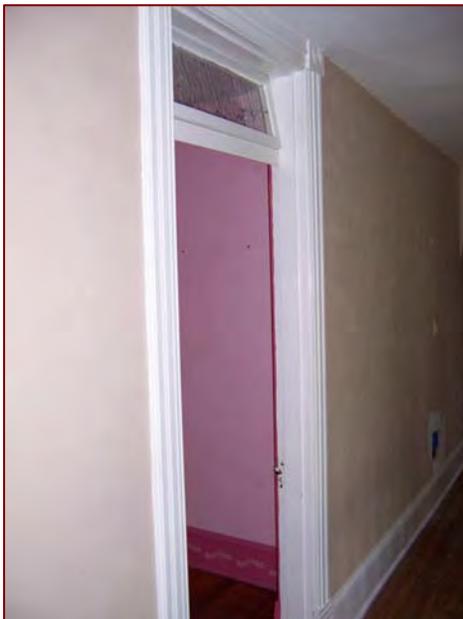
The transom windows above the bedroom doors are original. The door trim and corner blocks around the bedroom doors is also original.

*Image 3.7: Original Transom
Window at Door to Bedroom 201*

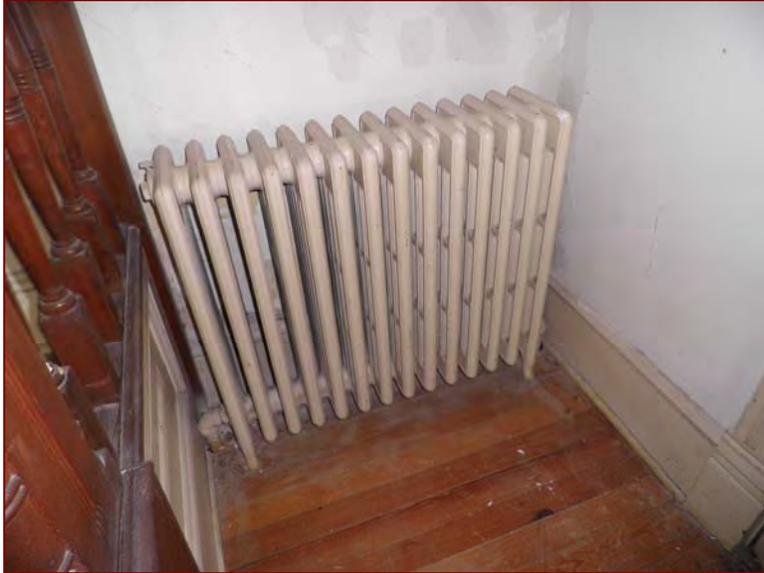
Early radiators exist in most of the rooms.

Image 3.8: Steam Radiator in Hall 200

Hydronic baseboard heaters are installed in the basement and radiators are installed throughout the 1st and 2nd floors. One of the radiators in the 2nd floor master bedroom is not connected and another radiator has been removed and is sitting in the hall near the bathroom. A mechanical thermostat is located on each floor. Several of the rooms on each floor have ceiling fans. All of the bathrooms except the second floor hall bathroom have exhaust fans. There is a wood stove located in the basement.

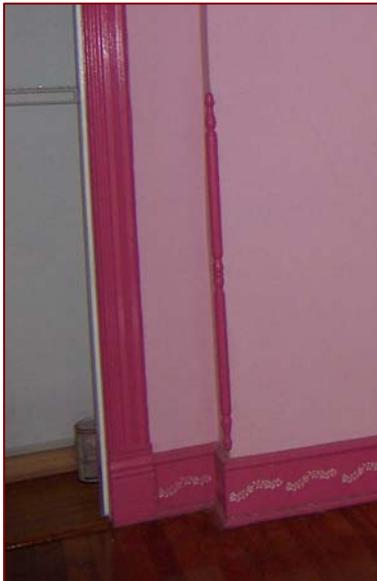
Spindle-shaped corner trim in the bedrooms is original.

Image 3.9: Corner Trim in Bedroom 201

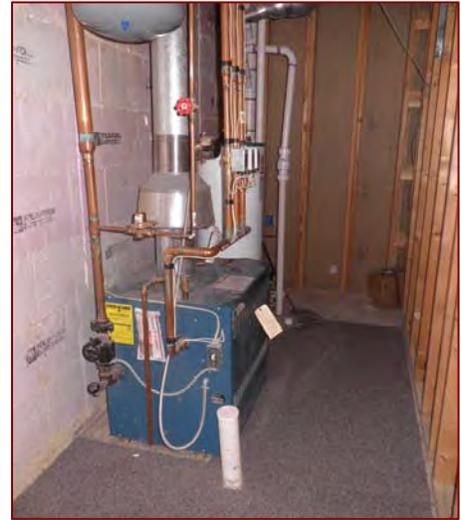
There is a mechanical room in the basement that houses a boiler, domestic water heater, sewage ejector pump, sump pump, and clothes washer and dryer outlets. The gas-fired boiler appears to be relatively new and has control valves three zones for heating (basement, 1st floor, and 2nd floor). Heating water piping consists of old steel piping and new copper piping. The majority of the piping has been insulated.

Image 3.10: Boiler

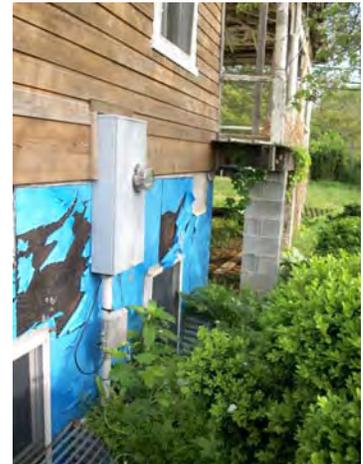
There is a relatively new underground electrical service supplying a utility meter mounted about midway on the east wall. The meter supplies two 200A disconnect switches mounted on the exterior basement wall. These switches supply two 200A, 120/240V single phase panelboards in the basement utility room at the south-west corner of the house. These panels supply the receptacles, lights and other electrical equipment throughout the house.

Image 3.11: Meter

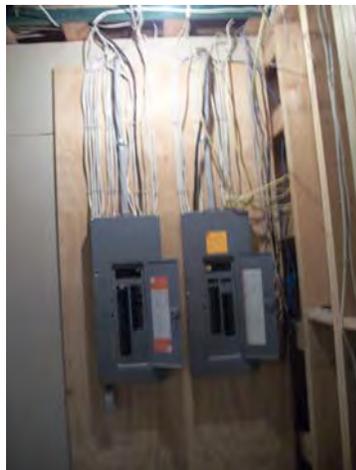
Image 3.12: Panelboards

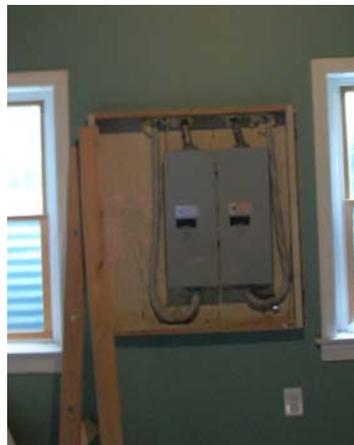
Image 3.13: Disconnects

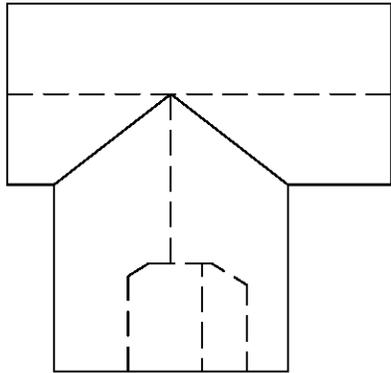
ROOF LAYOUT
CA. 1905
SCALE: NONE

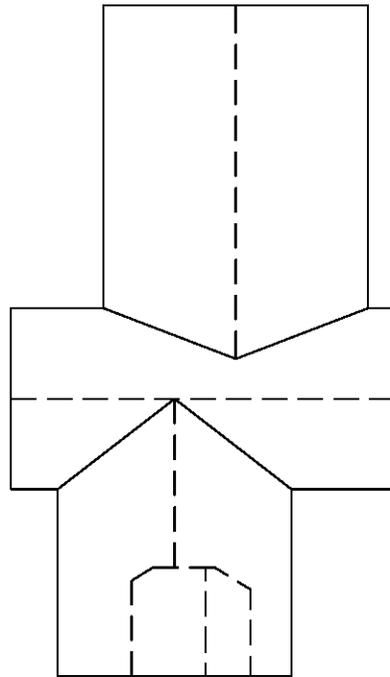
ROOF LAYOUT
BY 1937
SCALE: NONE

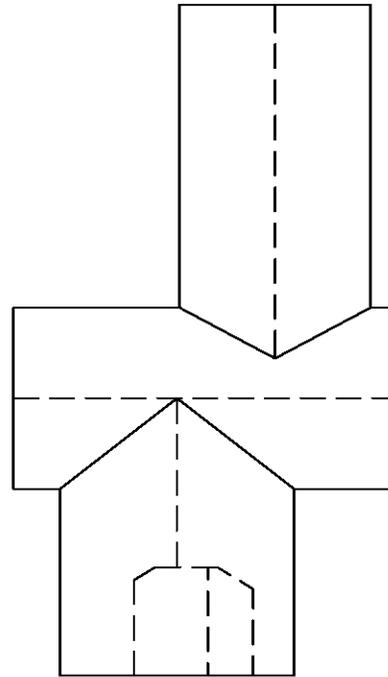
ROOF LAYOUT
CA. 1930
SCALE: NONE

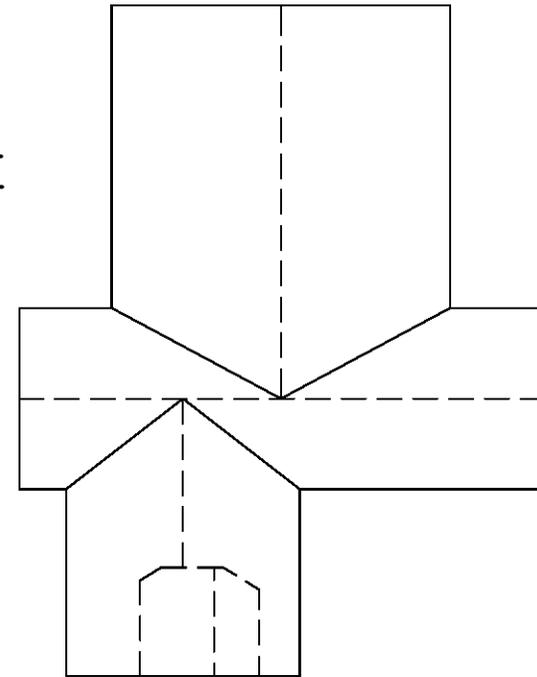
ROOF LAYOUT
CA. 2002
SCALE: NONE

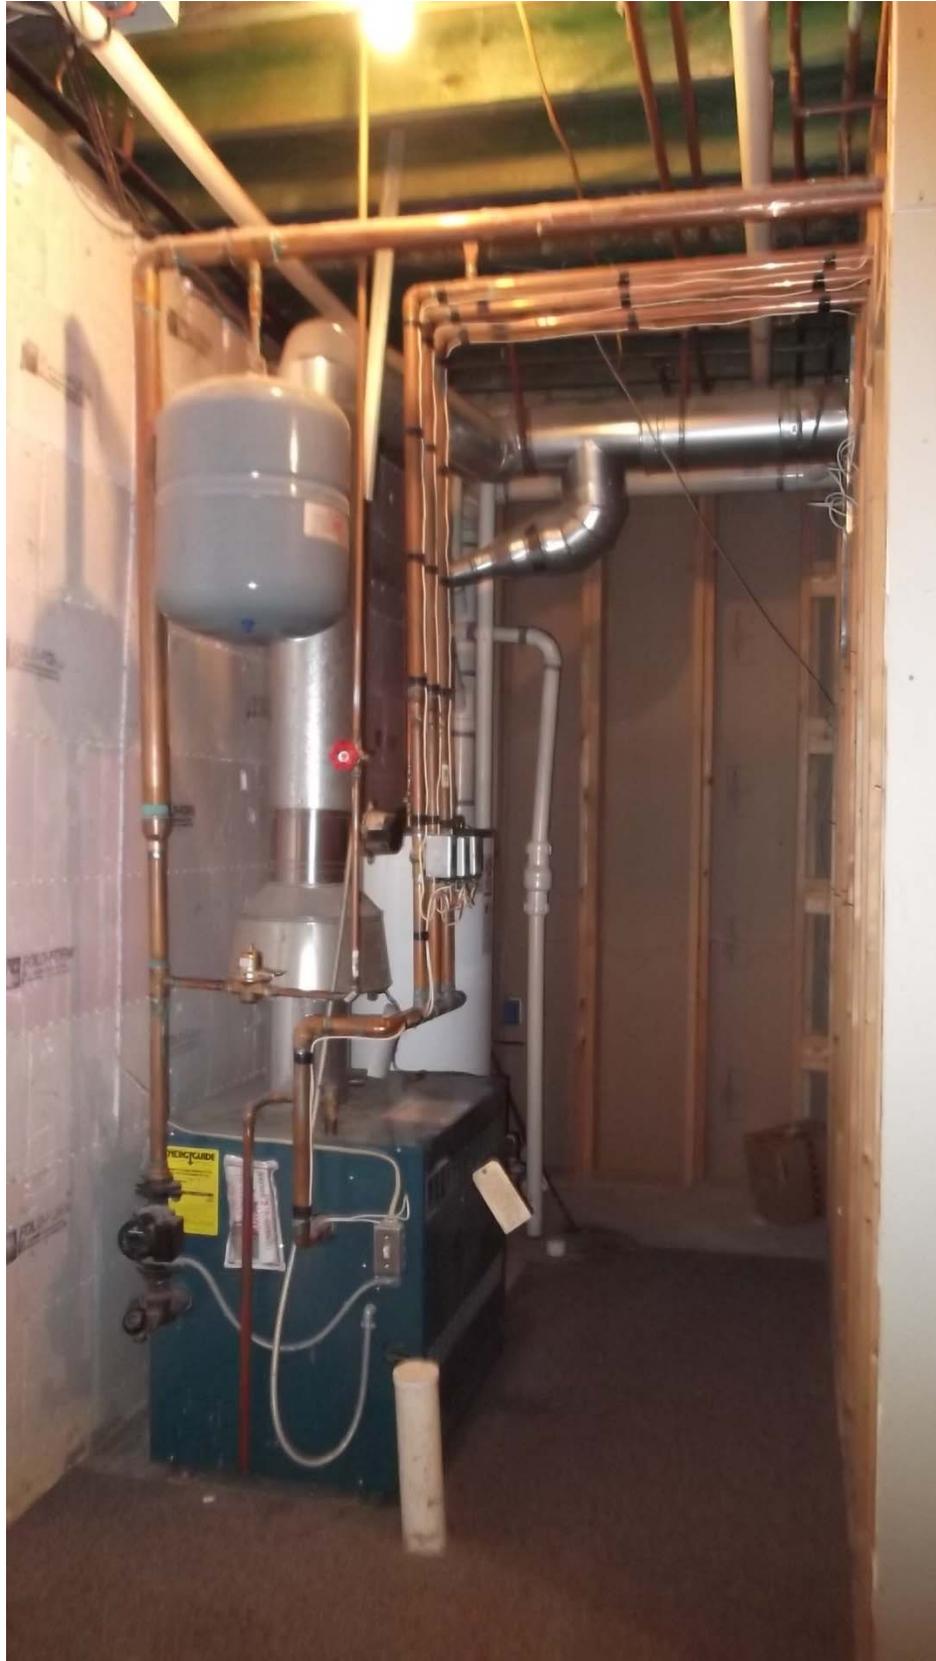
**Existing Condition Photo A19: Cellar
Utility Room - Room B04**

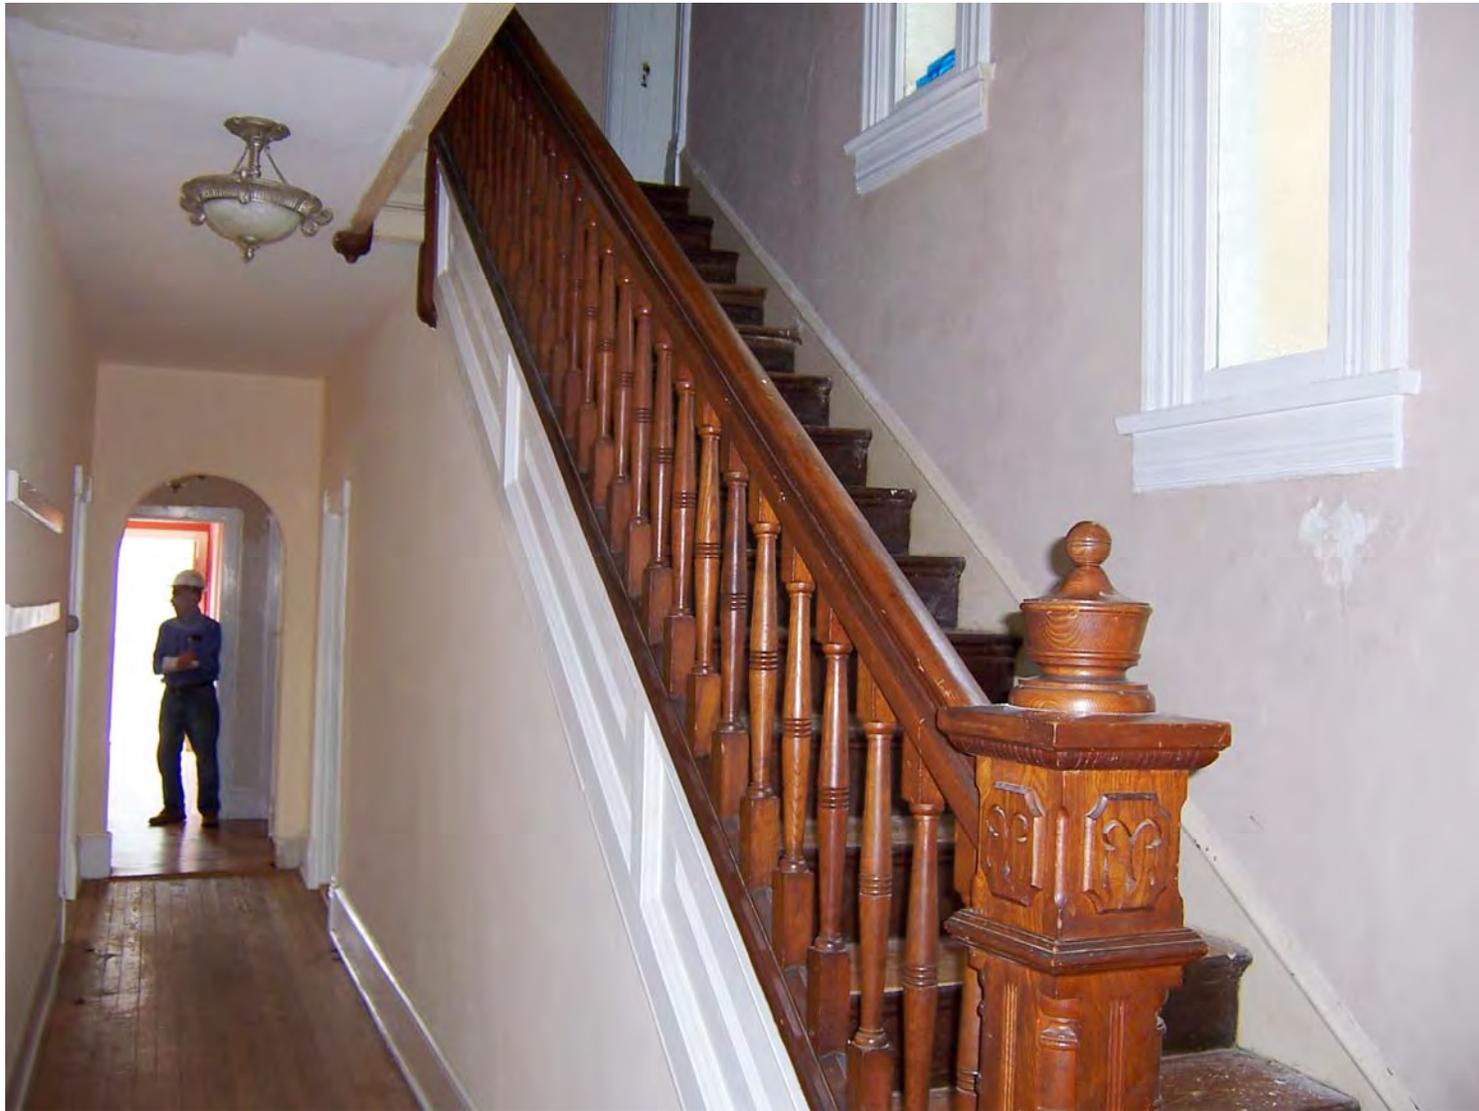
**Existing Condition Photo A24: First Floor, Newel Posts
Hall - Room 100**

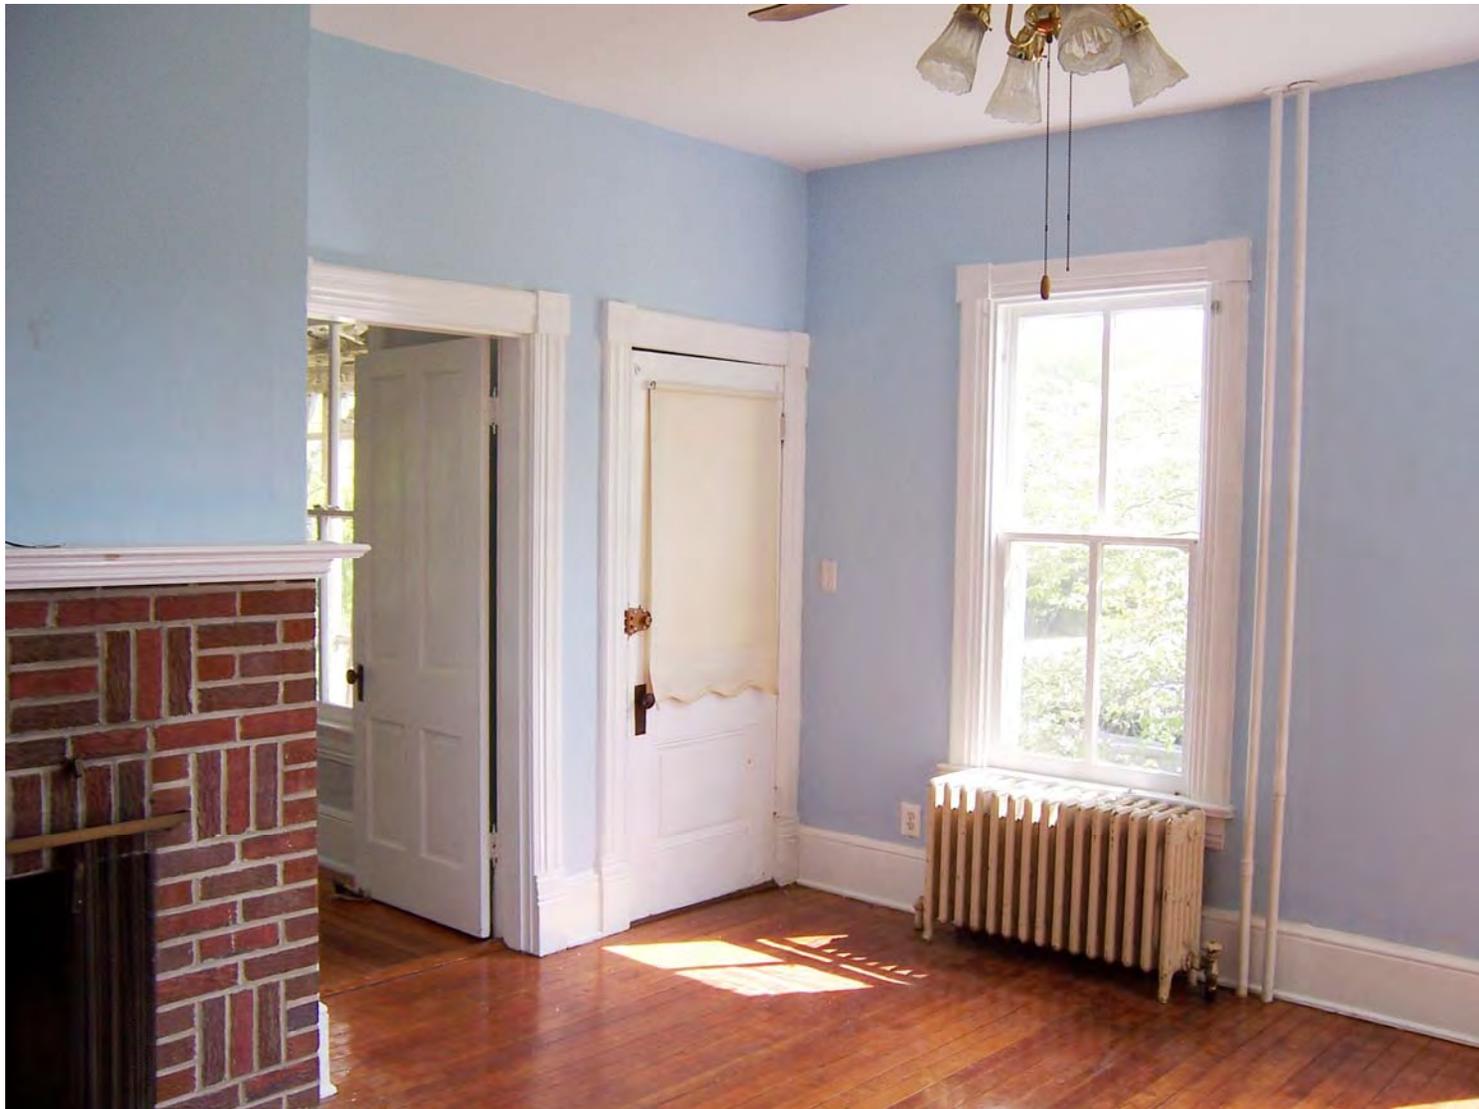
**Existing Condition Photo A29: First Floor, Pocket Doors
Living Room - Room 101**

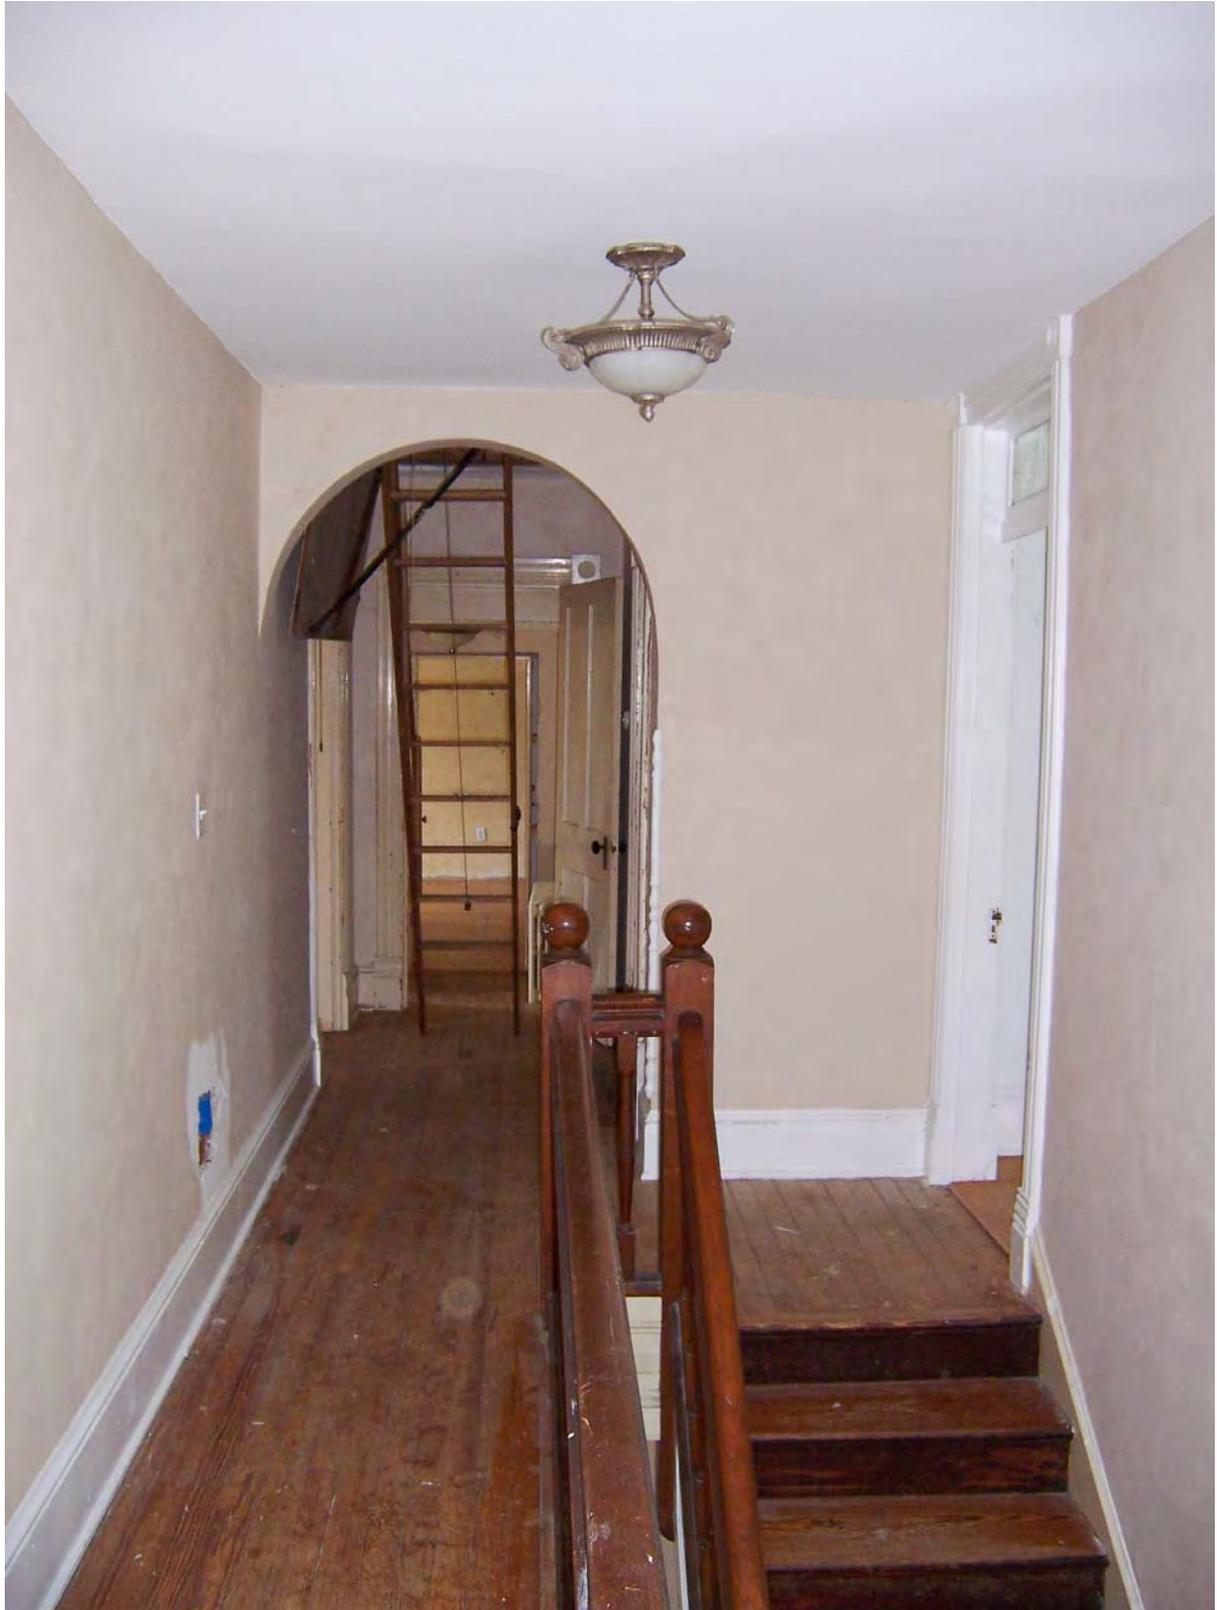
**Existing Condition Photo A47: Second Floor, Transom Window Above Door
Hall - Room 200**

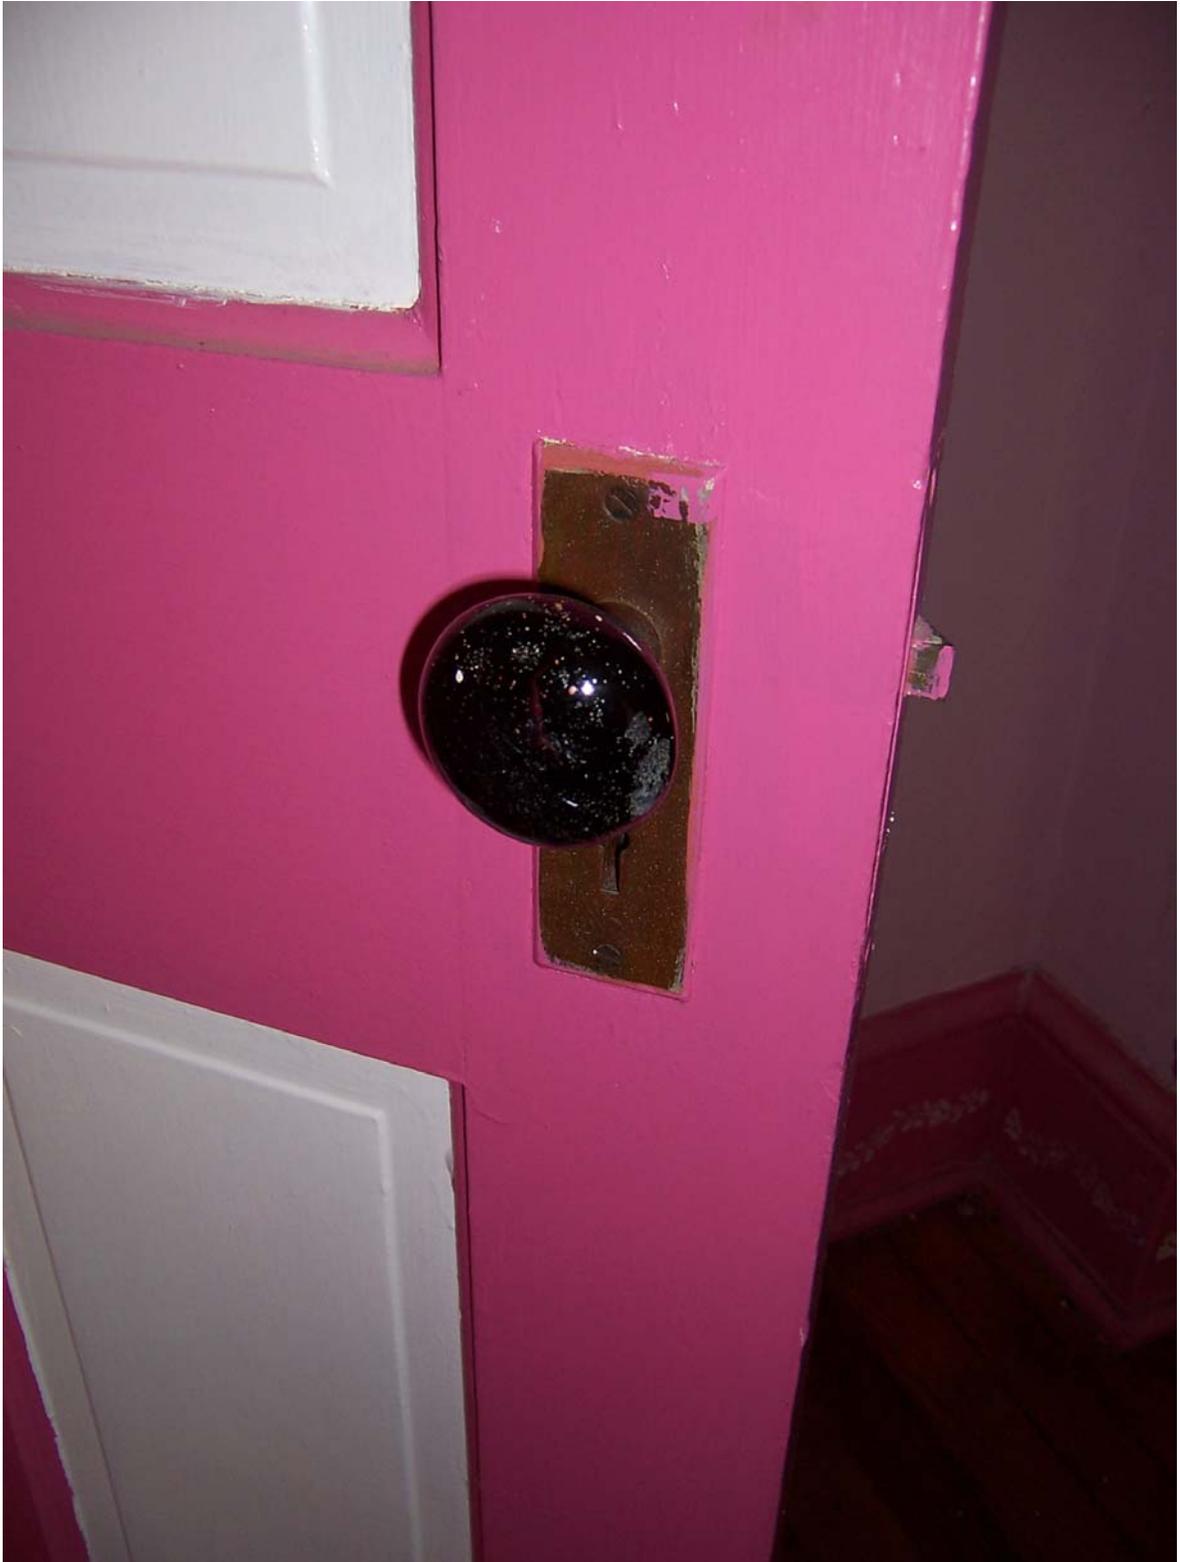
**Existing Condition Photo A55: Second Floor, Steeple-Tipped Decorative Door Hinge
Bedroom - Room 201**

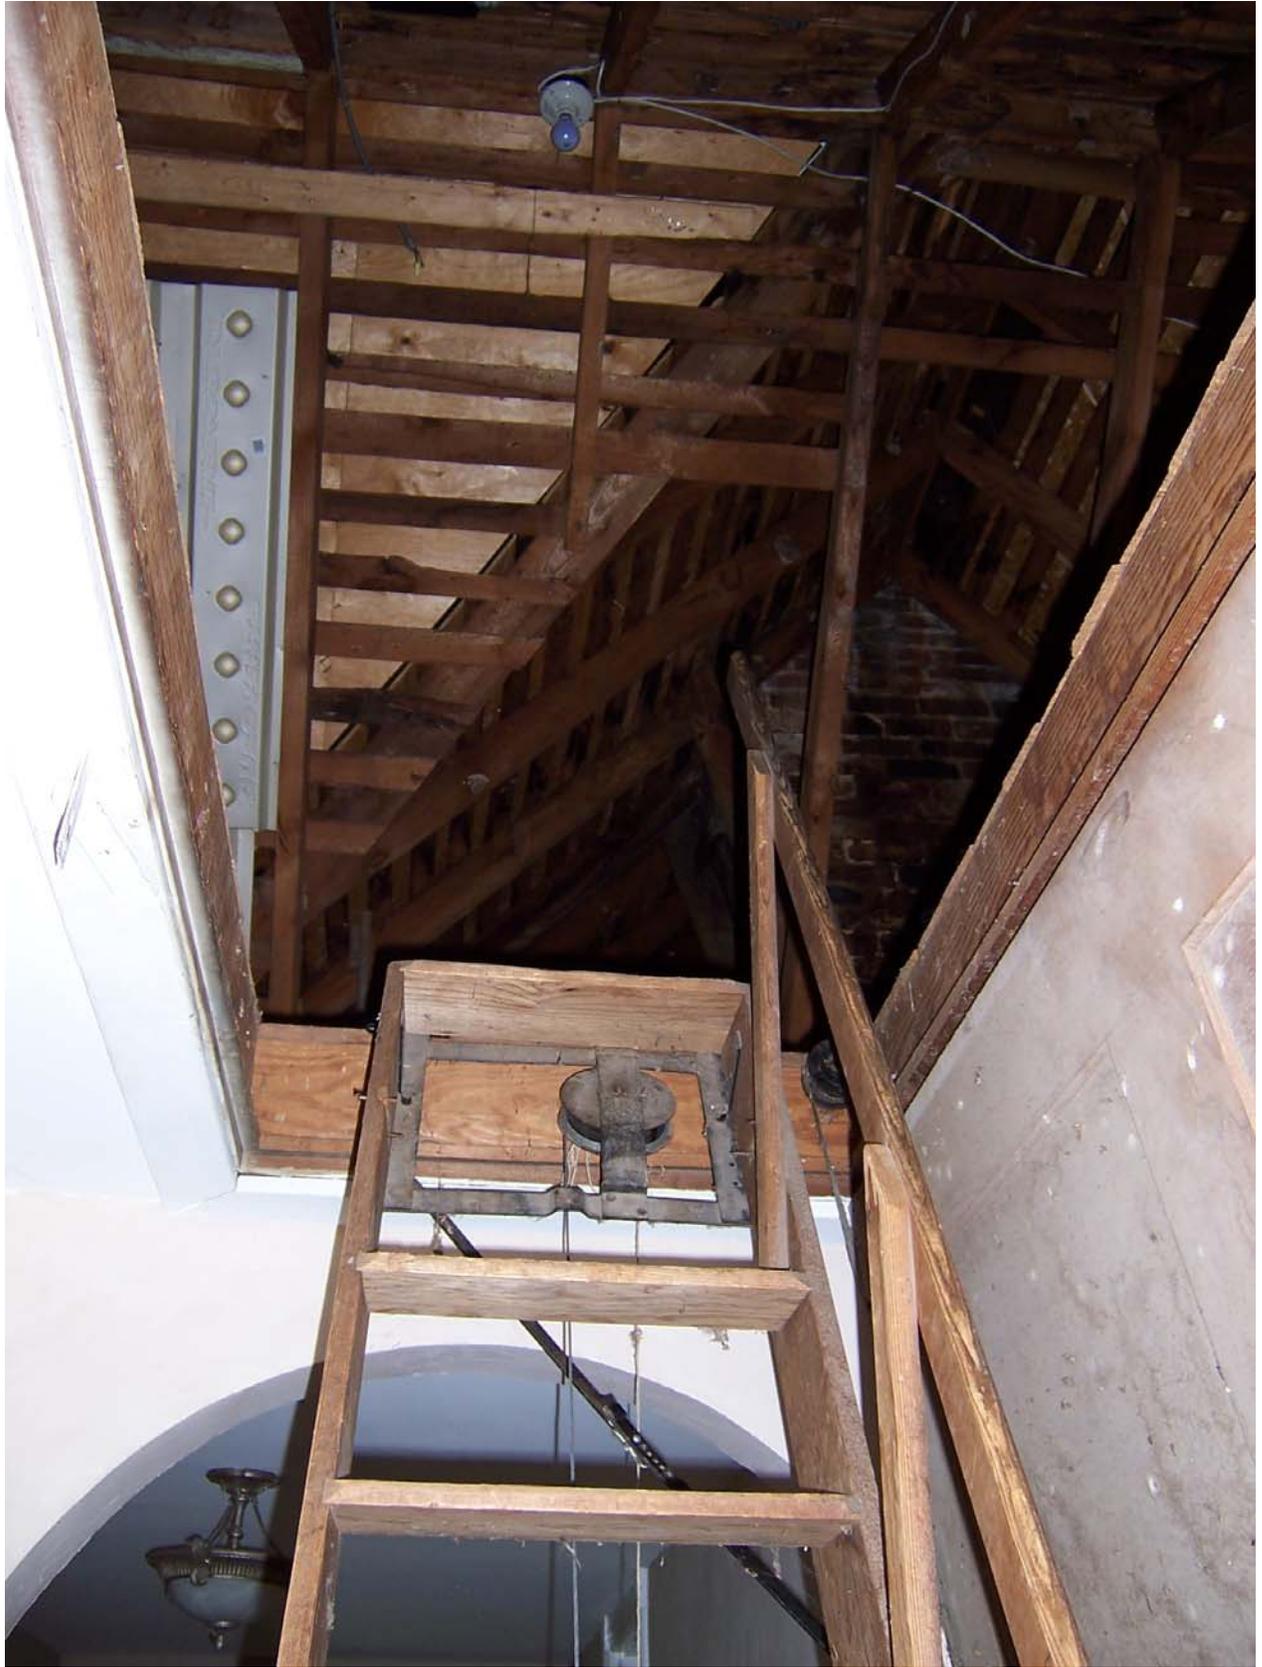
Existing Condition Photo A79: Attic, Circa 2002 Addition
