LAUREL HILL HOUSE

Historic Structure Report and Treatment Options

III. TREATMENT RECOMMENDATIONS

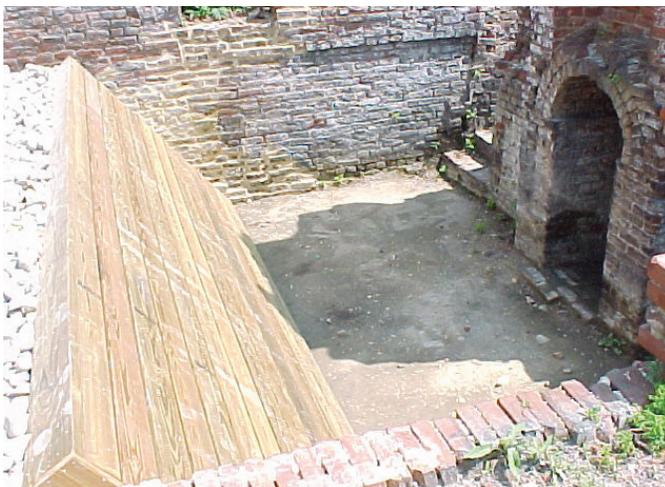
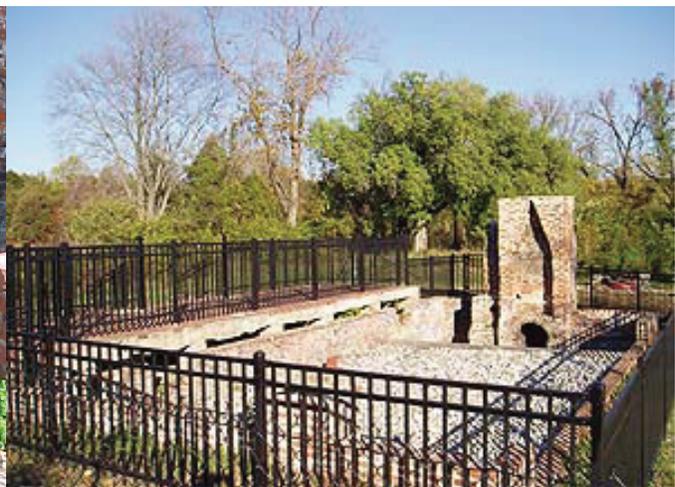
Photos of Mt. Air with foundation preserved and interpreted.

- i. Remove entire frame structure of the house along with associated building systems.
- ii. Retain perimeter stone and brick foundation of original house. Provide supplemental structural bracing as required to retain exposed foundation for long term. Provide limited masonry repair of existing foundation.
- iii. Provide finish grading of areas where the building was built over a crawlspace.
- iv. Provide site cleanup and appropriate paths, access and landscaping.
- v. Provide a protective rail as required to prevent public from falling into basement area.
- vi. Provide interpretive signage package to present history and significance of the Laurel Hill House in this context.
- vii. Cap existing utilities.
- viii. Make provision to drain foundation area.
- ix. Provide security lighting.
