LONG BRANCH CENTRAL WATERSHED IMPLEMENTATION WORK PLAN

Fairfax County Department of Public Works and Environmental Services

Biohabitats, Inc.

January 2023

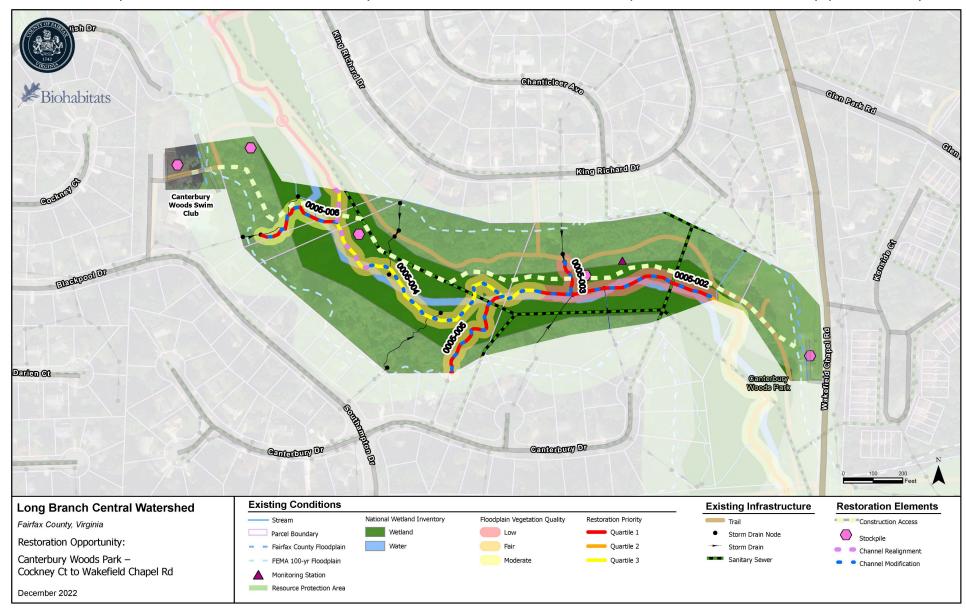
Canterbury Woods Park - Cockney Court to Wakefield Chapel Restoration Opportunity Map

- Control invasive plant species.
- Conduct restoration planting throughout the floodplain. Note that trees in poor health in the floodplain may be removed to reduce hazard trees, open light gaps to assist in regeneration, and provide large woody debris to improve stream and floodplain stability and habitat and to increase "roughness" to reduce erosion and trap organic debris.

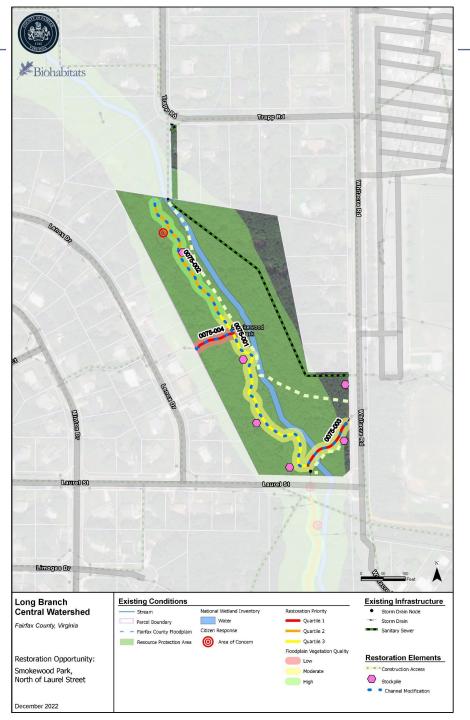
Smokewood Park, North of Laurel Street Restoration Opportunity Map

Previously stabilized outfall channel with grade control failure.

The stream is an incised, perennial channel that has downcut and widened due to past increases in stormwater runoff from development throughout the contributing drainage area. The banks along the perennial channel are two (2) to six (6) feet high with shall root depths and a lack of surface protection, exposing the bank to continued erosion. There are three outfall channels to the perennial stream. One outfall channel enters the perennial stream from Trapp Road. This outfall is highly degraded with an exposed sewer line and bank heights between four (4) and six (6) feet. Erosion of this channel threatens an adjacent home. Another outfall from Lenox Drive was recently stabilized; however, a small repair near the confluence with the perennial stream needs to be addressed within this restoration project area. The third outfall channel comes from Whitacre Road and is a downcut, perennial channel with bank heights between three (3) and four (4) feet. These banks have low root density and depth with very sparse trees along the immediate streambank exposing the banks to continued erosion.

- Place wood and supplemental rock structures within stream to reduce channel erosion and migration toward private property, increase channel "roughness", and improve habitat for fish and macroinvertebrates. Channel extents may be altered to protect private property and existing sewer infrastructure, and some grading will occur.
- Large wood may be placed in the stream and floodplain on a limited basis to protect banks, improve habitat for fish and other aquatic and terrestrial organisms, increase "roughness", and improve biodiversity and resiliency.
- Access work areas through degraded outfall corridors to the greatest extent possible.
- Restoration planting throughout the floodplain. Trees in poor health may be removed to reduce hazard trees, open light gaps to assist in regeneration, and provide large woody debris.

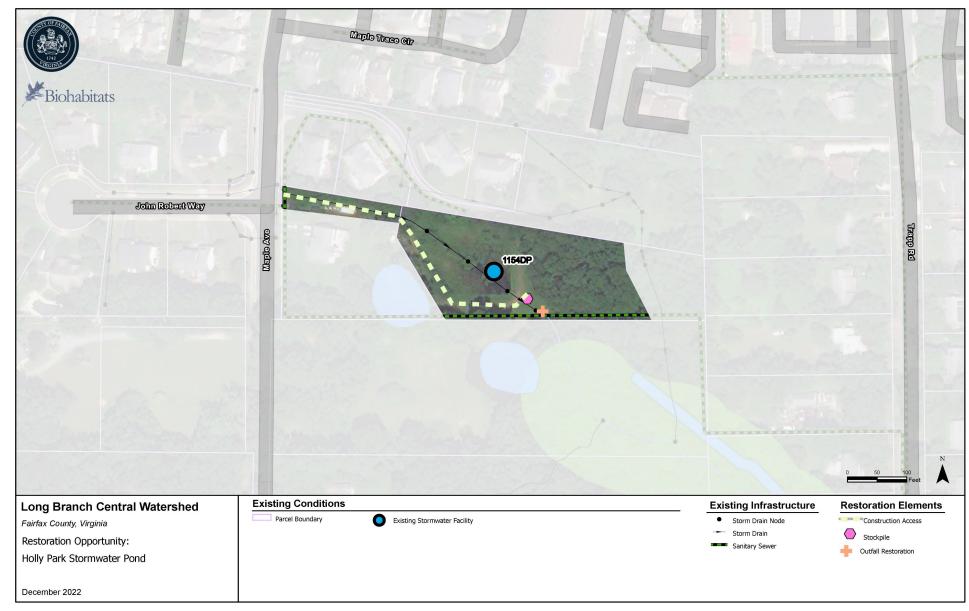
Holly Park Stormwater Pond Restoration Opportunity Map

Degraded outfall channel.

The Holly Park Stormwater Pond is located behind 4029 Maple Avenue and was constructed in the mid-1990s along with the neighborhood on John Robert Way. Stormwater enters the pond from the northwest from one storm drain ditch. The pond is located on property owned by the Fairfax County Board of Supervisors. The existing pond bottom is wet with small trees and undesirable species like phragmites growing within it. The stream corridor downstream of the pond is in poor condition and located within a stormwater easement. Some repairs are needed in within the pond itself and in the stream channel below the outfall structure.

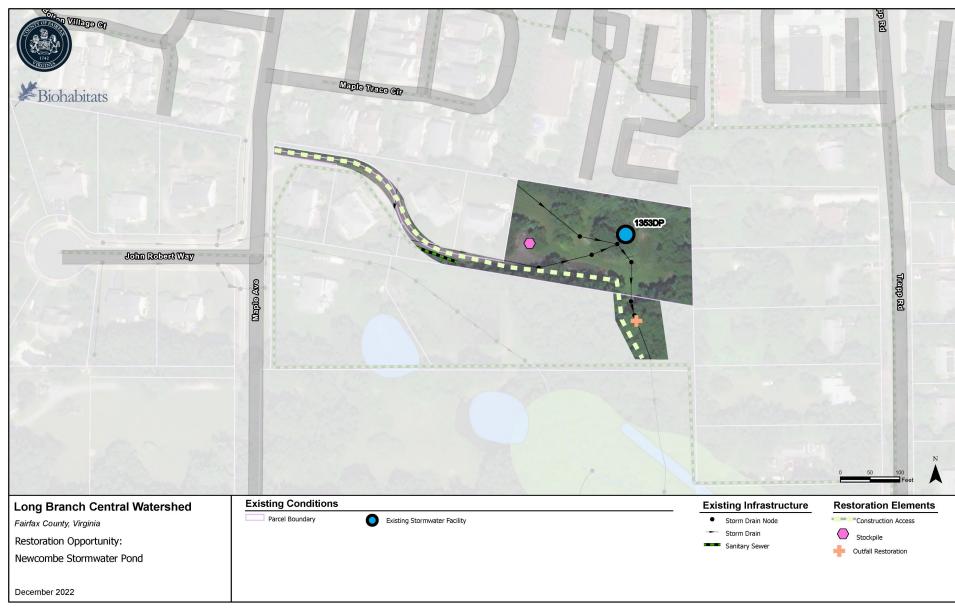
Newcombe Stormwater Pond Restoration Opportunity Map

Degraded outfall channel.

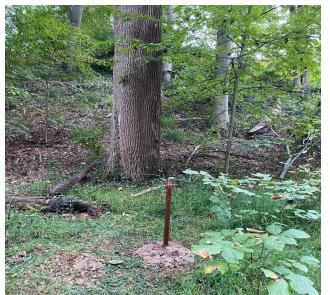
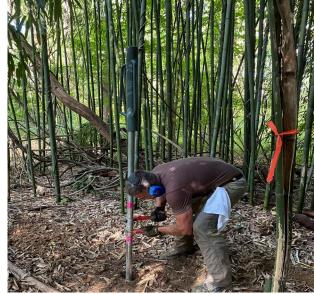
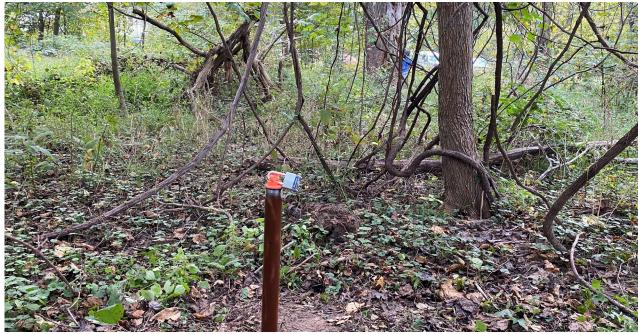
Groundwater was monitored continuously at six of the eight monitoring stations using groundwater loggers. Note, groundwater loggers at two of the eight stations were vandalized and taken offline.

At each monitoring station, three groundwater wells were set up in a transect perpendicular to the stream channel.

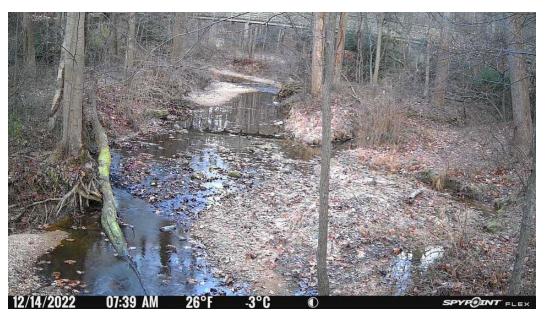
CAM4 during baseflow conditions.

Can correlate images to storm hydrographs and precipitation data whether flow overtops the banks or not.

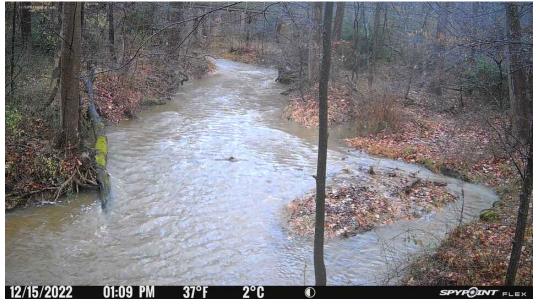
CAM4 midway through precipitation event on 12/15/22.

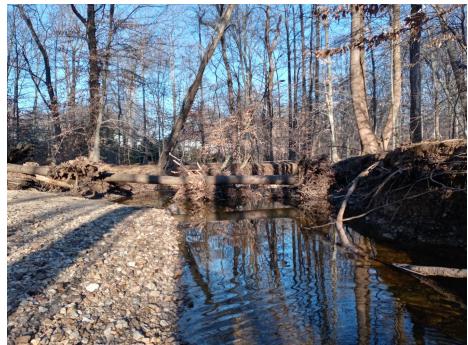
Watershed-Wide Monitoring, Year 1 (2022) Geomorphology: Cross Section Surveys, Example

Displayed below is an example cross section near Tabard Place at Monitoring Station 4.

Notice the steep right bank and bed deposition on the left bank under the current conditions (facing downstream).

Profiles can be graphically overlayed to visualize changes over time.

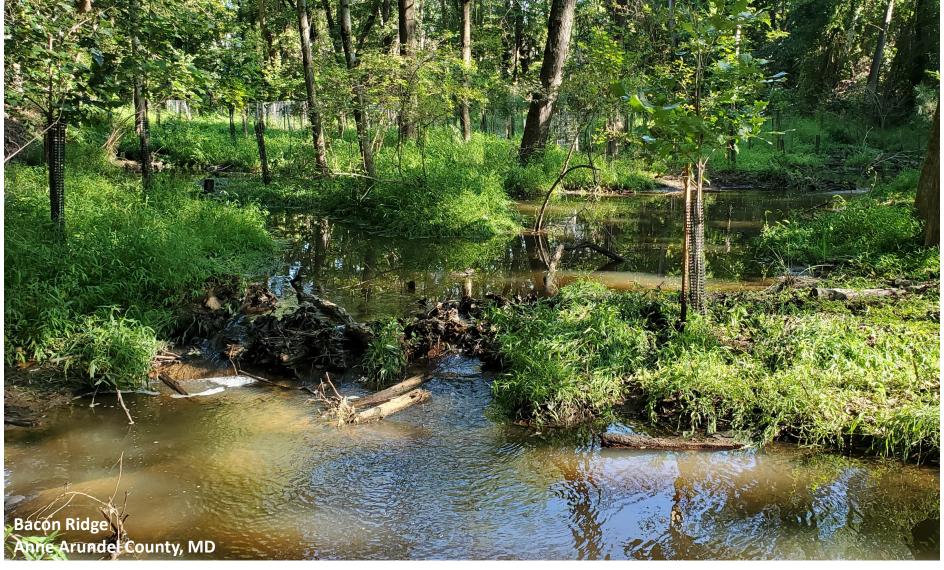
Restoration Technique – Engineered Log Jam

An engineered log jam is a wood structure that is designed to prevent channel degradation and promote the development of a specific hydraulic criteria and tie into the stream riparian corridor with minimal disturbance.

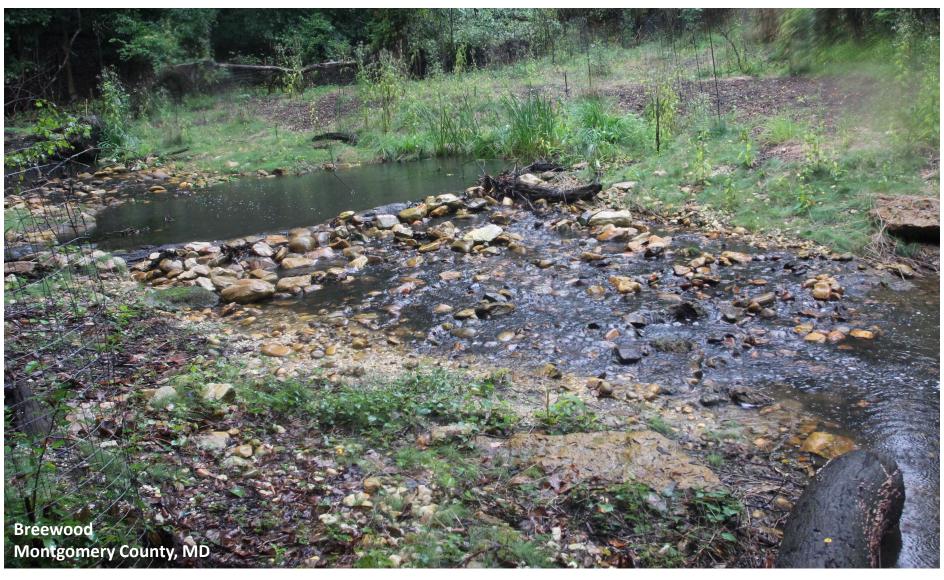
Restoration Technique – Constructed Riffle

Constructed riffles are composed of a mix of gravel and cobble sized material. These structures are proposed to ensure floodplain connection is maintained and are typically located downstream of concentrated flow inputs and where in-stream stormflow velocities and shear stress are predicted to be the greatest.

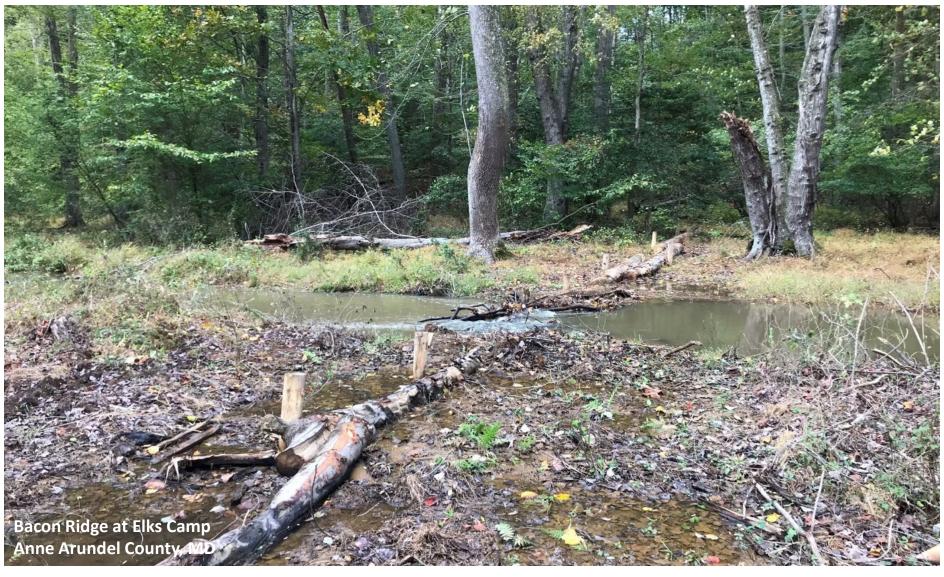
Restoration Technique – Floodplain Log Sill

Log sills provide protection of the reconnected floodplain laterally past the armored instream structure width during larger flood flows will be primarily provided by maintaining the existing floodplain vegetation with small, low ground pressure equipment and minimizing areas of disturbance. Permanent seeding is proposed in all disturbed floodplain areas to re-establish herbaceous plants intended to develop thick root densities, good ground cover, and protect slopes from soil erosion during out of bank flow events.

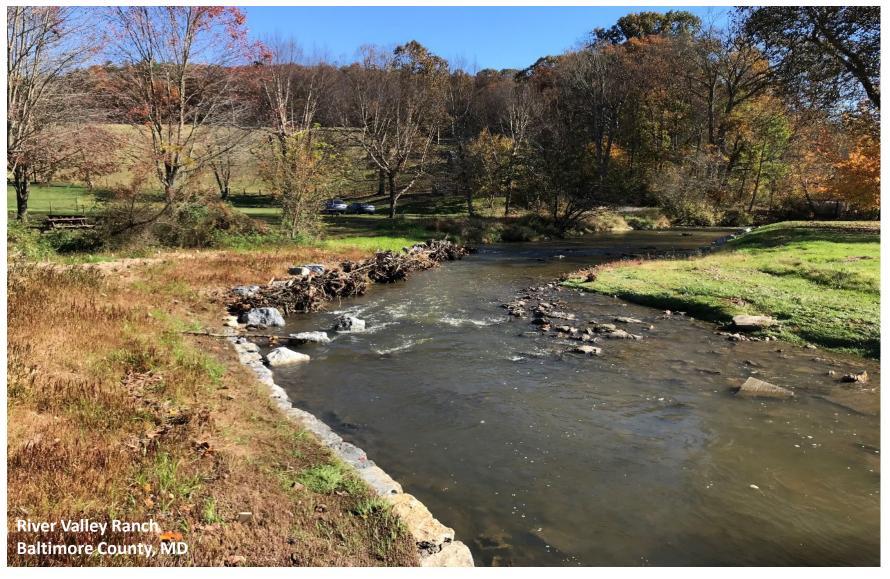
Restoration Technique – Bank Protection

Bank protection is one method to reduce erosive impacts on a stream bank. Boulders and/or tree rootwads can be positioned along the toe of an eroded bank and back filled with soil to create a new stable bank. Boulders provide a higher degree of stability for higher flows whereas rootwads provide increased habitat in addition to protection for moderate to low flows.

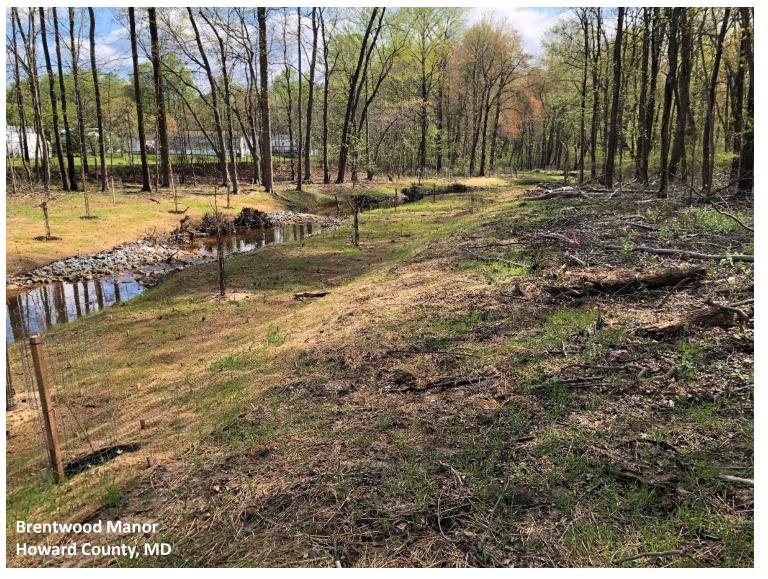
Restoration Technique – Floodplain Bench

Floodplain benches are implemented on either side of a pilot channel with natural geometry that handles typical baseflows. The bench provides a larger cross section with handles flows above baseflow, reducing flow velocity through surface roughness and protecting the stream bank. Floodplain benches can be used within over widened channels or areas in which the stream invert cannot be raised.

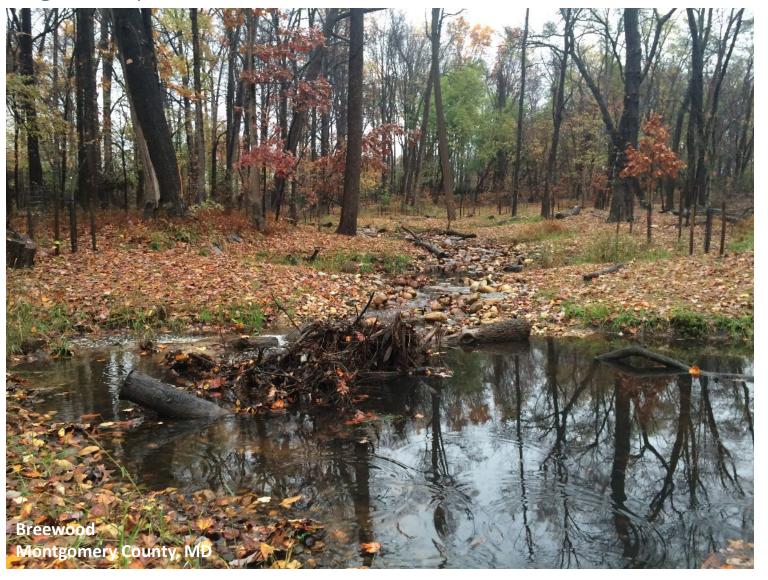
Restoration Technique – Large Woody Debris

Large woody debris are added to provide increase roughness, promote flow diversity, bank protection, and add habitat complexity to stream systems, most typically in constructed pools. Large woody debris can be added along a bank for bank protection or in the center of a pool for added roughness and habitat.

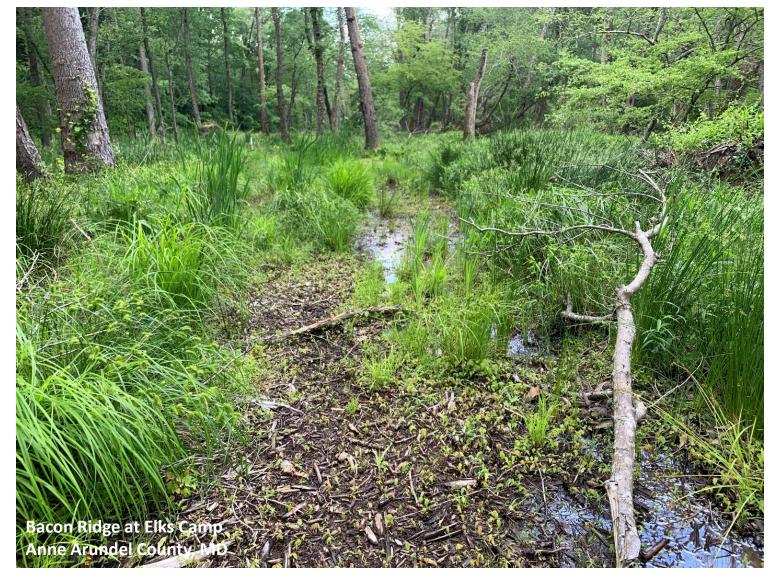
Restoration Technique – Stage 0 / Wetland Complex

Where site conditions allow. the Stage 0 restoration approach is proposed to restore the physical, chemical, and biological processes of a healthy, resilient stream ecosystem. Stage 0 refers to a prechannelization phase in which a stream valley is occupied by a forested wetland complex with many anabranching (interweaving) flowpaths and no defined single threaded channel exists. This approach would be utilized coming off small tributaries before reaching the mainstem.
