Technical Memo 3.2: Lower Occoquan Restoration Strategies Candidate Project Selection

Technical Memo 3.4, 3.5, and 3.6: Lower Occoquan Project Ranking

Lower Occoquan Watershed

Technical Memorandum 3.4/3.5

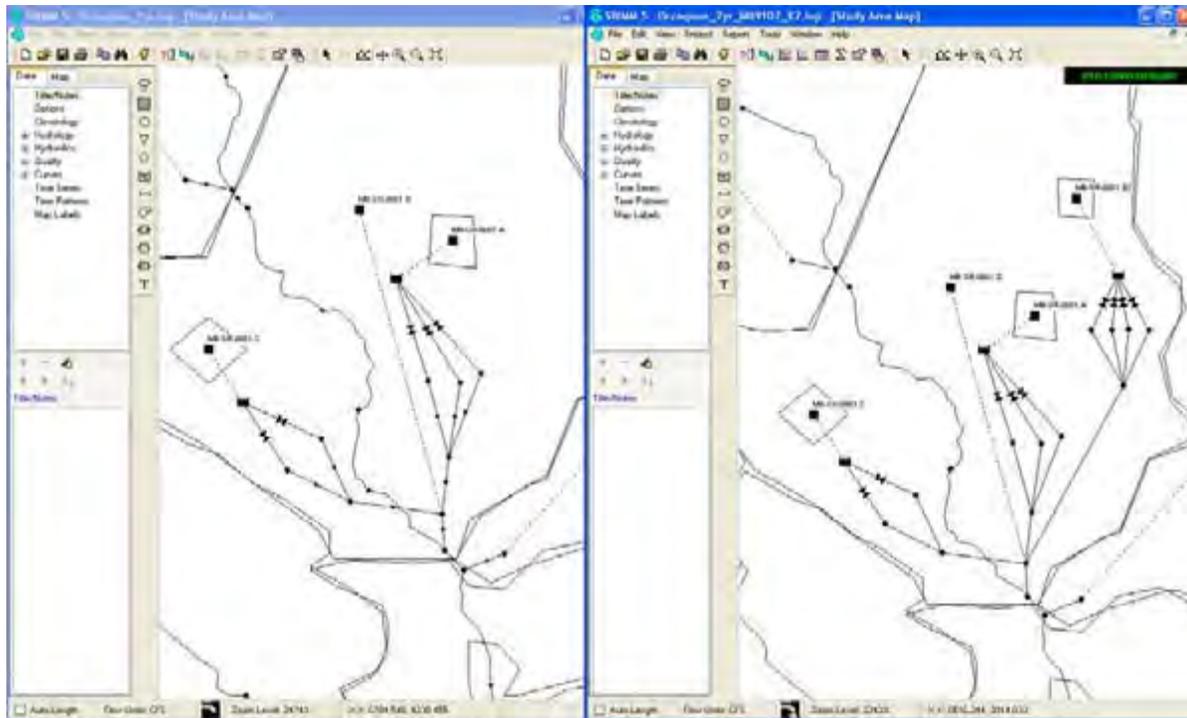
Figure 1. Comparison of Model Configuration – Sub-basin MB-GR-0001.

For the seven (7) projects that capture and treat a limited portion of the runoff from a specific sub-basin, the tools were fully applied. This is shown in Figure 1 where Classification Area D was converted to Classification Area B2 due to the proposed pond retrofit. The sketch on the left shows the model configuration in the Future without project scenario. The sketch on the right shows the model configuration for Sub-basin MB-GR-0001 in the Future with project scenario.

are recommended. Each of these retrofits calls for implementation of a dry pond. In the combined SWMM model, these projects were merged and simulated as a single dry pond that treats the combined drainage area of the proposed projects.

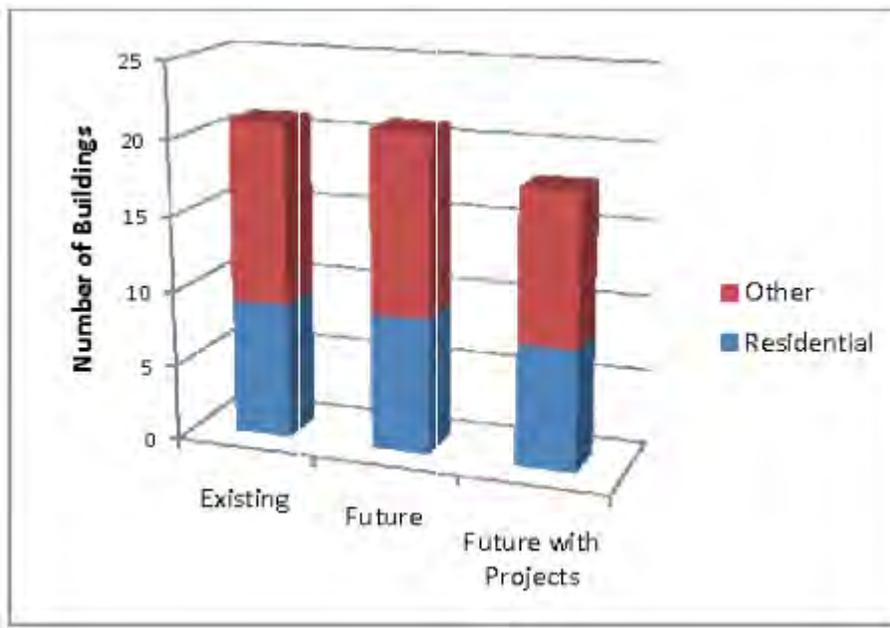
Figure 2. Buildings located in the 100-year floodplain

The following graphs (Figures 2-5) are an analysis of the number of buildings (residential and other types) located within the 100- and 10-yr floodplains, as well as located in or within a 15 foot buffer of the 100- and 10-yr floodplains.

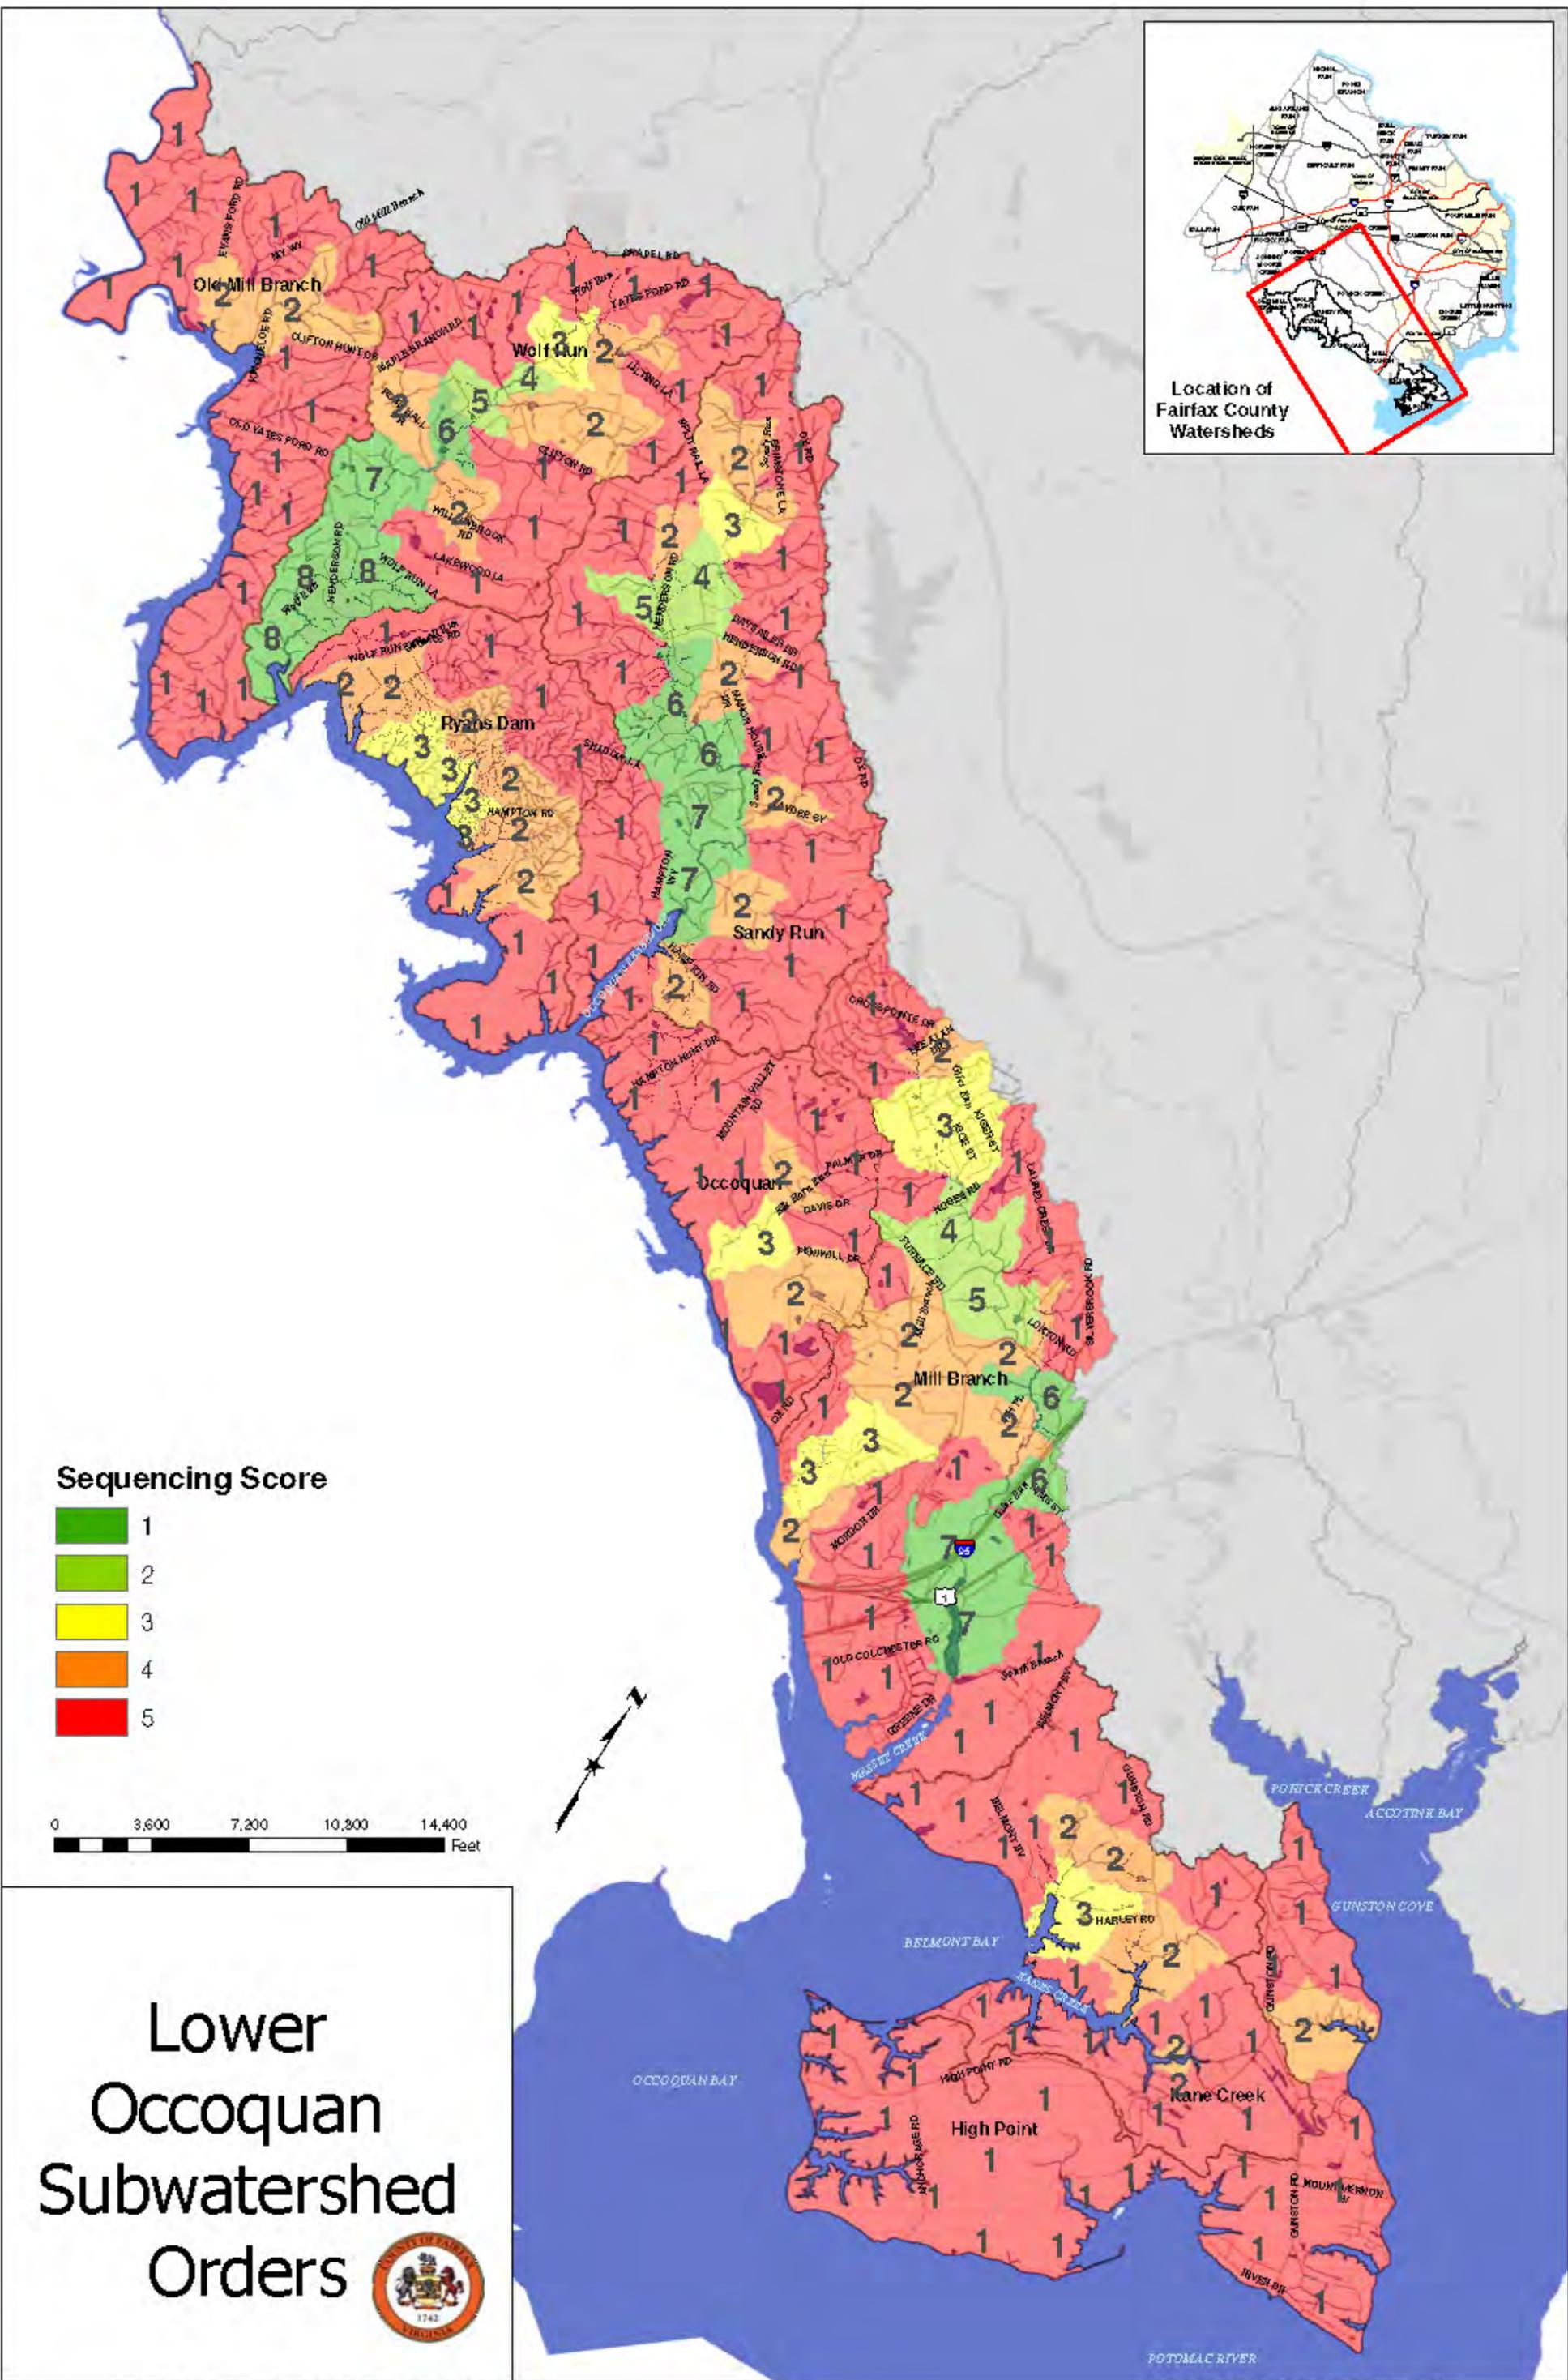
**Appendix L: Lower Occoquan Watershed
Subwatersheds by Stream Orders
Map**

Lower Occoquan Subwatershed Orders

Projects in headwater subwatersheds were considered the highest priority and given the highest project scores, per WMP Standards 3.2. The order of the subwatersheds was determined per Figure 1, Hypothetical Subwatershed Ordering Example, from the WMP Standards 3.2 and the following criteria:

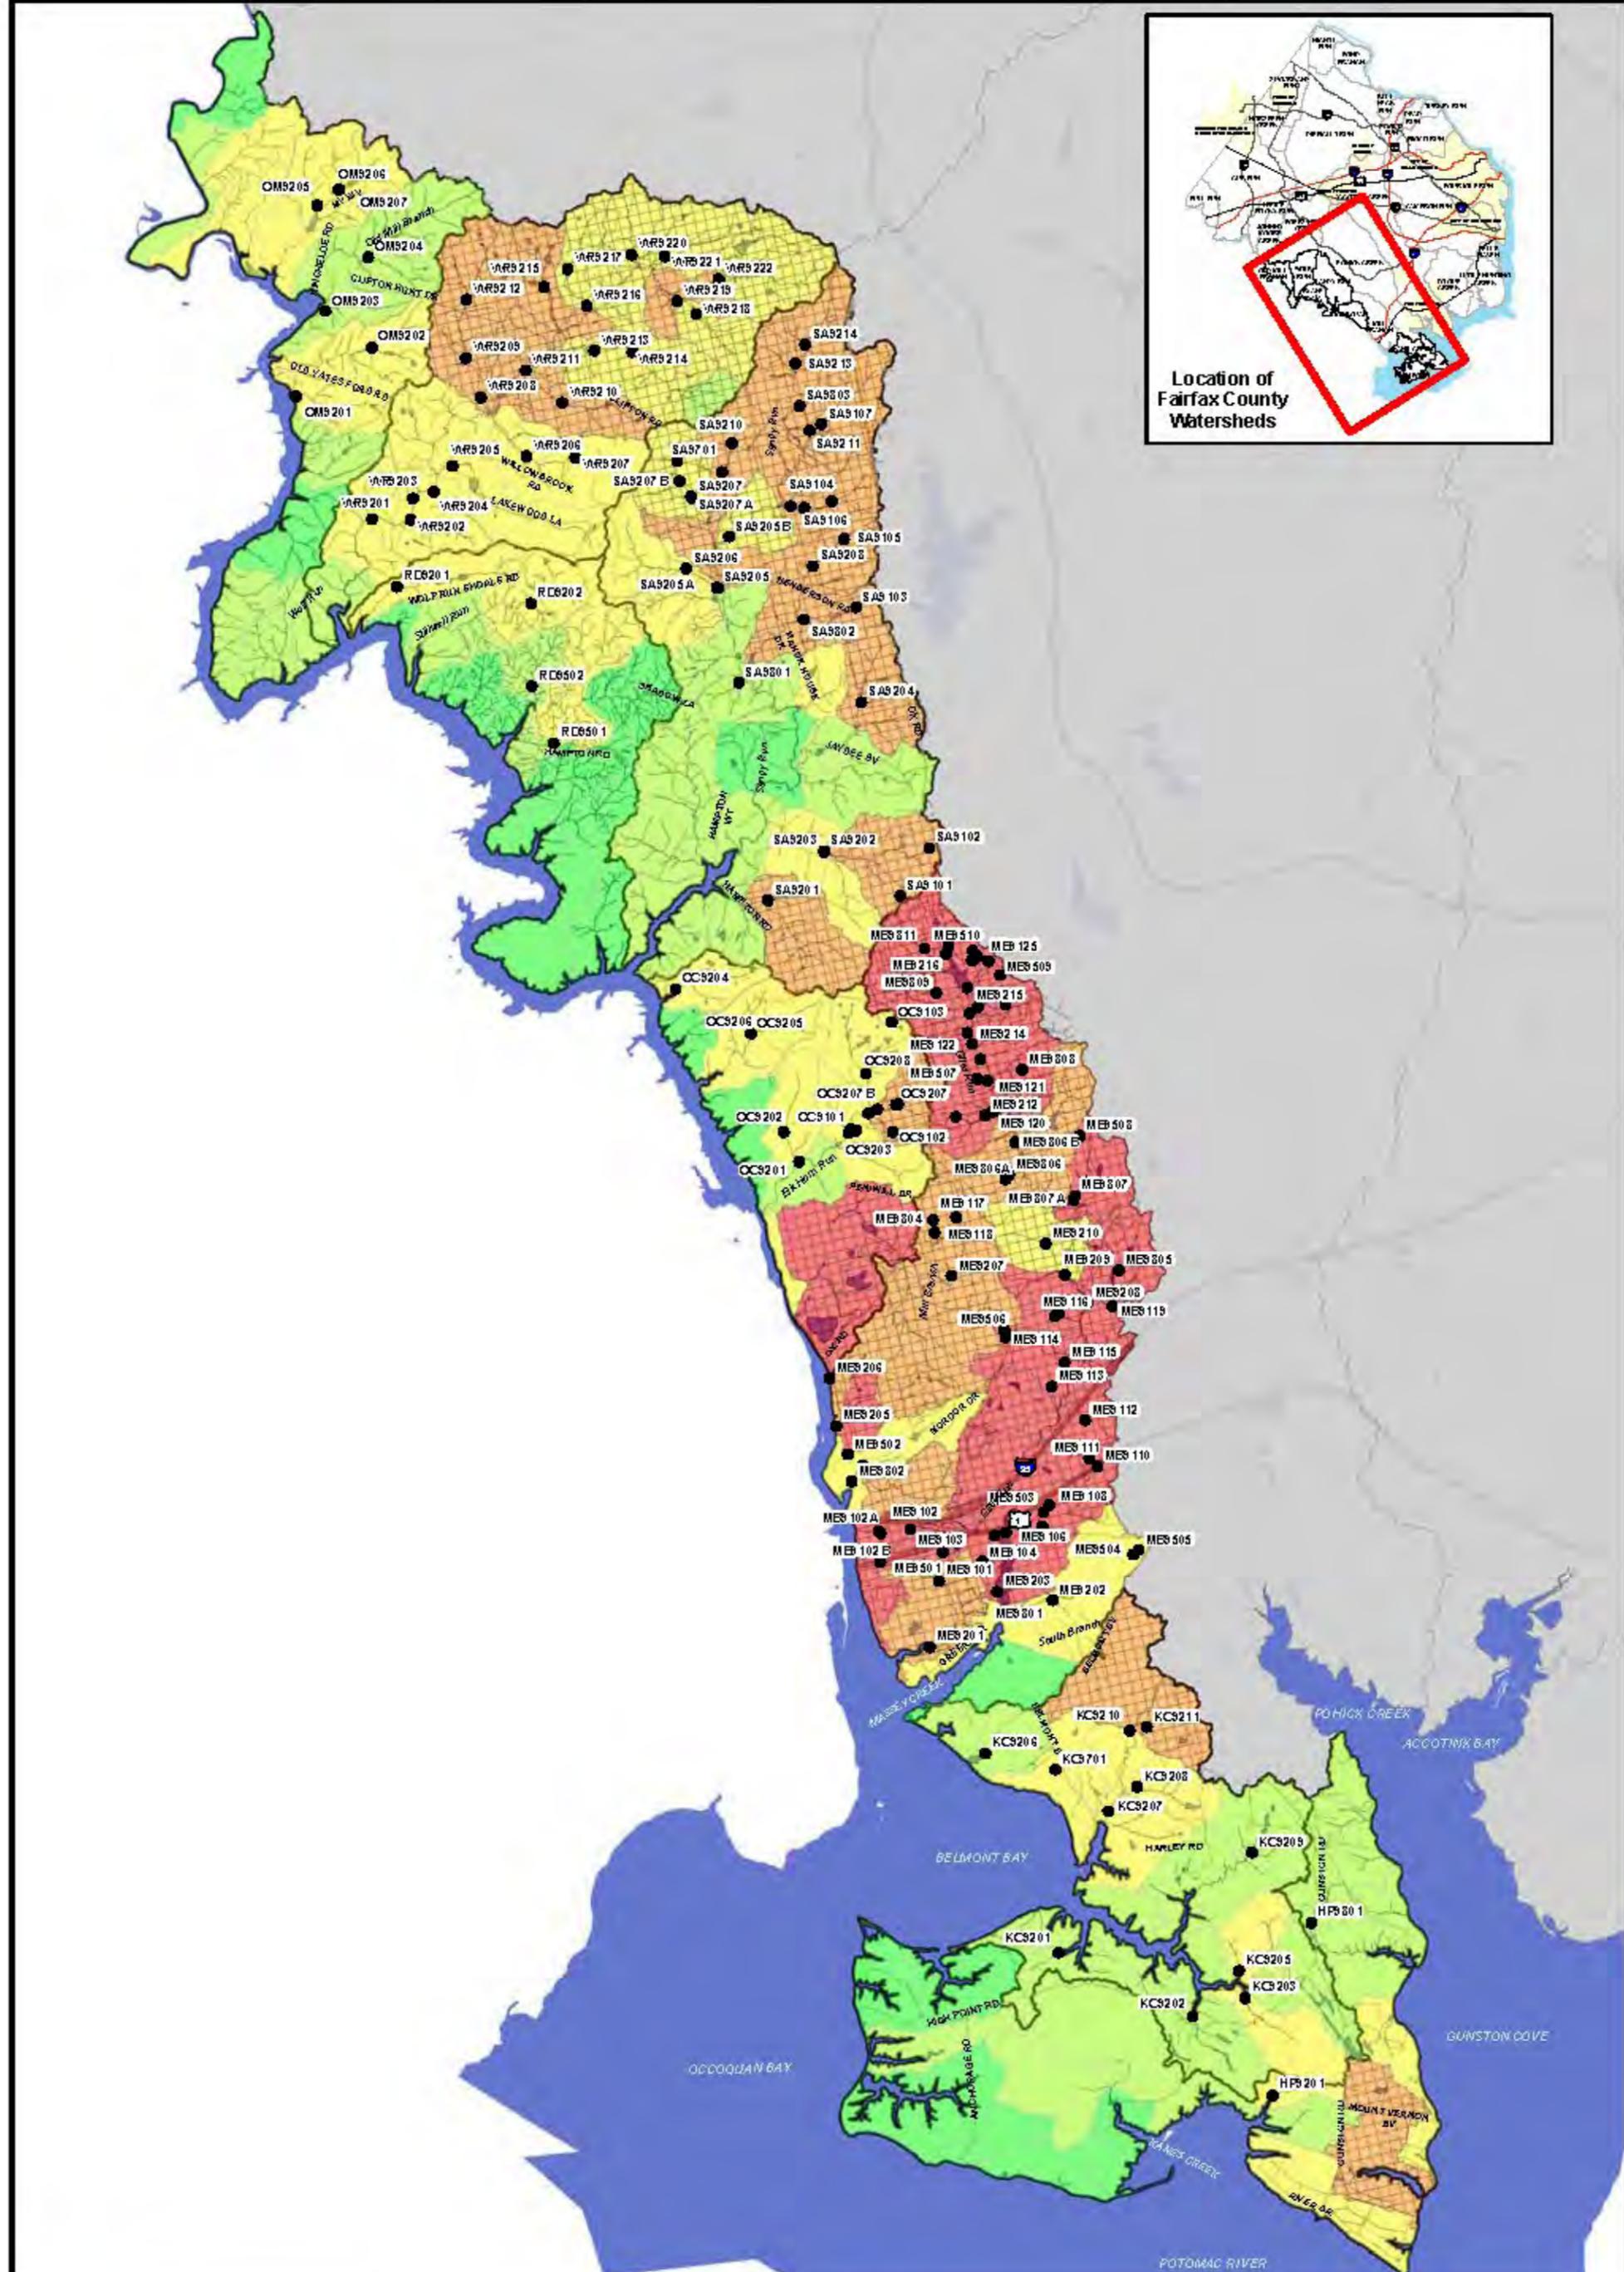
**Appendix M: Lower Occoquan Watershed All
Candidate Projects Map**

- ▣ Problem Areas
- Subwatershed Objective Composite Scores**
- 4.653492 - 5.499524
- 5.499525 - 6.319206
- 6.319207 - 7.079683
- 7.079684 - 7.867937
- 7.867938 - 8.893492
- Candidate Project Sites
