Chapter 4

Bull Neck Run Watershed

4.1 Watershed Condition

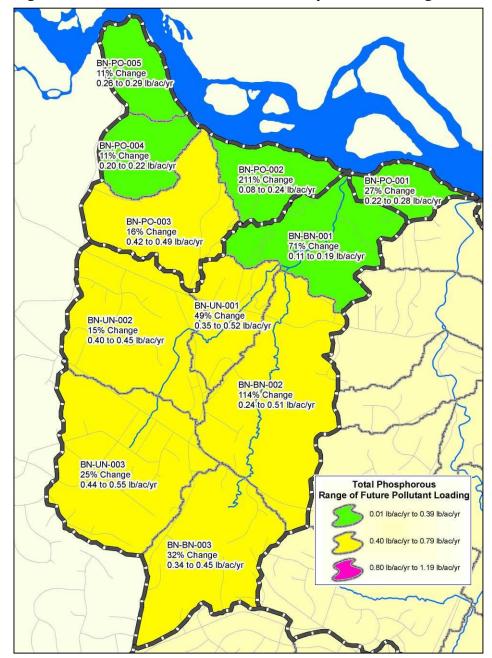
Figure 4.1 Bull Neck Run Future Total Phosphorous Loading

Watershed to simulate the generation of runoff, how the runoff is transported downstream, and the amount of pollutants in the runoff and stream flow. The hydrologic and water quality models include the entire Bull Neck Run Watershed, which consists of the area draining to Bull Neck Run and a smaller area draining directly to the Potomac River. Eleven subbasins were created for the model in order to provide more detail for the modeling results. The subbasins with the future total phosphorus loading are shown in Figure 4.1.

In the water quality model, the moderate levels of pollutants for both existing and future land use conditions can be attributed to the large amount of open space. The subbasins that drain to Bull Neck Run have a predominant land use of low density residential for both existing and future land use conditions. The predicted increase in pollutant loads can be attributed to the projected development of vacant parcels to low density residential areas. Table 4.6 shows the comparison of the existing and future pollutant loading rates for the Bull Neck Run Watershed.
