# Chapter 7

## Turkey Run Watershed

### 7.1 Watershed Condition

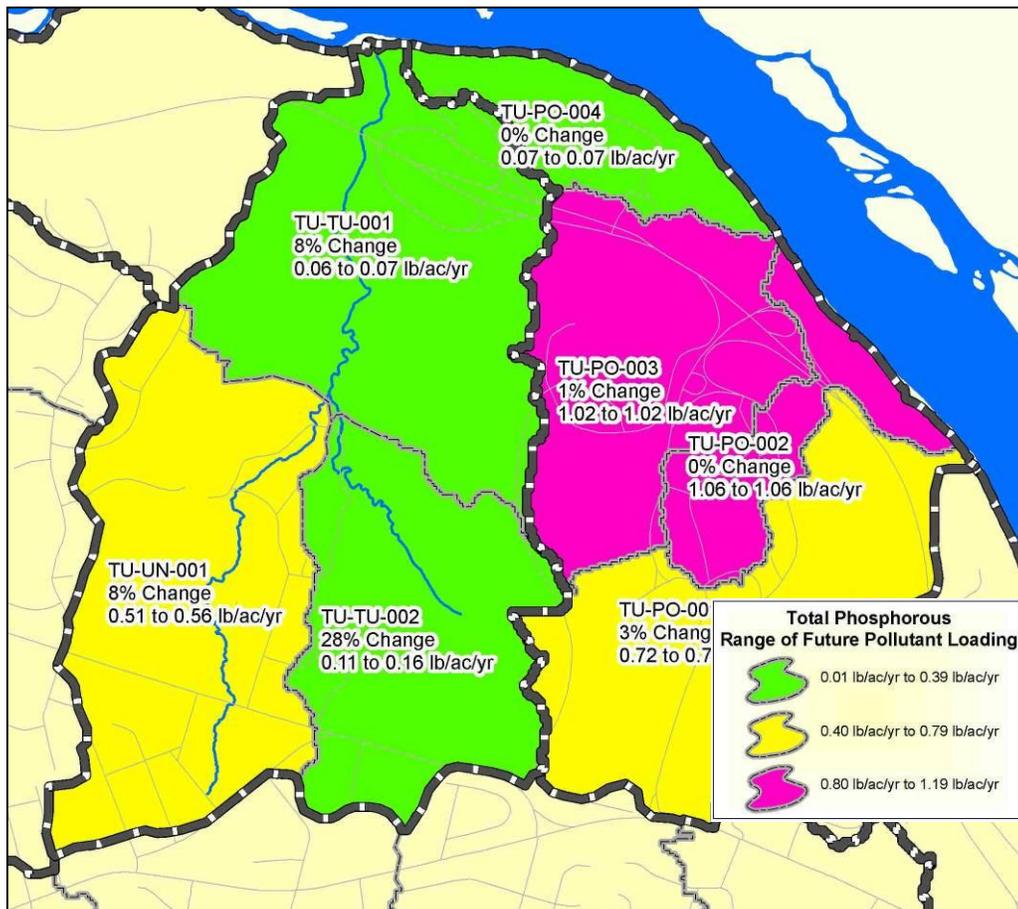
**Figure 7.1 Turkey Run Future Total Phosphorous Loading**

Hydrologic, hydraulic, and water quality models were developed for the Turkey Run Watershed to simulate the generation of runoff, how the runoff is transported downstream, and the amount of pollutants in the runoff and stream flow. The hydrologic and water quality models include the entire Turkey Run Watershed, which consists of the area draining to Turkey Run and a smaller area draining directly to the Potomac River. Seven subbasins were created for the model in order to provide more detail for the modeling results. The subbasins with the future total phosphorus loading are shown in Figure 7.1.

In the water quality model, the moderate levels of pollutants for both existing and future land use conditions can be attributed to the large amount of open space. Most of the land in the subbasins that drain directly to the Potomac River (TU-PO-001, TU-PO-002, TU-PO-003 and TU-TU-004) is federally owned. The CIA and FHWA properties are designated as a low intensity commercial land use, whereas the Turkey Run Recreation Park, the Claude Moore Colonial Farm, and Langley Fork Park are designated as open space. The subbasins that drain to Turkey Run have a predominant land use of low density residential for both existing and future conditions. Table 7.6 shows the comparison of the existing and future pollutant loading rates in pounds per acre per year for the Turkey Run Watershed. The pollutant loads increase the most in Subbasin TU-TU-002 because of the many changes from existing to future land use. All of the vacant land in Subbasin TU-TU-002, as well as a portion of the open space and a portion of the estate residential land will be low-intensity residential in the future, which generates more pollutants than the existing land use types.
