PINECREST GOLF COURSE

PRELIMINARY MASTER PLAN REPORT

June 1983

MORTENSEN ASSOCIATES

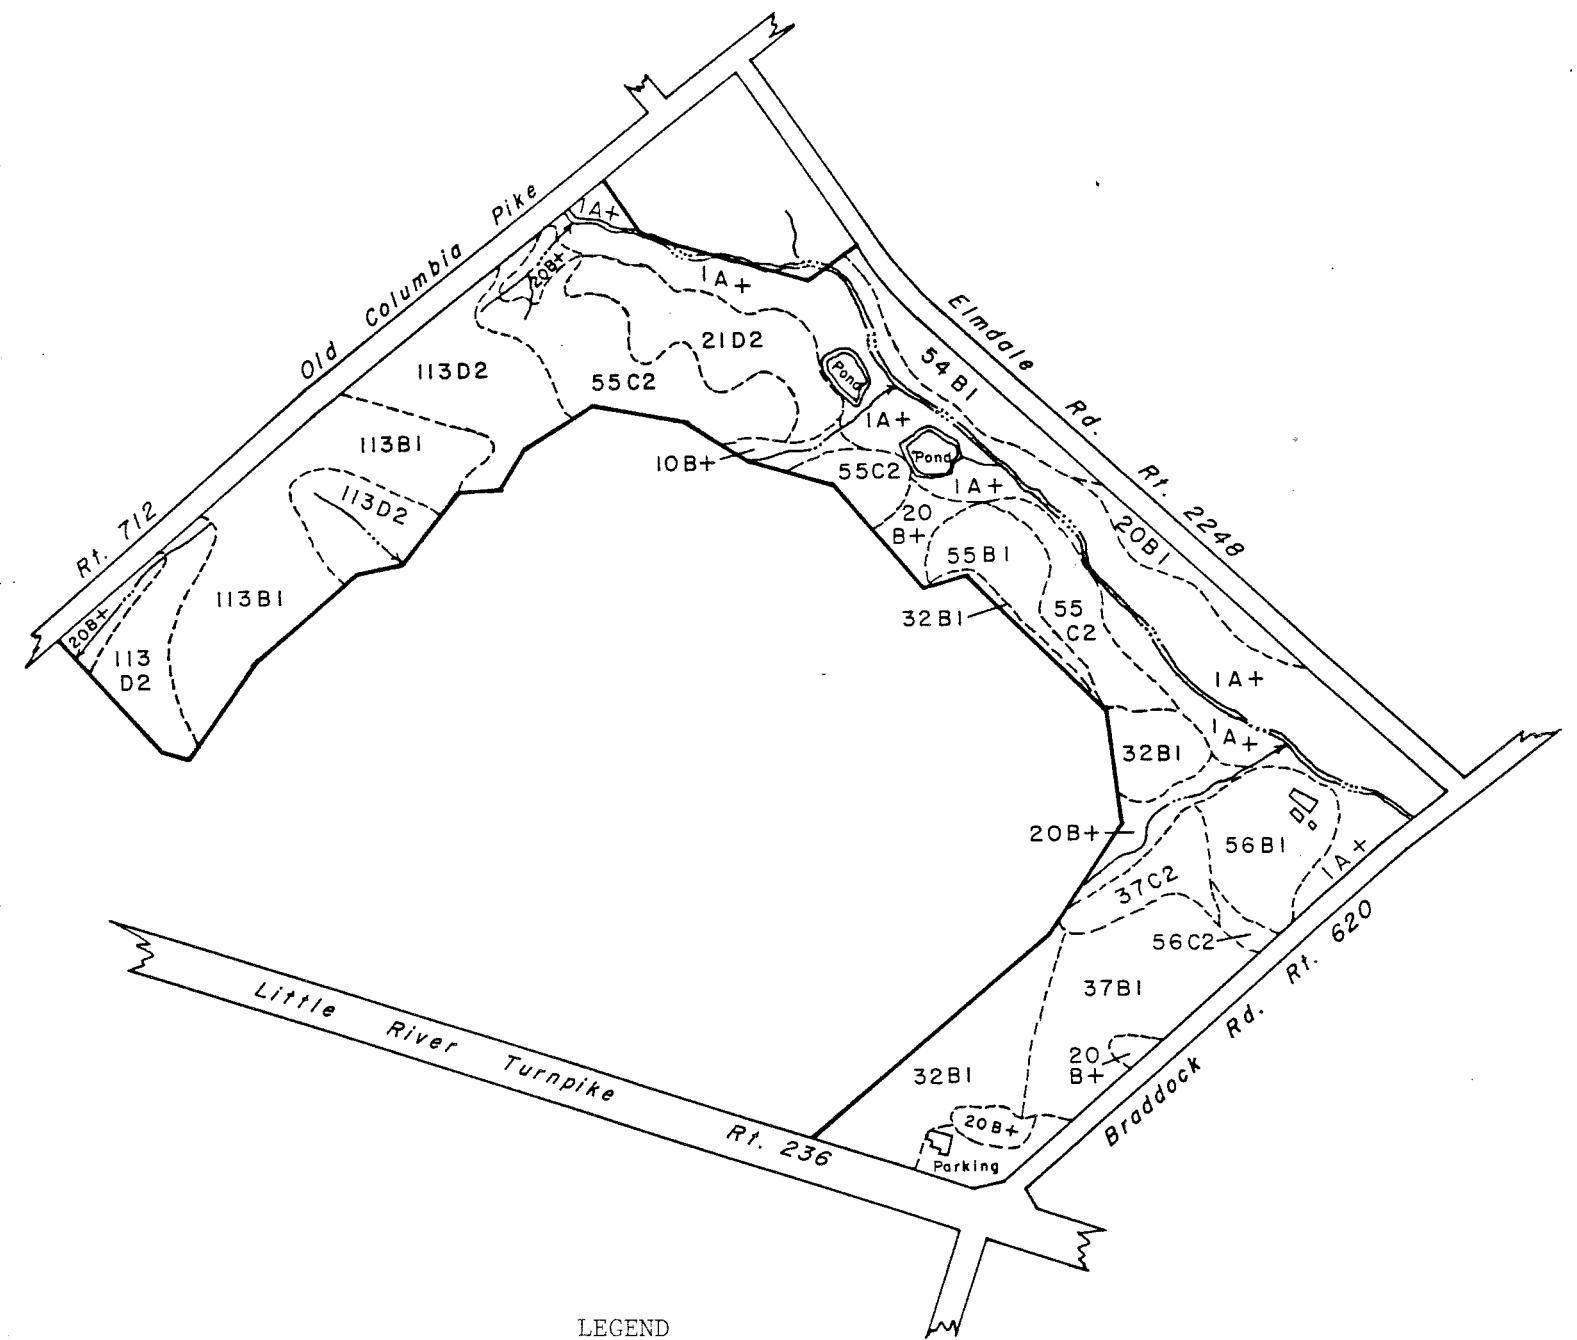
<u>Soil Symbol</u>	Soil Name	<u>% Slope</u>
lA+	Alluvial Soils (Flood Plain)	0-2
10B+	Glenville Silt Loam	2-7
20B+	Meadowville Silt Loam	2-7
21D2	Manor Silt Loam	14-25
32B1	Fairfax Silt Loam	2-7
37B1	Beltsville Silt Loam	2-7
54B1	Sassafras Loam	2-7
55B1	Glenelg Silt Loam	2-7
55C2	Glenelg Silt Loam	7-14
113B1	Fairfax Gravelly Loam	2-7
1·13C2	Fairfax Gravelly Loam	7-14
	Soil Boundary	
Scale:	1" = 500 feet	
By:	L. K. Johnson, Soil Scientist	•
	Fairfax County Soil Survey Office	
Date:	June 6, 1983 15

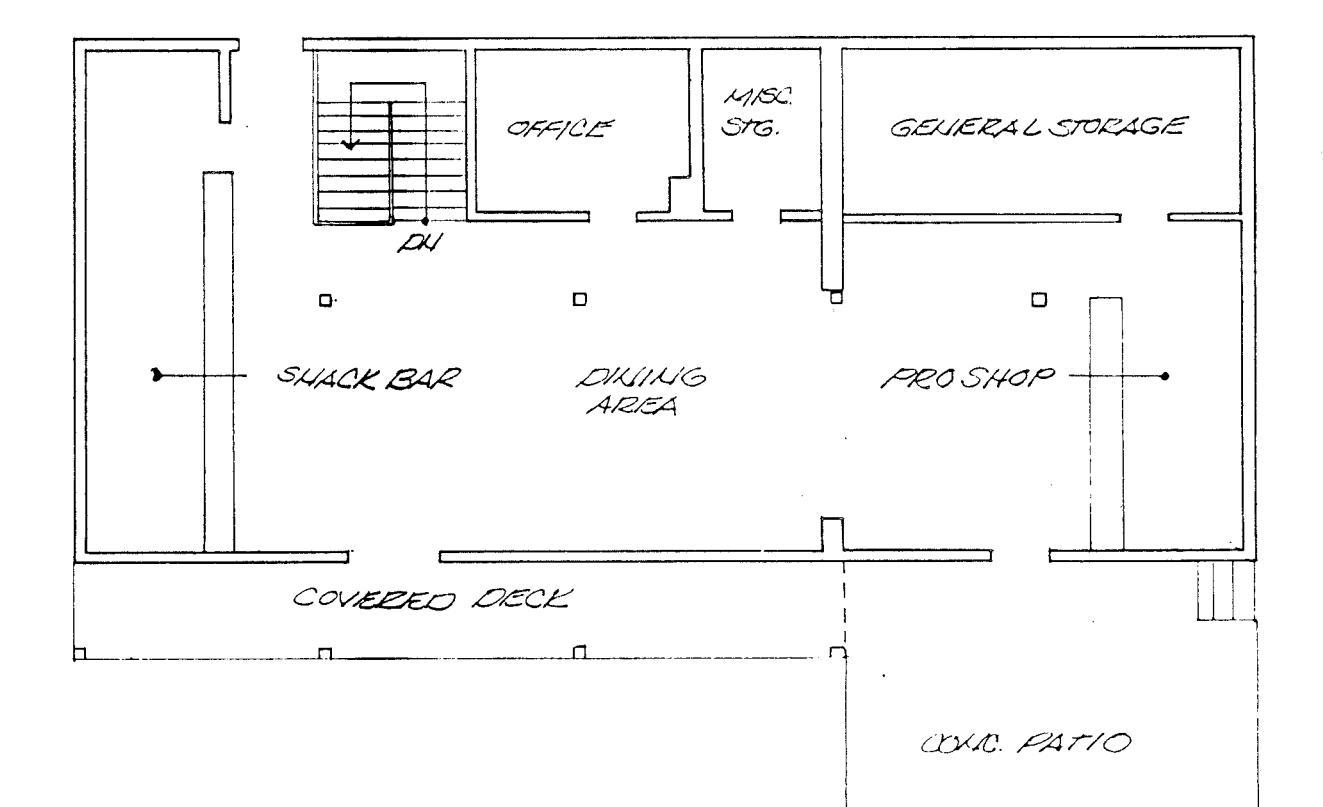
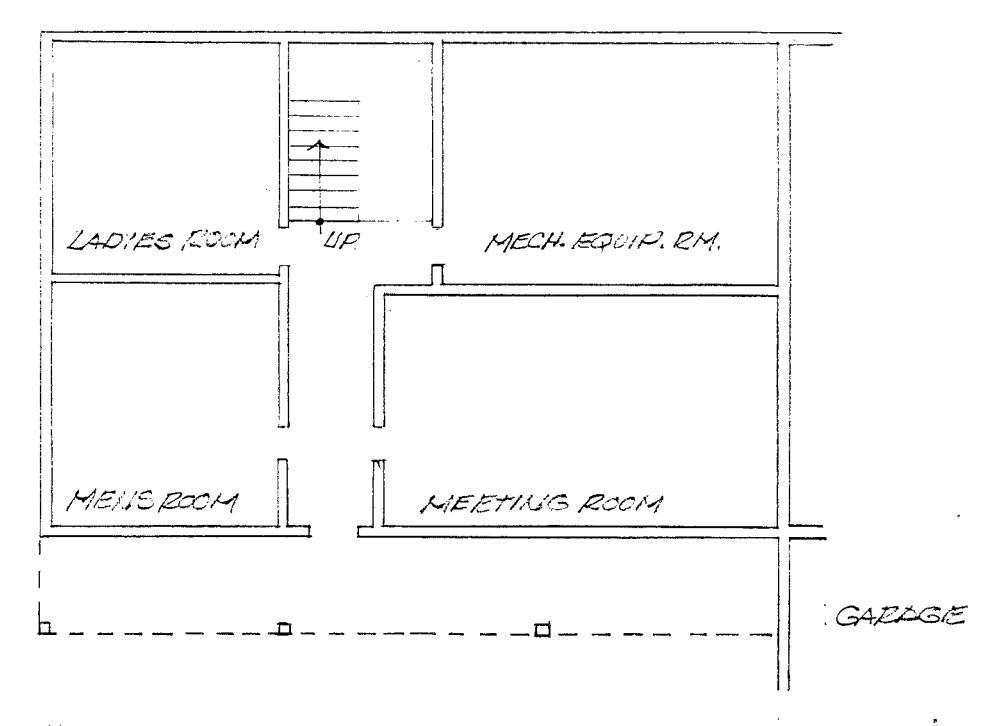
LOWER LEVEL

The building's structural system is heavy timber post and beam with heavy timber roof rafters, wood deck, and composition aggregate roofing on a gable roof. The high point of the gable runs along the long axis of the building. The perimeter wall infill is a combination of brick veneer, wood siding, and floor to ceiling glazing. Due to the simplicity of this system the building would be easily expandable along the long axis to the east and west or perpendicular to the main axis to the north and south. Expansion to the north and south parallel to the main axis would be more difficult. Since this expansion would take place at the eave line of the roof a new roof form would have to be introduced because an extension of the present roof slope would (depending on the width of the expansion) result in new eave line with less than acceptable head room off the finish floor. We feel that to introduce a new roof form of relatively small square footage would most likely result in visual discord. The following space/square foot analysis compares the space requirements identified in the programming portion of this study with the spaces as they presently exists.

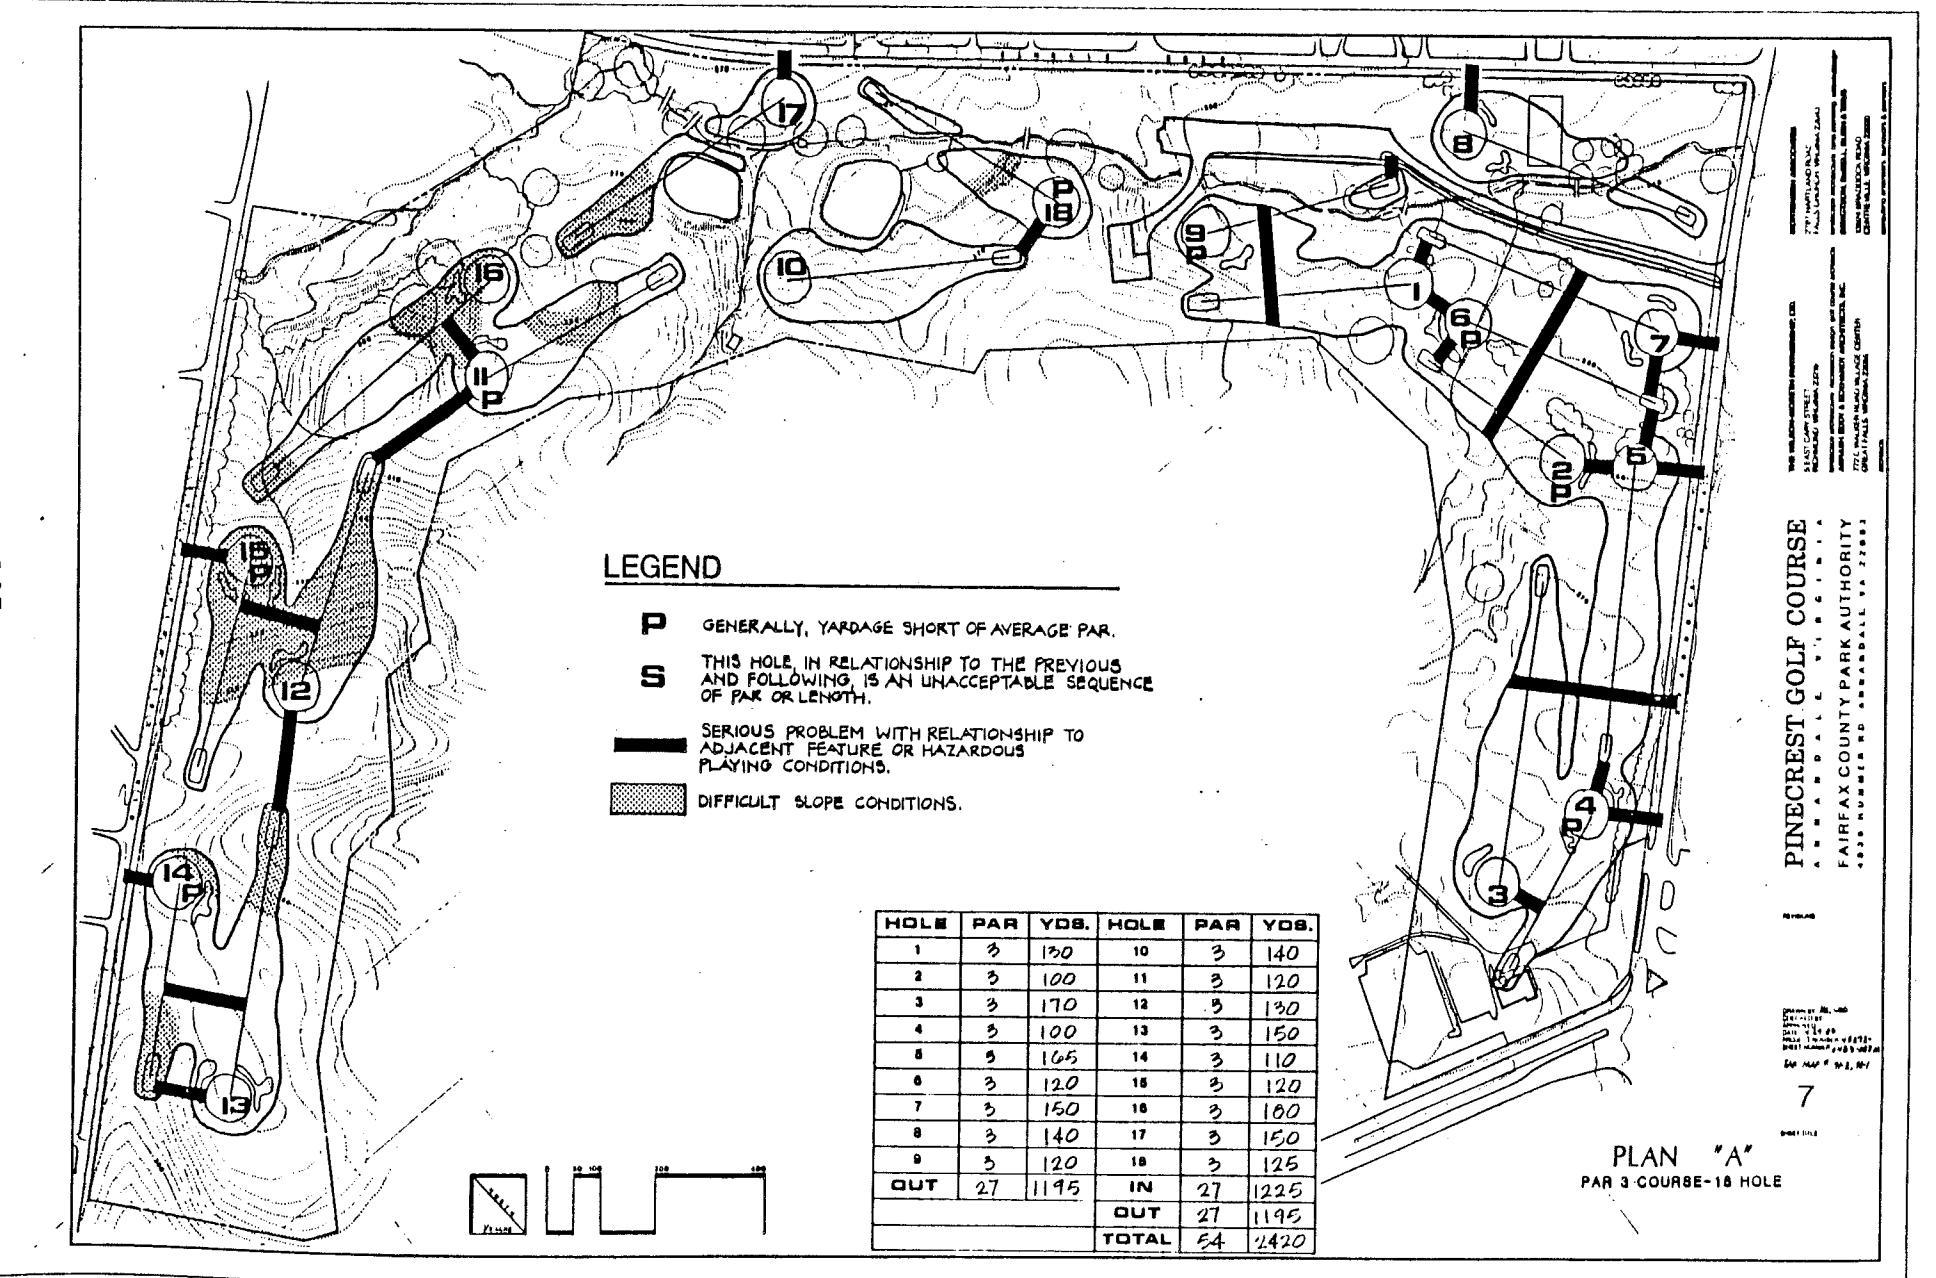
PINECREST GOLF COURSE REVIEW OF PLAN "A"

- I. UTILITIES
 - A. Sanitary
 - 1) A 12" sewer line is available on the south side of Elmdale Road; however, the existing sewer line is higher than the stream invert.

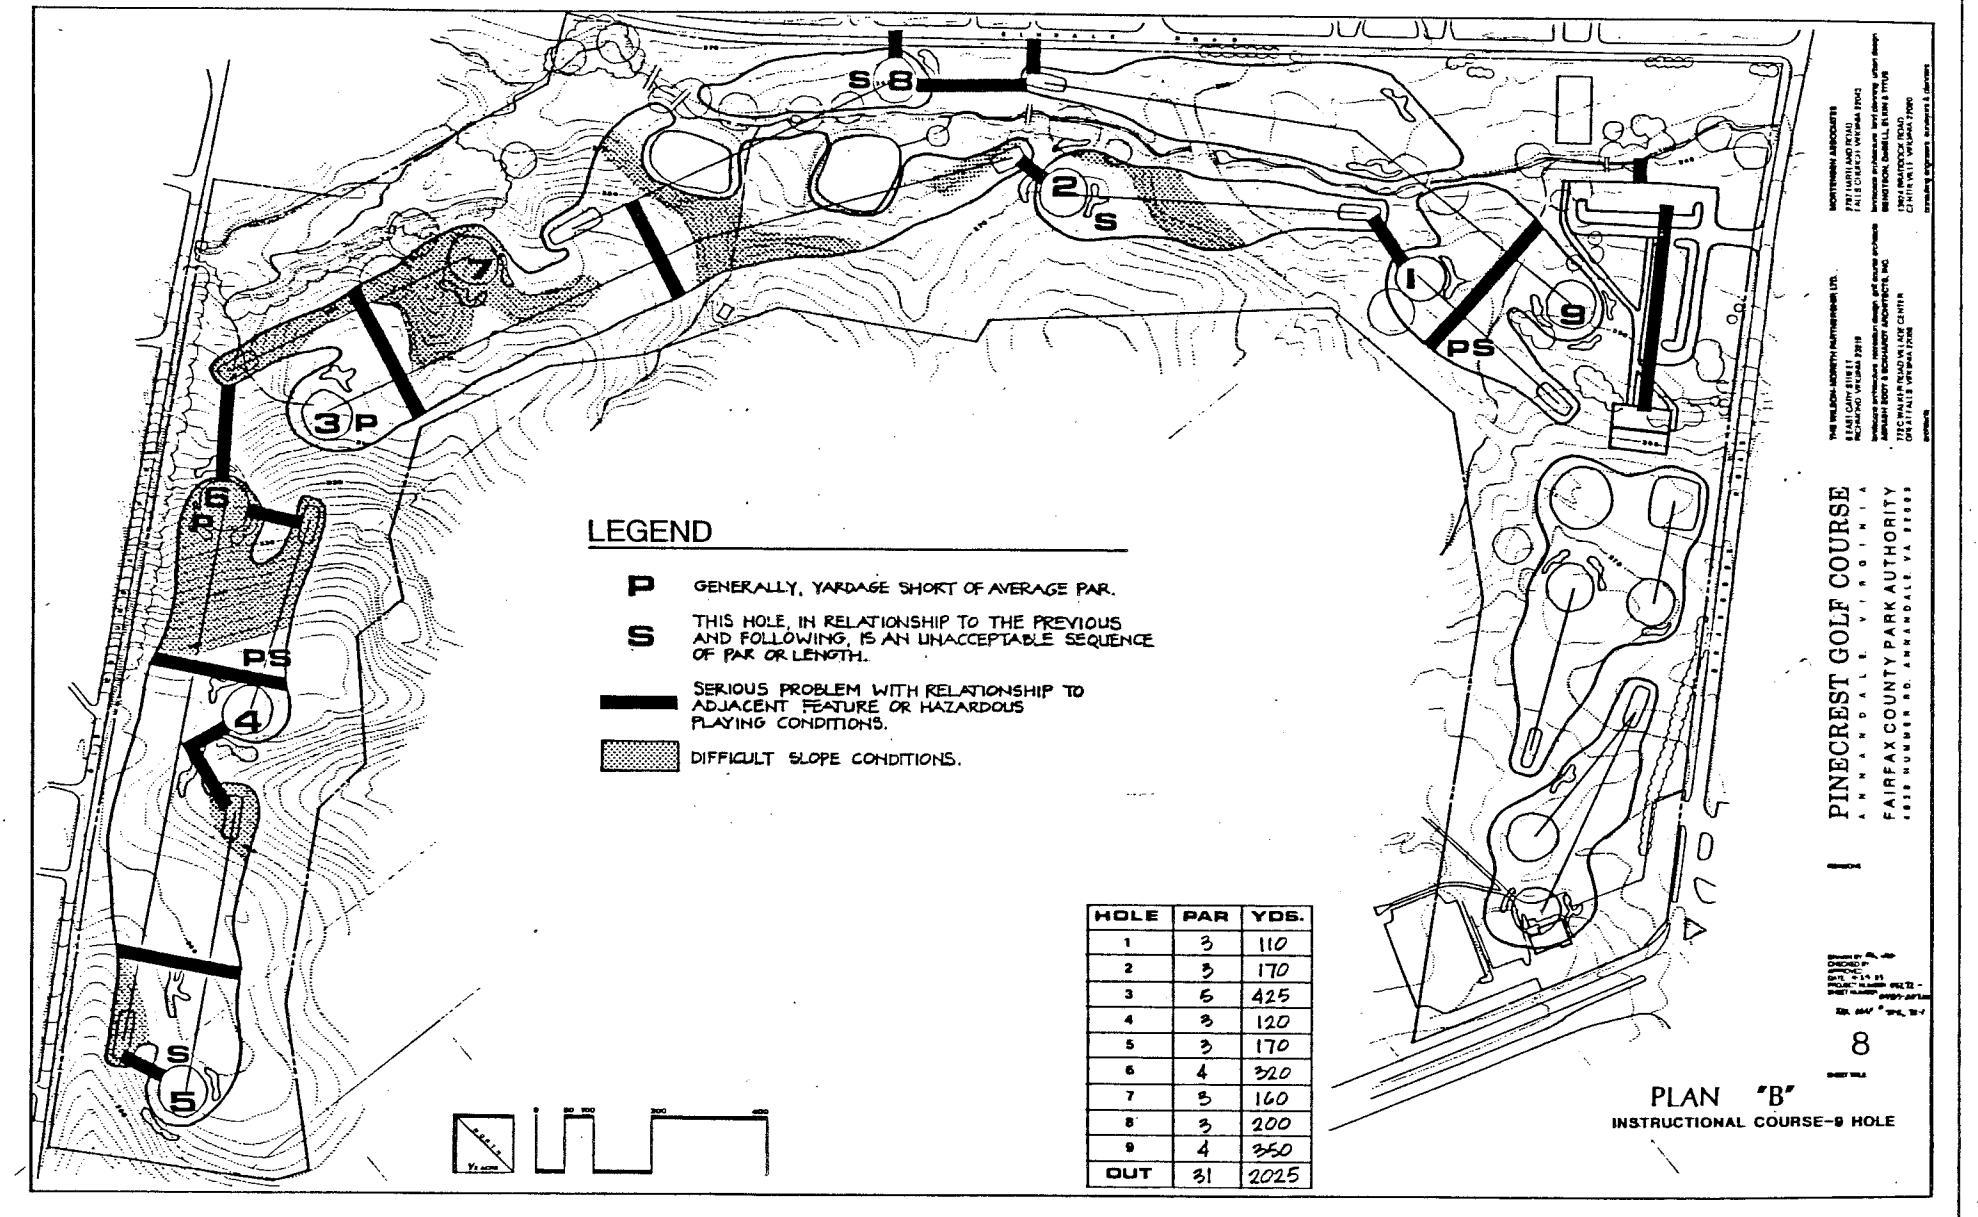
PINECREST GOLF COURSE REVIEW OF PLAN "B"

I. UTILITIES

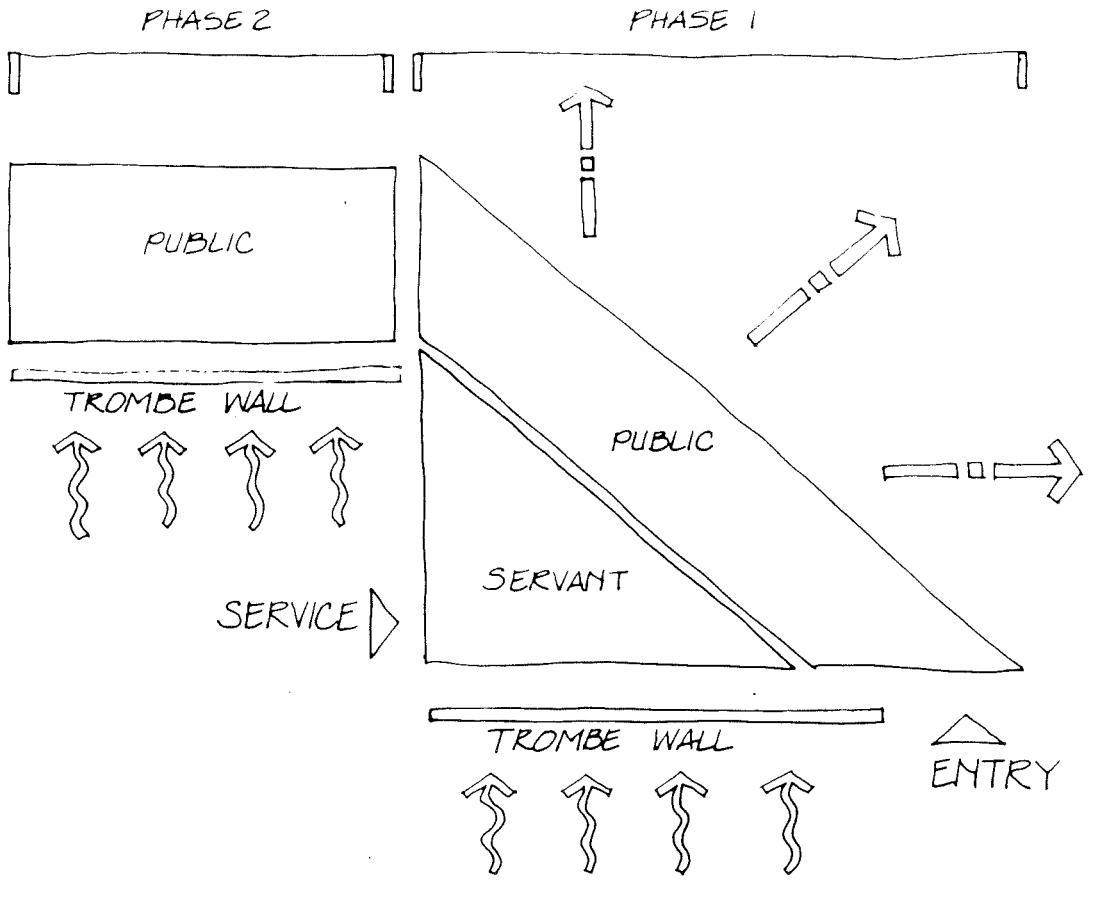
SITE CONSIDERATIONS

- SOLAR GAIN
- MAXIMIZE PUBLIC EXPOSLIRE TO GOLF COURSE/CONVENIENT ACCESS TO BERVANT FUNCTIONS AND GOLF COURSE
- · GROUP SERVANT FUNCTIONS FOR MOST EFFICIENT OPERATION/CONTROL

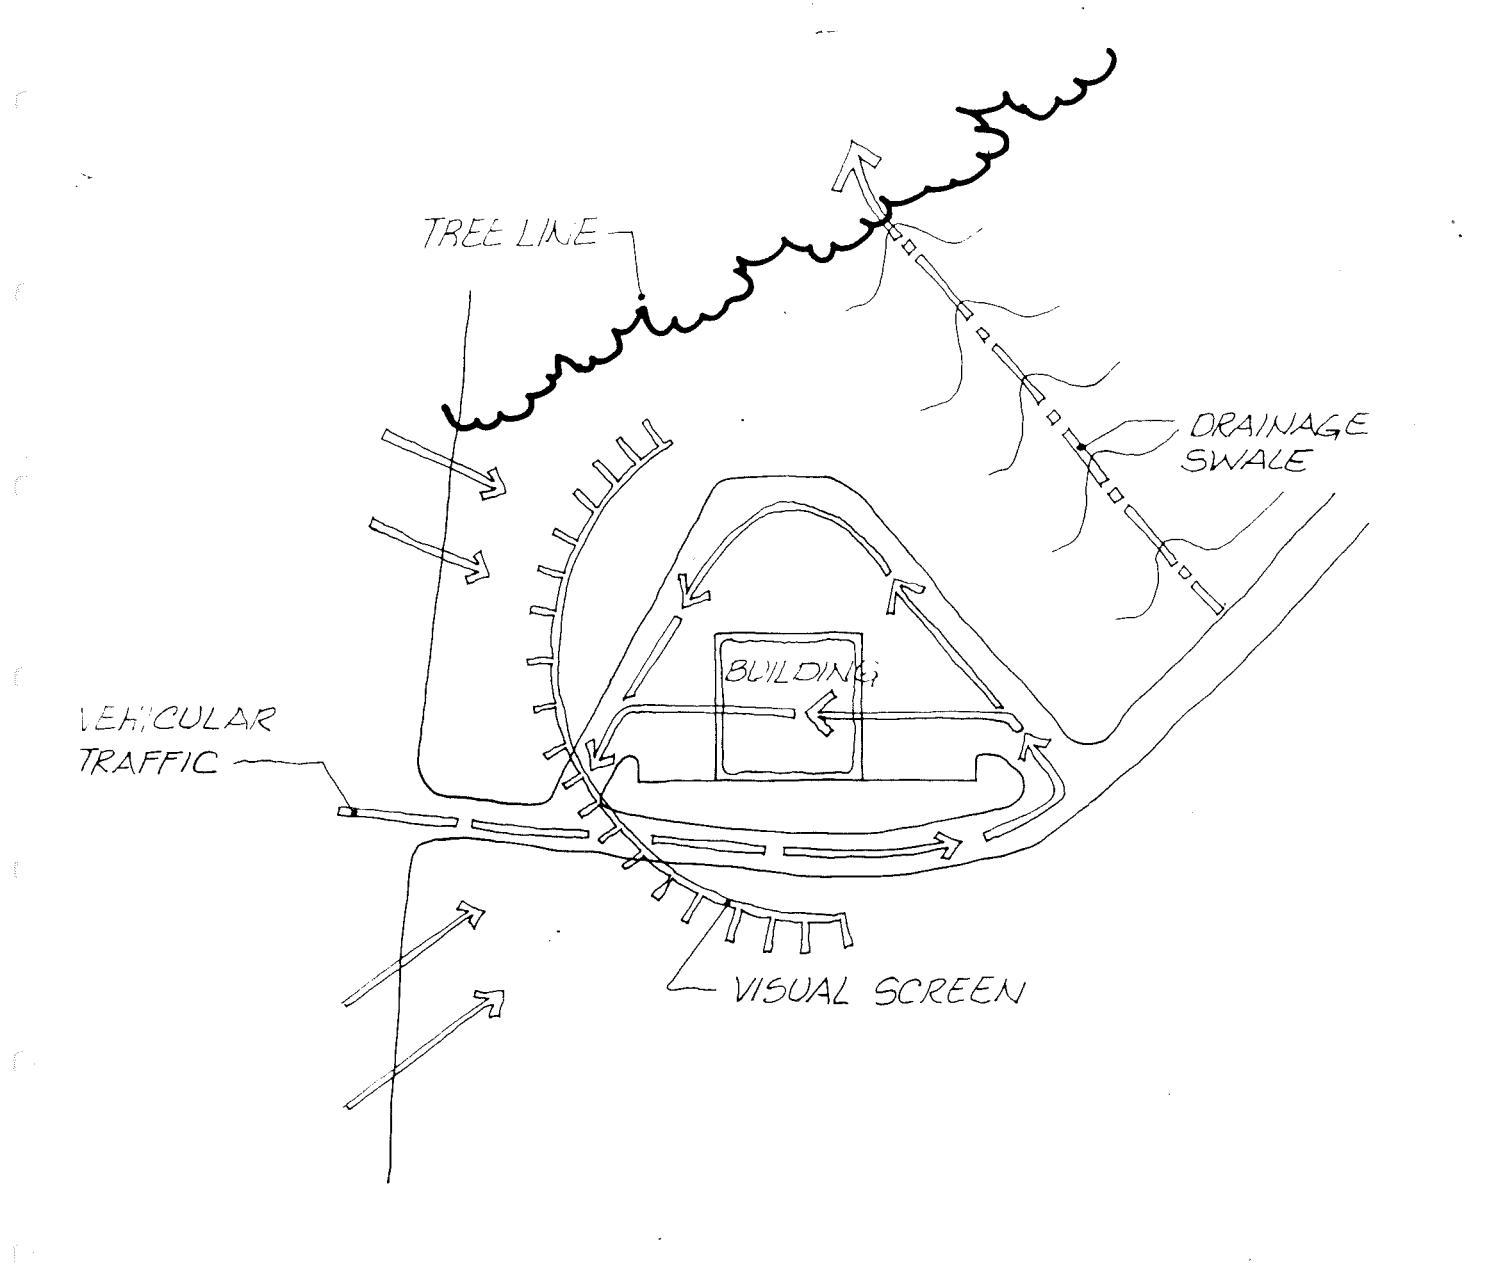
1 SITE CONSIDERATIONS

- · PROPOSED ROADS.
- EXISTING TREES/DRAINAGE SYSTEM.
- · TRAFFIC FLOW-AROUND AND THRU BUILDING.
- · SCREEN MAINTENANCE AREA FROM VIEW.

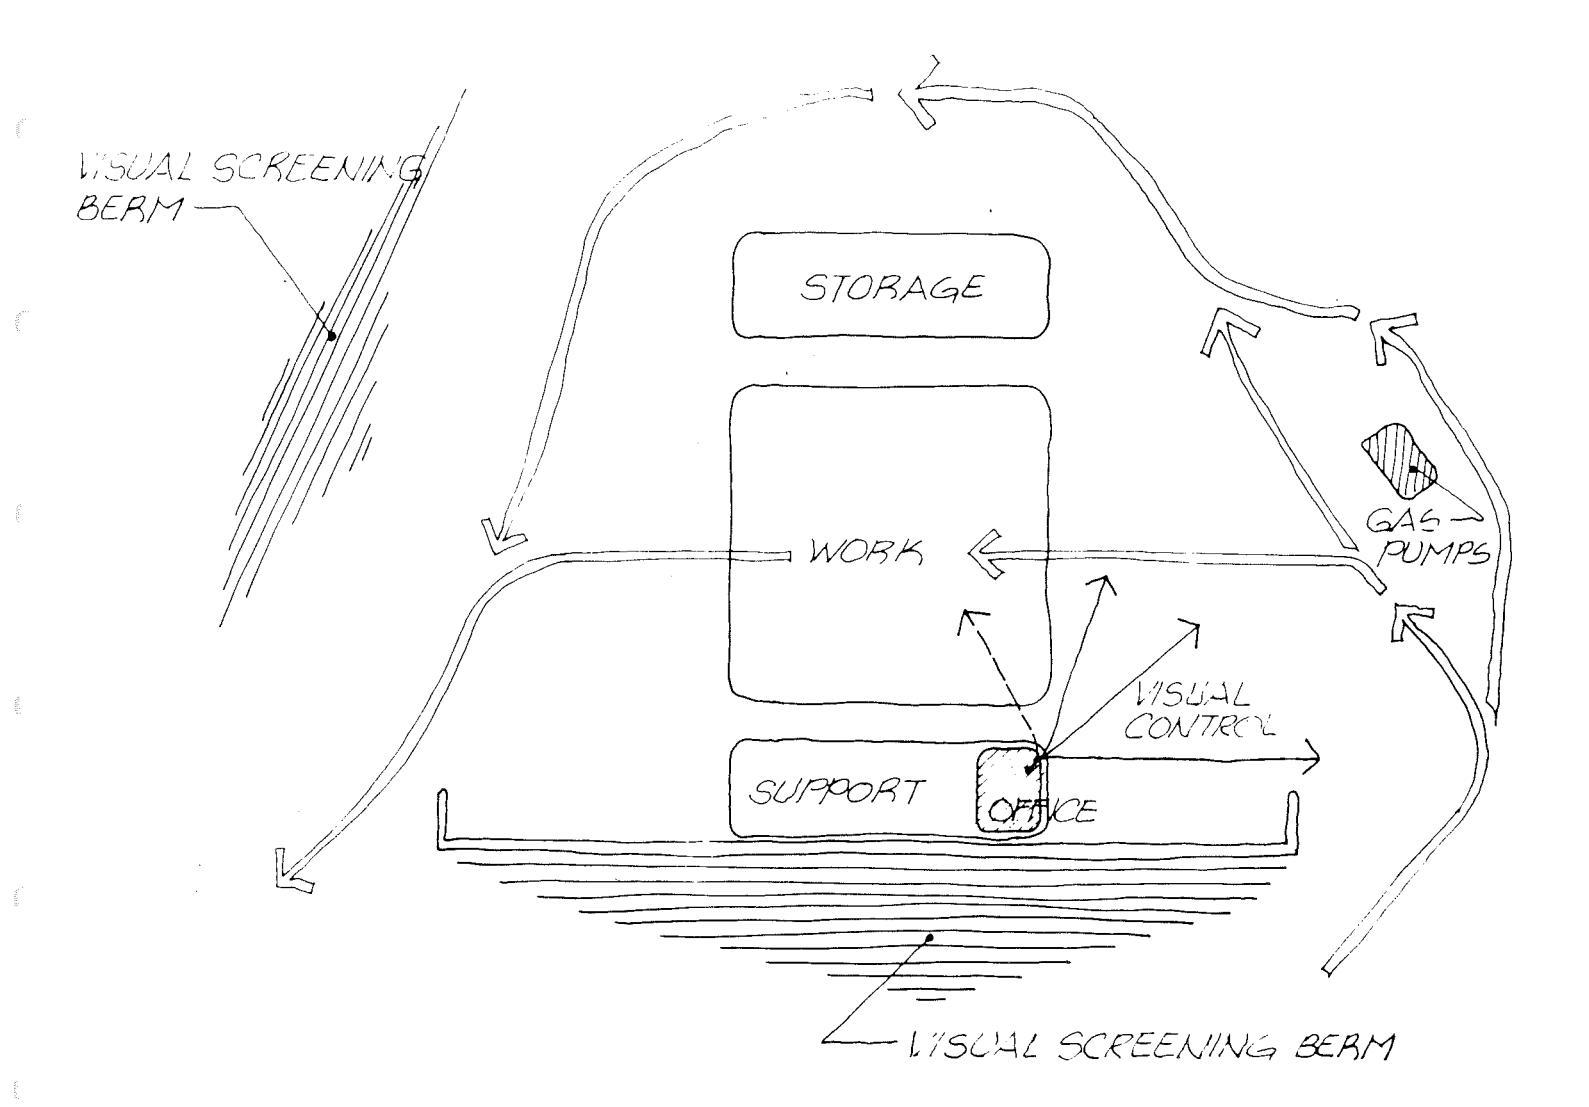
- OFFICE TO HAVE VIEW OF ALL VEHICLES ENTERING THE MAINTENANCE YARD; GAS PUMPS AND WORK VEHICLE. ENTERING MAINTENANCE WORK AREA.
- · BUILDING SHOULD BE COMPACT, EASILY ACCESSAIBLE AND REQUIRE A MINIMUM OF MAINTENANCE.
