PINECREST GOLF COURSE

PRELIMINARY MASTER PLAN REPORT

June 1983

MORTENSEN ASSOCIATES

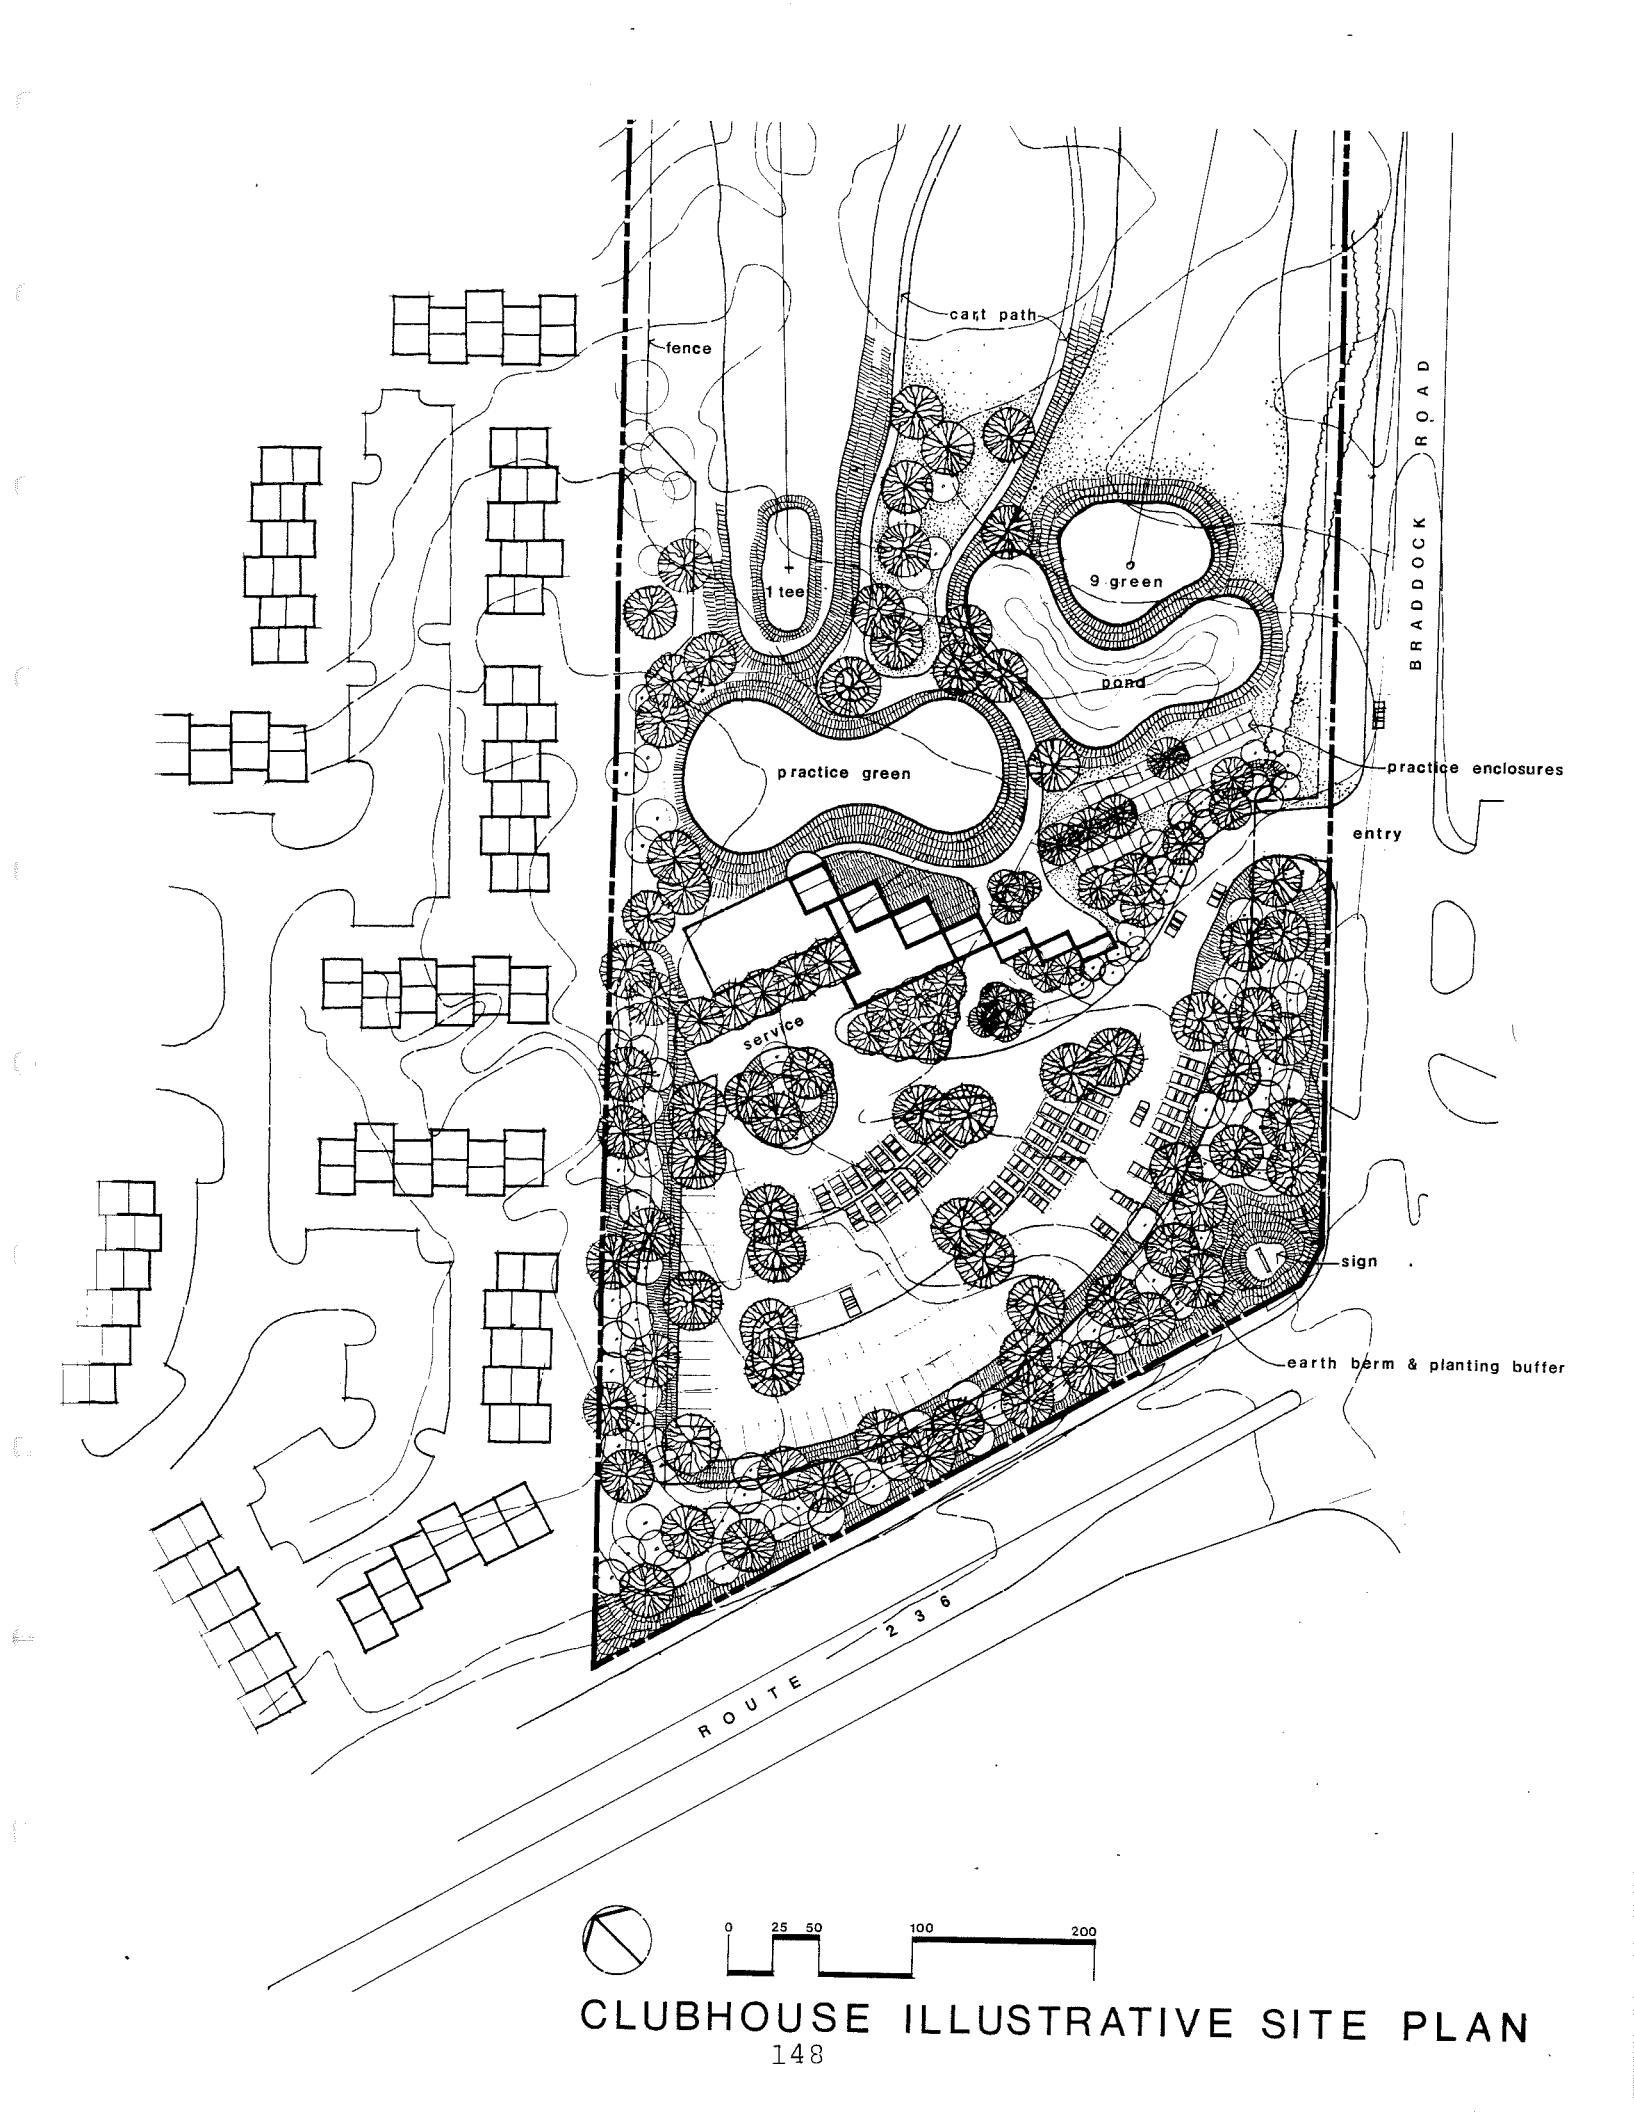
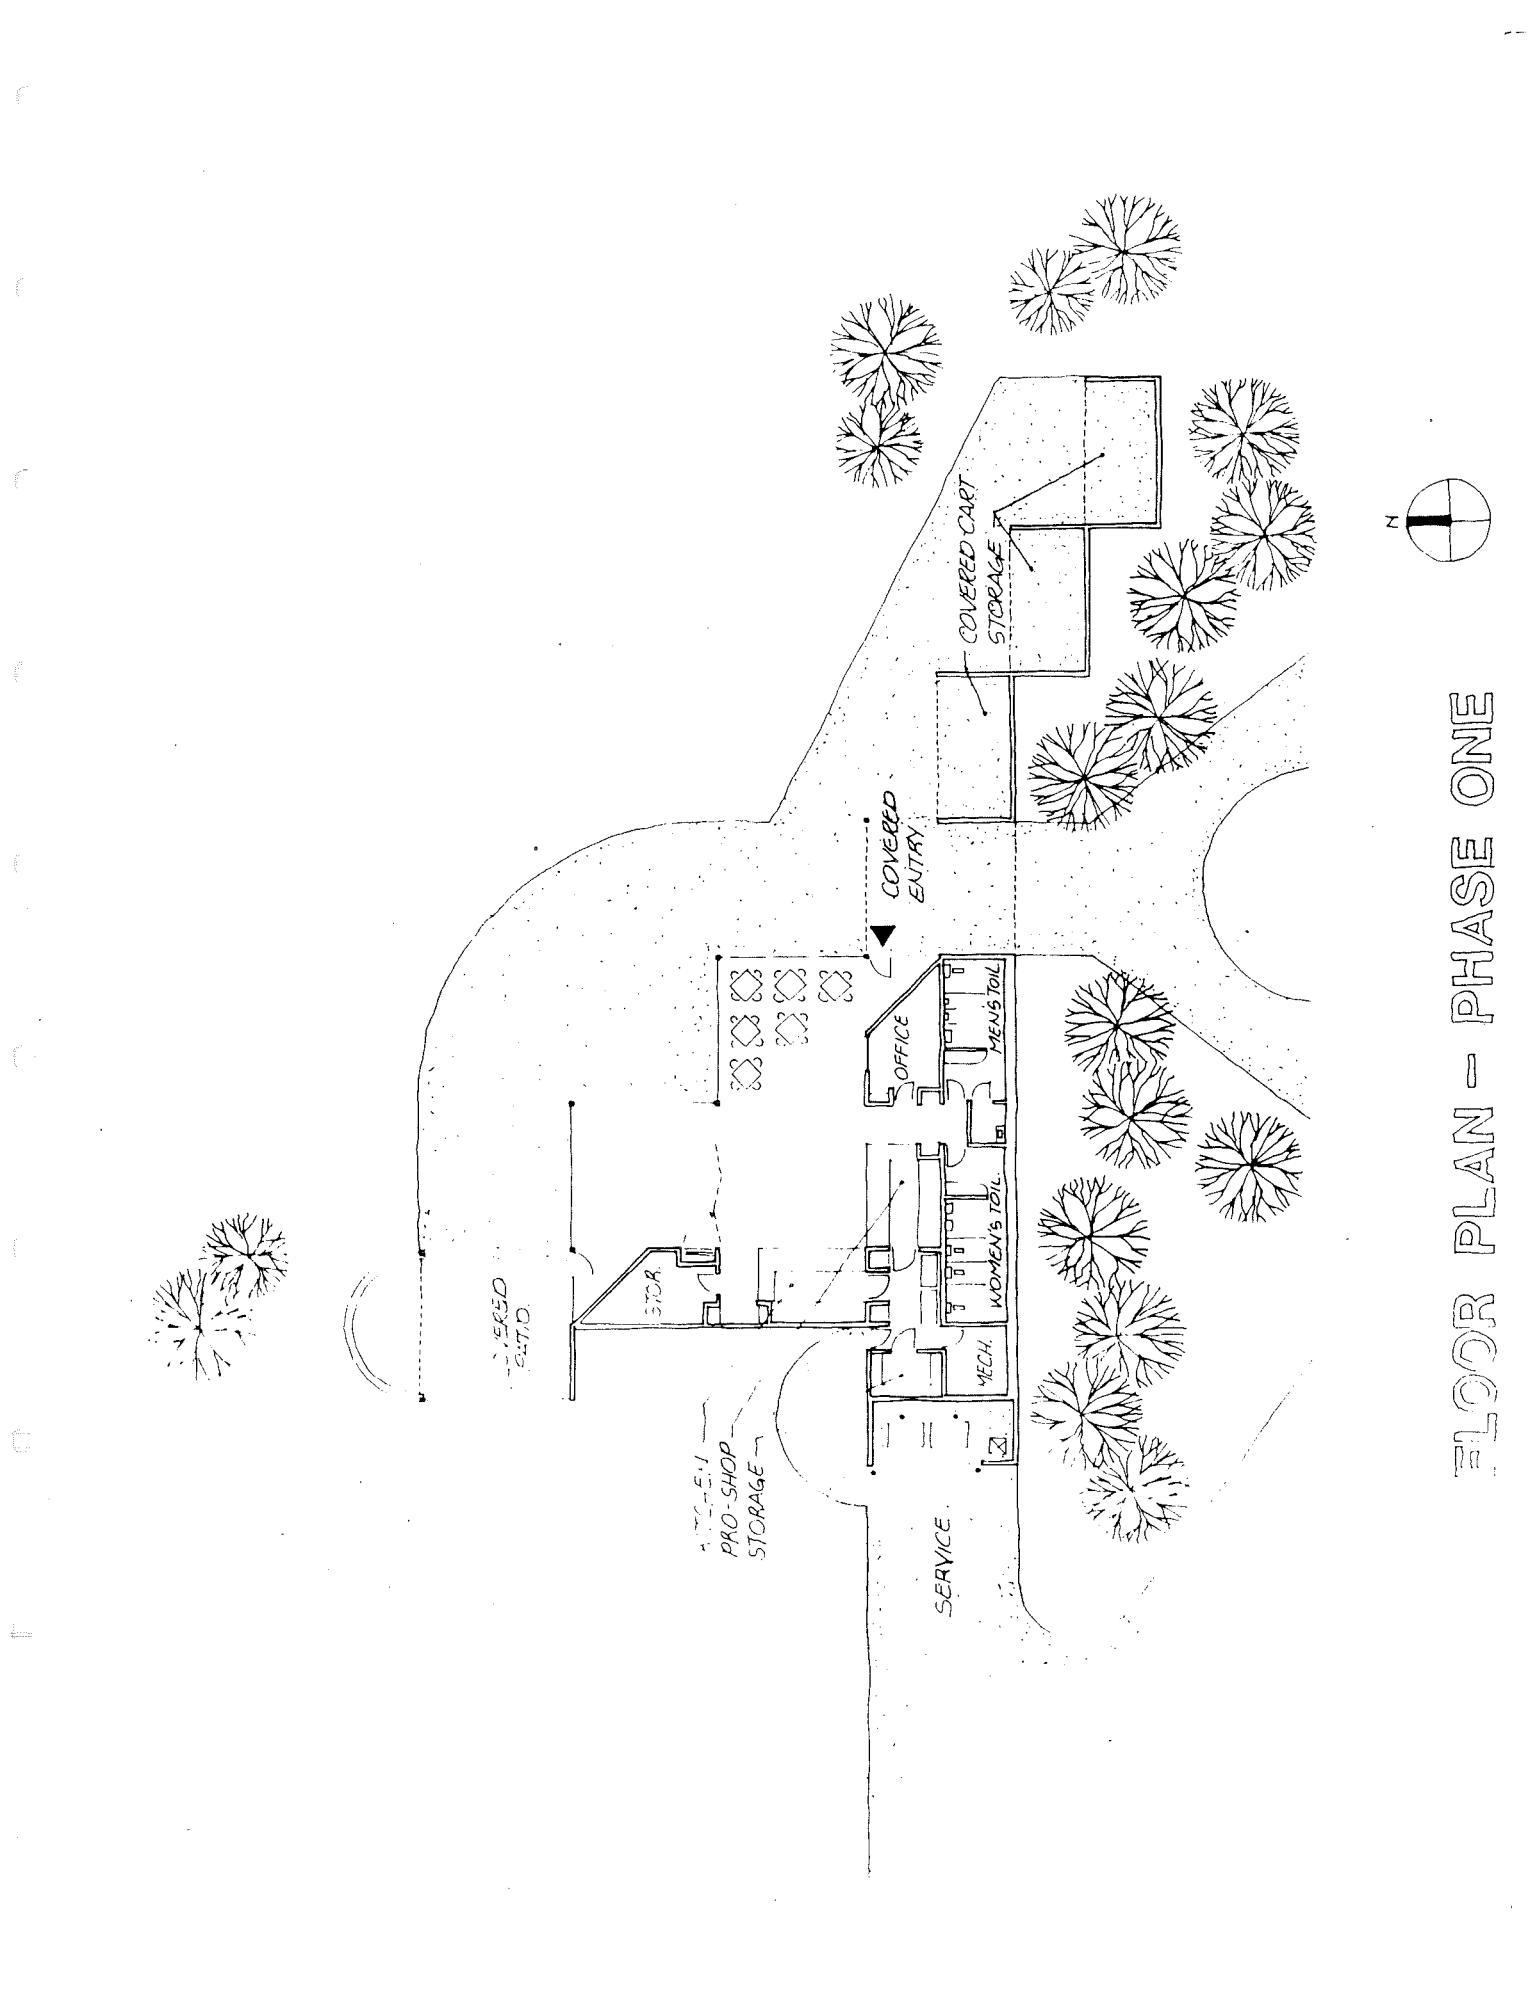
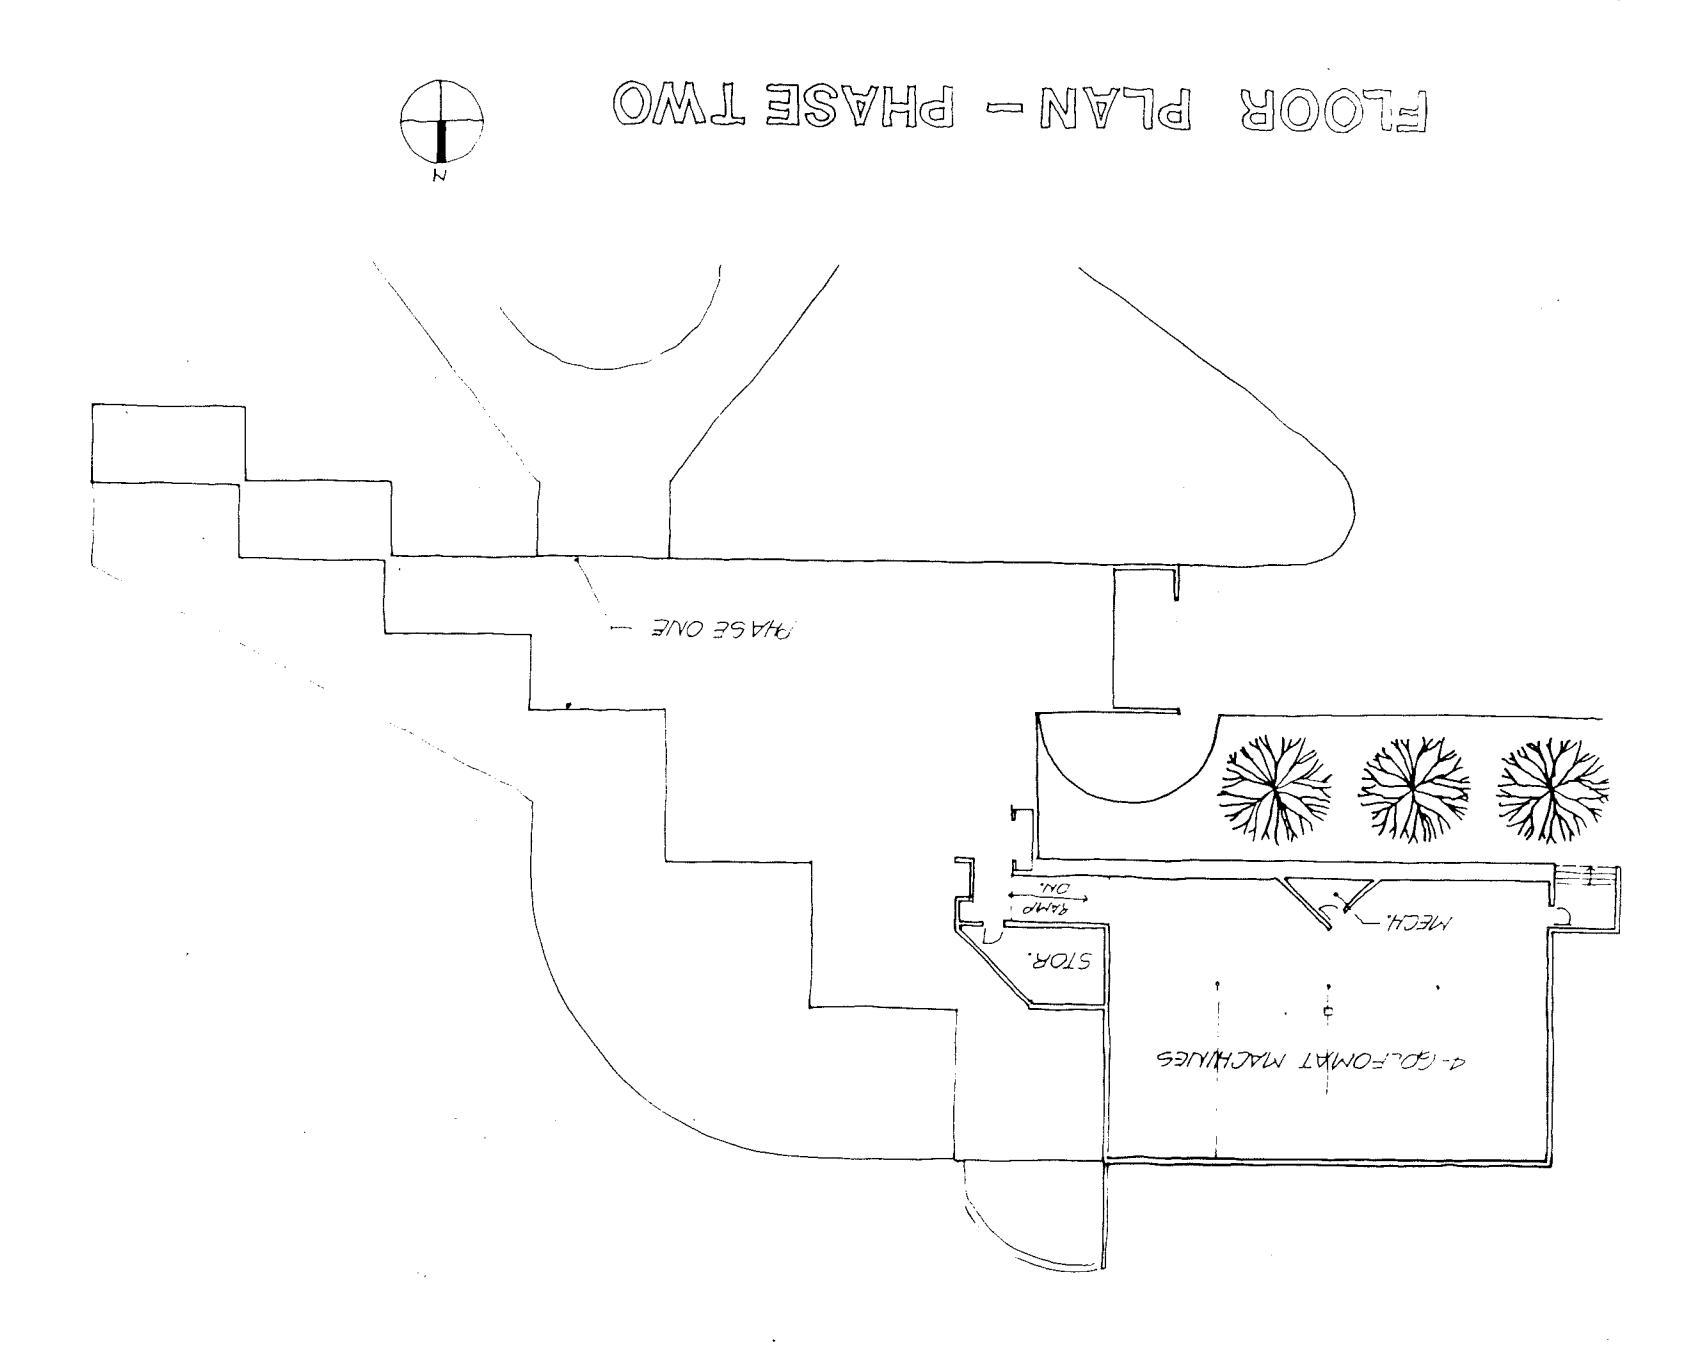
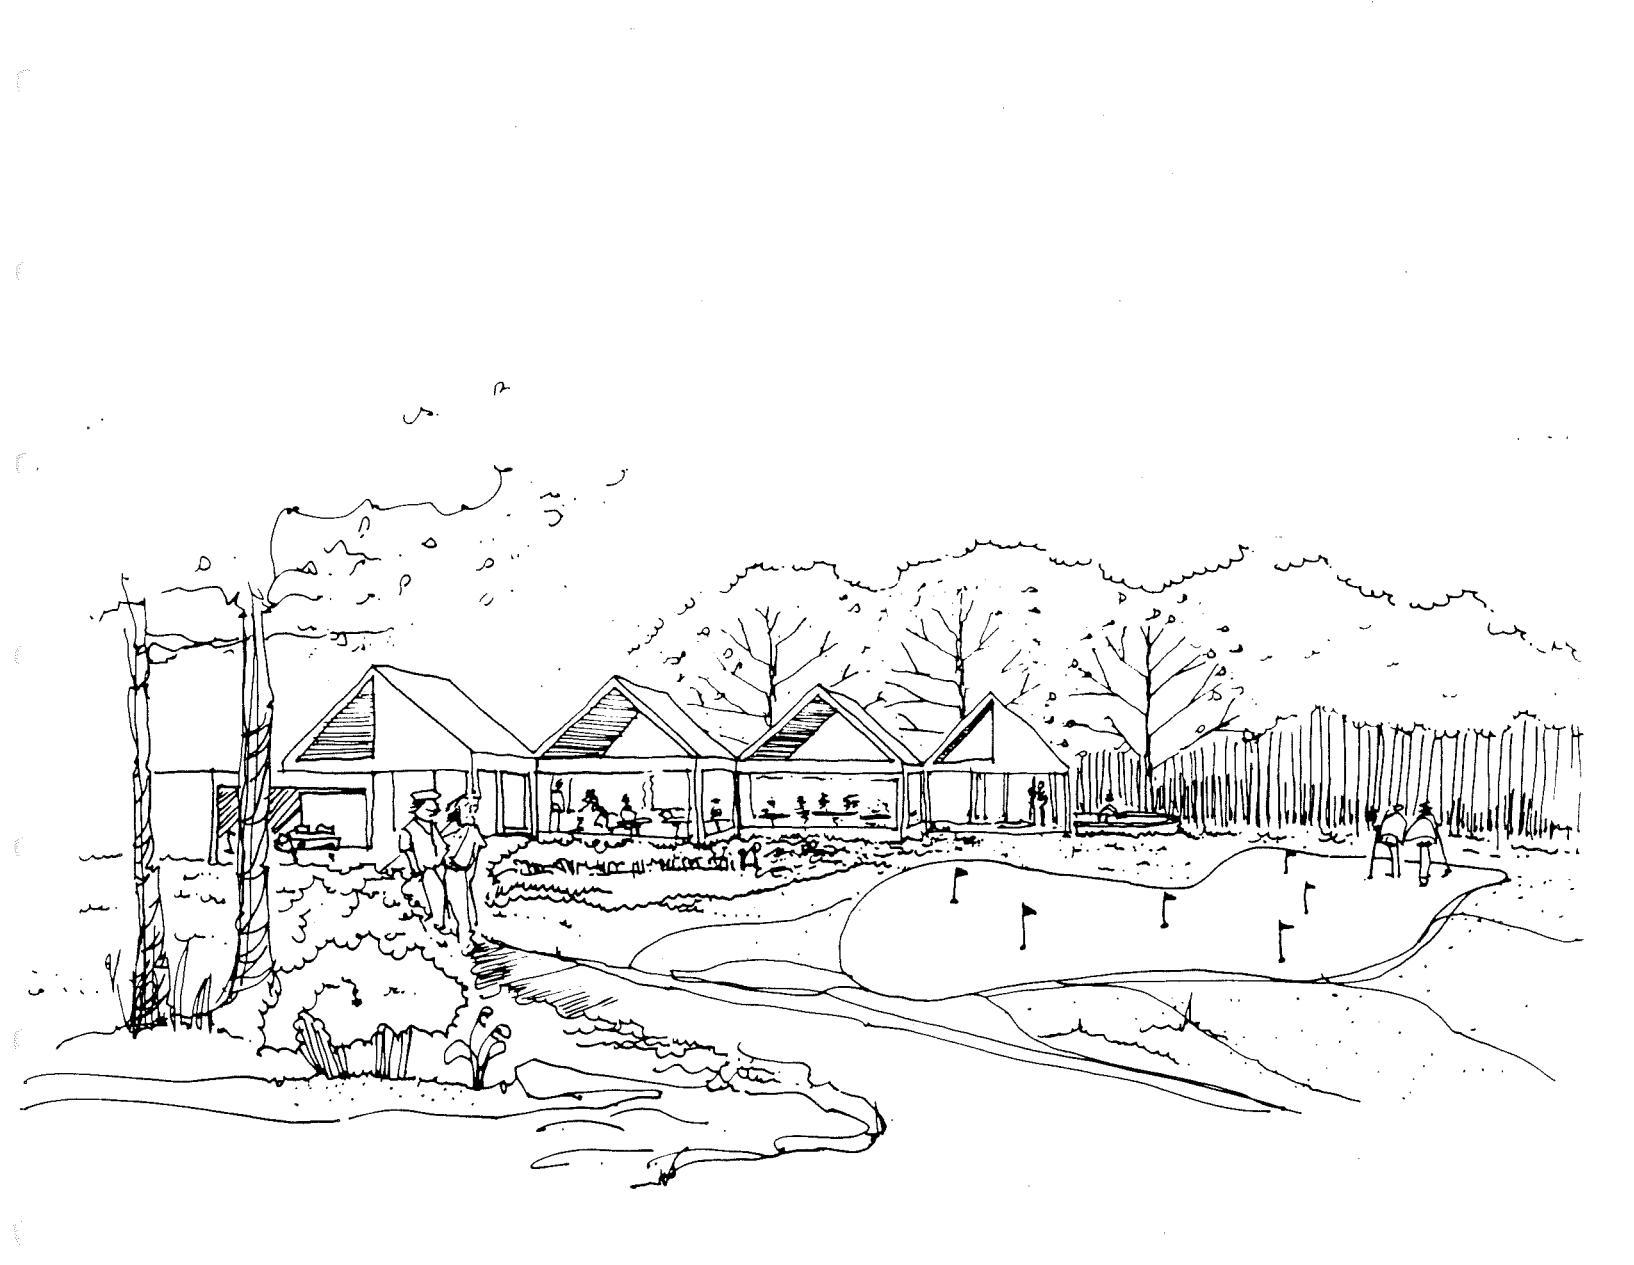
CLUBHOUSE

Materials to be used on the interior of the building are discussed in the Program for each of the spaces being housed. Proposed exterior materials are wood siding, wood shingle roofing (on the gabled roofs), single ply membrane roofing on the flat roof, insulated glazing materials, and hollow metal exterior doors.

Phase II of the project is a 2600 square foot structure to house four computer operated golfomatic machines. Circulation to the structure will be from the main clubhouse. Its form and materials will be a natural extension of the main clubhouse structure.

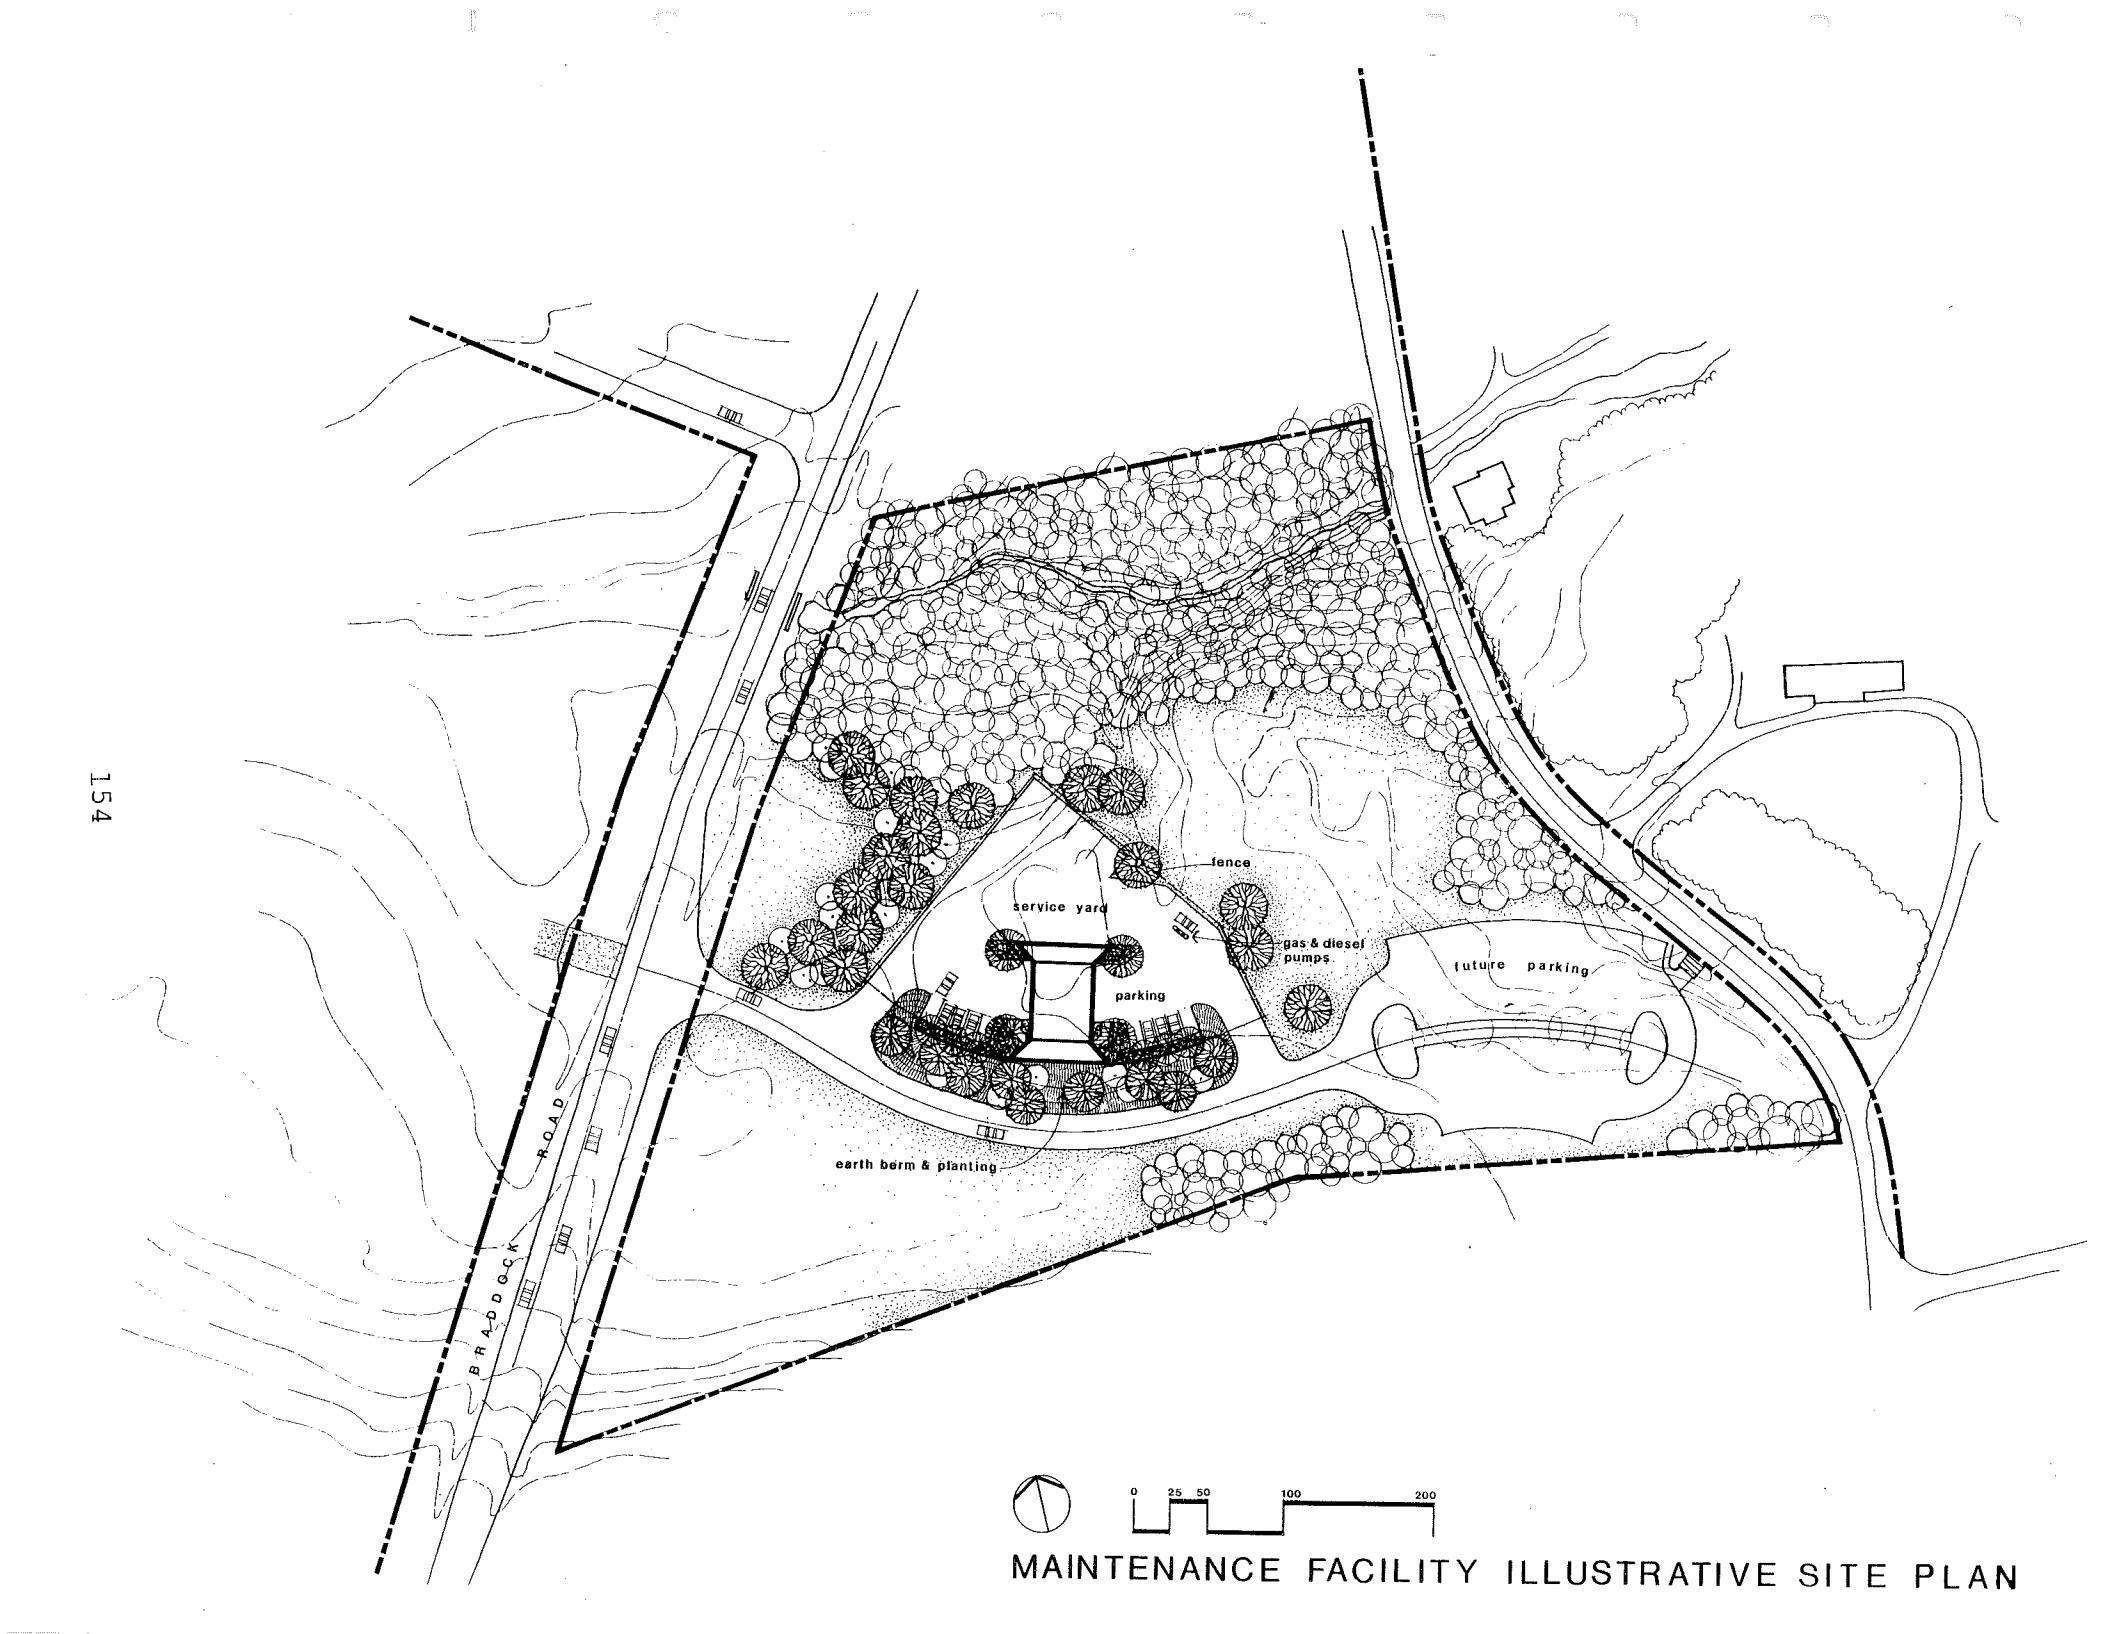
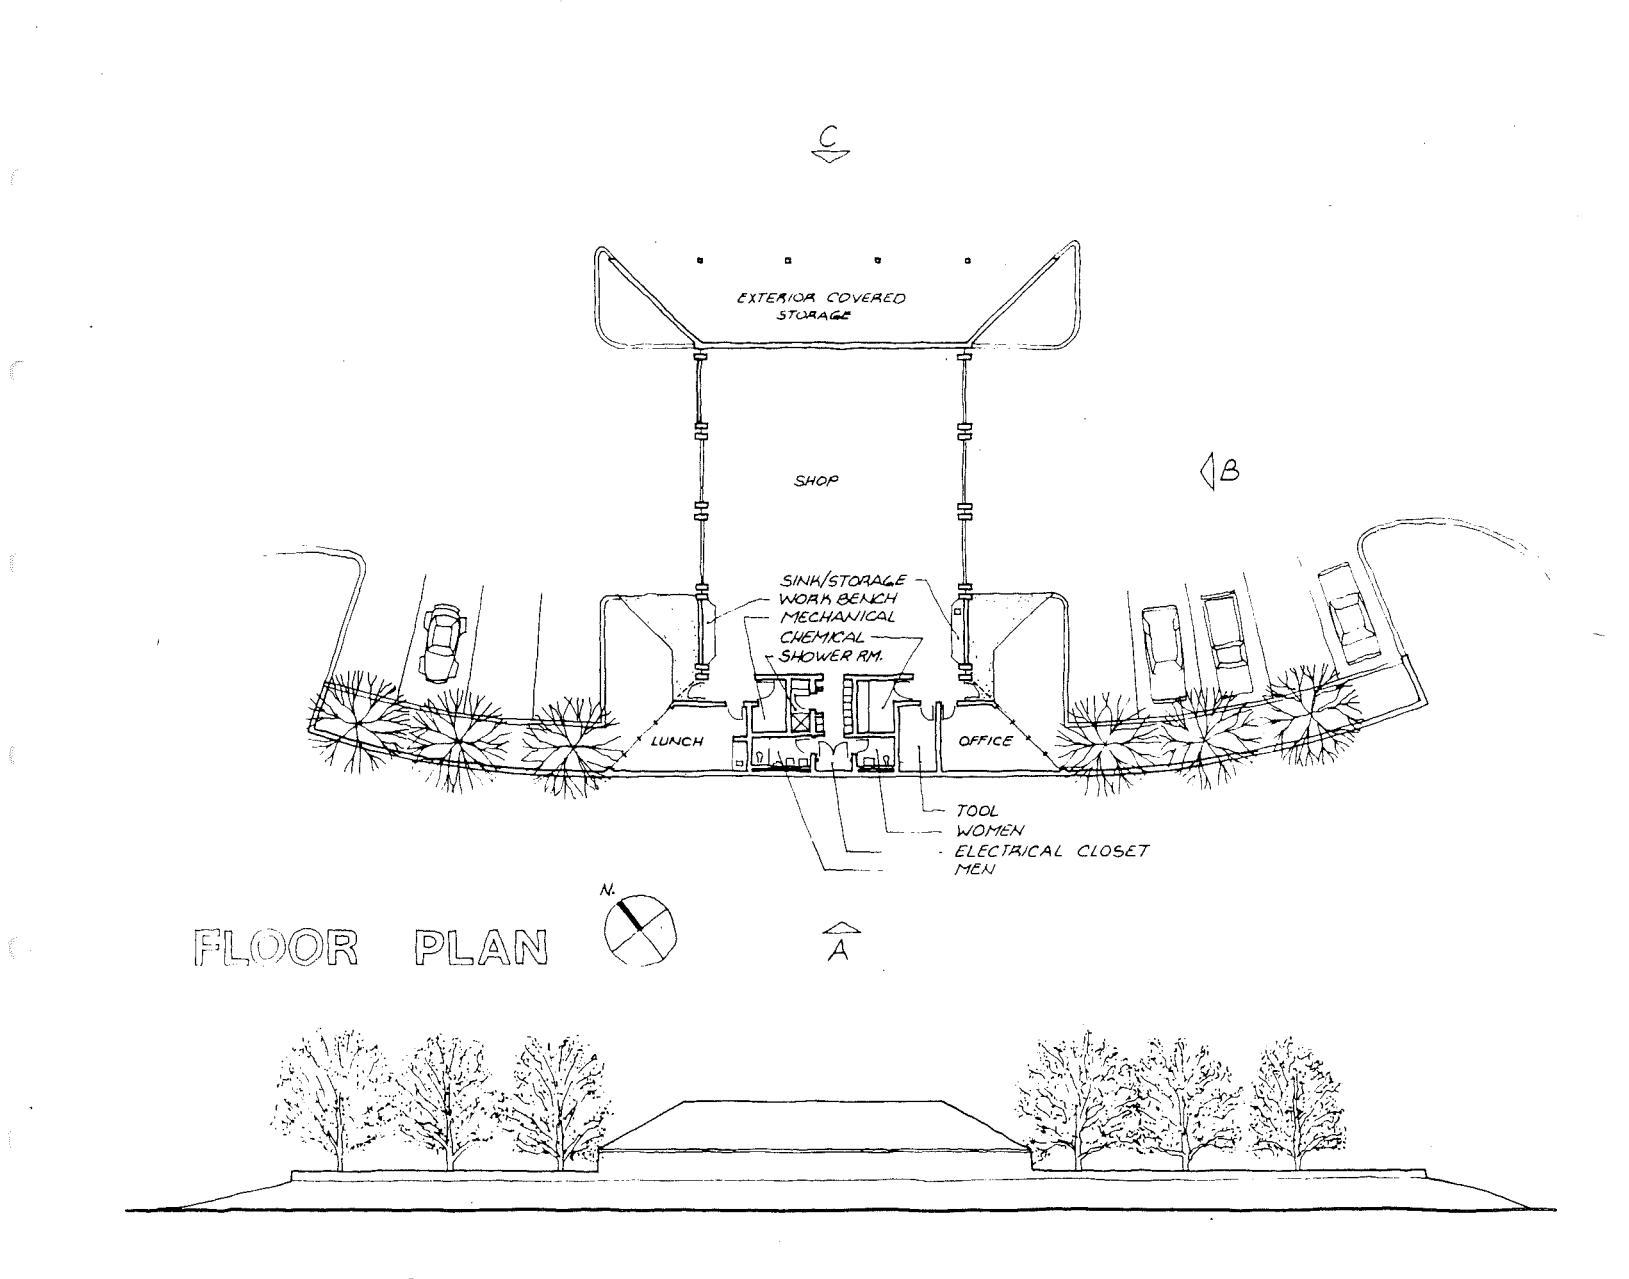
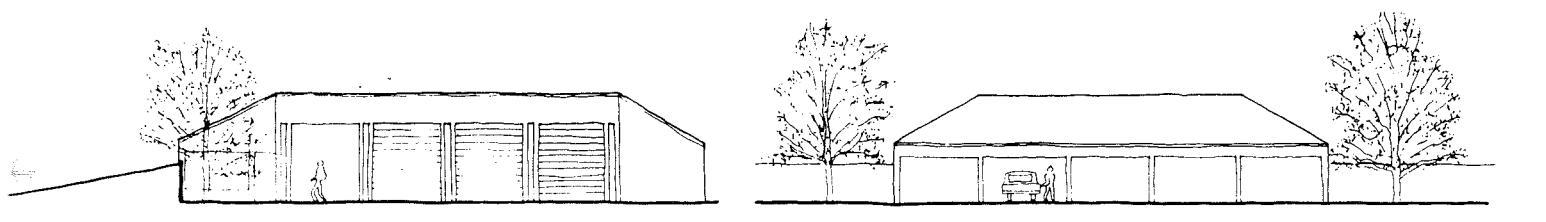
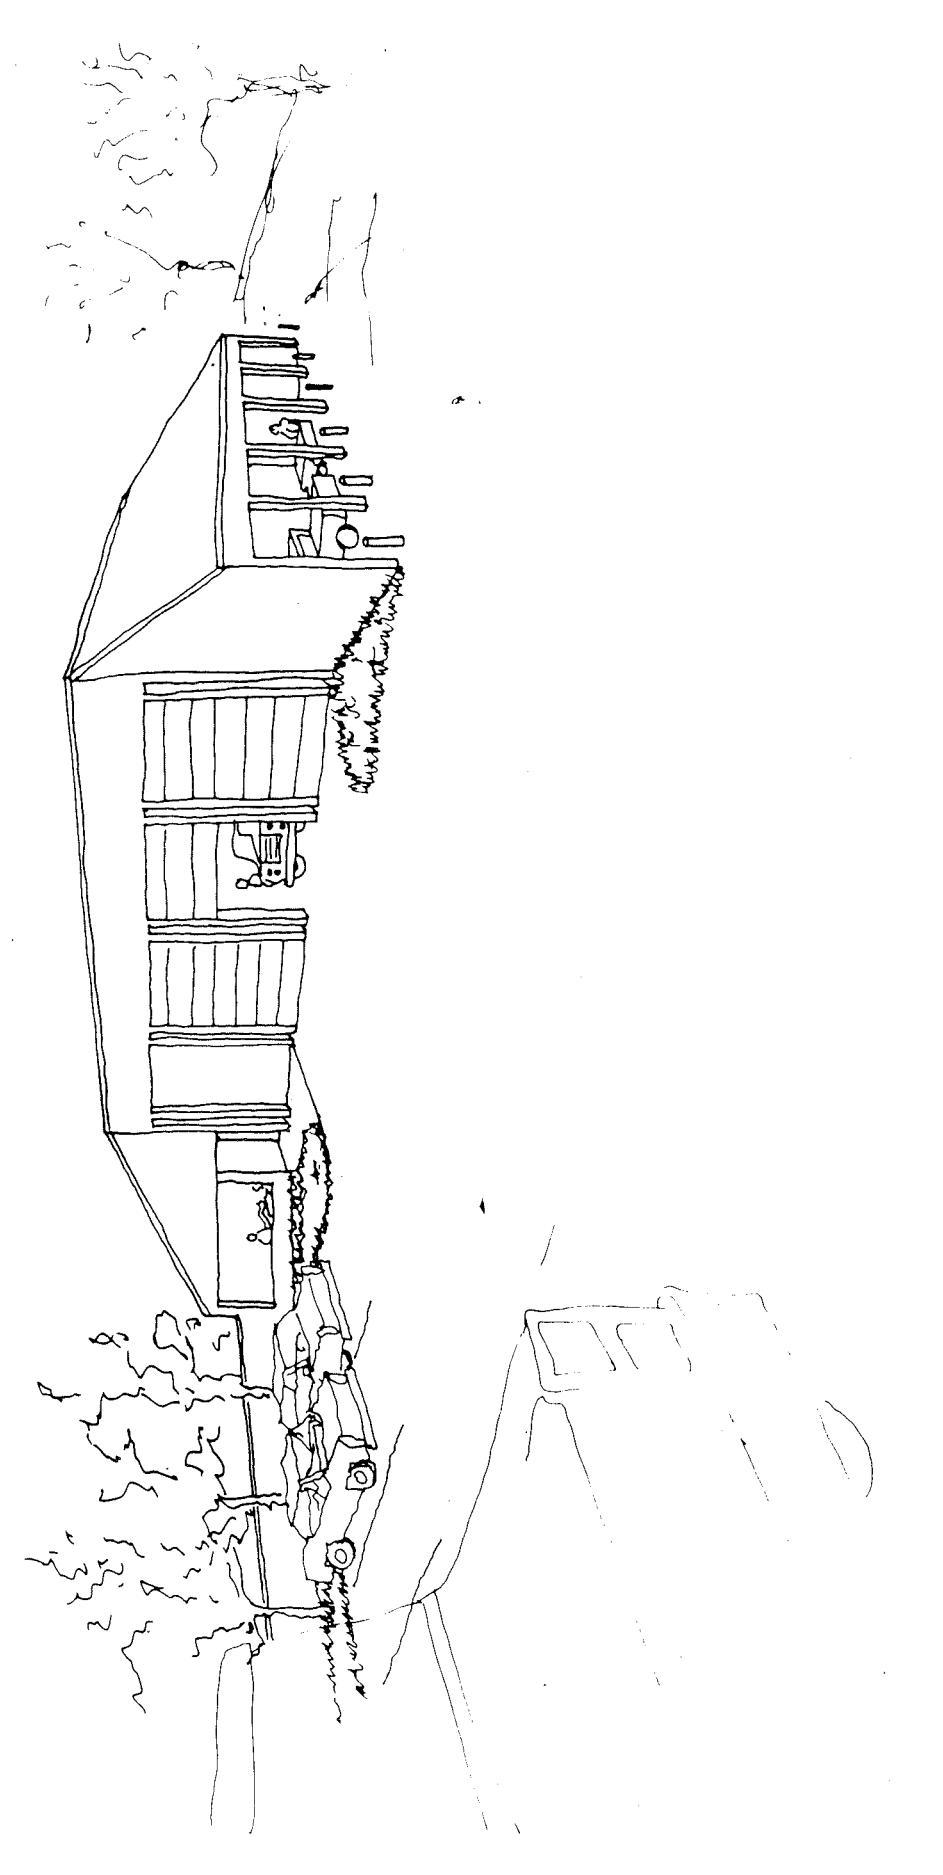
MAINTENANCE FACILITY

The materials proposed for use on the interior of the building are discussed in the program. Proposed exterior materials are exposed concrete block walls, asphalt shingles on the sloped roof and either single ply membrane roofing on 3-ply built-up roofing on the flat roof, insulated glazing materials, and insulated metal garage doors, entry doors and infill panels.
