Map 4.1
Bull Neck Run
Watershed Characteristics and
Storm Drain Infrastructure

Map 4.2
Bull Neck Run Watershed
Stream Geomorphology and
Habitat Quality

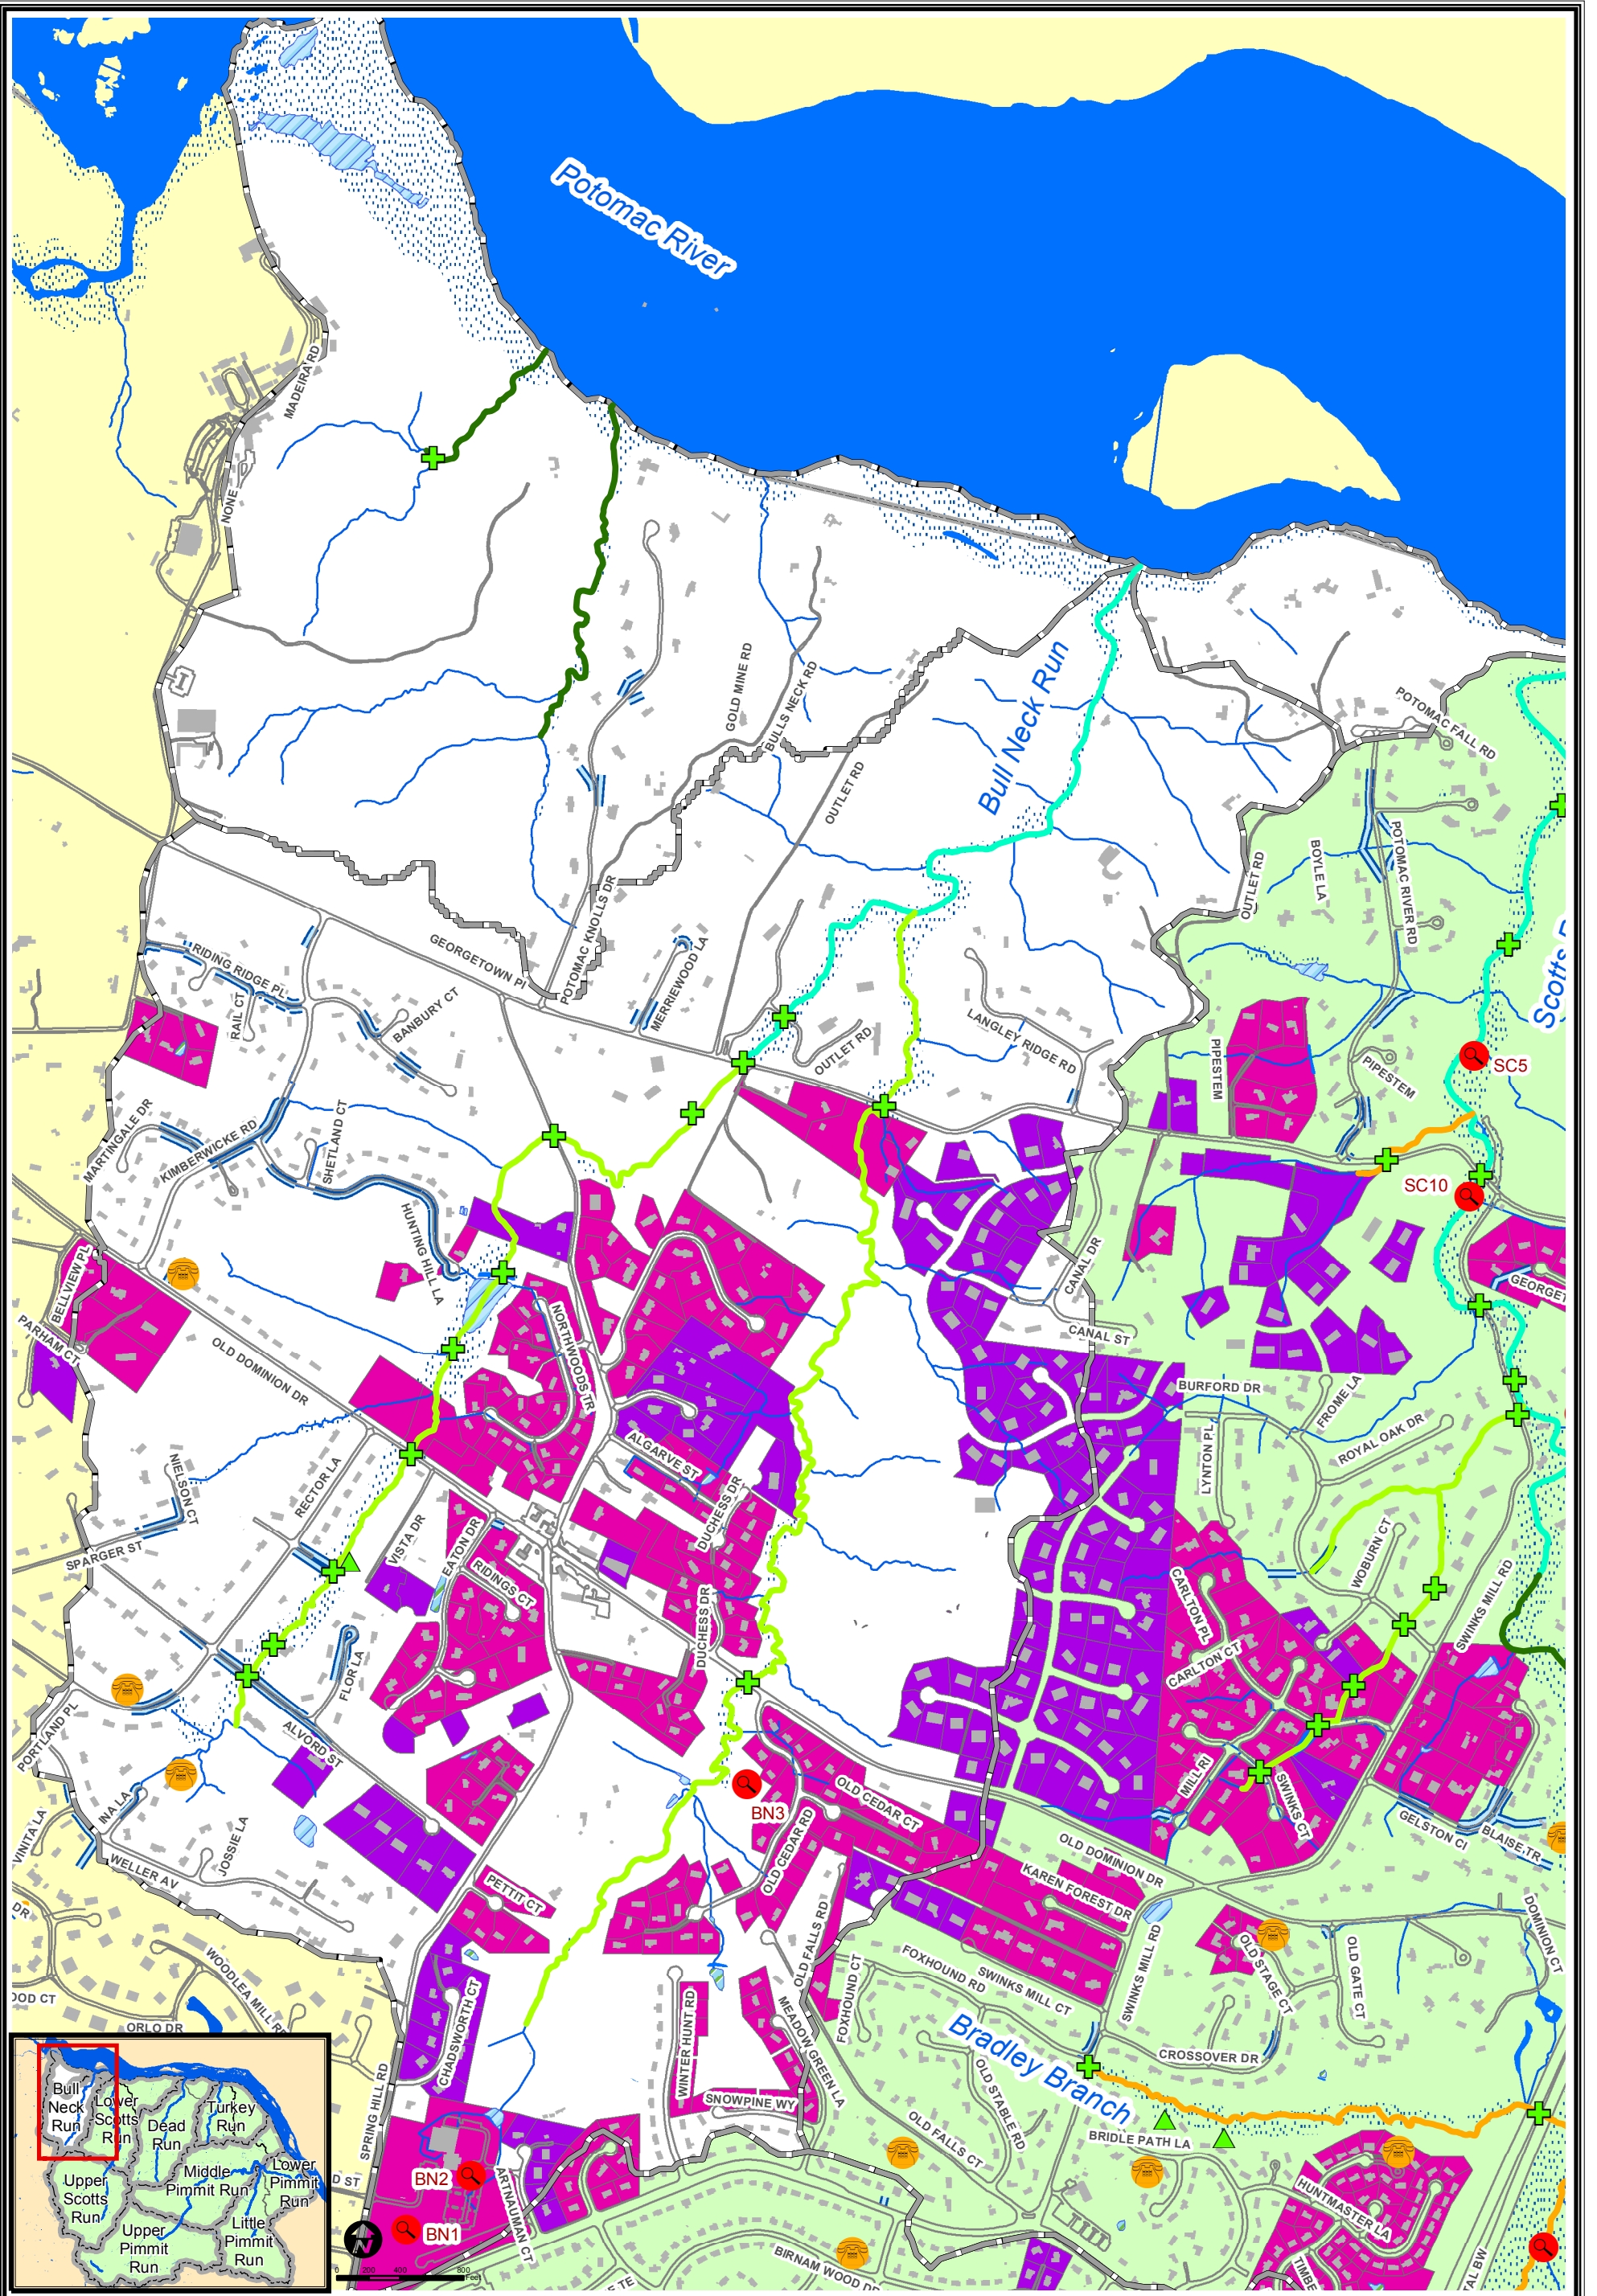
<ul style="list-style-type: none"> Subwatershed Boundary Roads Buildings Creeks/Streams 	<ul style="list-style-type: none"> Drainage Complaint Problem Locations Floodplains Paved Ditch 	Crossing Impact <ul style="list-style-type: none"> Minor to Moderate Impact Moderate to Severe Impact Severe to Extreme Impact 	Ditch Impact <ul style="list-style-type: none"> Minor to Moderate Impact Moderate to Severe Impact Severe to Extreme Impact 	Pipe Impact <ul style="list-style-type: none"> Minor to Moderate Impact Moderate to Severe Impact Severe to Extreme Impact 	<ul style="list-style-type: none"> Parcel Controlled by BMP Parcel Controlled by Detention Facility Dry Pond Wet Pond All Other Storm Facility Types 	Habitat Assessment <ul style="list-style-type: none"> No Assessment Very Poor Poor Fair Good Excellent
-----------------------------------------------------------------------------------------------------------------------------------	-------------------------------------------------------------------------------------------------------------------------------------------	------------------------------------------------------------------------------------------------------------------------------------------------------------------------	---------------------------------------------------------------------------------------------------------------------------------------------------------------------	--------------------------------------------------------------------------------------------------------------------------------------------------------------------	---------------------------------------------------------------------------------------------------------------------------------------------------------------------------------------------------------	---------------------------------------------------------------------------------------------------------------------------------------------------------------------------

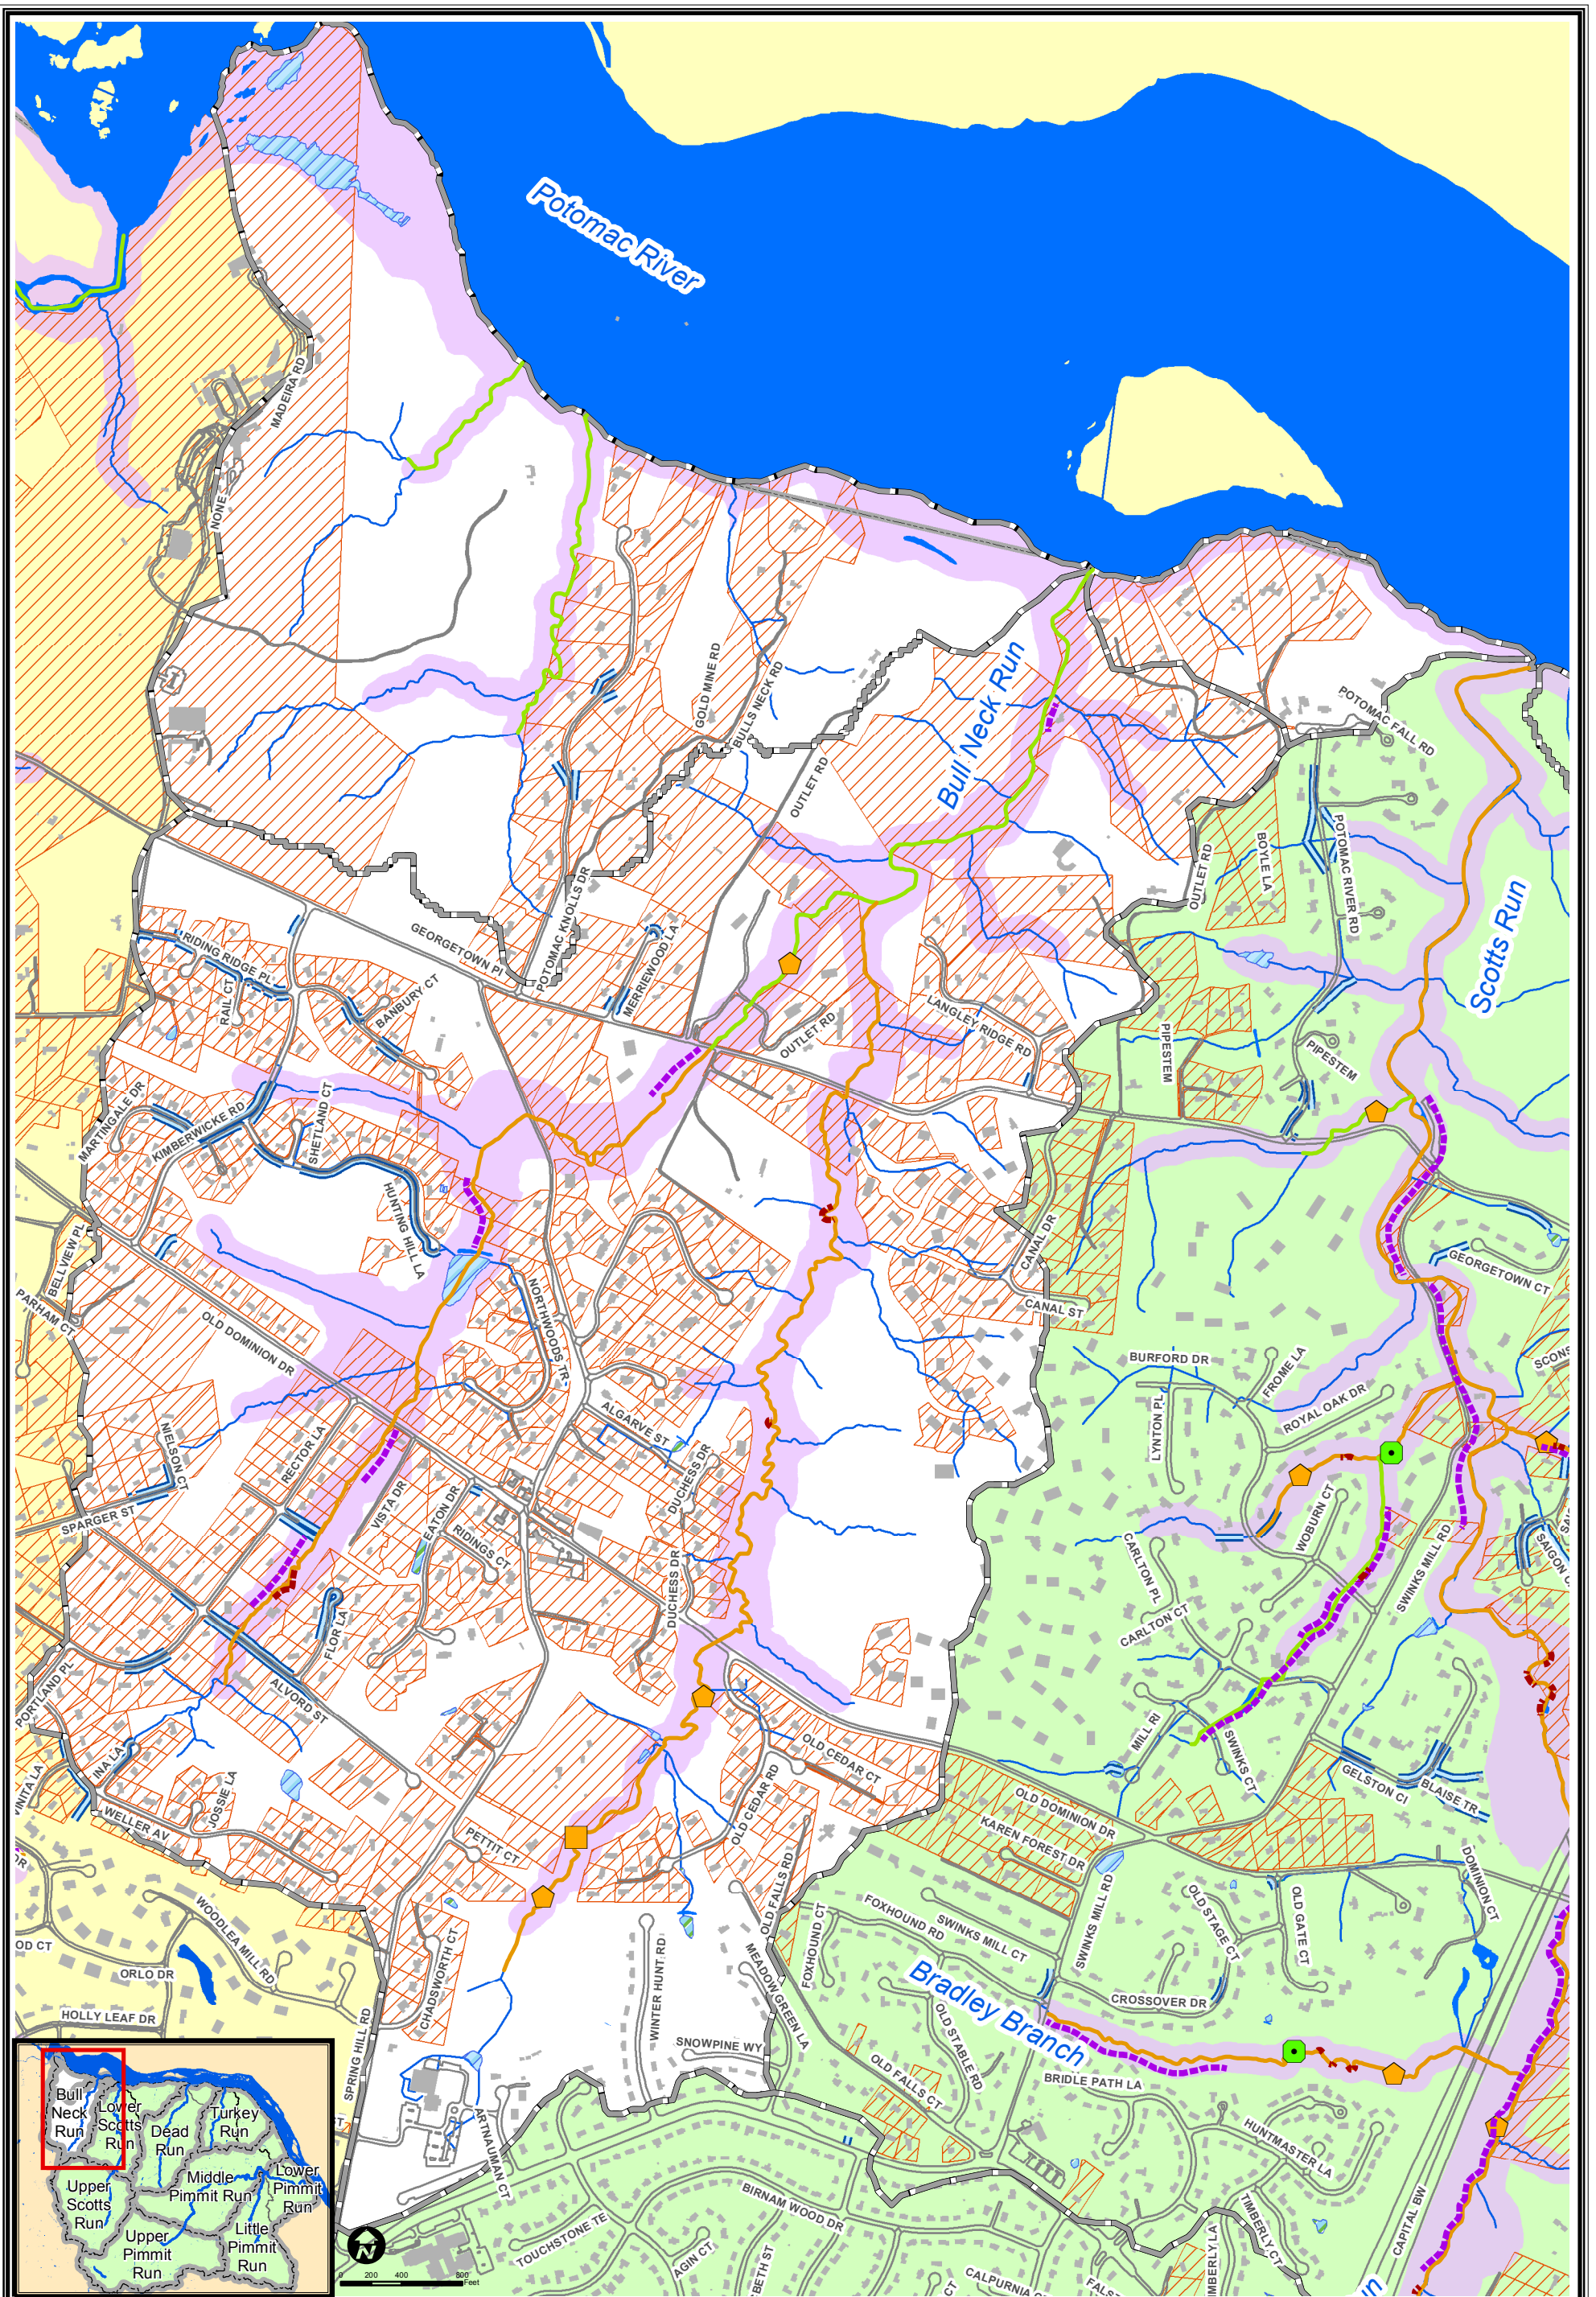
<ul style="list-style-type: none"> Subwatershed Boundary Roads Buildings 	<ul style="list-style-type: none"> Creeks/Streams Paved Ditch 	Obstruction Impact <ul style="list-style-type: none"> Minor to Moderate Moderate to Severe Severe to Extreme 	Utility Impact <ul style="list-style-type: none"> Minor to Moderate Moderate to Severe Severe to Extreme 	Dump Site Impact <ul style="list-style-type: none"> Minor to Moderate Moderate to Severe Severe to Extreme 	CEM Category <ul style="list-style-type: none"> No Assessment Stable Channel Incised Channel Widening Channel Stabilizing Channel Stable Channel 	Headcut Height <ul style="list-style-type: none"> 0.5' to 1' Height 1' to 2' Height > 2' Height 	Stream Impact <ul style="list-style-type: none"> Insufficient Buffer Erosion 	<ul style="list-style-type: none"> On-Site Sewage Disposal System
-----------------------------------------------------------------------------------------------------------	---------------------------------------------------------------------------------------	---------------------------------------------------------------------------------------------------------------------------------------------------------	-----------------------------------------------------------------------------------------------------------------------------------------------------	-------------------------------------------------------------------------------------------------------------------------------------------------------	------------------------------------------------------------------------------------------------------------------------------------------------------------------------------------------------------------------------	-----------------------------------------------------------------------------------------------------------------------------------------------	----------------------------------------------------------------------------------------------------------------	----------------------------------------------------------------------------------
