2003 Annual Report

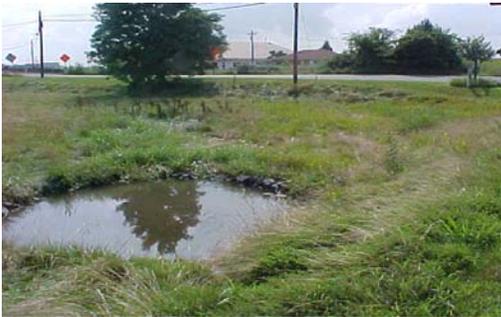
Figure 16. Rock Sediment Trap a few hours after a rain event at Sunset Ridge, Centreville (Photo Courtesy of MSMD)

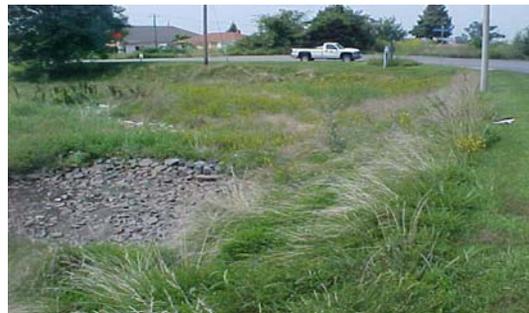
Figure 17. Rock Sediment Trap a few days after rain event at Sunset Ridge, Centreville (Photo Courtesy of MSMD)

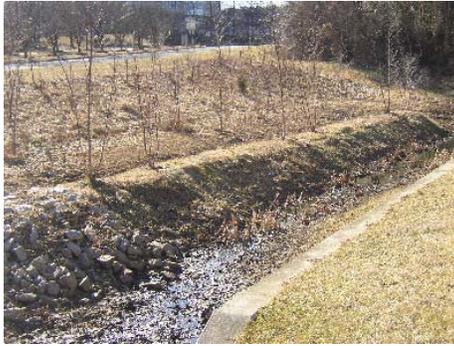
Figure 18. Stormwater Pond at the Government Center Complex, Feb. 2004 (Side view picture taken just above outlet point)

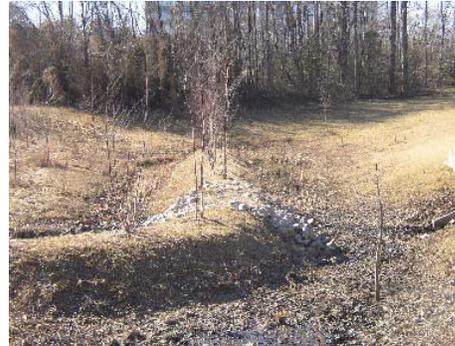
Figure 19 Stormwater Pond at the Government Center Complex, Feb. 2004 (Photo taken from one end of oblong-shaped pond)
