4 Watershed Restoration Strategies

4.1 Subwatershed Strategies

4.2 Description of Watershed Restoration Practices

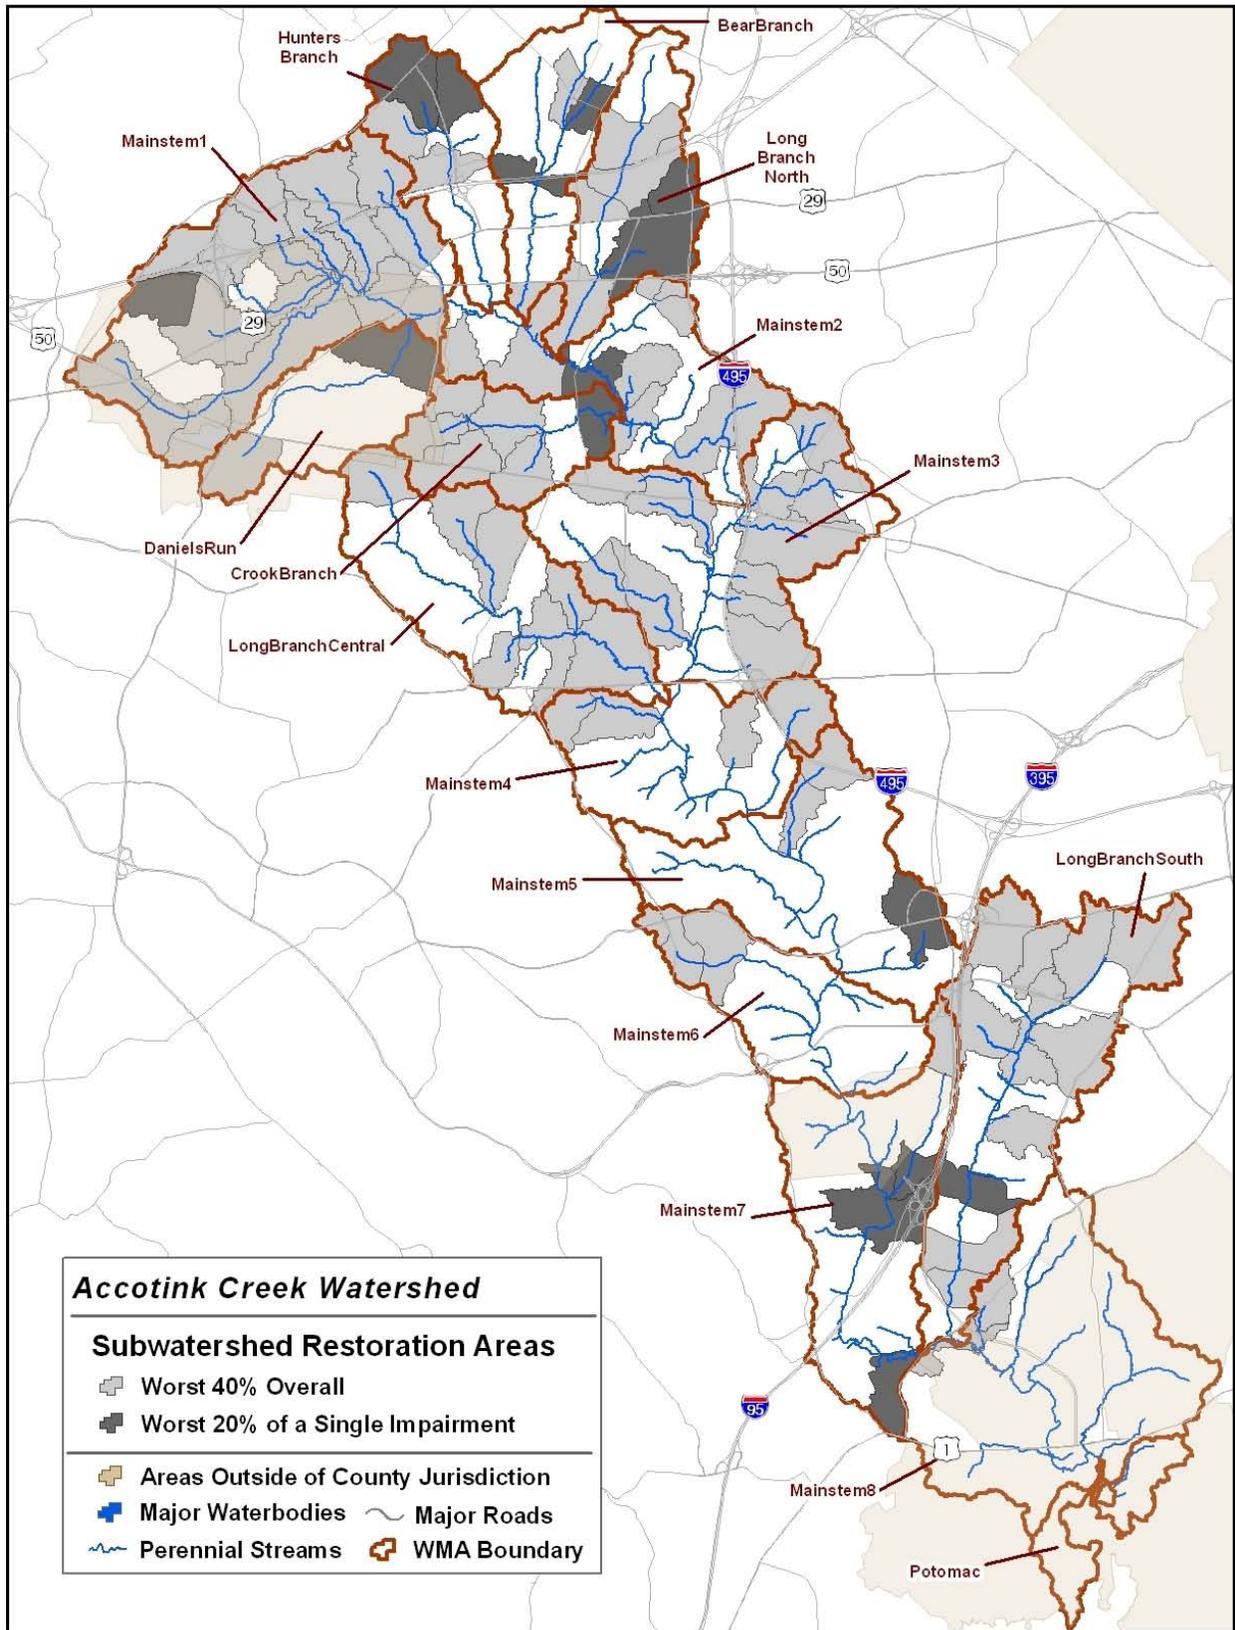
Map 4-1: Priority Subwatershed Restoration Areas

Impaired subwatersheds (identified by the two shades of grey in **Map 4-1**) were highlighted as priority subwatershed restoration areas using the indicator data discussed in Section 2.3. These are the areas in most need of projects to reduce the effects of uncontrolled stormwater or to restore the integrity of the stream system. The indicators were divided into four summary groups, and then each subwatershed was ranked based on the score from the four summary groups and the overall ranking. If the subwatershed scored among the worst 40 percent overall (light grey), or the worst 20 percent for one of the indicator groups (dark grey), it was presumed to be impaired. The four groups are as follows: areas in most need of projects to reduce the effects of uncontrolled stormwater or to restore the integrity of the stream system.

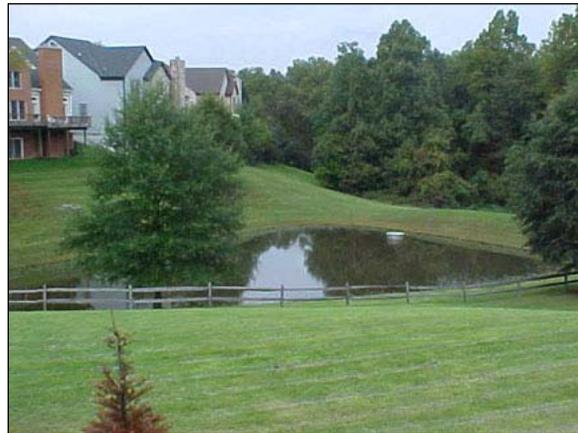
**Figure 4-2: Stormwater Management wet pond
(Source: Fairfax County)**

Wet ponds and stormwater wetlands can also provide water quality and habitat benefits through landscaping with aquatic vegetation. Vegetation is added to the pond design to treat dissolved nutrients (nitrogen and phosphorus), which can be difficult to remove through settling and filtering. In the process of growing, aquatic vegetation takes the nutrients up out of the water through its roots and sequesters them.

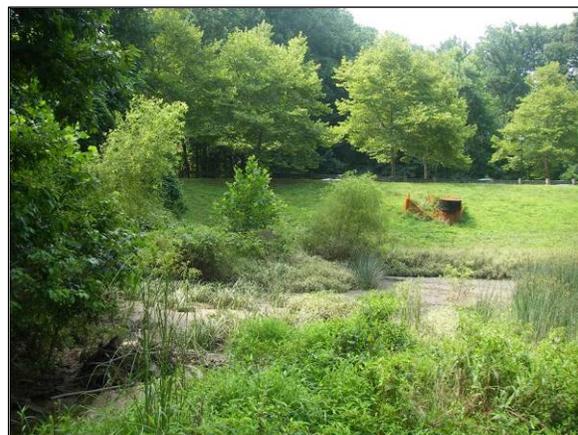
**Figure 4-1: Engineered stormwater wetland
(Source: Fairfax County)**

1. Dry ponds, which are quantity controls to capture rapidly flowing runoff and release it slowly over a longer time period;
2. Wet ponds, which have a permanent pool that allows for sedimentation along with an level of storage above the pool to provide extended detention like a dry pond; and
3. Stormwater wetlands, which function similarly to a wet pond but are landscaped to provide better treatment of dissolved nutrients and aquatic habitat for a wider variety of species.

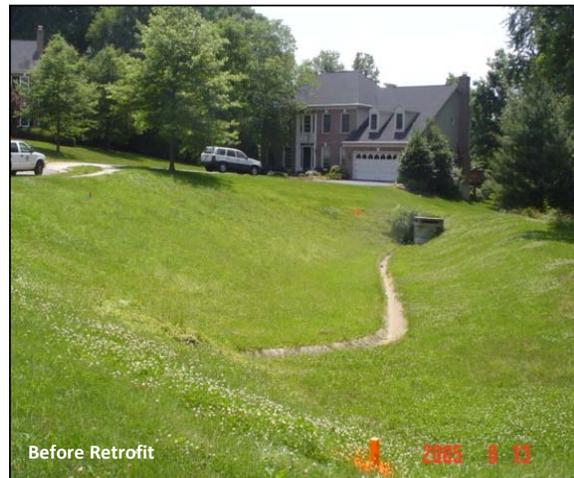
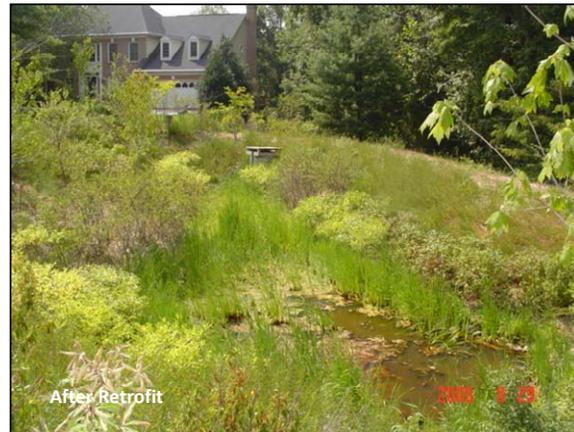
Figure 4-3: Stormwater dry pond retrofit (Source: Fairfax County)

- Changing outflow controls or adding a BMP plate for extended detention
- Changing the flow path within the pond so water travels farther between the inlet and the outlet
- Creating multiple pond cells within a single pond. Reconfiguring the pond and the landscape to capture more stormwater

- Creating a shallow subsurface wetland bench around the perimeter which provides an opportunity for aquatic vegetation to take up nutrients
- Creating wetland areas within the pond
- Creating a forebay to capture sediment before it enters the pond, which improves maintainability
- Creating a micropool at the outlet to add an additional location for sedimentation

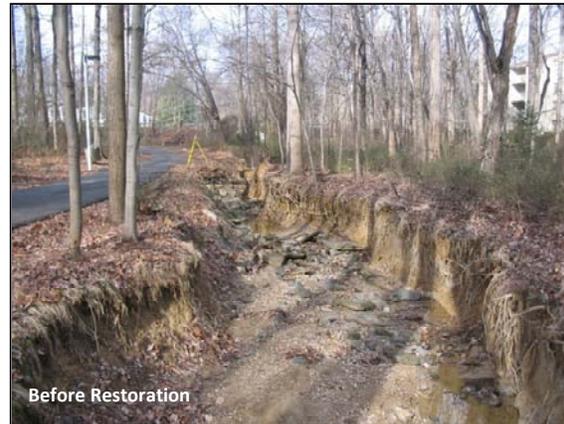
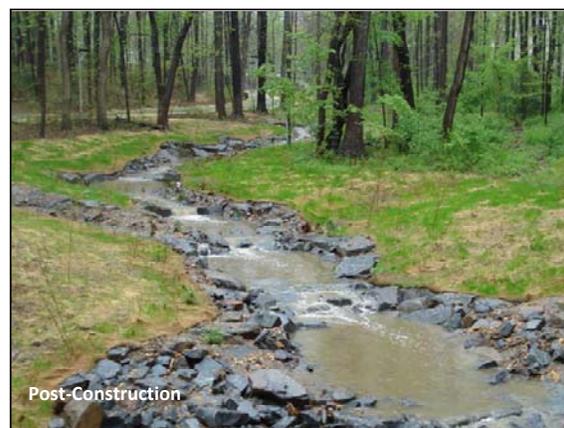
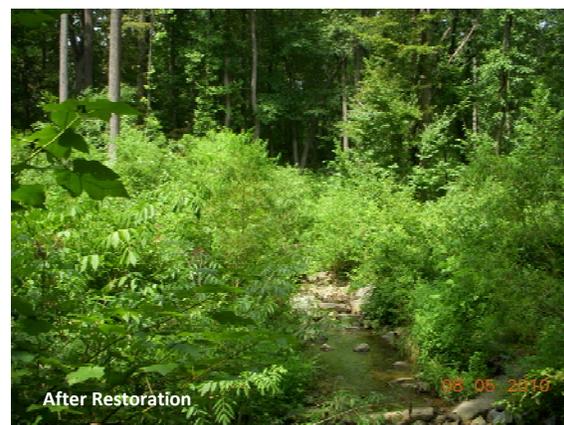
Figure 4-4: Stream restoration (Source: Fairfax County)

For incised urban channels, there are several options available depending on the severity of the degradation and availability of adjacent land. The most extensive restoration designs may move the stream itself, creating a new channel on a new alignment at the original floodplain elevation. Other alternatives could involve adjusting the cross-section, reducing bank slopes, or creating a new floodplain bench within an over-widened channel. For incised channels with no room to increase meander width, a restoration design could include using grade controls to flatten the slope of the stream and dissipate stream energy.

Less extensive restoration approaches could be undertaken where there is insufficient space or the existing flows make it infeasible to recreate a natural channel. These could involve armoring stream banks with rock or bioengineering materials to prevent further erosion, grading to lay back over-steepened banks and create a more stable cross-section.

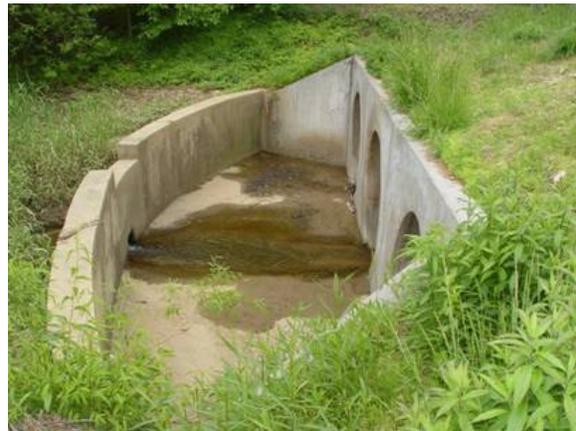
Figure 4-5: Culvert retrofit control structure, flow left to right (Source: KCI)

This retrofit option is installed upstream from existing road culverts by constructing a control structure and potentially excavating a micro-pool similar to that seen in Figures 4-5 and 4-6.

These projects are usually designed for headwater, intermittent streams. The control structure will detain and reduce stormwater flow; the micropool prevents resuspension of previously settled sediments and also prevents clogging of the low flow orifice and may be able to infiltrate the runoff from smaller storms, improving water quality. Additional water quality treatment can be obtained through sedimentation or vegetative uptake.

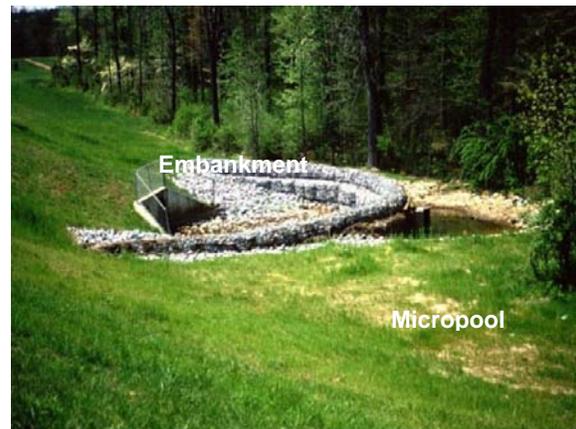
Figure 4-6: Culvert retrofit, flow right to left (Source: Center for Watershed Protection)

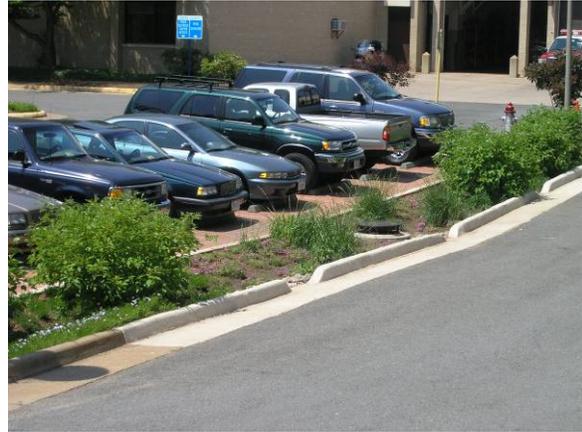
Figure 4-7: Parking lot bioretention (Source: Fairfax County)

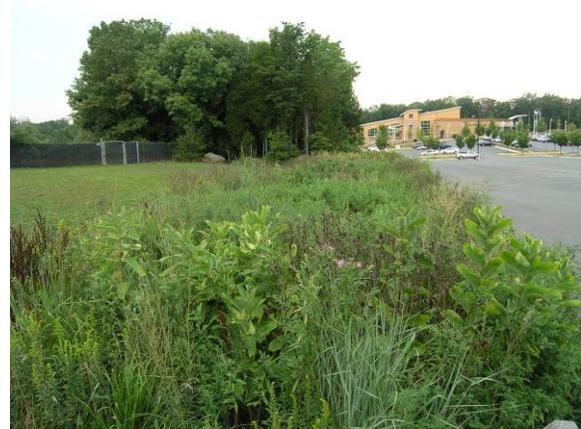
Figure 4-8: Vegetated swale (Source: Fairfax County)

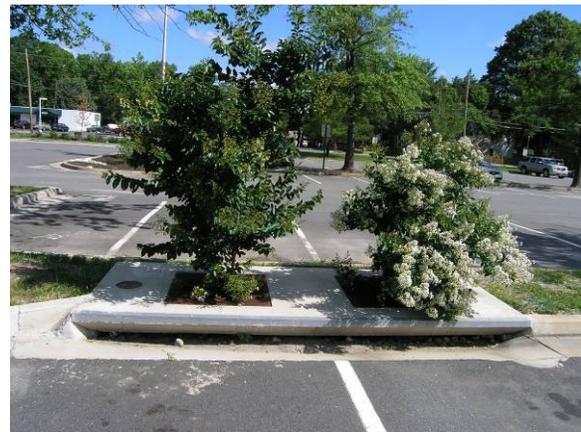
Figure 4-9: Tree box filter (Source: Fairfax County)

Area-Wide Drainage Improvements are projects (or suites of projects) which improve multiple outfalls and/or other stormwater infrastructure throughout a neighborhood. Controls could be custom-designed swales or bioretention systems (Figure 4-13), proprietary devices such as inlet filters (Figure 4-14) or the tree boxes described earlier (Figure 4-9).

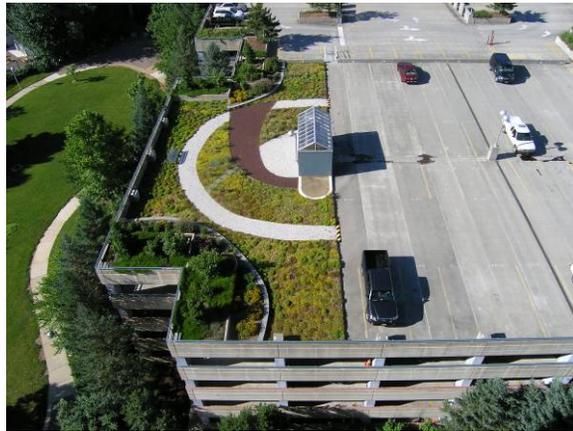
Figure 4-10: Green roof on a parking building (Source: Fairfax County)

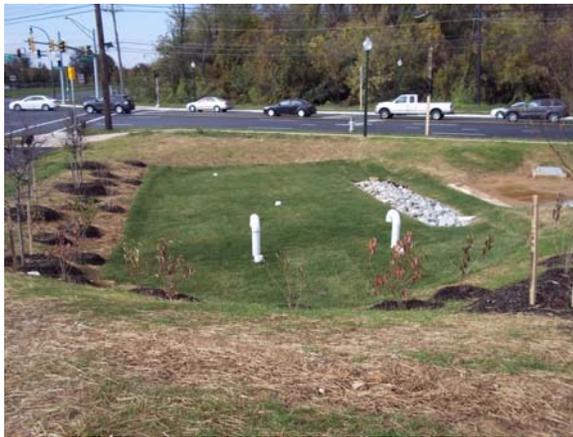
Figure 4-11: Sand filter along MD355 (Source: KCI)

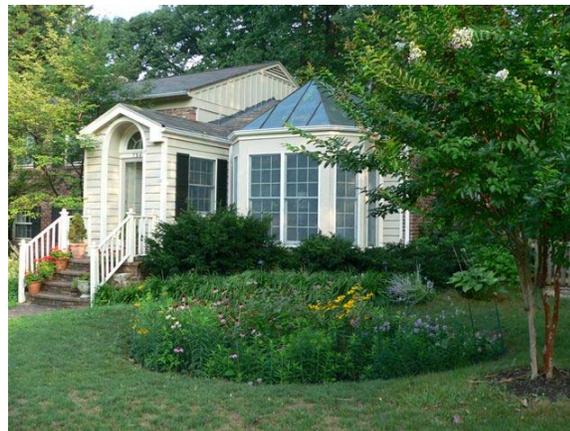
Figure 4-12: Residential rain garden (Source: Fairfax County)

Rain gardens are essentially a non-engineered form of bioretention that treats rooftop runoff from individual roof leaders or overland runoff. They consist of small, landscaped depressions with a sand/soil mixture planted with native shrubs, grasses or flowering plants. Runoff is detained in the depression for no more than a day. Rain gardens can replenish groundwater, reduce stormwater volumes downstream and remove pollutants.

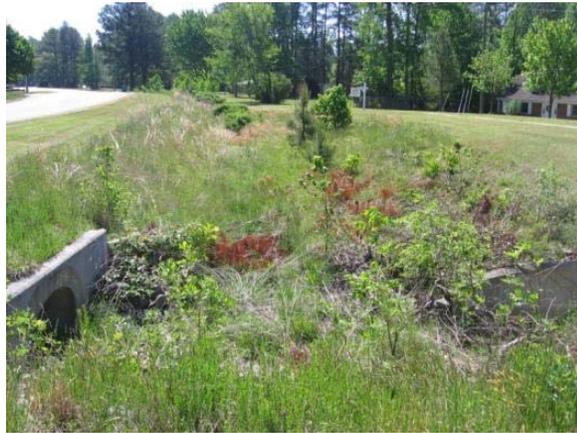
Figure 4-13: Vegetated swale for roadside drainage (Source: KCI)

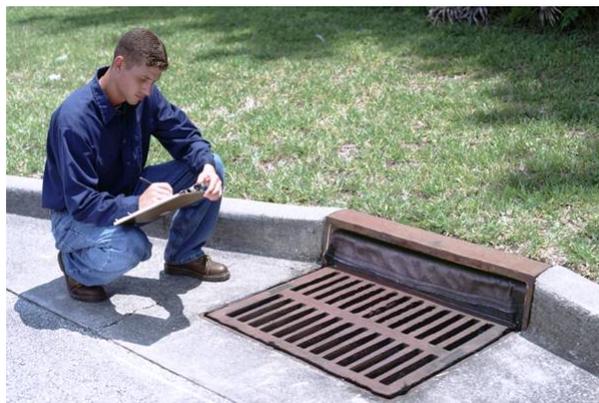
Figure 4-14: Inlet filter (Source: Ultra-Tech Int'l)

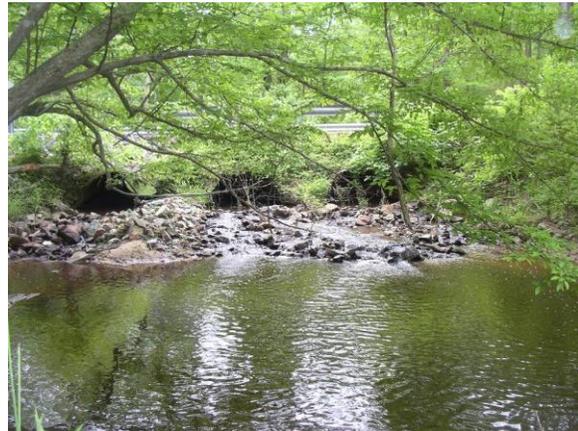
Figure 4-15: Obsolete culvert (Source: KCI)

These improvements can include raising the roadbed above the flood level, rebuilding culverts so they can pass more water, replacing worn or damaged culverts with newer ones that allow water to flow more quickly. The example shown in Figures 4-15 and 4-16 include all of these techniques, with the roadway height increased and the larger double box culvert replacing the three smaller round metal ones.

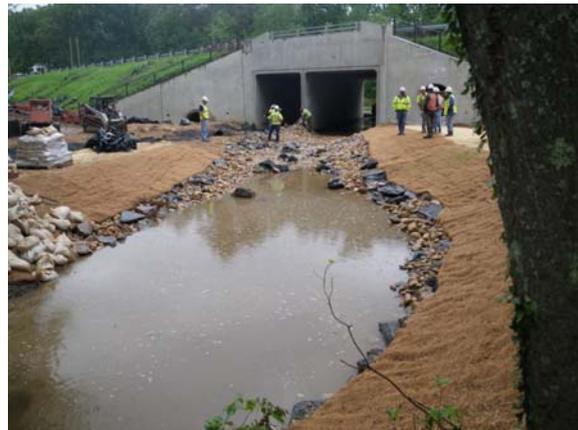
Figure 4-16: New replacement culvert (Source: KCI)

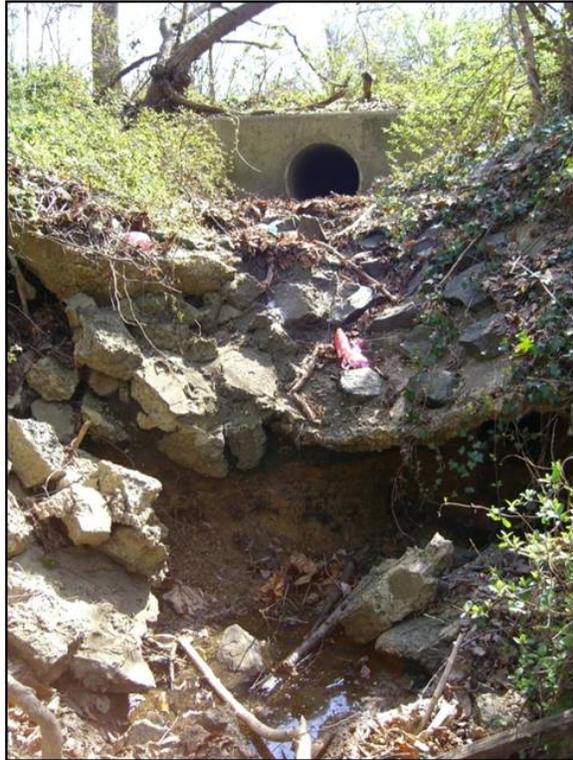
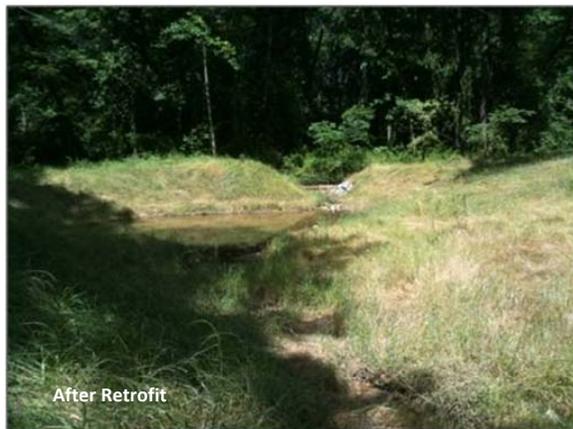
Figure 4-17: Outfall improvement (Source: Fairfax County)

Outfall improvements can be designed to provide water quality treatment along with energy dissipation. In an area with more constraints, a more common approach is to improve the conveyance immediately below the outfall structure to provide additional energy dissipation and reduce scour and erosion. Methods include the use of rip rap, plunge pools to break the flow of water and energy dissipation structures which adds turbulence to reduce the velocity of the outfall discharge.

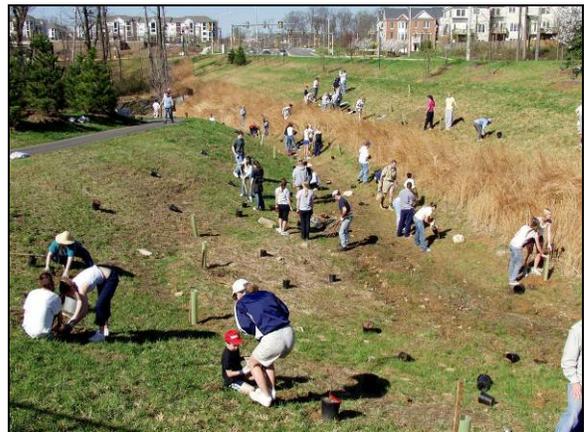
Figure 4-18: Buffer restoration project in Fairfax County (Source: Fairfax County)

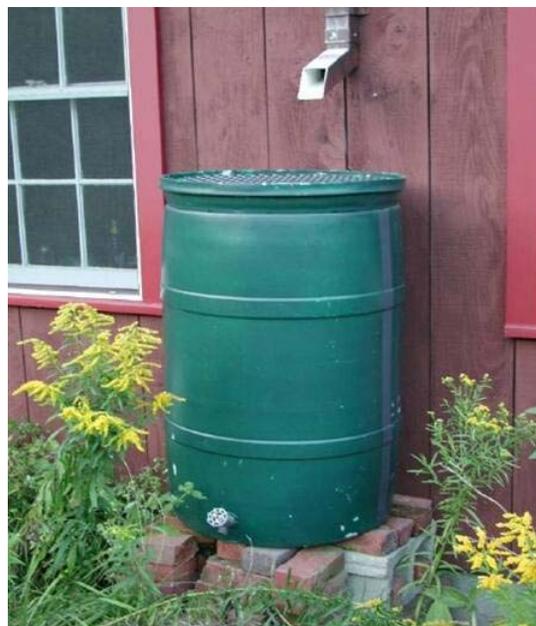
Figure 4-19: Rain barrel (Source: Project Clean Water)

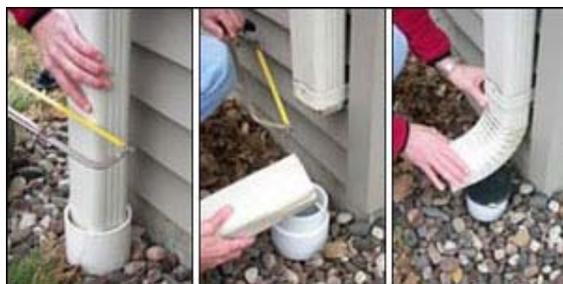
Figure 4-20: Disconnecting a downspout (Source: City of Toronto)

Downspout disconnection consists of adding piping or gutter systems on the ground to turn the flow from a downspout away from driveways or sidewalks to lawns or landscaped areas. Rooftop runoff redirected in this fashion is treated by surface filtration through the vegetated area and infiltration into the soil. Directing runoff onto vegetation allows the biological processes to reduce pollutants. This is also an effective method of preventing temperature increases in runoff.

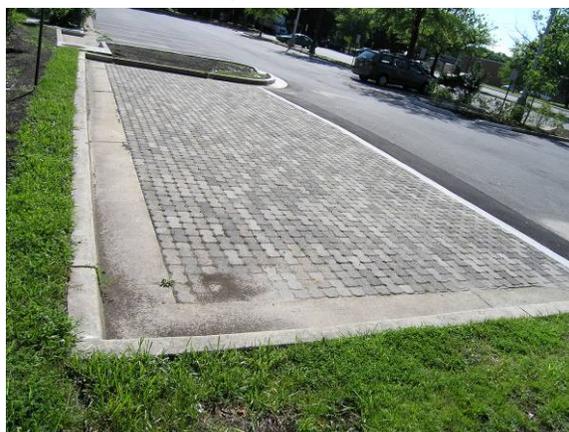
Figure 4-21: Permeable pavement blocks in a parking lot (Source: Fairfax County)

The use of pervious pavement systems can provide a form of disconnection for parking lots, driveways, walkways and other hard surfaces. These systems may consist of a special asphaltic paving material (porous pavement), a special concrete material (porous concrete) or open jointed concrete blocks (permeable pavement blocks). They allow stormwater to infiltrate directly through the surface instead of flowing to a collection system. The most significant constraint is the requirement for an underdrain if the soils below the surface are not permeable and will not allow the runoff to infiltrate. Maintenance is also required to prevent sediment from clogging the surface and preventing the water from infiltrating through the surface.

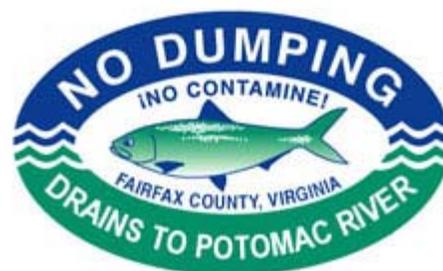
Figure 4-24: Fairfax County storm drain label (Source: Fairfax County, label produced by Das Manufacturing, Inc.)

Storm drain stenciling or labeling is a relatively easy method of outreach that involves labeling storm drain inlets with painted or prefabricated signs that indicate that materials thrown into the storm drain are not treated and go directly to a water body, which is typically named on the sign.

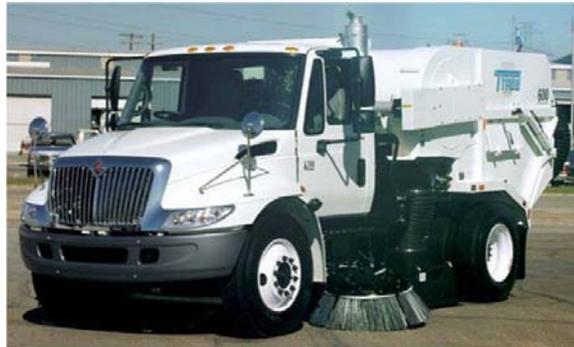
Figure 4-27: Street sweeper (Source: Tymco, Inc.)

There is a wide range of variability and efficiency among street sweeping equipment. Mechanical sweepers are effective for larger particles and cleanup of winter deicing materials. Much of the pollutants picked up by stormwater runoff consist of smaller particles in the micrometer range. A regenerative air sweeper can be effective at removing this material. Frequency of sweeping activities is also a key factor in pollutant removal efficiency.

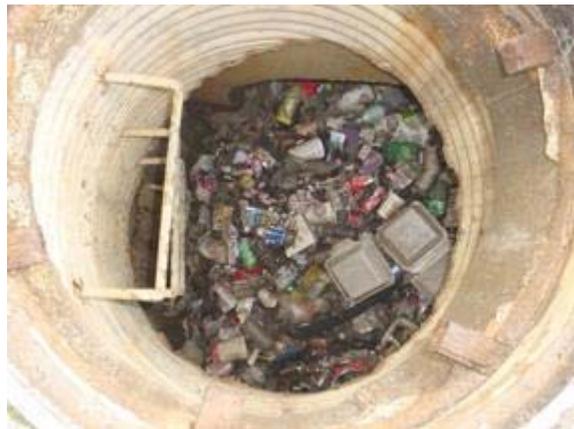
Figure 4-28: Catch basin (Source: Fairfax County)

An alternative to street sweeping is catch basin cleaning, which consists of periodically opening storm drain inlets and removing the material that has accumulated at the bottom. However, resident outreach and education is needed to stop the practice of disposing of materials into storm drain inlets.
