Section 6

Watershed Plan Structural Actions

6.1 Introduction

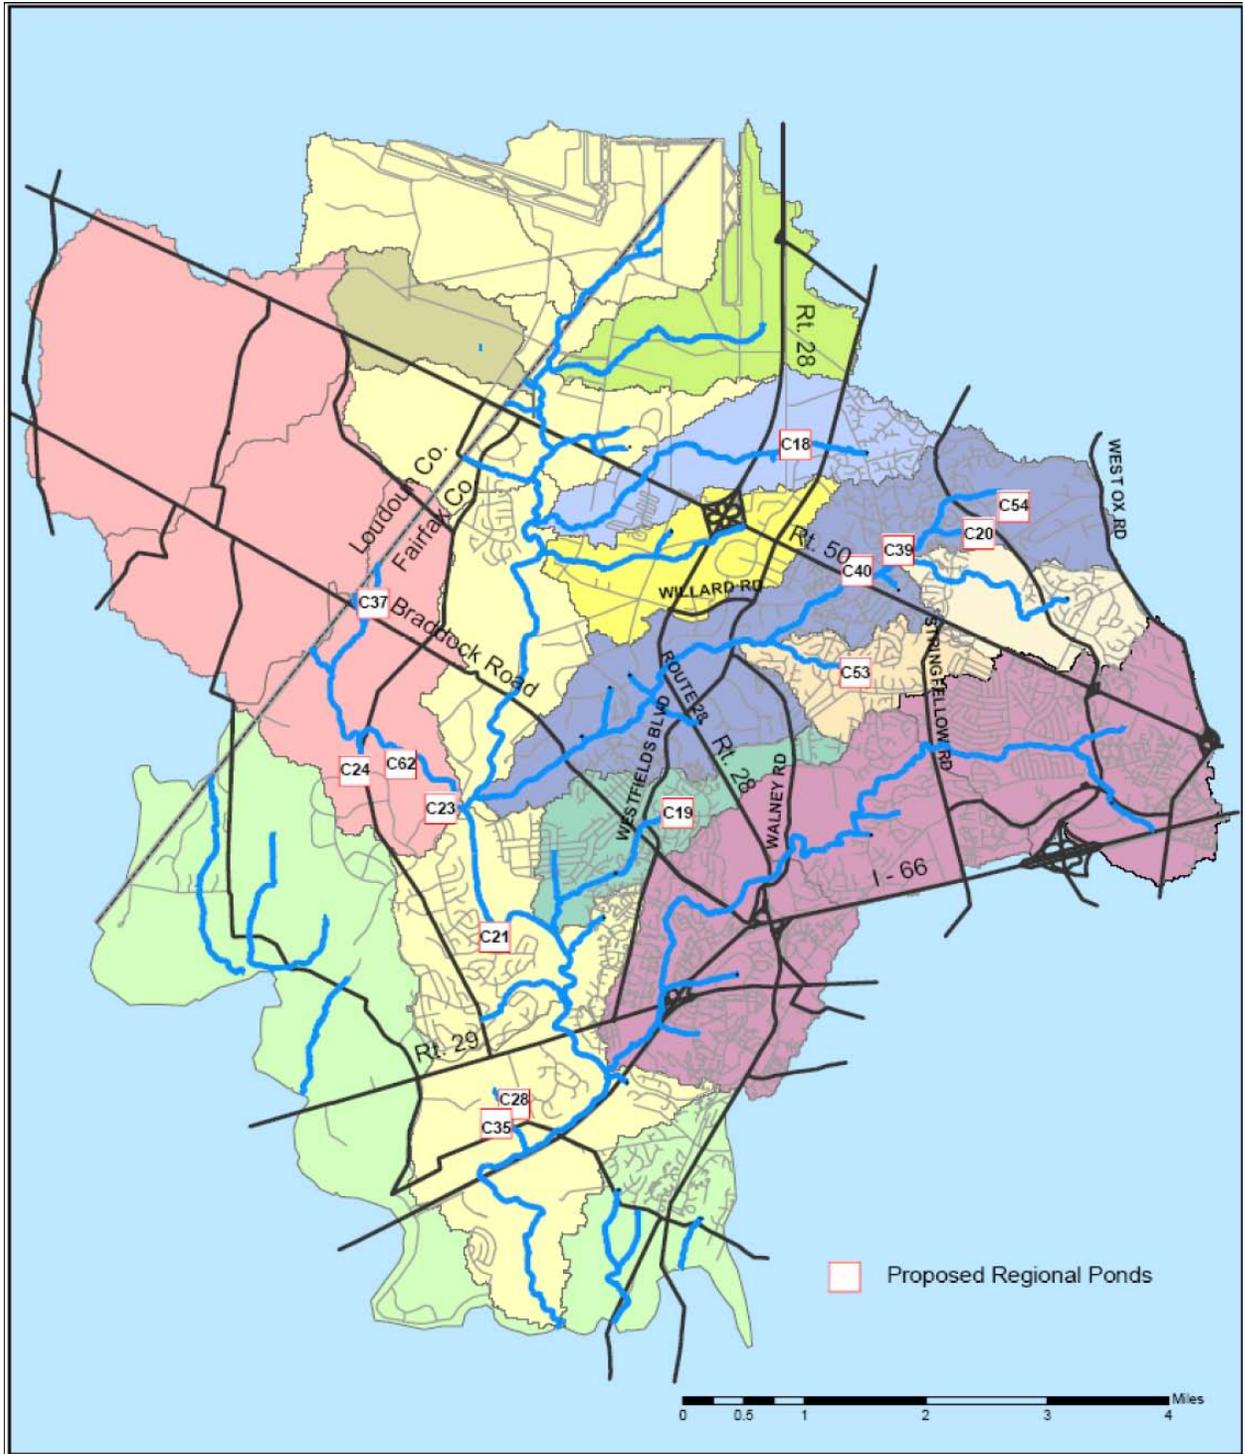
Figure 6-2
Unconstructed Proposed Regional Ponds

Seven of the 14 proposed regional ponds (C21, C23, C24, C28, C35, C37 and C62) are within the R-C District. These regional ponds were included in the 1989 Regional Stormwater Management Plan to control runoff from potential future development in case the rezoning was legally overturned. The rezoning has withstood several legal challenges over the years. A key factor in this defense was that the Estate Residential density of one house per 5 acres did not require structural water quality BMPs to provide the required water quality protection for the Occoquan Reservoir.

Seven of the proposed but unbuilt ponds (C18, C19, C20, C39, C40, C53 and C54) are outside the R-C District. As described below, the land area upstream from these remaining ponds is largely developed. The development upstream from the proposed unbuilt ponds is mostly medium- and low-density residential. As described in the following sections, in nearly all cases the upstream development includes onsite dry ponds or wet ponds that manage the stormwater runoff from these areas. As such, conditions have changed significantly from the time that the regional ponds were proposed in 1989.

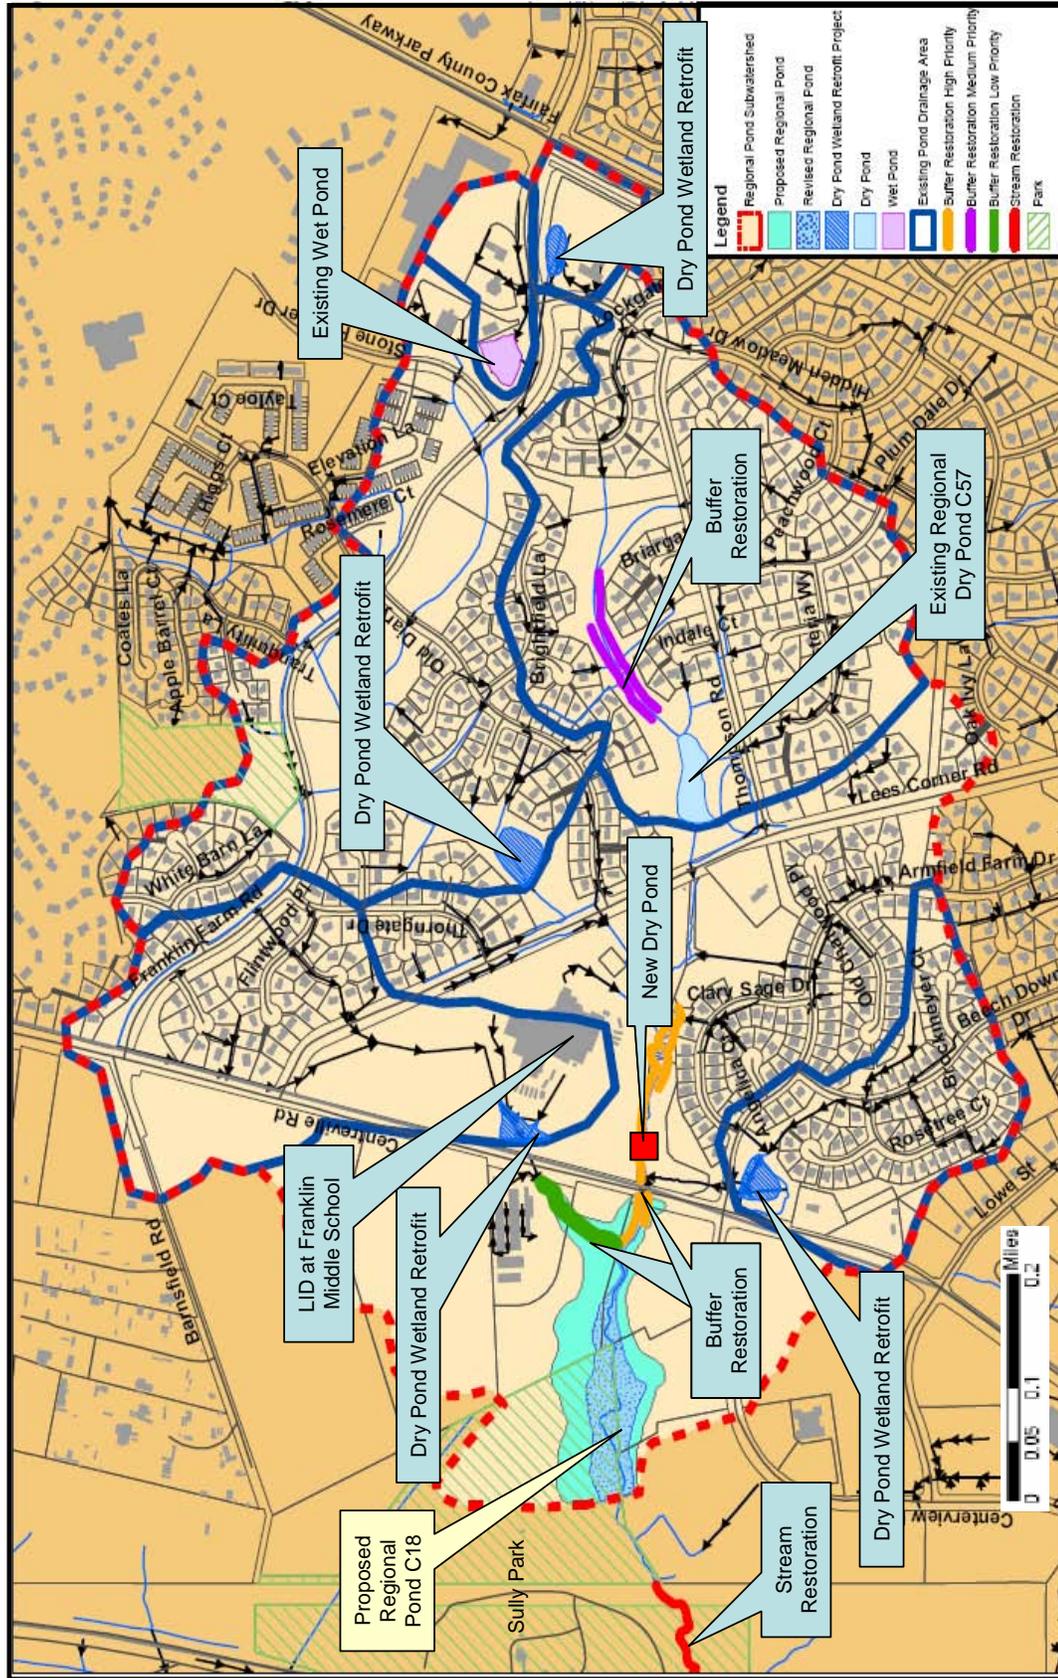
Figure 6-3
Proposed Regional Pond C18

The map on Figure 6-3 and data in Table 6-2 provides an overview of the conditions within the proposed regional pond watershed. These include the existing stormwater facilities and watershed plan structural projects.

<hr/>			
Summary of Stream Conditions Near Proposed Pond:	Erosion inventory lines with impact score of four approximately 1,000 feet downstream of proposed regional pond. This erosion indicates that peak flow control is required to prevent further erosion. Stream habitat is classified as good at the proposed pond.		
<hr/>			
Alternative Stormwater Control Options	Number of Projects	Description	
Dry pond wetland retrofit projects	4	CU9711 - Franklin Middle School (54 acres) CU9713 - Lees Corner Road & Old Dairy Road (81 acres) CU9712 - Centreville Road & Armfield Farm Road (30 acres) CU9714 - Franklin Farm Village Center (7 acres)	
LID retrofit at public facilities	1	CU9825 - Franklin Middle School (0.6 acres)	
Stream restoration projects	1	CU9220 - Restoration Project 4 located approximately 500 feet downstream from proposed regional pond.	
Buffer restoration projects	3	Projects CU9335, CU9336 and CU9334

Upstream culvert retrofit projects	-	Closed pipe systems preclude this alternative.	
Other Projects	1	Construct smaller dry pond at the existing site or immediately upstream.	
<hr/>			
Watershed Management Plan Recommendations	Construct regional pond C18 as a 1-year, 24-hour extended detention dry pond with a smaller pond area than proposed to reduce impacts on parkland and commercial area (project CU9002). The pond would provide enhanced stormwater control benefits at a critical headwater location. If the proposed pond is not constructed, then implement alternative stormwater controls including a smaller dry pond at an upstream location.

This pond enhances nutrient reduction in a critical headland portion of the watershed, further protecting the Cub Run streams and approaching the level of control provided by the originally recommended wet pond. The proposed pond has a smaller footprint compared to the proposed wet pond and is more compatible with the surrounding land uses and land cover. Construction of this facility would require approval from the Fairfax County Park Authority. This regional pond C18 is watershed plan project CU9002.

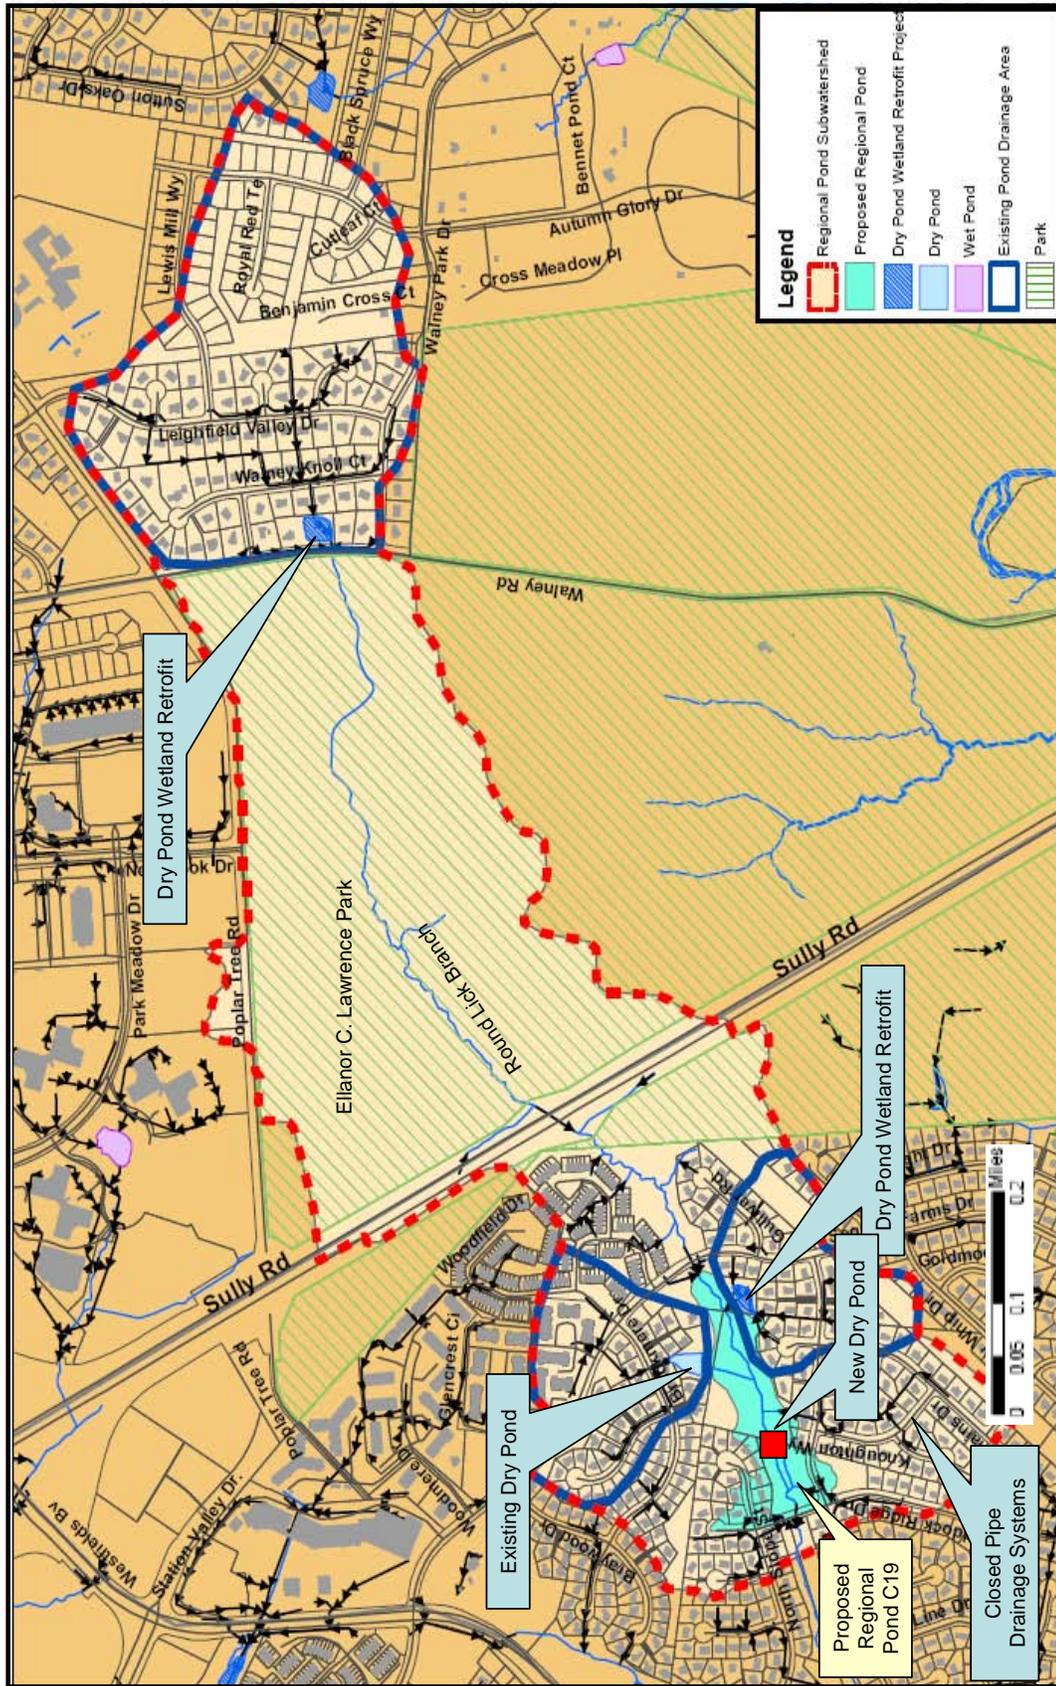
Figure 6-4
Proposed Regional Pond C19

Regional pond C19 has a drainage area of 310 acres and was planned as a wet pond, which controls the 2- and 10-year peak flow to predevelopment conditions. The pond is on the upper reaches of the Round Lick Branch main stem upstream from Braddock Ridge Road. C19 was formally removed from the regional pond plan in 1998; however, it is included in this study for the development and evaluation of alternative projects.

The map in Figure 6-4 and data in Table 6-4 provide an overview of the conditions within the proposed regional pond watershed. These include the existing stormwater facilities and watershed plan structural projects.

Sixteen percent of the drainage area is single-family homes without stormwater controls. The closed pipe systems lack of open space leaves no potential sites for new ponds or upstream culvert retrofit projects.

Drainage Area: 310 Acres			
Location: Round Lick Branch main stem upstream from Braddock Ridge Road			
Type of Pond: Wet pond which controls the two-year and 10-year peak flow to predevelopment conditions			
Status of Pond Site: Pond can no longer be constructed due to nearby single-family homes.			
	Number of Facilities	Total Controlled Area (Acres)	Percent of Total Area
Existing Upstream Stormwater Controls			
Dry ponds with proposed wetland retrofit	2	88	28%
Dry Ponds (no retrofit)	1	20	6%
Wet Ponds	0	-	-
Ellanor C. Lawrence Park	-	<u>152</u>	49%
Total	3	260	84%
Regional wet pond (C63) is downstream from the proposed pond (was constructed as two ponds).			
Summary of Uncontrolled Developed Area		Area (Acres)	Percent of Total Area
Single-family residential with piped drainage system		50	16%
No potential for future development within watershed.			
Summary of Stream Conditions Near Proposed Pond Site	No erosion inventory points within 2,500 feet. A stream restoration project is located about 2,900 feet downstream from the proposed pond. Stream habitat is classified as fair and poor at the proposed pond.

Number of Projects	Description	
Alternative Stormwater Control Options			
Dry pond wetland retrofits	2	Project CU9159 - Walney Road & Walney Park Drive (70 acres) Project CU9158 - Belle Plains Drive & Sequoia Farms Drive (17 acres)	
LID retrofit at public facilities	-		
Stream restoration projects	1	Project CU9212 is 2,900 feet downstream	
Buffer restoration projects	-		
Upstream culvert retrofit projects	-	Closed pipe systems preclude this alternative.	
Other Projects	1	Construct smaller dry pond upstream from proposed regional pond location.	
Watershed Management Plan Recommendations	Delete regional pond C19 and implement the identified alternative stormwater control options. Do not construct smaller dry pond. Eighty-three percent of the upstream area is controlled by existing ponds or is in parkland. Also, a major regional wet pond (C63) is located downstream. The alternative stormwater projects (excluding the new smaller dry pond) compensate for a portion of the water quality improvements produced by the regional ponds and the stream restoration project addresses stream erosion in Round Lick Branch. Downstream regional ponds reduce the water quality benefits of the proposed regional pond and alternative dry pond.

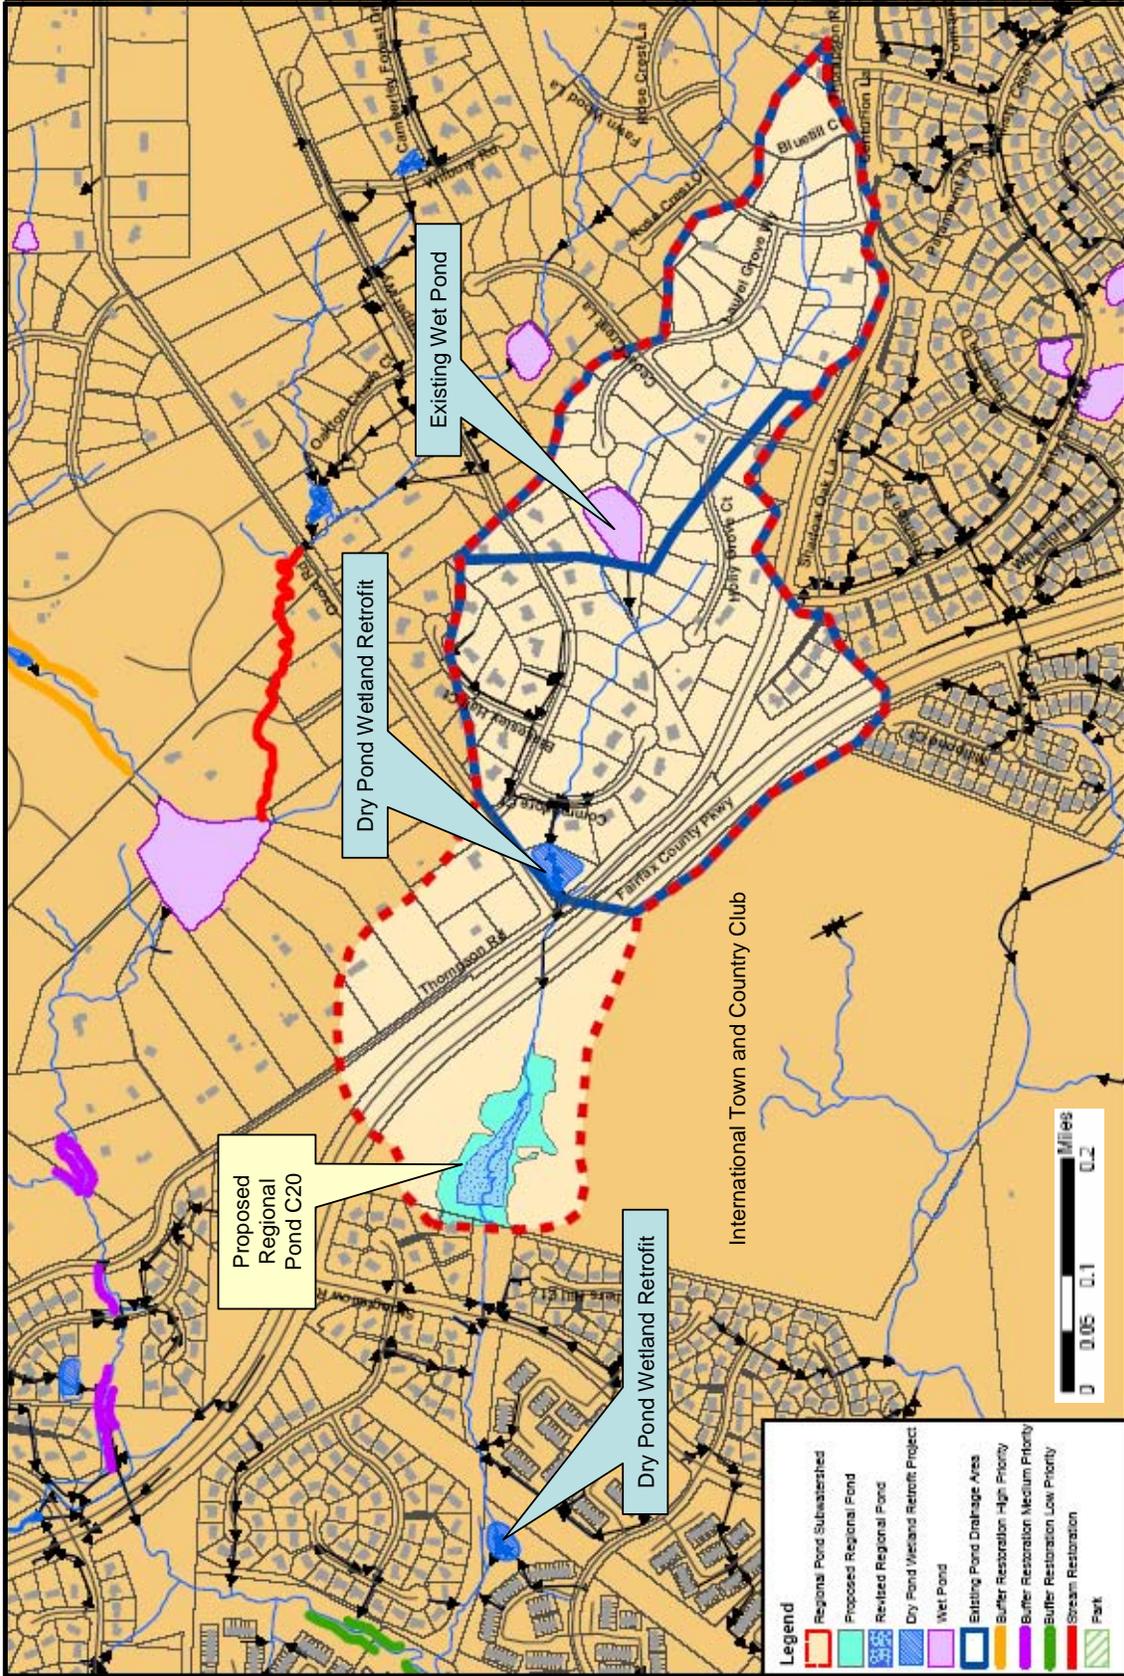
Figure 6-5
Proposed Regional Pond C20

The map in Figure 6-5 and data in Table 6-6 provide an overview of the conditions within the proposed regional pond watershed. These include the existing stormwater facilities and watershed plan structural projects.

Nearby residential development requires that the C20 dam be moved 110 feet upstream to avoid existing structures. This new upstream location has insufficient storage for a one-year, 24-hour extended detention dry pond. An extended detention dry pond with a smaller extended detention volume (e.g., standard 0.86 inches of runoff from the impervious area) could be created at this site.

Golf Course fairways and forested land		36	29%
No potential for future development. There is a constructed dry pond 1,400 feet downstream from proposed pond. This pond was not constructed as part of the County regional pond program but can be considered regional in nature due to its large drainage areas. This pond is a proposed wetland bottom retrofit project.			
Summary of Stream Conditions Near Proposed Pond Site :		Single erosion inventory point 2,100 feet downstream from pond indicates that streams are not severely eroded. The physical habitat within the pond area is classified as fair.	
Alternative Stormwater Control Options			
	Number of Projects	Description	
Dry pond wetland retrofits	2	Project CU9194 - Fairfax County Parkway & Oxon Road (52 acres) Project CU9193 - Mazewood Lane (Downstream of proposed pond) (89 acres)	
LID retrofit at public facilities	-		
Stream restoration projects	-

Buffer restoration projects	-		
Upstream culvert retrofit projects	-		
Other Projects	-		
Watershed Management Plan Recommendations		Defer proposed regional pond and construct alternative projects. The upstream and downstream ponds effectively control the runoff from the developed areas in the watershed. Implement the regional pond if the dry pond retrofit projects are not implemented.

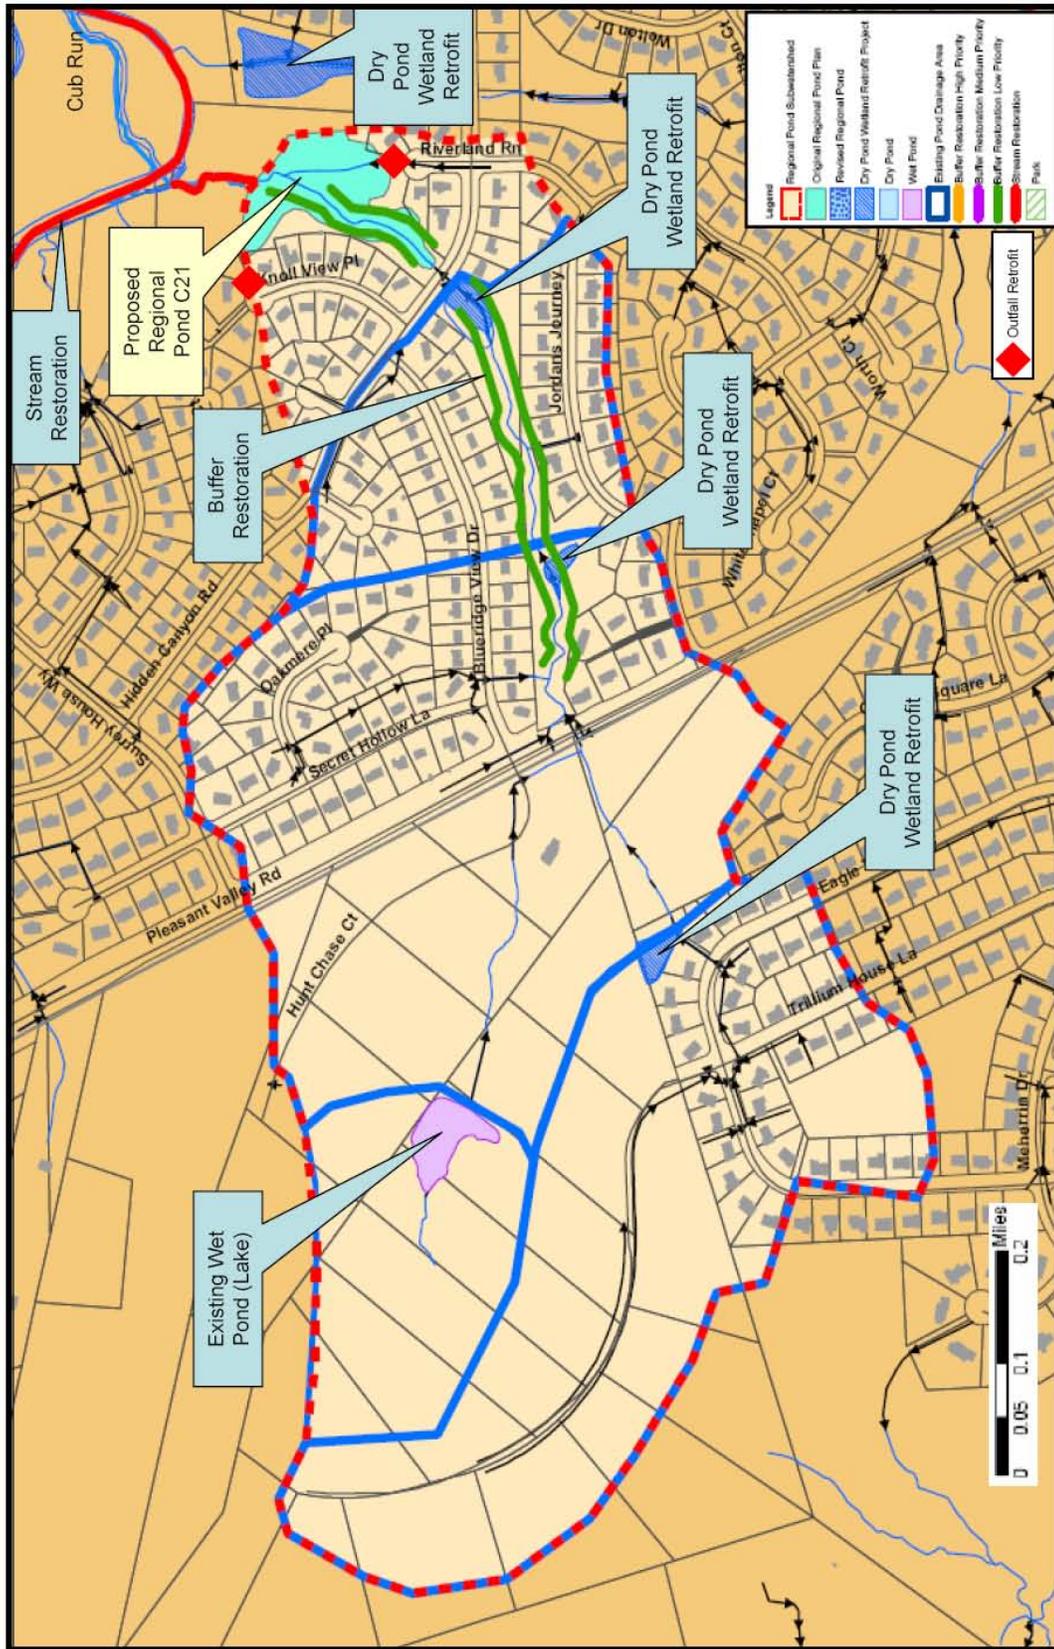
Figure 6-6
Proposed Regional Pond C21

Regional pond C21 is in the R-C District in the Virginia Run/Pleasant Hills community (downstream from Hidden Canyon Road adjacent to Knoll View Place). The pond is on an unnamed tributary to the Middle Cub Run main stem. The pond has a drainage area of 156 acres and was planned as a wet pond that reduces the peak two-year flow to pre-development conditions. The drainage area is largely developed as medium-density residential, which was planned before rezoning.

The map in Figure 6-6 and data in Table 6-8 provide an overview of the conditions within the proposed regional pond watershed. These include the existing stormwater facilities and watershed plan structural projects.

Proposed regional pond C21 removes 41 pounds of phosphorus per year (Table 6-9). The following bullets discuss conditions at the proposed site:

- The dam is within FCPA parkland, which is a valuable watershed resource. The pond would need to demonstrate significant watershed improvements to be constructed at this location.
- Nearby residential development precludes construction of a wet pond with the originally proposed storage volume.

Drainage Area: 156 Acres			
Location: R-C District in the Virginia Run/Pleasant Hills community (downstream from Hidden Canyon Road adjacent to Knoll View Place. Unnamed tributary to the Middle Cub Run main stem.			
Type of Pond: Wet pond that controls the peak two-year flow to predevelopment conditions.			
Status of Pond Site: The proposed regional pond is located within Fairfax County Park Authority Parkland. Nearby residences prevent construction of pond with the proposed storage volume.			
	Number of Facilities	Total Controlled Area (Acres)	Percent of Total Area
Existing Upstream Stormwater Controls			
Dry ponds with proposed wetland retrofit	3	130	83%
Dry Ponds (no retrofit)	0	0	0%
Wet Ponds	<u>1</u>	<u>16</u>	<u>10%</u>
Total	4	146	93%
Summary of Uncontrolled Developed Area		Area (Acres)	Percent of Total Area
Stream Valley and about 15 single family homes		10	7%
No potential for future development.

Summary of Stream Conditions Near Proposed Pond Site:	Erosion inventory line (approximately 320 feet) with impact score of seven on tributary stream where it joins Cub Run. This erosion results from down cutting of Cub Run. The physical habitat is classified as fair near this pond site.		
Alternative Stormwater Control Options	Number of Projects	Description	
Dry pond wetland retrofits	4	CU9160 - Oakengate Way (Outside Watershed) (10 acres) CU9162 - Blueridge View Drive (59 acres) CU9161 - Hidden Canyon Road (12 acres) CU9163 - Eagle Tavern Place (47 acres)	
LID retrofit at public facilities	-		
Stream restoration projects	1	Restoration included in Middle Cub Run Stream Restoration Project CU9211 which includes restoration in this tributary where it joins Cub Run	
Buffer restoration projects	1	Restore buffer throughout much of stream upstream from the proposed pond - Project CU9316	
Upstream culvert retrofit projects	-

Other Projects	2	Stormwater outfall retrofit projects for Riverland Run and Knoll View Place cul-de-sacs.	
Watershed Management Plan Recommendations	Delete regional pond C21 and construct all identified alternative stormwater control options. Upstream ponds effectively control runoff from 93 percent of the developed areas in the watershed including Estate Residential Development. Alternative stormwater control options enhance pollution reduction provided by the existing stormwater control facilities, mitigate runoff from uncontrolled areas, improve health of stream by addressing buffer impact and address stream erosion downstream from the proposed pond.

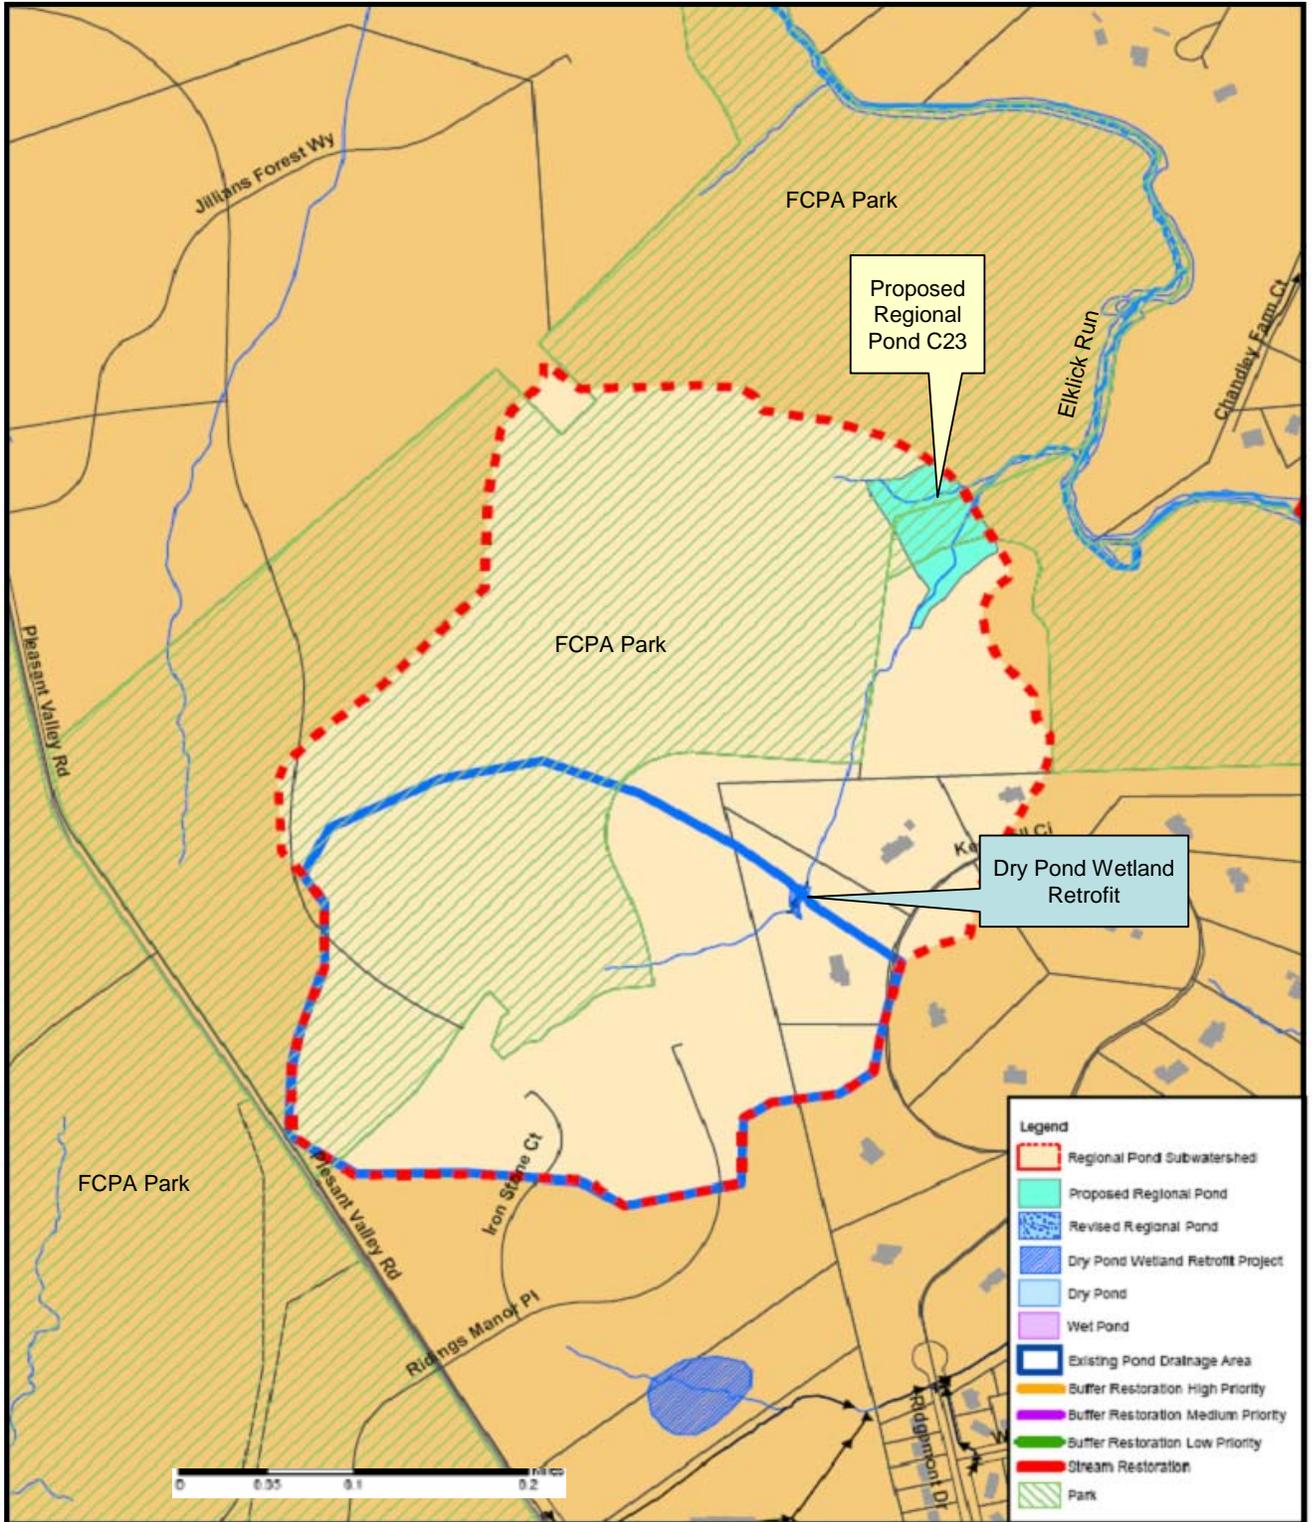
Figure 6-7
Proposed Regional Pond C23

- Option 1 presents the phosphorus reduction produced by the existing stormwater controls.
- Option 2 presents the additional phosphorus reduction produced by the dry pond retrofit project.
- Option 3 presents the additional phosphorus reduction produced by the proposed regional pond C23 together with the existing stormwater controls.

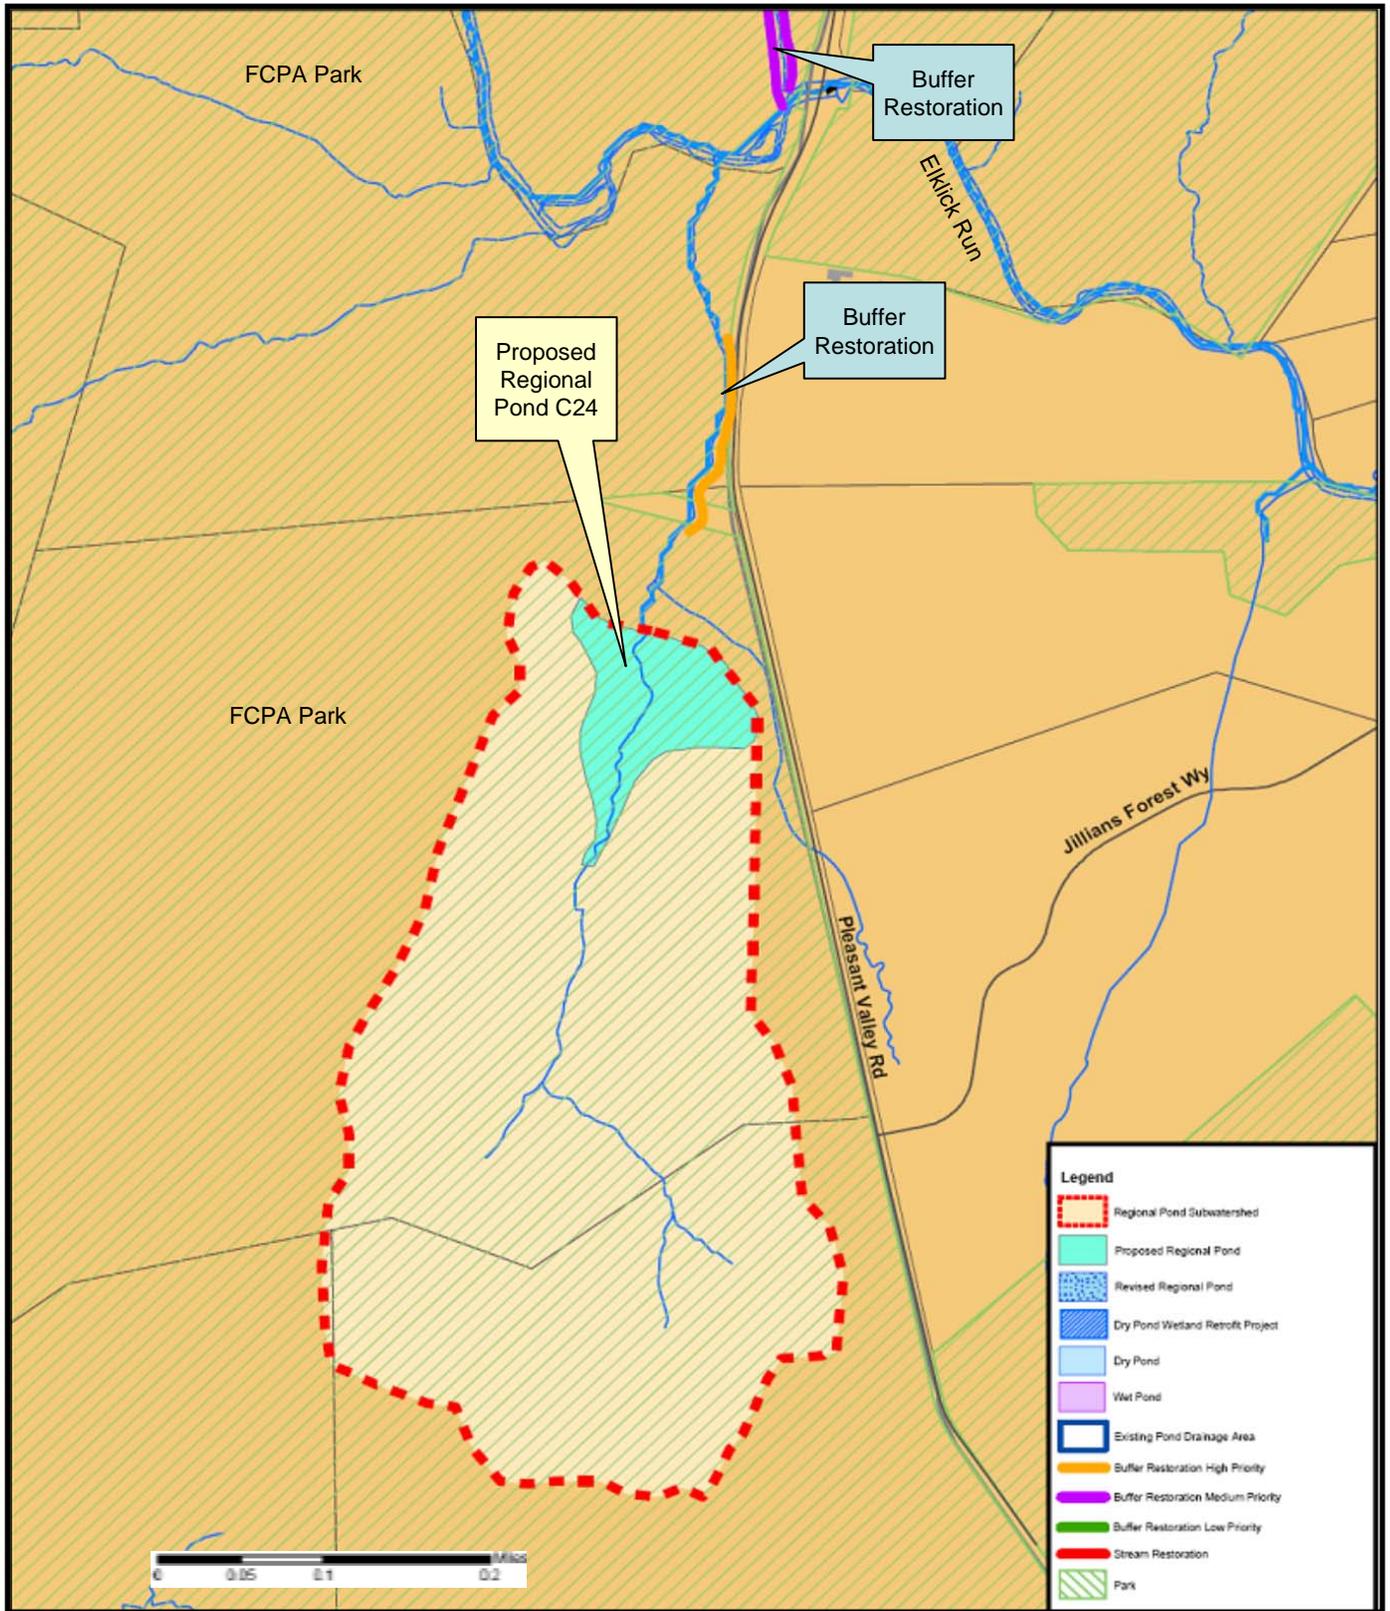
Figure 6-8
Proposed Regional Pond C24

The following structural projects were evaluated as alternative stormwater control projects for regional pond C24:

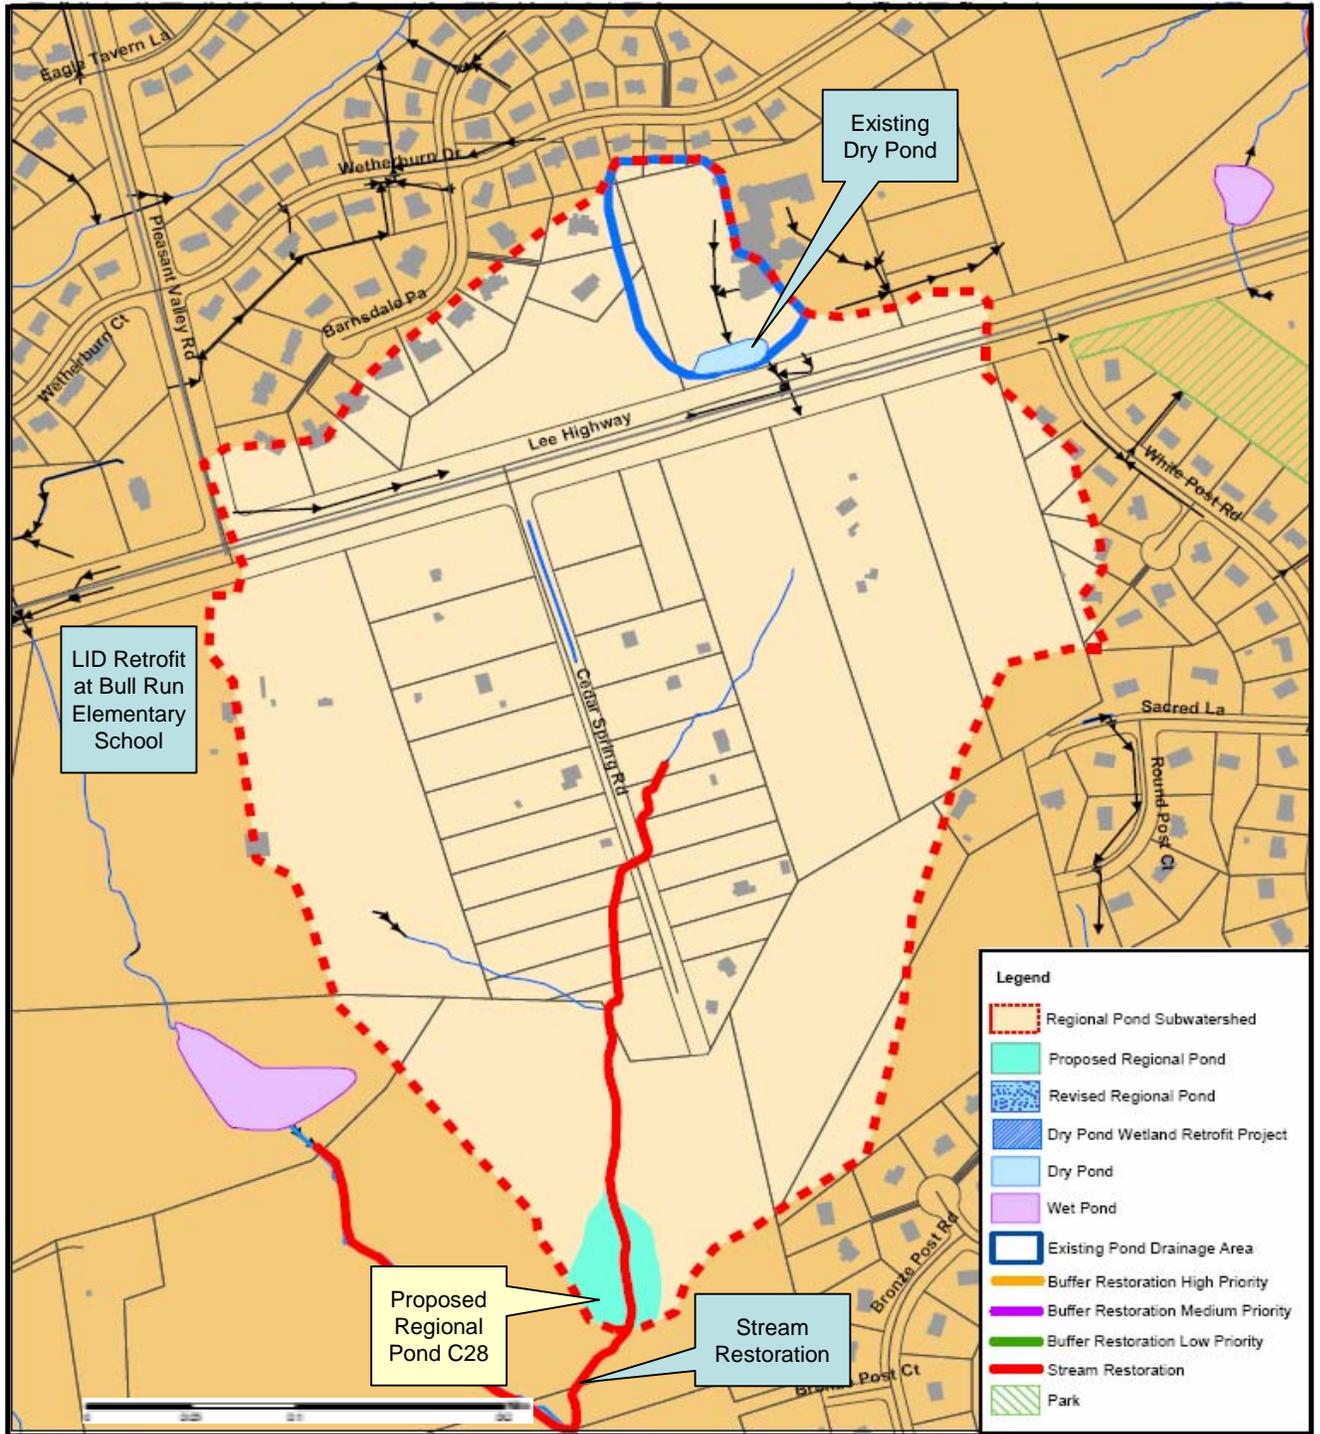
Figure 6-9
 Proposed Regional Pond C28

Although the watershed is entirely within the R-C district, it includes 30 acres with 0.7- to 1.2-acre lots that existed at the time of the rezoning. The remaining area can be developed at the five-acre Estate Residential density.

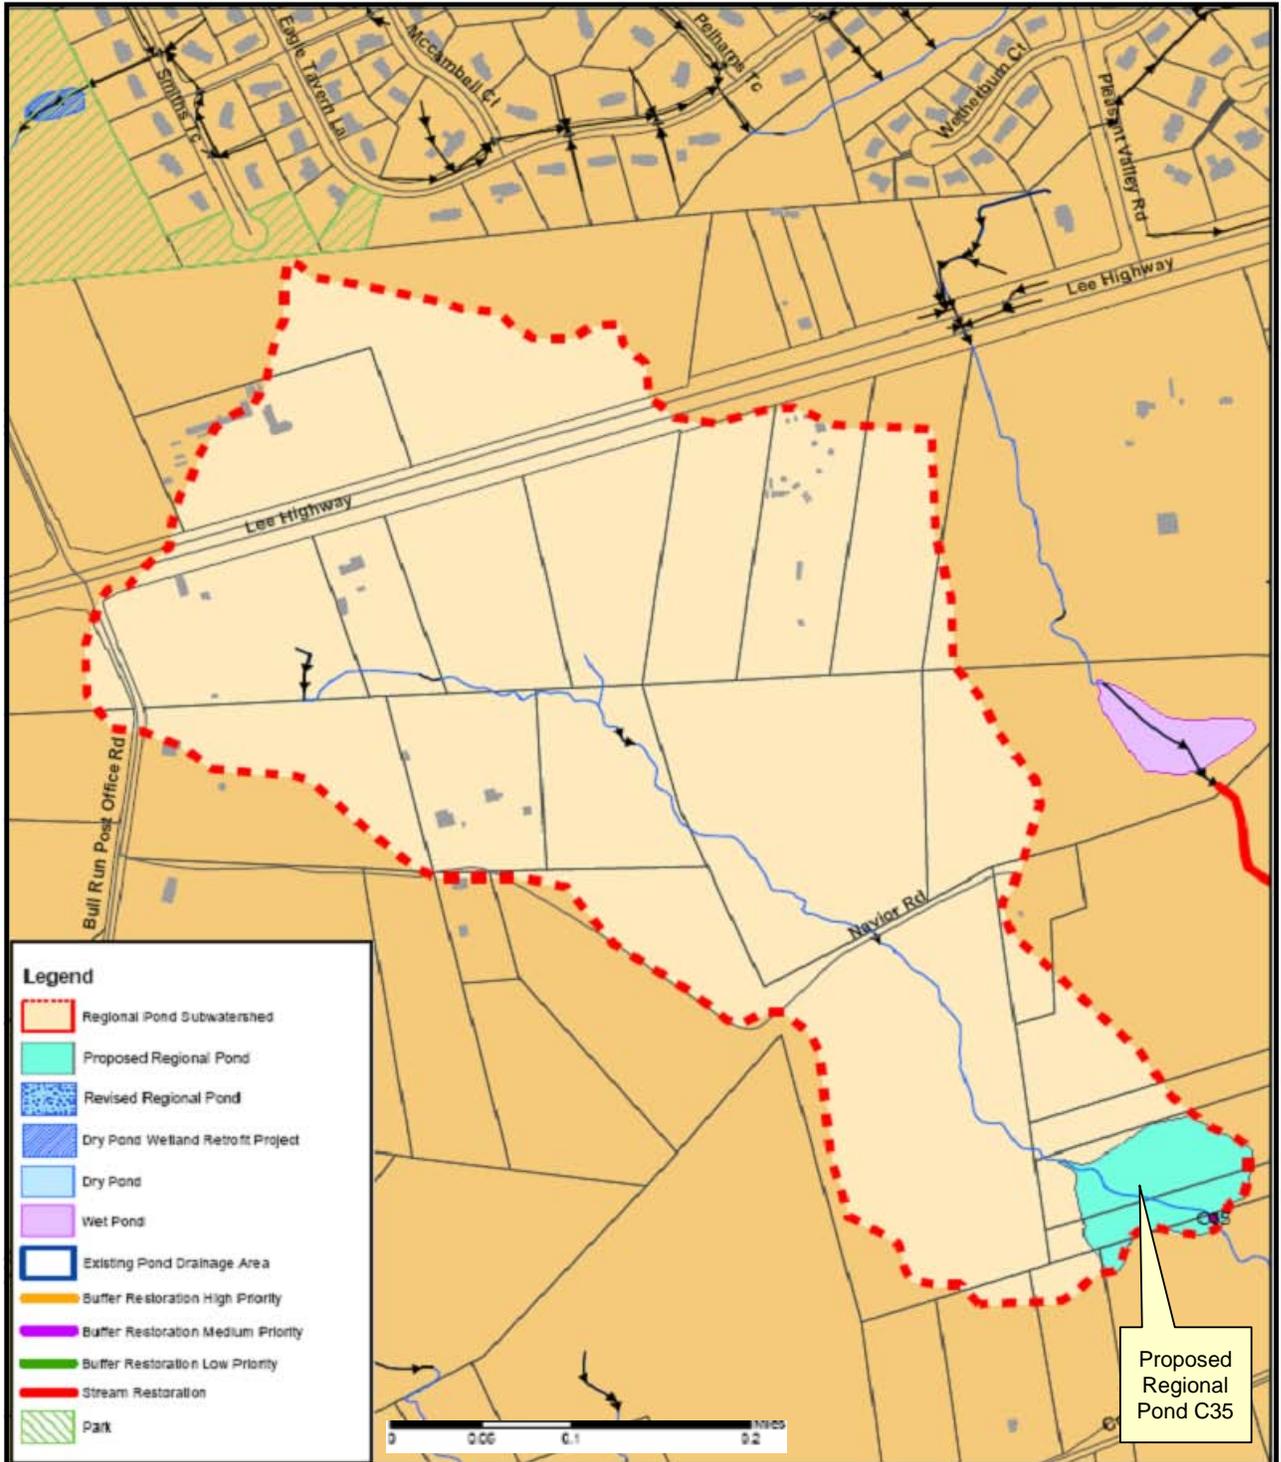
Figure 6-10
Proposed Regional Pond C35

Table 6-17 presents the total phosphorus reduction produced from three alternative combinations of the stormwater control options, listed in order of decreasing effectiveness.

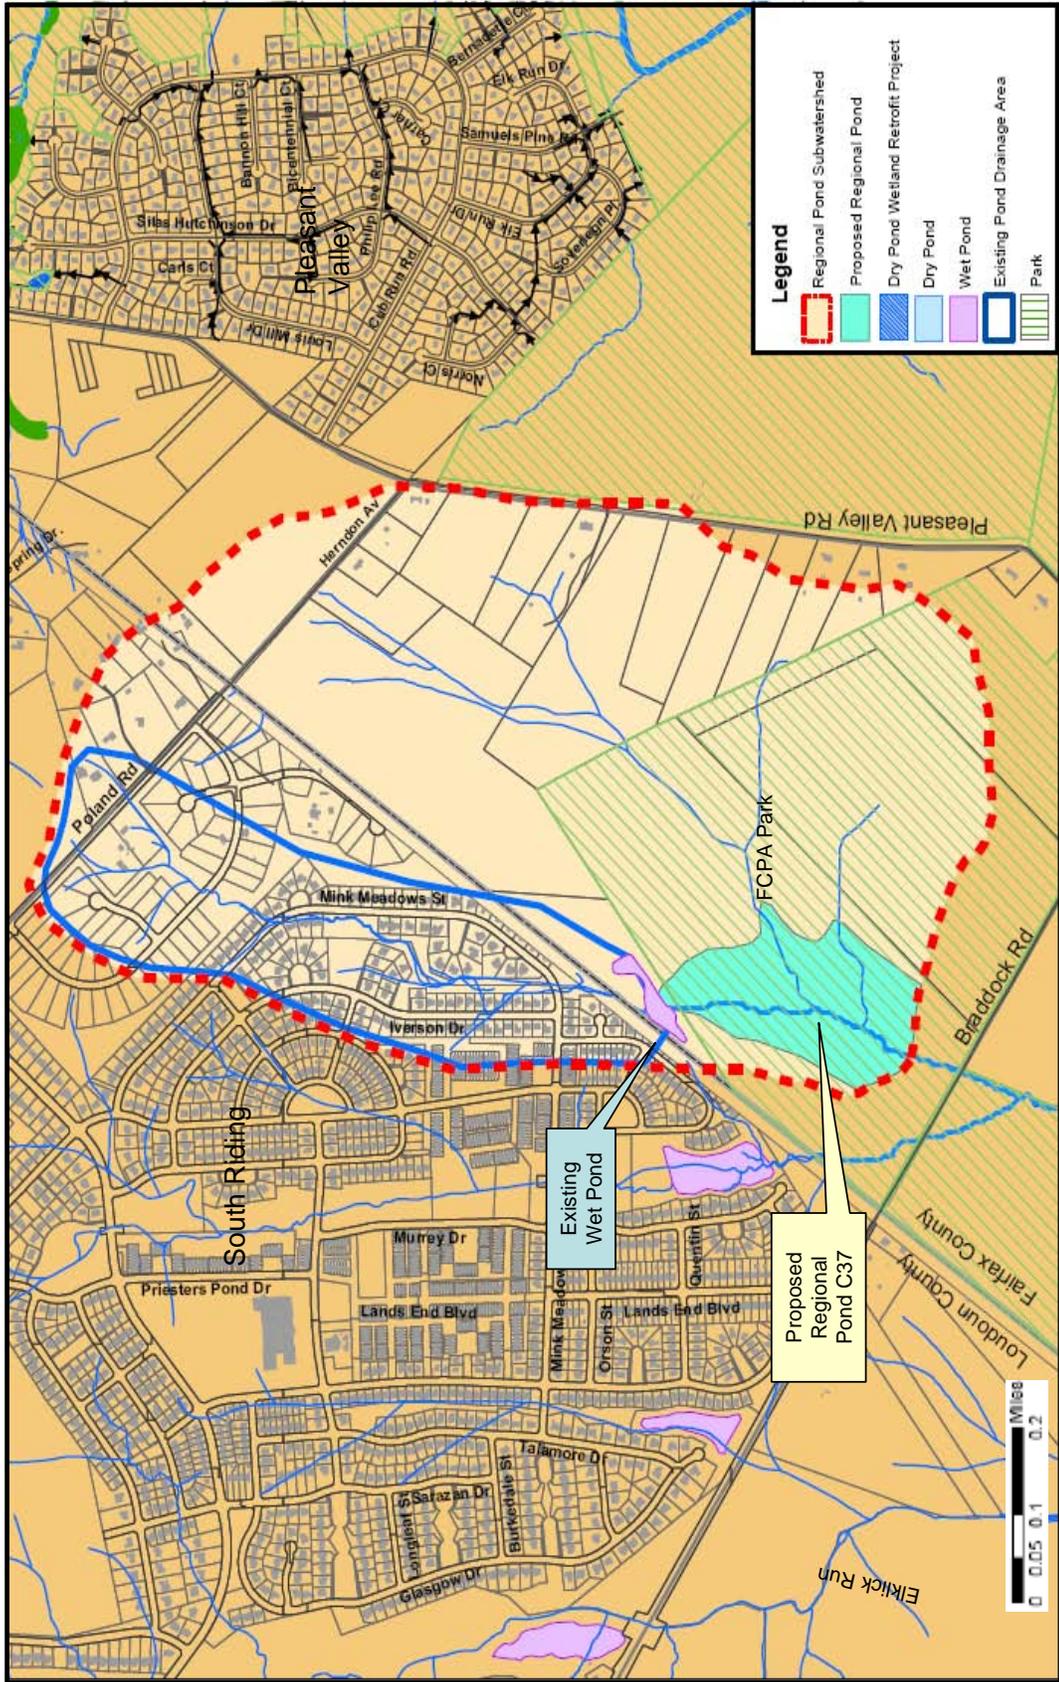
Figure 6-11
Proposed Regional Pond C37

The following bullets evaluate the conditions at proposed regional pond C37:

Table 6-19 summarizes the incremental annual phosphorus removed by the stormwater control options and alternatives.
